Design of Safe Timber Structures - How Can we Learn from Structural Failures in Concrete, Steel and Timber?

Frühwald, Eva; Serrano, Erik; Toratti, Tomi; Emilsson, Arne; Thelandersson, Sven

Report TVBK-3053
Lund 2007

**Design of safe timber structures –
How can we learn from structural failures in concrete,
steel and timber?**

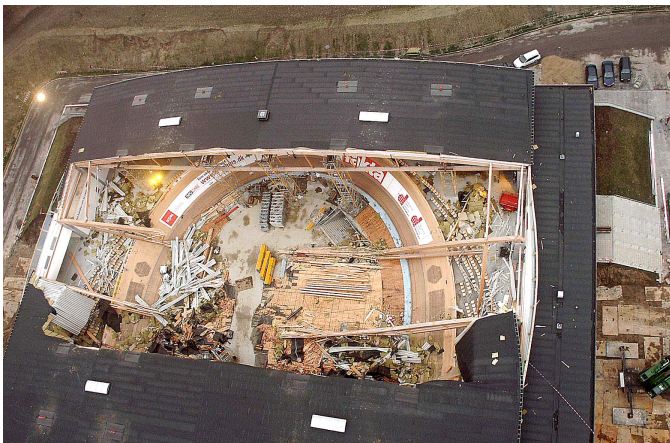
Fig. 2. Photo taken from above after the failure of the Ballerup arena roof.

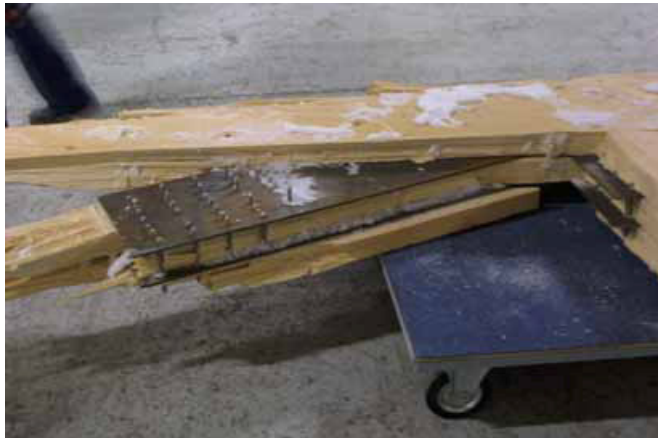
The same winter 2003 another structural collapse took place in Finland. Four main roof trusses for exhibition hall B2 of Jyväskylä Paviljonki collapsed two weeks after the hall was opened for the public [15,16]. The snow load at the time of failure was about 50 kg/m² and there was no wind. The design snow load at this location is 200 kg/m² according to the Finnish code. The primary cause of failure was manufacturing errors leading to malfunctioning slotted-in steel plate joints in the main glulam trusses, see Fig. 3. The failure was initiated in a joint where only 7 out of 33 dowels were in place.

Fig. 3. Slotted-in steel plate joint where dowels were not mounted as intended.

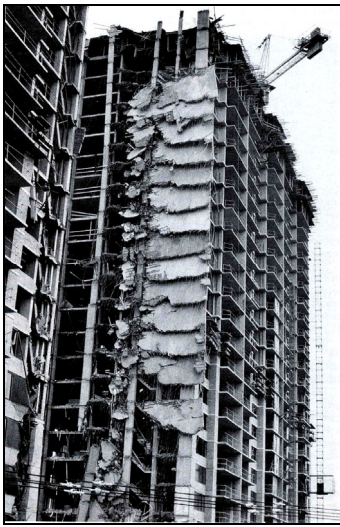
Fig. 4. Progressive failure of multi-storey concrete building due to premature removal of shoring, 1973, Virginia, USA.

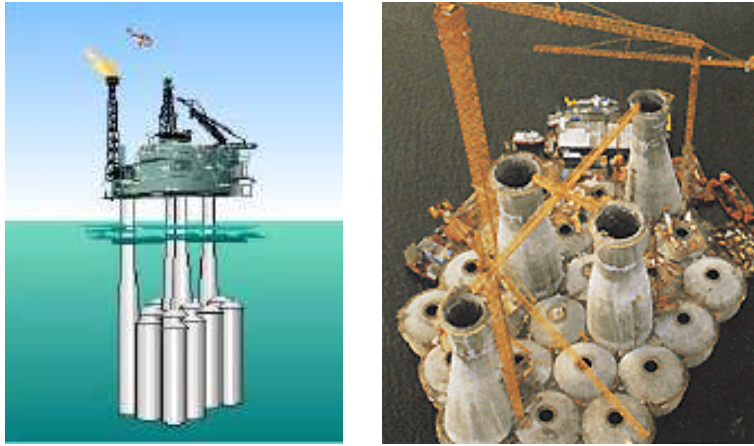
Fig. 5. The Sleipner A offshore platform

total base area of 16000 m². Errors in detailing of the reinforcement in the vertical joints between the concrete cells lead to shear failure during the operations to sink the platform to the seabed, see e.g. [30]. The economical loss from this detailing error was estimated to 700 Million US\$, the most expensive shear failure in history.

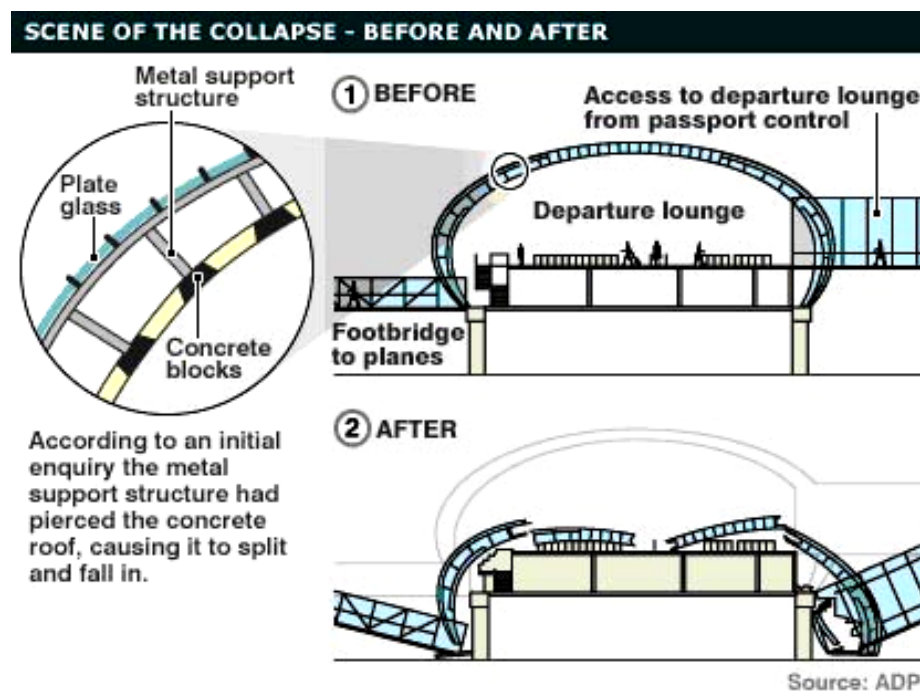
An example of an innovative concrete structure is the terminal building at Charles de Gaulle airport in Paris, which was built with an elliptical reinforced concrete shell roof. The roof suddenly collapsed in May 2004, 11 months after it was opened, killing four people, see Fig. 6. The official investigation identified four errors in design and construction of the unusual type of structure.

Fig. 6. Collapse of terminal roof at Charles de Gaulle airport in Paris

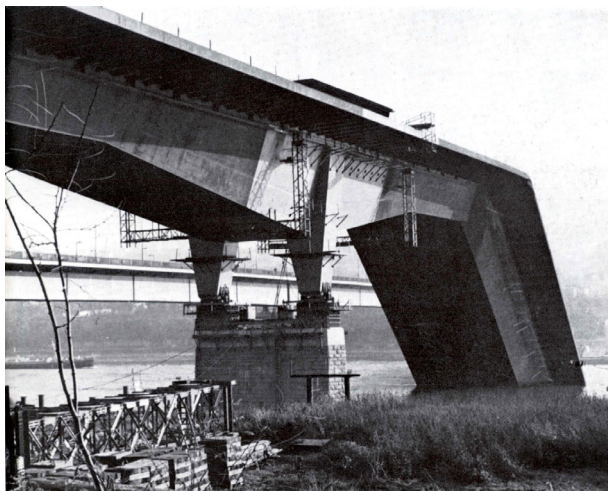
Fig. 8. Collapse of steel box girder during cantilever construction, Rheinbrücke, Koblenz, 1971, Source: Ref. [31].

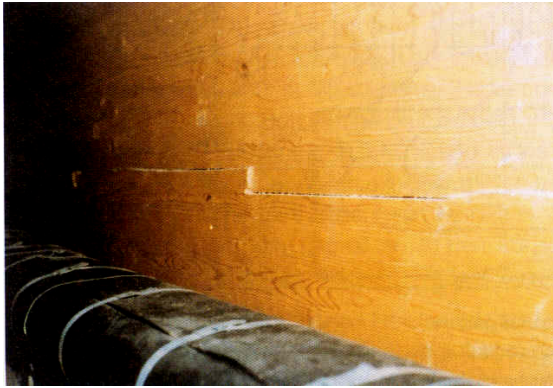
when the building (sport hall) was 2 years old. The cracks were mainly caused by rapid drying of the wood after it was finished. Particularly heavy cracking took place in that part of the roof where installations of hot water tubes were present. The cracks led to increased and nonuniform deflection of the flat roof, which in turn led to ponding during a heavy rain. The roof did not collapse but had to be temporarily supported for safety reasons.

Fig. 9. Longitudinal through crack in glulam roof girder due to shrinkage effects. Hot water piping in the vicinity of the girder contributed to fast drying. Source: Ref. [7].

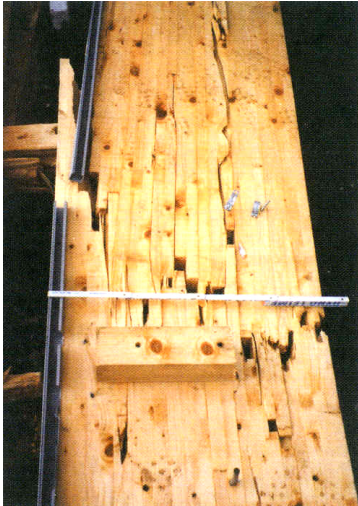
Fig. 10. Failed glulam beam due to low quality finger joints. The failure line is staggered and coincides with the finger joints. Source: Ref. [9].

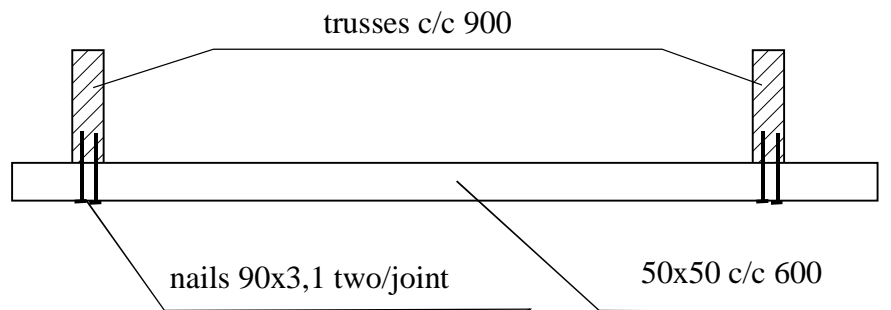
Figure 11. Support connection for ceiling in supermarket.

withdrawal capacity of the nails fastening the 50 x 50 mm² wood battens for the ceiling to the bottom chord of the roof truss. The designer had prescribed three nails in each joint, but only two were provided during construction. One reason for this was that the designer did not realise that there was not enough space – as given in relevant standards – for three nails in the contact surface between the battens and the bottom chord of the truss. In this case the failure was classified as 0.5 (50 %) due to poor manufacturing principles and 0.5 (50 %) due to design error. In cases where only one cause was identified, the weight for this error type was set to 1.0. With this method the sum of all error types over all cases will equal 127, and the corresponding percentages can be calculated.

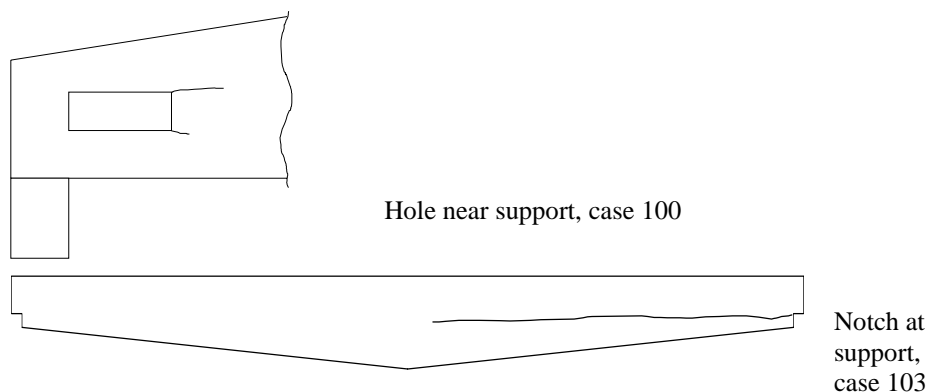
Figure 18 shows cracking patterns from two cases, *100* and *103*, with inappropriate design of holes and notches respectively, which led to perpendicular to grain failure.

Figure 18. Schematic illustrations of perpendicular to grain failures in connection with holes and notches in large glulam beams.

Risks related to tensile stresses perpendicular to grain have to be carefully considered in design of timber structures. The problem is rather complex, but design tools are in most cases available even if they have been introduced during later years. Thus, some old buildings might have been designed e.g. for notches and holes with methods which later have been found to overestimate the strength.

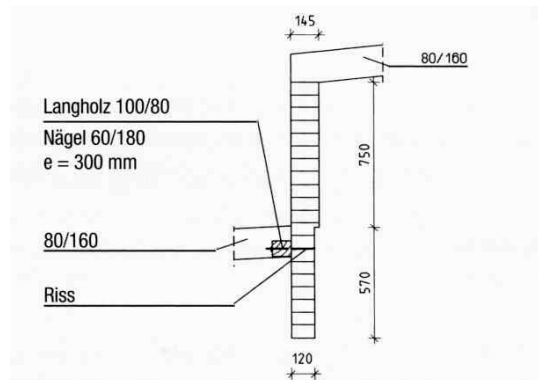
Figure 19. Section through glulam beam where failure was initiated, case 6.
Source: Ref. [7].

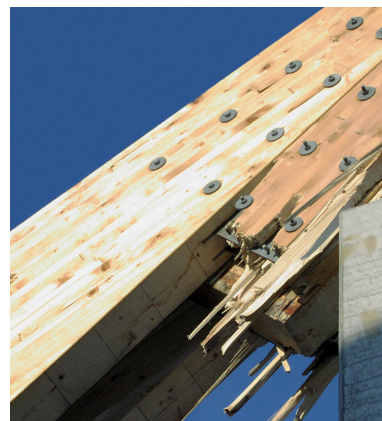
Failed heel joint

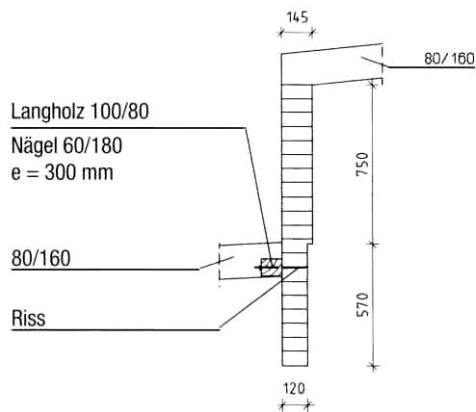
A sports hall (33.6m x 18m) is roofed in the central part by double-tapered glulam beams placed at 4.2 m centres. At the two gable ends of the building, the roof is on a lower level. Here, straight glulam beams with a depth of 1.32 m and a width of 145 mm in the upper part (h=750mm) and 120 mm in the lower part (h=570mm) carry the roof, see Figure 6-1. Structural timber 100 mm x 80 mm is nailed along the lower part of the glulam beam, to provide support for the lowered roof. The lowered roof is carried by structural timber (cross-section 80 mm x 160 mm). At the support, the glulam beam is notched, with a notch height equal to the lower part of the beam, i.e. 570 mm.

Figure 6-1: Glulam beam with support of lowered roof. Picture from Dröge G. & Dröge T.: *Schäden an Holztragwerken, Schadenfreies Bauen, Band 28*, Fraunhofer IRB Verlag, 2003.

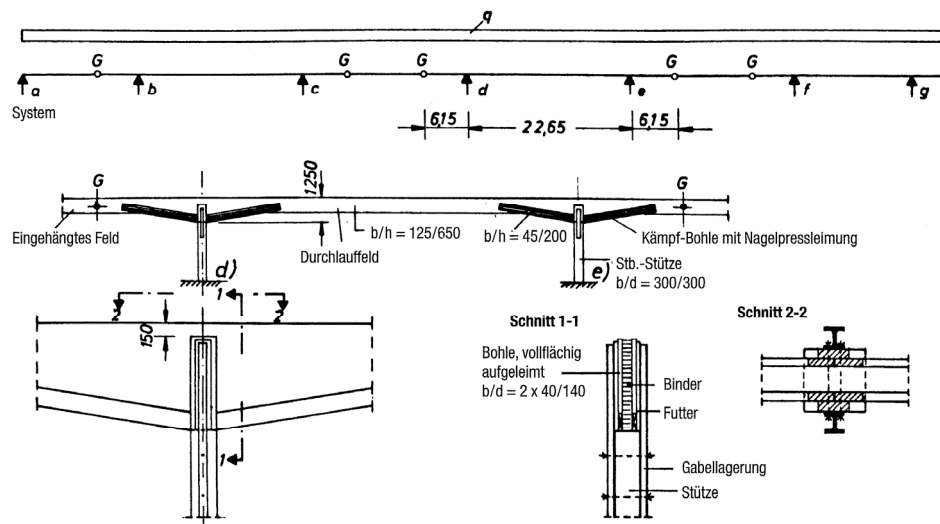
A 125 m wide industrial building is covered by continuous glulam beams with Gerber type hinges in every second span (span 22.6 m), see figure 7-1. Near the supports, the beam is tapered to increase the depth near the support. The roof is completely flat, leading to large water pools after rain. Glulam beams and purlins have been designed for uniform load comprised of dead load, extra load due to fixtures and fittings and snow load. The beams had been designed with full utilization both in the bays and at supports. As the support area is too small to transfer the support load with respect to compression perpendicular to the grain, standing boards were glued to both sides of the beam. The boards transfer the support load via their end grain to the concrete column.

Figure 7-1. Top: Continuous glulam beams of Gerber type with hinges in every second span. Middle: Strengthening with boards, glued to lower edge of beams in the tapered area, carried out after first failure. Bottom: Detail at support before first failure. Picture from Dröge G. & Dröge T.: Schäden an Holztragwerken, Schadenfreies Bauen, Band 28, Fraunhofer IRB Verlag, 2003.

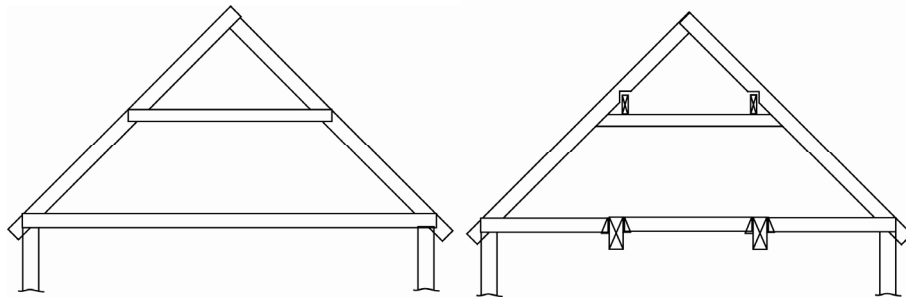
Inclined exterior walls indicate problems with horizontal forces from the roof structure. The investigation showed that the roof structure of the log house was executed differently from the design. The design was made for a roof with collar beam, where the beams in the slab between ground floor and first floor should serve as tie beams, see figure 56-1 (left). However, the roof structure was executed with intermediate purlins above the collar beam that were not in contact with the rafters and thus not statically used at all. However, notches had been prepared, which weaken the cross-section (about 30% reduction) and load-bearing capacity of the rafter. The rafter dimensions were smaller than in the design. The smaller dimensions and notches imply that the stresses exceed the design stresses by 25%. Furthermore, due to the long span in the ground floor (living room), two binding beams are used and the tie beams were jointed with the binding beams via sheet metal joist hangers. However, the joist hangers were not properly nailed to neither binding beams or tie beams and were only supposed to transfer vertical loads. Horizontal loads cannot be transferred here, but have to be taken in the joint between rafters and exterior walls. This led to an outward compression on the exterior walls. Additionally, the tie beams were drawn out of the bag of joists (about 5 cm). Due to risk of collapse of the whole construction, the residents were evacuated and the structure had to be changed. The failure in this case was due to changes on the building site, compared to the design (on-site alterations).

Figure 56-1: Designed roof structure (left) and executed roof structure (right).

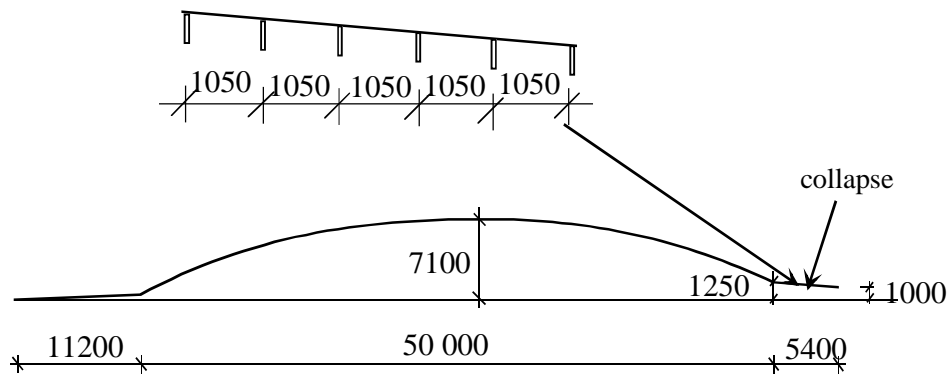
Figure 76-1: Roof structure of ice rink. The straight part on the right side of the building collapsed.

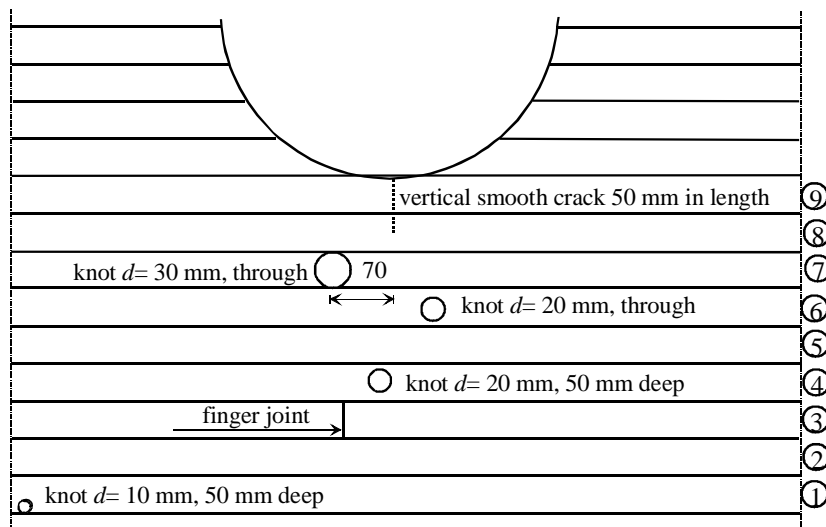
Figure 79-1: Part of fractured beam.

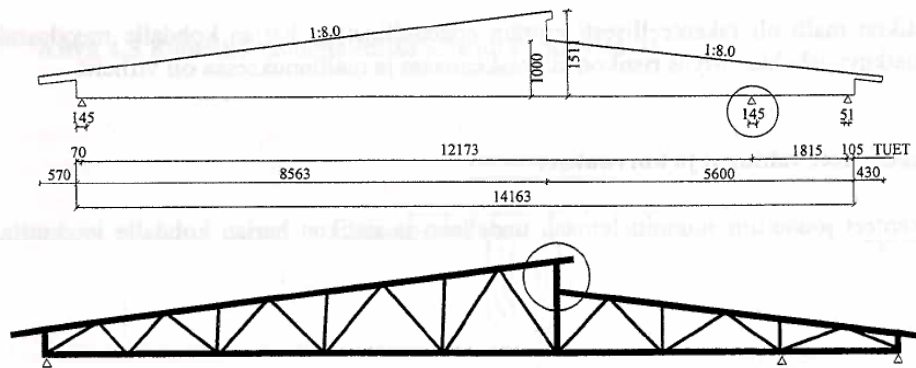
Figure 89-1: The top chord is not aligned at centre span causing a high bending load on the vertical member.

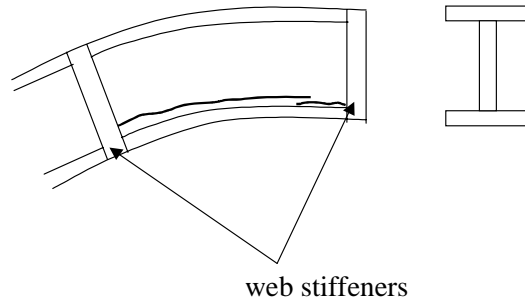
Figure 105-1. Schematic of arch apex with cracks. The crack length was about 4 m.

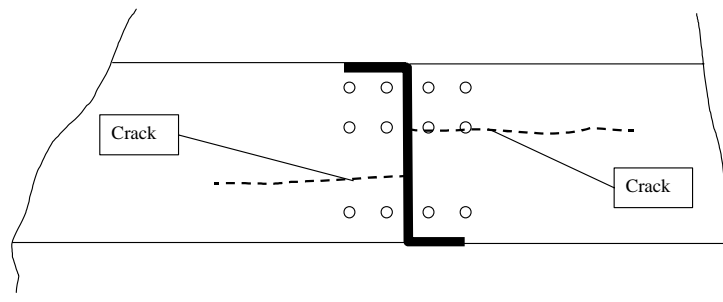
Figure 109-2. Schematic of beam connection and cracks found.

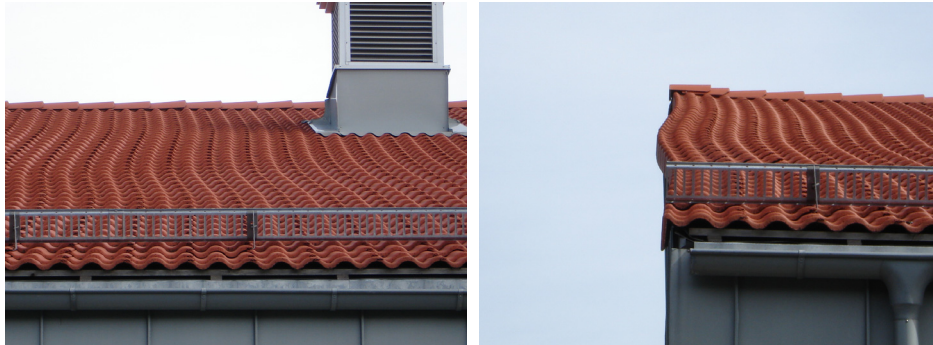
Figure 114-3. Example of deformations at failure.

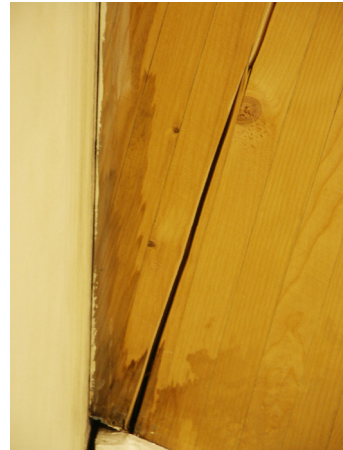
Figure 115-2. Crack at column fitting to the steel part.

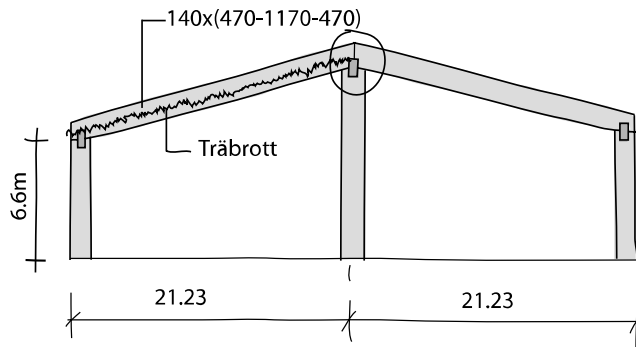
Figure 127-1: Storage building with glulam columns and glulam beams. Jagged line indicates timber failure.

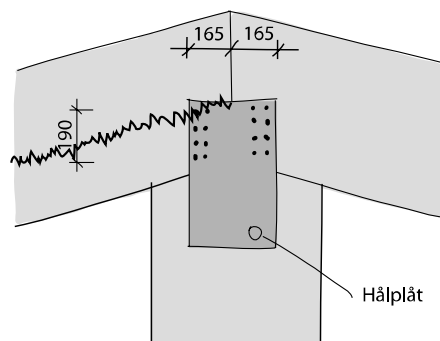
Figure 127-2: Detail of joint between beam and column at the centre of the building. Jagged line indicates timber failure.
