LUND UNIVERSITY

Design of Safe Timber Structures - How Can we Learn from Structural Failures in Concrete, Steel and Timber?

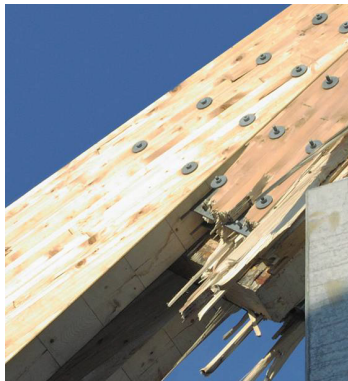
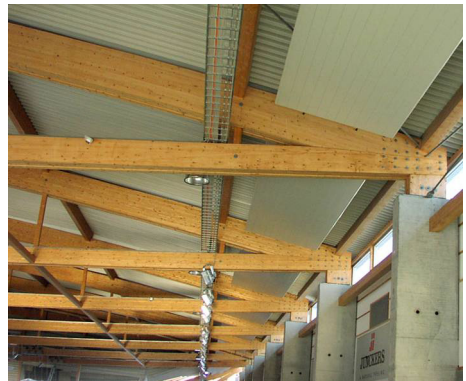
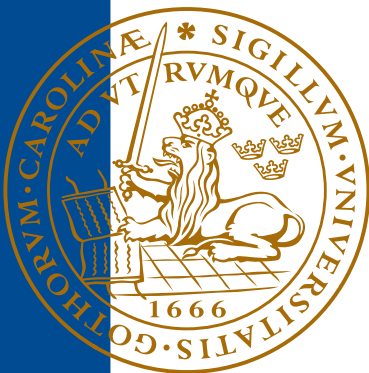
**Eva Frühwald
Erik Serrano
Tomi Toratti
Arne Emilsson
Sven Thelandersson**

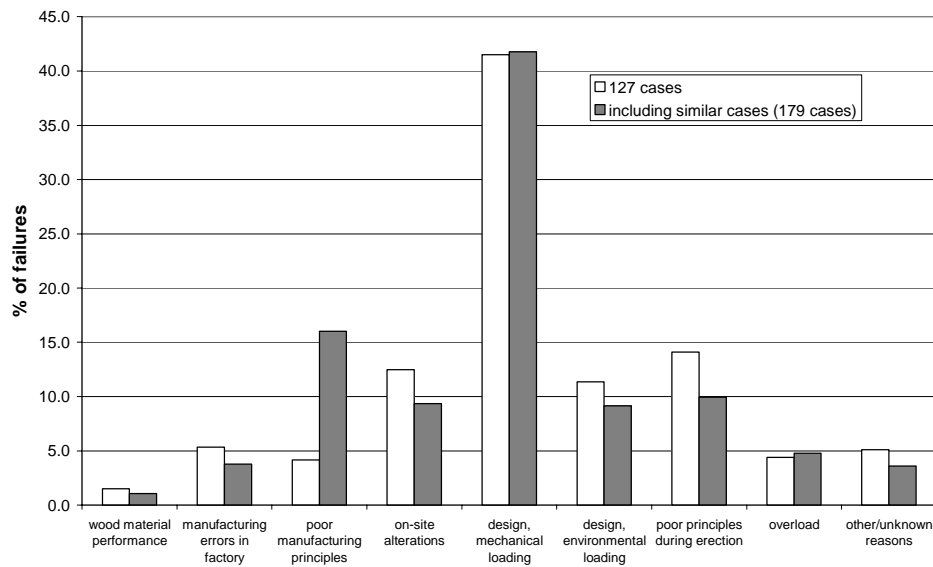
Figure 12. Distribution of error types for the cases in the data base with or without including parallel cases.

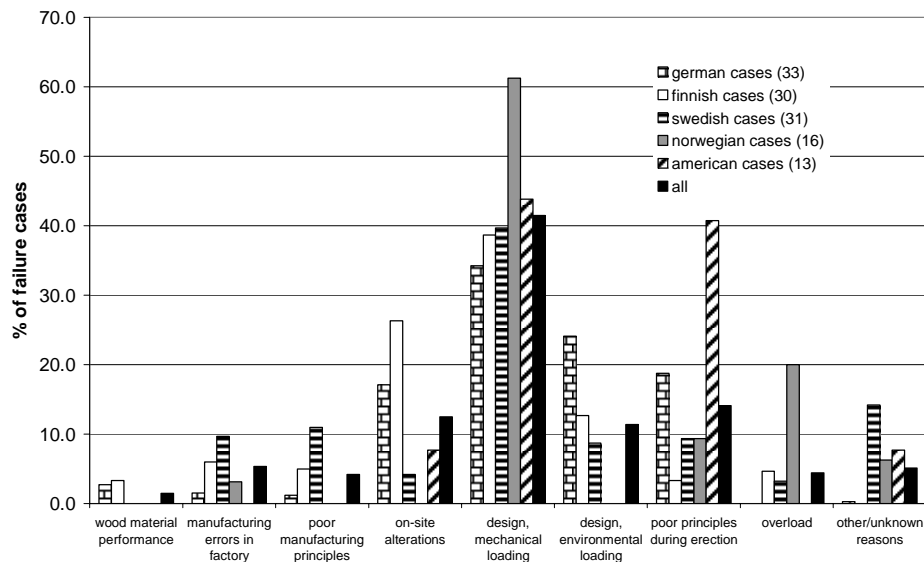
Figure 13. Failure causes depending on country.

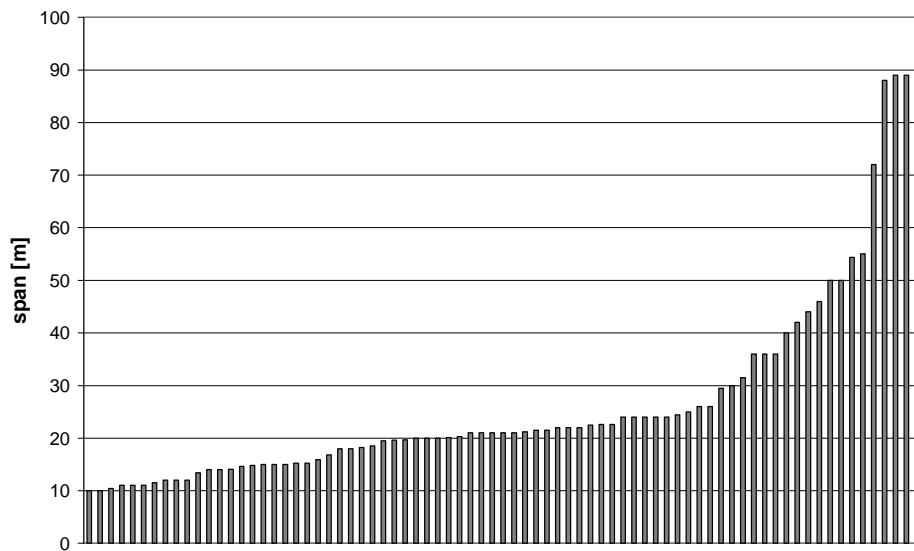
Figure 14. Span of failed structures (only spans above 10 m, 76 cases with known span).

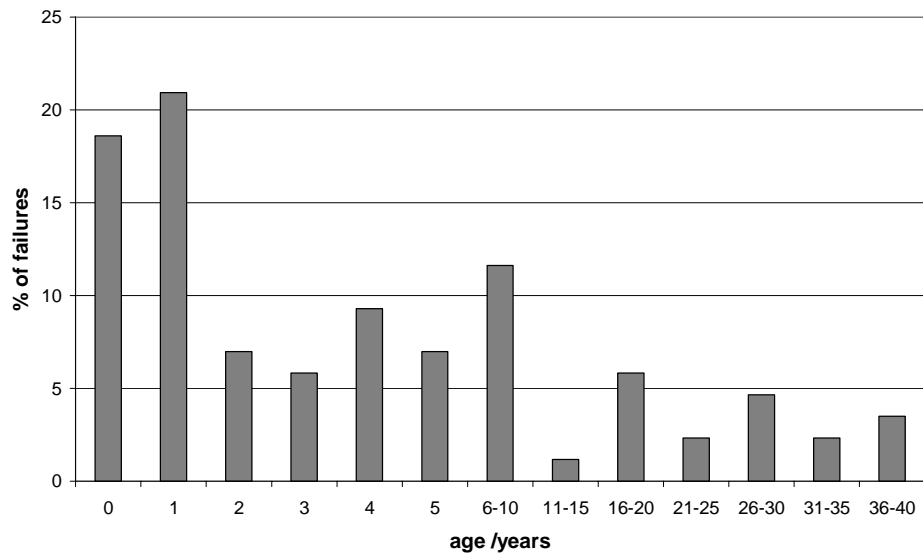
Figure 15. Age of the failed structures.

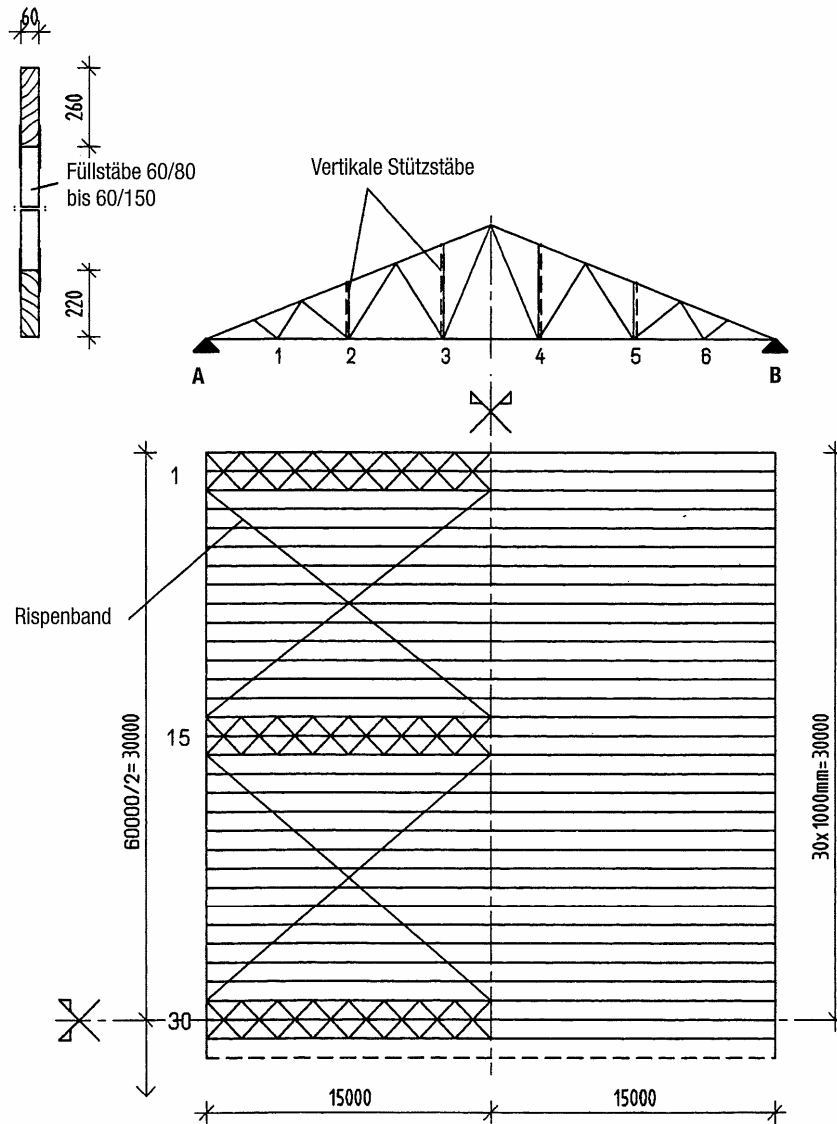
Figure 11-1. Bracing of roof structure. Picture from Dröge G. & Dröge T.: Schäden an Holztragwerken, Schadenfreies Bauen, Band 28, Fraunhofer IRB Verlag, 2003.

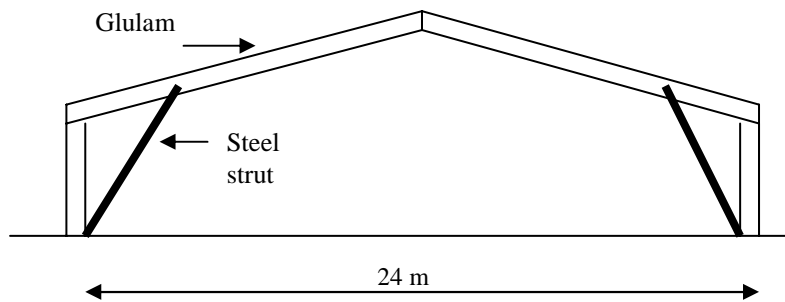
Figure 32-1. Schematic of frame structure

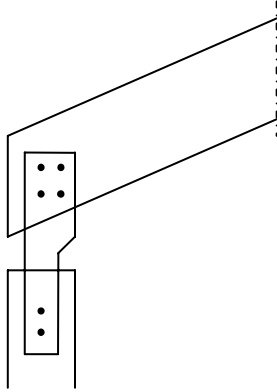
Figure 34-1. Detail of beam-column connection. After Skaug (2004).

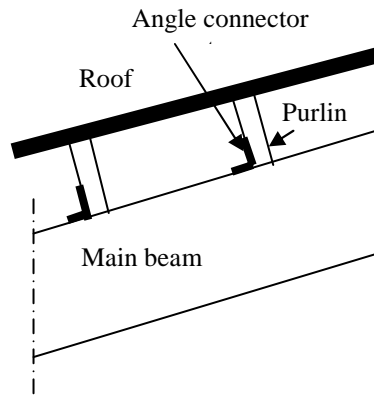
Figure 36-1. Design of purlin-beam connection

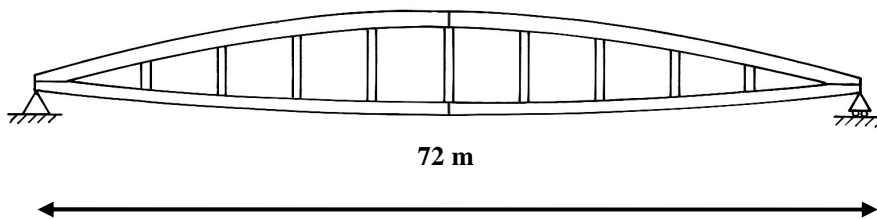
Figure 41-1. Design of glulam truss.

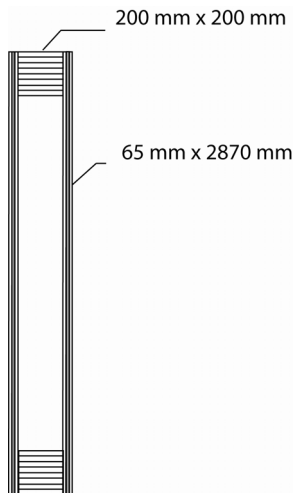
Figure 45-1: Box girders used in roof structure.

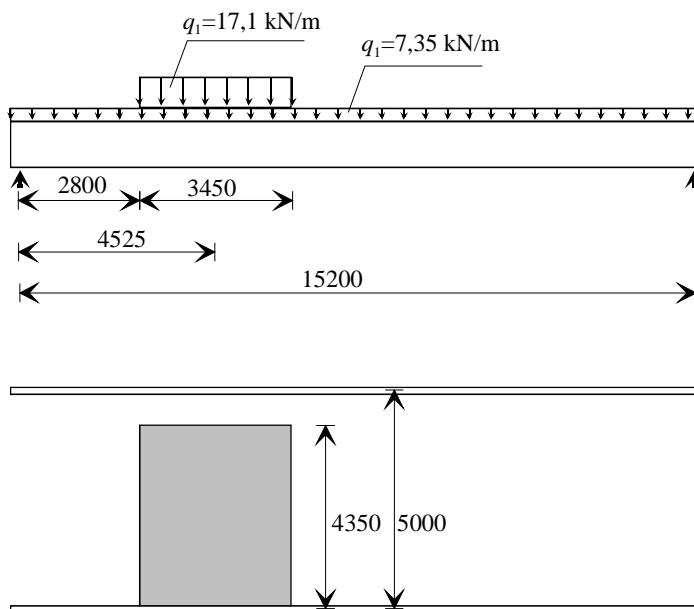
Figure 69-1: Dimensions of the main beams and top view of 2 beams and the insulated air pipe in-between.

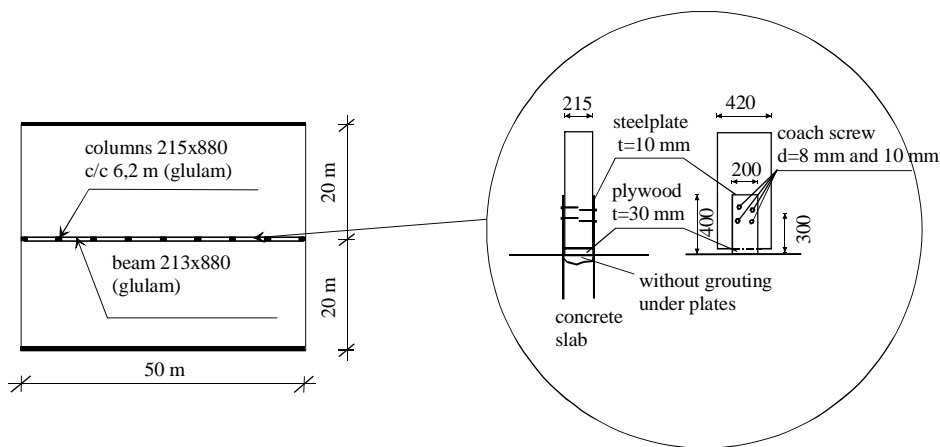
Figure 70-1: Detail of the column connections which provide the only lateral support in the span direction.

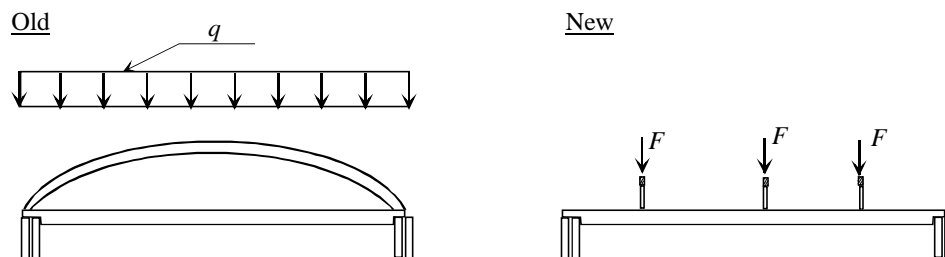
Figure 71-1: Old (left) and new (right) roof structures.

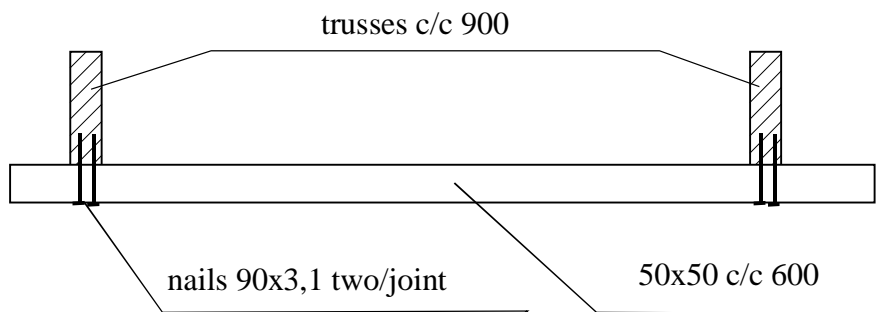
Figure 72-1: Support connection of inner ceiling.

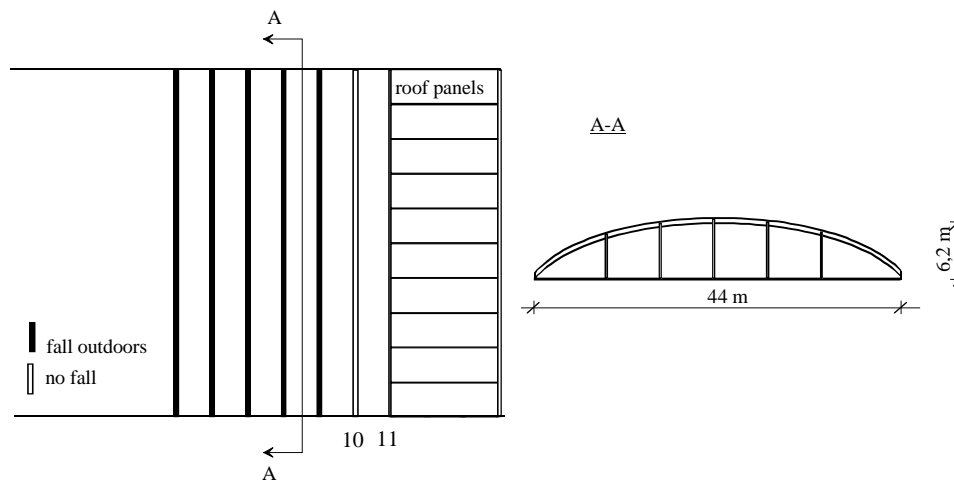
Figure 73-1: Structures installed at the time of failure.

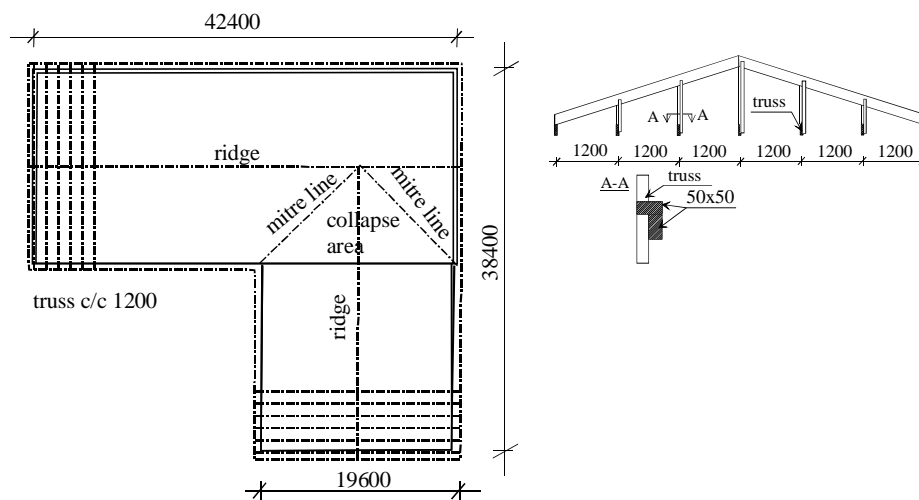
Figure 74-1: Roof structure of market building.

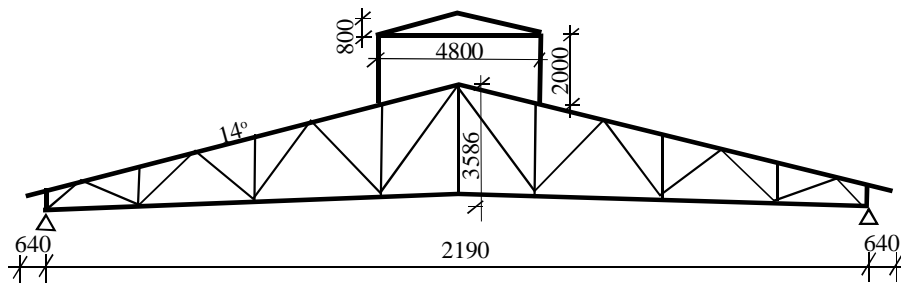
Figure 75-1: Roof structure with elevated part.

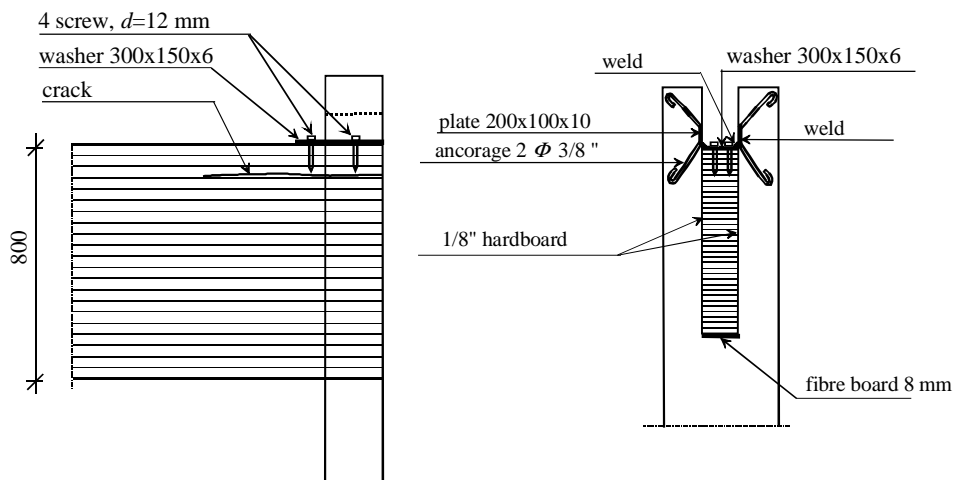
Figure 94-1: Support connection of glulam beam to concrete column.

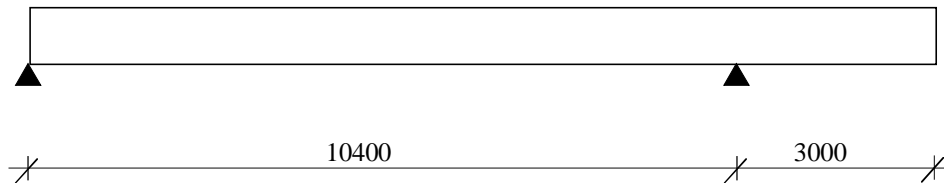
Figure 95-1: Beam in roof structure.

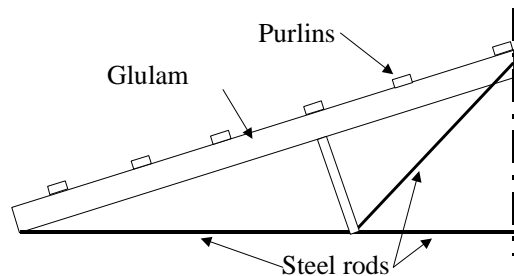
Figure 104-1. Combined glulam-tension rod truss (not to scale).

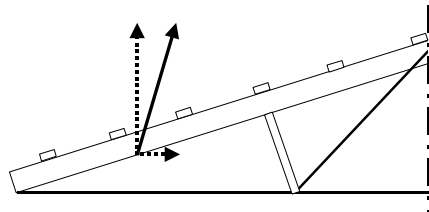
Figure 104-2. Strap placement.

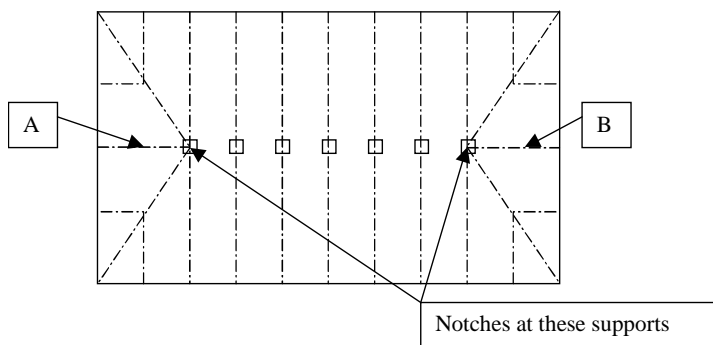
Figure 106-1. Schematic of roof structure

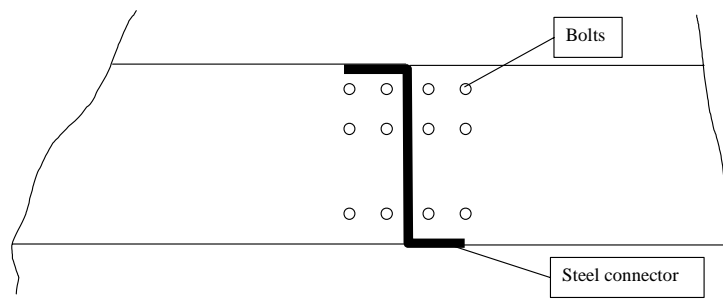
Figure 109-1. Schematic of beam connection.

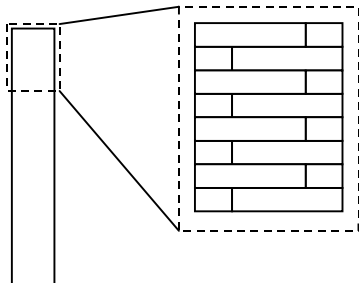
Figure 112-2. Beam cross-section built up from edgewise glued laminations.

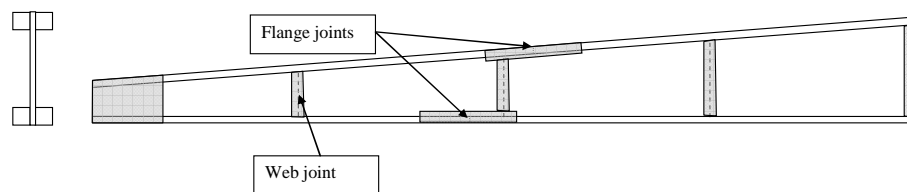
Figure 113-1. Beam with joint reinforcements.

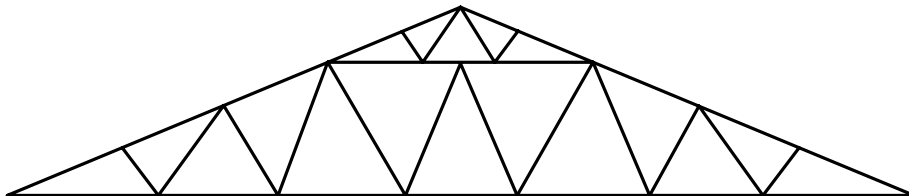
Figure 114-2. Truss divided in two parts for transportability.

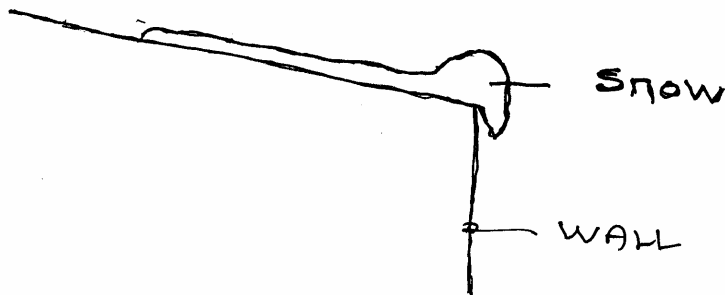
Figure 118-1: Snow load at time of failure.

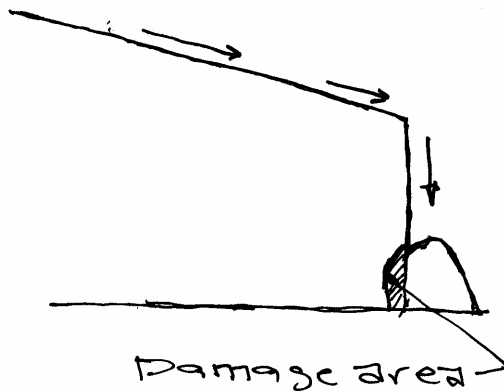
Figure 119-1: Snow load at time of failure.

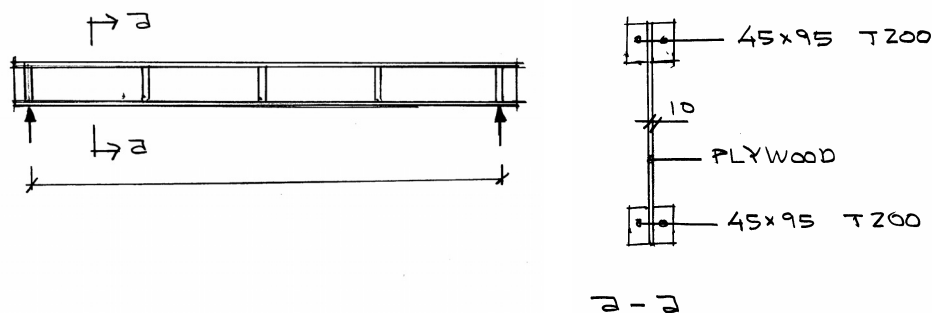
Figure 121-1: Light-weight I-beams.

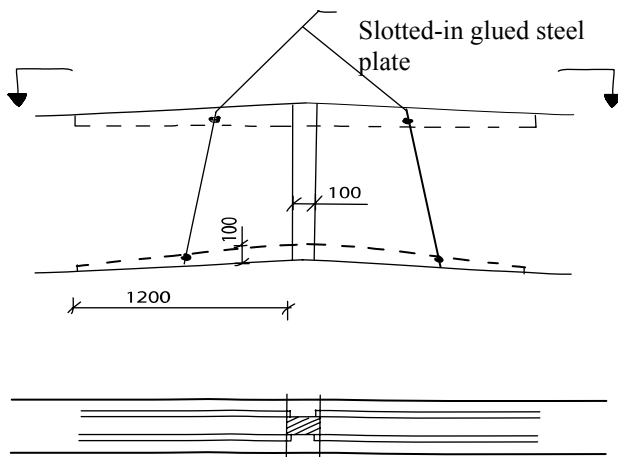
Figure 122-2: Glued connection at the ridge, using slotted-in steel plates.

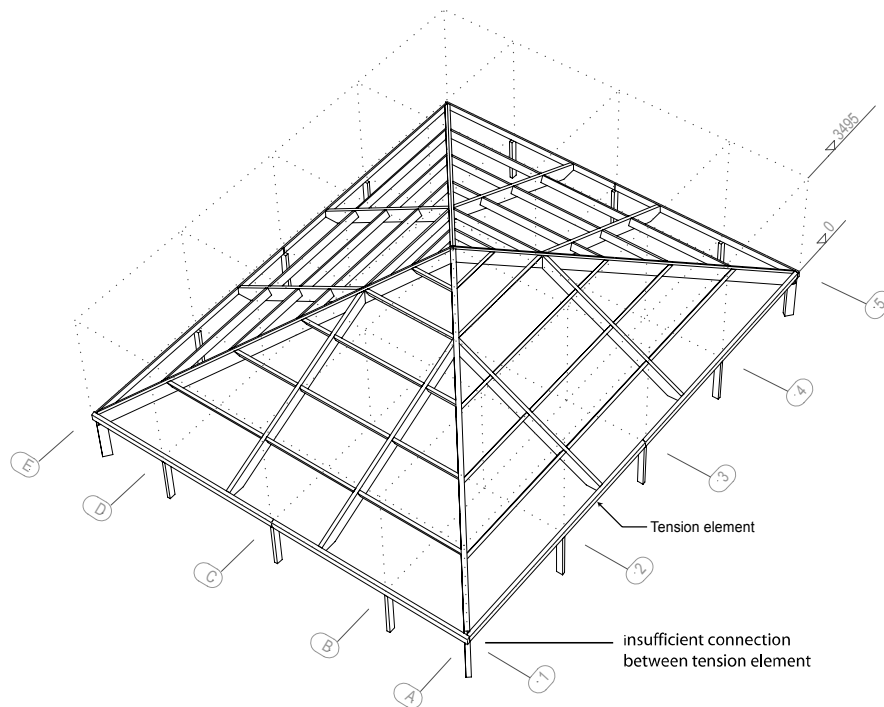
Figure 124-1: Pyramid structure, built with glulam and glass.

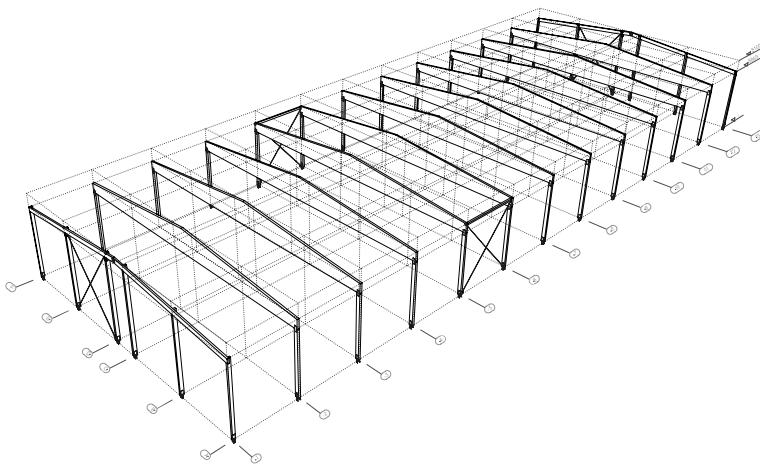
Figure 125-1: Industrial building with glulam beams and columns.

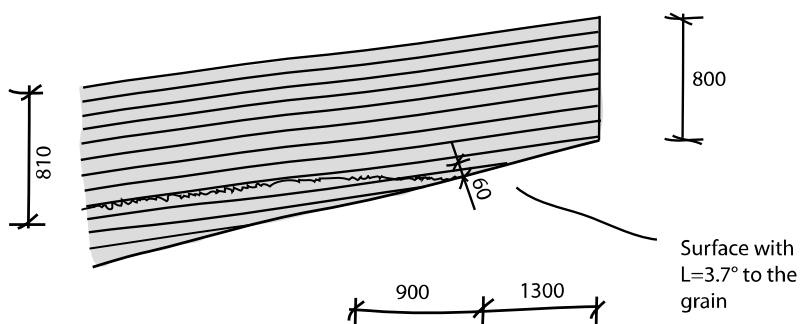
Figure 126-2: Detail view of double-tapered beam (near right support). Jagged line indicates cracking.

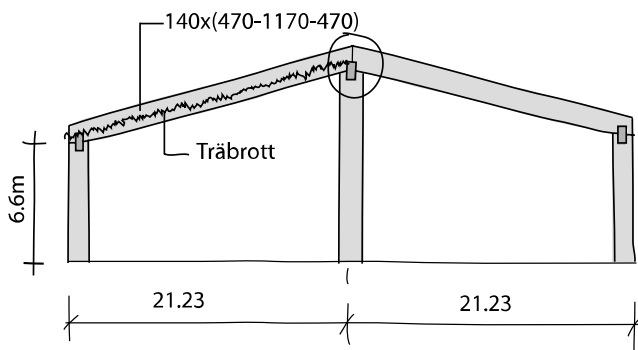
Figure 127-1: Storage building with glulam columns and glulam beams. Jagged line indicates timber failure.

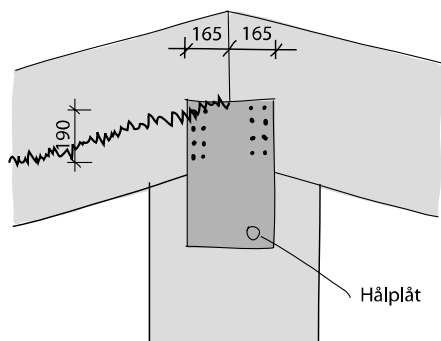
Figure 127-2: Detail of joint between beam and column at the centre of the building. Jagged line indicates timber failure.
