Design of Safe Timber Structures - How Can we Learn from Structural Failures in Concrete, Steel and Timber?

Frühwald, Eva; Serrano, Erik; Toratti, Tomi; Emilsson, Arne; Thelandersson, Sven

Division of Structural Engineering
Lund Institute of Technology, Lund University

Report TVBK-3053
Lund 2007

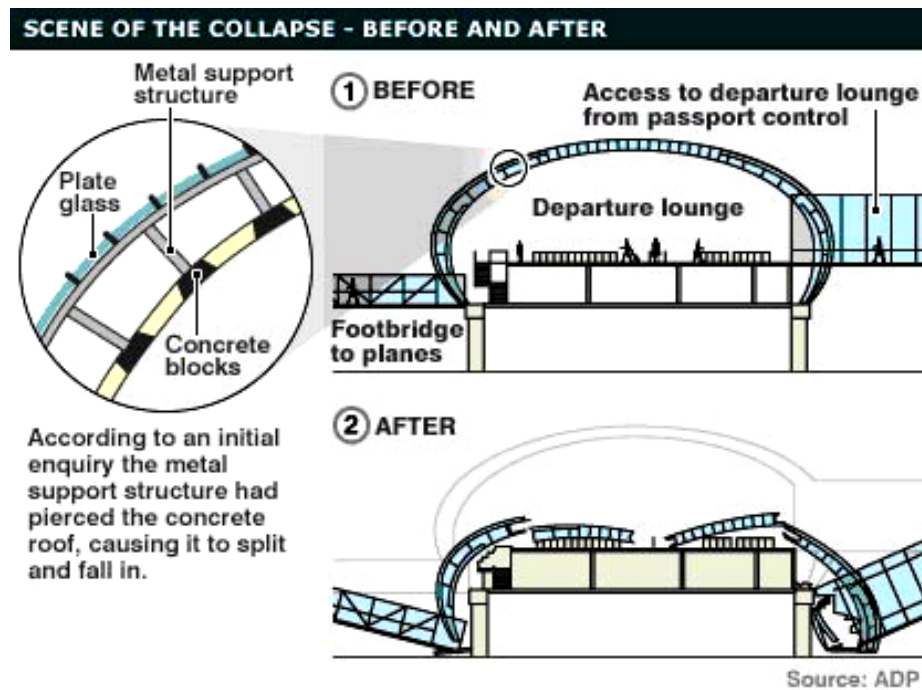
An example of an innovative concrete structure is the terminal building at Charles de Gaulle airport in Paris, which was built with an elliptical reinforced concrete shell roof. The roof suddenly collapsed in May 2004, 11 months after it was opened, killing four people, see Fig. 6. The official investigation identified four errors in design and construction of the unusual type of structure.

Fig. 6. Collapse of terminal roof at Charles de Gaulle airport in Paris

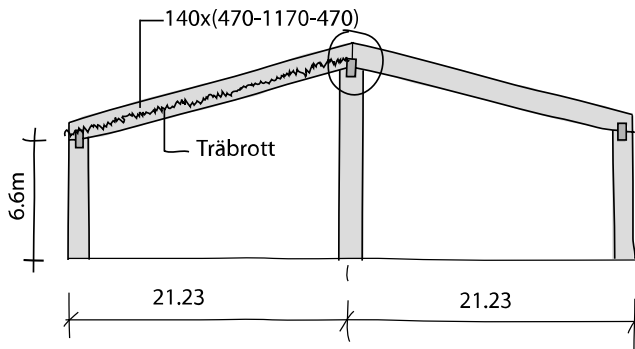
Figure 127-1: Storage building with glulam columns and glulam beams. Jagged line indicates timber failure.
