HOW A SHIP'S BRIDGE KNOWS ITS POSITION – ECDIS ASSISTED ACCIDENTS FROM A CONTEMPORARY HUMAN FACTORS PERSPECTIVE

Thesis work submitted in partial fulfillment of the
requirements for the MSc in Human Factors and System Safety

Mads Ragnvald Nielsen

LUND UNIVERSITY
SWEDEN

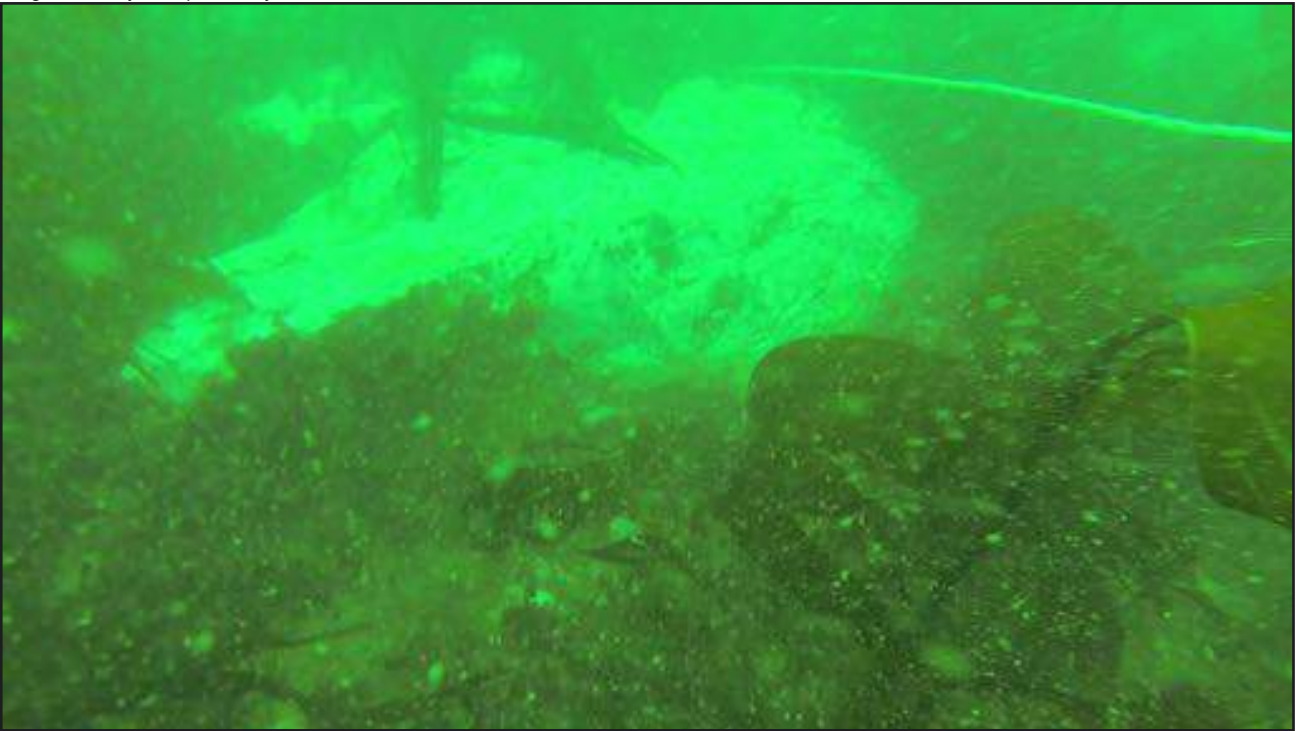
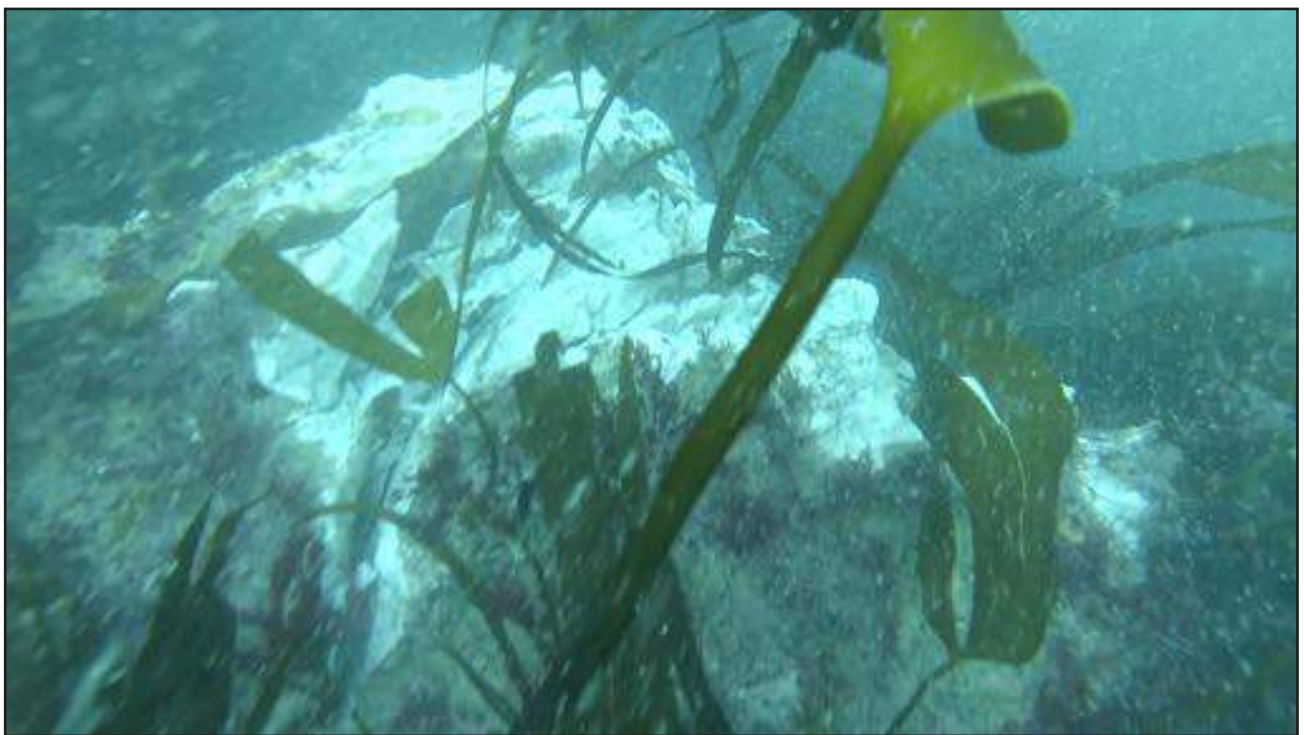
A post-accident dive survey of the seabed in the location of the grounding identified that *Commodore Clipper* had struck two granite pinnacles on a rocky shoal that was charted at a depth of 5.2m. During the grounding the tops of the two pinnacles broke away (**Figure 5**).

Figure 5: Granite pinnacles struck by *Commodore Clipper*

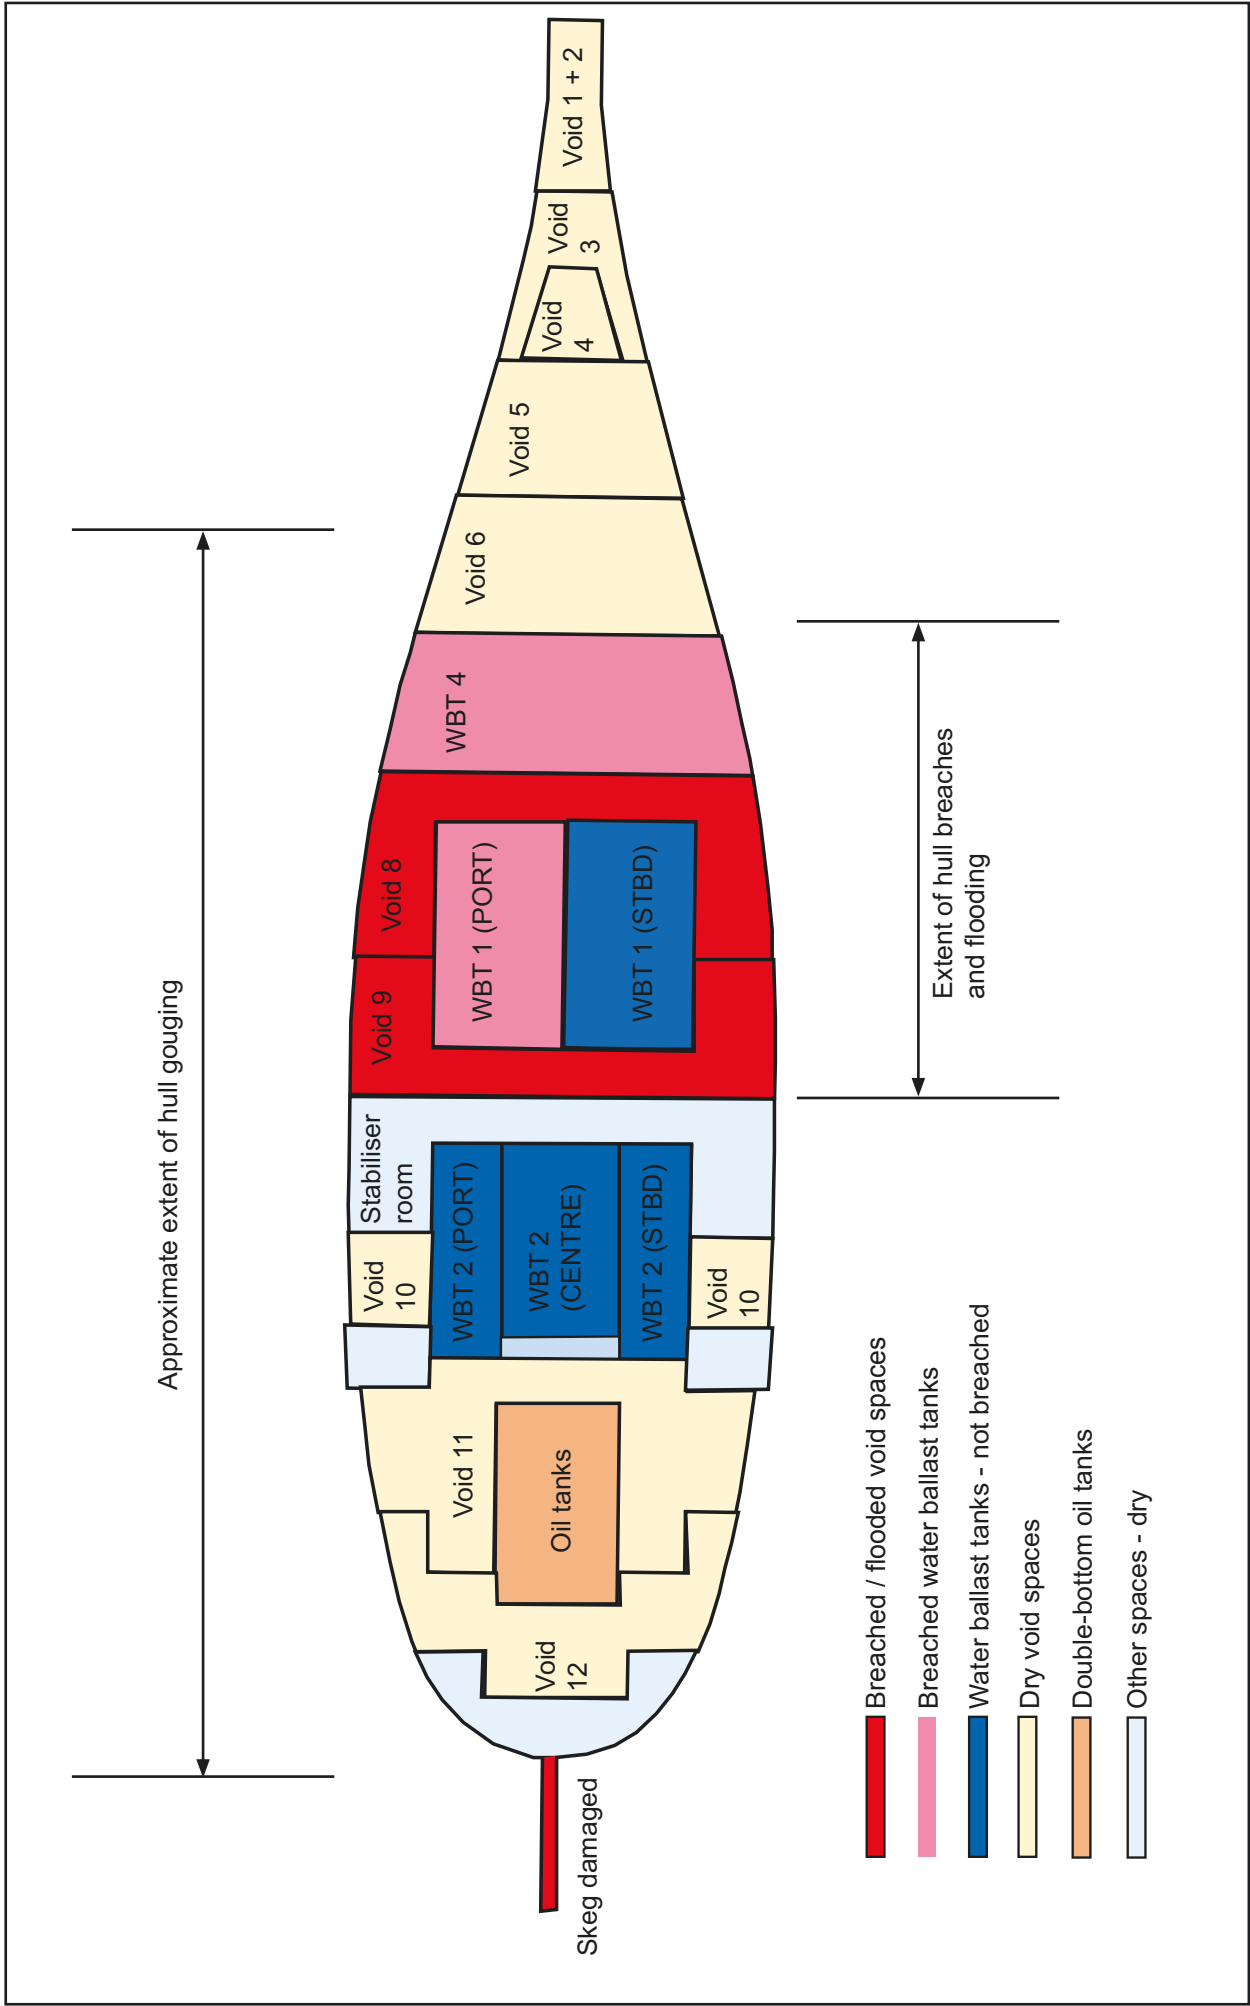
The grounding caused significant damage (**Figure 6**) including:

Figure 6: Commodore Clipper's double-bottom general arrangement showing extent of damage (not to scale)

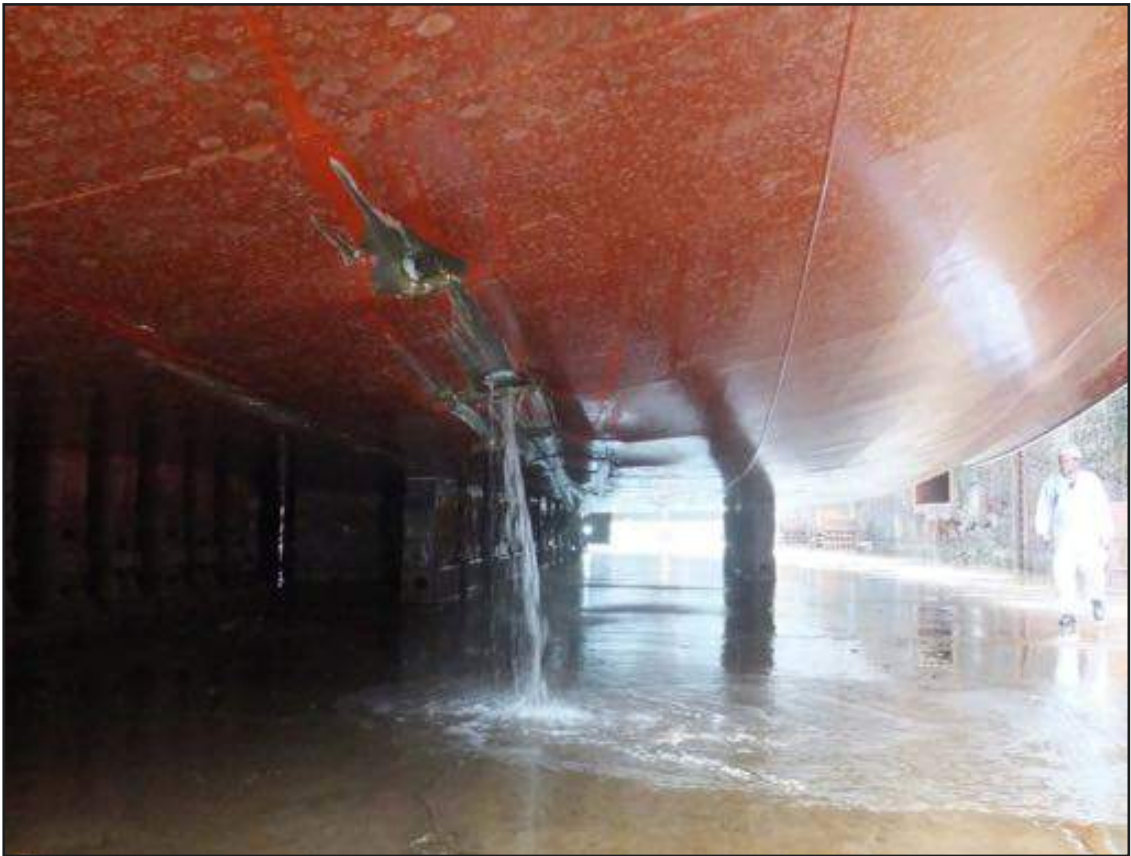
- The shell plating of the hull on the port side was subject to a deep gouging distortion along approximately two thirds of its length (**Figure 7**).
- Water ballast tank 4 was holed in two places (**Figures 8 and 9**).
- Void space 8, void space 9 and water ballast tank 1 (port) were all breached by small holes and fracture damage to the hull (**Figure 10**).
- Although the propellers and rudders were not struck, the skeg was damaged along its entire underside length (**Figure 11**).

Figure 7: Hull gouging looking aft

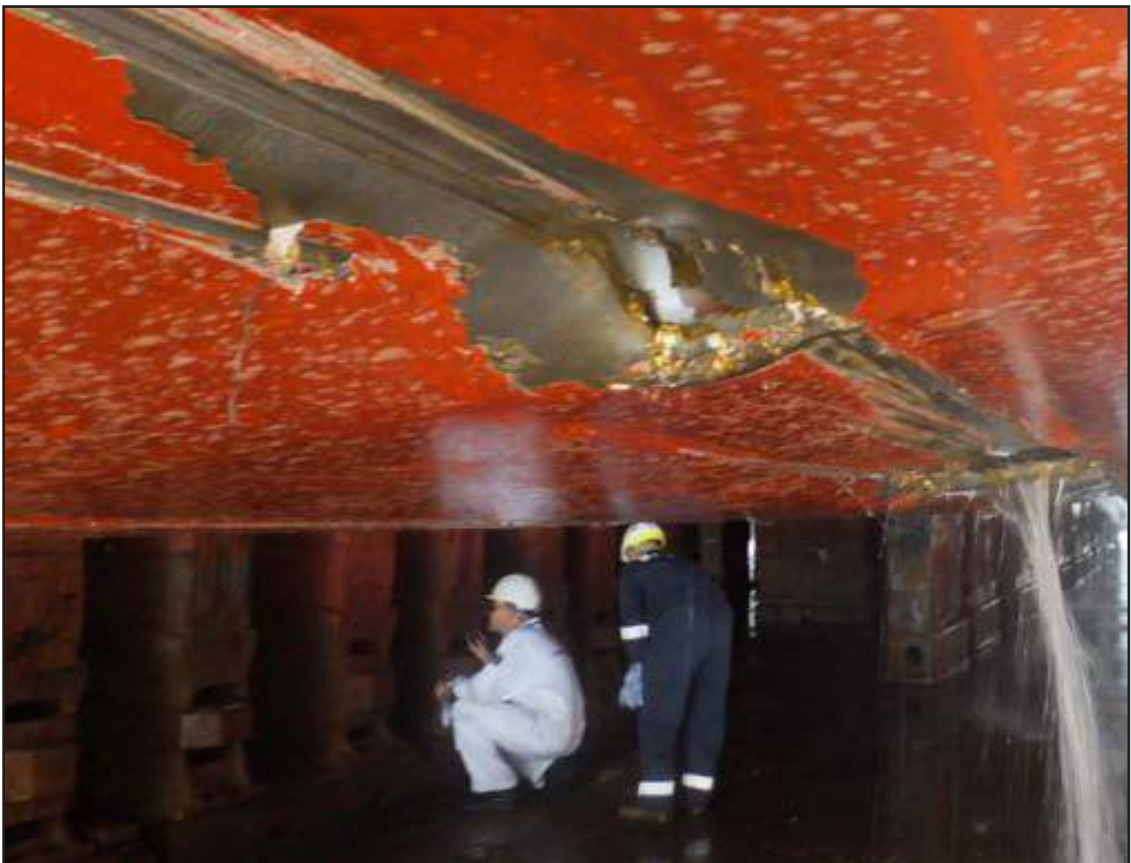
Figure 8: First hole in water ballast tank 4

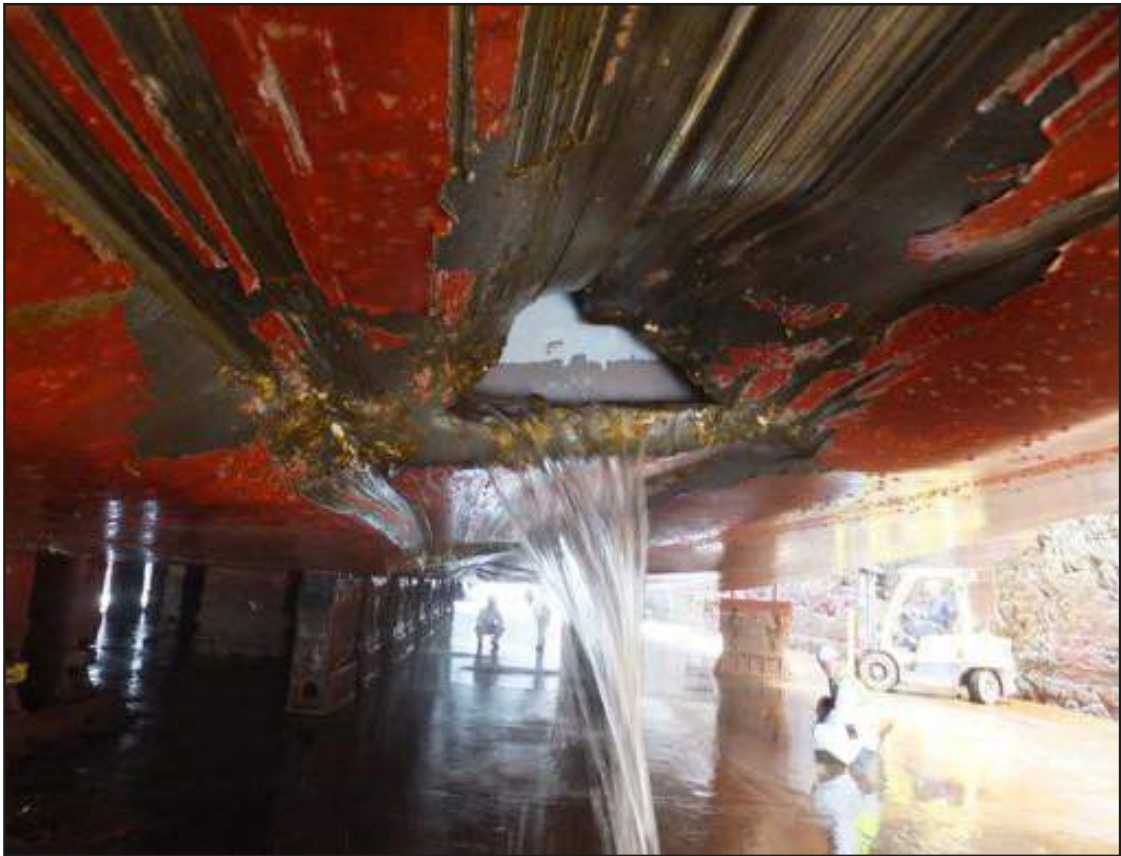
Figure 9: Second hole in water ballast tank 4

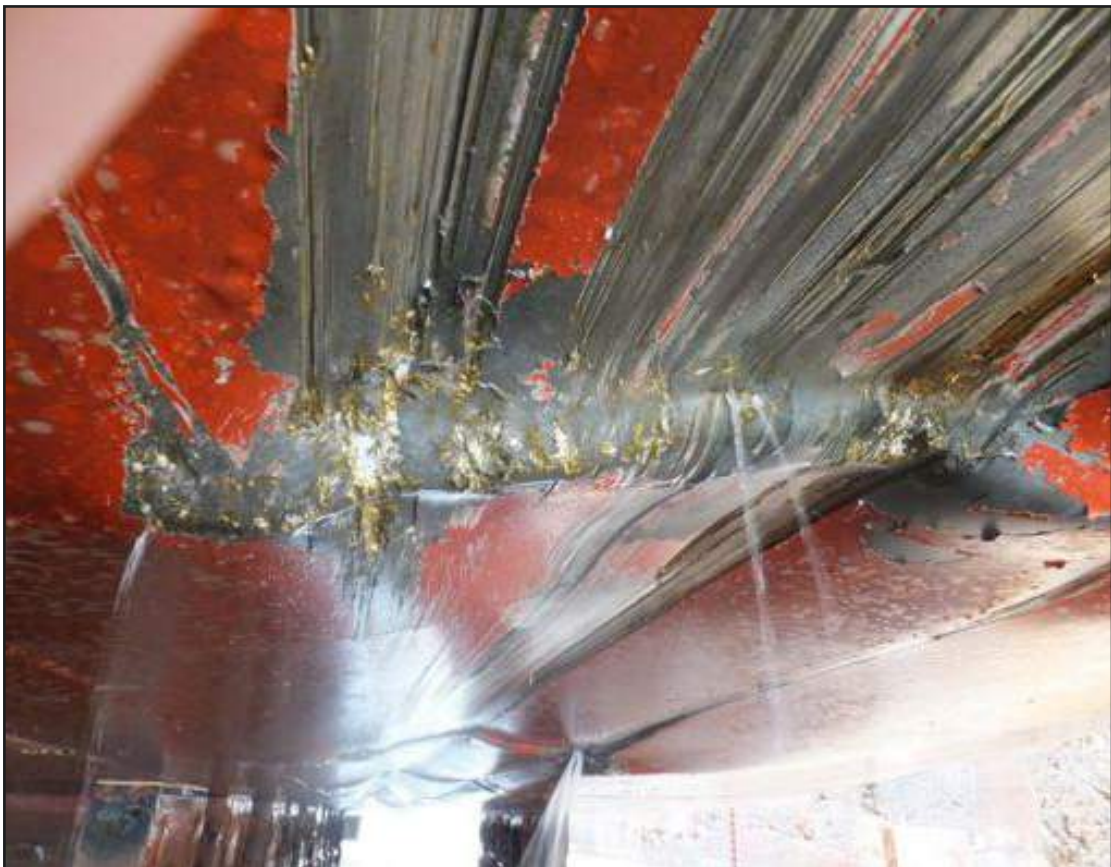
Figure 10: Detail of hull fracture damage

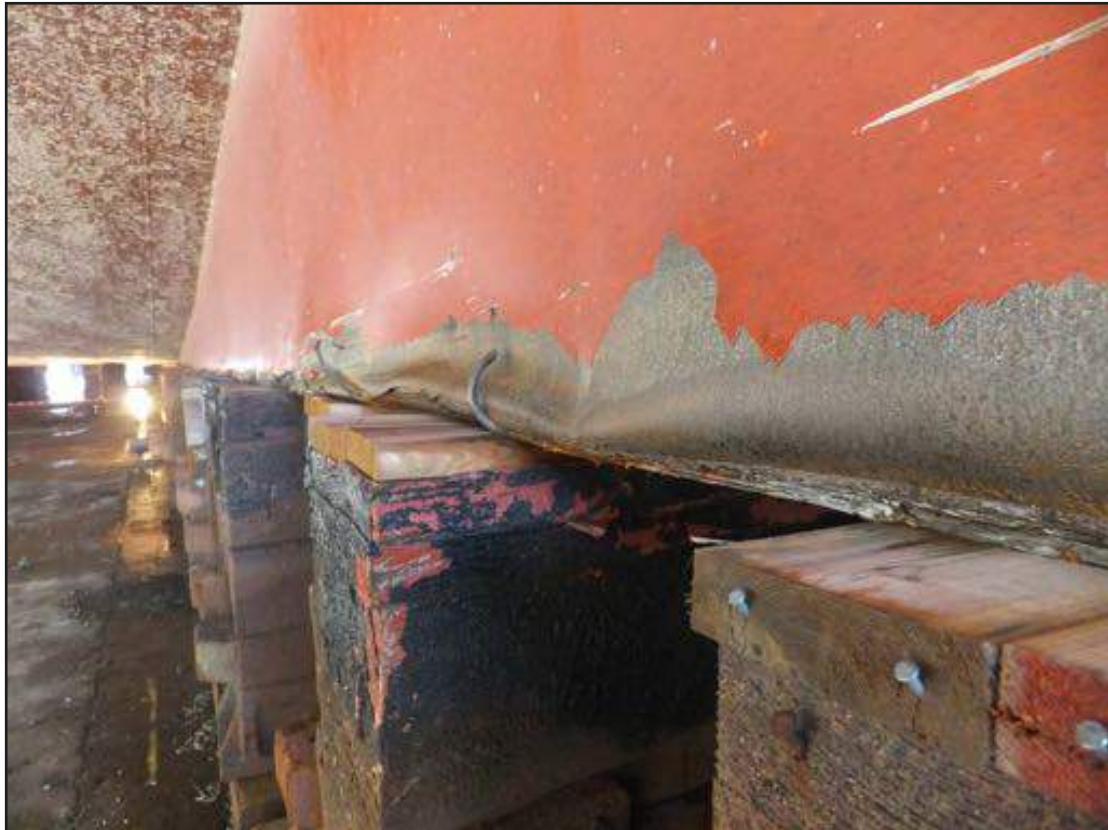
Figure 11: Detail of damage to keel skeg

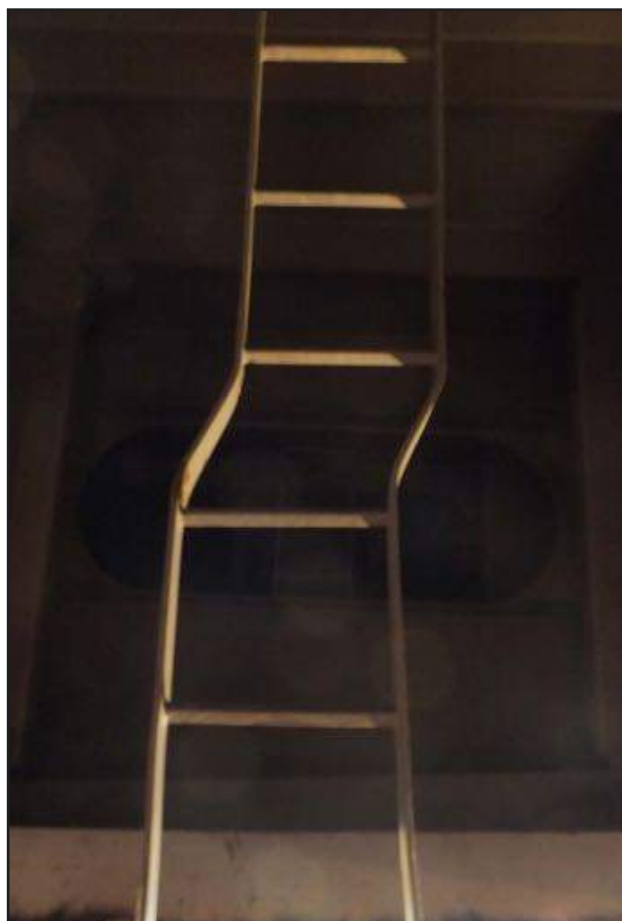
Figure 12: Example of internal ladder damage in a void space

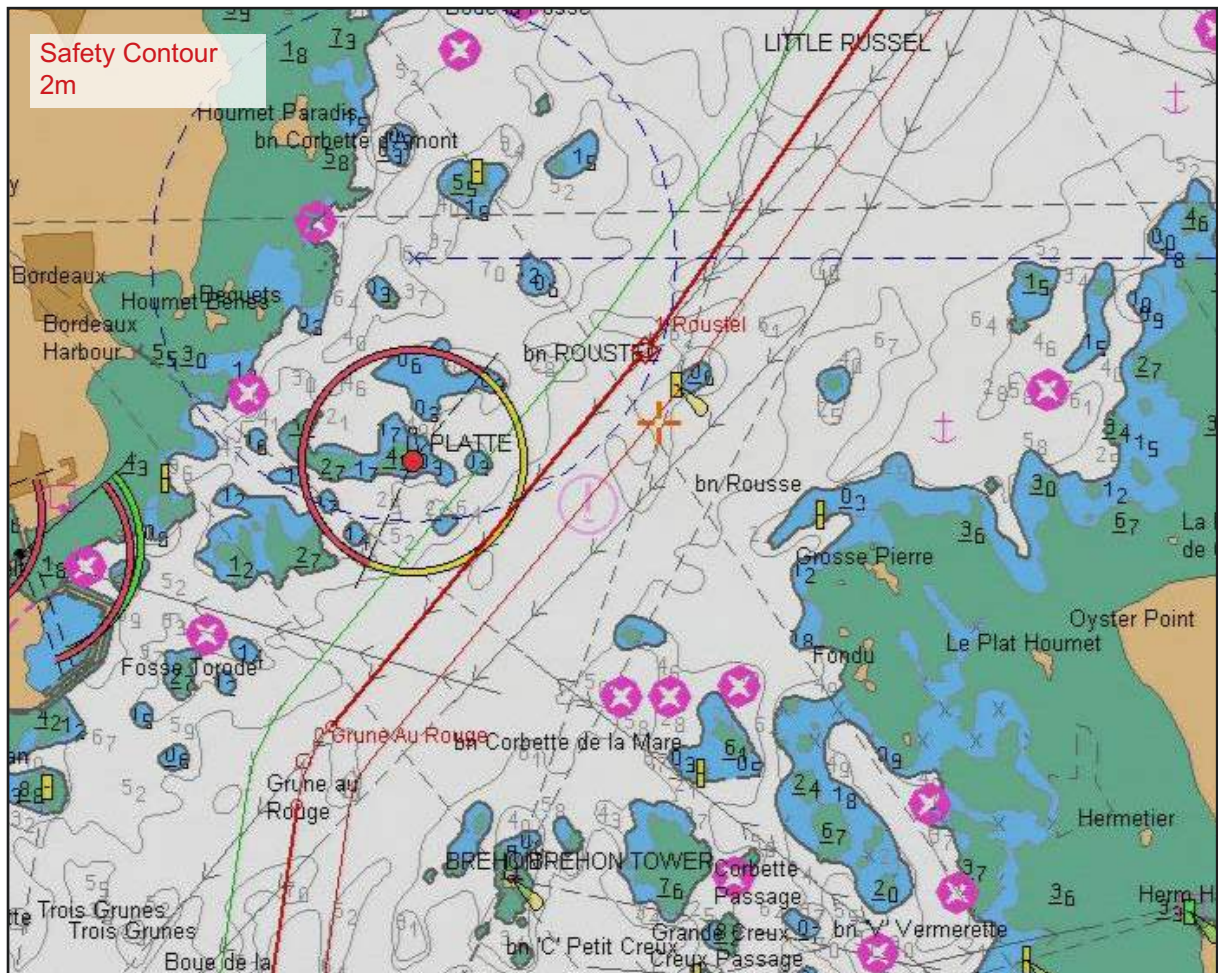
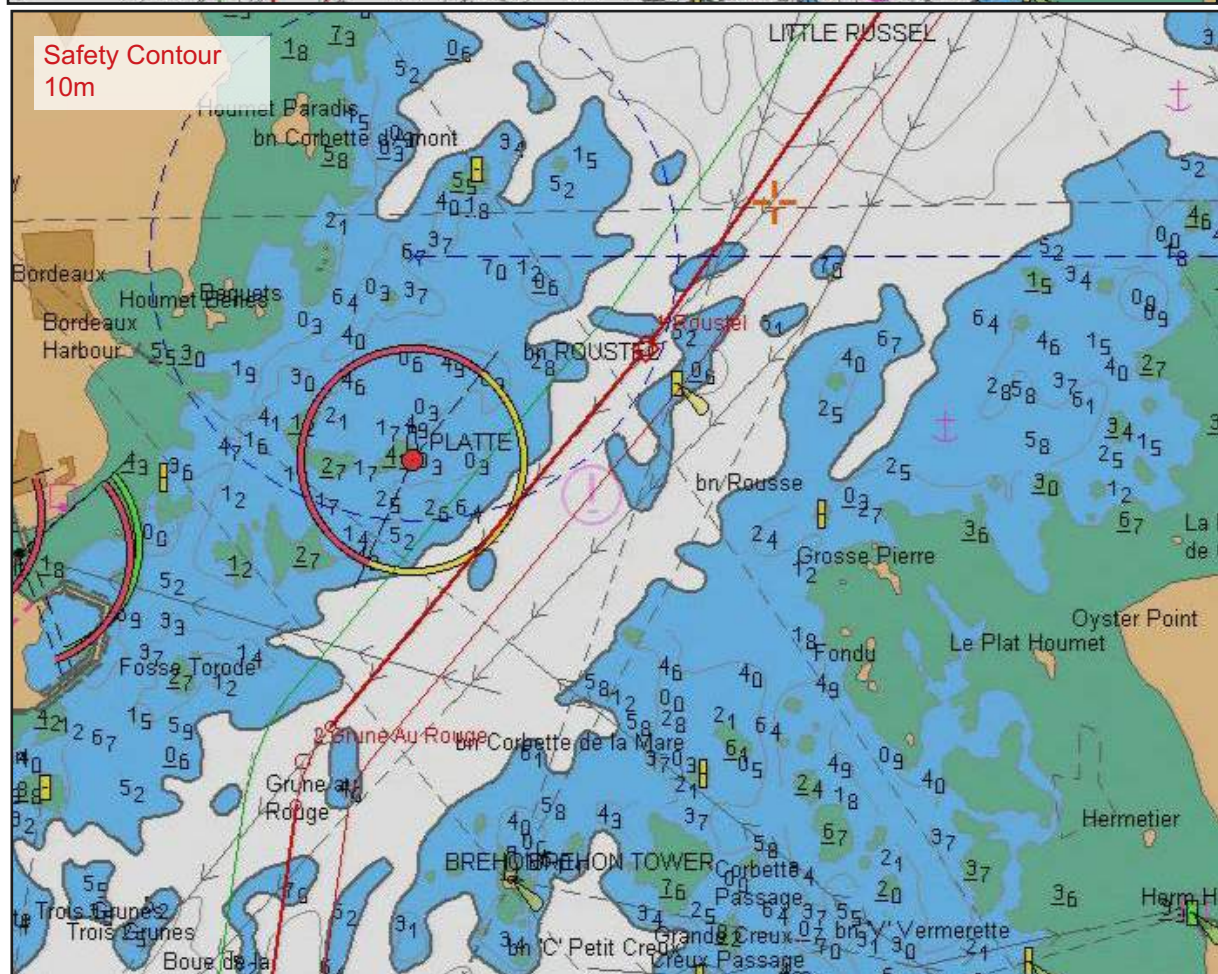
Had the bridge team produced a berth to berth voyage plan, taking the chart accuracy into consideration, a worst case depth of 4.0m (5.2m – 1.2m) for the rocky shoals adjacent to Roustel and Boue de la Rade would have been applied. Had this been the case, the area where the vessel grounded and the Boue de la Rade would have been identified as unsafe, and avoided.

Figure 21: Comparison of ECDIS 2m and 10m safety contour lines in the Little Russel

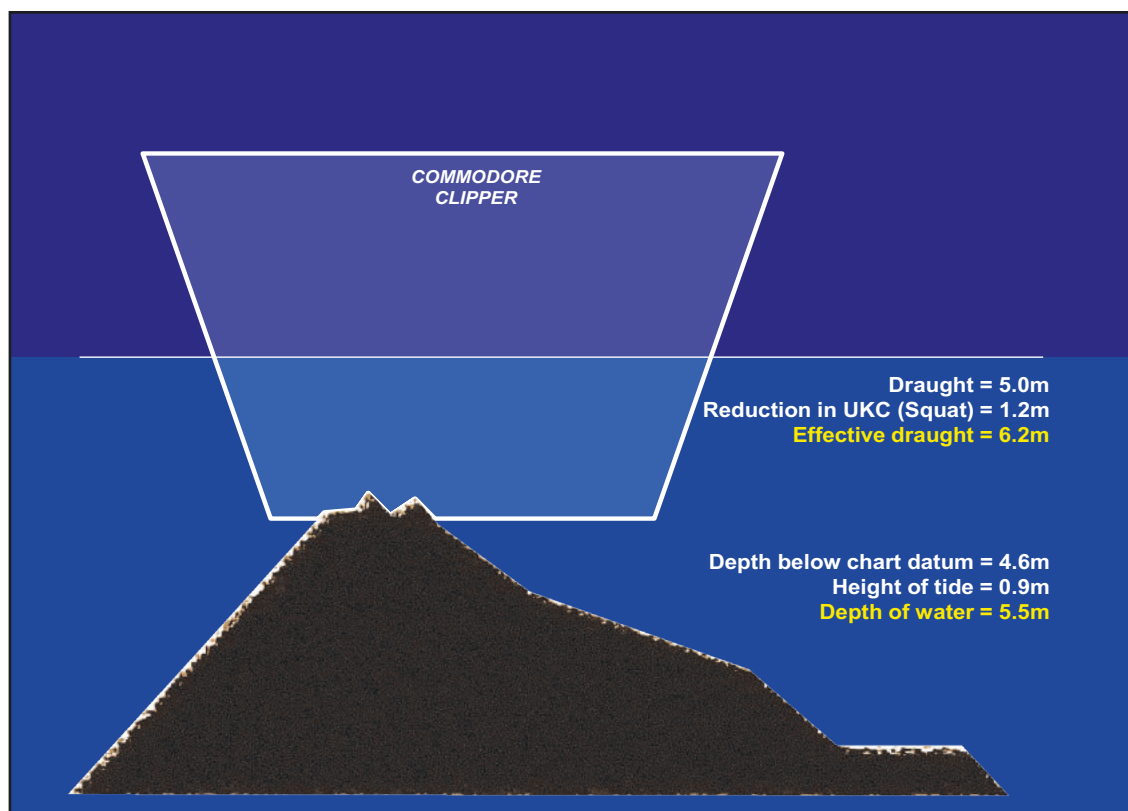
Figure 22 is an illustration of the assessed values for the moment of grounding.

Figure 22: Assessment of actual values of draught and depth during grounding

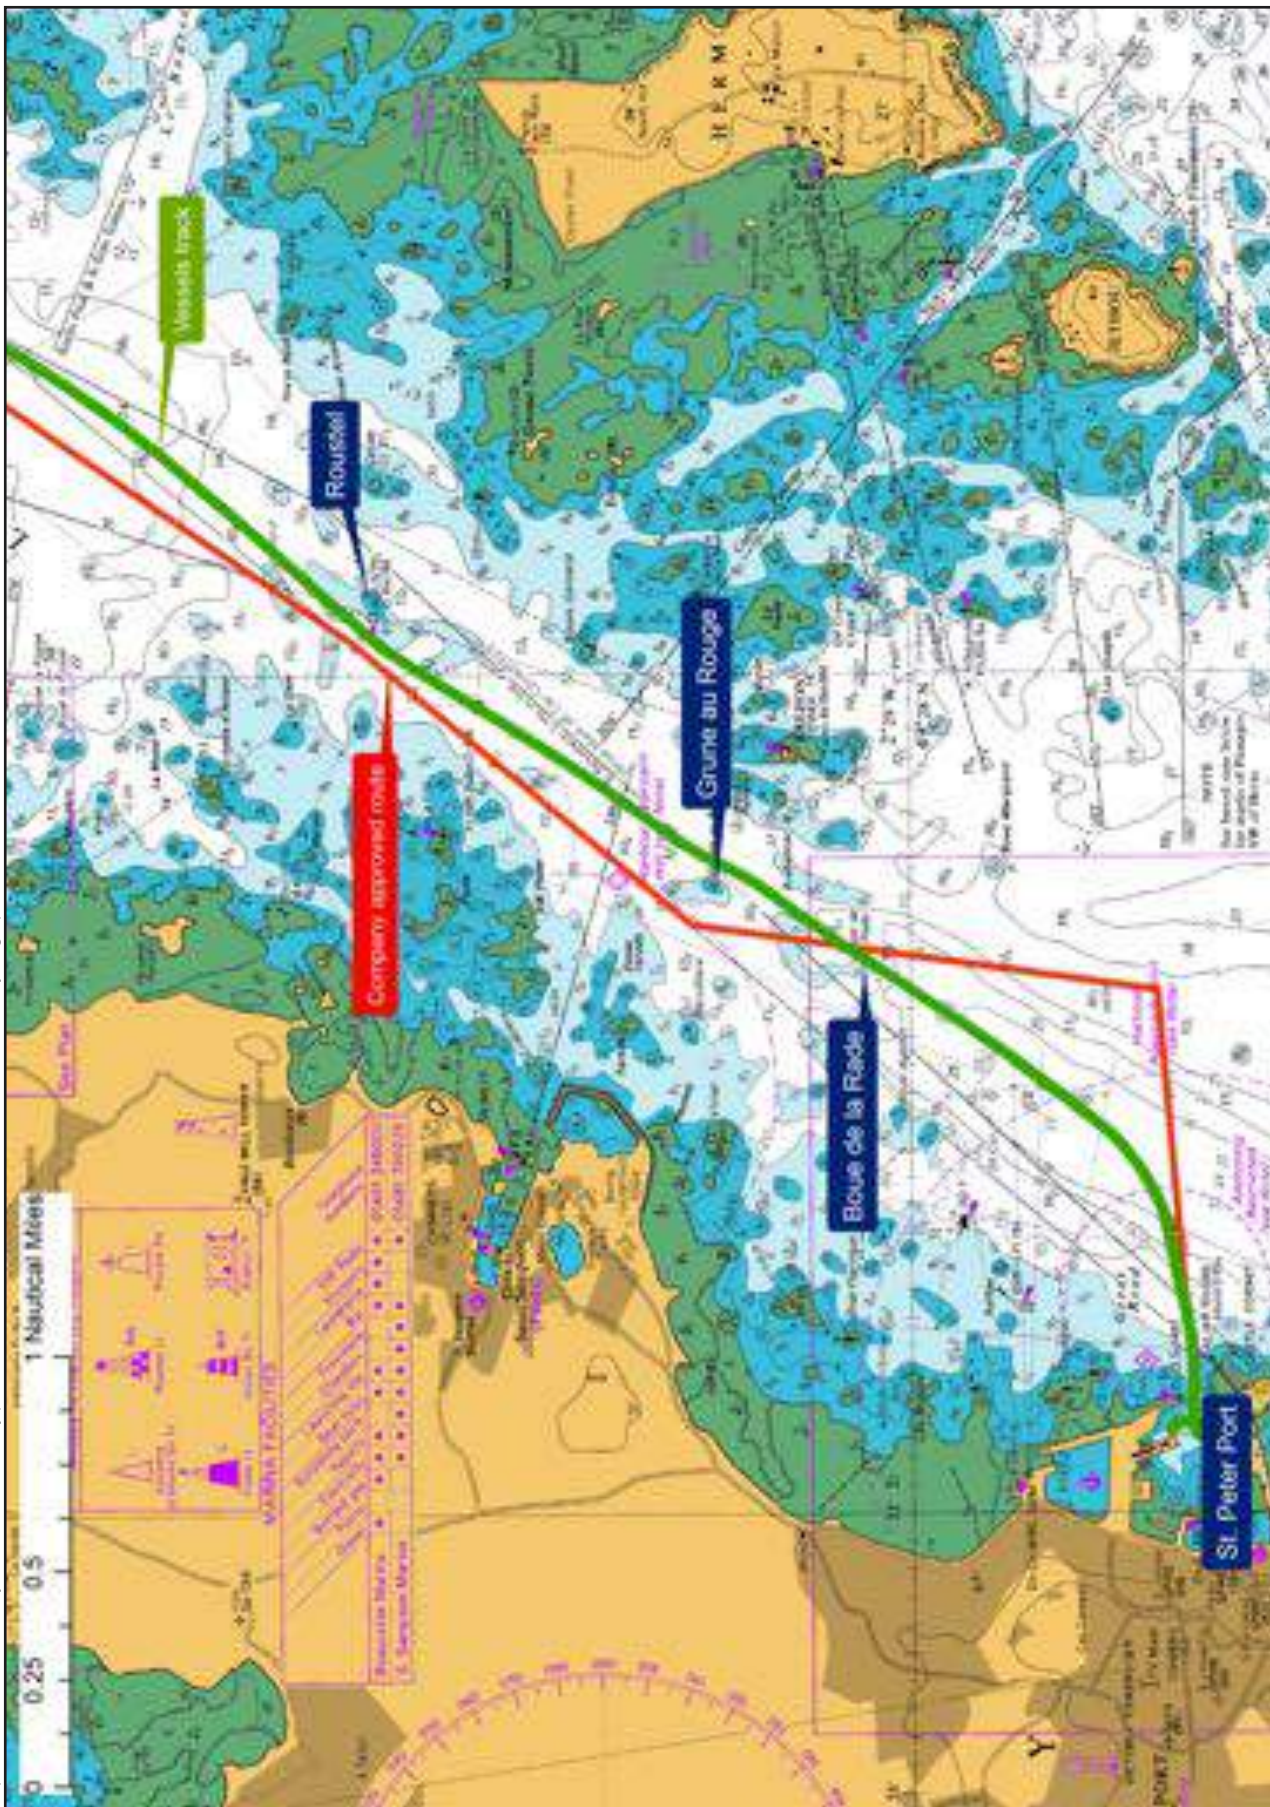
Figure 23: Comparison of company approved route and Commodore Clipper's actual track

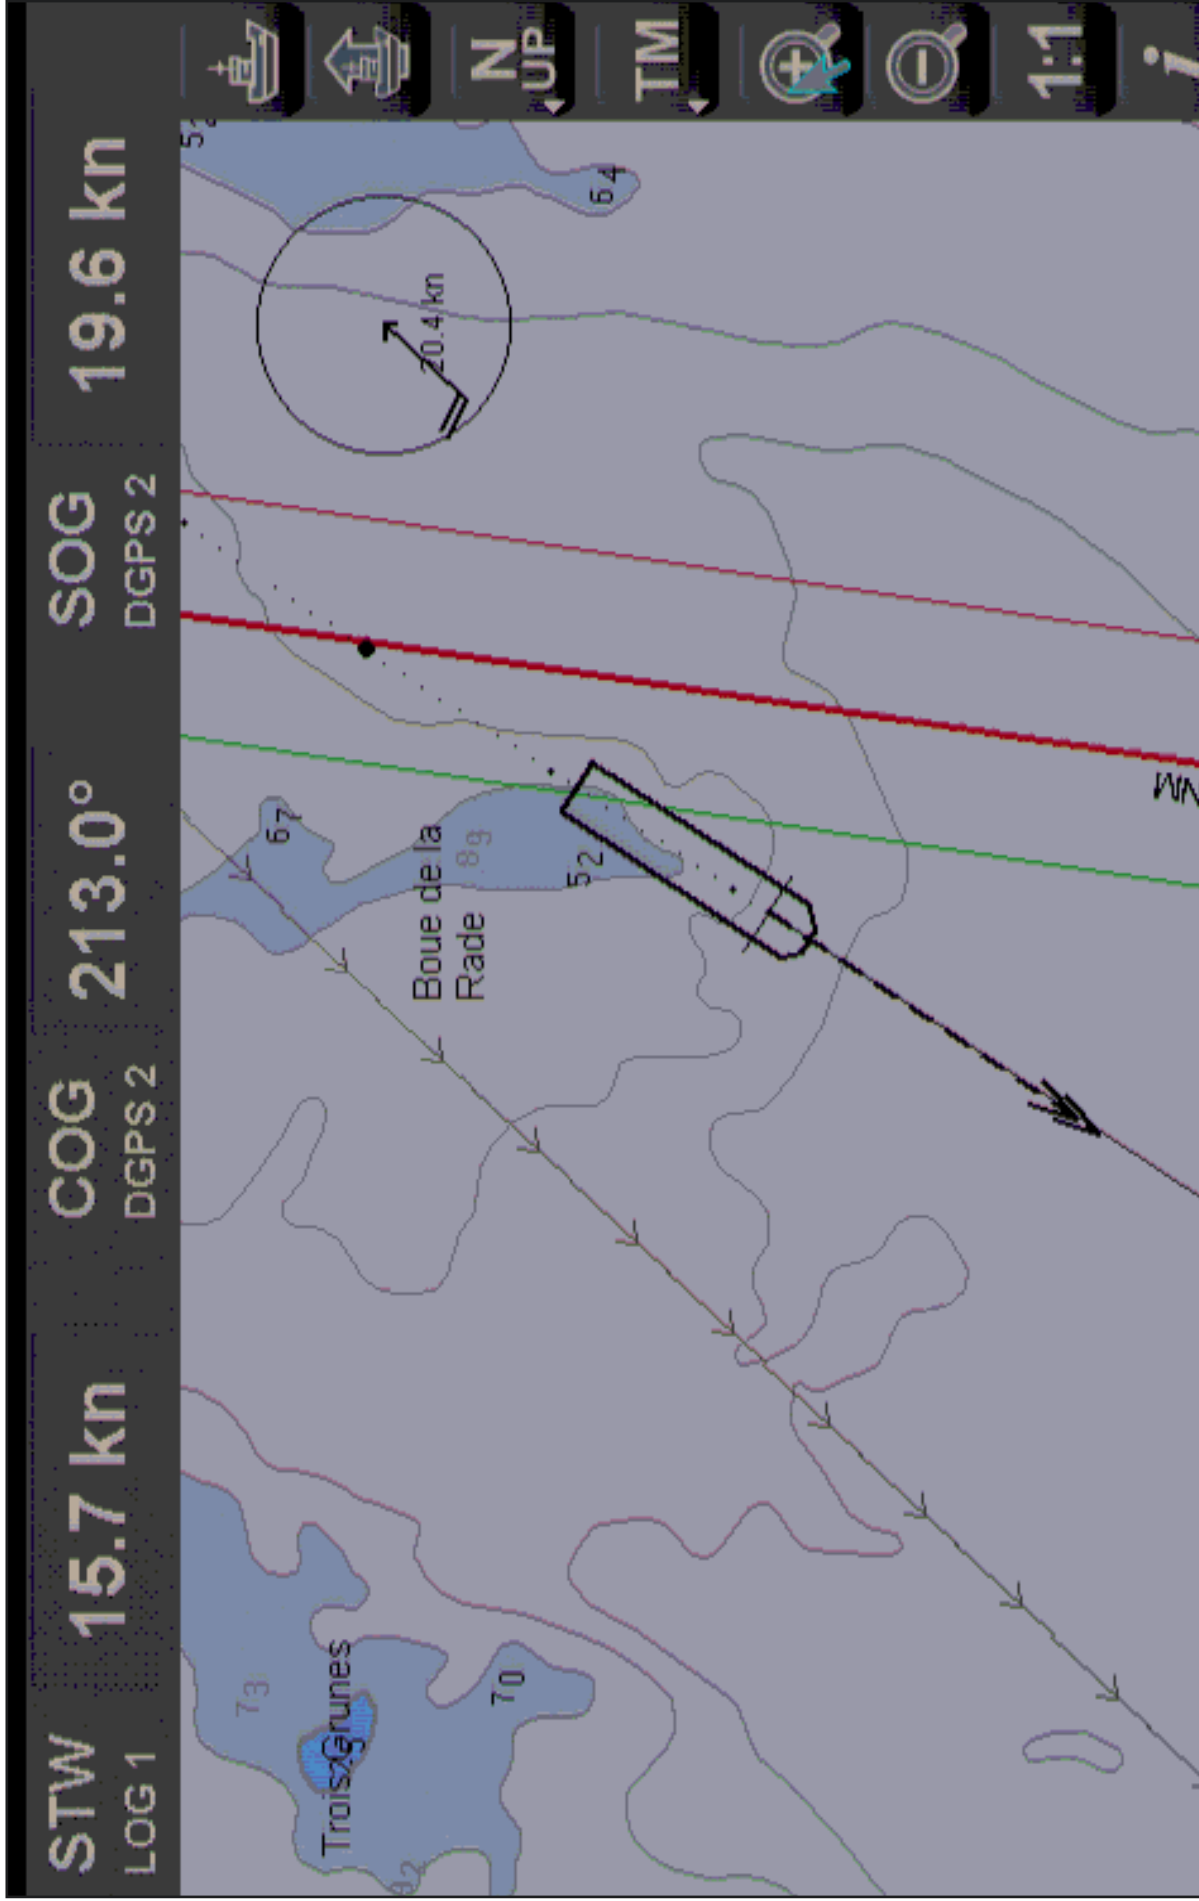
Figure 25: Details of ECDIS display as vessel crossed Boue de la Rade shoal

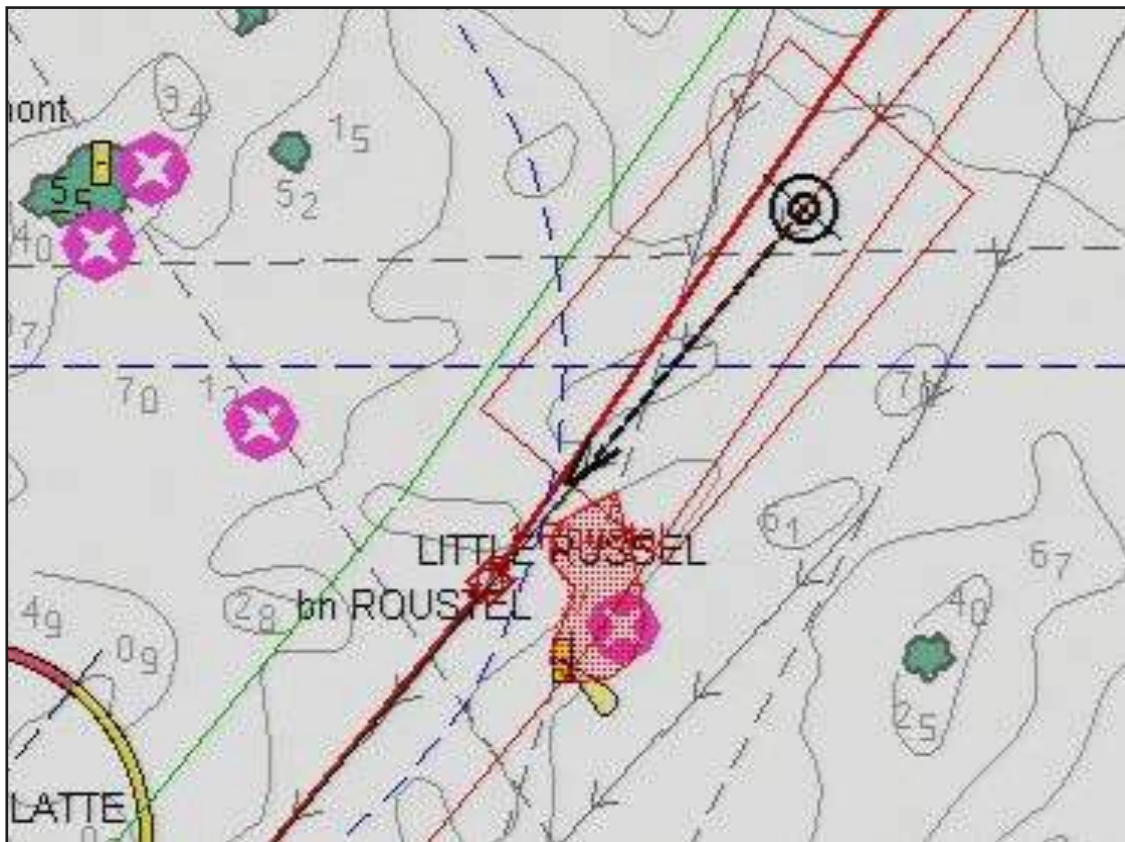
Figure 30: Reconstructed ECDIS display showing safety frame crossing 6.3m LDL

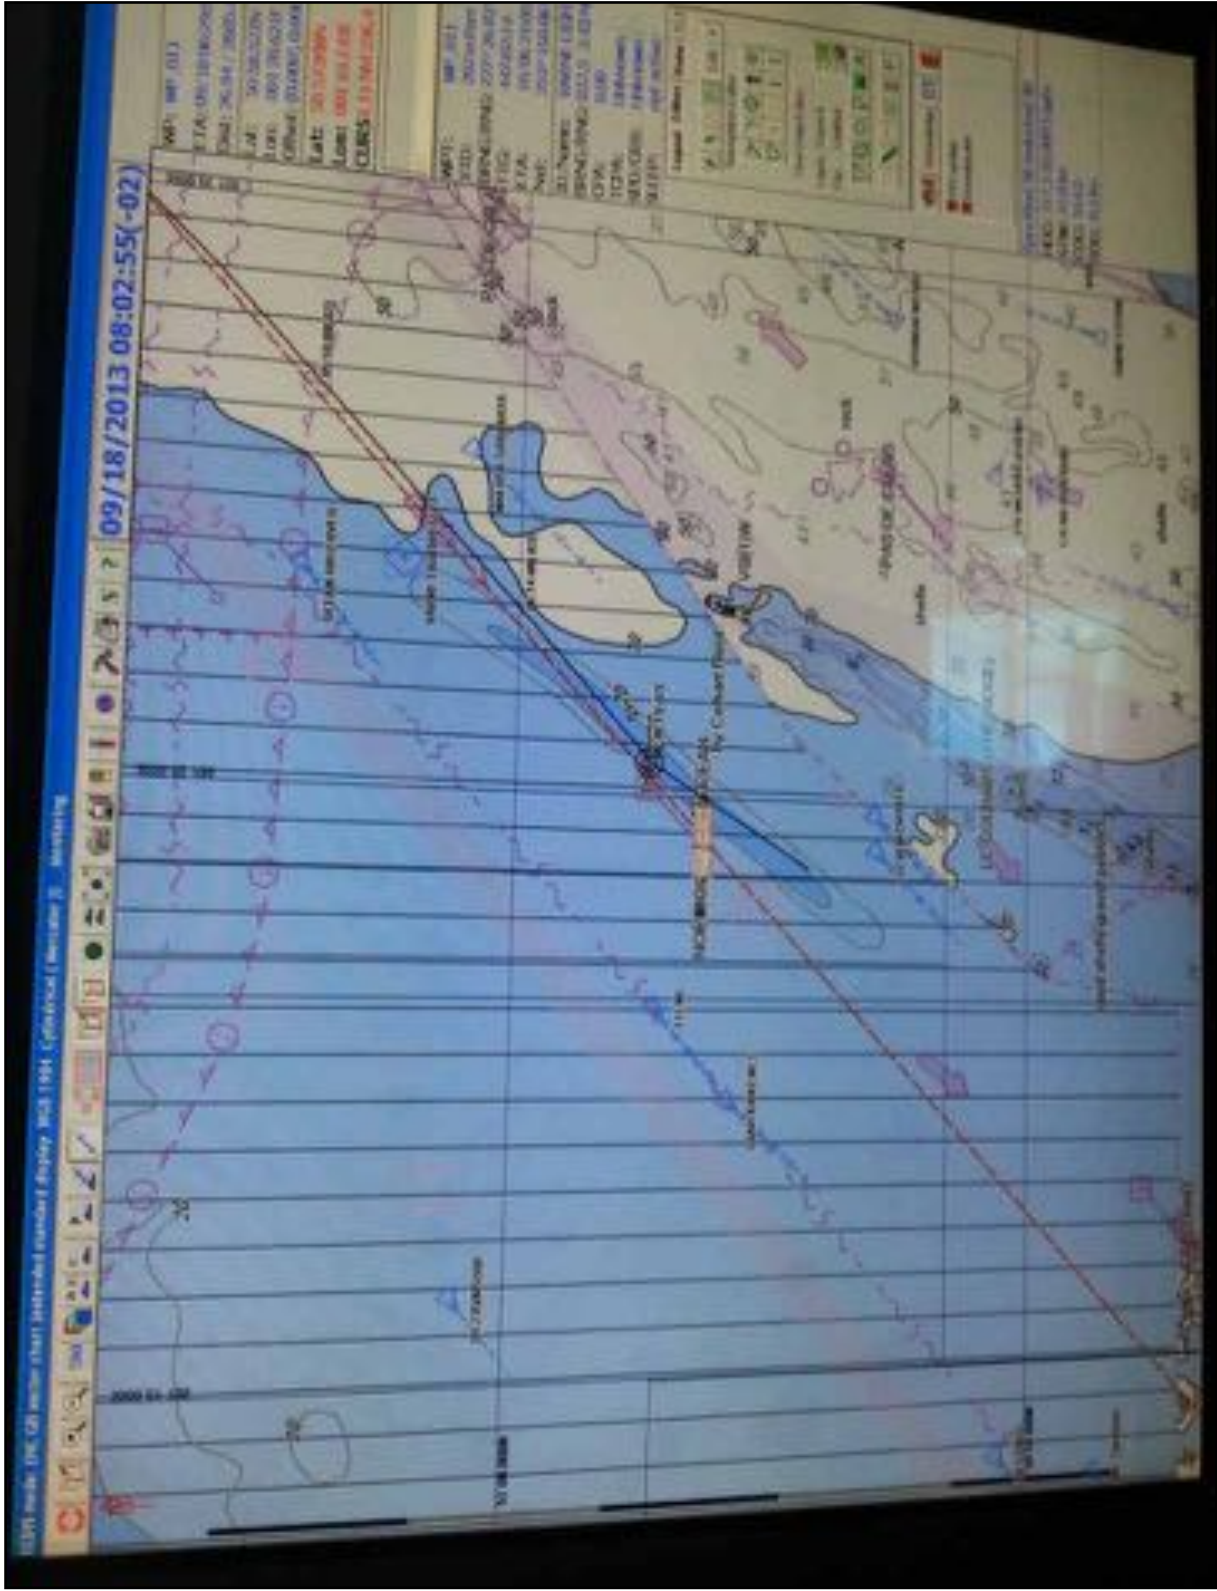
A photograph taken of the ECDIS display at 0602 is at **Figure 6**. Between 0716 and 0722, *Ovit* refloated on the rising tide. The vessel subsequently berthed alongside in Dover, UK, to enable the hull to be inspected by divers.

Figure 6: Ovit's ECDIS display when the ship was aground

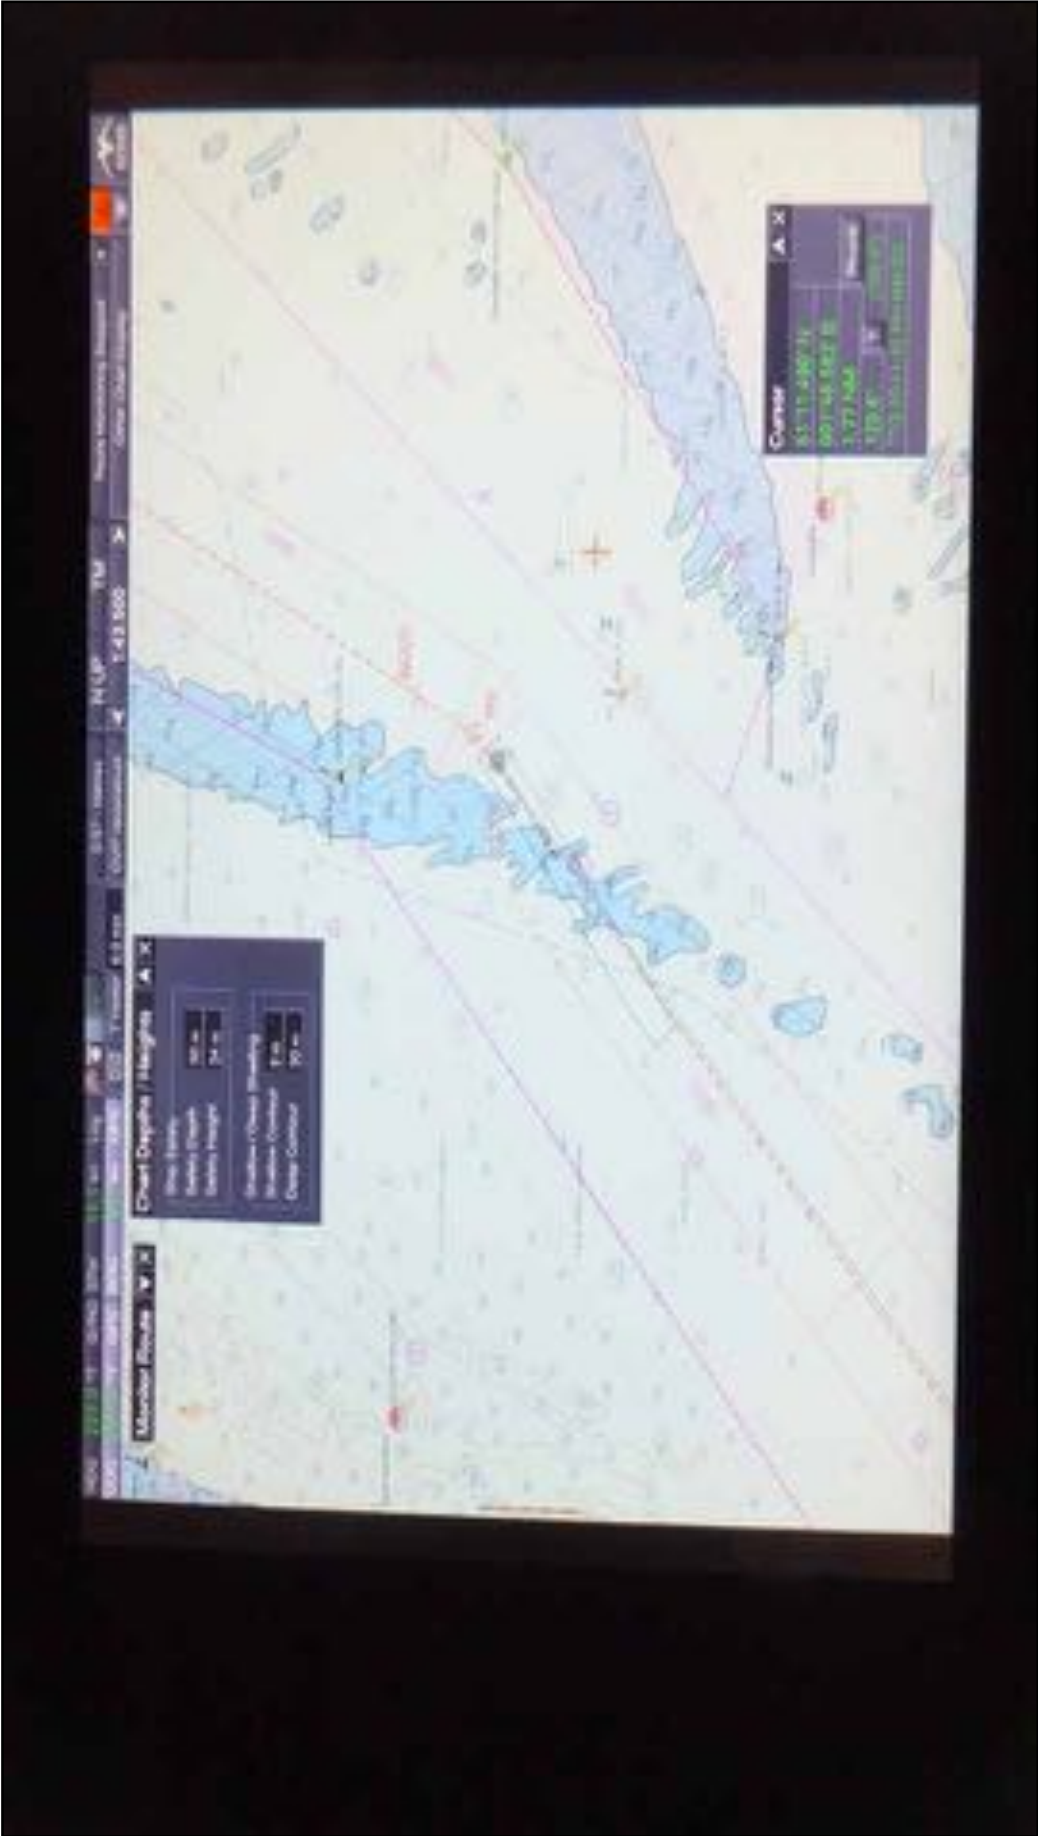
- *Ovit* crossed the 30m safety contour at 0251 (**Figure 12**) and 0417.
- *Ovit* passed over a charted depth of 13m at 0427 which initiated the 'grounding alarm'.
- The Varne Light Float was sighted at a range of just over 10nm.
- The lights on the cardinal buoys marking the east and west sides of the Varne Bank were sighted at 5nm.

Figure 12: Reconstruction showing Ovi's earlier 30m contour crossing
