HOW A SHIP'S BRIDGE KNOWS ITS POSITION – ECDIS ASSISTED ACCIDENTS FROM A CONTEMPORARY HUMAN FACTORS PERSPECTIVE

Thesis work submitted in partial fulfillment of the
requirements for the MSc in Human Factors and System Safety

Mads Ragnvald Nielsen

LUND UNIVERSITY
SWEDEN

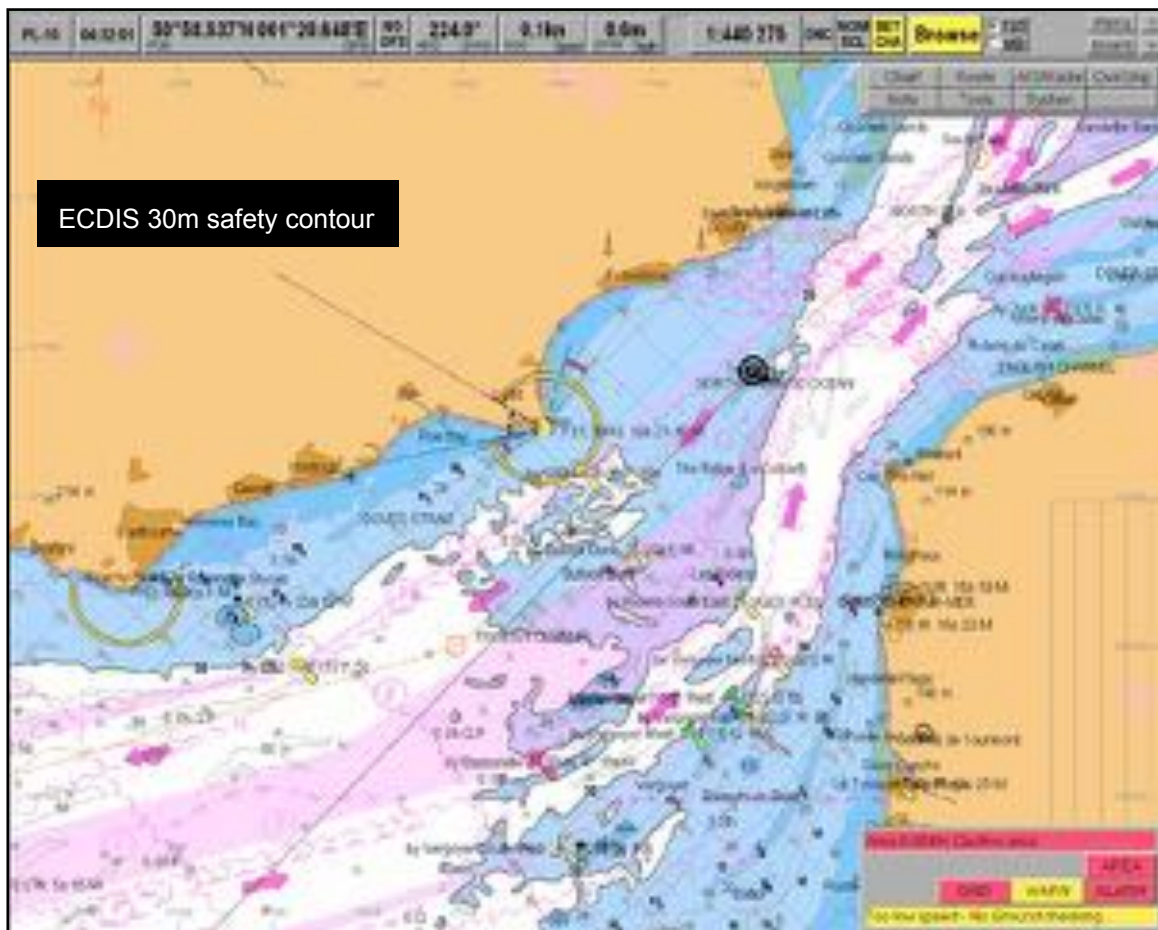
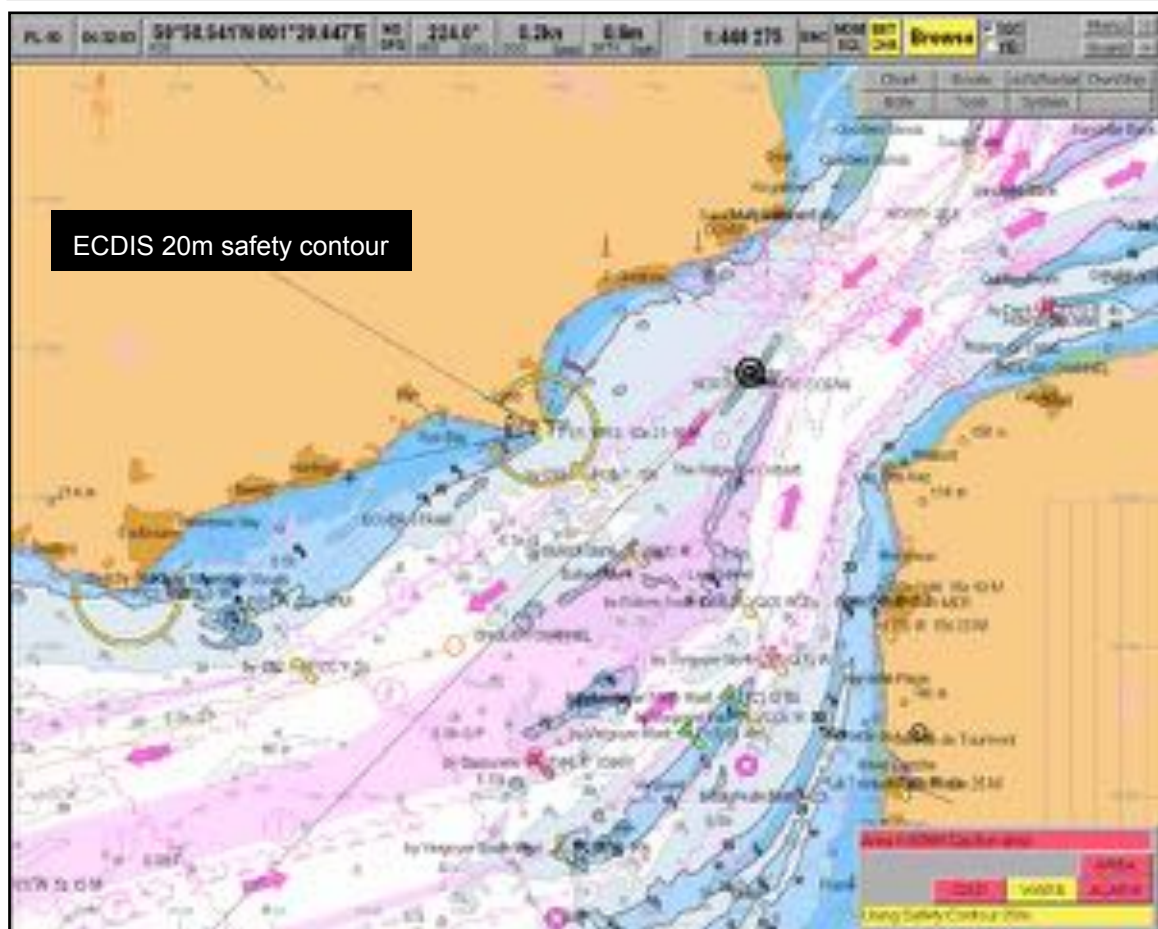
Figure 13: ECDIS display comparison of 30m and 20m safety contours
