A study on how to improve mass evacuation at sea with the use of survival crafts

**Rapport 5536, Lund 2017
Examensarbete på brandingenjörsutbildningen**

Report 5536

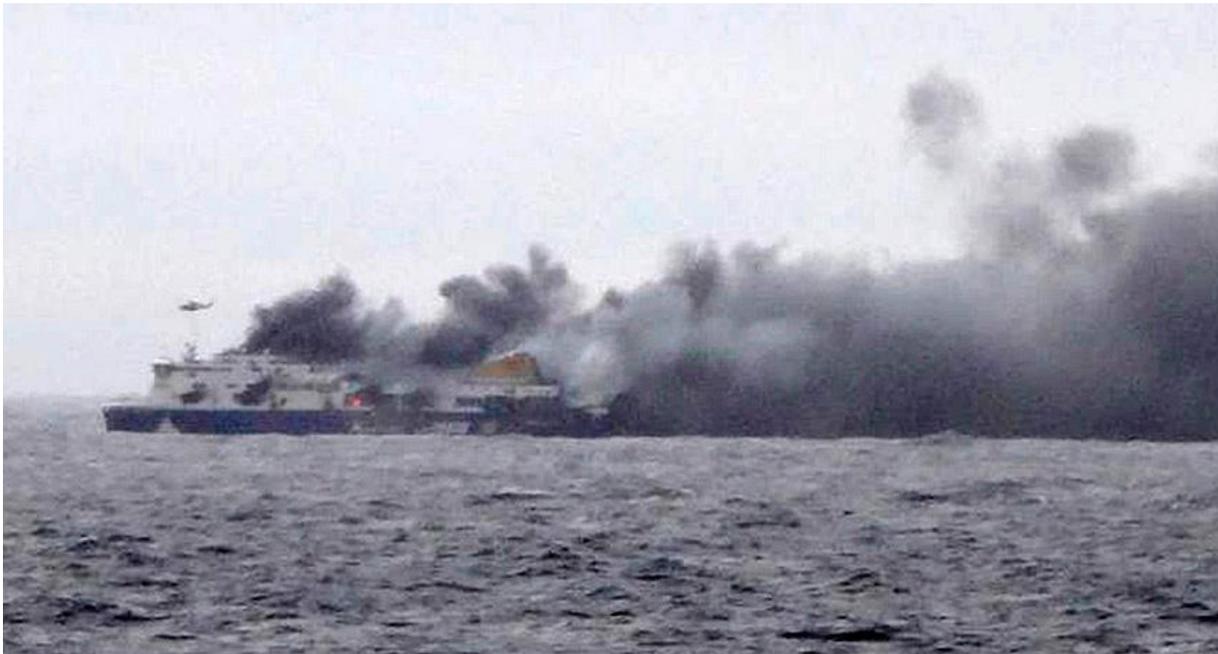
According to the investigation, conducted by the Ministry of Infrastructure and Transport in Italy, the wind condition and motion of ship changed the smoke plume in the ship’s partially opened cargo space. This delayed the smoke detection considerably. The preliminary results of the investigation show that the fire started on deck 3 and continued spreading to other decks. It is estimated that the temperatures have reached over 1000°C on deck 4, which is the main ro-ro cargo deck. Fabio Croccolo says, in his presentation that the high temperatures make it impossible to determine the exact location and cause of fire. However, plausible ignition sources have still been identified. During the night of voyage, the ship was completely booked up and was therefore very crowded. It is not uncommon, mentioned by Fabio Croccolo, that unauthorized persons remain in the ro-ro deck to escape the congestion above. Since it was only

Figure 18 shows MS Norman Atlantic burning and a rescue helicopter evacuating persons. Picture: AP Photo/SKAI TV Station.

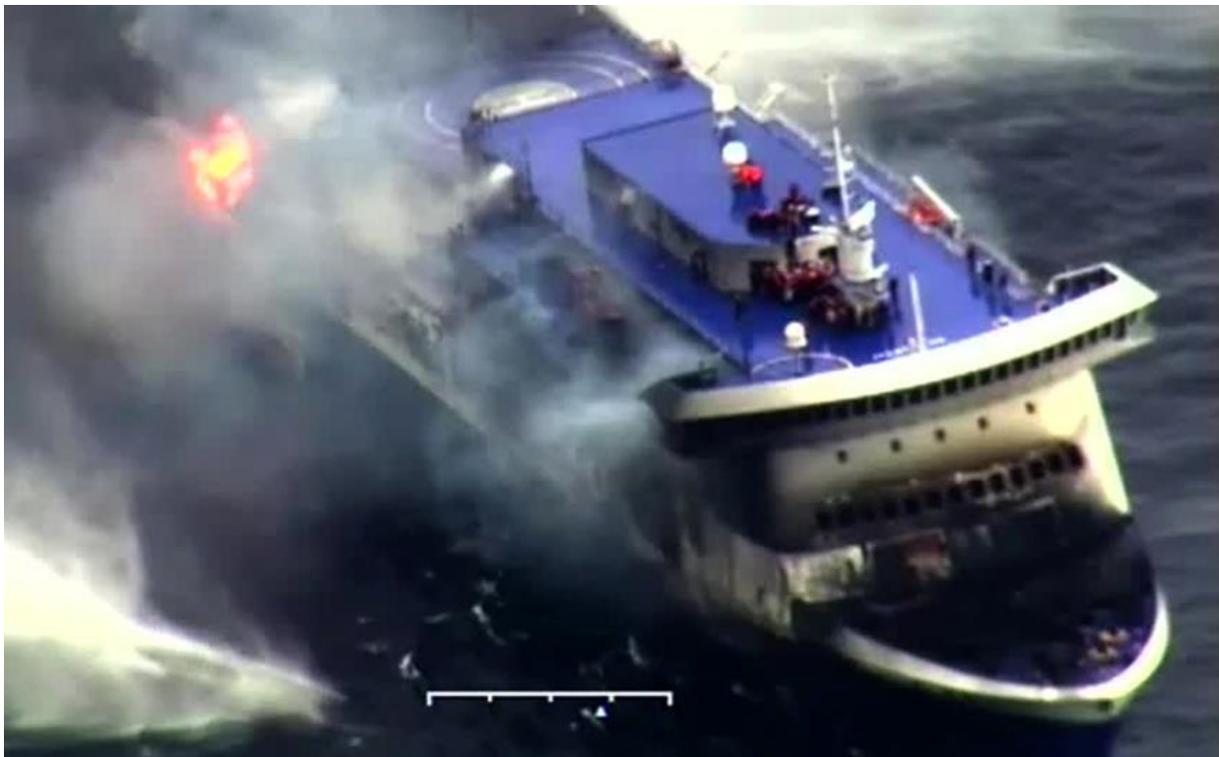
As the evacuation possibilities by survival crafts became limited and the intensity of fire increased, people went up to the bow of the ship, deck 8, hoping for rescue. According to the investigation, this was the only safe area available for the passengers (Marine Investigations, 2015) . This can be seen in Figure 17.

Figure 19 shows MS Norman Atlantic on fire. Evacuees are waiting on deck 8 for helicopter extraction. Picture: Guardia Costiera/AFP.

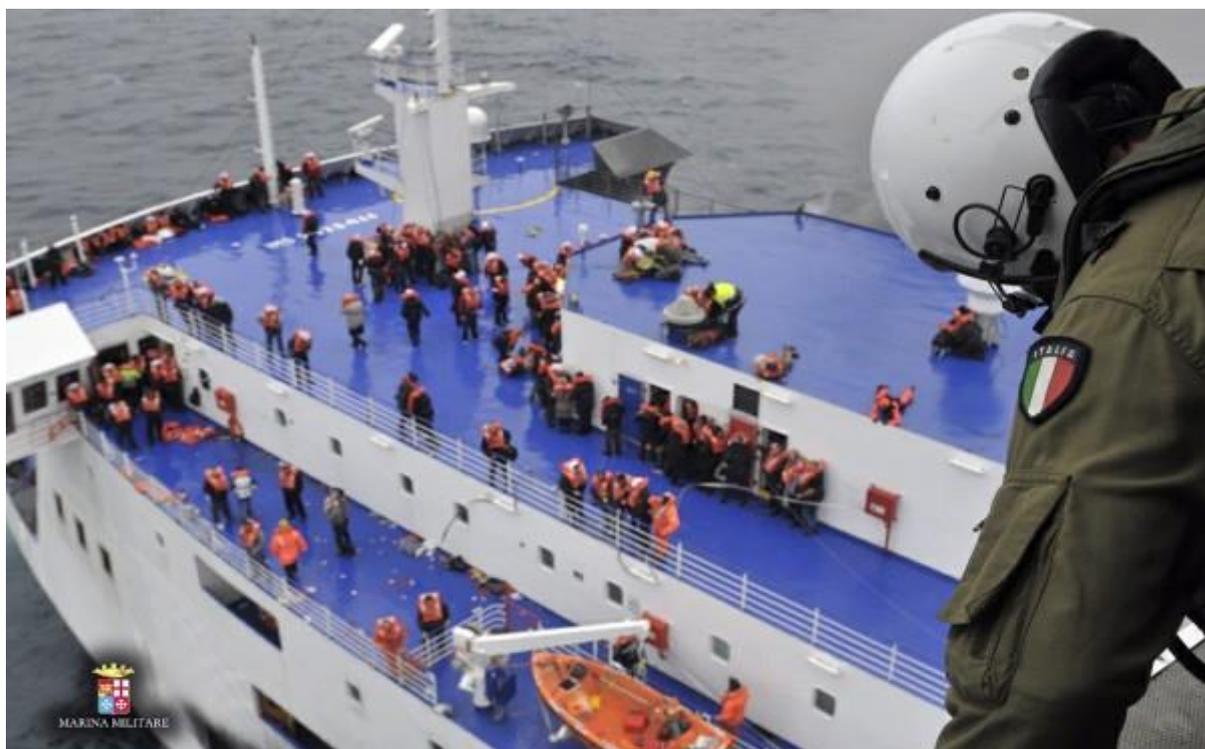
According to Fabio Crocolo, during his presentation, that the SAR operation was hampered by weather and fire conditions. The conditions created by the fire damaged the SAR resources. Strong winds and high seas made it very difficult to evacuate persons. The tugboats' ability to tug was impeded by the flames and smoke. Consequently, the tugboats had limited access to the vessel and could only assist by stabilizing the ship to reduce the roll movements and by steering the ship so that the direction of smoke plume could be controlled (Maritime Executive, 2015). The helicopters airlifted nonstop for approximately 35 hours to extract all persons. Several evacuees suffered from hypothermia due to the long exposure to cold, rain and wind (Eaglenews, 2014).

Figure 20 shows passengers being evacuated with helicopter. Notice the un-launched rescue boat. Picture take from: (Keep Talking Greece, 2014).

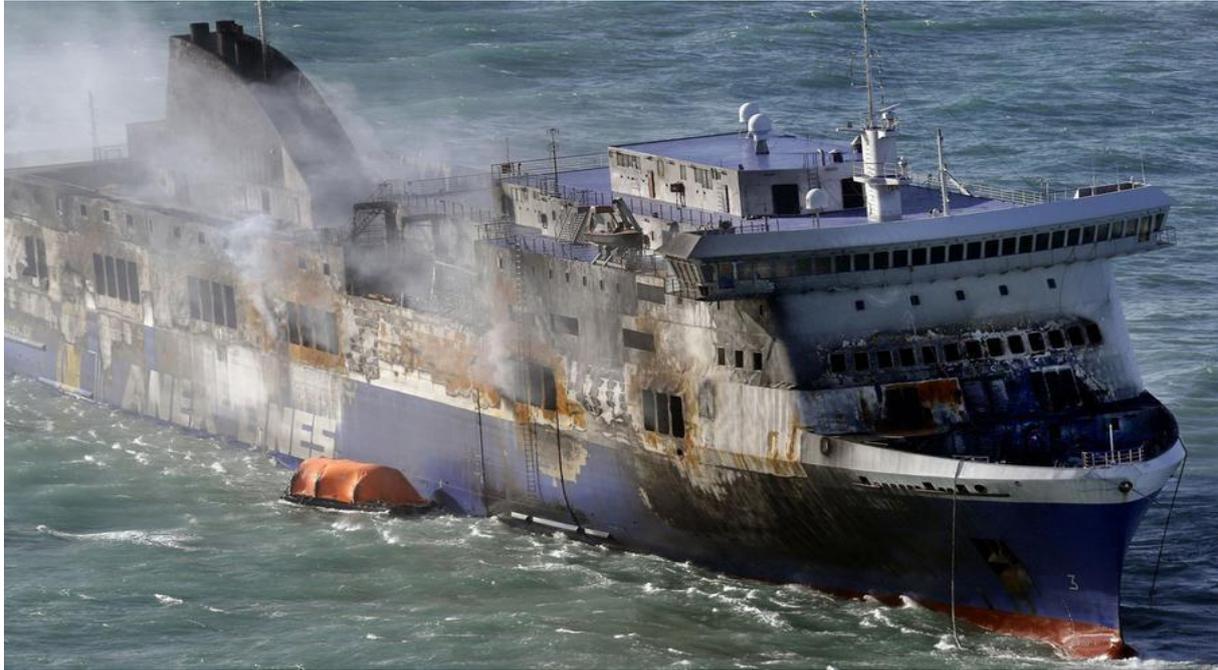
Norman Atlantic did not sink, but suffered severe damage from deck 3-7 damage and substantial on deck 8. The death toll of the incident is confirmed to be 18 (Maritime Executive, 2015). From the section of “Lessons learned” in the preliminary investigation Fabio Croccolo summarizes what has been learned so far:

Figure 21 shows the burned out Norman Atlantic. Picture: AP Photo/Antonio Calanni

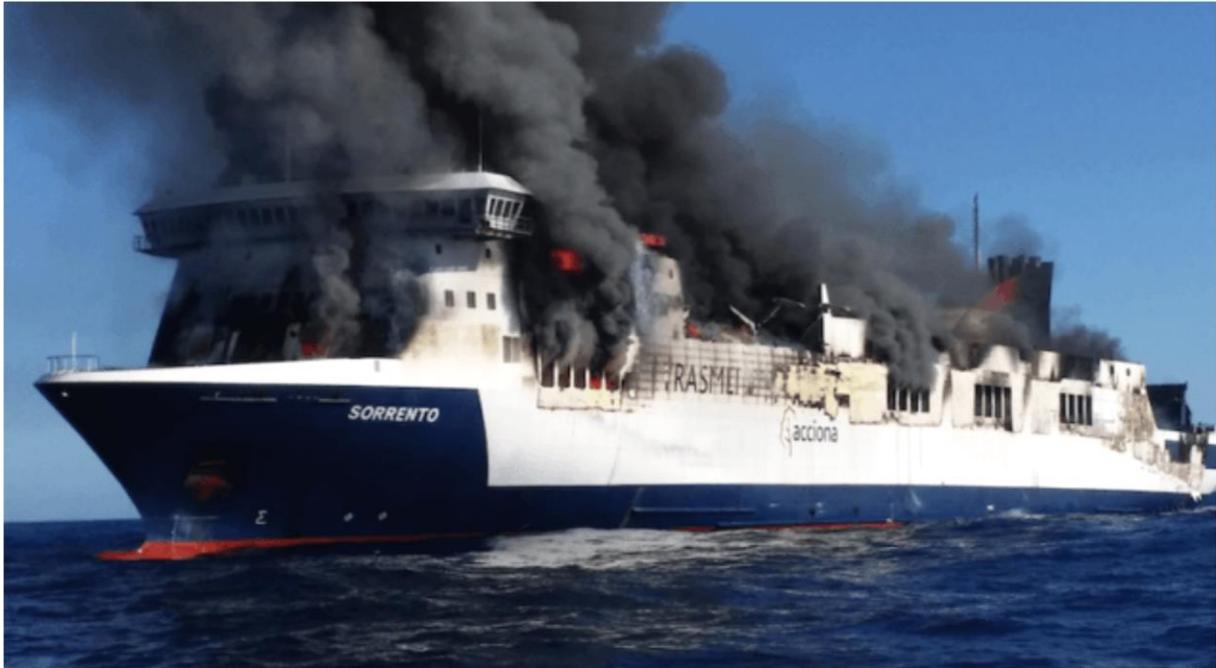
According to Fabio Croccolo, the head of investigation of the Sorrento ferry fire, the preliminary results of the investigation shows that a fire started in the cargo deck, deck 4, during the course of voyage. At 12.45 o'clock, a distress signal was transmitted by Sorrento, transmitting that a fire was on board. As a countermeasure, the drencher system was activated and a fire team was sent to the cargo deck to suppress the fire. However, the fire team had difficulties in accessing the fire, due to the small passages between vehicles. (Marine Investigations, 2015; Maritime Executive, 2015)

Figure 23 shows Sorrento on fire. Picture: Salvamento Marítimo.

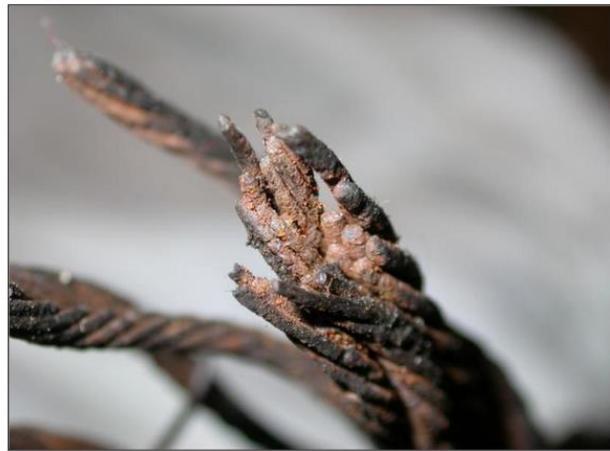
“The fall of the lifeboat was the result of a parted wire rope fall that was caused by severe internal corrosion at the break point”. (Marine Safety Investigation Unit, 2014)

Additional conclusions in the investigative report showed that the crew did not detect the wire rope’s deteriorating condition because they did not possess the knowledge of how to do it and because it is difficult to identify it. This conclusion was made, even though the personnel were trained and qualified according to the STCW regulations. The davit’s wire falls were not old, since they were replaced in August 2010. The investigative authority performed break load tests on the broken wire ropes to evaluate its strength. The

Figure 24 shows a close up of the internal corrosion on the wires, holding the lifeboat. Picture taken from: (Marine Safety Investigation Unit, 2014)

The results showed that it did not fulfill the specifications of the davit’s manufacturer or the specifications of ordered wire, ordered by Thomson Majesty during the replacement in 2010. According to the davit manufacturer, the break load should be 474kN. The ordered had 565kN, but the tested wire had only break load strength of 306kN, in its original condition. This means that a weaker wire rope was installed, than the specifications of the davit’s manufacturer required. This error was not identified. In April 2012, a thorough examination was made of lifeboats and its launching appliances on Thomson Majesty, according to regulations of SOLAS. The examination included examinations for corrosion and performance tests during overload. All lifeboats and launching appliances passed the examination. (Marine Safety Investigation Unit, 2014)

- **Lifeboats and rescue boats may fall down during launching** due to corrosion on wires. To prevent the problem, the maintenance of wires should be improved, the exchange period of the wires shortened and the reliability of wires increased by higher

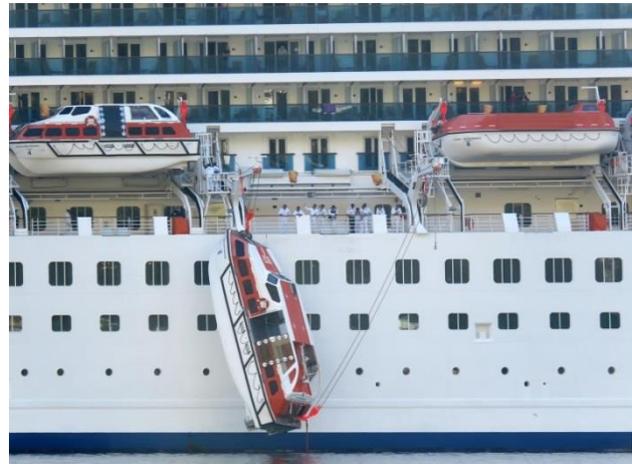
The 24th of August 2015, the cruise ship Costa Mediterranea was anchored in a port of Montenegro. It was lowering lifeboats to take passengers on excursions in the fjord of Kotor. Whilst lowering one of the lifeboats a cable broke causing the lifeboat to fall and hang in a vertical position. No one was on board during the lowering and there are no reports of injuries. Costa Cruises commented on the incident and explained that they experienced technical problem while lowering the lifeboat and that during the incident neither the safety of crew or passengers were put at risk. (Stuards, 2015)

Figure 25 shows the lifeboat hanging vertically. Picture: Drago Brdar, Shipspotting

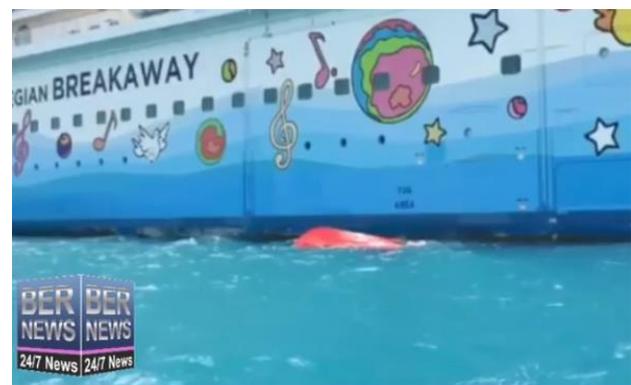
Figure 26 shows the rescue boat after incident. Picture captured from: (Schuler, 2016)

“the lifeboat was left hanging from one wire after it broke free from the tethering, resulting in the four crew members falling into the water.”
