Characterization of black corrosion in reinforced concrete structures: analyses of field samples from southern Sweden

Dissertations in Geology at Lund University,
Master's thesis, no 554
(45 hp/ECTS credits)

Department of Geology
Lund University
2019

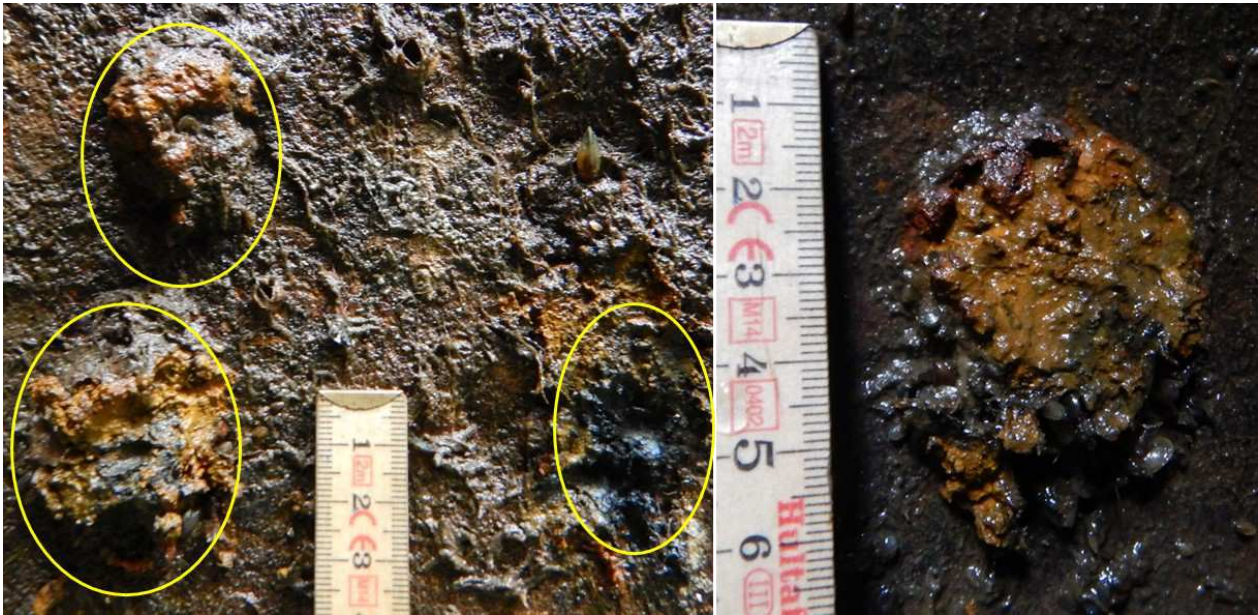
Fig. 6.1. Rust nodules covered with mainly red rust at a concrete wall in the field locality of The Sound. Generally these had a diameter of three to five centimeters. These are slightly covered by the surrounding biofilm.

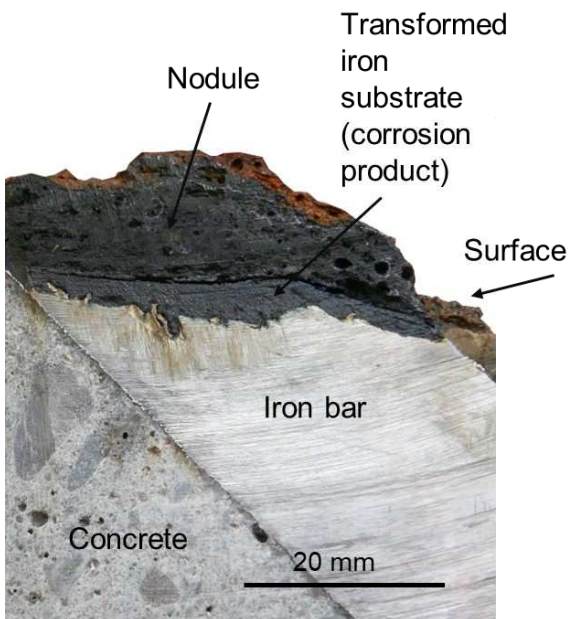
Fig. 6.2. A cross section from one of the samples from The Sound. The reinforcement is corroded in the upper part and is covered by a rust nodule. The sharp line between the nodule and corrosion product indicate to where the previous rebar reached.

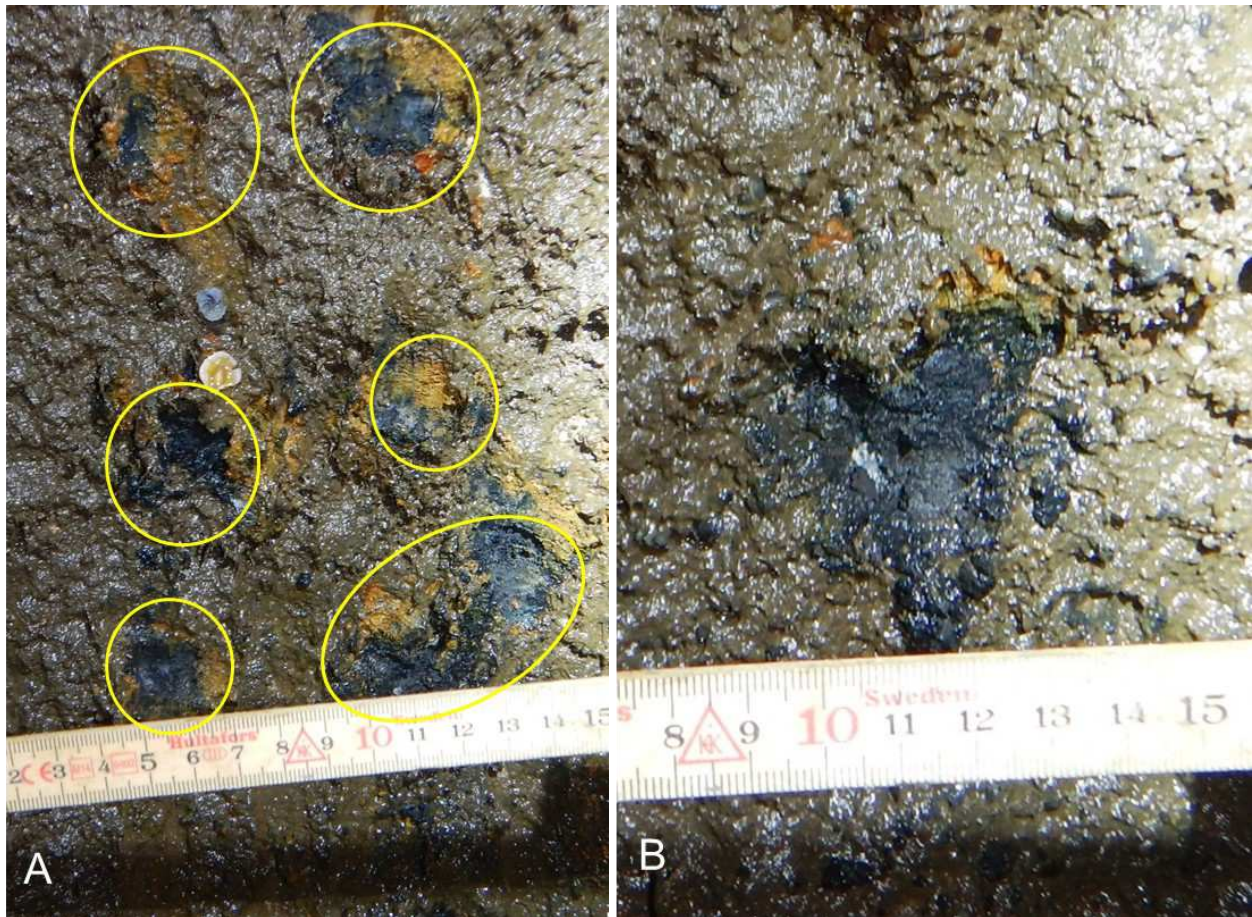
Fig. 6.3. The black spots on the concrete wall shows the interior of the nodules, which have been removed. The areas of these spots can be represented by the section area of the corroded rebar. This is how black rust looks like behind the layer of red rust. The surrounding brown/grey material is the biofilm covering the concrete wall. **A.** Several black spots within a relatively small area. **B.** A closer view of the black interior of a nodule.

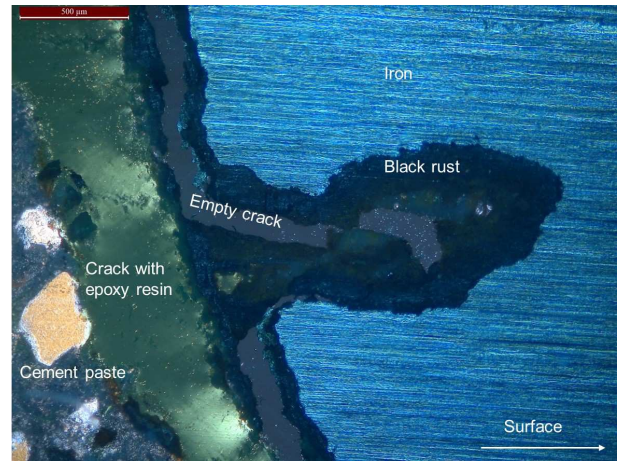
Fig. 6.9. A pit in the back of the reinforcement bar (iron) seen from the surface side (arrow). The pit is filled with corrosion products interpreted as black rust. An empty adhesion crack has recently formed in the corrosion products between the iron bar and the epoxy resin. This photomicrograph is taken in xpl with the darkfield mode enabled. The scale bar in the upper left corner is 500 µm.

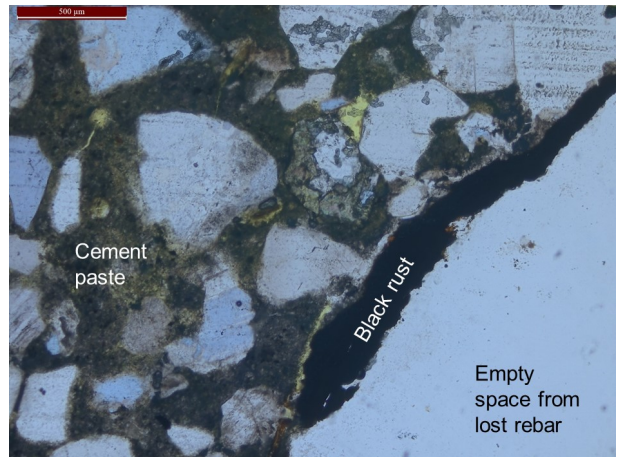
Fig. 6.10. The lower adhesion zone have small amounts of corrosion products compared to the upper rebar-concrete boundary. The line here is rather sharp without complete transformation of the cement paste. The piece of the reinforcement in this part of the thin section has vanished. The photomicrograph is in ppl and the scale bar in the upper left corner is 500 µm.

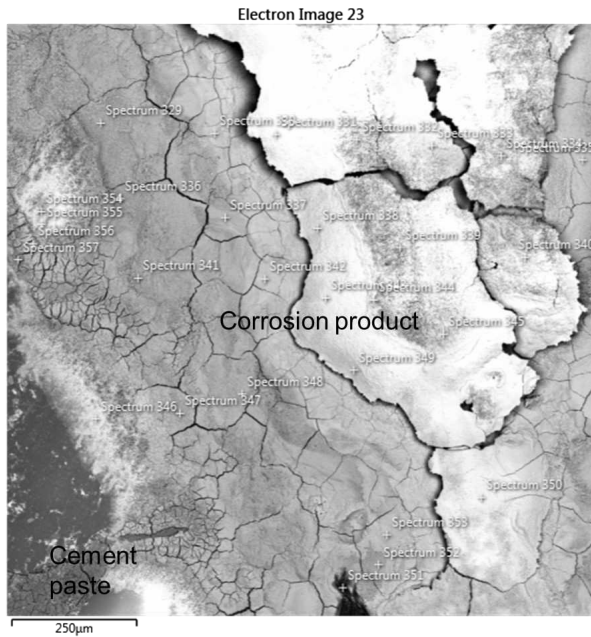
Fig. 6.16. Site 10 in Slice 1.1 has flakey and chloride rich corrosion products that is sitting on the rebar.

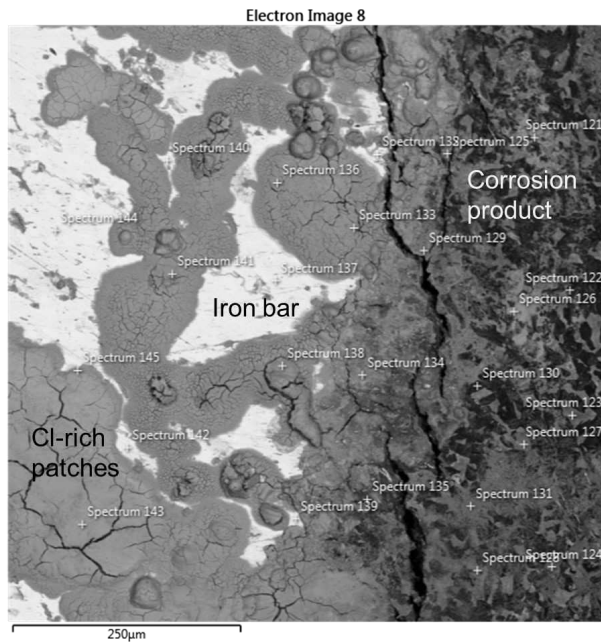
Fig. 6.22. BSE image of Site 8, Slice 1.2 is showing corrosion products in a dotted pattern. These are high in chlorides and formed on the iron surface after sample preparation. On the right side some corrosion product has infiltrated the cement paste.

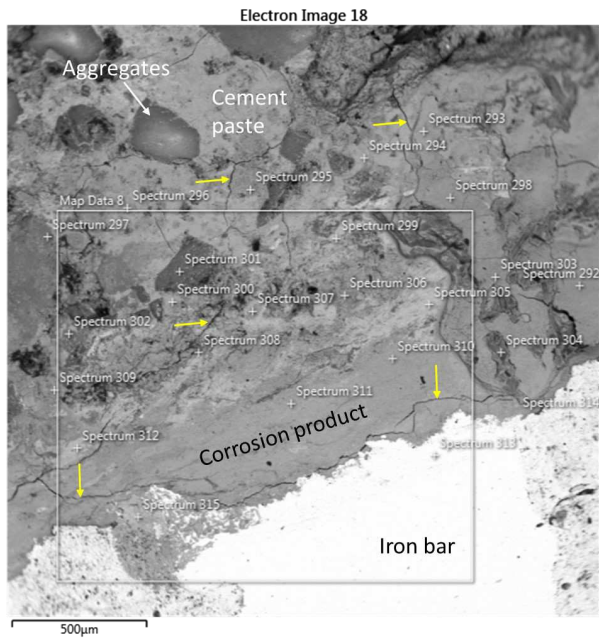
Fig. 6.26. Micro cracks are marked out with yellow arrows. In between the cement paste and the iron there is a zone of corrosion products.

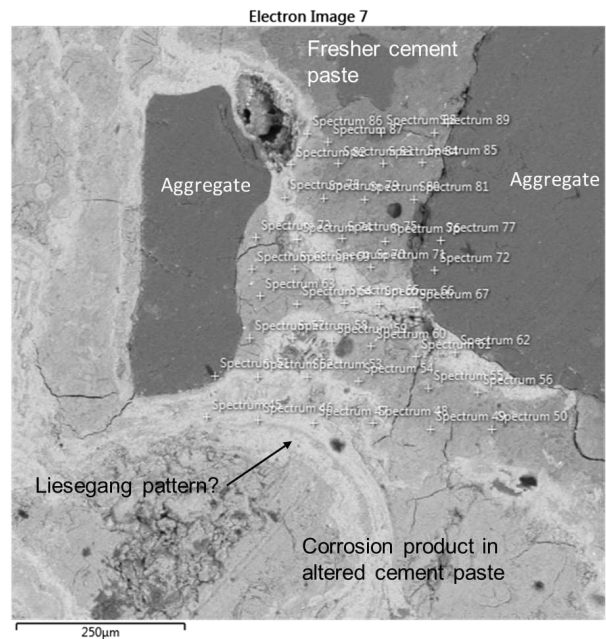
Fig. 6.28. The banded or layered structure that these corrosion products show are resembling of liesegang patterns. The lighter layers are slightly richer in iron compared to the areas in between.

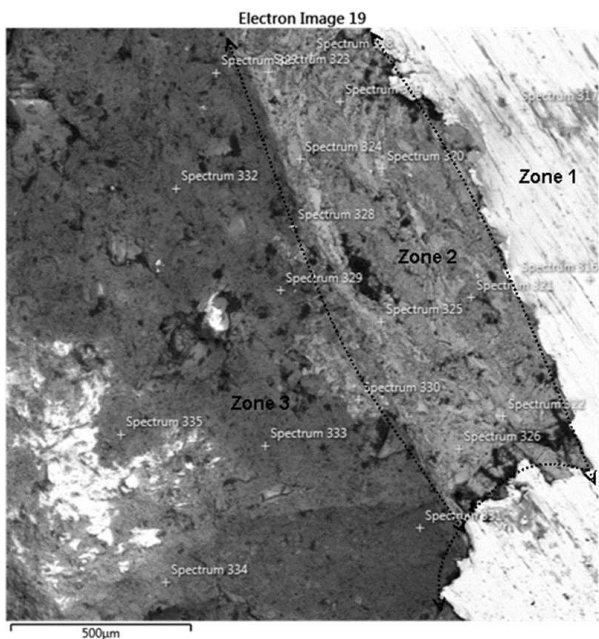
Fig. 6.27. A zone with corrosion products (Zone 2) in between the iron (Zone 1) and cement paste (Zone 3) has rather distinct borders. It seems to be a layered structure in Zone 2, which are likely to be a mixture of interlayered corrosion products.

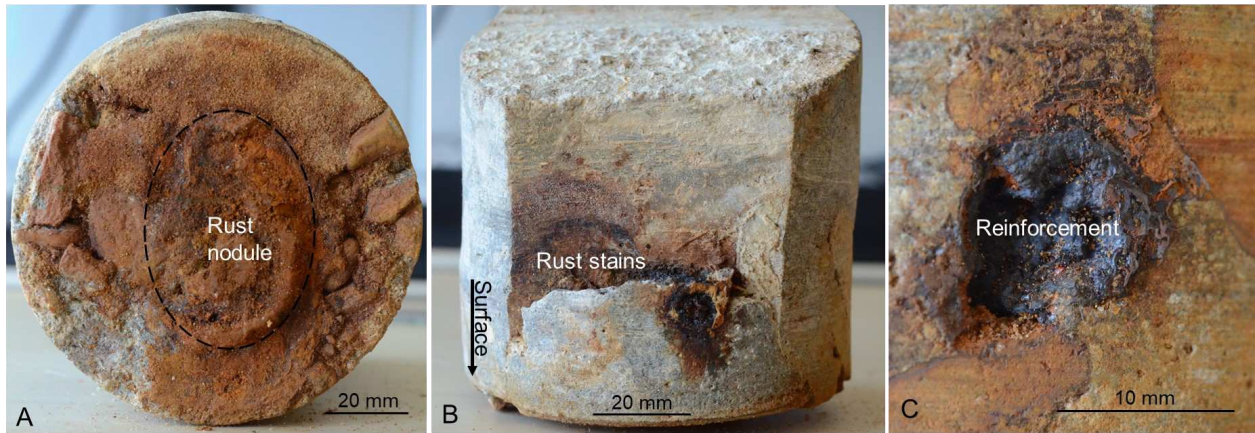
Fig. 6.30. The hand specimen of Sample 3 show several signs of deterioration of both cement paste and reinforcement. **A.** The surface of the concrete wall is represented by the top of this drill core. A rust nodule is covering the surface with red rust. **B.** Rust stains are seen around the reinforcement and at the side of the drill core. **C.** The reinforcement is totally covered with black rust. Photos: Fredrich, B.

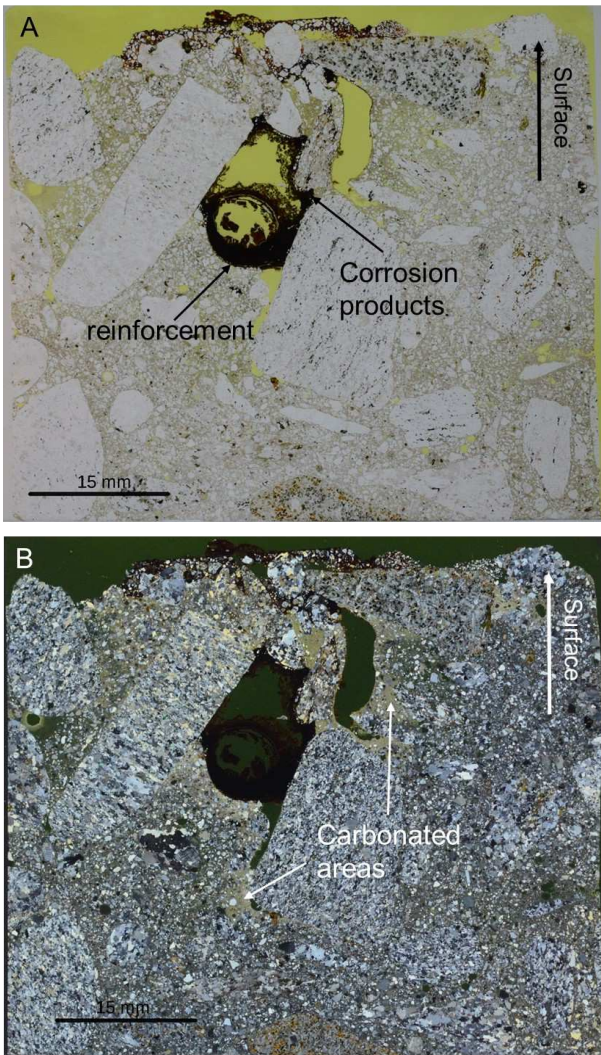
Fig. 6.31. Thin section 3 is shown in **A.** normal light where corrosion products are easily distinguished from the concrete, and **B.** polarized light, in which alteration of the cement paste (carbonation in this case) is easier to detect.

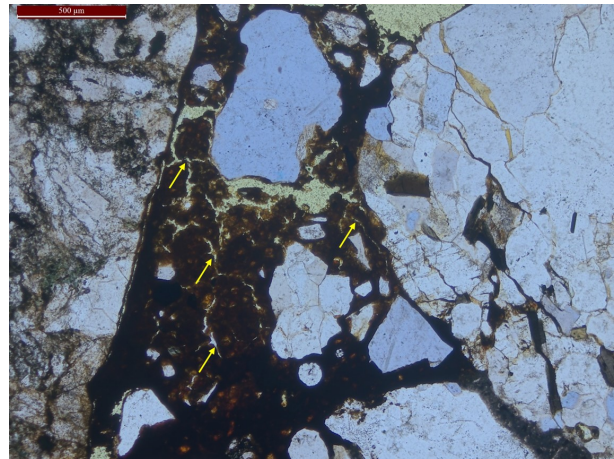
Fig. 6.32. Micro-cracks (yellow arrows) within the corrosion product is here a sign of dehydration or expansion. The scale bar in the upper left corner is 500 µm.

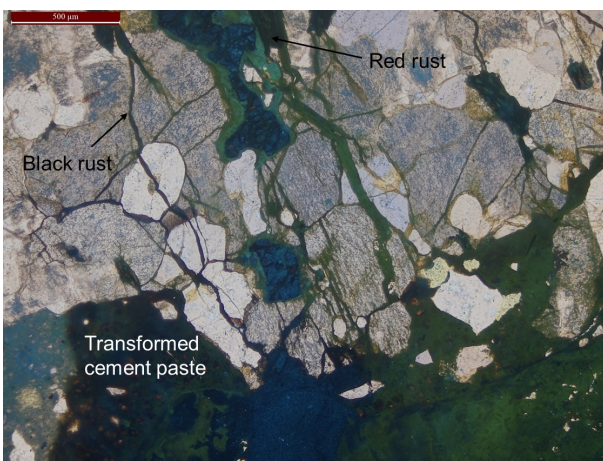
Fig. 6.33. Black rust within cracks that cross ballast particles. Red rust is mainly seen in the transformed cement paste. The scale bar is 500 μm.

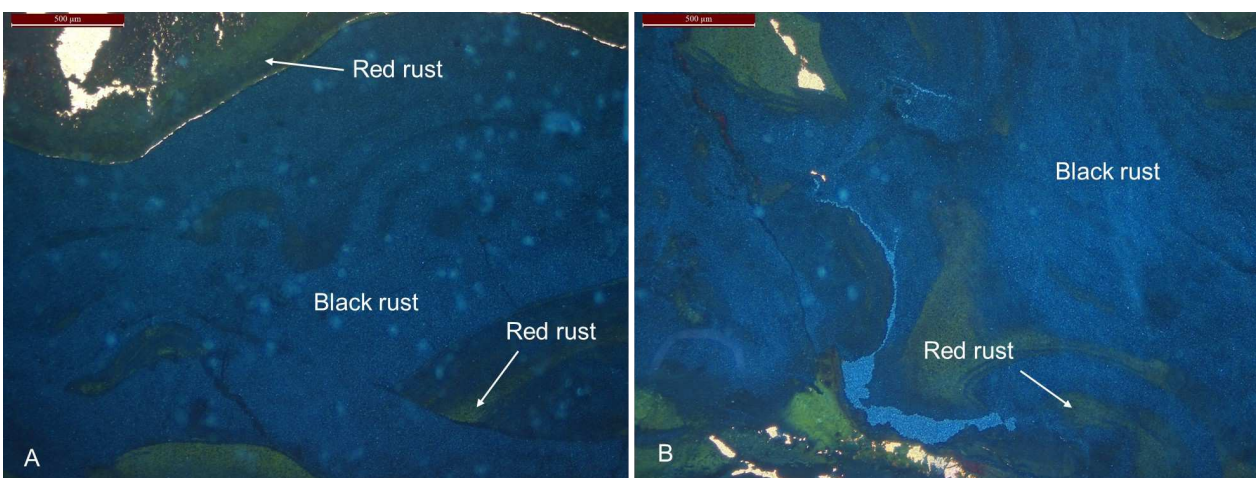
Fig. 6.34. Photomicrographs (ppl, darkfield mode) of the layered corrosion products of black rust in the transformed reinforcement. A. and B. both show corrosion products with a banded appearance where black and red rust are interlayered with red rust. Scale 500 μm.

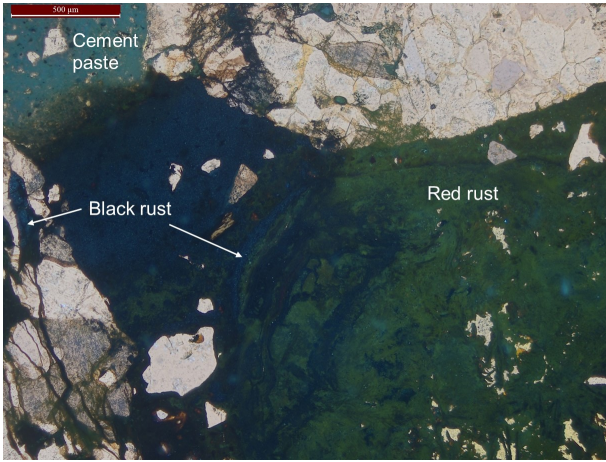
Fig. 6.35. The cement paste between two rock aggregates are more or less completely transformed to black and red rust. Scale 500 µm.

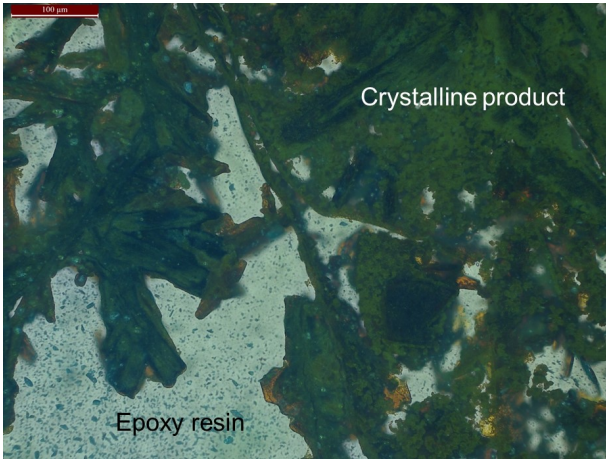
Fig. 6.36. Elongated crystalline products have grown within the hollow reinforcement bar. The darkfield mode in ppl is displaying these products as semi-transparent (brown crystals). Scale 100 µm.

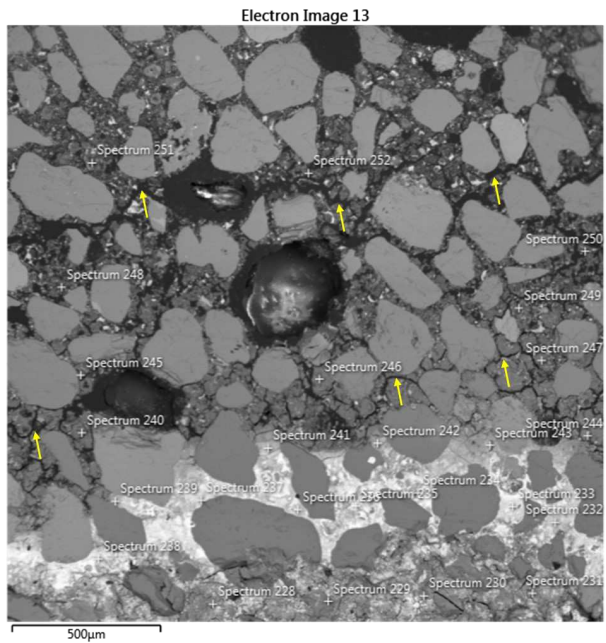
Fig. 6.39. A network of thin and dark epoxy filled cracks are pointed out with yellow arrows. The light band in the lower part of the BSE image is high in iron.

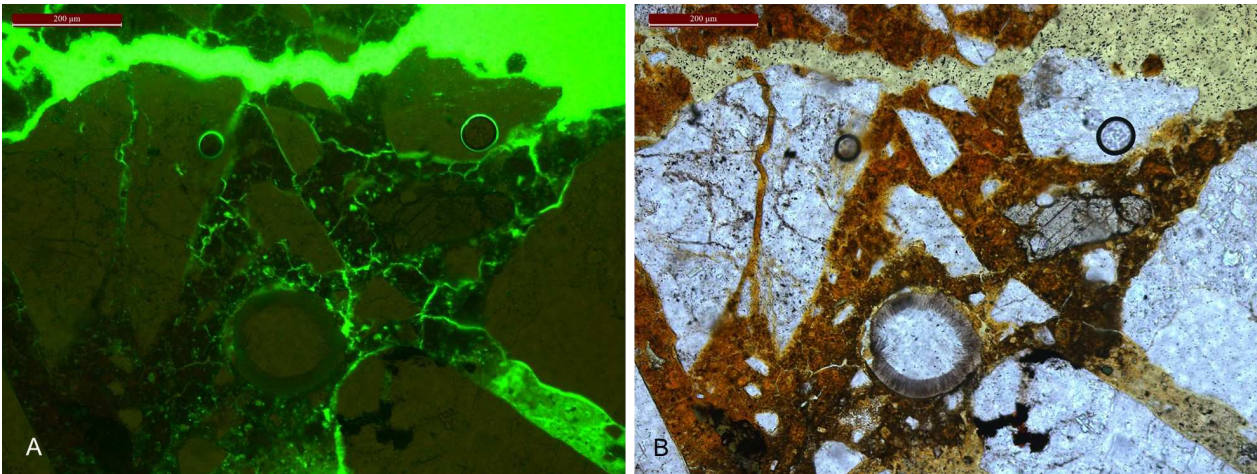
Fig. 6.45. Thin dehydration cracks in the transformed cement paste close to the surface. **A**. The fluorescent dye in the epoxy resin enhance cracks and porosity in the cement paste when it is illuminated with UV-light. **B**. The corrosion products are more visual in ppl. Scale 200 μm .

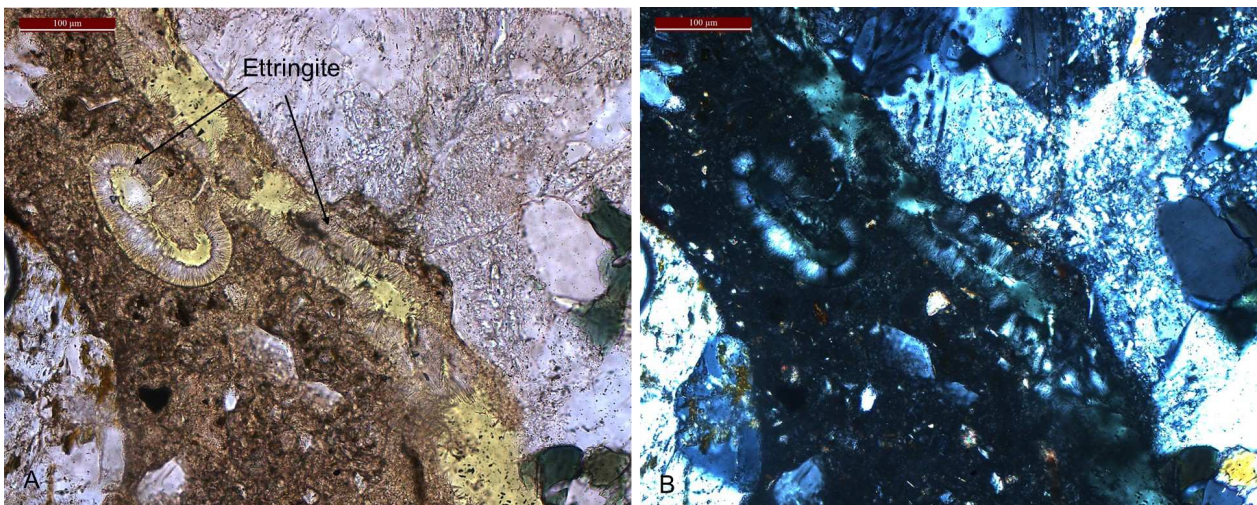
Fig. 6.46. A crack and with connected void filled with fibrous ettringite ($\text{Ca}_6\text{Al}_2(\text{SO}_4)_3(\text{OH})_{12} \cdot 26\text{H}_2\text{O}$) in **A**, ppl, and **B**, xpl. The ettringite is often a sign of that the concrete experienced a sulfate attack. Scale 100 μm .

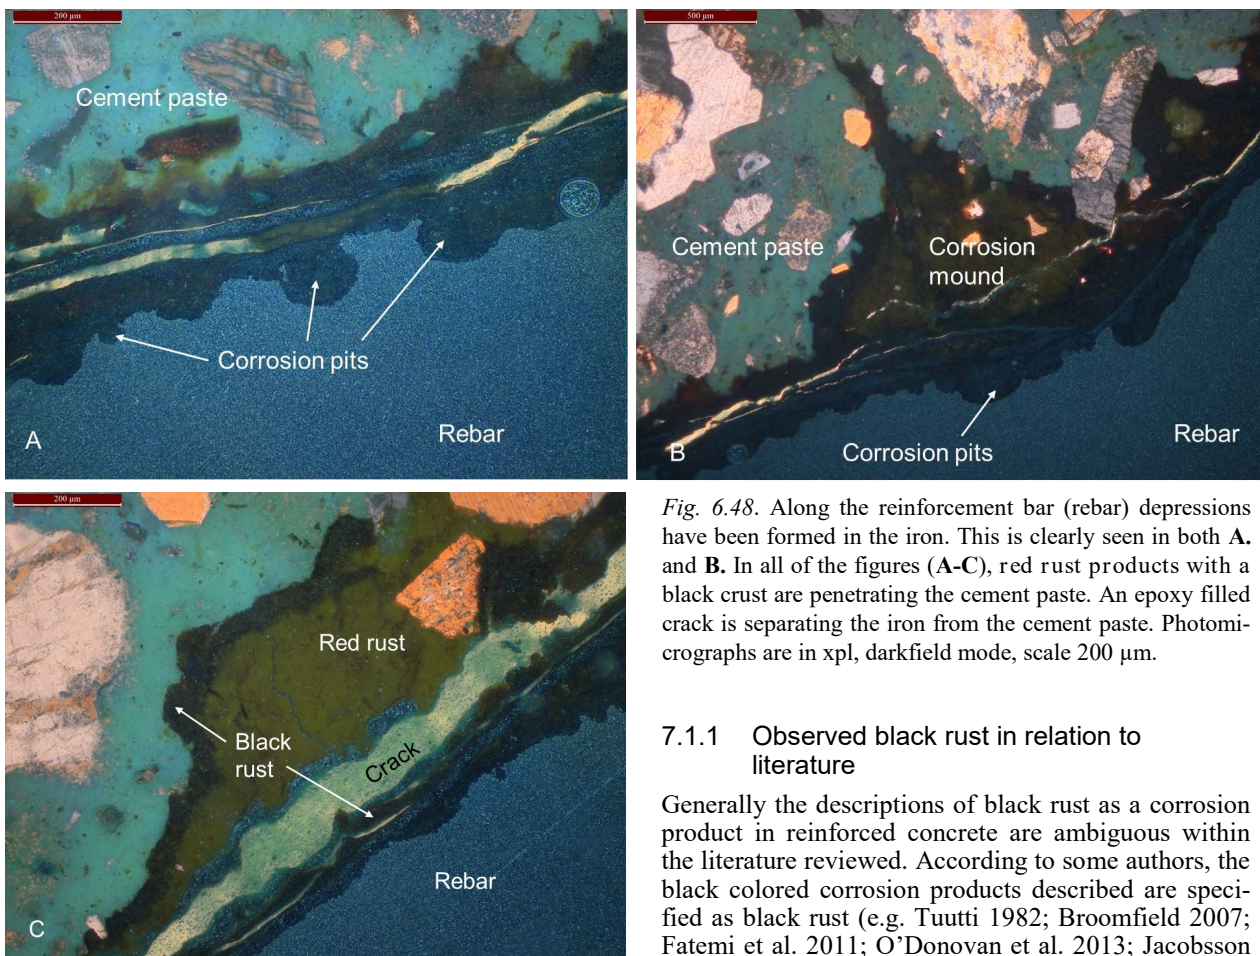
Fig. 6.48. Along the reinforcement bar (rebar) depressions have been formed in the iron. This is clearly seen in both **A**. and **B**. In all of the figures (**A-C**), red rust products with a black crust are penetrating the cement paste. An epoxy filled crack is separating the iron from the cement paste. Photomicrographs are in xpl, darkfield mode, scale 200 μm .

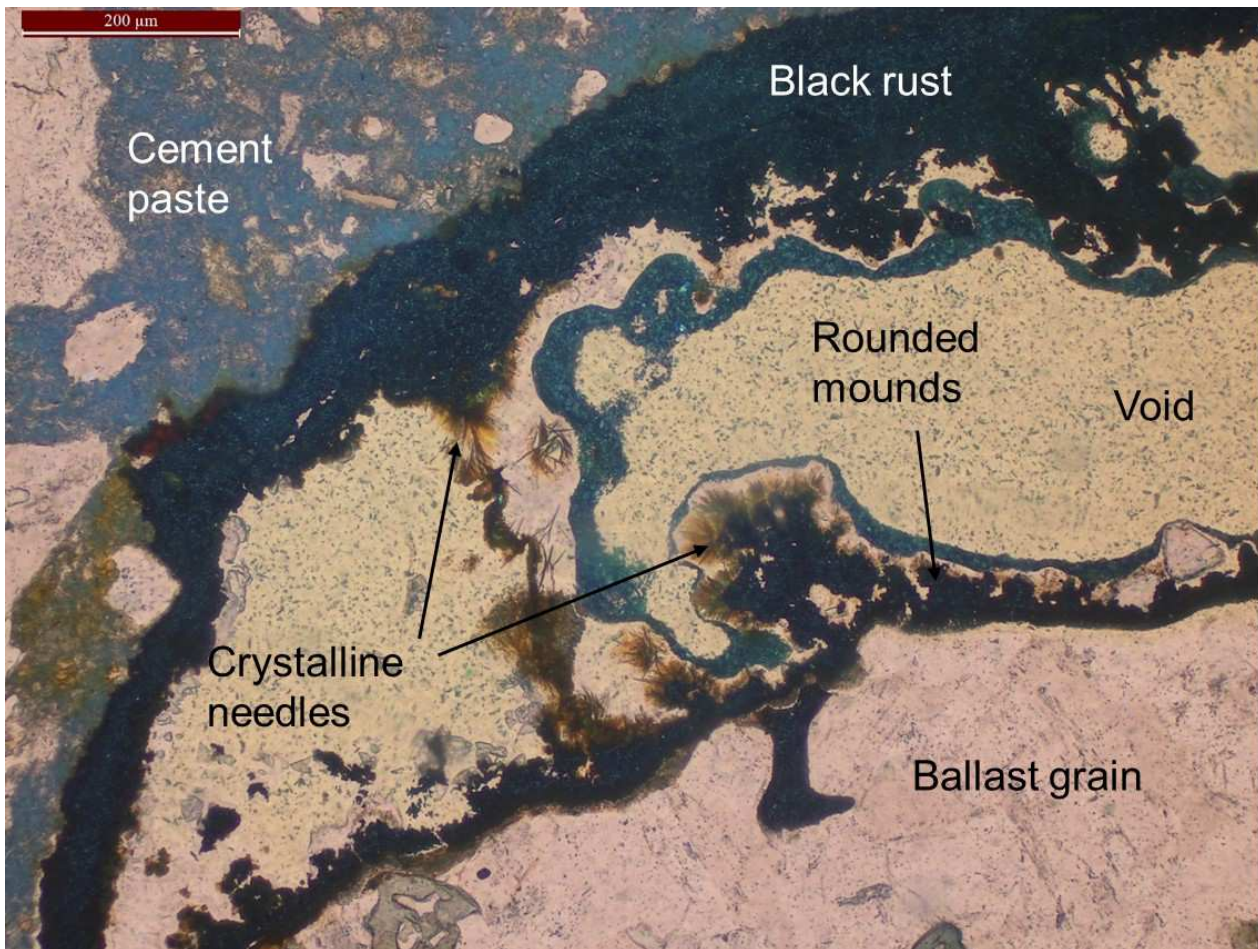
Fig. 6.49. Black rust and other corrosion products in a void close to the surface. The photomicrograph (in ppl, darkfield mode) is showing the different layers of products where the outer is the oldest product and the most central is the one which is most recently formed. Scale 200 μm.
