## **Wear mechanisms of silicon carbide-whisker-reinforced alumina (Al<sub>2</sub>O<sub>3</sub>-SiC<sub>w</sub>) cutting tools when high speed machining aged Alloy 718**

Volodymyr Bushlya<sup>1</sup>, Jinming Zhou<sup>1</sup>, Pajazit Avdovic<sup>2</sup>, Jan-Eric Ståhl<sup>1</sup>

### **Abstract**

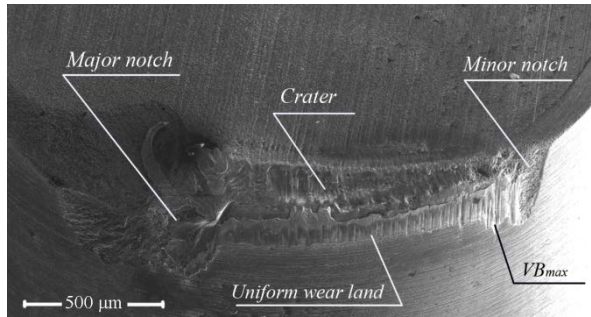
Irrespective of cutting conditions or coolant application the morphology of the worn-out tools comprises (see Fig. 1) of a notch on the major cutting edge (hereinafter major notch); crater; flank wear land (VB); notch on the minor cutting edge (hereinafter minor notch). Term major notch is used because the discovered morphology and formation mechanisms cannot be fully represented by a common term “depth-of-cut notch”, as shown in *section 3.1*.

**Fig. 1** Typical morphology of worn-out insert ( $v_c=250$  m/min,  $f=0.19$  mm/rev,  $a_p=0.53$  mm)

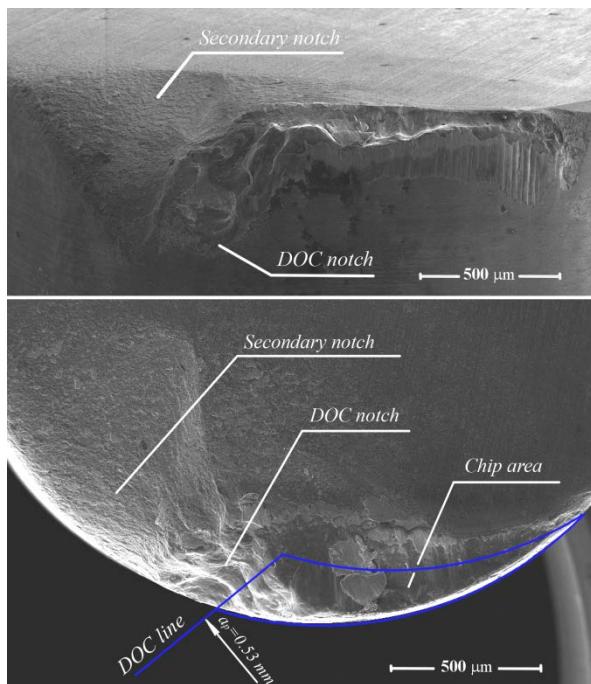
The present study has revealed existence of two notches formed on the major cutting edge. As seen in the Figure 2 the first notch is located at the depth-of-cut extremity (DOC notch), while the other, secondary notch, is located outside the chip area. Both crater and DOC notch exhibited smooth surface with low surface roughness (see Fig. 4.b). Distinguished feature of the secondary notch is its fracture-like appearance and high roughness (see Fig. 2) but it has minimum whisker exposure and limited bridging and pull out of whiskers which are intrinsic to an actual fracture surface.

Considering the location of DOC notch, it can be assumed that its formation may be called forth by several factors: thermal and mechanical stress gradients and attrition by burrs formed at depth-of-cut line. Only minor adhesion of the workpiece material was observed in this tool region. Formation of the secondary notch, which is located outside of chip contact area, on the opposite, has a major contribution from adhesive wear mechanism. Notch model by Xiao et al. [13] on the burrs being responsible for the formation of notch outside chip area didn't find support in the current experiments. Formation of the secondary notch in this study is attributed solely to the

**Fig. 2** Formation of two notches on the major cutting edge ( $v_c=250$  m/min,  $a_p=0.53$  mm,  $f=0.3$  mm/rev)

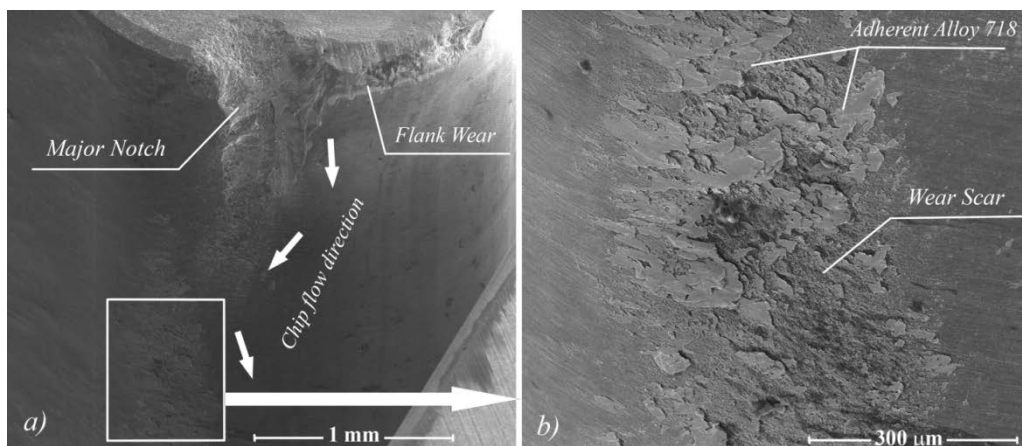
effect of chip curl-back. As seen from the Figure 3.a, the chips, when curling back towards the edge adhere to and abrade against the cutting edge. Fig. 3.b shows presence of severe adhesion of Alloy 718 on the flank surface of the tool. High temperature and high relative velocity of the chip and tool surfaces during their contact together with chemical affinity of silicon carbide whiskers and Alloy 718 can be seen as factors leading to adhesion. Tool/chip contact stresses are also expected to change their acting direction in presence of adhesion and therefore facilitate the wear. In overall, the discontinuous nature of the thermal and mechanical contact between the tool and the serrated edges of the chip (see Fig. 4.a) is expected to contribute to microfracture, fatigue cracking and pluck-out of the tool material.

Merger of DOC and secondary notches was found to lead to formation of a single major notch (see Fig. 3.a), which is governed by other combination of wear mechanisms. Formation of build-up edge (BUE) in the notch was observed on the regular basis, which complies with finding of other studies [6, 22]. Back scatter electron microscopy has revealed zones on the tools which are completely covered by adherent material and areas of freshly fractured surfaces. These fracture surfaces imply removal of tool aggregates due to delamination or removal of BUE. Figure 5.a shows a BUE removed from the major notch of a tool worn-out under  $v_c=300$  m/min,  $f=0.25$  mm/rev,  $a_p=0.53$  mm and machining with coolant. The inner surface of the BUE contains significant amount of tool material, as confirmed by EDX (Fig. 5.b). Analysis of major notch formation under different cutting conditions revealed significant presence of macrocracks which can be prompted by mechanical and thermal fatigue due to a periodic removal of BUE. Whisker pull-out and microcracking of the  $Al_2O_3$  matrix were also observed in majority of machining tests. These are expected to additionally decrease strength of the tool material and accelerate notch wear.

**Fig. 3** (a) Formation of major notch and (b) Chip adhesion on the tool flank ( $v_c=250$  m/min, dry machining)

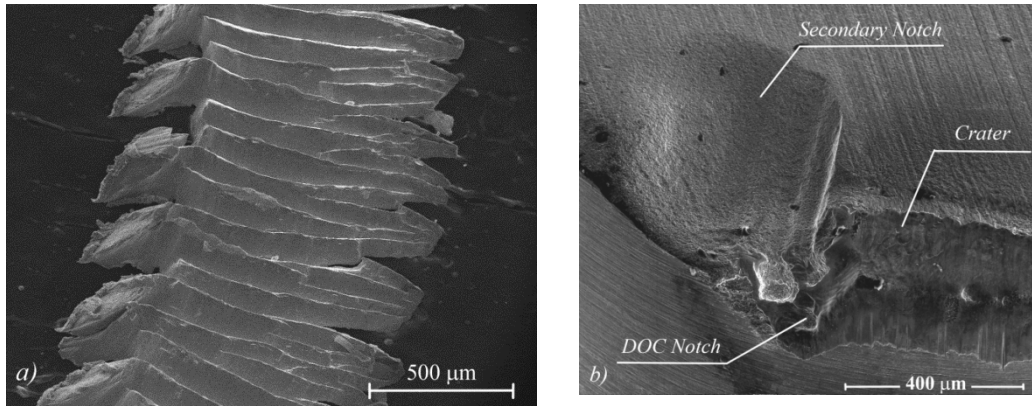
When machining with coolant, the amount of adherent material is less profound (see Fig. 4.b) and is limited to microwelding. Figure 4.b presents clear evidence that burrs do not influence the formation of the secondary notch since it is limited to the tool rake only. Furthermore limited amount of adherent material imply attrition wear mechanism. While the cause behind notch formation was found different, the acting mechanisms of adhesion and attrition comply with finding by Xiao et al. [13].

**Fig. 4** (c) Segmented chips ( $v_c=250$  m/min,  $VB_{max}=0.17$  mm, coolant) and (b) Formation of the secondary notch by chip attrition ( $v_c=200$  m/min, coolant)

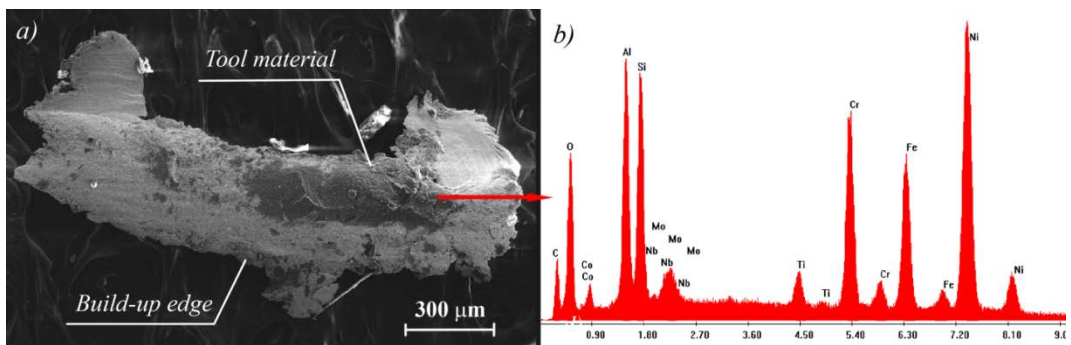
**Fig. 5** (a) Build-up edge of Alloy 718 with removed tool material and (b) respective EDX

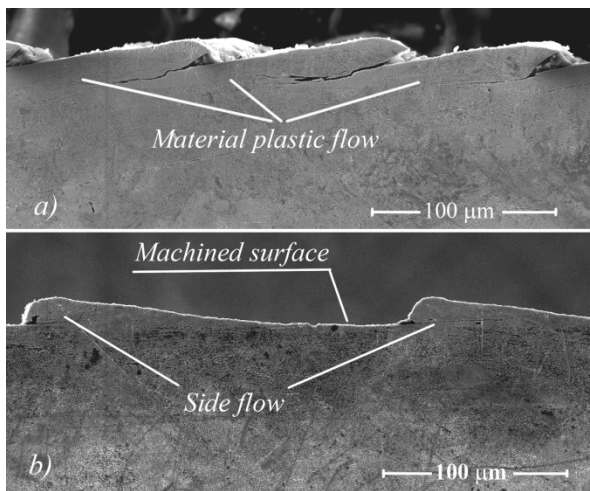
It was found in this study that minor notch is related to the defects left on the surface during machining. Two types of related surface defects were identified: severe plastic flow and side-flow. Presence of severe material plastic flow (Fig. 6.a) was observed under both dry and wet conditions. Similar surface defect was registered by Kitagawa et al. [1] and Narutaki et al. [9] when machining Alloy 718 with whisker reinforced, mixed alumina and  $Si_3N_4$  tooling at cutting speed around 150 m/min. In current study presence of material plastic flow was observed under majority of test conditions, yet intensity of this surface defect varied with process conditions. Increase in feed, speed and application of coolant strongly reduces presence of this type of damage up to the full disappearance. Machining under dry conditions and with slightly worn tools promotes formation of this damage. It was observed that as the tool wear progresses ( $VB>0.1-0.15$

mm) the material plastic flow is suppressed and replaced by formation of side-flow in its typical understanding (see Fig. 6.b).

Appearance of material plastic flow can be explained through the findings of Gatto and Iuliano [12] who have reported the presence of transverse material flow when machining Alloy 718 with ceramic tools. Such transverse flow, along with dramatic increase in ductility of Alloy 718 at temperature around 1000 °C up to 160 % [23] may facilitate separation of the chip at thickness higher than its otherwise minimum value  $h_{1min}$ . The remaining chip element is then ploughed to a side towards minor edge and left on the surface in the form of a continuous or discontinuous scale (Fig. 6.a).

**Fig. 6** (a) Formation of plastic flow and (b) Side flow on the machined surface

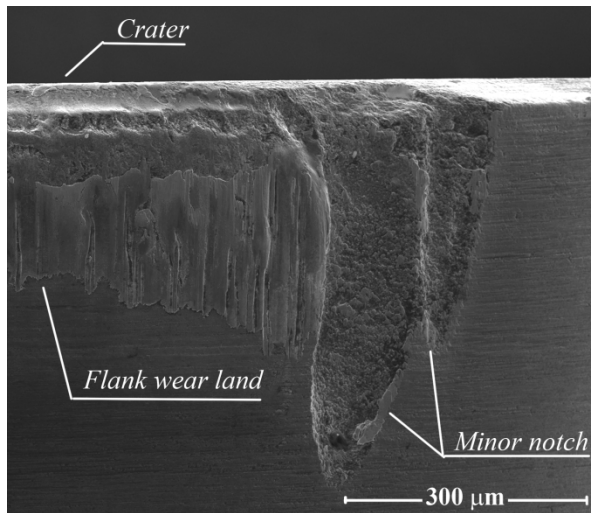
Both plastic flow scale and side-flow left on the machined surface dramatically increase its roughness leading to a contact between tool flank and these asperities. Measurement of microhardness on these surface defects has shown an increase up 590-620 HV as compared to ~470 HV of the bulk. Abrasion of the tool flank against these surface defects leads to formation of the notch. Multiple minor notch found on the tool flank (see Fig. 7) with uniform spacing between individual notches equaling to the feed value of  $f=0.15$  mm/rev presents a clear evidence on the suggested wear mechanism. Traces of adhered Alloy 718 found on the minor notch surfaces suggest a combined abrasive and adhesive mechanism of tool wear.

**Fig. 7** Minor notch due to abrasion between tool flank and machined surface ( $v_c=300$  m/min,  $f=0.15$  mm/rev,  $a_p=0.53$  mm)

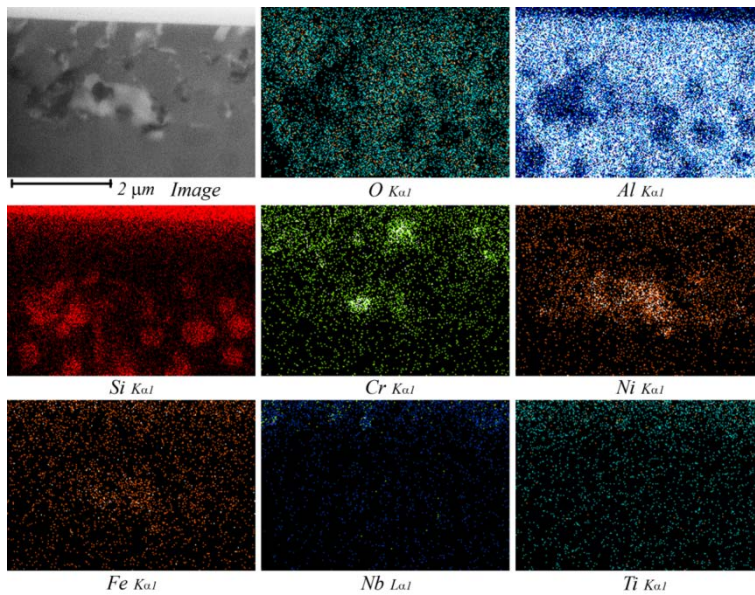
EDX mapping (see Fig. 8) on a lamellae removed from the rake of worn-out insert via focused ion beam (FIB) milling allowed to identify diffusion of Ni, Cr, Fe and to some extent Nb into SiC whiskers while no diffusional attack on alumina was evident. Previously reported diffusion of Ti [17], Mo and Co [24] was not observed. It can be seen that silicon is not present in a near-surface region which can be explained by counterdiffusion of silicon and Alloy 718 with replacement by diffusing elements. It is also noted that Ni and Fe diffuse markedly deeper than Cr (Fig. 8) due to an ease of formation of chromium carbides with free carbon left in the whiskers after replacement of Si. Intensive carbide-formation tendency of niobium can be similarly attributed to its limited diffusion into the near-surface region.

**Fig. 8** EDX map of diffusion of elements from Alloy 718 into the tool material

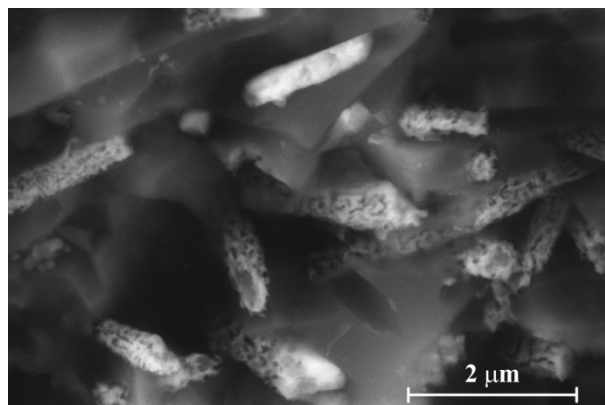
Decomposition of the whiskers and replacement of silicon in them reduces mechanical properties of both whiskers and the ceramic as a whole therefore enhancing susceptibility to mechanical damage. The back-scatter electron image of SiC whiskers on the tool rake (Fig. 9) shows that they completely or partially degrade due to diffusion of Ni, Cr, Fe. Weakening of tool material accompanied by intensive adhesion of Alloy 718 has been observed to lead to fracture, cracking and pluck out of both whiskers and Al<sub>2</sub>O<sub>3</sub> matrix (see Fig. 9). This particular type of degradation was observed to have the highest intensity in the area of DOC notch and on minor cutting edge where unstable tribolayer intensifies adhesion.

**Fig. 9** Diffusional degradation of SiC whiskers on the crater

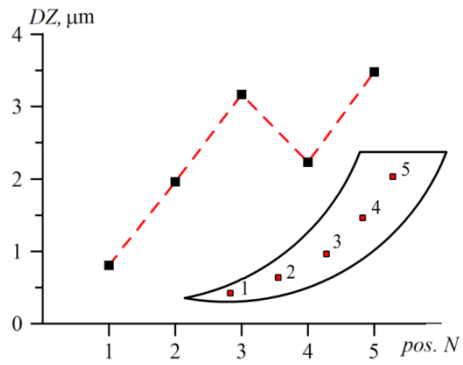
Figure 10 presents the variation of thickness of diffusion zone (DZ), measured along the edge line via FIB sectioning. Intensity of diffusion, which is temperature dependent, has its maximum in  $h_{1max}$  region of the tool and correlates well with the thermal load distribution on the rake of nose-radiused tools [15]. FIB cross section along the wear land on the flank has shown that thickness of diffusion zone is the highest in the middle of VB land. This behavior has a good correlation with the temperature distribution on the flank of worn-out ceramic tools [25].

**Fig. 10** Variation in thickness of diffusion zone along the crater ( $v_c=250$  m/min,  $f=0.3$  mm/rev)

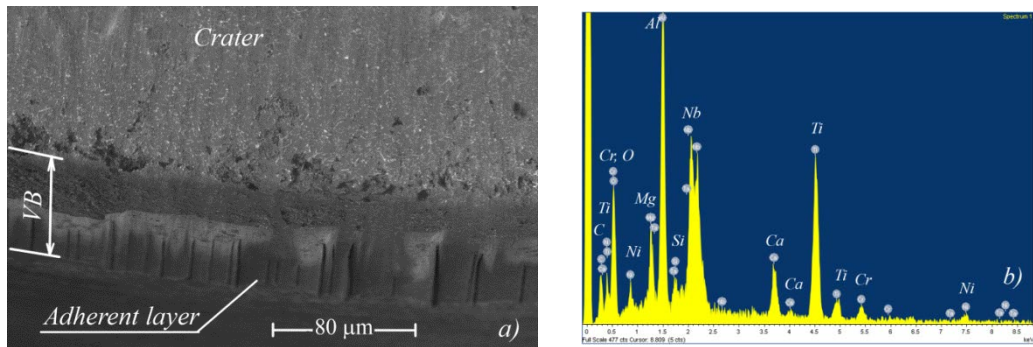
Chemical etching of worn-out tools with Kalling's No 2 etchant, which leads to dissolution of build-up and adherent layer of Alloy 718, allowed to identify presence of a film or a layer on tool surfaces. Such layer is known to form on ceramic tools during machining as a result of chemical reactions with workpiece material or environment [16, 19]. Two separate zones of tribolayer (see Fig. 11.a): on the crater and on the flank wear land were found on the worn tools, both varying in morphology and chemical composition. A deposit which consists of wear products and products of their reactions with coolant was also observed on the tool rake but outside the crater. It is seen (Fig. 11.a) that layer on the flank is not continuous and is concentrated in the lower part of wear

land. FIB cross sectioning provided evidence that approximately 50  $\mu\text{m}$  of VB land closest to the edge is layer-free while it gradually increases in thickness and reaches  $\sim 0.1\text{-}0.15 \mu\text{m}$  at the end of wear land. Identification of chemical composition of this layer is impeded by its low thickness. Large EDX excitation volume, when compared to the thickness, may lead to low sensitivity or may distort the results. For that reason the EDX (Fig. 11.b) was performed on a more massive accumulation of wear products found in a fracture cavity at the end of wear land. Markedly high concentrations of Ti, Nb and lesser of Cr were detected both on the flank and wear products deposition outside the crater. All three elements are prone to formation of carbides with carbon left in the whiskers after diffusion of silicon (see Fig. 8). Presence of TiC and NbC carbides in the microstructure of Alloy 718 and their severe fragmentation during machining [26] allows assuming simultaneous carbide formation and accumulation of debris from broken TiC and NbC on the tool flank. Identified presence of magnesium and calcium despite their absence in the material specification for Alloy 718 can be explained by the use low quantities of MgO as deoxidizer for Alloy 718 [2] whereas CaO is a regular deoxidizer for steels [16]. On the other hand, it can be argued that both calcium and magnesium come from a coolant consisting of 5% semi-synthetic additive and hard water rich in  $\text{Ca}^{2+}$  and  $\text{Mg}^{2+}$  ions. Hard water has a higher concentration of both elements (normally  $>100$  ppm) when compared to 30 ppm found by Brandt et al. [2] in Alloy 718. In either case expected are the reactions with  $\text{Al}_2\text{O}_3$  with generation of  $\text{MgO}\cdot n\cdot\text{Al}_2\text{O}_3$  spinel which forms at temperatures around  $1200^\circ\text{C}$  [27].

**Fig. 11** (a) Adherent layer on the tool flank after chemical etching ( $v_c=250$  m/min,  $f=0.13$  mm/rev) and (b) EDX spectra on the wear products accumulated in the fracture on the flank wear ( $v_c=250$  m/min,  $f=0.17$  mm/rev)

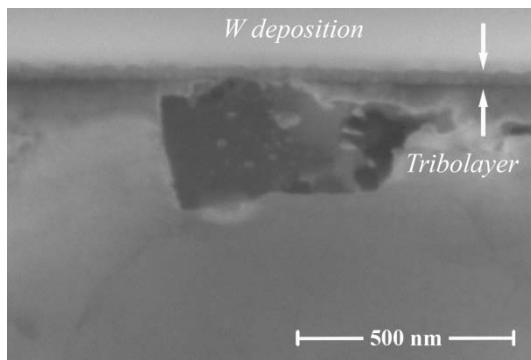
Figure 12 shows the FIB cross-section taken on the crater of worn tool at  $v_c=250$  m/min,  $f=0.19$  mm/rev and  $a_p=0.53$  mm. Uniform tribolayer of thickness of 40-80 nanometers was observed on the surface. Tribolayer on the rake completely covers the crater (Fig. 11.a) and as shown above has a low roughness and glass-like appearance. Such formation is normally attributed to formation of silica glass or several additional reactions discussed below. The main mechanism of silica formation is through the following oxidation reaction [28]:

**Fig. 12** FIB cross-section of the tribolayer on the crater of worn tool

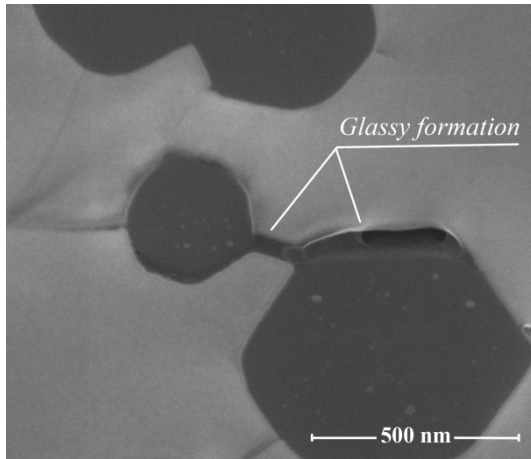
**Fig. 13** Formation of glassy phase in the near-surface region of the crater

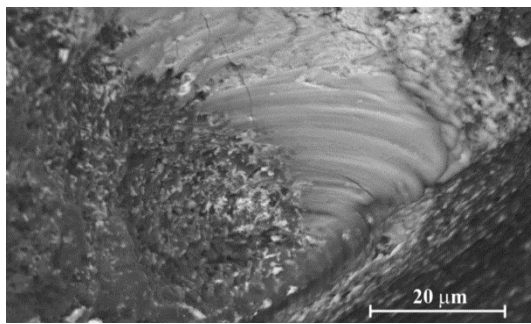
As seen from the observations, formation of either silica or aluminosilicate glass takes place during machining. Liquid, at high temperatures, glassy phase is pushed to a region of lesser tool/workpiece pressure and is squeezed outside chip area on major and minor cutting edge where it solidifies on cooling (see Fig. 14). Similar structures were observed both under dry machining and machining with coolant.

**Fig. 14** Liquefied tribolayer on the minor cutting edge side of the crater ( $v_c=250$  m/min,  $f=0.25$  mm/rev)

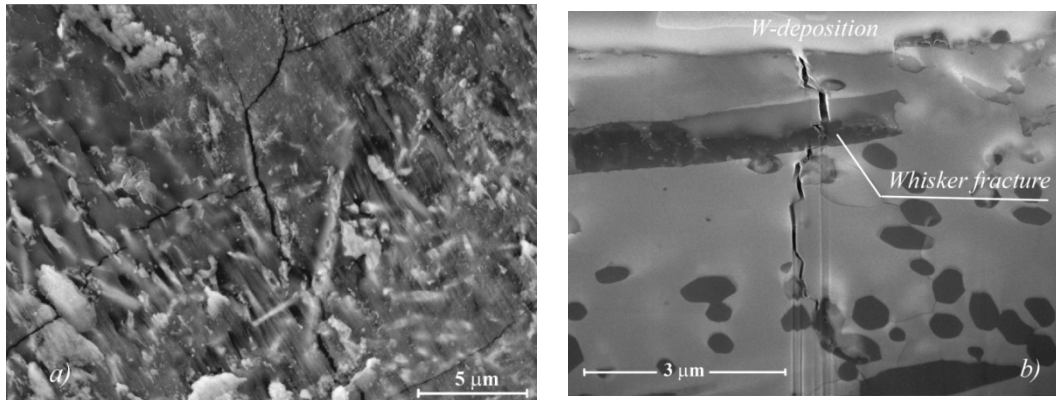
in thermal expansion coefficient for whiskers and therefore promotes cracking (see Fig. 15.a) through formation of tensile stresses upon cooling.

On the other hand, it was reported [16] that cracking may arise in the tribolayer upon tool disengagement and cooling. In such case the cracks are limited to the layer and do not penetrate into the tool bulk. FIB cross sectioning through the cracked region in our case has allowed to detect that cracks significantly extend into the bulk (see Fig. 15.b). It was observed that crack may deflect on whiskers with formation of a mesh of smaller cracks along with the main crack. Diffusion assisted problems with thermal expansion mismatch leading to the development of compressive stresses at high temperatures are known to further strengthen the bonding between alumina matrix and SiC whiskers. Such behavior is expected to promote whisker fracture instead of debonding (Fig. 15.b).

**Fig. 15** (a) Cracking on the crater and (b) propagation of the crack into the tool bulk

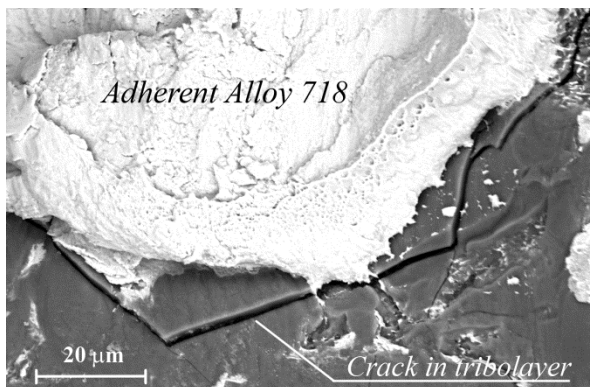
**Fig. 16** Adherent Alloy 718 on the crater and associated cracking

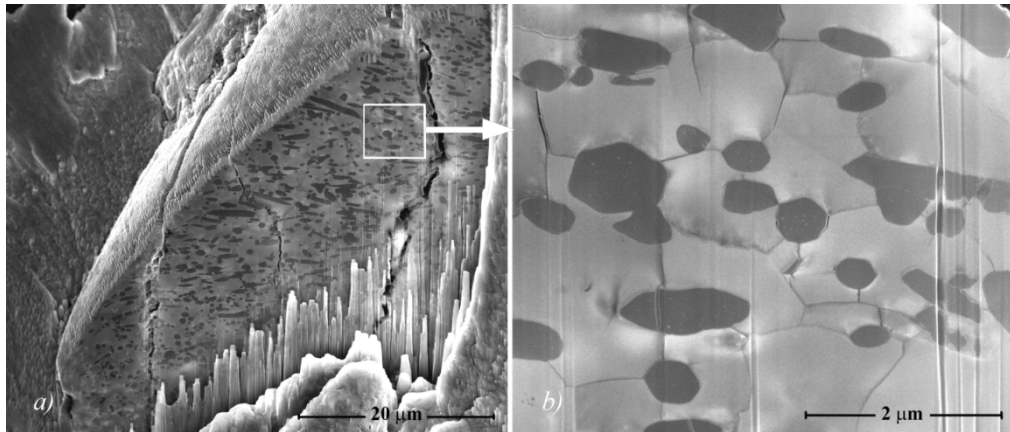
While it is commonly accepted that plastic deformation for ceramics takes place in superficial zones on the tool [16], bulk plastic deformation in machining is also reported [32, 33]. Observations of worn-out tools performed in this study did not provide a support for the bulk plastic deformation. However dry machining and machining with coolant under aggressive cutting conditions ( $v_c=250 \text{ m/min}$ ,  $f=0.25 \text{ mm/rev}$ ) generated localized cracking-like tool damage which is recognized as plastic deformation as well [34]. Small volumes of tool material close to the DOC notch region exhibited extensive cracking on the rake. FIB sectioning (see Fig. 17.a) of the discussed region has shown formation of several major cracks penetrating into tool bulk and complete fracture of alumina matrix on mainly grain boundaries (Fig. 17.b). The cavitation between  $\text{Al}_2\text{O}_3$  grains and between whiskers and alumina grains (see Fig. 17.b) is observed in this case. Such cracking and cavitation in  $\text{Al}_2\text{O}_3$ -SiC ceramics are reported to be the main mechanisms of plastic deformation by creep [35].

**Fig. 17** (a) FIB cross-section of plastically deformed zone with (b) Crack network of in the alumina matrix

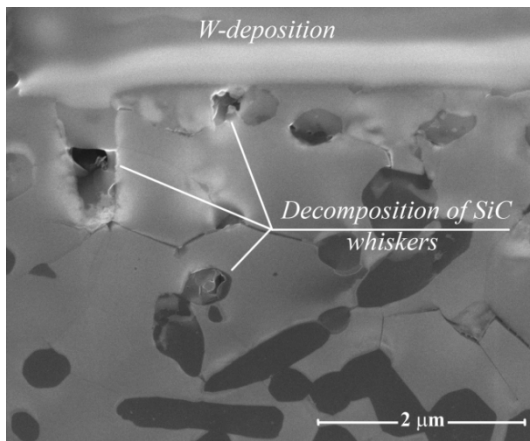
It was found that chemical degradation of whiskers is not limited to the diffusion and formation of silica on the whisker surface. Additional mechanism of chemical decomposition of whiskers was observed (Fig. 18) in near-surface regions of the worn tool. On the opposite to formation of silica, degradation takes place in the whisker core (see Fig. 18) with formation of a cavity.

Defective structure of SiC whiskers with concentration of defects and voids in their core [36] provides an easier pass for inwards progression of oxygen. Formation of cavities instead of glassy phase implies generation of gaseous products [37], where  $\text{SiC}_{(s)} + 2 \cdot \text{SiO}_{2(s)} = 3 \cdot \text{SiO}_{(g)} + \text{CO}_{(g)}$  and  $\text{SiC}_{(s)} + \text{O}_{2(g)} = \text{SiO}_{(g)} + \text{CO}_{(g)}$  are the two plausible reactions of whisker degradation [14], yet both are expected at temperatures above intrinsic to the machining of Alloy 718.

**Fig. 18** Chemical decomposition in the core of SiC whiskers
