Wear mechanisms of silicon carbide-whisker-reinforced alumina (Al₂O₃-SiCw) cutting tools when high-speed machining aged Alloy 718

Bushlya, Volodymyr; Zhou, Jinming; Avdovic, Pajazit; Ståhl, Jan-Eric

Published in:
International Journal of Advanced Manufacturing Technology

2013

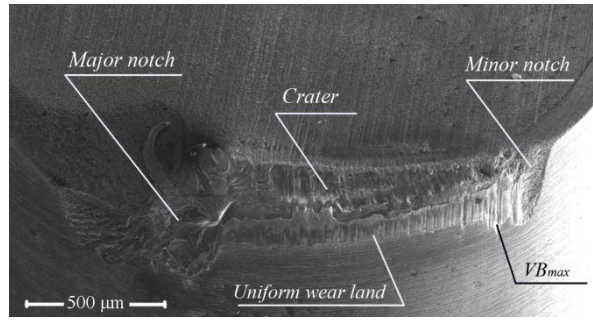
Irrespective of cutting conditions or coolant application the morphology of the worn-out tools comprises (see Fig. 1) of a notch on the major cutting edge (hereinafter major notch); crater; flank wear land (VB); notch on the minor cutting edge (hereinafter minor notch). Term major notch is used because the discovered morphology and formation mechanisms cannot be fully represented by a common term “depth-of-cut notch”, as shown in *section 3.1*.

Fig. 1 Typical morphology of worn-out insert ($v_c=250$ m/min, $f=0.19$ mm/rev, $a_p=0.53$ mm)

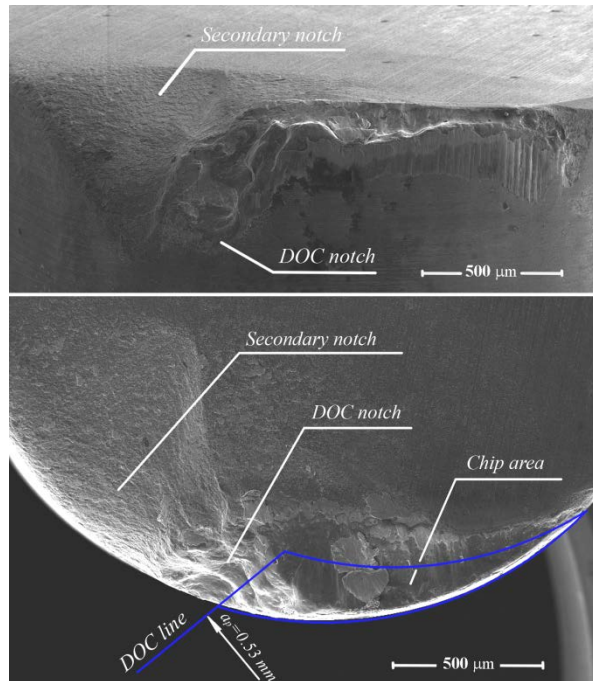
The present study has revealed existence of two notches formed on the major cutting edge. As seen in the Figure 2 the first notch is located at the depth-of-cut extremity (DOC notch), while the other, secondary notch, is located outside the chip area. Both crater and DOC notch exhibited smooth surface with low surface roughness (see Fig. 4.b). Distinguished feature of the secondary notch is its fracture-like appearance and high roughness (see Fig. 2) but it has minimum whisker exposure and limited bridging and pull out of whiskers which are intrinsic to an actual fracture surface.

Considering the location of DOC notch, it can be assumed that its formation may be called forth by several factors: thermal and mechanical stress gradients and attrition by burrs formed at depth-of-cut line. Only minor adhesion of the workpiece material was observed in this tool region. Formation of the secondary notch, which is located outside of chip contact area, on the opposite, has a major contribution from adhesive wear mechanism. Notch model by Xiao et al. [13] on the burrs being responsible for the formation of notch outside chip area didn't find support in the current experiments. Formation of the secondary notch in this study is attributed solely to the

Fig. 2 Formation of two notches on the major cutting edge ($v_c=250$ m/min, $a_p=0.53$ mm, $f=0.3$ mm/rev)

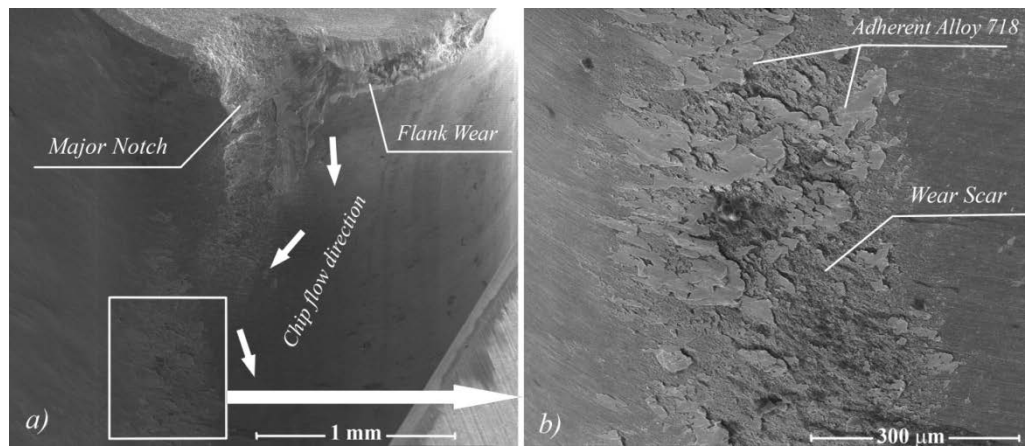
effect of chip curl-back. As seen from the Figure 3.a, the chips, when curling back towards the edge adhere to and abrade against the cutting edge. Fig. 3.b shows presence of severe adhesion of Alloy 718 on the flank surface of the tool. High temperature and high relative velocity of the chip and tool surfaces during their contact together with chemical affinity of silicon carbide whiskers and Alloy 718 can be seen as factors leading to adhesion. Tool/chip contact stresses are also expected to change their acting direction in presence of adhesion and therefore facilitate the wear. In overall, the discontinuous nature of the thermal and mechanical contact between the tool and the serrated edges of the chip (see Fig. 4.a) is expected to contribute to microfracture, fatigue cracking and pluck-out of the tool material.

Merger of DOC and secondary notches was found to lead to formation of a single major notch (see Fig. 3.a), which is governed by other combination of wear mechanisms. Formation of build-up edge (BUE) in the notch was observed on the regular basis, which complies with finding of other studies [6, 22]. Back scatter electron microscopy has revealed zones on the tools which are completely covered by adherent material and areas of freshly fractured surfaces. These fracture surfaces imply removal of tool aggregates due to delamination or removal of BUE. Figure 5.a shows a BUE removed from the major notch of a tool worn-out under $v_c=300$ m/min, $f=0.25$ mm/rev, $a_p=0.53$ mm and machining with coolant. The inner surface of the BUE contains significant amount of tool material, as confirmed by EDX (Fig. 5.b). Analysis of major notch formation under different cutting conditions revealed significant presence of macrocracks which can be prompted by mechanical and thermal fatigue due to a periodic removal of BUE. Whisker pull-out and microcracking of the Al_2O_3 matrix were also observed in majority of machining tests. These are expected to additionally decrease strength of the tool material and accelerate notch wear.

Fig. 3 (a) Formation of major notch and (b) Chip adhesion on the tool flank ($v_c=250$ m/min, dry machining)

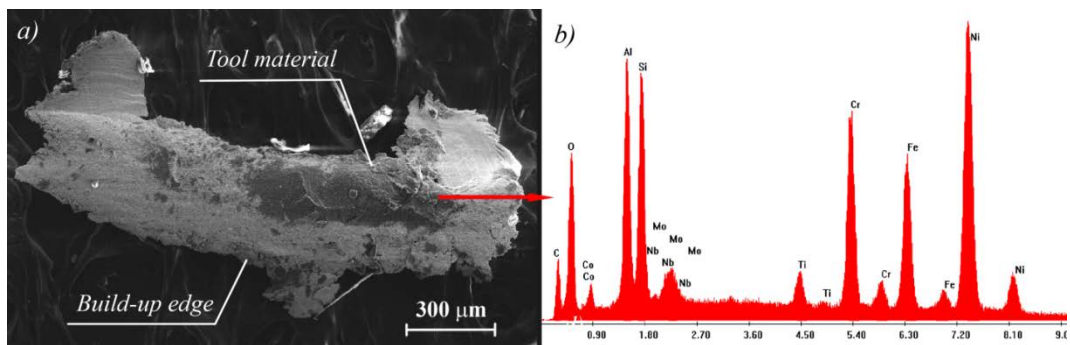
Fig. 5 (a) Build-up edge of Alloy 718 with removed tool material and (b) respective EDX

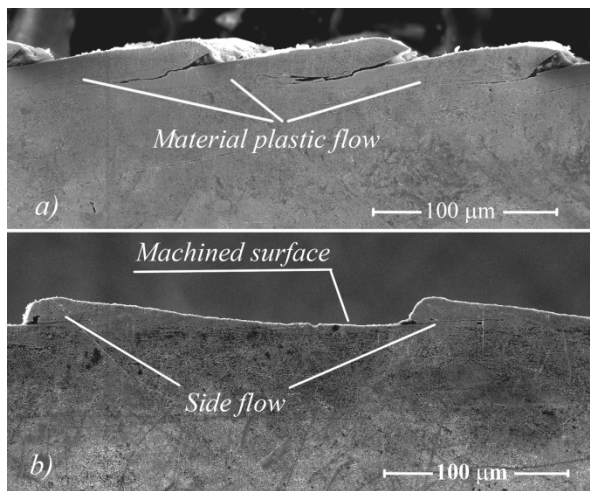
It was found in this study that minor notch is related to the defects left on the surface during machining. Two types of related surface defects were identified: severe plastic flow and side-flow. Presence of severe material plastic flow (Fig. 6.a) was observed under both dry and wet conditions. Similar surface defect was registered by Kitagawa et al. [1] and Narutaki et al. [9] when machining Alloy 718 with whisker reinforced, mixed alumina and Si_3N_4 tooling at cutting speed around 150 m/min. In current study presence of material plastic flow was observed under majority of test conditions, yet intensity of this surface defect varied with process conditions. Increase in feed, speed and application of coolant strongly reduces presence of this type of damage up to the full disappearance. Machining under dry conditions and with slightly worn tools promotes formation of this damage. It was observed that as the tool wear progresses ($VB>0.1$ - 0.15

mm) the material plastic flow is suppressed and replaced by formation of side-flow in its typical understanding (see Fig. 6.b).

Appearance of material plastic flow can be explained through the findings of Gatto and Iuliano [12] who have reported the presence of transverse material flow when machining Alloy 718 with ceramic tools. Such transverse flow, along with dramatic increase in ductility of Alloy 718 at temperature around 1000 °C up to 160 % [23] may facilitate separation of the chip at thickness higher than its otherwise minimum value h_{min} . The remaining chip element is then ploughed to a side towards minor edge and left on the surface in the form of a continuous or discontinuous scale (Fig. 6.a).

Fig. 6 (a) Formation of plastic flow and (b) Side flow on the machined surface

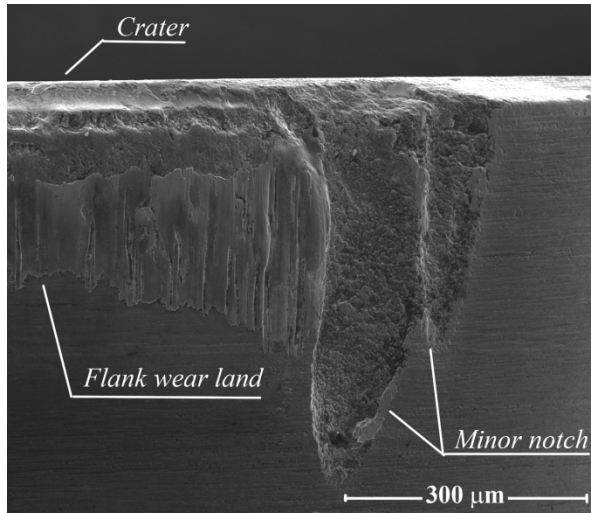
Both plastic flow scale and side-flow left on the machined surface dramatically increase its roughness leading to a contact between tool flank and these asperities. Measurement of microhardness on these surface defects has shown an increase up 590-620 HV as compared to ~470 HV of the bulk. Abrasion of the tool flank against these surface defects leads to formation of the notch. Multiple minor notch found on the tool flank (see Fig. 7) with uniform spacing between individual notches equaling to the feed value of $f=0.15$ mm/rev presents a clear evidence on the suggested wear mechanism. Traces of adhered Alloy 718 found on the minor notch surfaces suggest a combined abrasive and adhesive mechanism of tool wear.

Fig. 7 Minor notch due to abrasion between tool flank and machined surface ($v_c=300$ m/min, $f=0.15$ mm/rev, $a_p=0.53$ mm)

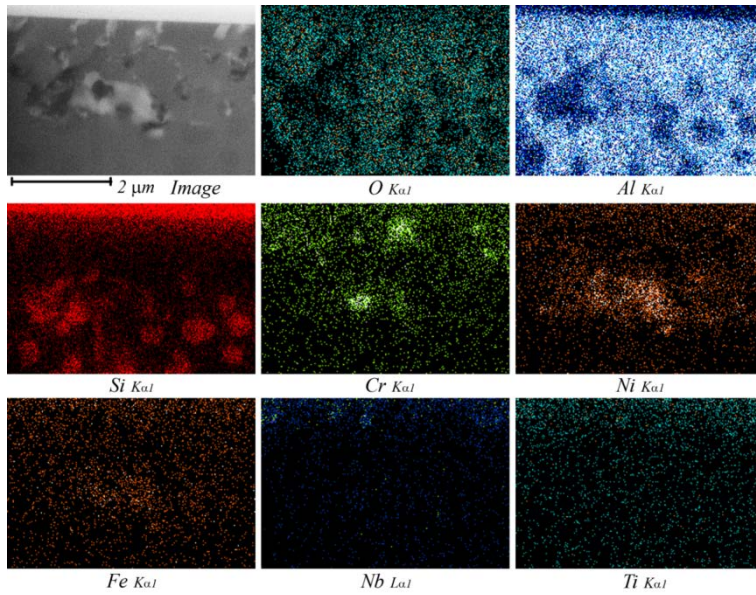
EDX mapping (see Fig. 8) on a lamellae removed from the rake of worn-out insert via focused ion beam (FIB) milling allowed to identify diffusion of Ni, Cr, Fe and to some extent Nb into SiC whiskers while no diffusional attack on alumina was evident. Previously reported diffusion of Ti [17], Mo and Co [24] was not observed. It can be seen that silicon is not present in a near-surface region which can be explained by counterdiffusion of silicon and Alloy 718 with replacement by diffusing elements. It is also noted that Ni and Fe diffuse markedly deeper than Cr (Fig. 8) due to an ease of formation of chromium carbides with free carbon left in the whiskers after replacement of Si. Intensive carbide-formation tendency of niobium can be similarly attributed to its limited diffusion into the near-surface region.

Fig. 8 EDX map of diffusion of elements from Alloy 718 into the tool material

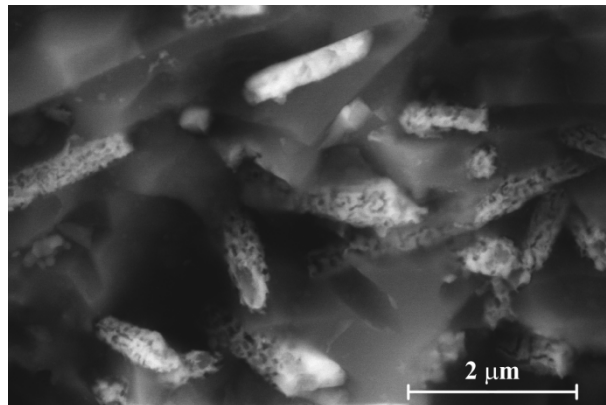
Decomposition of the whiskers and replacement of silicon in them reduces mechanical properties of both whiskers and the ceramic as a whole therefore enhancing susceptibility to mechanical damage. The back-scatter electron image of SiC whiskers on the tool rake (Fig. 9) shows that they completely or partially degrade due to diffusion of Ni, Cr, Fe. Weakening of tool material accompanied by intensive adhesion of Alloy 718 has been observed to lead to fracture, cracking and pluck out of both whiskers and Al_2O_3 matrix (see Fig. 9). This particular type of degradation was observed to have the highest intensity in the area of DOC notch and on minor cutting edge where unstable tribolayer intensifies adhesion.

Fig. 9 Diffusional degradation of SiC whiskers on the crater

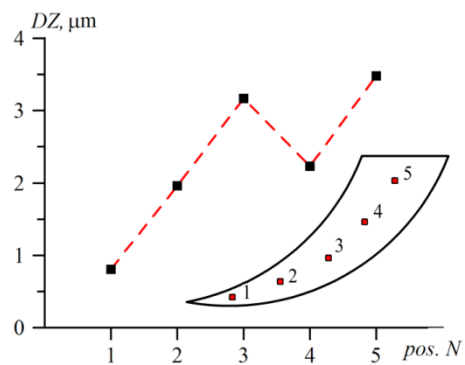
Figure 10 presents the variation of thickness of diffusion zone (DZ), measured along the edge line via FIB sectioning. Intensity of diffusion, which is temperature dependent, has its maximum in h_{max} region of the tool and correlates well with the thermal load distribution on the rake of nose-radiused tools [15]. FIB cross section along the wear land on the flank has shown that thickness of diffusion zone is the highest in the middle of VB land. This behavior has a good correlation with the temperature distribution on the flank of worn-out ceramic tools [25].

Fig. 10 Variation in thickness of diffusion zone along the crater ($v_c=250$ m/min, $f=0.3$ mm/rev)

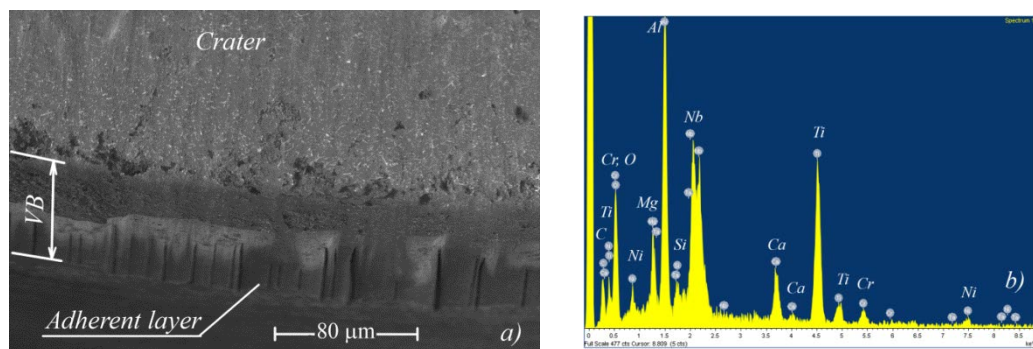
Chemical etching of worn-out tools with Kalling's No 2 etchant, which leads to dissolution of build-up and adherent layer of Alloy 718, allowed to identify presence of a film or a layer on tool surfaces. Such layer is known to form on ceramic tools during machining as a result of chemical reactions with workpiece material or environment [16, 19]. Two separate zones of tribolayer (see Fig. 11.a): on the crater and on the flank wear land were found on the worn tools, both varying in morphology and chemical composition. A deposit which consists of wear products and products of their reactions with coolant was also observed on the tool rake but outside the crater. It is seen (Fig. 11.a) that layer on the flank is not continuous and is concentrated in the lower part of wear

land. FIB cross sectioning provided evidence that approximately 50 μm of VB land closest to the edge is layer-free while it gradually increases in thickness and reaches $\sim 0.1\text{-}0.15\ \mu\text{m}$ at the end of wear land. Identification of chemical composition of this layer is impeded by its low thickness. Large EDX excitation volume, when compared to the thickness, may lead to low sensitivity or may distort the results. For that reason the EDX (Fig. 11.b) was performed on a more massive accumulation of wear products found in a fracture cavity at the end of wear land. Markedly high concentrations of Ti, Nb and lesser of Cr were detected both on the flank and wear products deposition outside the crater. All three elements are prone to formation of carbides with carbon left in the whiskers after diffusion of silicon (see Fig. 8). Presence of TiC and NbC carbides in the microstructure of Alloy 718 and their severe fragmentation during machining [26] allows assuming simultaneous carbide formation and accumulation of debris from broken TiC and NbC on the tool flank. Identified presence of magnesium and calcium despite their absence in the material specification for Alloy 718 can be explained by the use low quantities of MgO as deoxidizer for Alloy 718 [2] whereas CaO is a regular deoxidizer for steels [16]. On the other hand, it can be argued that both calcium and magnesium come from a coolant consisting of 5% semi-synthetic additive and hard water rich in Ca^{2+} and Mg^{2+} ions. Hard water has a higher concentration of both elements (normally $>100\ \text{ppm}$) when compared to 30 ppm found by Brandt et al. [2] in Alloy 718. In either case expected are the reactions with Al_2O_3 with generation of $\text{MgO}\cdot n\cdot\text{Al}_2\text{O}_3$ spinel which forms at temperatures around $1200\ ^\circ\text{C}$ [27].

Fig. 11 (a) Adherent layer on the tool flank after chemical etching ($v_c=250$ m/min, $f=0.13$ mm/rev) and (b) EDX spectra on the wear products accumulated in the fracture on the flank wear ($v_c=250$ m/min, $f=0.17$ mm/rev)

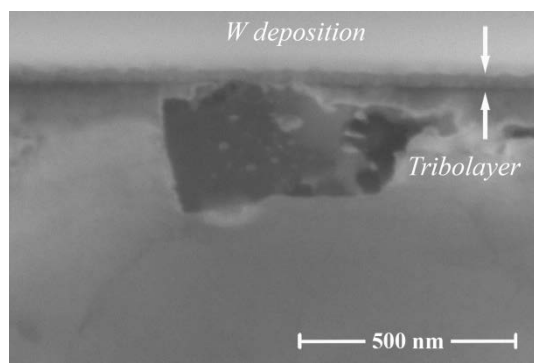
Figure 12 shows the FIB cross-section taken on the crater of worn tool at $v_c=250\ \text{m/min}$, $f=0.19\ \text{mm/rev}$ and $a_p=0.53\ \text{mm}$. Uniform tribolayer of thickness of 40-80 nanometers was observed on the surface. Tribolayer on the rake completely covers the crater (Fig. 11.a) and as shown above has a low roughness and glass-like appearance. Such formation is normally attributed to formation of silica glass or several additional reactions discussed below. The main mechanism of silica formation is through the following oxidation reaction [28]:

Fig. 12 FIB cross-section of the tribolayer on the crater of worn tool

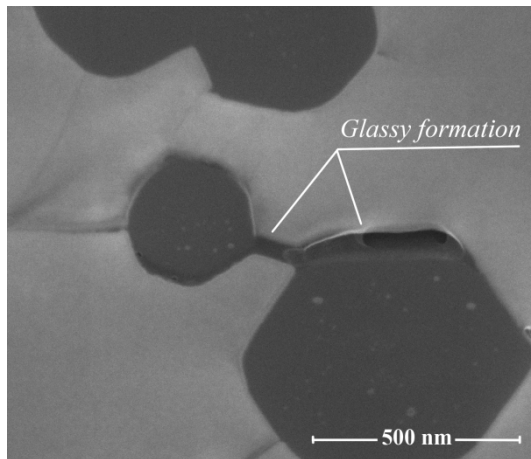
As seen from the observations, formation of either silica or aluminosilicate glass takes place during machining. Liquid, at high temperatures, glassy phase is pushed to a region of lesser tool/workpiece pressure and is squeezed outside chip area on major and minor cutting edge where it solidifies on cooling (see Fig. 14). Similar structures were observed both under dry machining and machining with coolant.

Fig. 13 Formation of glassy phase in the near-surface region of the crater

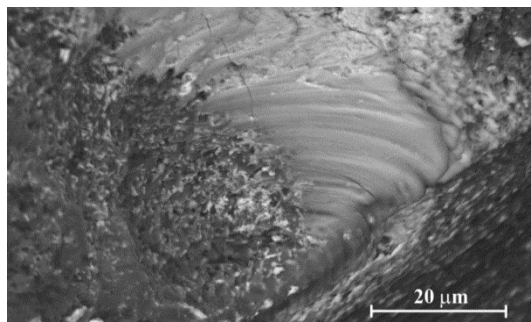
Fig. 14 Liquefied tribolayer on the minor cutting edge side of the crater ($v_c=250$ m/min, $f=0.25$ mm/rev)

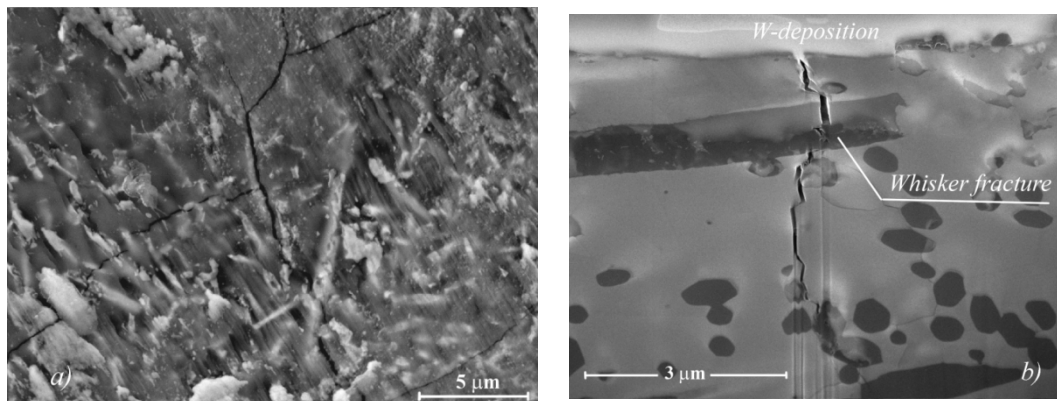
in thermal expansion coefficient for whiskers and therefore promotes cracking (see Fig. 15.a) through formation of tensile stresses upon cooling.

On the other hand, it was reported [16] that cracking may arise in the tribolayer upon tool disengagement and cooling. In such case the cracks are limited to the layer and do not penetrate into the tool bulk. FIB cross sectioning through the cracked region in our case has allowed to detect that cracks significantly extend into the bulk (see Fig. 15.b). It was observed that crack may deflect on whiskers with formation of a mesh of smaller cracks along with the main crack. Diffusion assisted problems with thermal expansion mismatch leading to the development of compressive stresses at high temperatures are known to further strengthen the bonding between alumina matrix and SiC whiskers. Such behavior is expected to promote whisker fracture instead of debonding (Fig. 15.b).

Observed, in this study, cracking is dominantly located at the end of the crater towards where the coolant flow is directed. This allows to assume that cracks are developing during machining and not on disengagement. Highest temperature is located close to the edge [31] and thermal stress gradient on disengagement should promote cracking on the edge rather than the far end of the crater. It was also observed that unstable tribolayer at the end of the crater may promote adherence of Alloy 718, which during shrinkage ($\alpha_L = 13.1 \cdot 10^{-6} \text{ }^\circ\text{C}^{-1}$) at cooling inflicts tensile stresses on the tool in the surrounding area. Unfavorable stress state was seen to lead to cracking either in tribolayer or penetrate into the bulk (see Fig. 16). While this is not critical if machining is performed in one engagement over the entire tool life, it can accelerate crater wear or tool failure on multiple entry operations.

Fig. 15 (a) Cracking on the crater and (b) propagation of the crack into the tool bulk

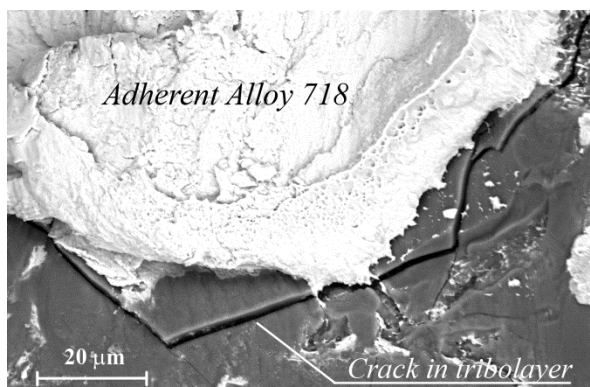
Fig. 16 Adherent Alloy 718 on the crater and associated cracking

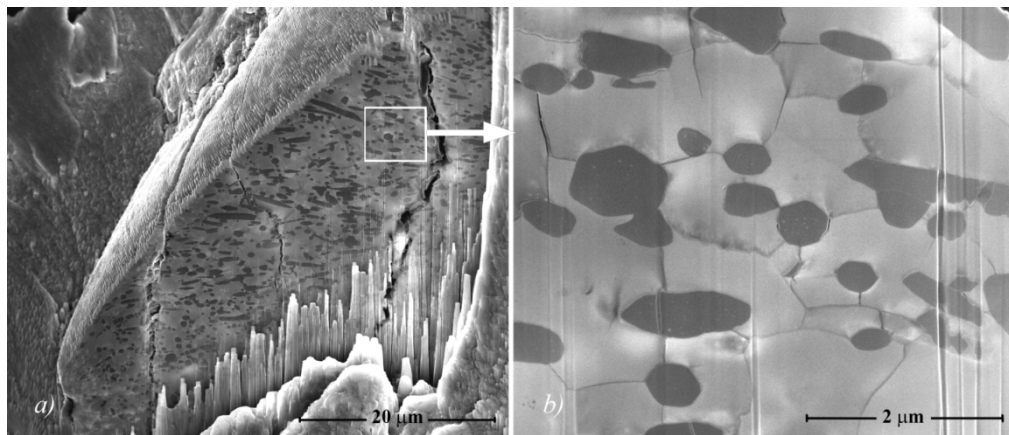
While it is commonly accepted that plastic deformation for ceramics takes place in superficial zones on the tool [16], bulk plastic deformation in machining is also reported [32, 33]. Observations of worn-out tools performed in this study did not provide a support for the bulk plastic deformation. However dry machining and machining with coolant under aggressive cutting conditions ($v_c = 250 \text{ m/min}$, $f = 0.25 \text{ mm/rev}$) generated localized cracking-like tool damage which is recognized as plastic deformation as well [34]. Small volumes of tool material close to the DOC notch region exhibited extensive cracking on the rake. FIB sectioning (see Fig. 17.a) of the discussed region has shown formation of several major cracks penetrating into tool bulk and complete fracture of alumina matrix on mainly grain boundaries (Fig. 17.b). The cavitation between Al_2O_3 grains and between whiskers and alumina grains (see Fig. 17.b) is observed in this case. Such cracking and cavitation in Al_2O_3 -SiC ceramics are reported to be the main mechanisms of plastic deformation by creep [35].

Fig. 17 (a) FIB cross-section of plastically deformed zone with (b) Crack network of in the alumina matrix

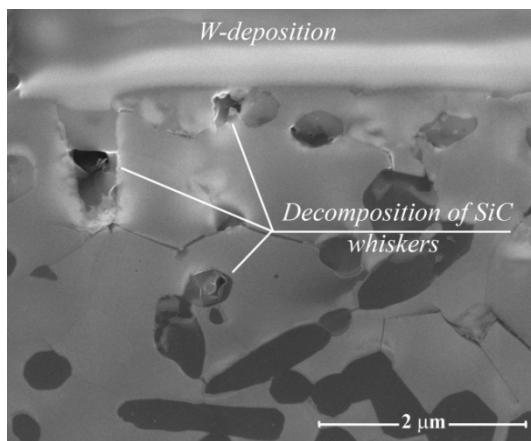
It was found that chemical degradation of whiskers is not limited to the diffusion and formation of silica on the whisker surface. Additional mechanism of chemical decomposition of whiskers was observed (Fig. 18) in near-surface regions of the worn tool. On the opposite to formation of silica, degradation takes place in the whisker core (see Fig. 18) with formation of a cavity.

Defective structure of SiC whiskers with concentration of defects and voids in their core [36] provides an easier pass for inwards progression of oxygen. Formation of cavities instead of glassy phase implies generation of gaseous products [37], where $\text{SiC}_{(s)} + 2 \cdot \text{SiO}_{2(s)} = 3 \cdot \text{SiO}_{(g)} + \text{CO}_{(g)}$ and $\text{SiC}_{(s)} + \text{O}_{2(g)} = \text{SiO}_{(g)} + \text{CO}_{(g)}$ are the two plausible reactions of whisker degradation [14], yet both are expected at temperatures above intrinsic to the machining of Alloy 718.

Fig. 18 Chemical decomposition in the core of SiC whiskers
