Design of Safe Timber Structures - How Can we Learn from Structural Failures in Concrete, Steel and Timber?

Frühwald, Eva; Serrano, Erik; Toratti, Tomi; Emilsson, Arne; Thelandersson, Sven

Report TVBK-3053
Lund 2007

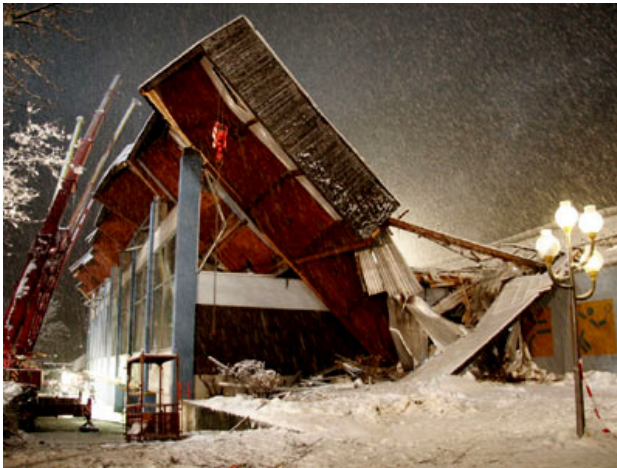
trusses fell down in spite of the fact that there was no snow load at all on the roof [14, 15]. The investigation [14] of the failure revealed that the main cause was multiple errors related to the structural analysis and conceptual modelling of the primary structure. This event created a heated debate in Denmark concerning quality assurance and control systems in the building process. Minor quality deficiencies of the glulam used in the structure were also revealed in the investigation, but these were found to be irrelevant for the occurrence of failure.

Fig. 1. Collapse of wooden roof for ice skating arena in Bad Reichenhall, Germany

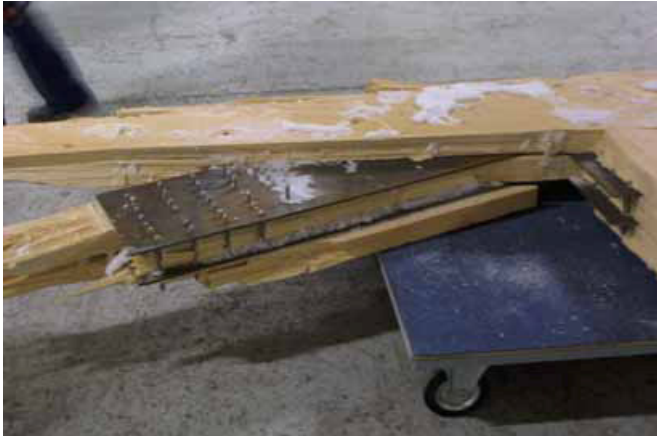
The same winter 2003 another structural collapse took place in Finland. Four main roof trusses for exhibition hall B2 of Jyväskylä Paviljonki collapsed two weeks after the hall was opened for the public [15,16]. The snow load at the time of failure was about 50 kg/m² and there was no wind. The design snow load at this location is 200 kg/m² according to the Finnish code. The primary cause of failure was manufacturing errors leading to malfunctioning slotted-in steel plate joints in the main glulam trusses, see Fig. 3. The failure was initiated in a joint where only 7 out of 33 dowels were in place.

Fig. 3. Slotted-in steel plate joint where dowels were not mounted as intended.

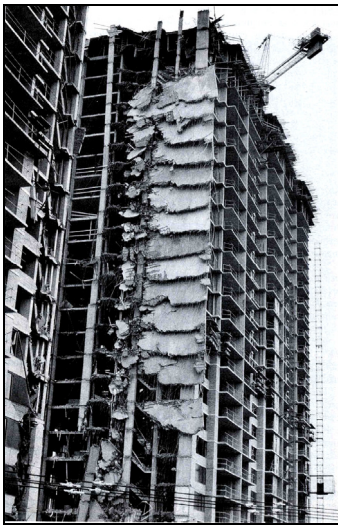
Damage related to work execution includes inadequate vibration, placement of reinforcement in wrong position, deformation of formwork, inadequate curing conditions of the concrete after casting etc. Furthermore, damage during construction may occur due to premature removal of shoring, too weak shoring, insufficient lateral bracing of shores etc., see also [27] and [28]. An example of catastrophic failure due to premature removal of shoring is shown in Fig. 4. Failure of the supporting system during casting lead to a progressive collapse initiated by punching shear failure in a flat slab. The collapse caused the death of fourteen construction workers.

Fig. 4. Progressive failure of multi-storey concrete building due to premature removal of shoring, 1973, Virginia, USA.

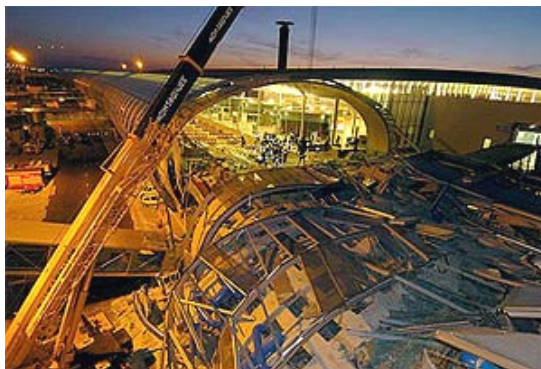
An example of an innovative concrete structure is the terminal building at Charles de Gaulle airport in Paris, which was built with an elliptical reinforced concrete shell roof. The roof suddenly collapsed in May 2004, 11 months after it was opened, killing four people, see Fig. 6. The official investigation identified four errors in design and construction of the unusual type of structure.

Fig. 6. Collapse of terminal roof at Charles de Gaulle airport in Paris

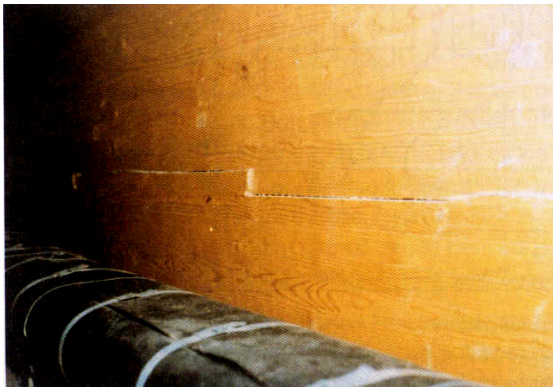
when the building (sport hall) was 2 years old. The cracks were mainly caused by rapid drying of the wood after it was finished. Particularly heavy cracking took place in that part of the roof where installations of hot water tubes were present. The cracks led to increased and nonuniform deflection of the flat roof, which in turn led to ponding during a heavy rain. The roof did not collapse but had to be temporarily supported for safety reasons.

Fig. 9. Longitudinal through crack in glulam roof girder due to shrinkage effects. Hot water piping in the vicinity of the girder contributed to fast drying. Source: Ref. [7].

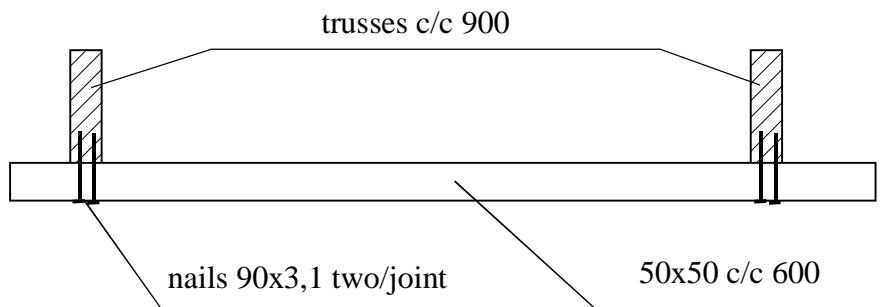
withdrawal capacity of the nails fastening the 50 x 50 mm² wood battens for the ceiling to the bottom chord of the roof truss. The designer had prescribed three nails in each joint, but only two were provided during construction. One reason for this was that the designer did not realise that there was not enough space – as given in relevant standards – for three nails in the contact surface between the battens and the bottom chord of the truss. In this case the failure was classified as 0.5 (50 %) due to poor manufacturing principles and 0.5 (50 %) due to design error. In cases where only one cause was identified, the weight for this error type was set to 1.0. With this method the sum of all error types over all cases will equal 127, and the corresponding percentages can be calculated.

Figure 11. Support connection for ceiling in supermarket.

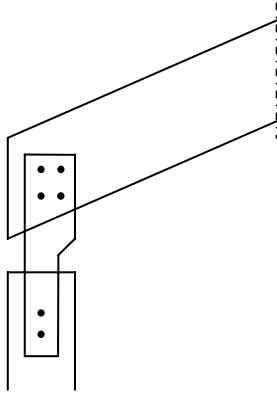
The failure is caused by insufficient design of the load-bearing structure. The execution of the connection between column and beam is not adequate.

Figure 34-1. Detail of beam-column connection. After Skaug (2004).

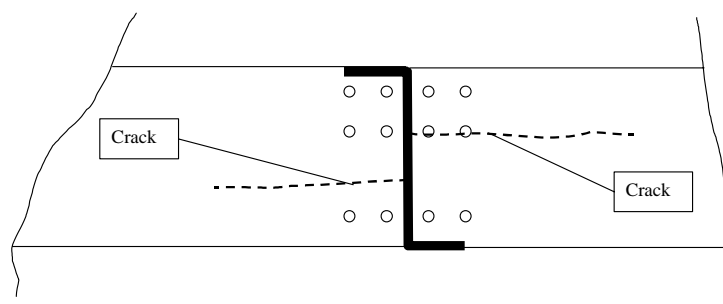
Figure 109-2. Schematic of beam connection and cracks found.

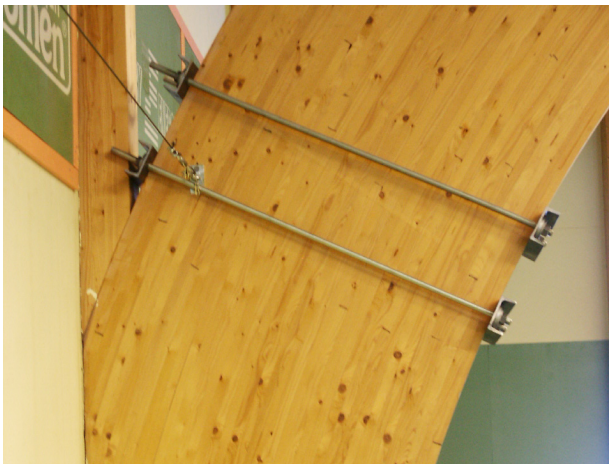
Figure 115-3. Temporary steel fixings attached to the column.

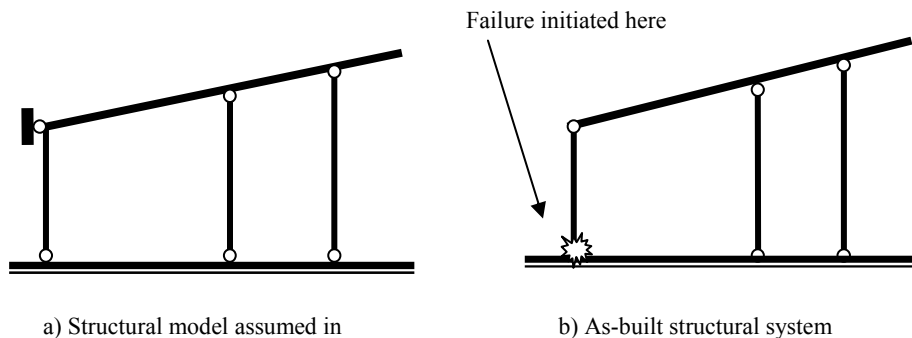
Figure 120-1: Assumed and real structural systems

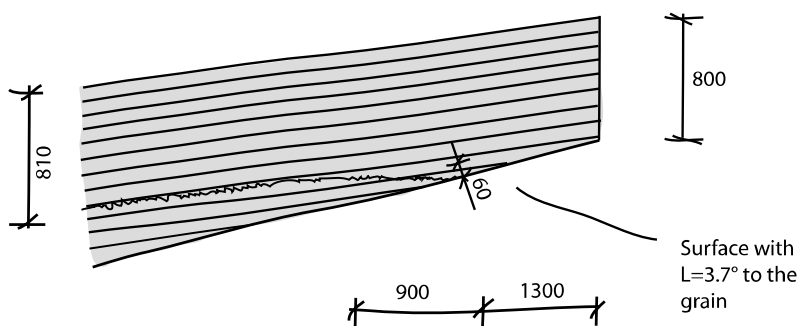
Figure 126-2: Detail view of double-tapered beam (near right support). Jagged line indicates cracking.
