Using resistivity measurements for dam safety evaluation at Enemossen tailings dam in southern Sweden

Sjödahl, Pontus; Dahlin, Torleif; Johansson, S

Published in:
Environmental Geology

2005

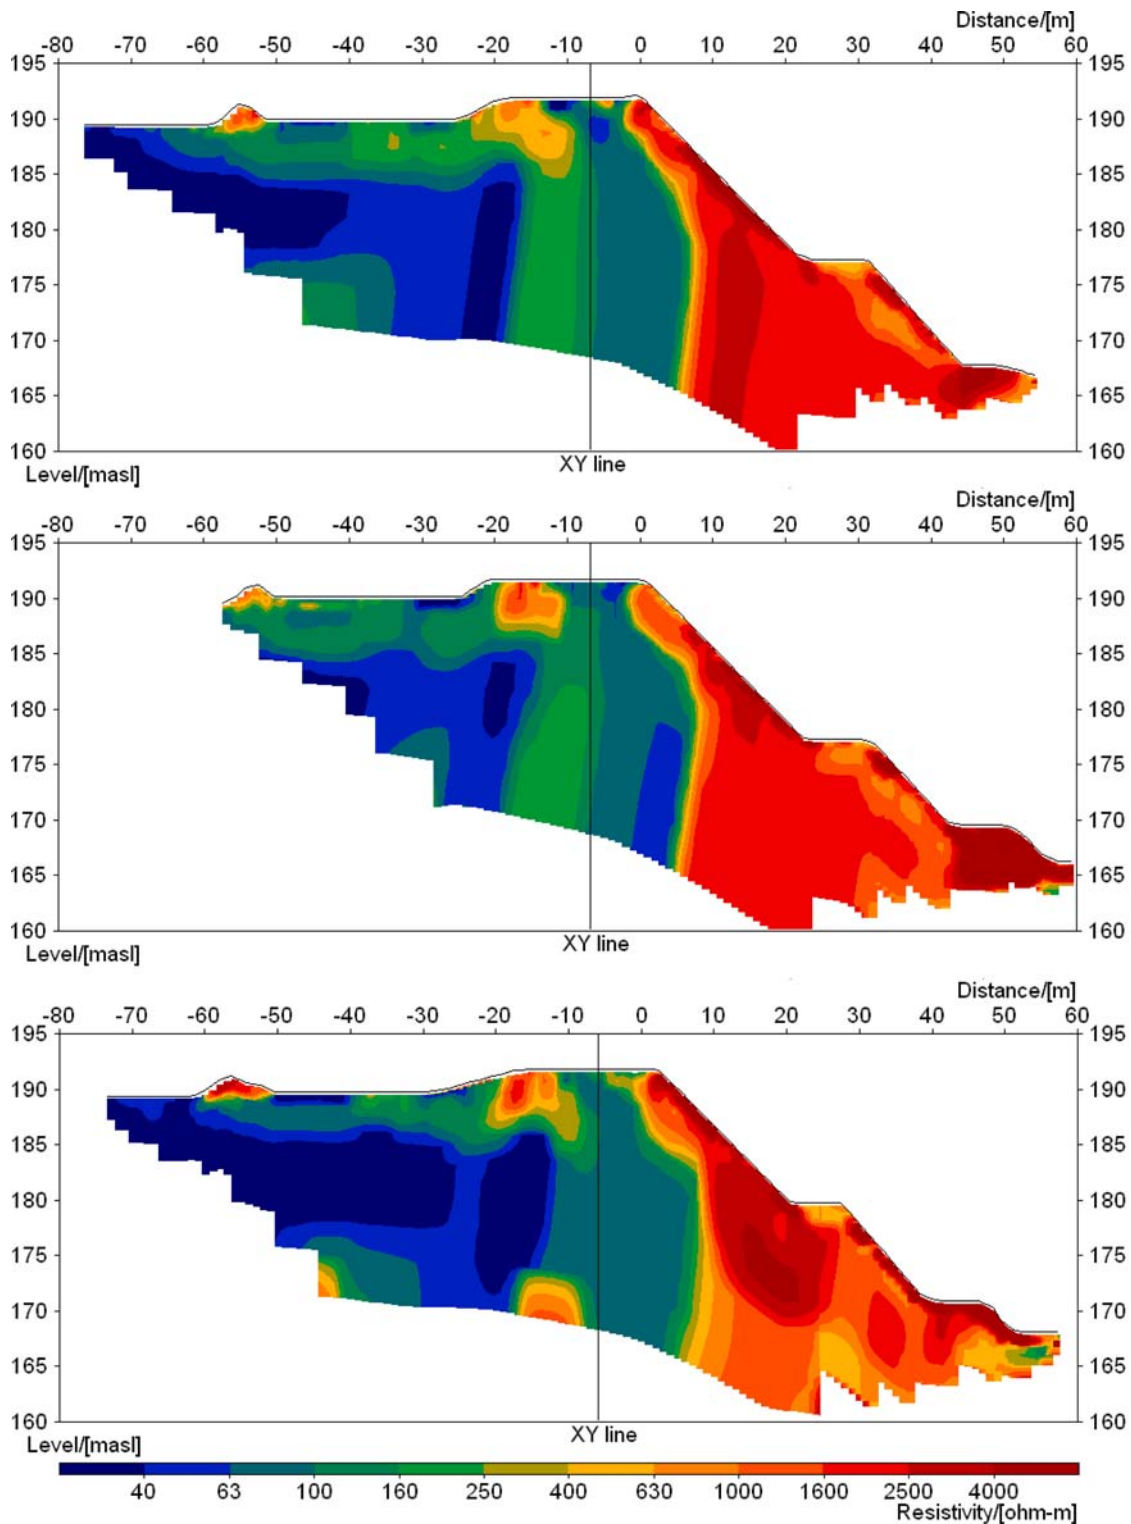
The cross section at chainage 0/471 m (Fig. 3) shows a sequence of zones with different resistivity with steep to vertical interfaces, going from low ($\approx 40 \Omega \text{ m}$) over intermediate ($\approx 200 \Omega \text{ m}$) and rather low ($< 100 \Omega \text{ m}$) to very high ($> 1,000 \Omega \text{ m}$). These zones correspond well with that which can be expected from the way the dam is built. Starting from the upstream side on the left in the diagram, the low-resistive zone that continues up to –

The cross section at chainage 0/492 m (Fig. 3) agrees well with the one at 0/471 m, but the top high-resistive part corresponding to the upper part of the upstream support fill is not so well developed. The latter explains the high-resistive zone at 0/471 m in the sections measured along the dam (Fig. 2). The extra low-resistive part of the zone interpreted as the core might be an indication of a change in the properties connected to the sinkhole development. The groundwater level was recorded at elevation 165 masl at +3 m on the cross section (chainage 0/500 m).

The cross section at chainage 0/310 m (Fig. 3) is similar to the one at 0/471 m with one important exception. The high-resistivity zone corresponding to the upstream filter is interrupted by a large zone (around 10 m high) with resistivity below $100 \Omega \text{ m}$. This can be interpreted as an effect of anomalous seepage through the dam, which fits well with the occurrence of old sinkholes. Measured groundwater levels at elevation 187 masl at –40 m and elevation 185 masl at –20 m fit well with the image. At +3 m the measured groundwater level at 171 masl is not visible, as would neither be expected in fine-grained material. The bedrock level at elevation 165 masl at –15 m may be situated below the depth penetration. At +20–25 m the bedrock at elevation 171 masl appears to be slightly less resistive than the downstream support fill.

425 m, and 0/525–0/550 m. The resistivity in the area of the latest sinkhole (at chainage 0/500 m) is similar compared to the other parts of the dam. The cross section at chainage 0/492 m shows, however, a lower resistivity in the downstream part of the core. This is similar to the result at chainage 0/310 m where a high-resistivity zone (corresponding to the upstream support fill) is interrupted by a large low-resistive zone. This can be interpreted as an effect of anomalous seepage through the dam, which fits well with the occurrence of previous sinkholes. The overall conclusion, based on the result from these investigations, is that none of the detected resistivity or temperature anomalies immediately need any further investigation, but the result shows the importance and need of the ongoing monitoring program for the dams.

Fig. 3 Inverted resistivity cross sections from the X-Y dam. Above: chainage 0/471 m (mean residual 3.1%). Centre: chainage 0/492 m (mean residual 3.3%) Below: chainage 0/310 m (mean residual

1.7%). Level refers to meters above sea level and chainage to length along the dam in meters
