# Performance of joints for glued laminated timber exposed to the ISO fire temperature curve

**Report 5638, Lund 2021**

**Master thesis in fire safety engineering**

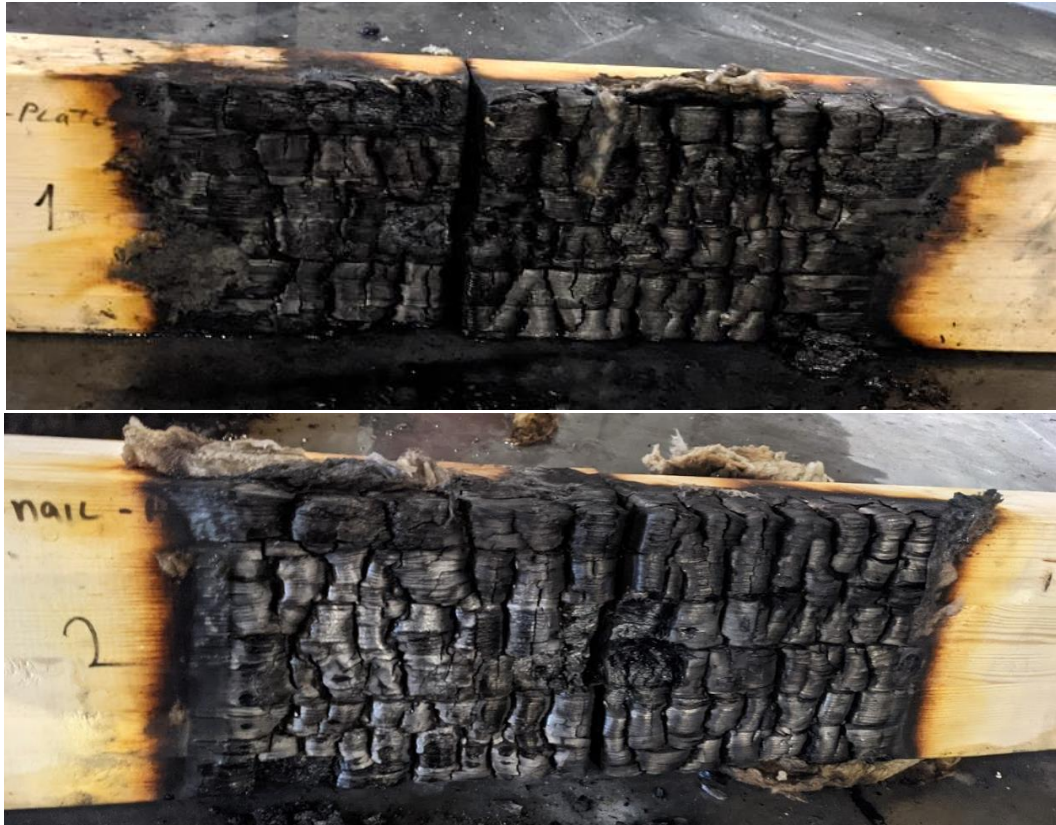
*Figure 27. Exposed side of the Test 1 and 2 after 30 minutes of the ISO 834 fire curve*

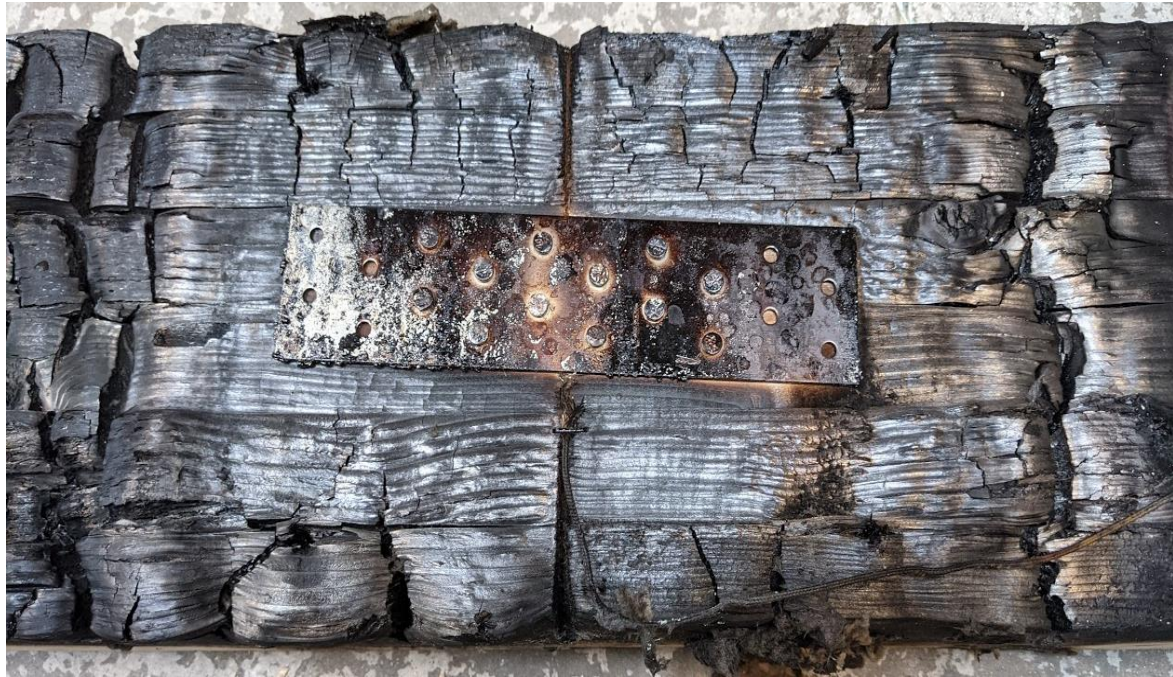
*Figure 28. Exposed side of the protected sample after 30 minutes of the ISO 834 fire curve (test 4)*

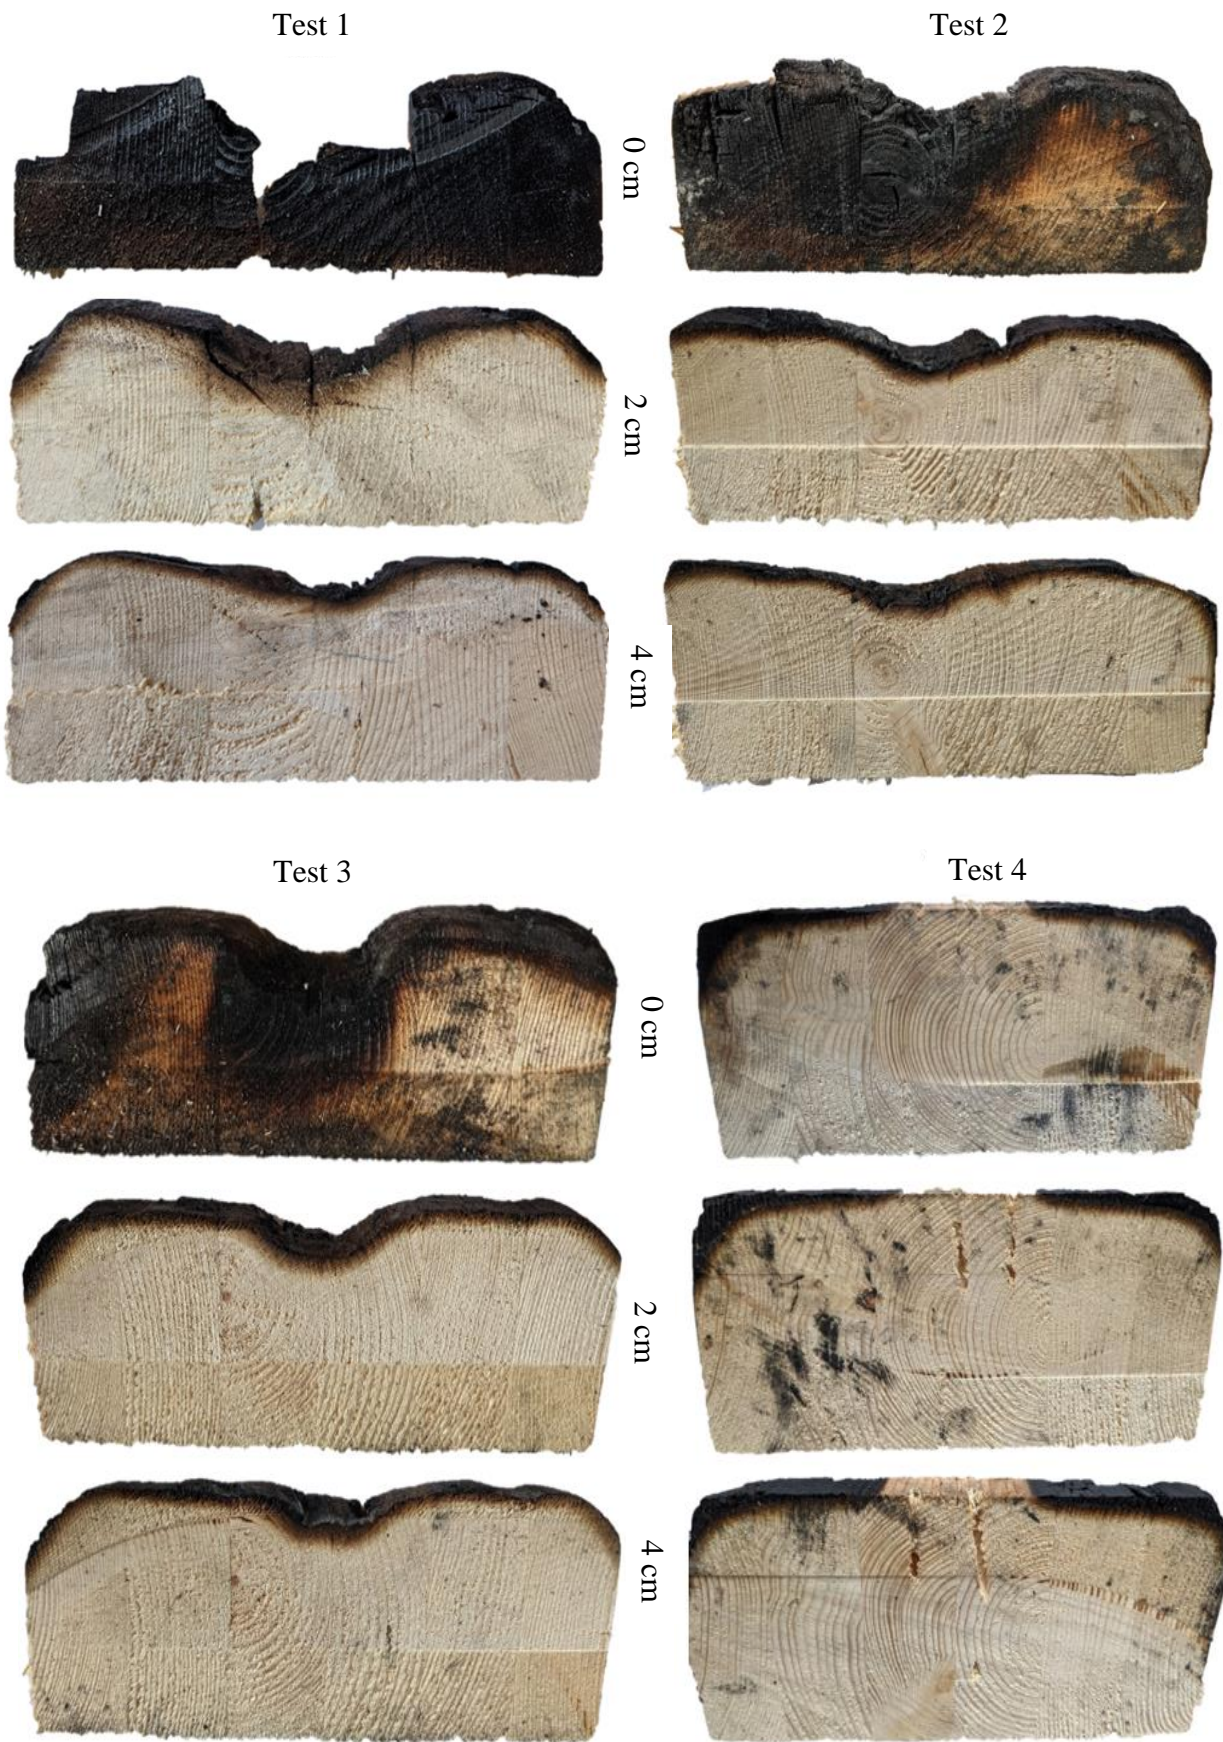
Figure 29. Cutouts of the tested samples, from top to bottom each image represents a 2 cm slice from the jointed area to the free side

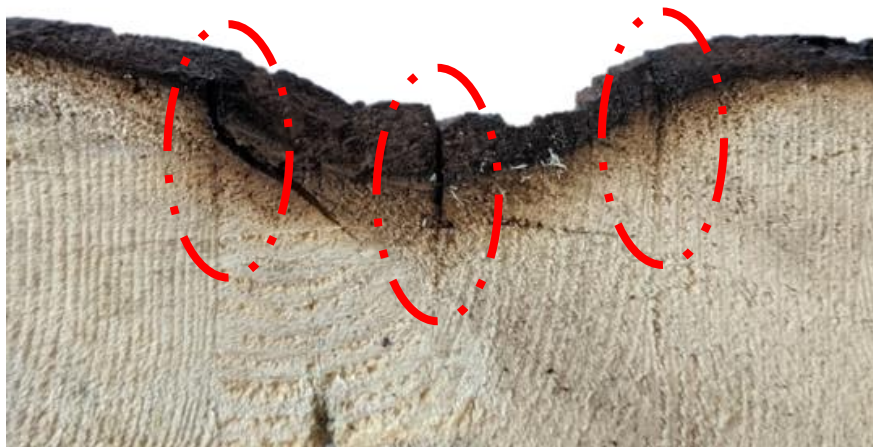
This phenomena is clearer to see in the second cut, in here three different black cracks can be seen near the bonding interphase of the slates composing the glulam, these cracks were not significant enough to propagate through the whole glued laminated member and split it but they were significant enough as to increase the pyrolysis of the area surrounding them, this is denoted by a larger “halo” of darker timber when compared to the other samples. The delamination in the 3<sup>rd</sup> cut for the first sample was not as visible, occurring mostly closer to the gap.

*Figure 30. Second cut of the first test showing signs of delamination*

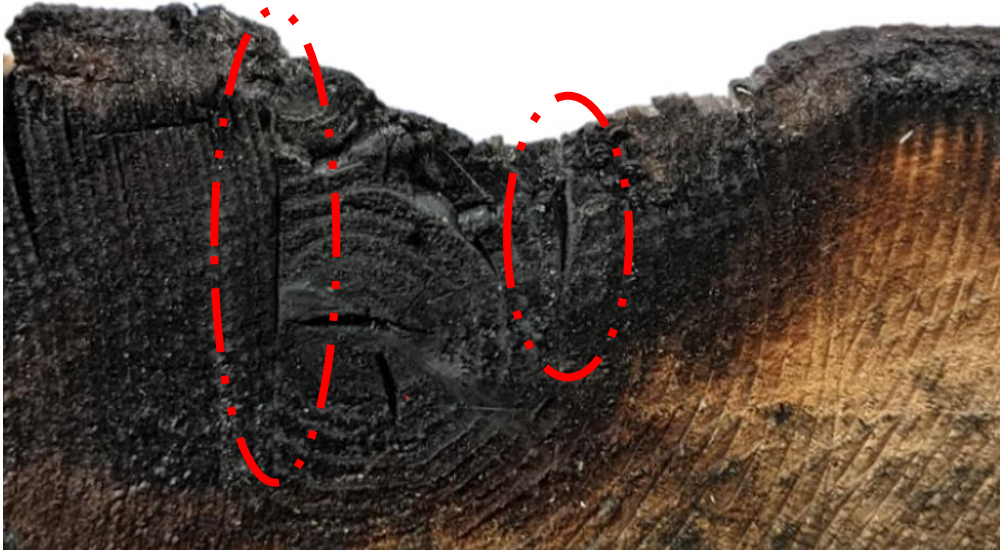
For the second test (a larger plate with nails) the first cut remained mostly intact during the cutting showing more structural integrity than the first test, in this cut also the severity of the fire condition seemed to be lesser, as spots of the original color of the timber still persisted even after the 30 minutes. Something harder to see in this cut is the small delamination occurring in the third board of timber (left to right), this is showed in the next picture.

*Figure 31. First cut of the second test showing signs of delamination*

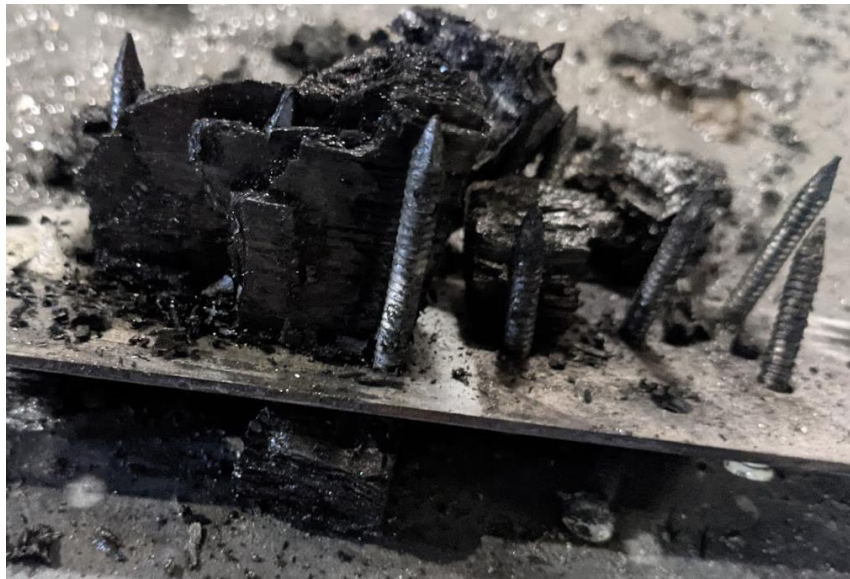
In the picture below is possible to see one of the plates-fastener systems after a test, in here we can see that there was no major deformation in the exposed plate, and that the char was able to encompass the exposed nails, this was the case for all configurations except for the protected one where the base materials only showed small discoloration around the nails.

*Figure 33. Plate and fasteners extracted from the test 1*

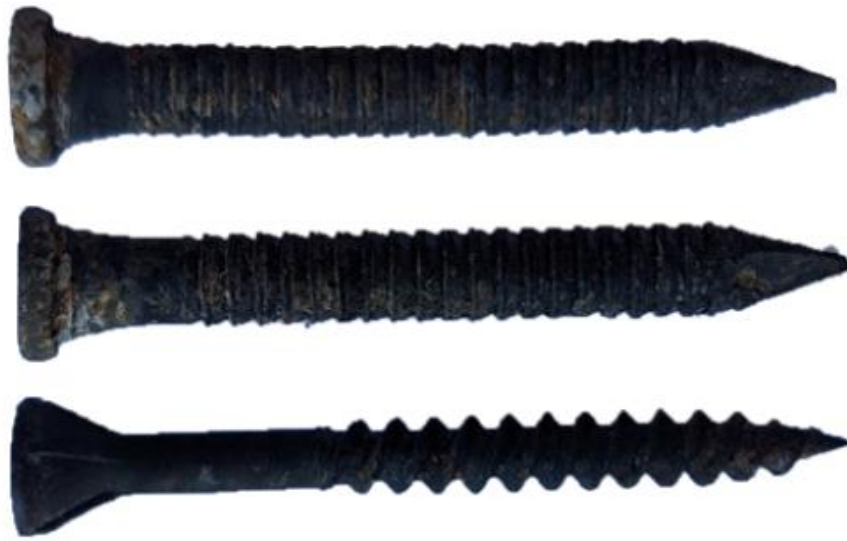
The same procedure was done with the fasteners, their dimensions were measured as well as their angle and compared to the unaffected fasteners, this showed almost no deformation in the nails, most of the changes that did occurred were the oxidation and the deposition of a soot layer surrounding the fasteners for the samples 1, 2, and 3, this is represented in the next figure.

*Figure 34. Fasteners after being exposed to the ISO 834 curve, from test 1, 2 and 3 (from top to bottom)*

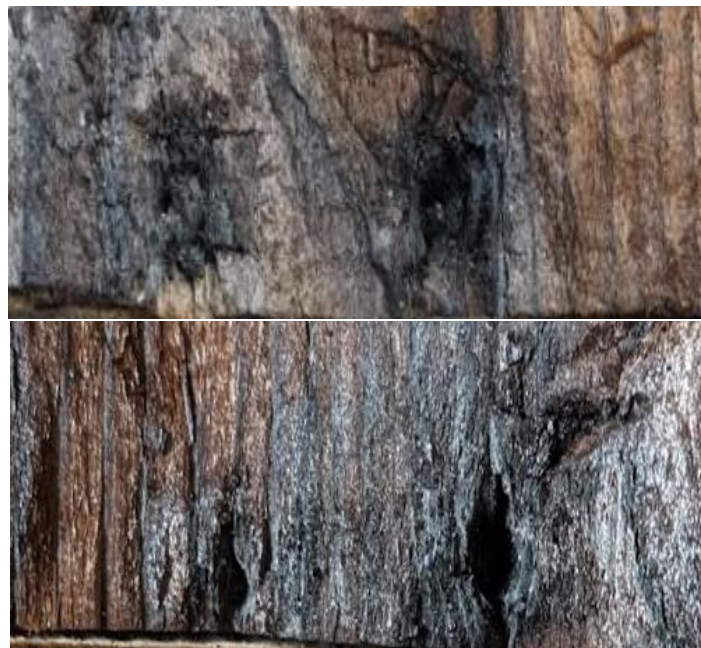
One of the differences that is noticeable between the screws and the shank nails used is their difference in regard to their mass, being the nail almost as twice as heavy as the self-tapping screw (4.1 grams vs 2.2 grams). To see any possible changes caused by this in the interaction of the fastener towards the charring of the member the visible marks left after the removal of the joints were inspected, this can be seen in Figure 35.

*Figure 35. Pictures of the jointed area showing marks from the mechanical fasteners, Test 2 using nails (upper picture), and Test 3 using screws (bottom picture)*

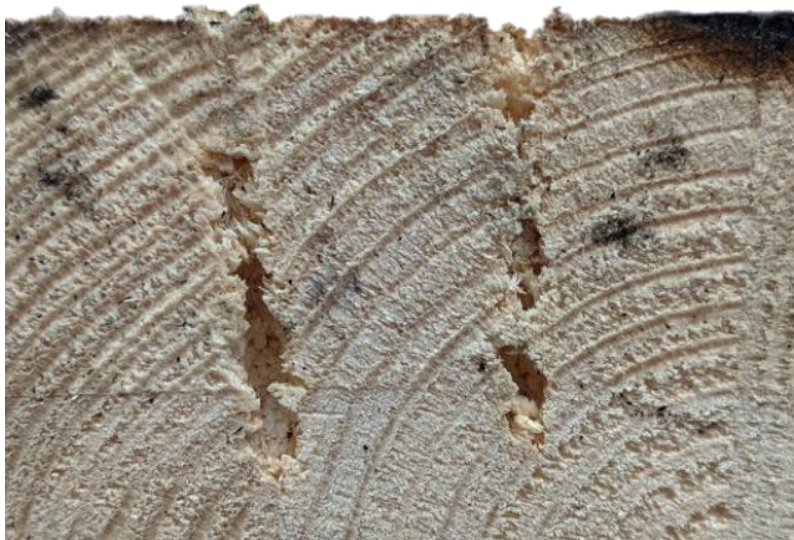
*Figure 37. Bores in the 4th test showing discoloration*
