Wear mechanisms of silicon carbide-whisker-reinforced alumina (Al2O3-SiCw) cutting tools when high-speed machining aged Alloy 718

Bushlya, Volodymyr; Zhou, Jinming; Avdovic, Pajazit; Ståhl, Jan-Eric

Published in: International Journal of Advanced Manufacturing Technology

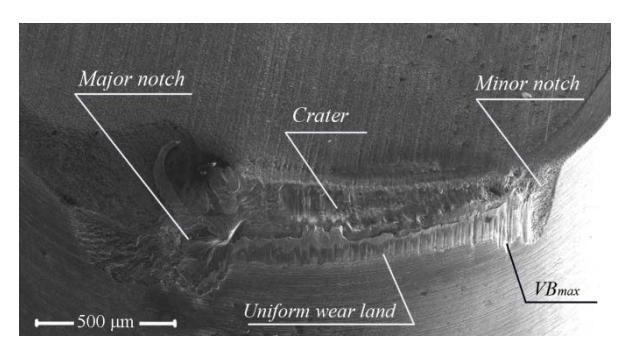
Irrespective of cutting conditions or coolant application the morphology of the worn-out tools comprises (see Fig. 1) of a notch on the major cutting edge (hereinafter major notch); crater; flank wear land (VB); notch on the minor cutting edge (hereinafter minor notch). Term major notch is used because the discovered morphology and formation mechanisms cannot be fully represented by a common term "depth-of-cut notch", as shown in *section 3.1*.

Fig. 1 Typical morphology of worn-out insert (v_c =250 m/min, f=0.19 mm/rev, a_p =0.53 mm)

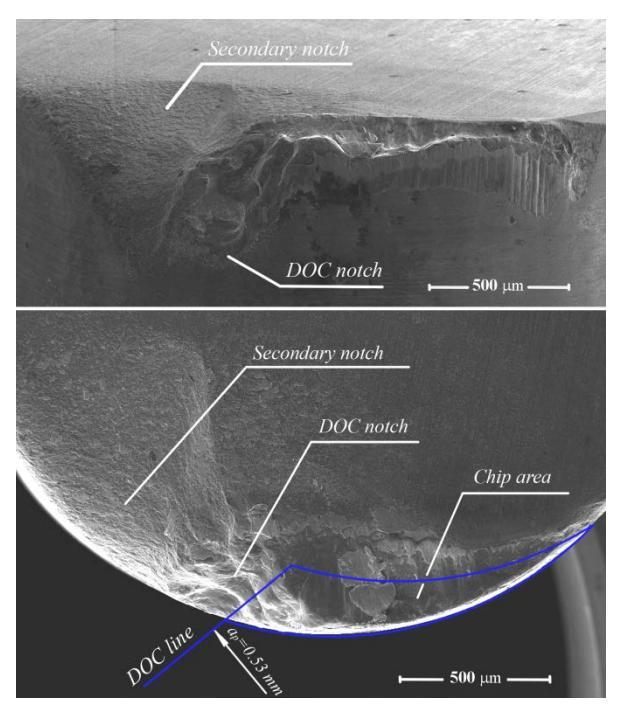
The present study has revealed existence of two notches formed on the major cutting edge. As seen in the Figure 2 the first notch is located at the depth-of-cut extremity (DOC notch), while the other, secondary notch, is located outside the chip area. Both crater and DOC notch exhibited smooth surface with low surface roughness (see Fig. 4.b). Distinguished feature of the secondary notch is its fracture-like appearance and high roughness (see Fig. 2) but it has minimum whisker exposure and limited bridging and pull out of whiskers which are intrinsic to an actual fracture surface.

Fig. 2 Formation of two notches on the major cutting edge (v_c =250 m/min, a_p =0.53 mm, f=0.3 mm/rev)

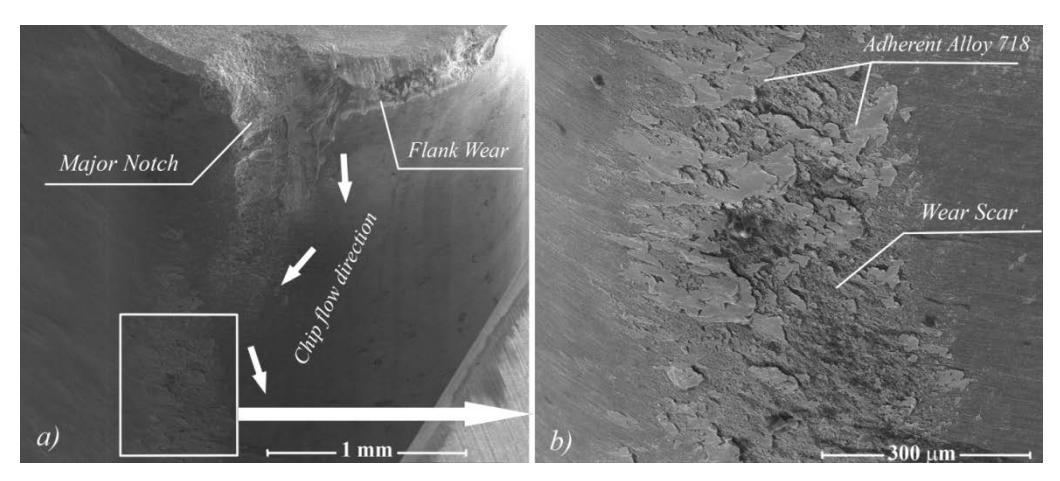
Merger of DOC and secondary notches was found to lead to formation of a single major notch (see Fig. 3.a), which is governed by other combination of wear mechanisms. Formation of build-up edge (BUE) in the notch was observed on the regular basis, which complies with finding of other studies [6, 22]. Back scatter electron microscopy has revealed zones on the tools which are completely covered by adherent material and areas of fleshly fractured surfaces. These fracture surfaces imply removal of tool aggregates due to delamination or removal of BUE. Figure 5.a shows a BUE removed from the major notch of a tool worn-out under v_c =300 m/min, *f*=0.25 mm/rev, a_p =0.53 mm and machining with coolant. The inner surface of the BUE contains significant amount of tool material, as confirmed by EDX (Fig. 5.b). Analysis of major notch formation under different cutting conditions revealed significant presence of BUE. Whisker pull-out and microcracking of the Al₂O₃ matrix were also observed in majority of machining tests. These are expected to additionally decrease strength of the tool material and accelerate notch wear.

Fig. 3 (a) Formation of major notch and (b) Chip adhesion on the tool flank (v_c =250 m/min, dry machining)

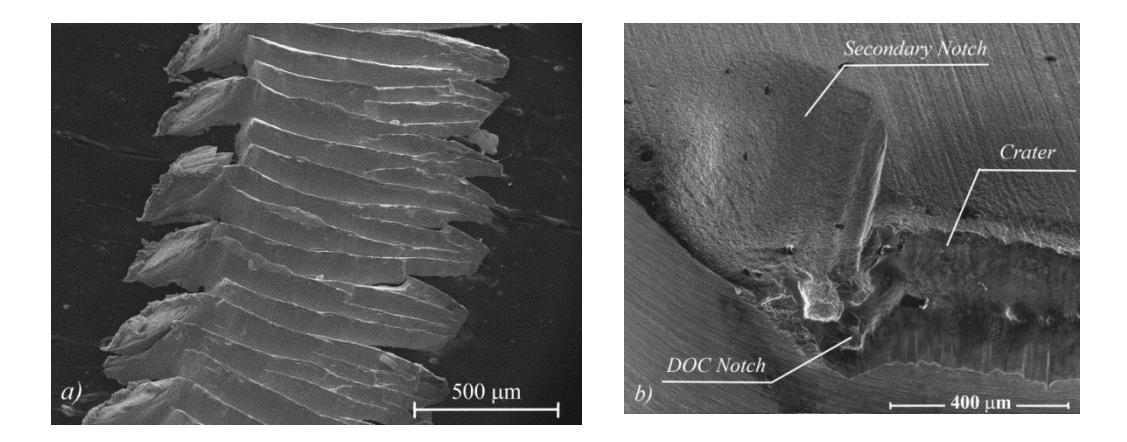
When machining with coolant, the amount of adherent material is less profound (see Fig. 4.b) and is limited to microwelding. Figure 4.b presents clear evidence that burrs do not influence the formation of the secondary notch since it is limited to the tool rake only. Furthermore limited amount of adherent material imply attrition wear mechanism. While the cause behind notch formation was found different, the acting mechanisms of adhesion and attrition comply with finding by Xiao et al. [13].

Fig. 4 (*c*) Segmented chips (v_c =250 m/min, VB_{max} =0.17 mm, coolant) and (b) Formation of the secondary notch by chip attrition (v_c =200 m/min, coolant)

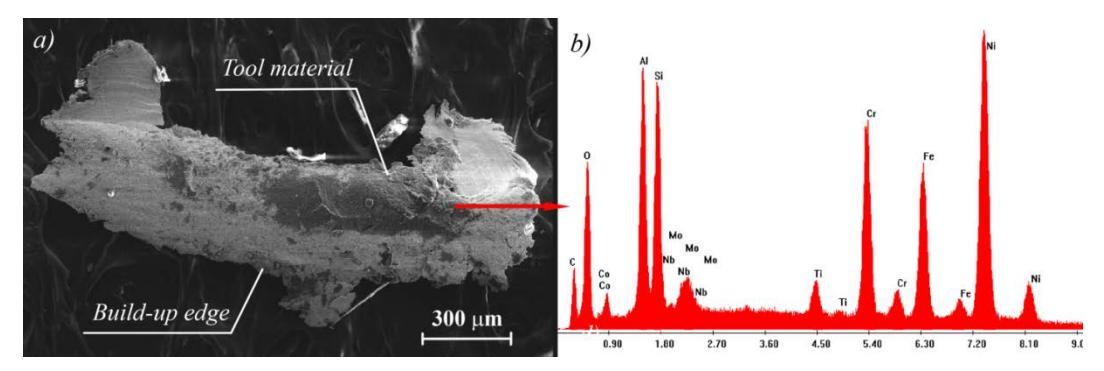
Fig. 5 (a) Build-up edge of Alloy 718 with removed tool material and (b) respective EDX

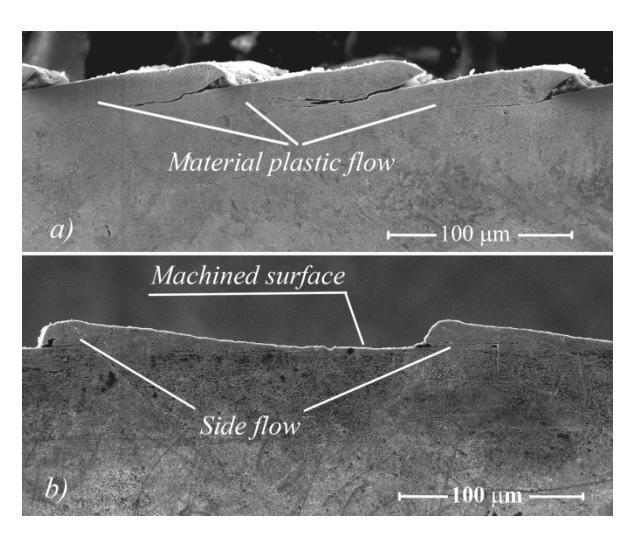
It was found in this study that minor notch is related to the defects left on the surface during machining. Two types of related surface defects were identified: severe plastic flow and side-flow. Presence of severe material plastic flow (Fig. 6.a) was observed under both dry and wet conditions. Similar surface defect was registered by Kitagawa et al. [1] and Narutaki et al. [9] when machining Alloy 718 with whisker reinforced, mixed alumina and Si_3N_4 tooling at cutting speed around 150 m/min. In current study presence of material plastic flow was observed under majority of test conditions, yet intensity of this surface defect varied with process conditions. Increase in feed, speed and application of coolant strongly reduces presence of this type of damage up to the full disappearance. Machining under dry conditions and with slightly worn tools promotes formation of this damage. It was observed that as the tool wear progresses (*VB*>0.1-0.15

mm) the material plastic flow is suppressed and replaced by formation of side-flow in its typical understanding (see Fig. 6.b).

Appearance of material plastic flow can be explained through the findings of Gatto and Iuliano [12] who have reported the presence of transverse material flow when machining Alloy 718 with ceramic tools. Such transverse flow, along with dramatic increase in ductility of Alloy 718 at temperature around 1000 °C up to 160 % [23] may facilitate separation of the chip at thickness higher than its otherwise minimum value h_{1min} . The remaining chip element is then ploughed to a side towards minor edge and left on the surface in the form of a continuous or discontinuous scale (Fig. 6.a).

Fig. 6 (a) Formation of plastic flow and (b) Side flow on the machined surface

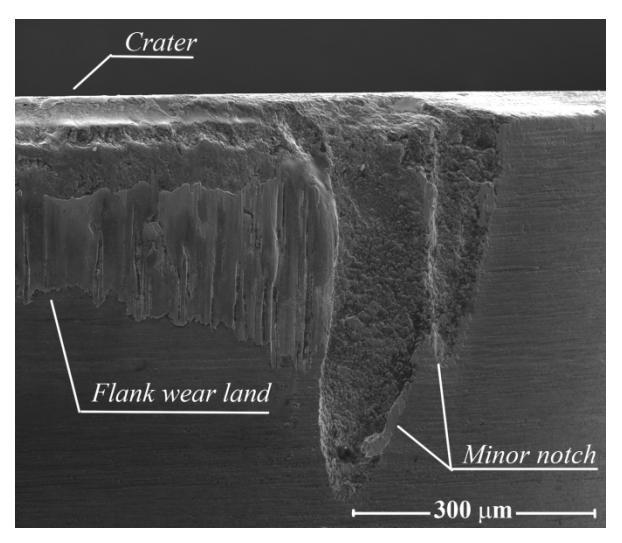
Both plastic flow scale and side-flow left on the machined surface dramatically increase its roughness leading to a contact between tool flank and these asperities. Measurement of microhardness on these surface defects has shown an increase up 590-620 HV as compared to \sim 470 HV of the bulk. Abrasion of the tool flank against these surface defects leads to formation of the notch. Multiple minor notch found on the tool flank (see Fig. 7) with uniform spacing between individual notches equaling to the feed value of *f*=0.15 mm/rev presents a clear evidence on the suggested wear mechanism. Traces of adhered Alloy 718 found on the minor notch surfaces suggest a combined abrasive and adhesive mechanism of tool wear.

Fig. 7 Minor notch due to abrasion between tool flank and machined surface (v_c =300 m/min, f=0.15 mm/rev, a_p =0.53 mm)

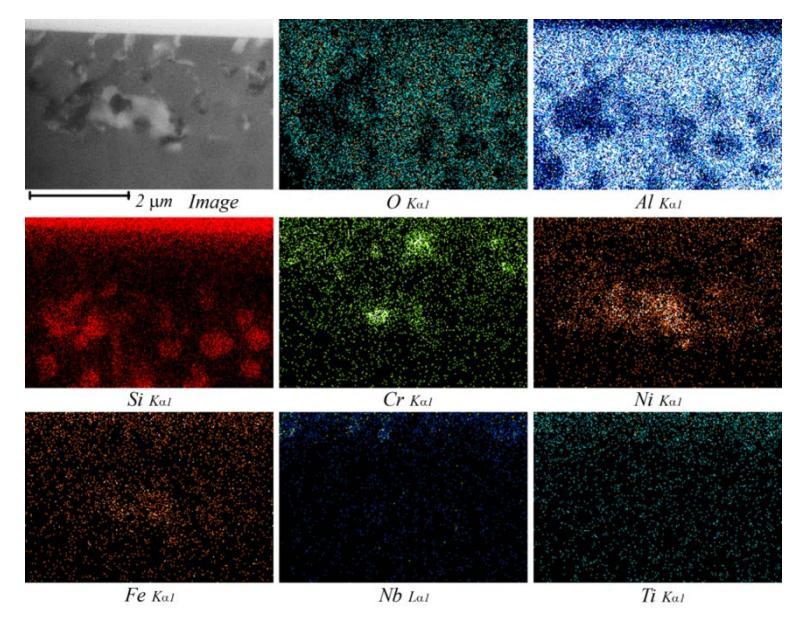
EDX mapping (see Fig. 8) on a lamellae removed from the rake of worn-out insert via focused ion beam (FIB) milling allowed to identify diffusion of Ni, Cr, Fe and to some extent Nb into SiC whiskers while no diffusional attack on alumina was evident. Previously reported diffusion of Ti [17], Mo and Co [24] was not observed. It can be seen that silicon is not present in a near-surface region which can be explained by counterdiffusion of silicon and Alloy 718 with replacement by diffusing elements. It is also noted that Ni and Fe diffuse markedly deeper than Cr (Fig. 8) due to an ease of formation of chromium carbides with free carbon left in the whiskers after replacement of Si. Intensive carbide-formation tendency of niobium can be similarly attributed to its limited diffusion into the near-surface region.

Fig. 8 EDX map of diffusion of elements from Alloy 718 into the tool material

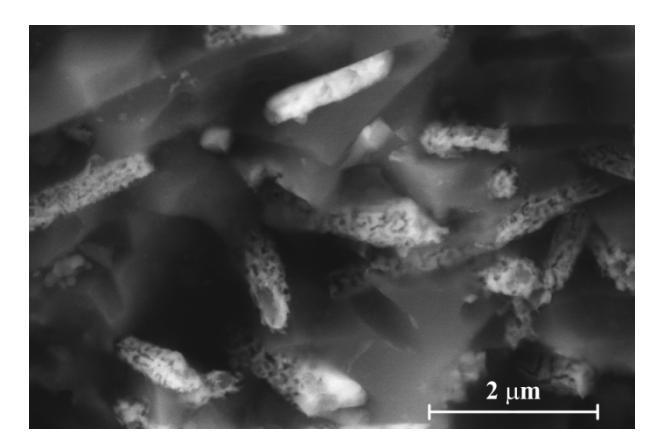
Decomposition of the whiskers and replacement of silicon in them reduces mechanical properties of both whiskers and the ceramic as a whole therefore enhancing susceptibility to mechanical damage. The back-scatter electron image of SiC whiskers on the tool rake (Fig. 9) shows that they completely or partially degrade due to diffusion of Ni, Cr, Fe. Weakening of tool material accompanied by intensive adhesion of Alloy 718 has been observed to lead to fracture, cracking and pluck out of both whiskers and Al_2O_3 matrix (see Fig. 9). This particular type of degradation was observed to have the highest intensity in the area of DOC notch and on minor cutting edge where unstable tribolayer intensifies adhesion.

Fig. 9 Diffusional degradation of SiC whiskers on the crater

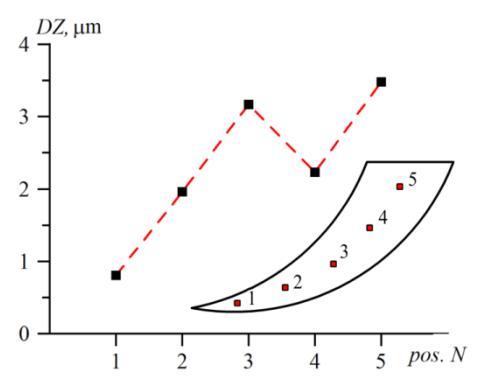
Figure 10 presents the variation of thickness of diffusion zone (DZ), measured along the edge line via FIB sectioning. Intensity of diffusion, which is temperature dependent, has its maximum in h_{1max} region of the tool and correlates well with the thermal load distribution on the rake of nose-radiused tools [15]. FIB cross section along the wear land on the flank has shown that thickness of diffusion zone is the highest in the middle of VB land. This behavior has a good correlation with the temperature distribution on the flank of worn-out ceramic tools [25].

Fig. 10 Variation in thickness of diffusion zone along the crater (v_c =250 m/min, f=0.3 mm/rev)

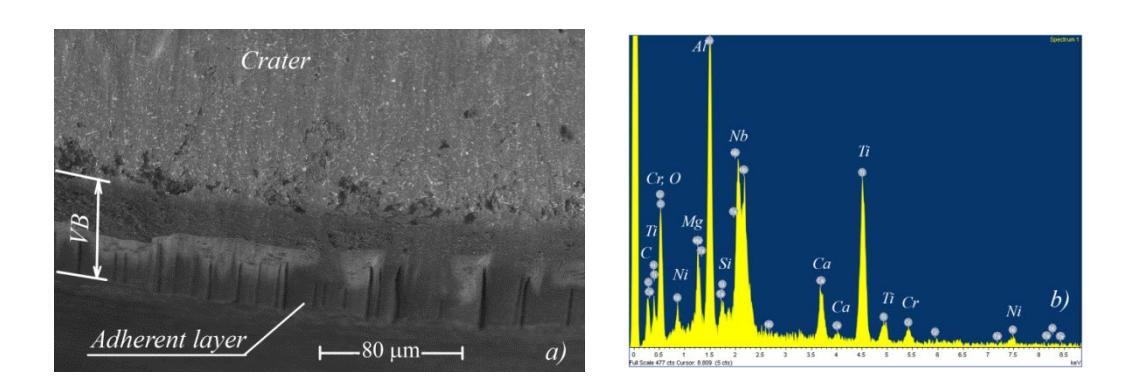
Chemical etching of worn-out tools with Kalling's No 2 etchant, which leads to dissolution of build-up and adherent layer of Alloy 718, allowed to identify presence of a film or a layer on tool surfaces. Such layer is known to form on ceramic tools during machining as a result of chemical reactions with workpiece material or environment [16, 19]. Two separate zones of tribolayer (see Fig. 11.a): on the crater and on the flank wear land were found on the worn tools, both varying in morphology and chemical composition. A deposit which consists of wear products and products of their reactions with coolant was also observed on the tool rake but outside the crater. It is seen (Fig. 11.a) that layer on the flank is not continuous and is concentrated in the lower part of wear

land. FIB cross sectioning provided evidence that approximately 50 µm of VB land closest to the edge is layer-free while it gradually increases in thickness and reaches ~ 0.1-0.15 μ m at the end of wear land. Identification of chemical composition of this layer is impeded by its low thickness. Large EDX excitation volume, when compared to the thickness, may lead to low sensitivity or may distort the results. For that reason the EDX (Fig. 11.b) was performed on a more massive accumulation of wear products found in a fracture cavity at the end of wear land. Markedly high concentrations of Ti, Nb and lesser of Cr were detected both on the flank and wear products deposition outside the crater. All three elements are prone to formation of carbides with carbon left in the whiskers after diffusion of silicon (see Fig. 8). Presence of TiC and NbC carbides in the microstructure of Alloy 718 and their severe fragmentation during machining [26] allows assuming simultaneous carbide formation and accumulation of debris from broken TiC and NbC on the tool flank. Identified presence of magnesium and calcium despite their absence in the material specification for Alloy 718 can be explained by the use low quantities of MgO as deoxidizer for Alloy 718 [2] whereas CaO is a regular deoxidizer for steels [16]. On the other hand, it can be argued that both calcium and magnesium come from a coolant consisting of 5% semi-synthetic additive and hard water rich in Ca²⁺ and Mg²⁺ ions. Hard water has a higher concentration of both elements (normally >100 ppm) when compared to 30 ppm found by Brandt et al. [2] in Alloy 718. In either case expected are the reactions with Al_2O_3 with generation of MgO- $n \cdot Al_2O_3$ spinel which forms at temperatures around 1200 °C [27].

Fig. 11 (a) Adherent layer on the tool flank after chemical etching ($v_c=250 \text{ m/min}, f=0.13 \text{ mm/rev}$) and (b) EDX spectra on the wear products accumulated in the fracture on the flank wear ($v_c=250 \text{ m/min}, f=0.17 \text{ mm/rev}$)

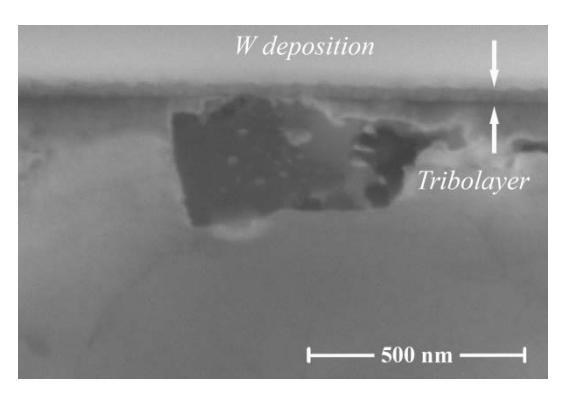
Figure 12 shows the FIB cross-section taken on the crater of worn tool at $v_c=250$ m/min, f=0.19 mm/rev and $a_p=0.53$ mm. Uniform tribolayer of thickness of 40-80 nanometers was observed on the surface. Tribolayer on the rake completely covers the crater (Fig. 11.a) and as shown above has a low roughness and glass-like appearance. Such formation is normally attributed to formation of silica glass or several additional reactions discussed below. The main mechanism of silica formation is through the following oxidation reaction [28]:

Fig. 12 FIB cross-section of the tribolayer on the crater of worn tool

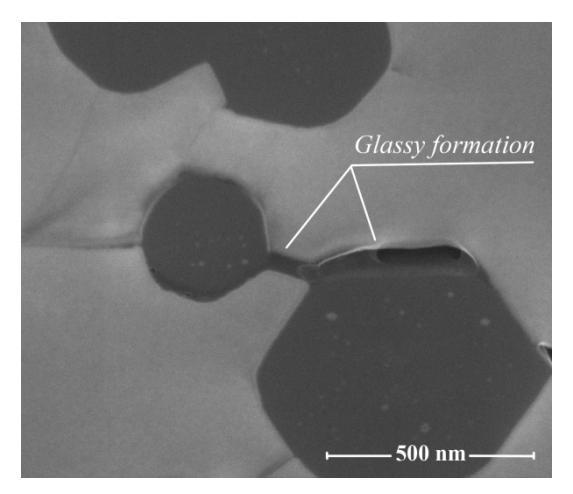
Fig. 13 Formation of glassy phase in the near-surface region of the crater

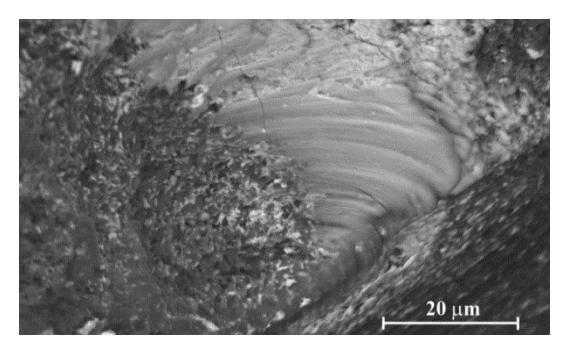
Fig. 14 Liquefied tribolayer on the minor cutting edge side of the crater (v_c =250 m/min, f=0.25 mm/rev)

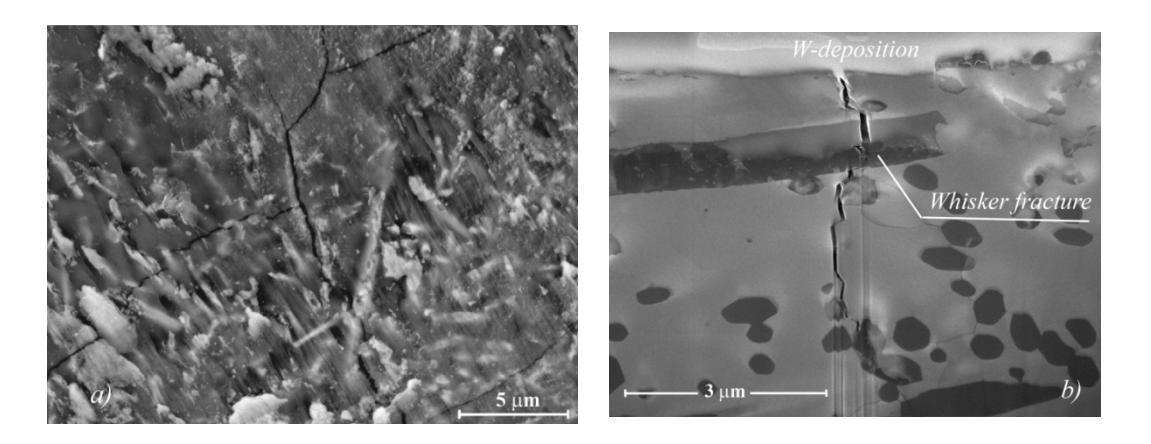
Cracking on the tool surfaces is known to form when machining Alloy 718 with ceramic and cemented carbide tools. It is attributed either the thermal shock or the thermal fatigue [6, 29]. Tiegs and Becher [30] have shown that as manufactured whisker reinforced alumina has low susceptibility to thermal stress cracking. Flexural strength of Al₂O₃-SiC_w has not degraded either upon single or multiple high temperature shock. The principal mechanism behind thermal cracking is the thermal expansion mismatch between alumina and silicon carbide. Thermal expansion of the SiC whiskers (α_L =2.7·10⁻⁶ °C⁻¹) is less than the Al₂O₃ matrix (α_L =6.3·10⁻⁶ °C⁻¹). In this case, the tensile stresses at elevated temperatures change to compressive ones upon cooling while formation of a crack requires the opposite. Diffusional ingress of Ni, Cr and Fe into SiC leads to an increase

in thermal expansion coefficient for whiskers and therefore promotes cracking (see Fig. 15.a) through formation of tensile stresses upon cooling.

On the other hand, it was reported [16] that cracking may arise in the tribolayer upon tool disengagement and cooling. In such case the cracks are limited to the layer and do not penetrate into the tool bulk. FIB cross sectioning through the cracked region in our case has allowed to detect that cracks significantly extend into the bulk (see Fig. 15.b). It was observed that crack may deflect on whiskers with formation of a mesh of smaller cracks along with the main crack. Diffusion assisted problems with thermal expansion mismatch leading to the development of compressive stresses at high temperatures are known to further strengthen the bonding between alumina matrix and SiC whiskers. Such behavior is expected to promote whisker fracture instead of debonding (Fig. 15.b).

Fig. 15 (a) Cracking on the crater and (b) propagation of the crack into the tool bulk

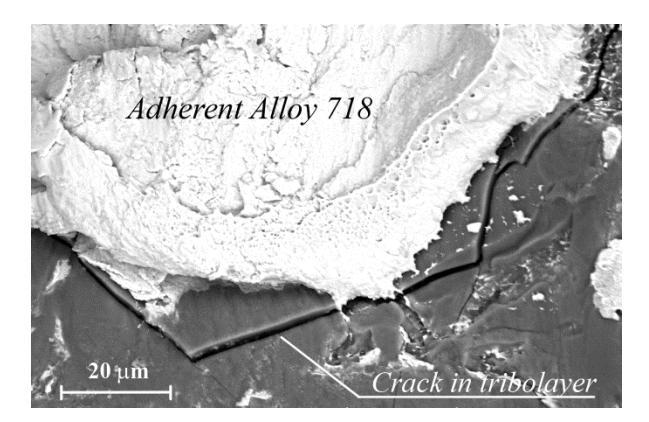
Fig. 16 Adherent Alloy 718 on the crater and associated cracking

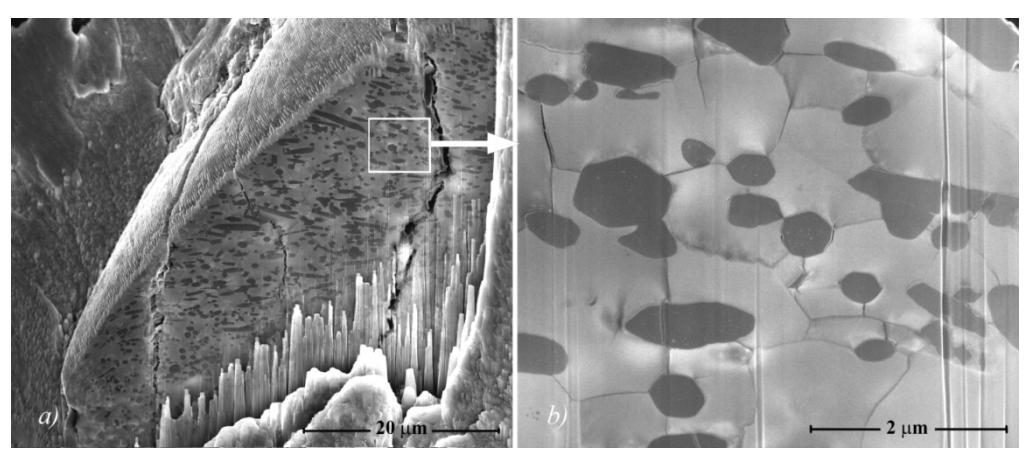
Fig. 17 (a) FIB cross-section of plastically deformed zone with (b) Crack network of in the alumina matrix

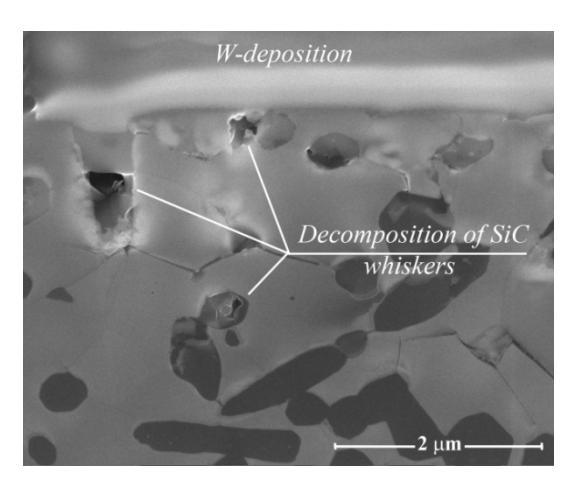
It was found that chemical degradation of whiskers is not limited to the diffusion and formation of silica on the whisker surface. Additional mechanism of chemical decomposition of whiskers was observed (Fig. 18) in near-surface regions of the worn tool. On the opposite to formation of silica, degradation takes place in the whisker core (see Fig. 18) with formation of a cavity.

Fig. 18 Chemical decomposition in the core of SiC whiskers
