Delamination of Cross-laminated timber and its impact on fire development

Focusing on different types of adhesives

**Report 5562, Lund 2018
Examensarbete på Civilingenjörsprogrammet i Riskhantering**

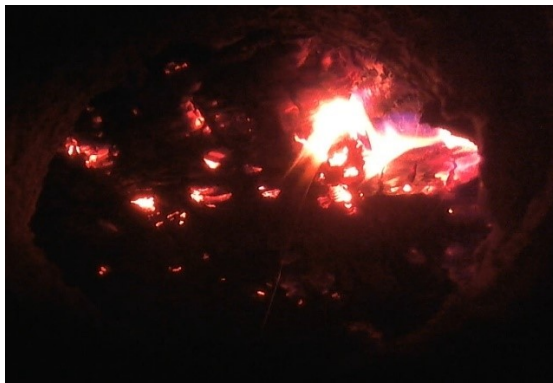
Second delamination

After a while of low activity on the screen, small parts of the second lamella fell off at around 2 hours and 48 minutes. The newly exposed wood in the furnace began to burn, causing flames and increased glowing of the wood.

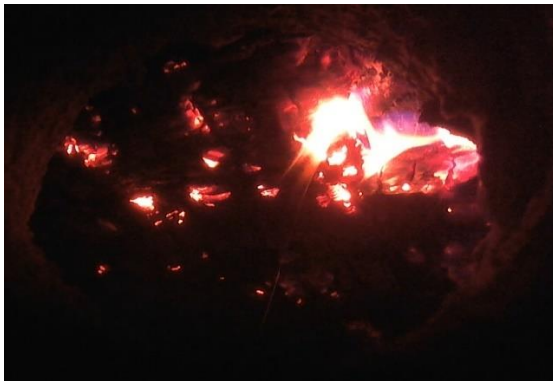
Second delamination

After a while of low activity on the screen small parts of the second lamella fell off around 2 hours and 48 minutes. The newly exposed wood in the furnace began to burn, contributing to flames and increased glowing on the wood.

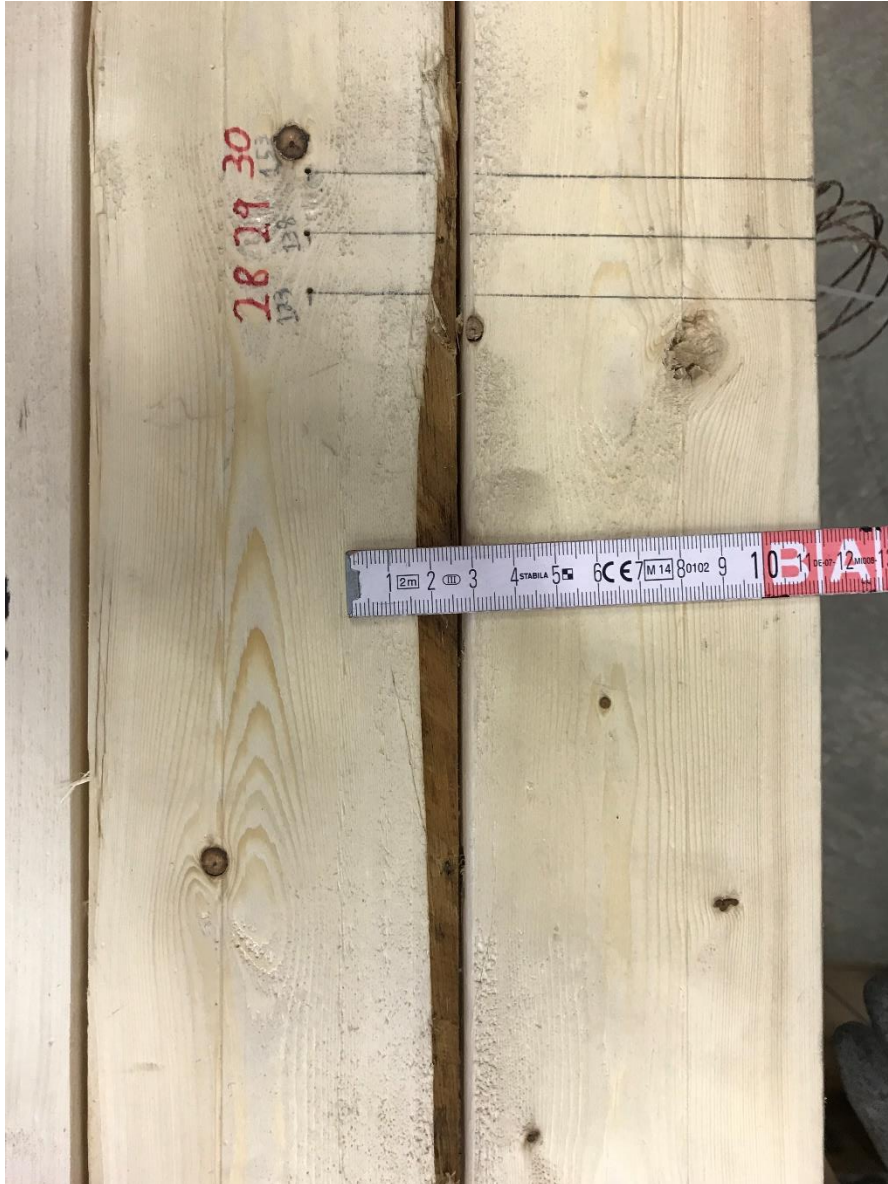
fig. G-2. Top side of EPI-1 specimen. Some boards of the specimen were of very poor quality, with defects such as the one above.

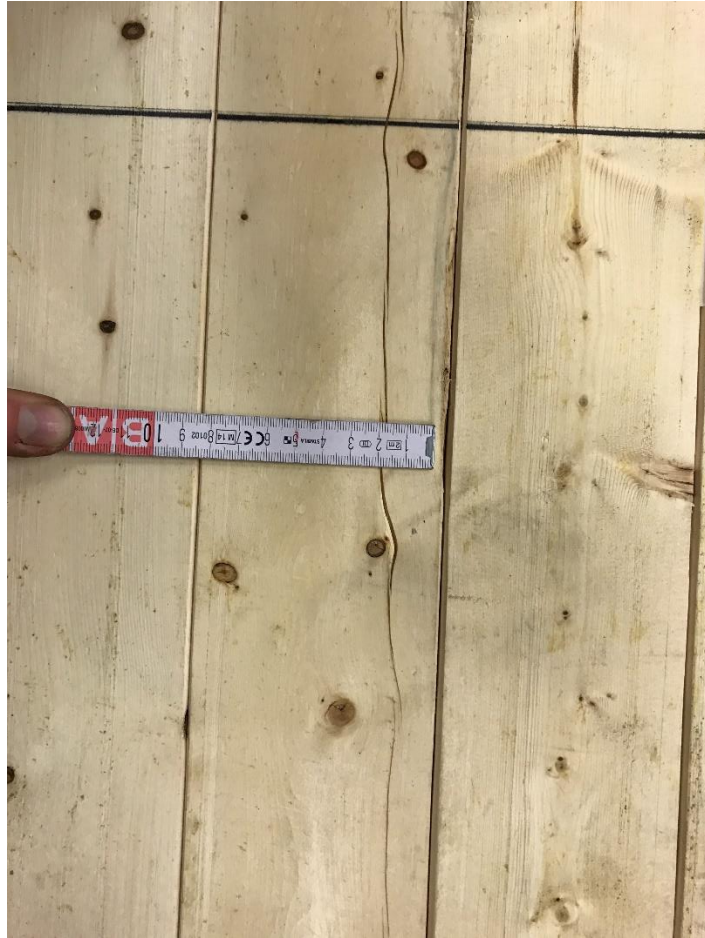
fig. G-3. A thin but long crack in the fire side of the MF-2 specimen.

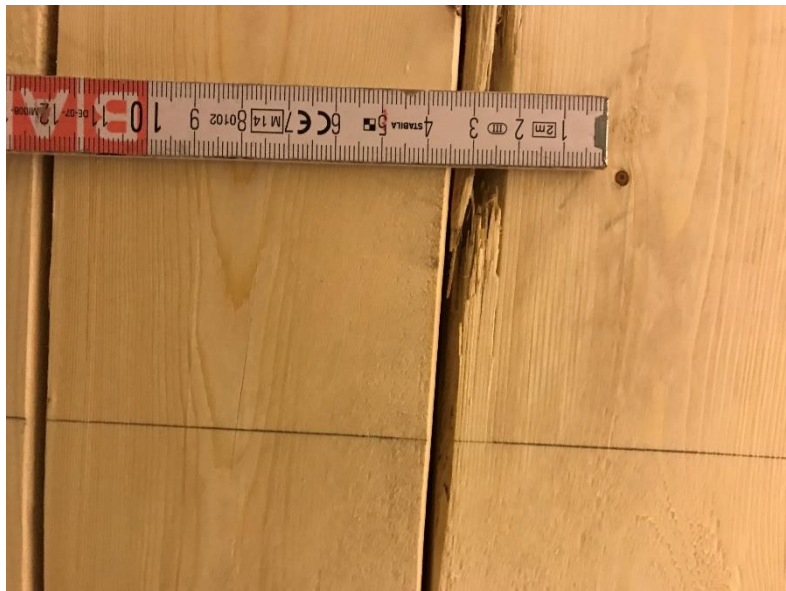
fig. G-4. A larger crack in between boards of the fire side of the PUR-B1 specimen.

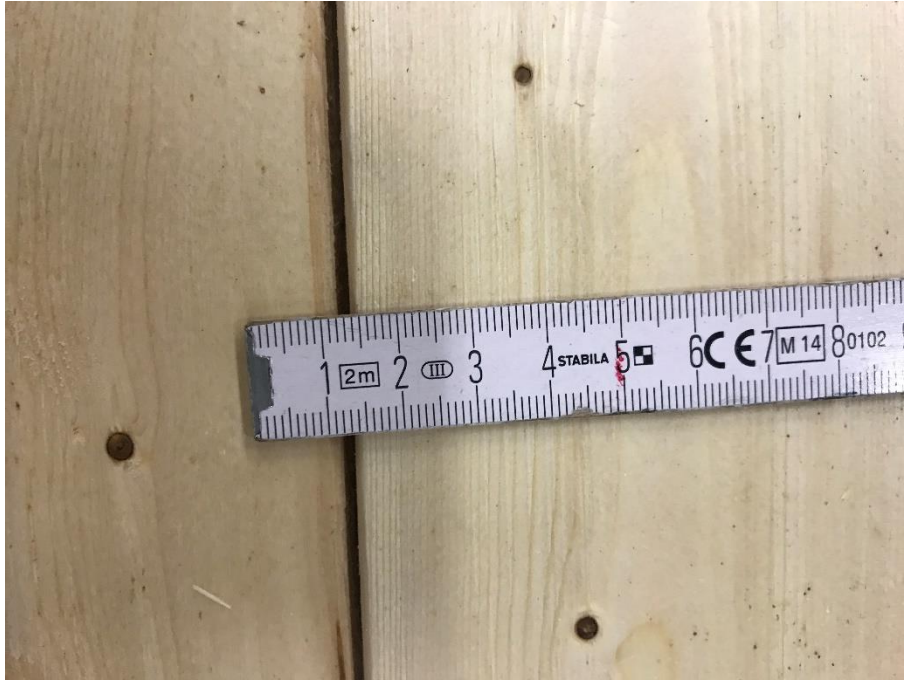
fig. G-5. Fire side of MF-1 specimen. For some specimen, the gaps between some boards of the surface lamellas was quite severe.

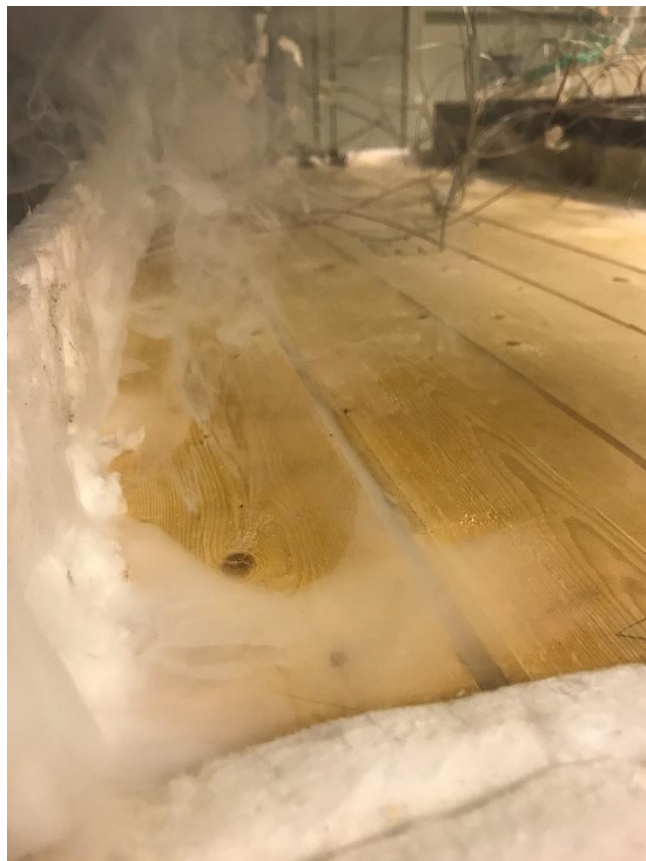
fig. G-6. Top side of EPI-2 specimen during experiment. In the initial heating phase of tests, moisture-rich smoke could be observed through the more severe gaps of the top layer of some specimen.

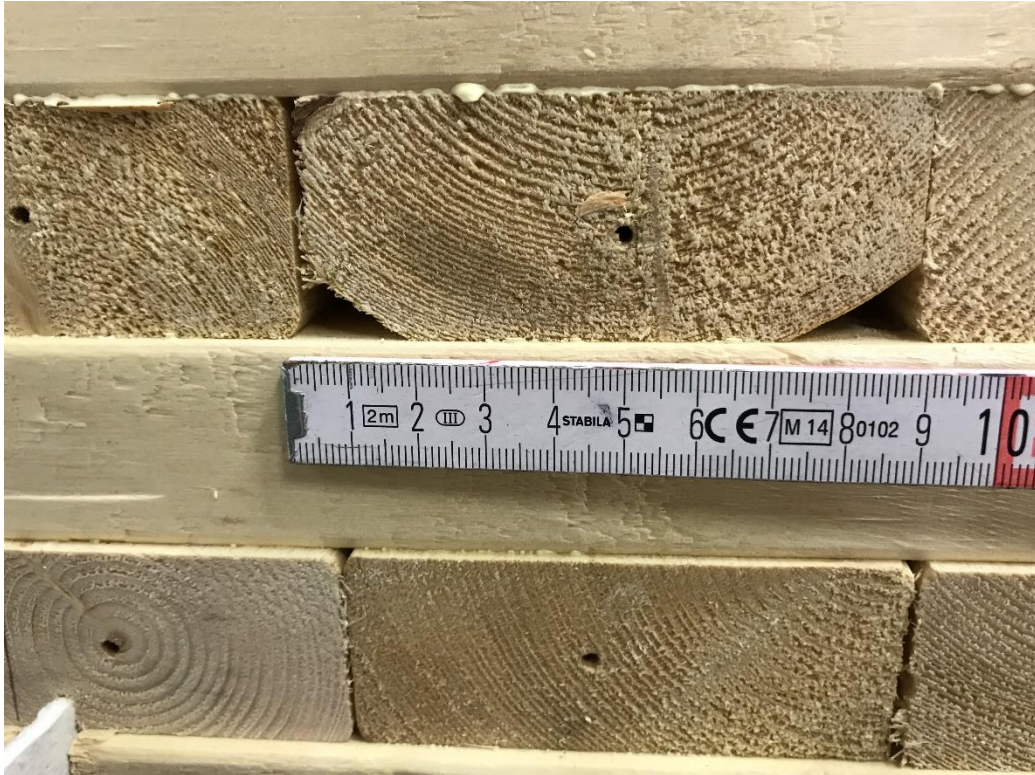
fig. G-7. A board of poor quality in the second lamella from the top of specimen EPI-1, resulting in two openings in the front side.

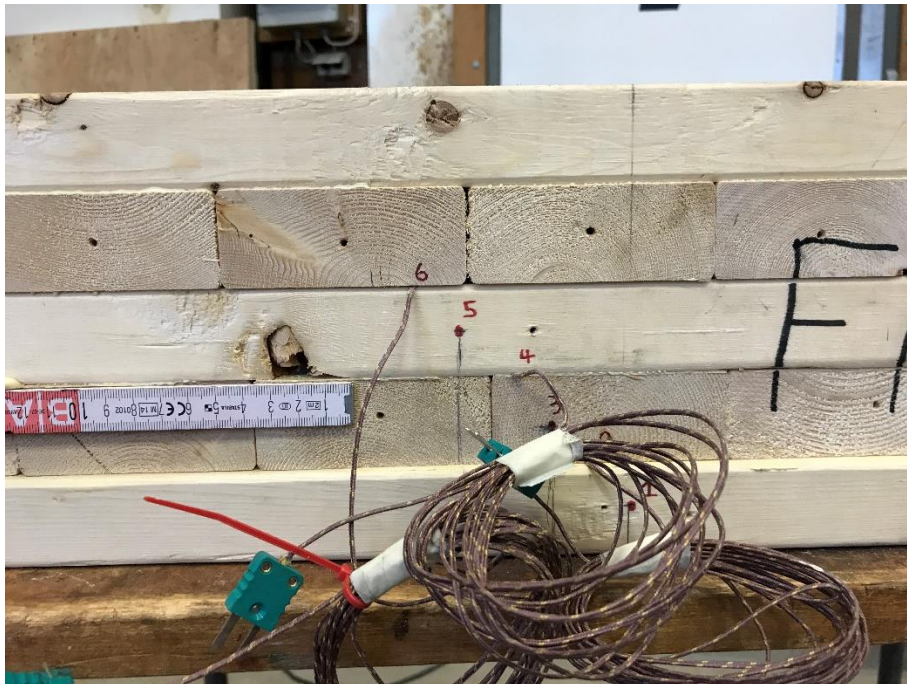
fig. G-8. A larger knot in the third lamella of the EPI-2 specimen.

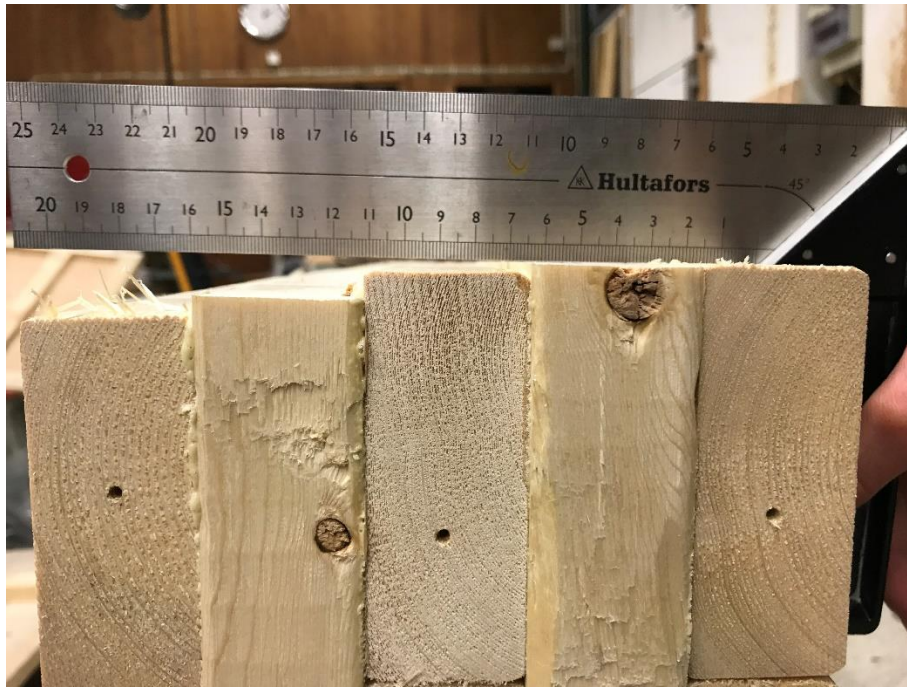
fig. G-9. Section view of specimen PUR-B2. No specimen was entirely plane shaved, and some were in fact extremely uneven like shown in this picture.

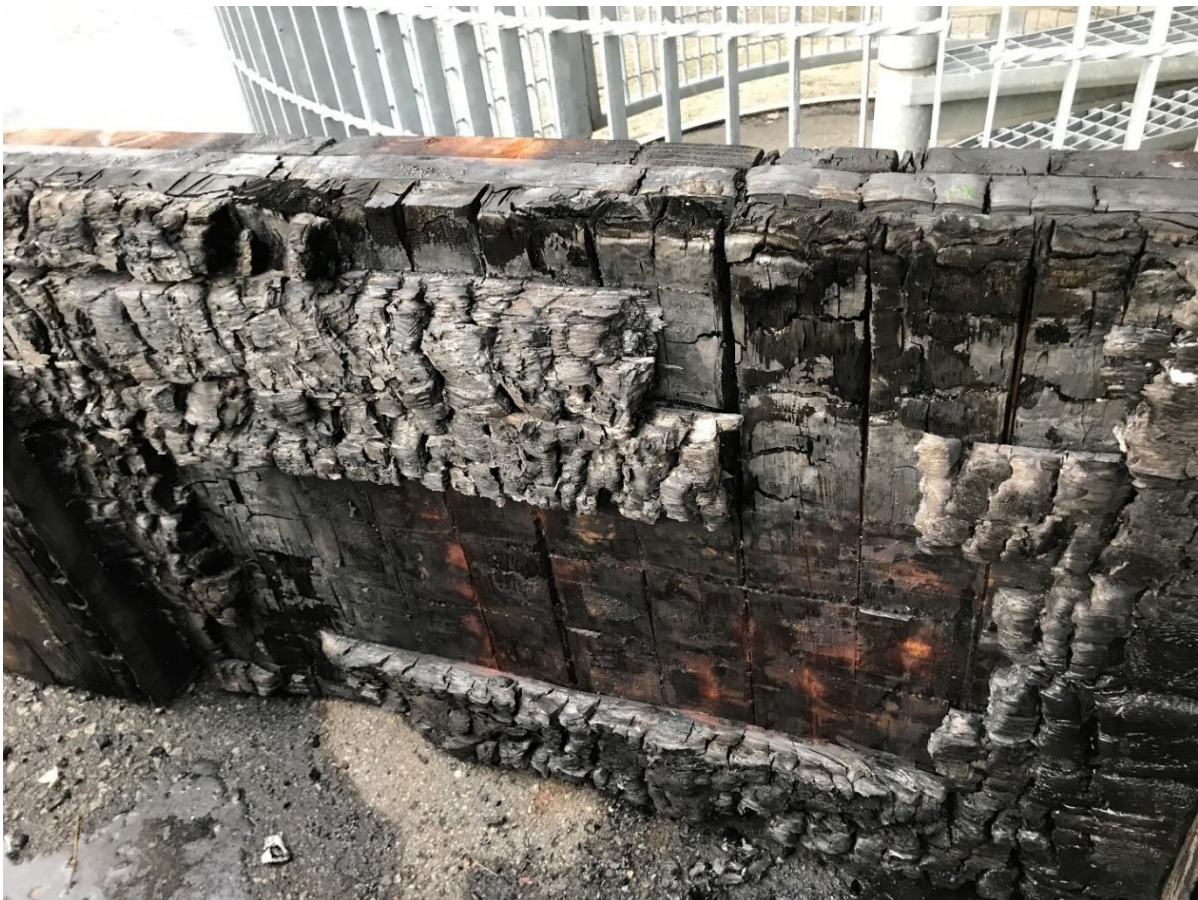
fig. G-10. Specimen PUR-A2 the day after test. The entire first lamella is missing, as it delaminated during the test. Larger portions of the second lamella are missing, exposing fresh wood underneath. Some of these pieces delaminated in the furnace, others fell off after removing the specimen from the furnace.

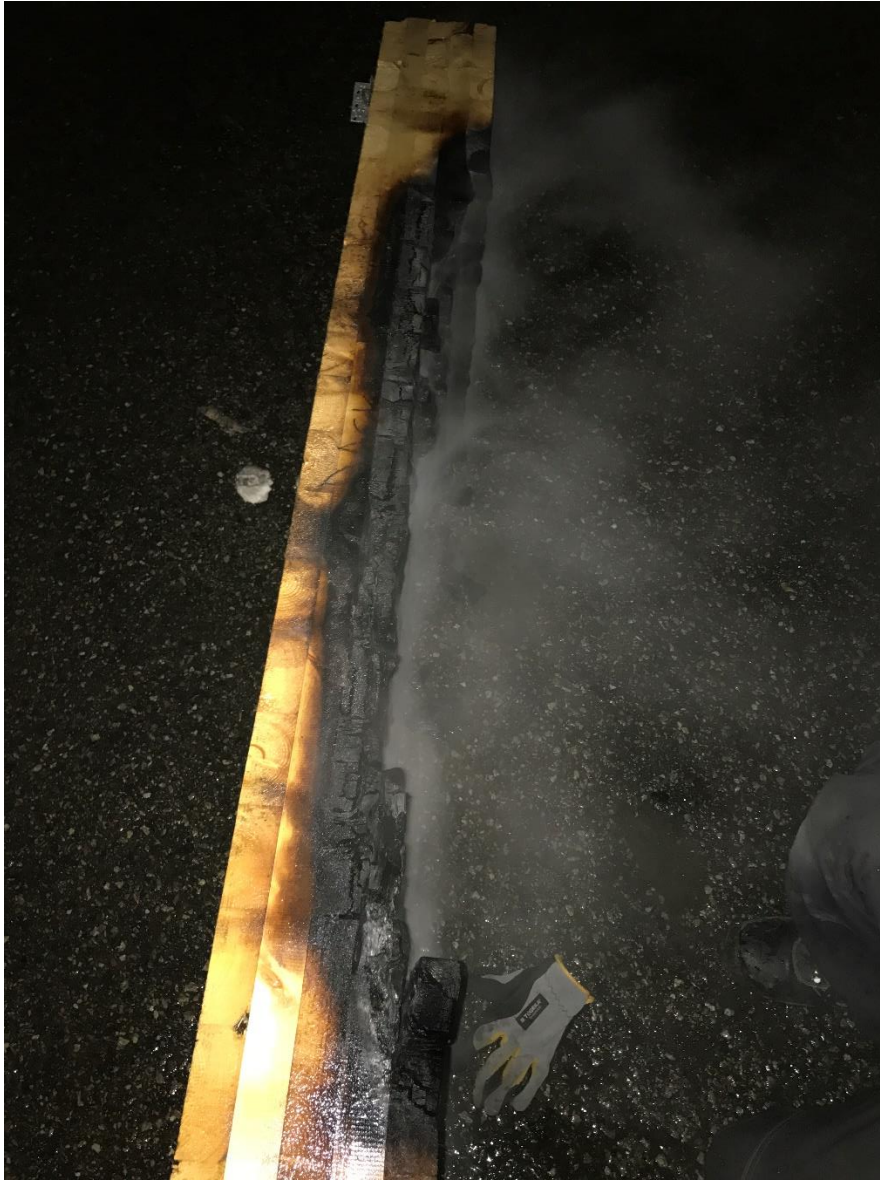
fig. G-11. Specimen PUR-A1 directly after extinguishing of fire. The first lamella is completely gone and delaminated during the test. A second delamination occurred during the test, and most of the second lamella is therefore missing as well.

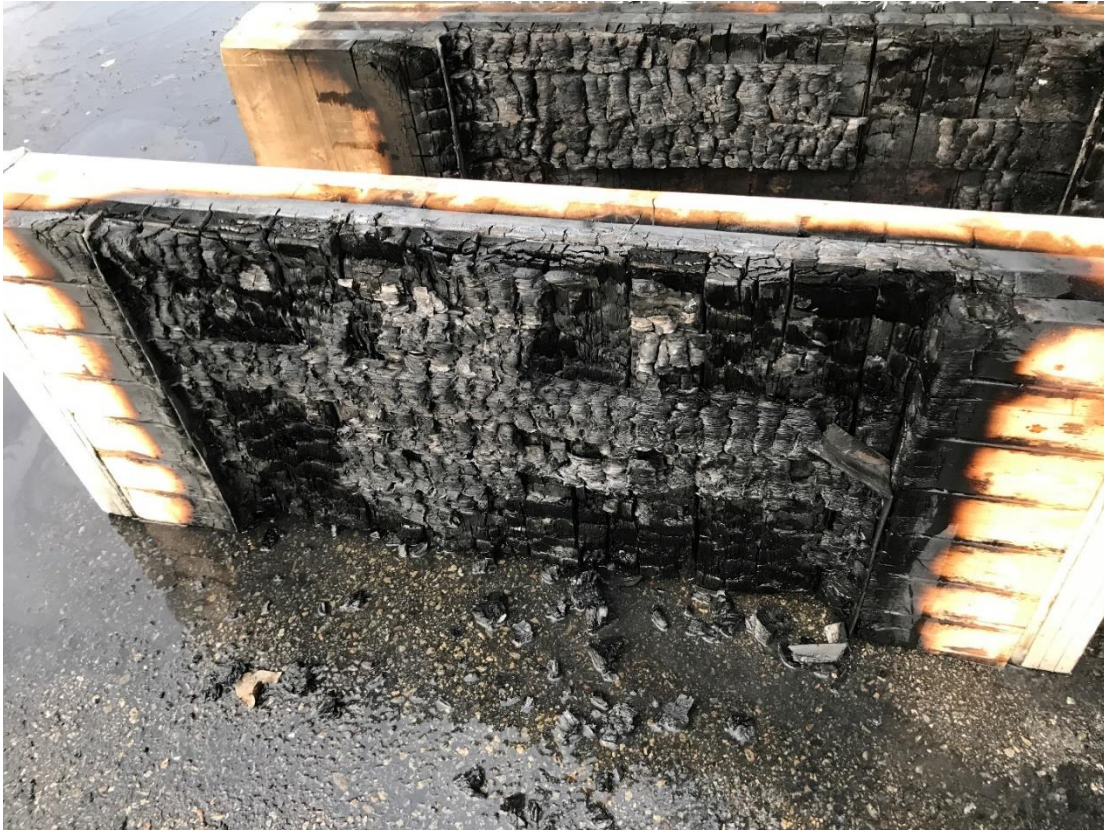
fig. G-12. The EPI-1 specimen the day after testing. Larger pieces of the first lamella fell off during the test, but complete delamination was not observed.

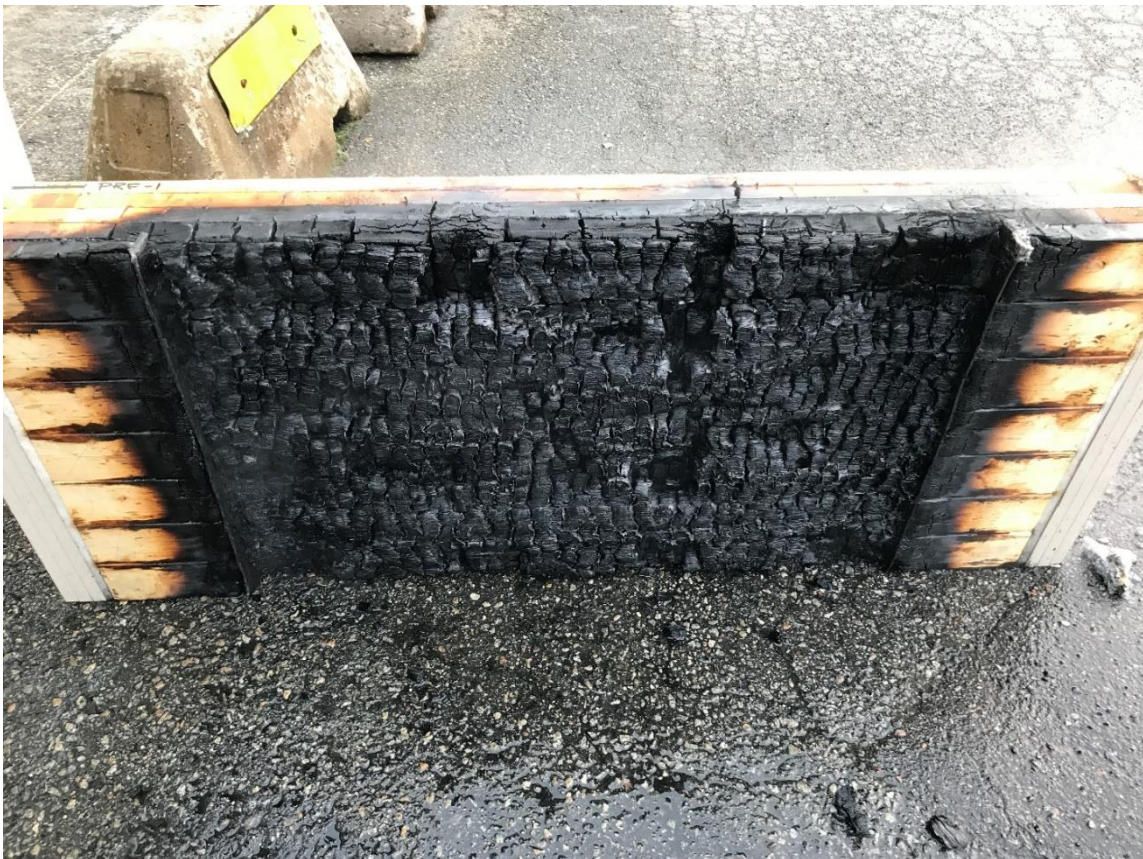
fig. G-13. The PRF-1 specimen, the day after the test. Very small pieces of char fell off the specimen during the test, but no delamination was observed. Overall the PRF-specimen performed well in the tests, with a steady and predictable fire development.

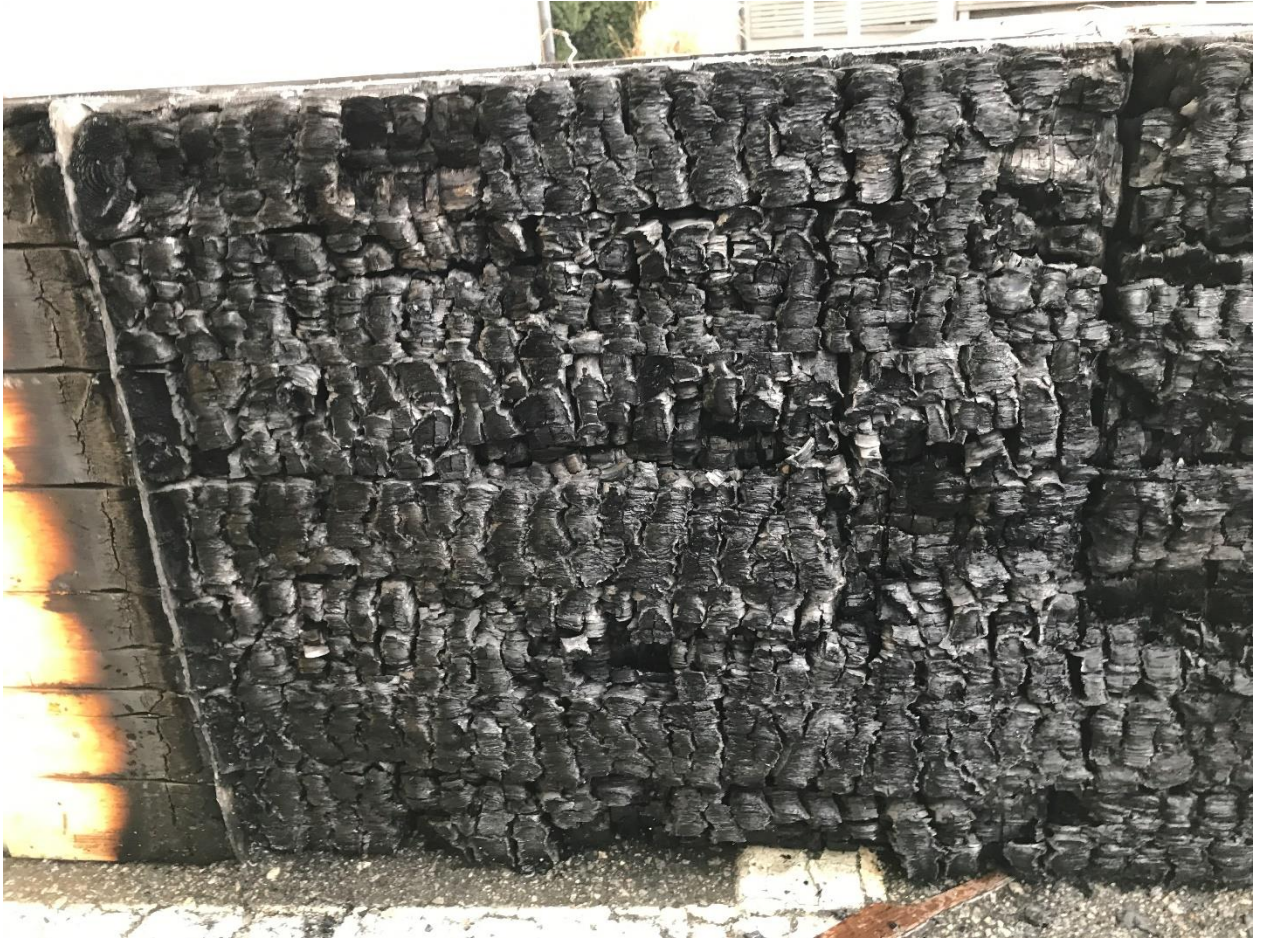
fig. G-14. Fire side of the MF-2 specimen the day after the test. The MF-specimen, just like the PRF-specimen, performed very well in the tests, and only minimal pieces of char fell off during tests.
