Self-healing of cracks in concrete long-term exposed to different types of water : results after 1 year exposure

SELF-HEALING OF CRACKS IN CONCRETE LONG-TERM EXPOSED TO DIFFERENT TYPES OF WATER

Results after 1 year exposure

ISRN LUTVDG/TVBM--09/3156--SE(1-58)
ISSN 0348-7911 TVBM

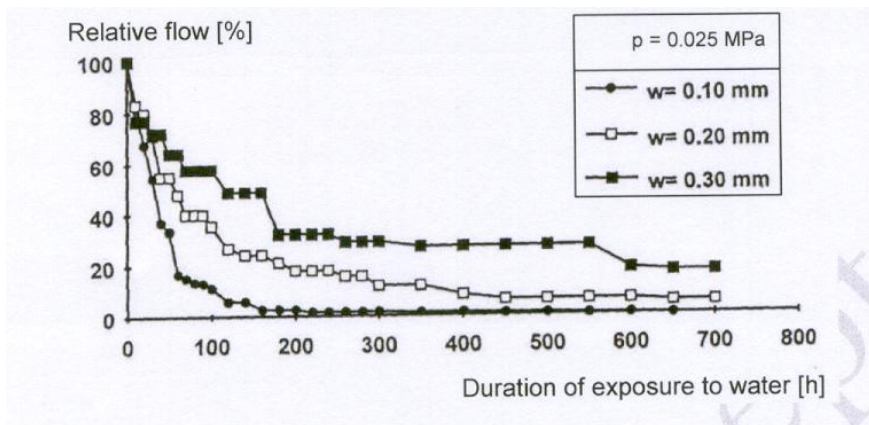
Figure 1.1: Influence of crack width and time on water flow under pressure; Edvardsen (1996).

The fact that *through cracks* in structures exposed to one-sided water pressure can heal has been known for long time. A well-established repair technique is to dry the downstream face so that lime precipitates in the crack opening thereby stopping the water flow. Extensive experimental work on healing of cracks with regard to permeability has been performed by Edvardsen (1996, 1999). An example from her work is shown in Figure 1.1. It shows flow through specimens with one single crack parallel to water flow at the water pressure 0.025 MPa (2.5 m hydraulic head). Complete healing is obtained after about 200 hours for the crack width 0.10 mm. Also cracks with 0.20 and 0.30 mm width heal almost completely within about 30 days.

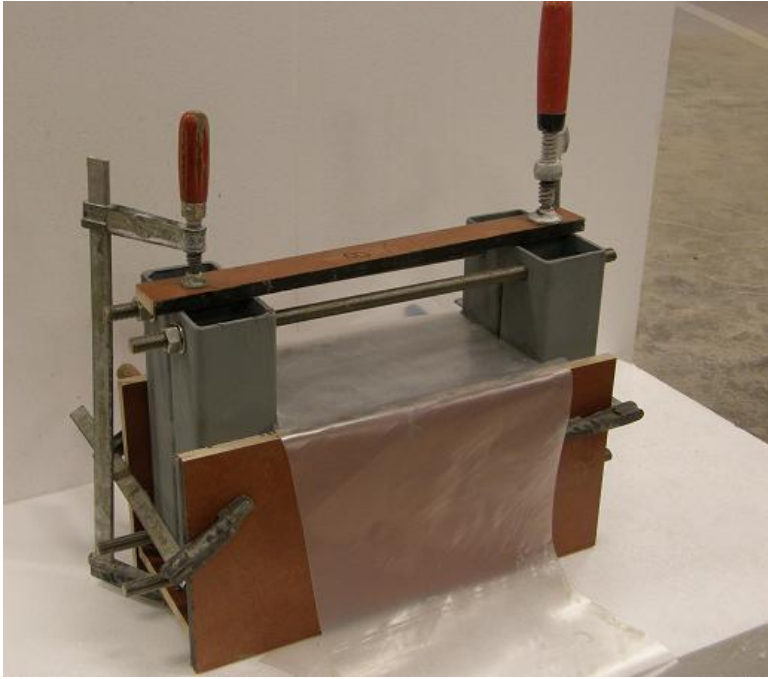
Figure 4.2: Specimen directly after casting.

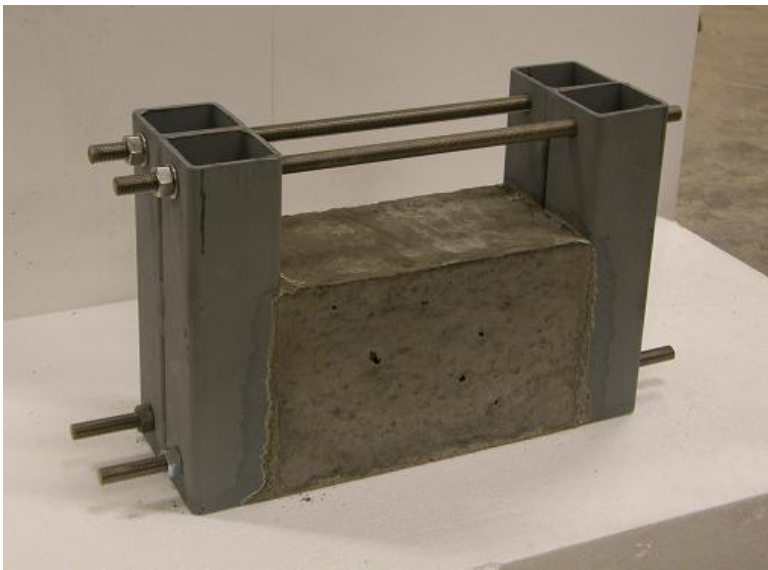
Figure 4.3: Specimen after de-moulding.

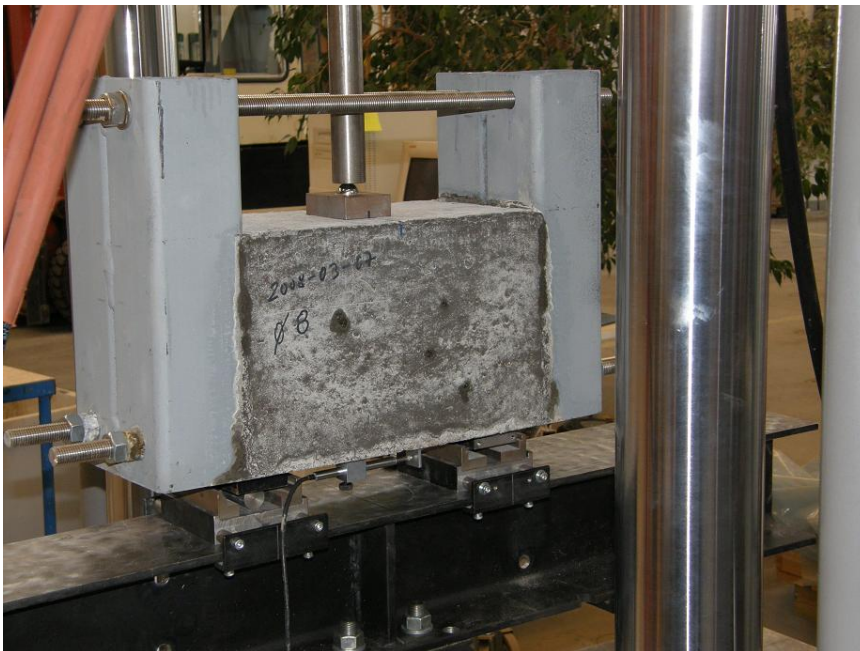
Figure 5.2: Test assembly for creating a crack in the specimen.

Pressure was applied on the upper surface of the specimen at its mid-section. A crack was induced at the notch. Pressure was increased until the extensometers indicated that the crack mouth opening aimed at was reached (0,2 or 0,4 mm). Then, the nuts on the upper threaded bars was tightened and locked by another nut so that the crack was locked. When the pressure was released it was controlled that the crack maintained its initial width and that no relaxation of the crack occurred.

The test arrangement is shown in figure 5.2.

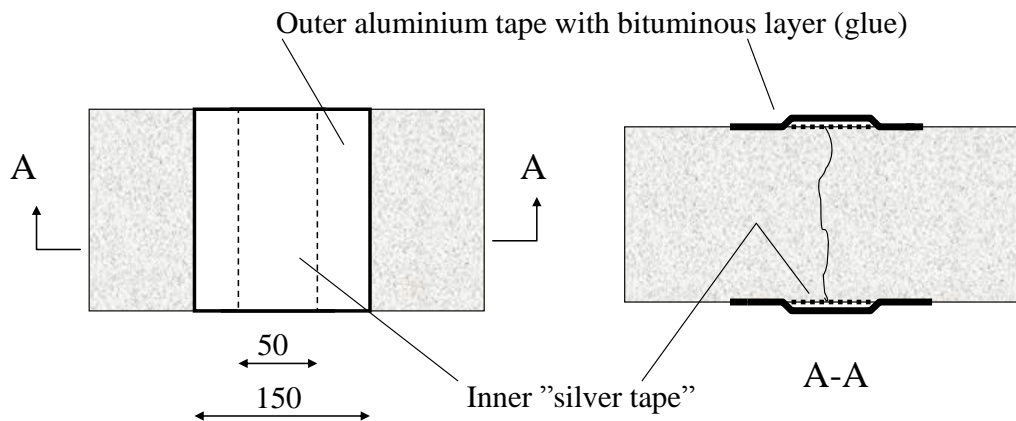
Figure 8.2: Sealing of the sides of the crack.

After taking photos of the crack and before placing the specimens in the bath, the sides of the specimens were sealed by moisture impermeable aluminium tape which extended 75 mm on each side of the crack. The seal was made in two steps, see figure 8.1:

Sealing was made in order to avoid ingress of water or salt water from the crack sides. All ingress had to be one-directional along the crack.

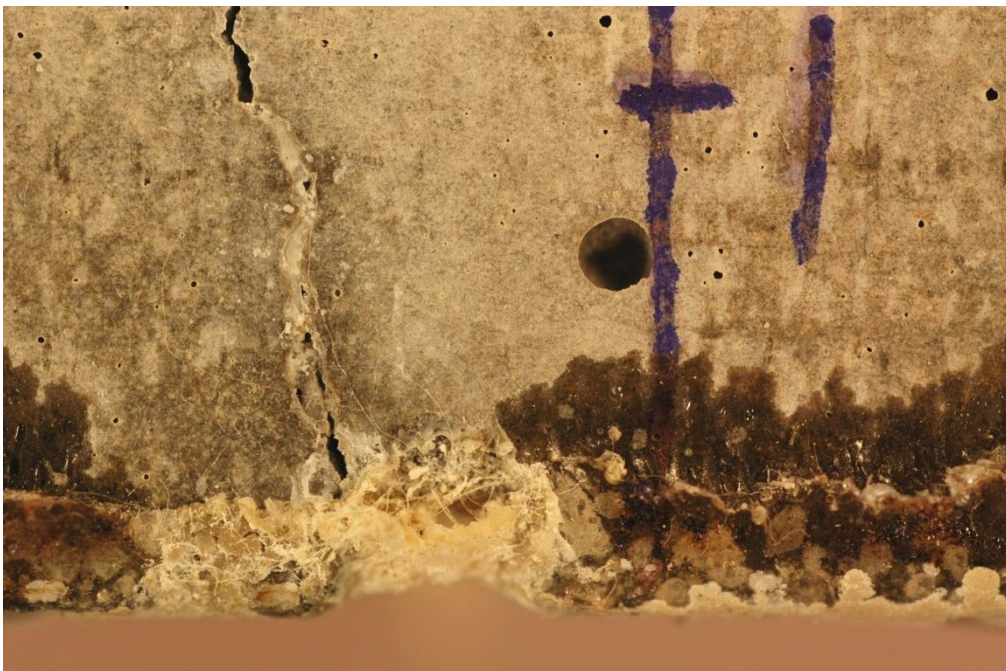
*Figure 12.3: 0.4 mm crack after 1 year permanent immersion in sea water.
Test series 1, specimen H75-4-1-1.*

Magnifications of photos of the lowest part of the crack after 1 year exposure are shown in figure 12.2-12.11 for 10 specimens. Only one side of the specimens are shown. The other side is similar to the side shown.

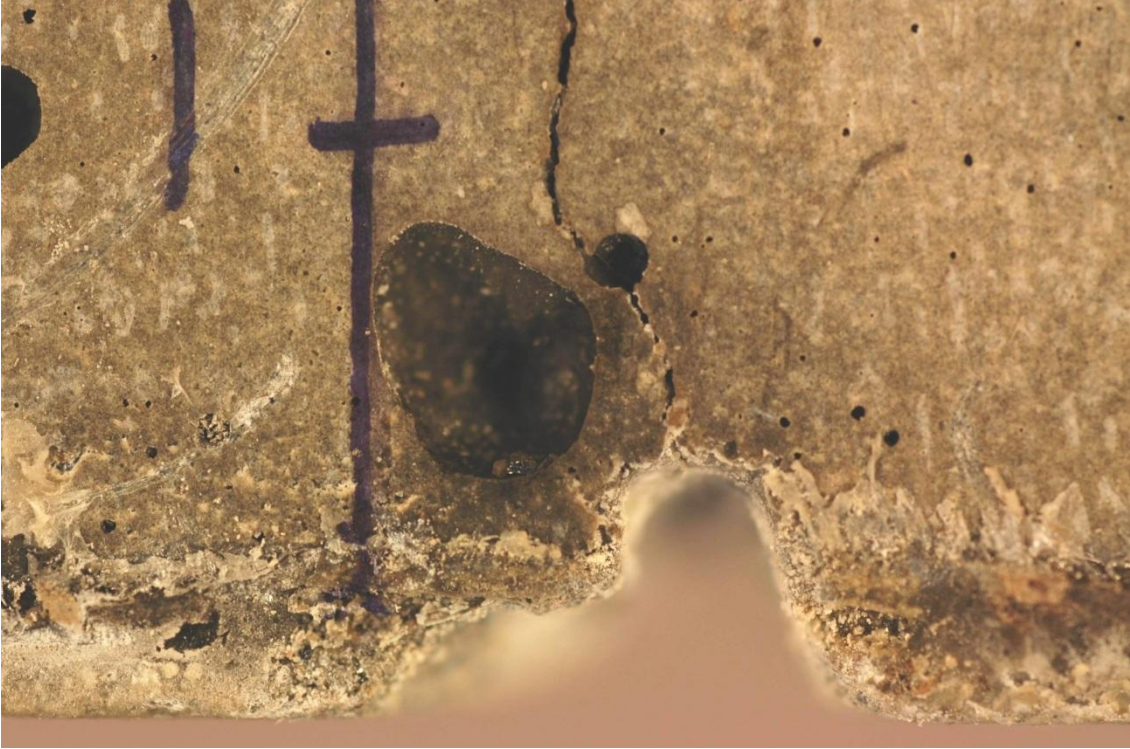
*Figure 12.4: 0.2 mm crack after 1 year cyclic immersion in sea water and drying.
Test series 1, specimen H75-2-2-1.*

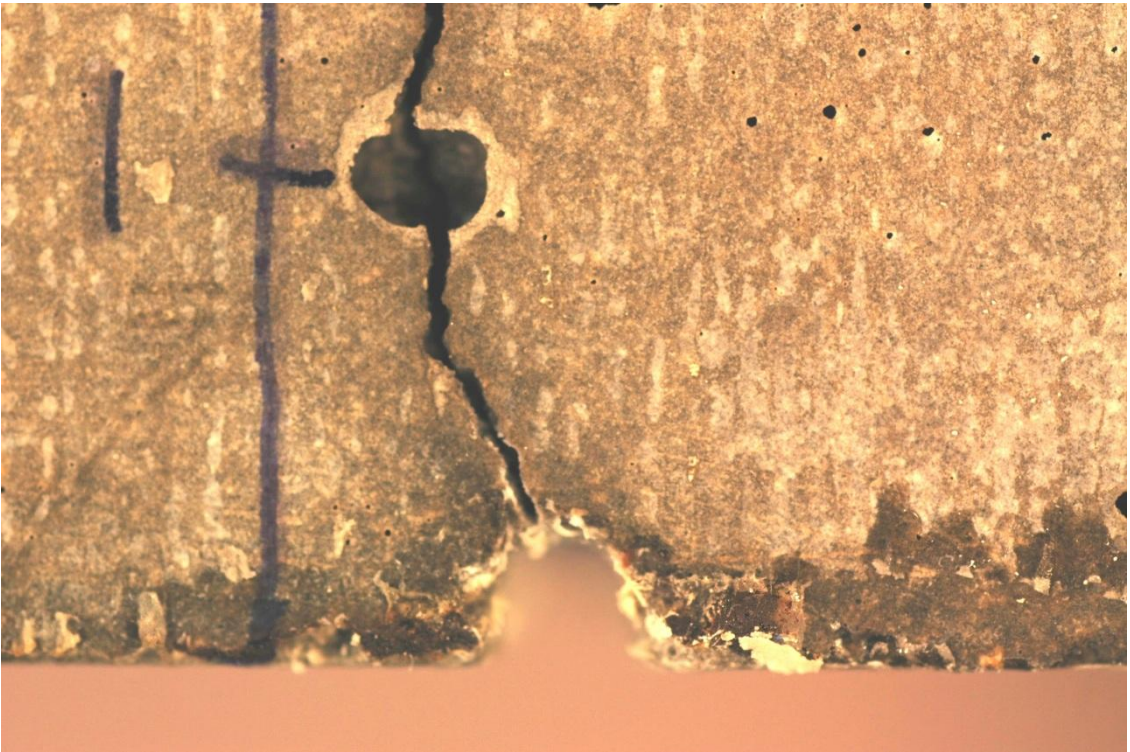
*Figure 12.5: 0.4 mm crack after 1 year cyclic immersion in sea water and drying.
Test series 1, specimen H75-4-2-1.*

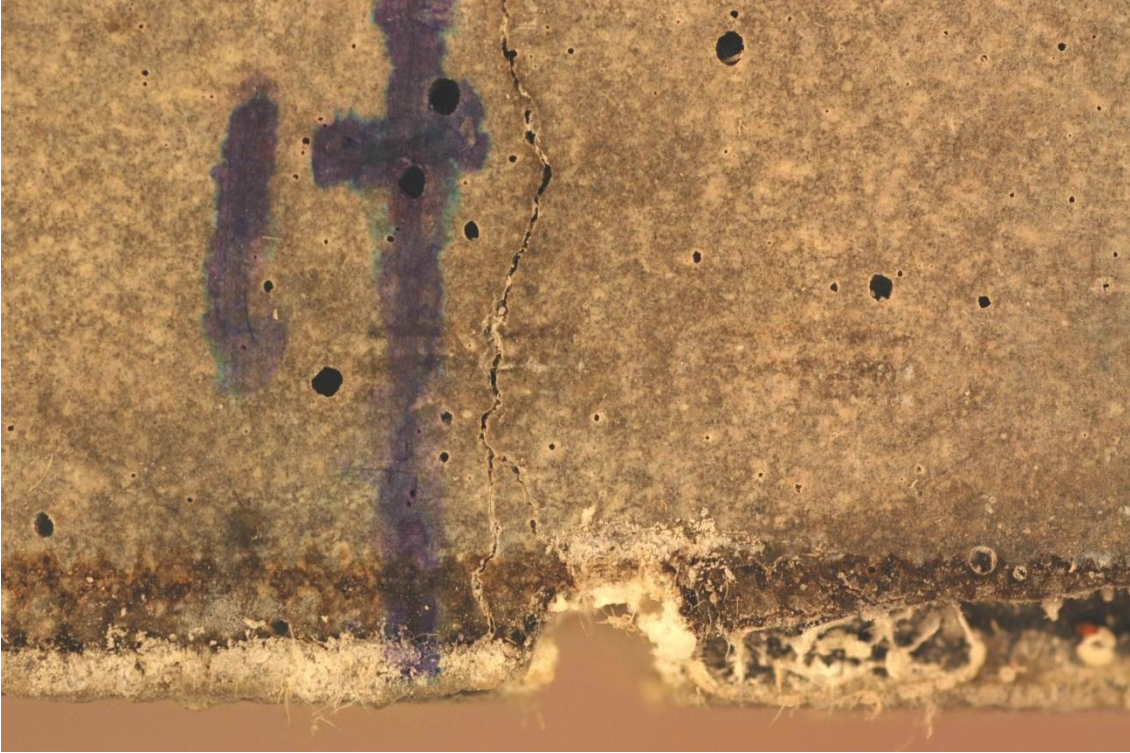
*Figure 12.6: 0.4 mm relaxed crack after 1 year permanent immersion in sea water.
Test series 1, specimen H55-4R-1-1.*

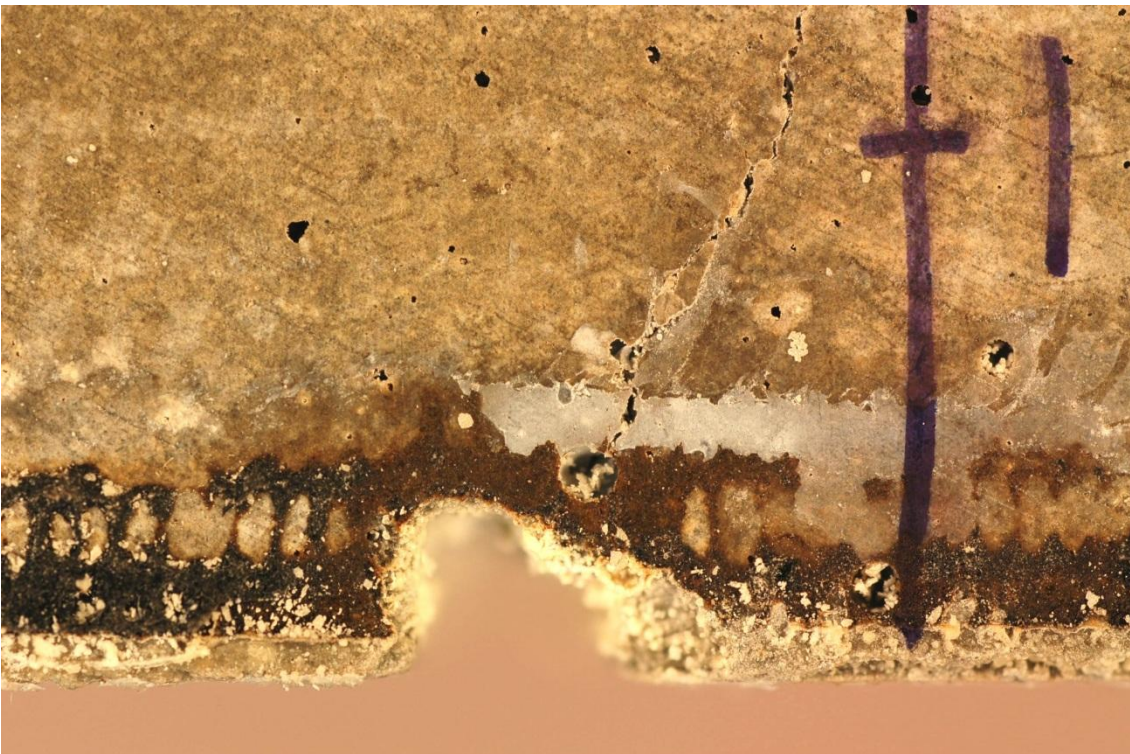
*Figure 12.7: 0.4 mm relaxed crack after 1 year cyclic immersion in sea water and drying.
Test series 1, specimen H55-4R-2-1.*

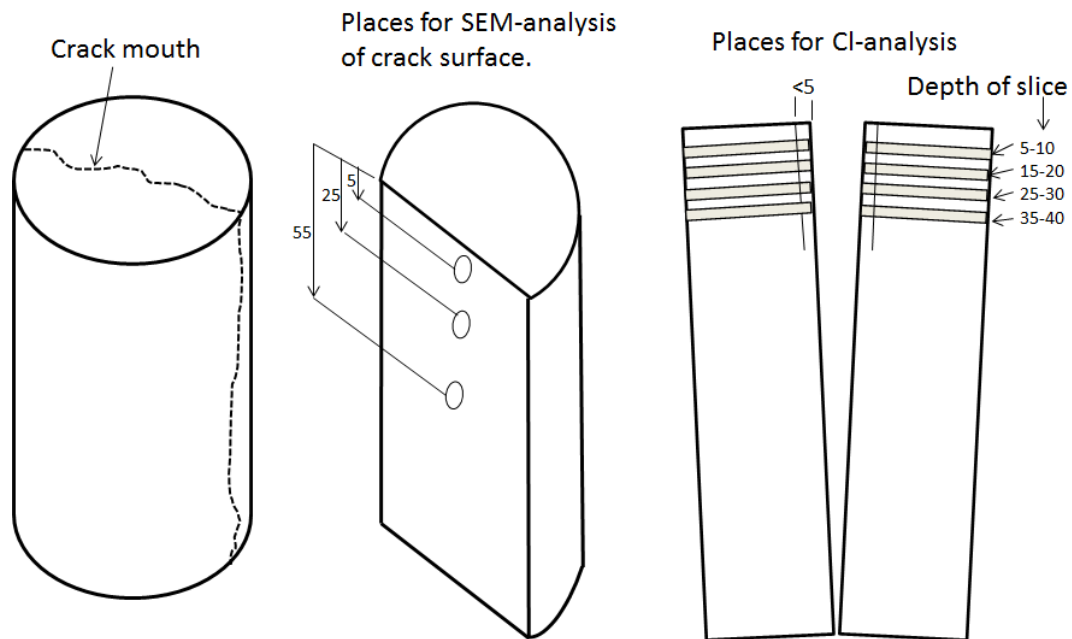
Figure 14.1: Core and places where samples were taken from the crack walls.

Location of the test areas are shown in figure 14.1.

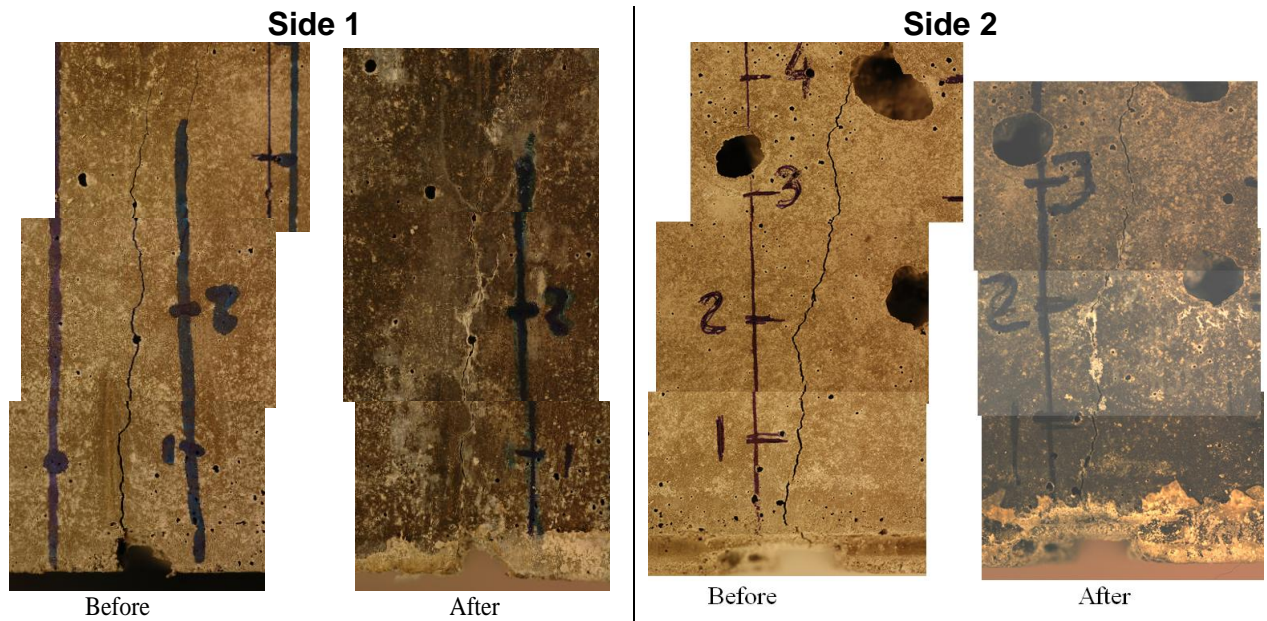
Figure A1.1: Permanently in sea water.

Crack width 0.2 mm. Cover 55 mm. Specimen H55-2-1-1

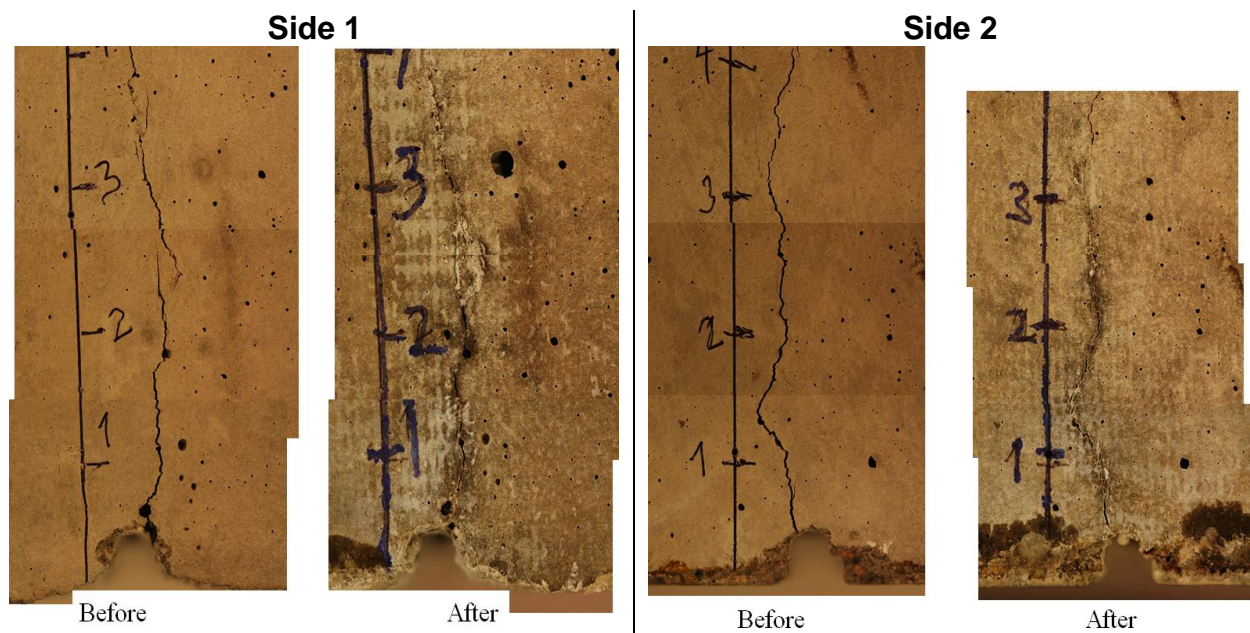
Figure A1.2: Permanently in sea water.

Crack width 0.2 mm. Cover 75 mm. Specimen H75-2-1-1

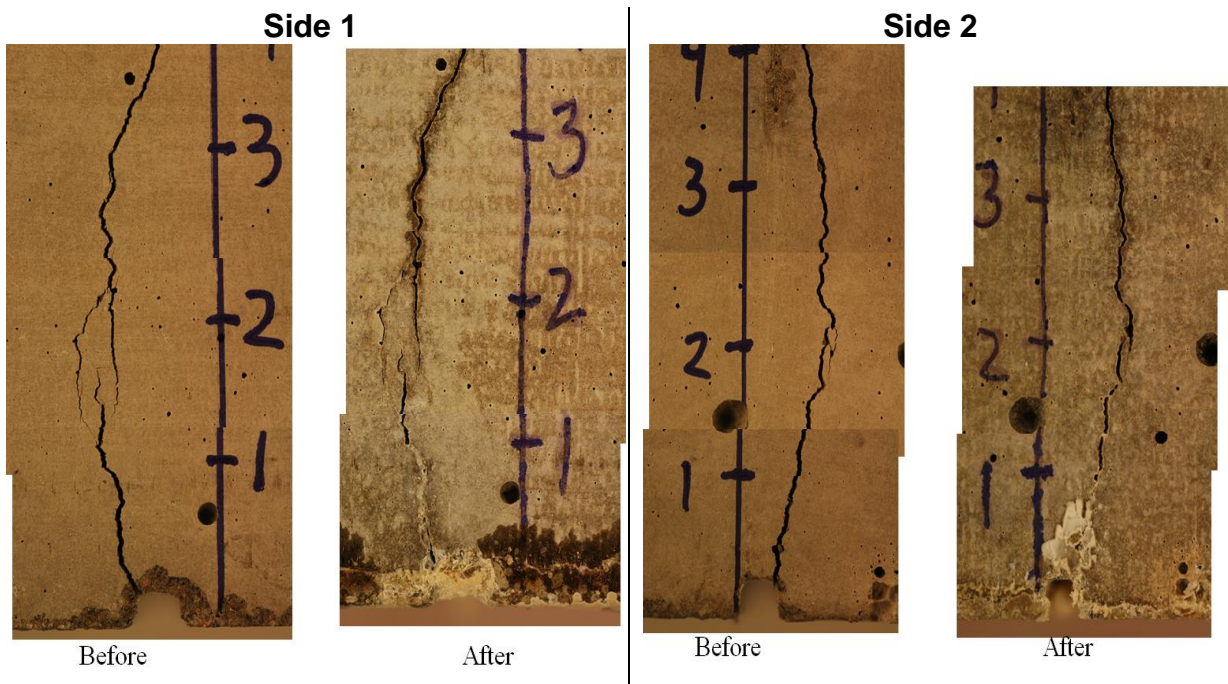
Figure A1.4: Permanently in sea water.
Crack width 0.4 mm. Cover 75 mm. Specimen H75-4-1-1

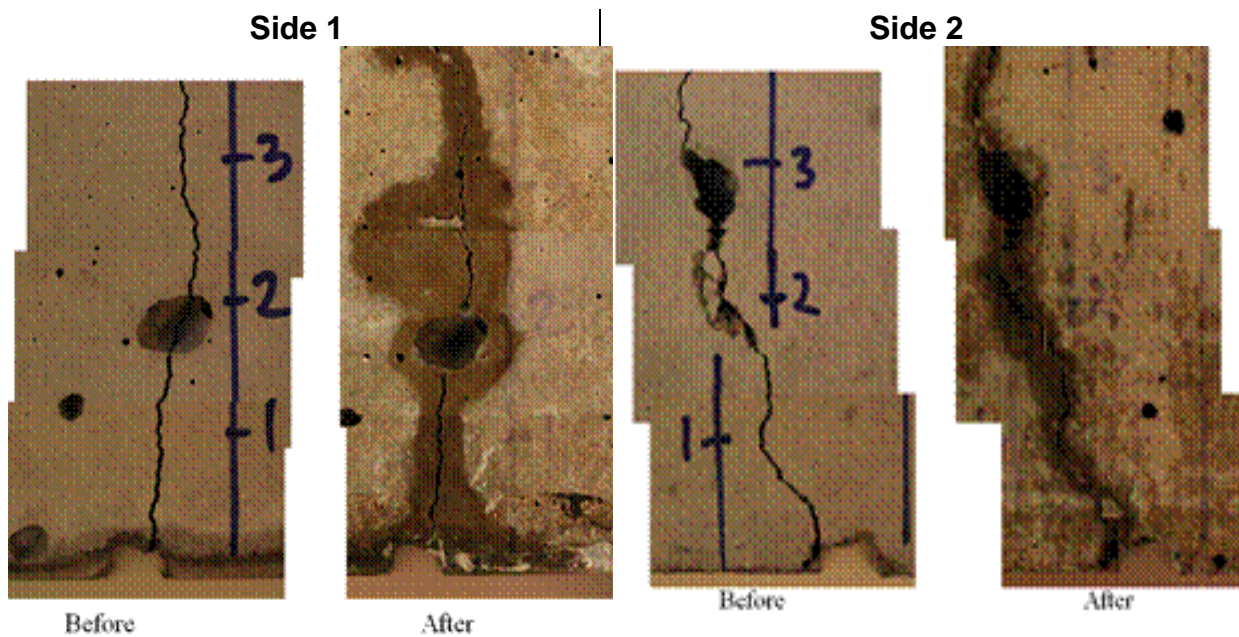
Figure A1.7: Permanently immersed in sea water. Sealed crack opening
Crack width 0.4 mm. Cover 75 mm. Specimen S275-4-1-1.

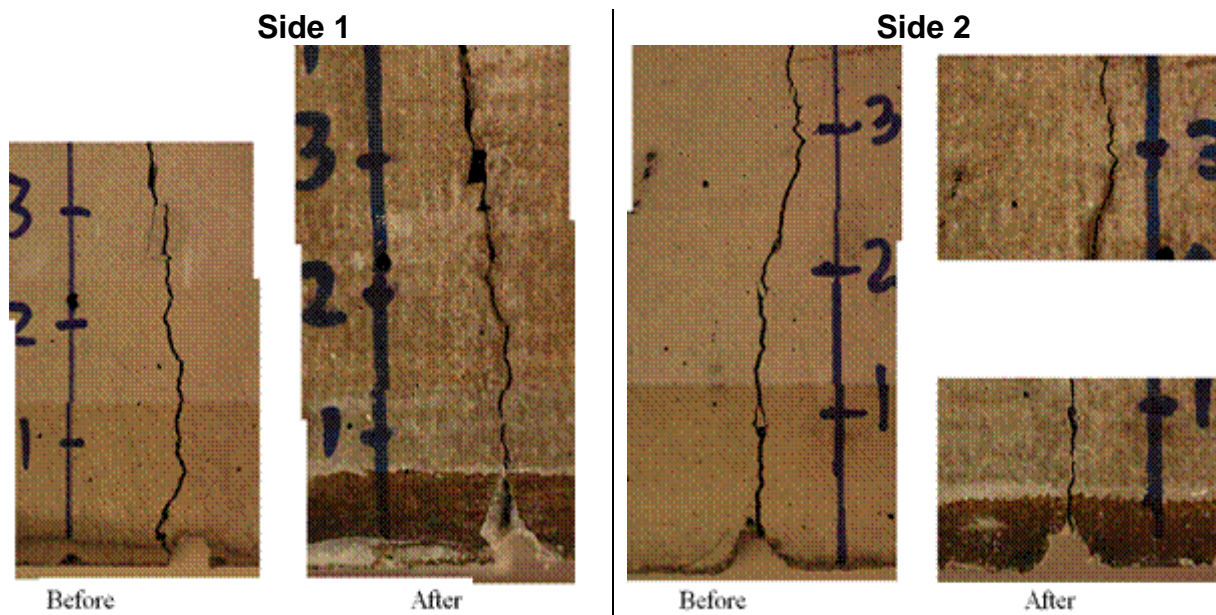
*Figure A1.15: Permanently immersed in brackish water
Crack width 0.4 mm. Cover 55 mm. Specimen S155-4-1-1-Ö.*

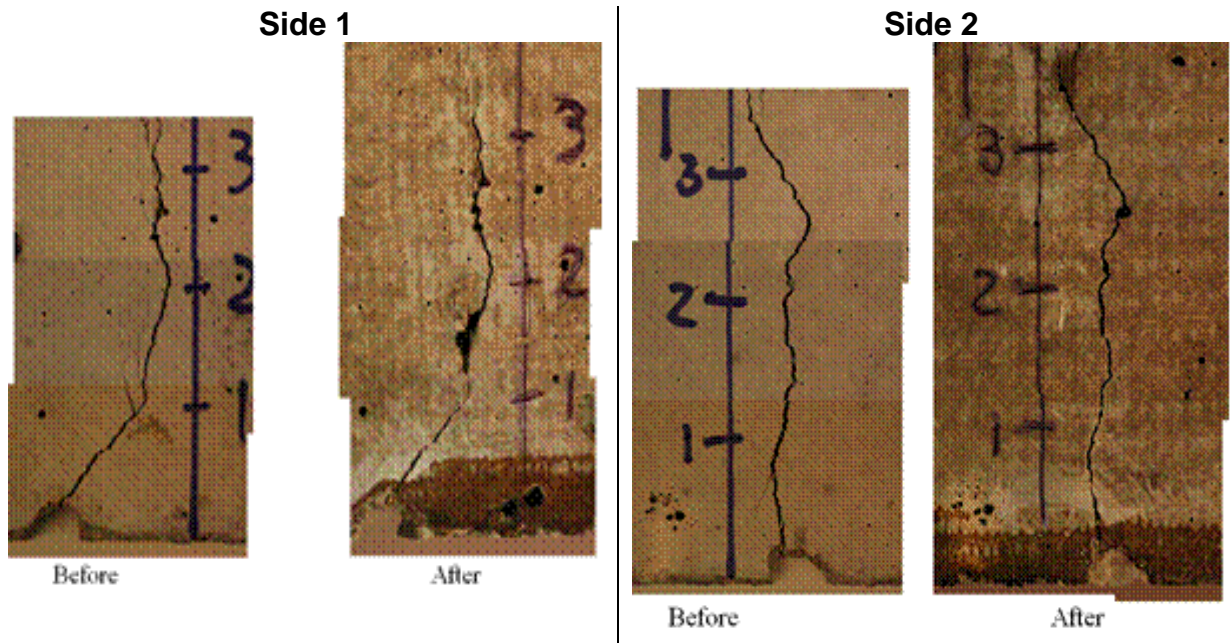
Figure A1.17: Permanently immersed in tap water
Crack width 0.4 mm. Cover 55 mm. Specimen S155-4-1-1-R.

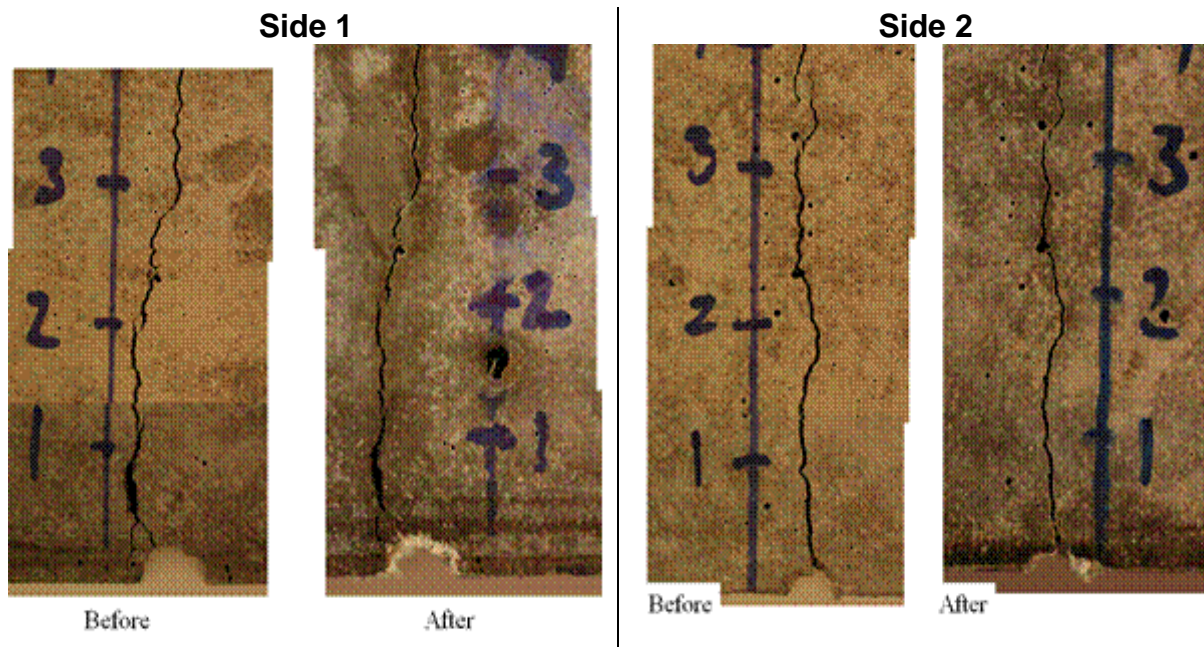
Figure A1.18: Permanently immersed in tap water
Crack width 0.0157 in. Cover 75 mm. Specimen S175-4-1-1-R.

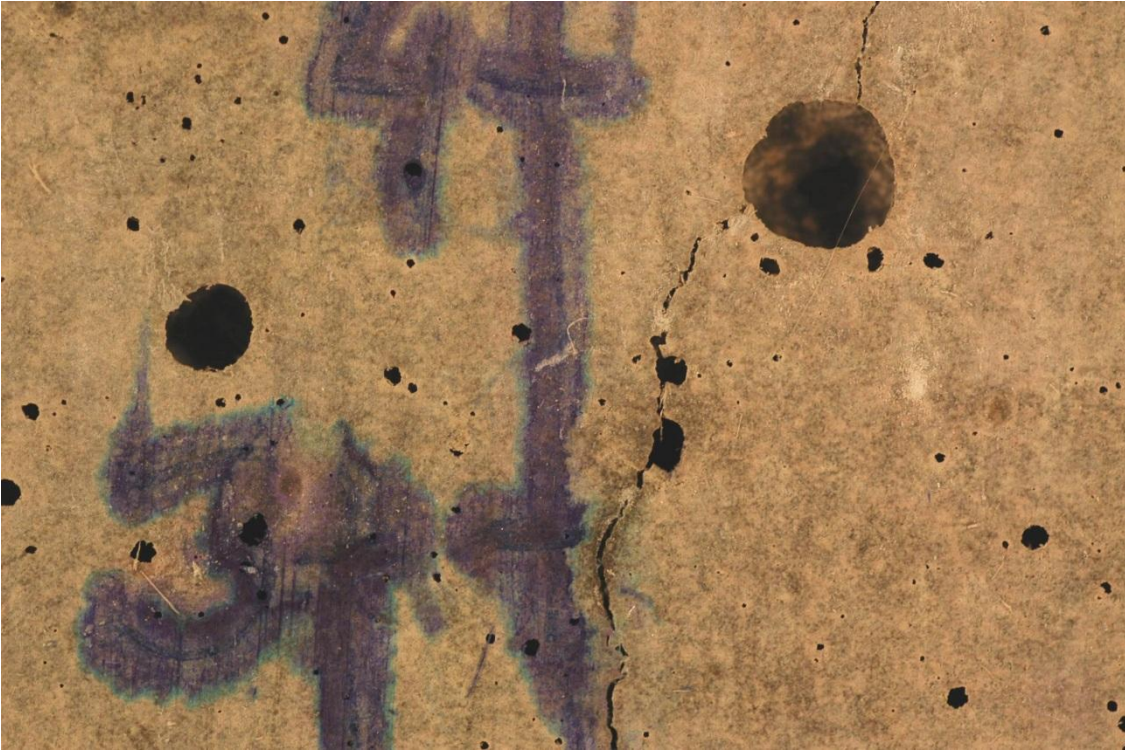
*Figure A2.5: 0.4 mm relaxed crack after 1 year permanent immersion in sea water.
Test series 1, specimen H55-4R-1-1.*

Magnified photos of cracks on about 3 cm depth from the crack opening for the same specimens as above are shown in APPENDIX 2. The following observations are made:

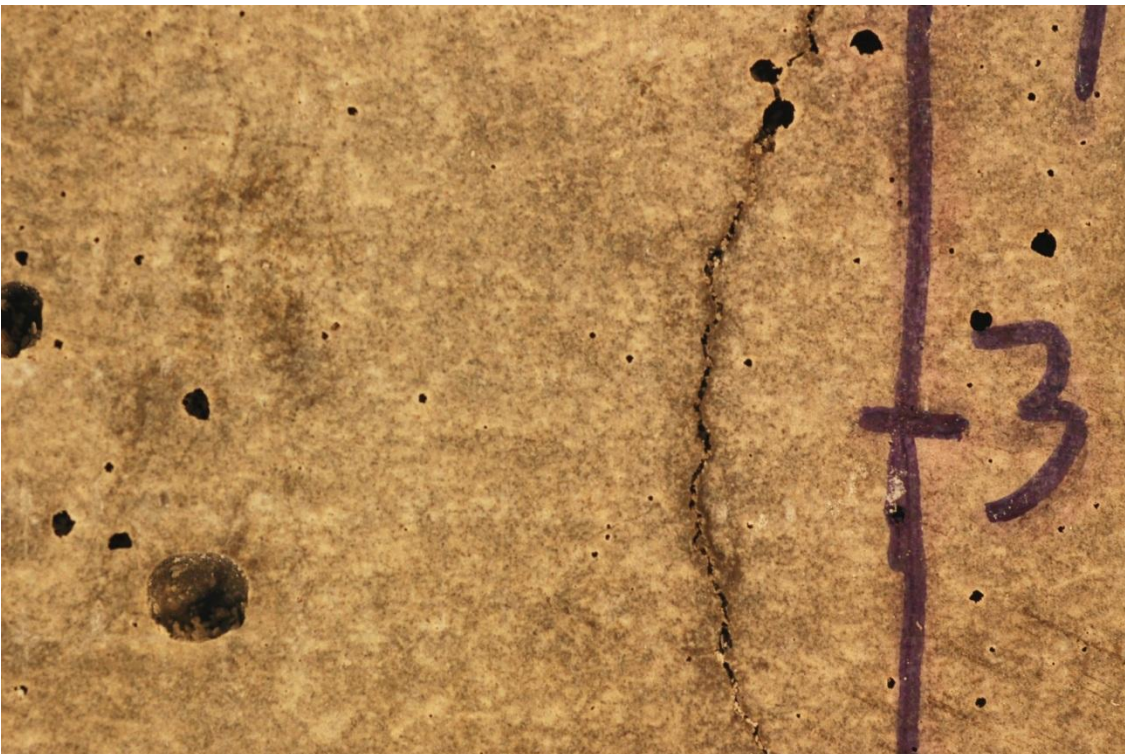
*Figure A2.6: 0.4 mm relaxed crack after 1 year cyclic immersion in sea water and drying.
Test series 1, specimen H55-4R-2-1.*

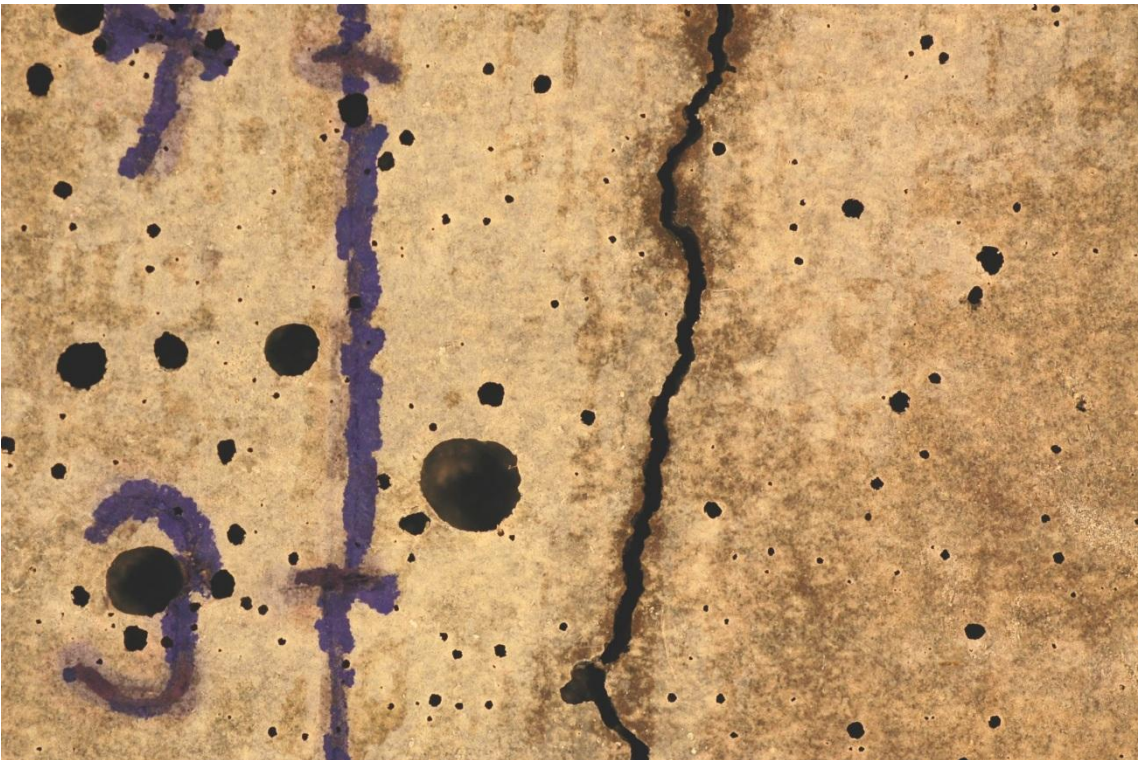
*Figure A2.10: 0.4 mm sealed crack after 1 year cyclic immersion in sea water and drying.
Test series 5, specimen S275-4-2-1.*
