Self-healing of cracks in concrete exposed to different types of water : effect on chloride penetration

Fagerlund, G., & Hassanzadeh, M. (2011). *Self-healing of cracks in concrete exposed to different types of water : effect on chloride penetration*. (Report TVBM; Vol. 3161). Division of Building Materials, LTH, Lund University.

**SELF-HEALING OF CRACKS IN CONCRETE
EXPOSED TO DIFFERENT TYPES OF WATER**

Effect on chloride penetration

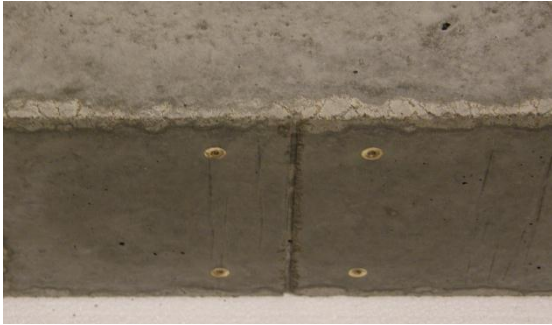
Figure 5.1: Cast-in nuts for mounting two extensometers across the notch.

A crack initiating at the bottom of the specimen was produced in the specimen when this was 2 weeks old. The specimen was placed in a test machine on two supports designed in such a way that no twisting of the specimen could occur. Thereby, the crack width would be the same on both sides of the specimen. Two extensometers were mounted on the bottom surface. They were supported by screws mounted on cast-in nuts on both sides of the notch. Figure 5.1 shows the bottom surface with cast-in nuts.

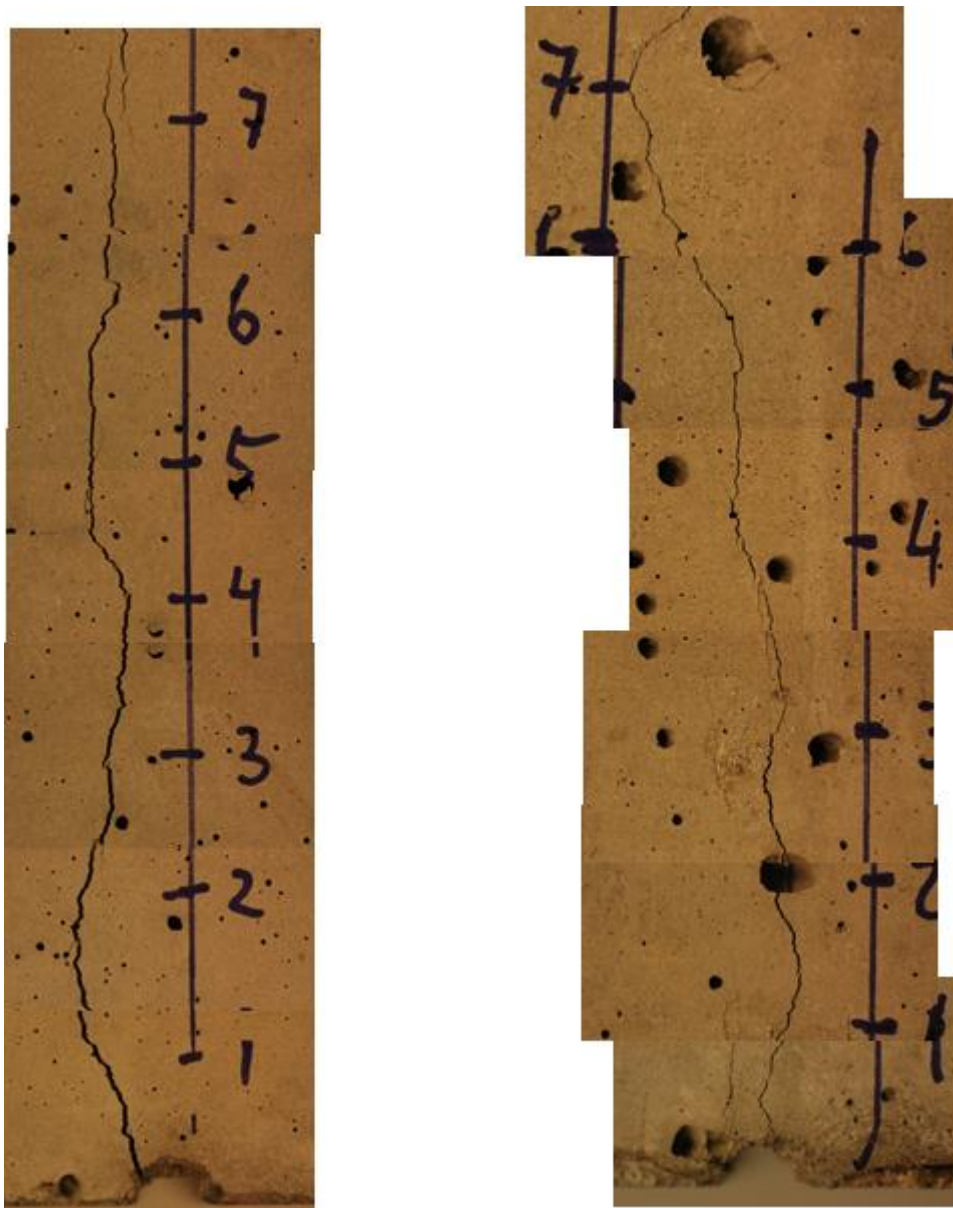
Figure 7.1: Photography of cracks before exposure. 75 mm cover. cm-scale indicated.

Left: Crack width 0.4 mm (specimen H75-4-1-2 left side).

Right: Crack width 0.2 mm (specimen H75-2-1-2 left side).

Photos were taken of the crack before it was sealed, i.e. before the concrete placed in the bath. 5 to 8 photos were taken along the crack on each side of this. Each photo covered about 12 mm of the crack length. Examples of photos of two cracks are shown in figure 7.1.

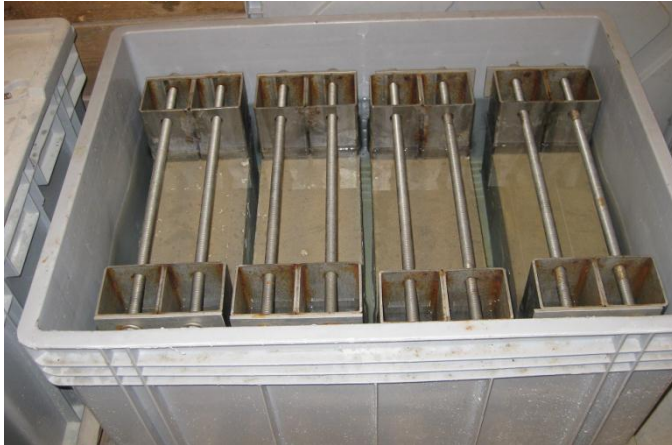
Figure 10.1: Water exposure type 1; permanently under water.

- Type 1: Permanently stored under water. The specimens were completely covered by water during 28 months. A basin with specimens is shown in figure 10.1.
- Type 2: Cyclic. 1 week immersed in water followed by 1 week in lab air. In total 55 cycles.
- Type 3: Water suction from the un-cracked side. The specimens were turned upside down and the un-cracked upper surface was immersed some millimetres in water. Drying in lab-air occurred from the cracked side. The specimens were stored in this way during 28 months. A basin with specimens is shown in figure 10.2.

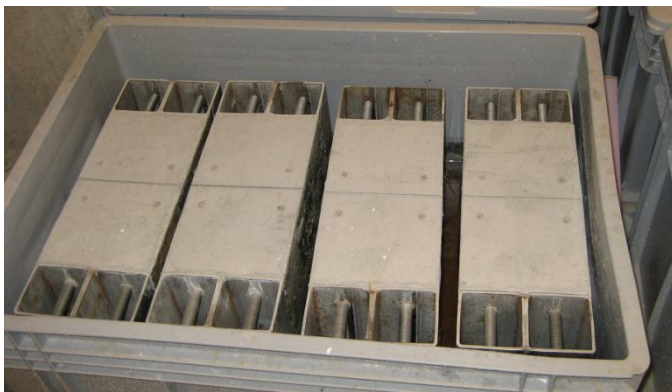
Figure 10.2: Water exposure type 3: Capillary suction from the un-cracked top side.

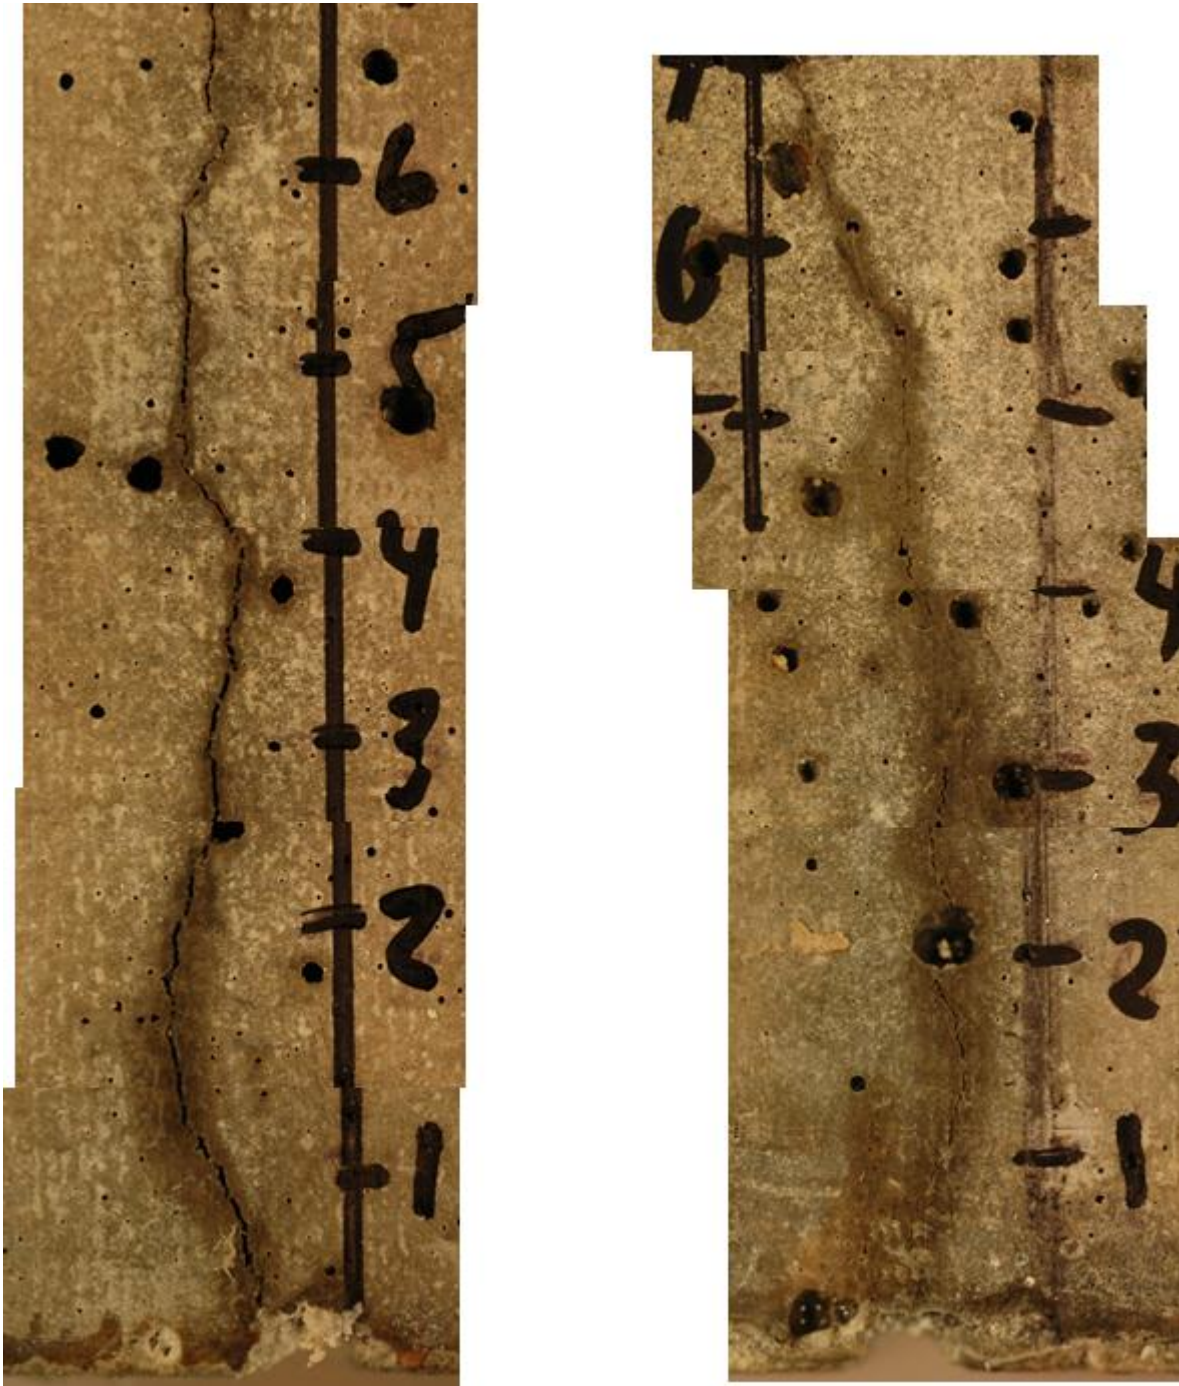
Figure 12.1: Photographs of cracks after exposure. The same specimens as in figure 7.1.

Left: Crack width 0.4 mm (specimen H75-4-1-2 left side).

After about one year exposure the crack seal was removed. Thereafter photos of the cracks were taken in the same manner as before exposure. Examples of photos are given in figure 12.1 which shows the same cracks as are shown in figure 7.1 before exposure. There is a clear indication of healing, particularly for the thinner crack, which seems to be almost completely healed on 2 cm from the crack tip.

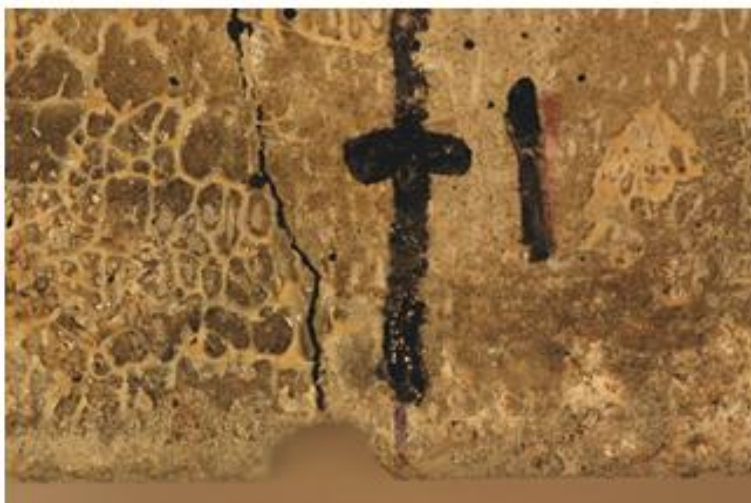
Permanent immersion
H75-2-1-2

Cyclic immersion
H75-2-2-2

Water suction from the
un-cracked side
H75-2-3-2

Figure 12.2: 0.2 mm crack after 28 month exposure to sea water. Concrete cover 75 mm.

Magnifications of photos of the lowest part of the crack after 28 month exposure for all 16 specimens are shown in figure 12.2-12.7. Only one side of the specimens is shown. The other side is similar to the side shown.

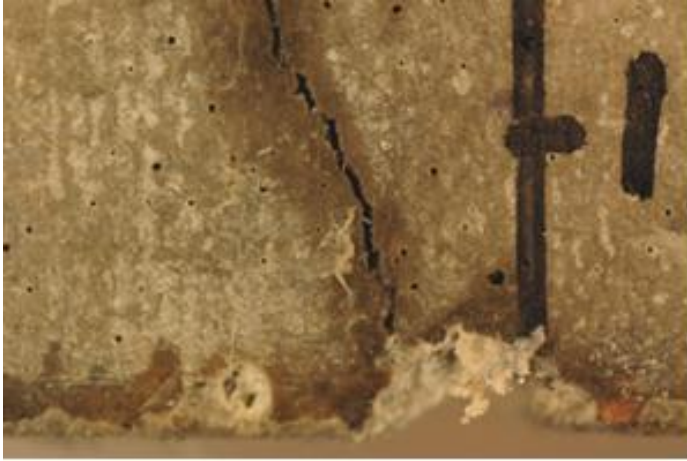
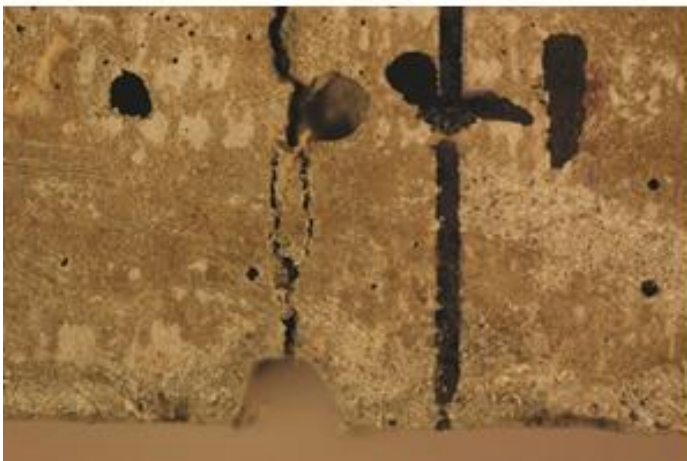
Permanent immersion
H75-4-1-2

Cyclic immersion
H75-4-2-2

Water suction from the
Un-cracked side
H75-4-3-2

Figure 12.3: 0.4 mm crack after 28 month exposure to sea water. Concrete cover 75 mm.

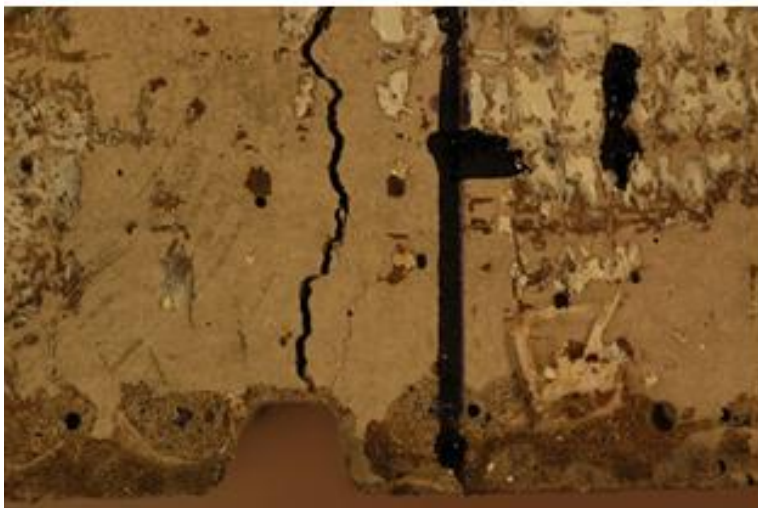
Permanent immersion
H55-2-1-2

Cyclic immersion
H55-2-2-2

Water suction from
the un-cracked side
H55-2-3-2

Figure 12.4: 0.2 mm crack after 28 month exposure to sea water. Concrete cover 55 mm.

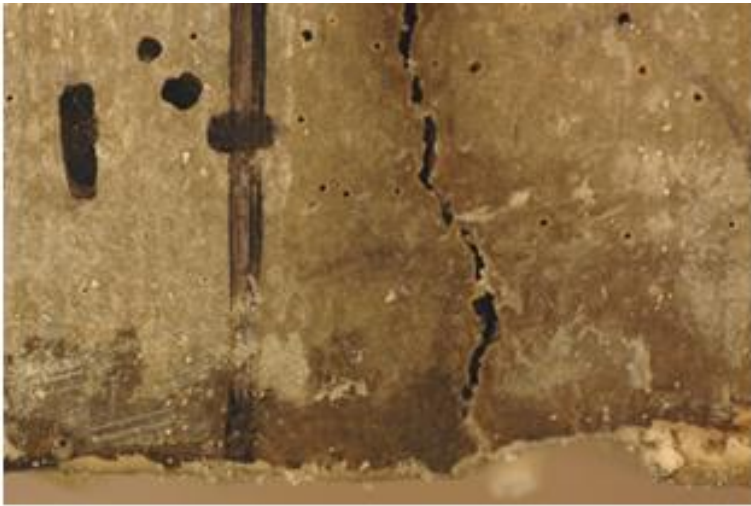
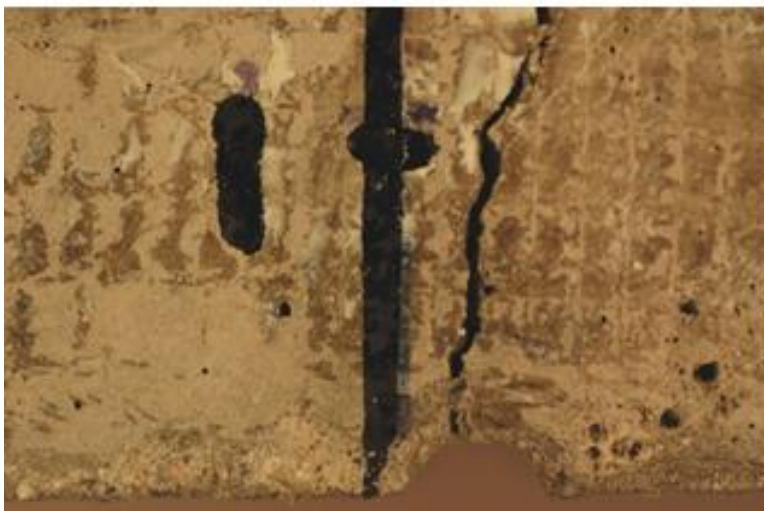
Permanent immersion
H55-4-1-2

Cyclic immersion
H55-4-2-2

Water suction from the
un-cracked side
H55-4-3-2

Figure 12.5: 0.4 mm crack after 28 month exposure to sea water. Concrete cover 55 mm.

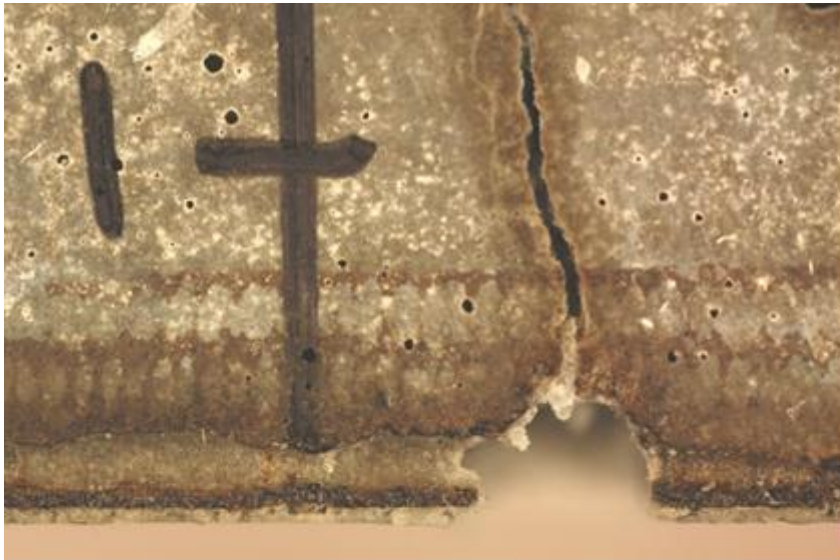
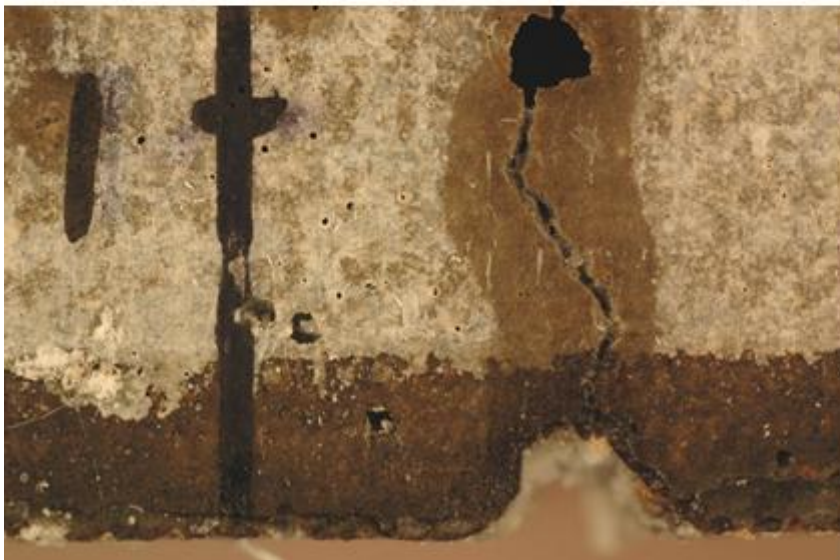
Permanent immersion
S175-4-1-2-Ö

Permanent immersion
S155-4-1-2-Ö

*Figure 12.6: 0.4 mm crack after 28 month permanent exposure to brackish water.
Upper: 75 mm cover. Lower: 55 mm cover*

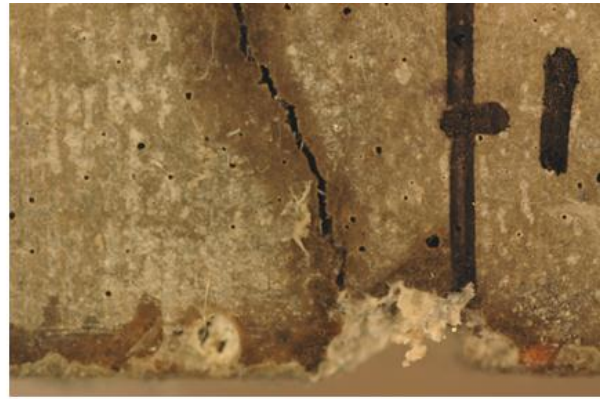
28 month exposure
Specimen H75-4-1-2

Figure 13.2: Crack width 0.4 mm. Cover 75 mm. Permanent immersion in sea water for 12 and 28 months.

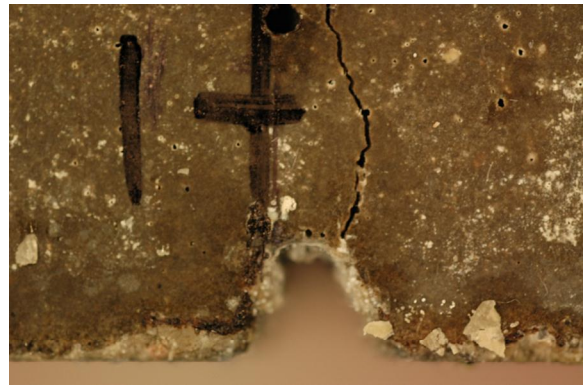
28 month exposure
Specimen H55-2-1-2

Figure 13.3: Crack width 0.2 mm. Cover 55 mm. Permanent immersion in sea water for 12 and 28 months.

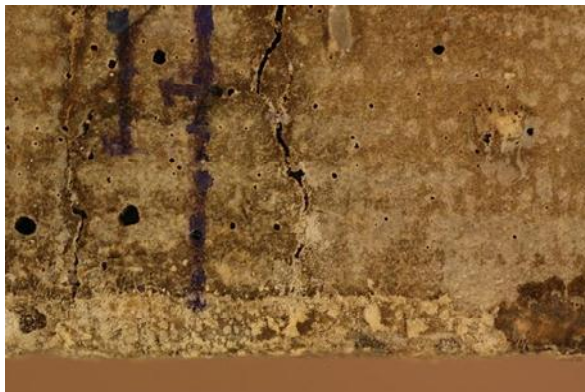
12 month exposure
Specimen H55-4-1-1

Figure 13.4: Crack width 0.4 mm. Cover 55 mm. Permanent immersion in sea water for 12 and 28 months.

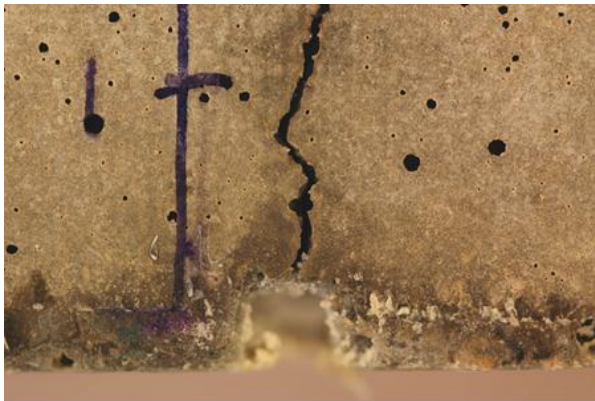
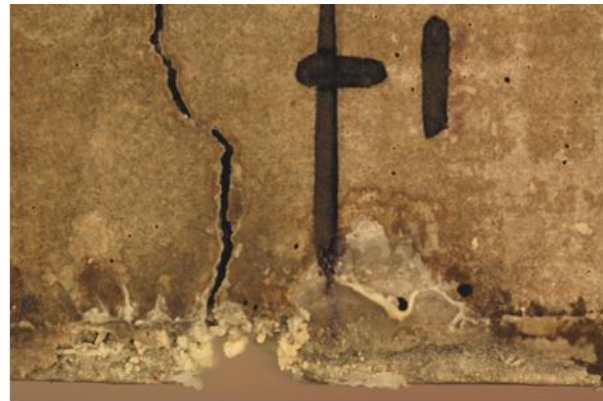
12 month exposure
Specimen H75-4-2-1

28 month exposure
Specimen H75-4-2-2

Figure 13.6: Crack width 0.4 mm. Cover 75 mm. Cyclic immersion in sea water for 12 and 28 months.

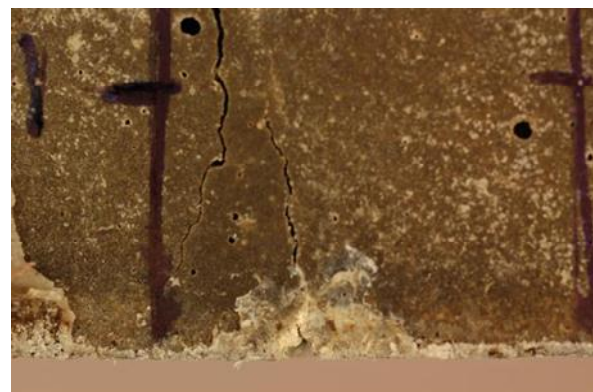
28 month exposure
Specimen H55-2-2-2

Figure 13.7: Crack width 0.2 mm. Cover 55 mm. Cyclic immersion in sea water for 12 and 28 months.

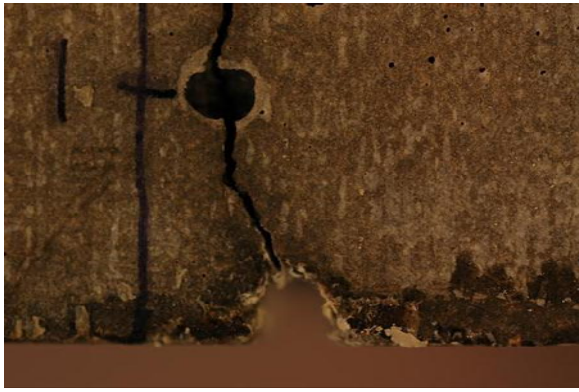
12 month exposure
Specimen H55-4-2-1

Figure 13.8: Crack width 0.4 mm. Cover 55 mm. Cyclic immersion in sea water for 12 and 28 months.

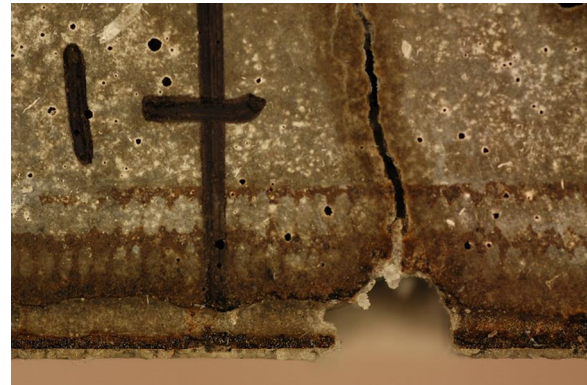
28 month exposure
Specimen S175-4-1-2Ö

Figure 13.9: Crack width 0.4 mm. Cover 75 mm. Permanent immersion in brackish water for 12 and 28 months.

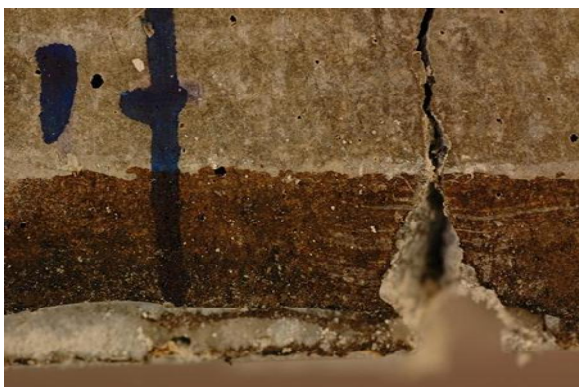
12 month exposure
Specimen S155-4-1-1Ö

Figure 13.10: Crack width 0.4 mm. Cover 55 mm. Permanent immersion in brackish water for 12 and 28 months.

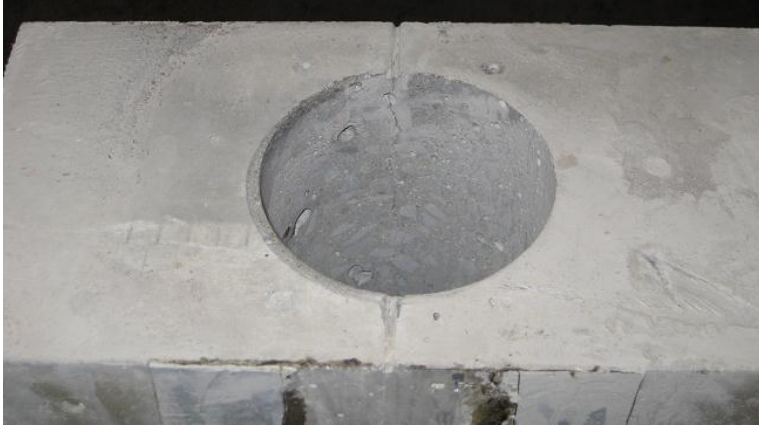
Figure 14.1: Example of a specimen after the core has been drilled out.

After terminated exposure a 10 cm core was drilled centrally in the specimen from its bottom side along the crack. Drilling was made with water-cooled drill. An example of the specimen after drilling is shown in figure 14.1. An example of a drilled-out core is shown in figure 14.2.

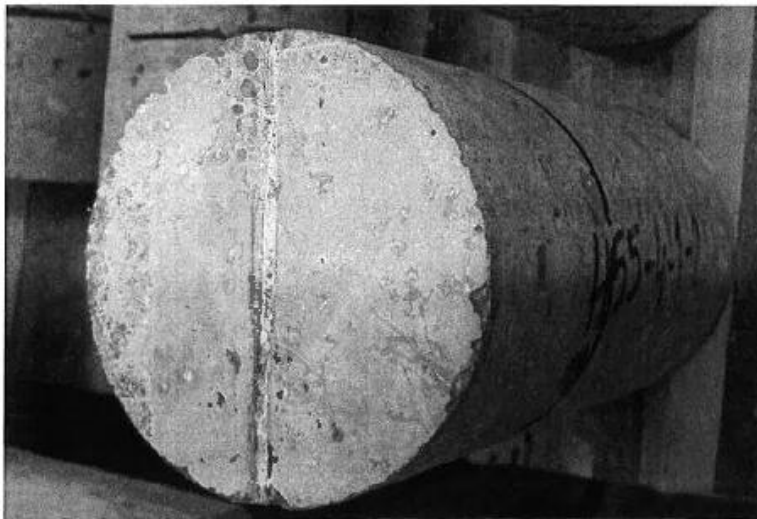
Figure 14.2: Example: core drilled out from specimen H55-4-1-2 (55 mm cover, crack width 0.4 mm, permanently exposed to pure water).

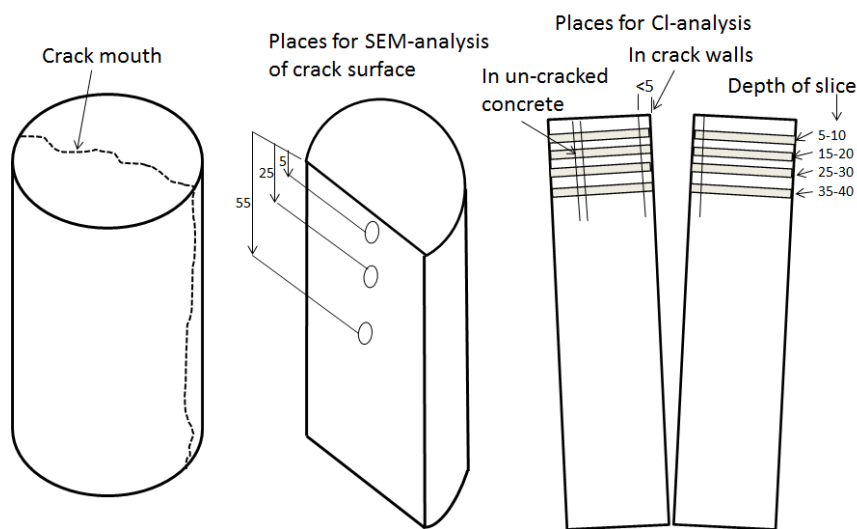
Figure 15.1: Core and places where samples were taken from the crack walls.

Location of the test areas are shown in figure 15.1.

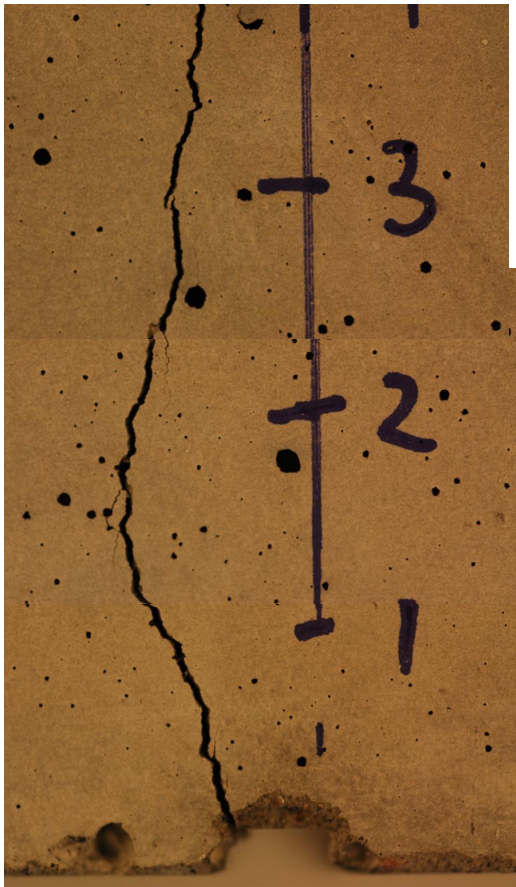
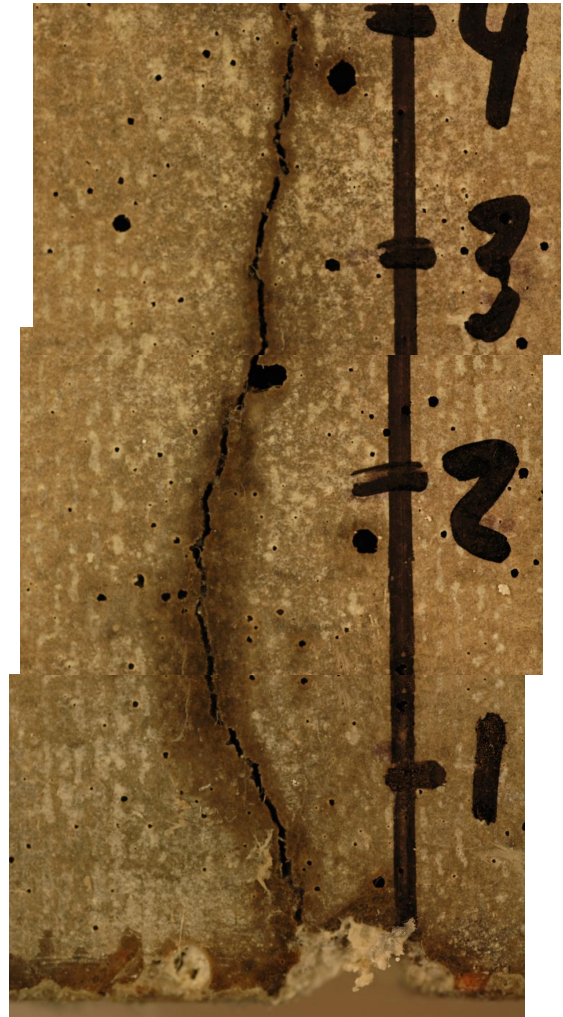
*Figure A1.3: Permanently in sea water.
Crack width 0.2 mm. Cover 55 mm. Specimen H55-2-1-2*

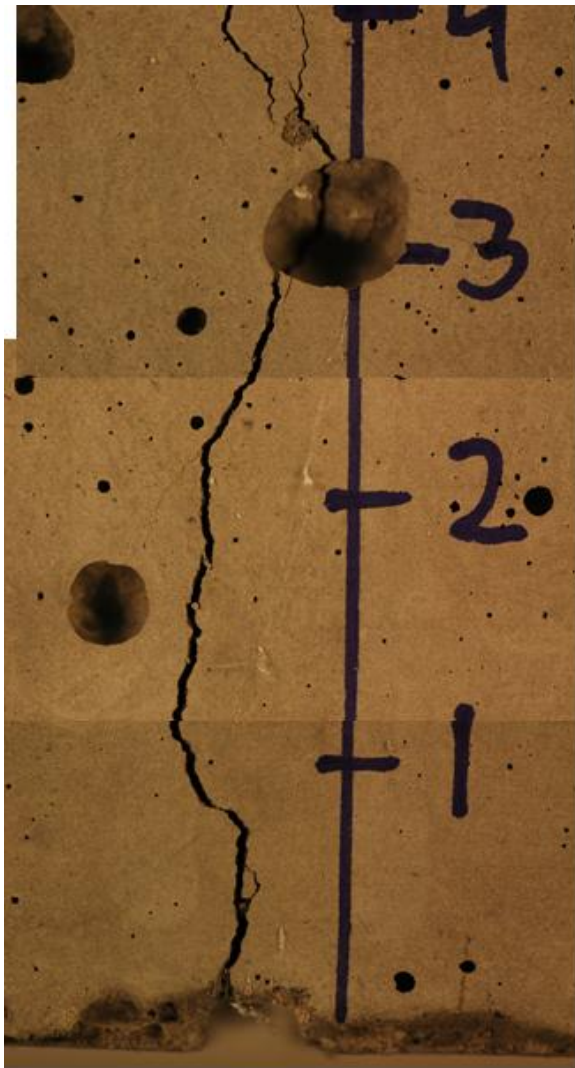
*Figure A1.6: Cyclic immersion in sea water and drying.
Crack width 0.4 mm. Cover 75 mm. Specimen H75-4-2-2*

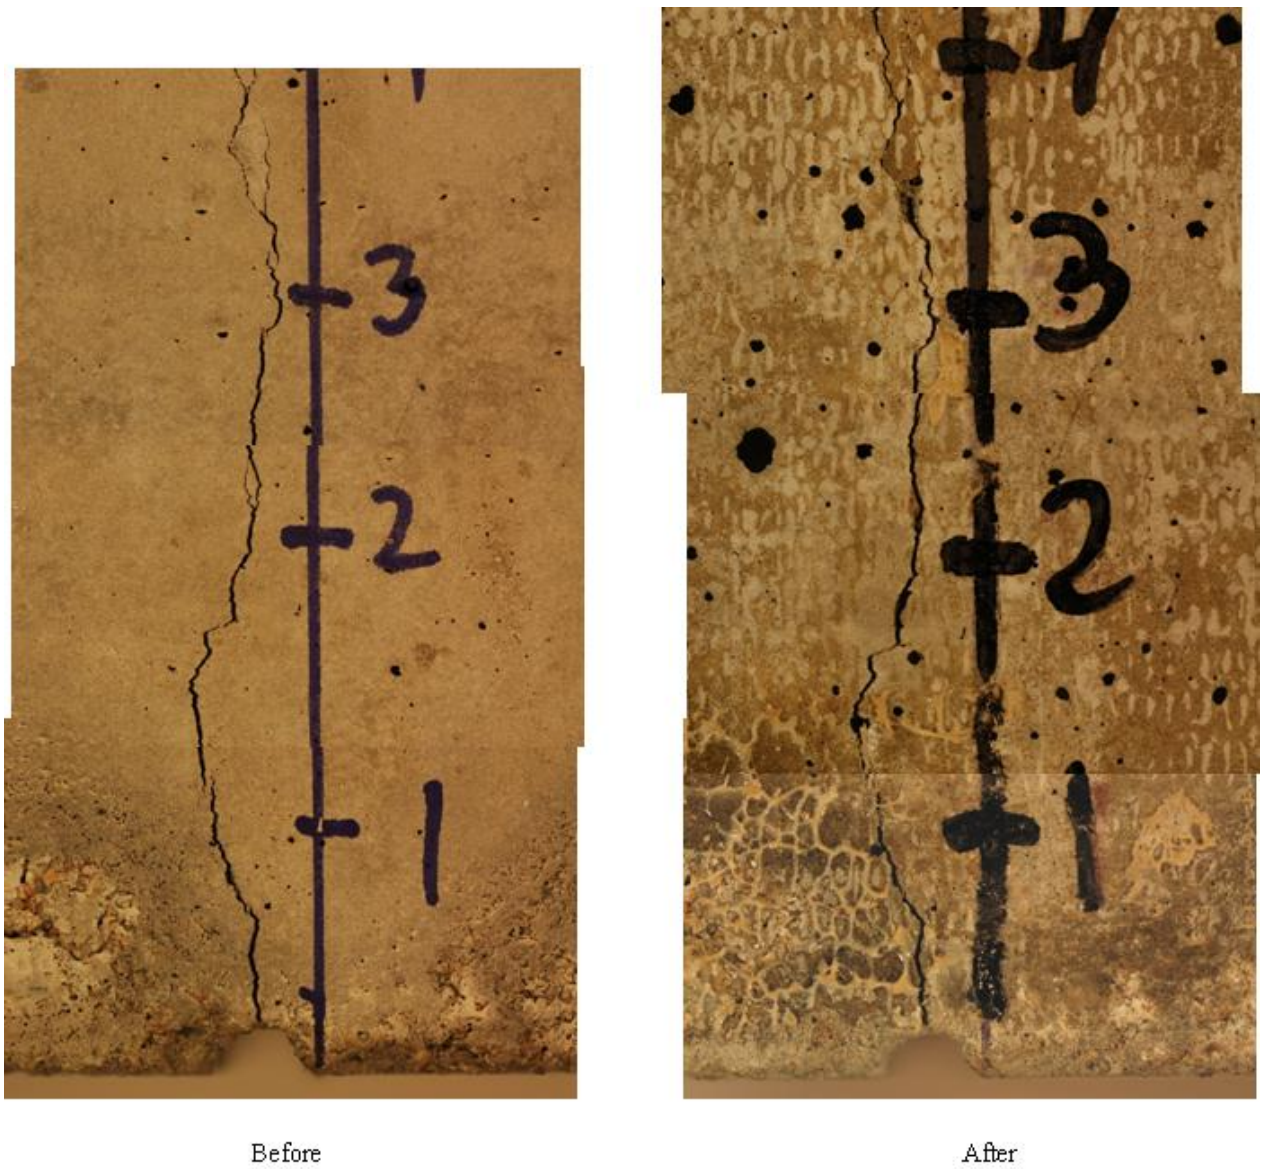
*Figure A1.9: Water suction from the un-cracked side.
Crack width 0.2 mm. Cover 75 mm. Specimen H75-2-3-2*

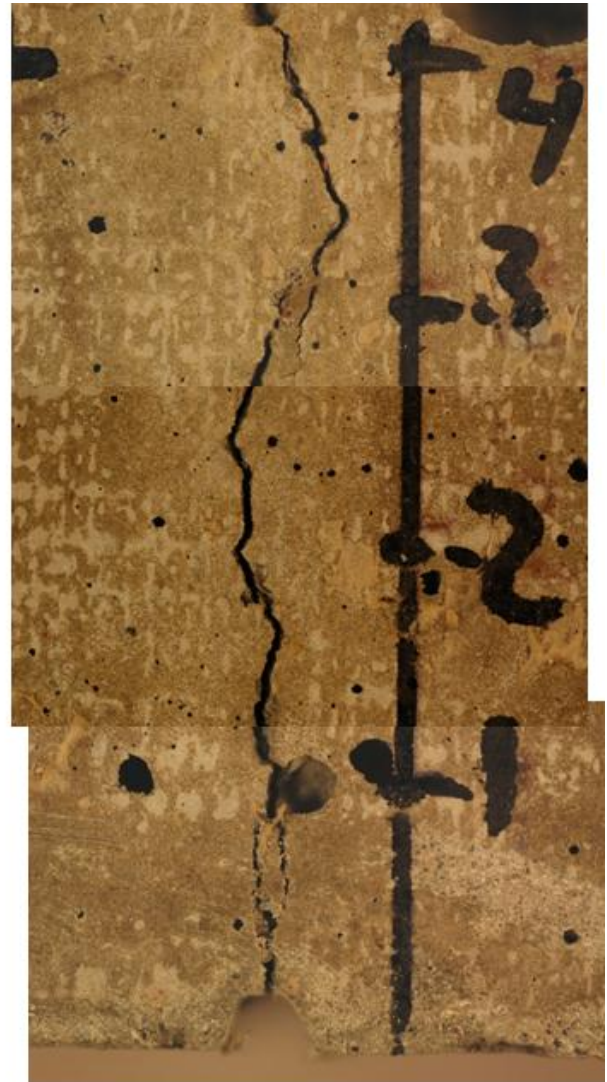
*Figure A1.10: Water suction from the un-cracked side.
Crack width 0.4 mm. Cover 75 mm. Specimen H75-4-3-2*

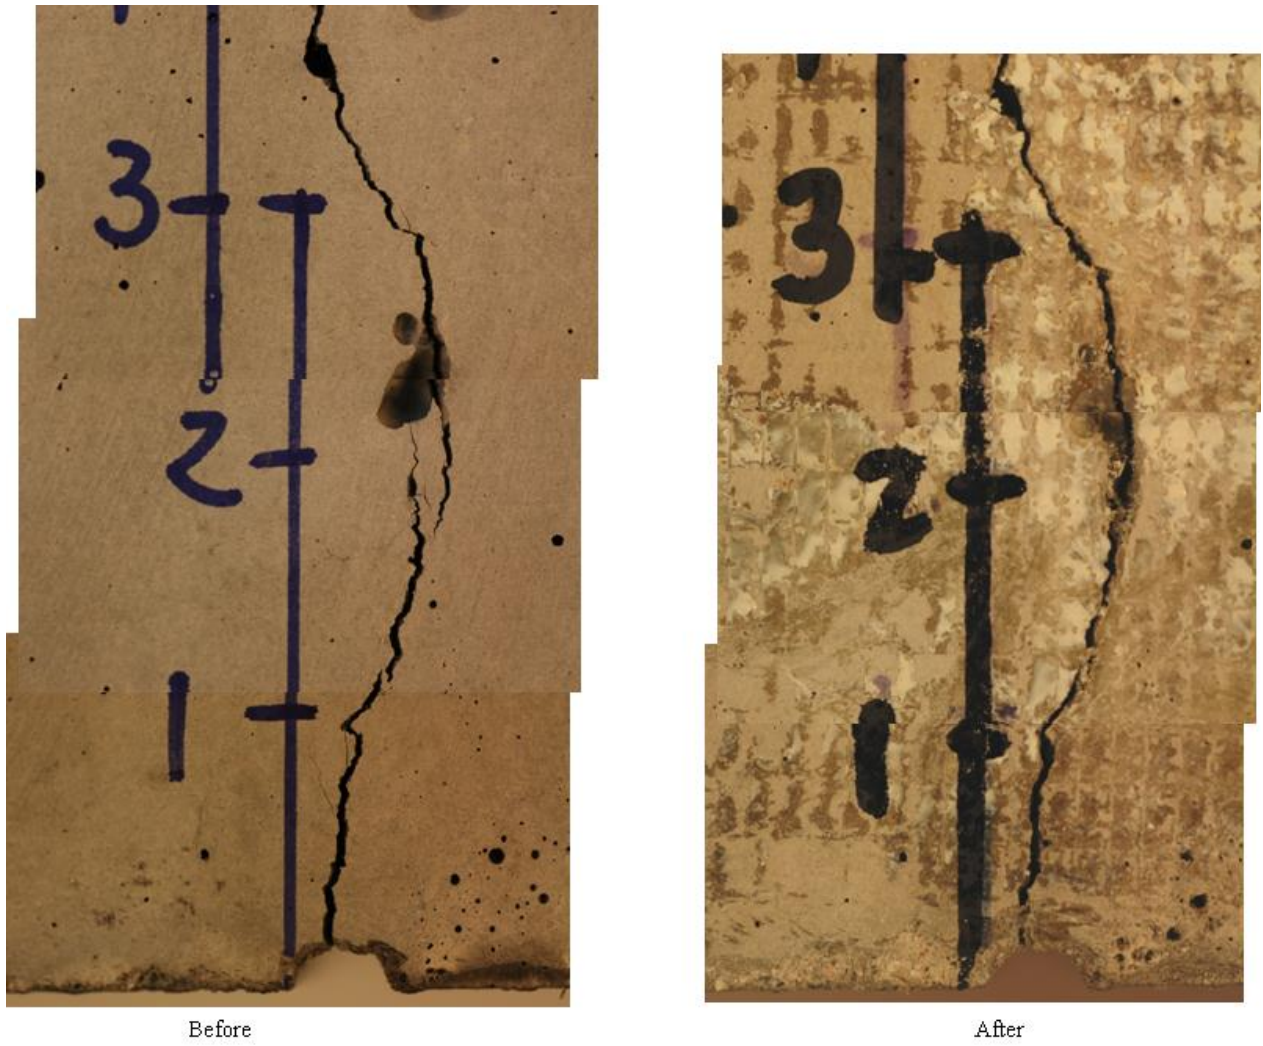
*Figure A1.12: Water suction from the un-cracked side.
Crack width 0.4 mm. Cover 55 mm. Specimen H55-4-3-2*

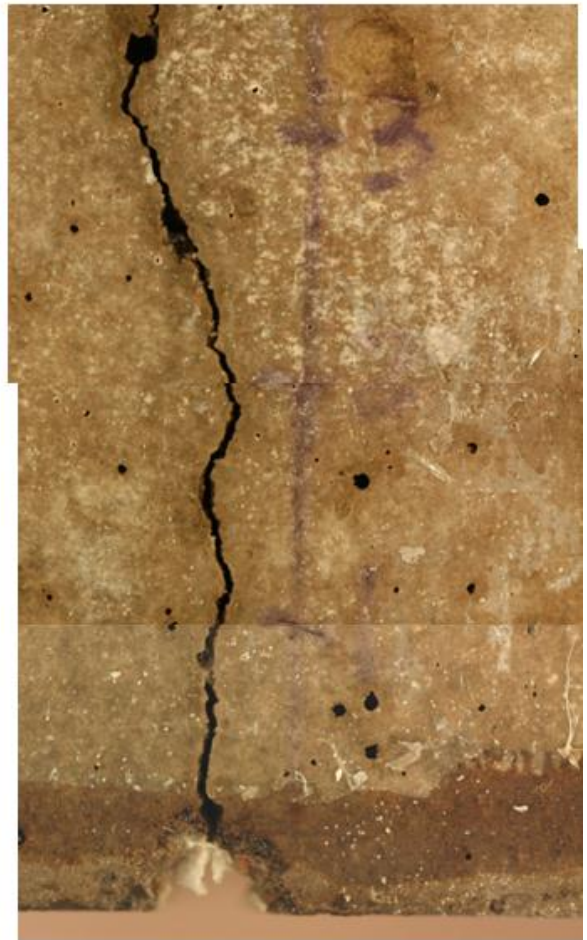
After

Figure A1.16: Permanently in sea water.

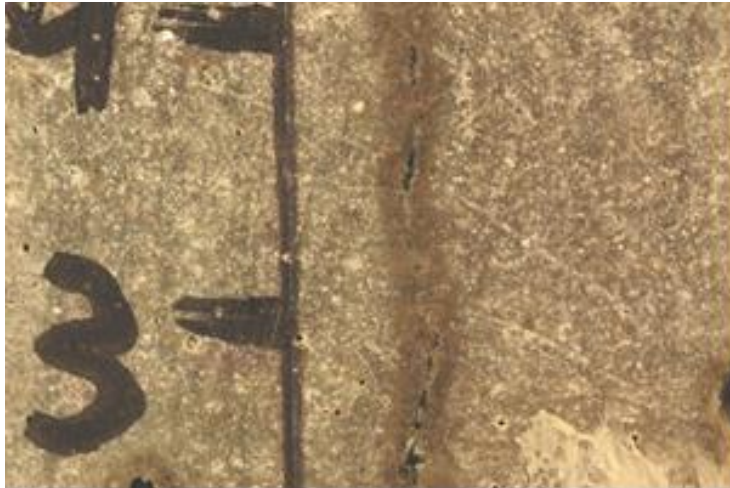
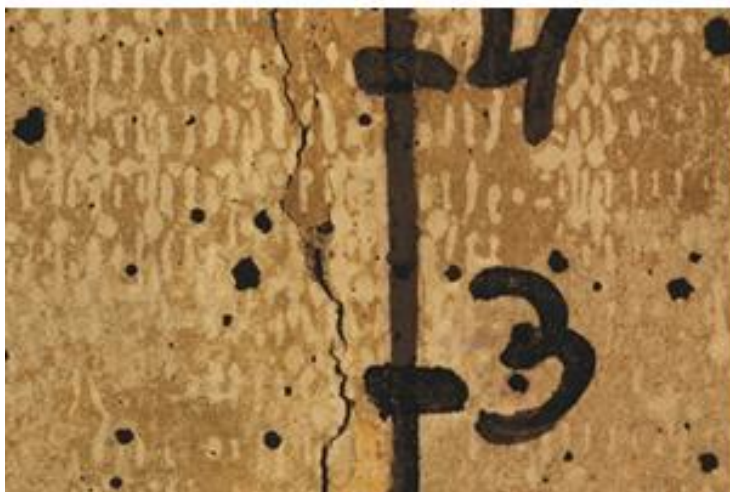
Figure A2.1: 0.2 mm crack width, 75 mm cover. Exposure to sea water.

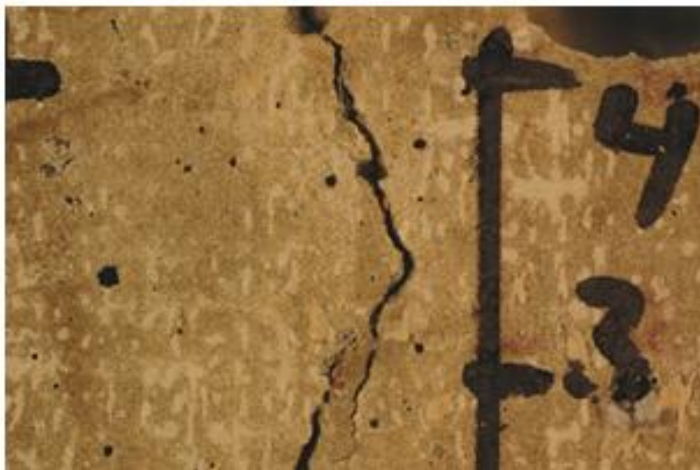
Figure A2.2: 0.4 mm crack width. 75 mm cover. Exposure to sea water.

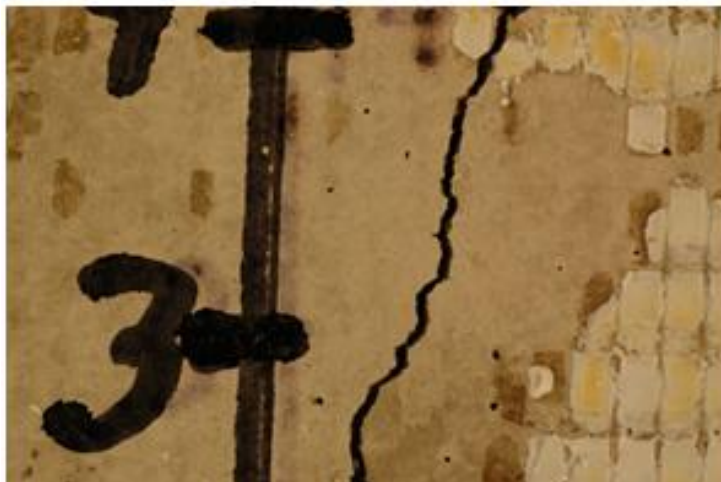
Figure A2.3: 0.2 mm crack width. 55 mm cover. Exposure to sea water.

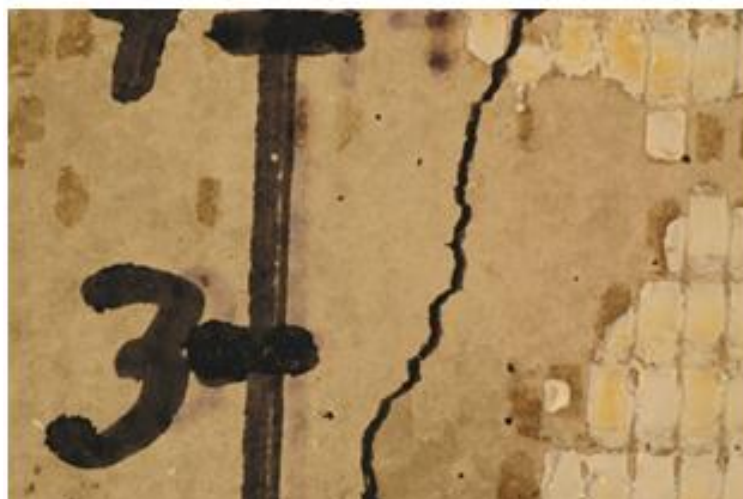
Figure A2.4: 0.4 mm crack width. 55 mm cover. Exposure to sea water.

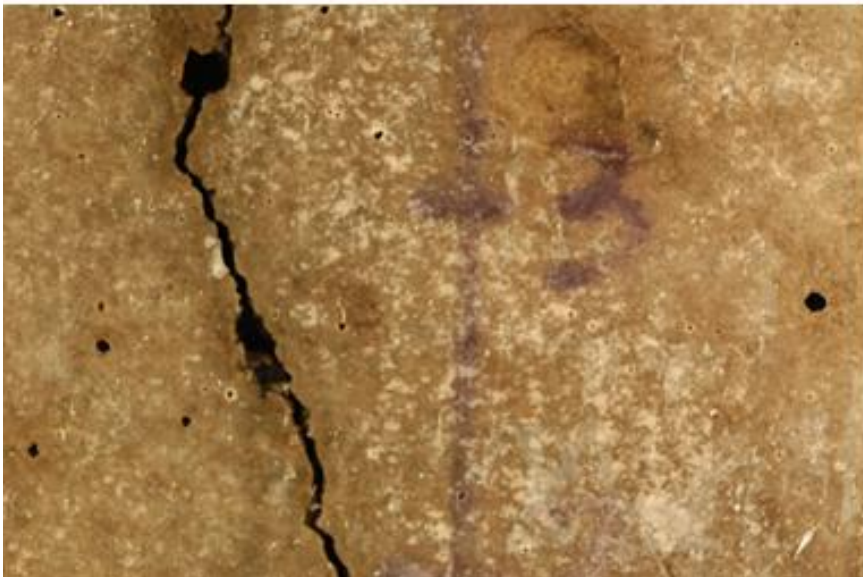
*Figure A2.6: 0.4 mm crack width. Exposure to pure water.
Upper: 75 mm cover. Lower: 55 mm cover.*
