Moisture Conditions and Frost Resistance of Concrete in Hydraulic Structures

Division of Building Materials

Report TVBM-3173

Licentiate thesis

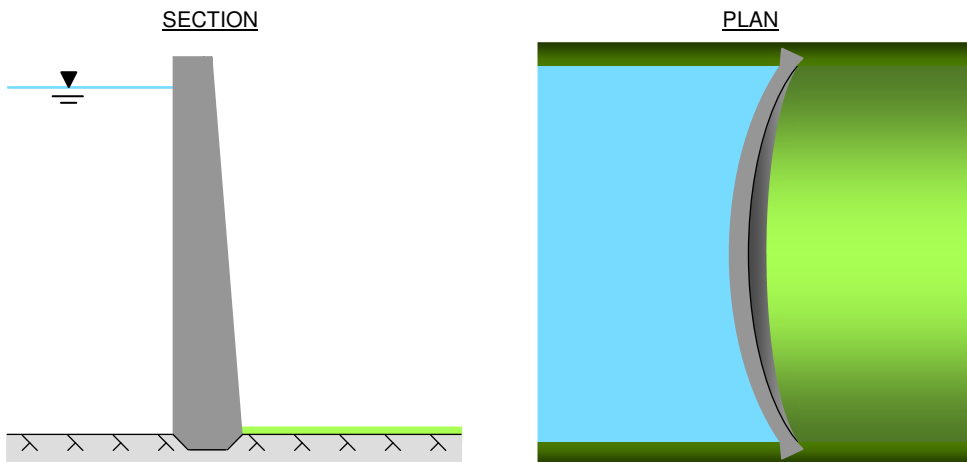
Figure 2-6. Section and plan of an arch dam.

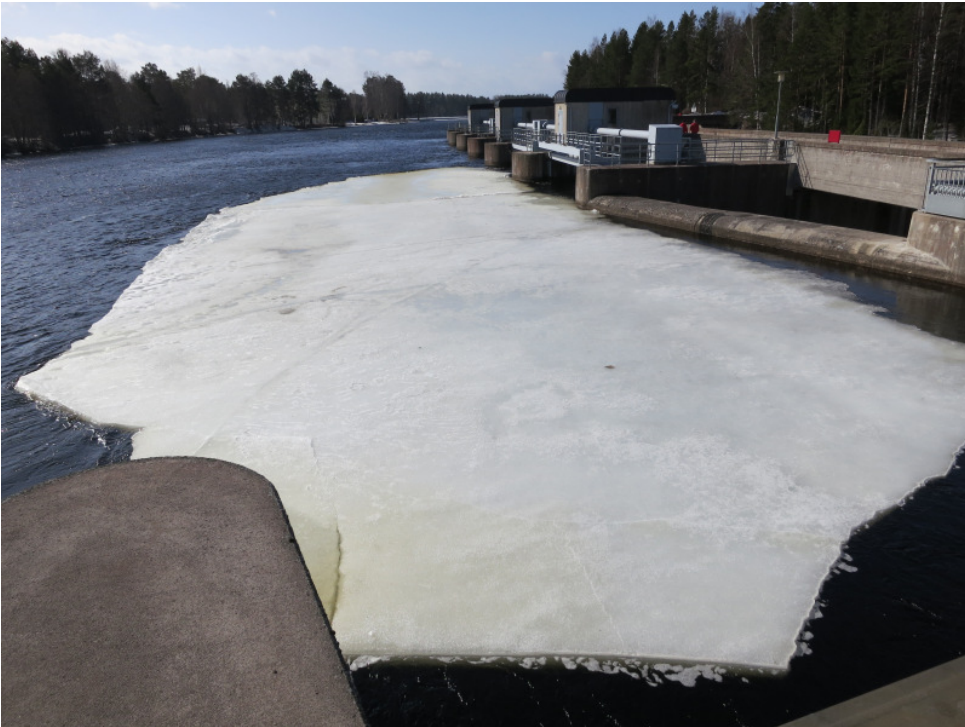
Figure 2-9. Ice floe pushing against a bridge column in spring.

The ice cover breaks up into ice floes of different sizes during spring. The ice floes are then slowly brought downstream by the river current. If the ice floes do not melt away until they reach a hydraulic structure, the ice floes push against the structure until they break apart into pieces or melt away (Figure 2-9).

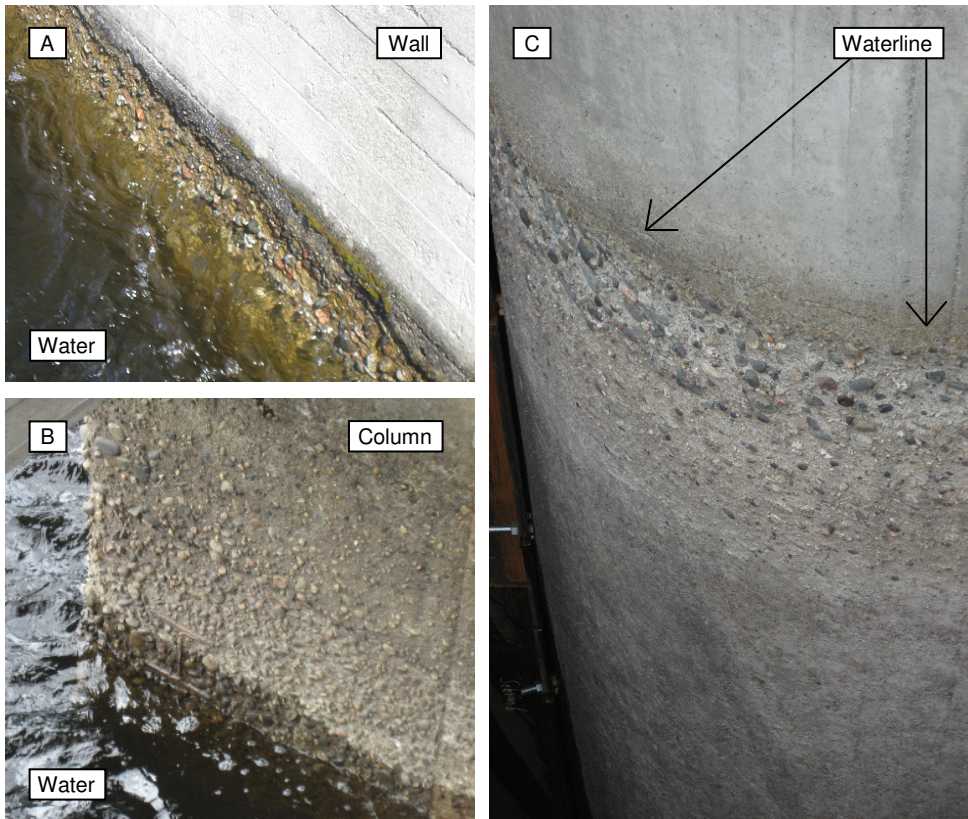
Figure 3-1. Photos of damage to the concrete surface at the waterline of hydro power structures. The photos A and C are taken on the upstream side, whereas the photo B is taken on the downstream side of the dams.

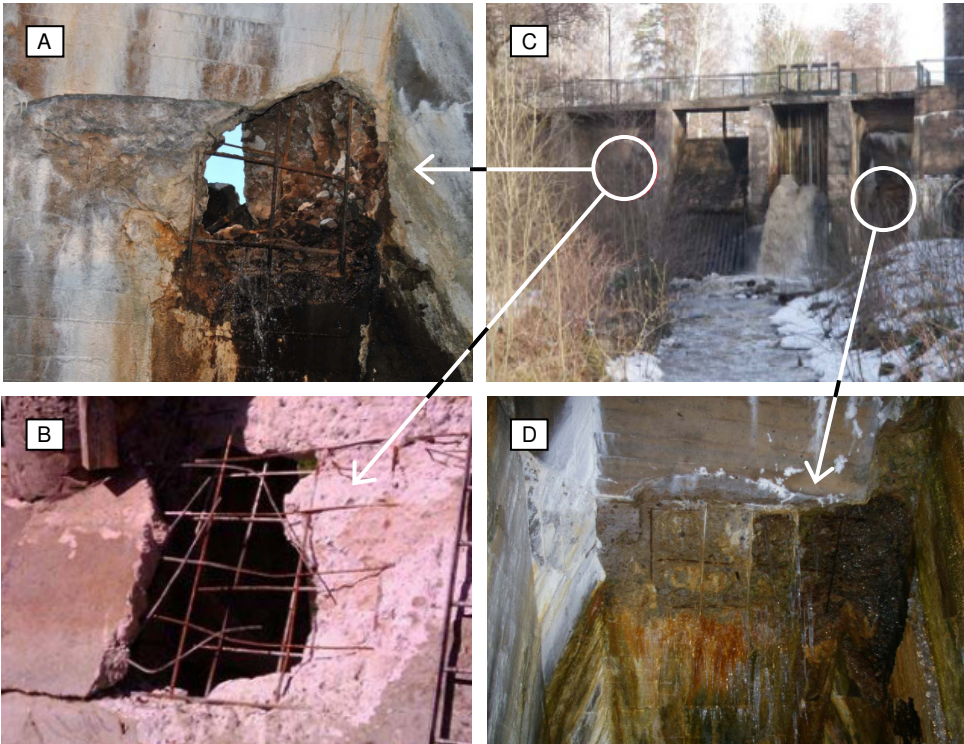
Figure 3-3. A severely damaged buttress dam (C). The concrete cover was missing in some places in the vicinity of water leakage through cracks on the downstream face (D). A hole appeared in the flat slab in another place and water escaped flushing away loose pieces of concrete (A-B). Only the reinforcing steel was left.

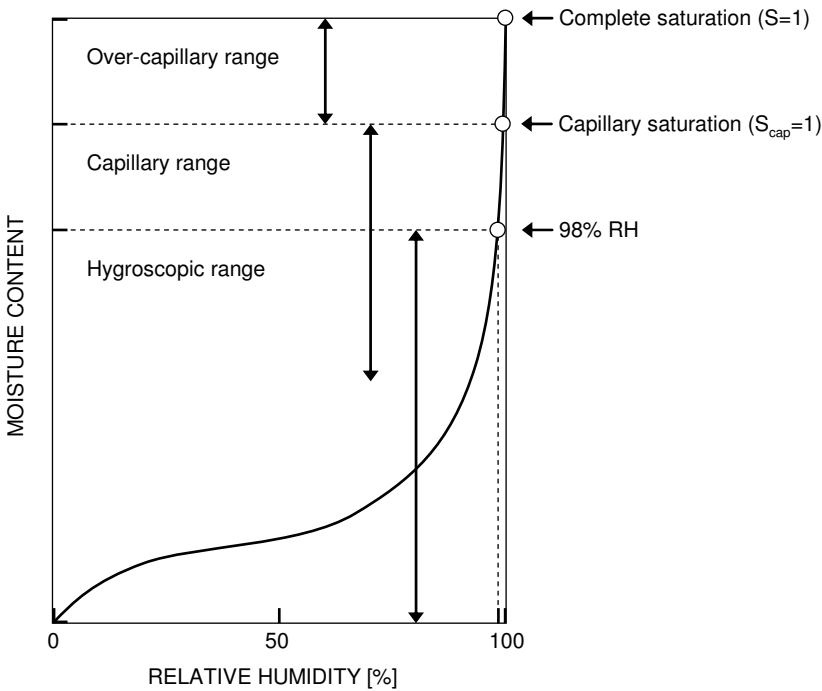
Figure 3-4. Absorption isotherm completed with moisture ranges. Graph from Fagerlund (2006).

entrapped air in compaction voids and air voids. An absorption isotherm completed with moisture ranges is shown in Figure 3-4.

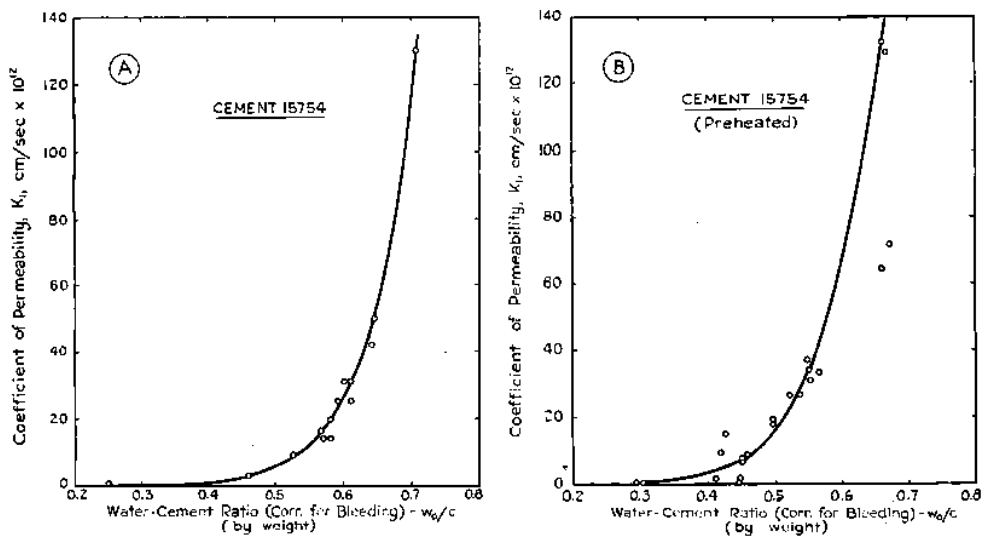
Figure 3-6. Relationships between hydraulic conductivity and w/c-ratio for mature cement paste. Graphs from Powers et al (1954).

According to Powers et al (1954), the overall permeability of concrete depends on the hydraulic conductivity of the cement paste, aggregate particles and the relative proportions of the two. Relationships between the hydraulic conductivity and the w/c-ratio for mature cement paste are shown in Figure 3-6.

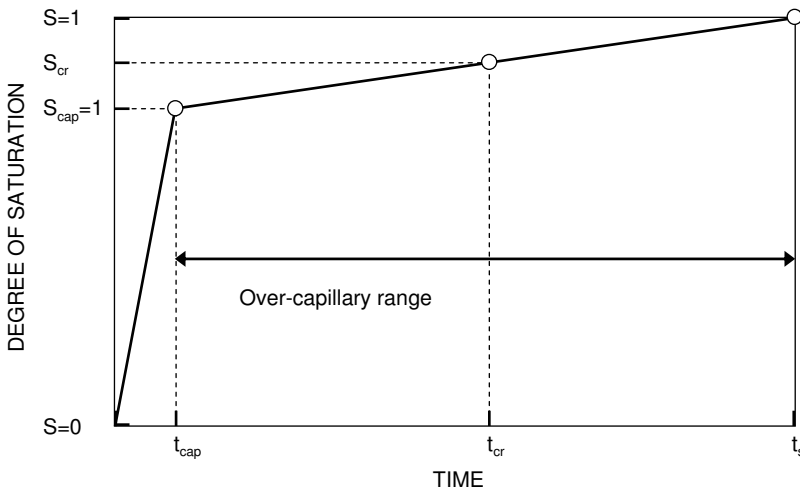
Figure 3-7. Water absorption of concrete as a function of time. The critical degree of saturation (S_{cr}) prevails at the critical time (t_{cr}).

Freezing of air entrained concrete with high moisture content causes a greater amount of damage than freezing of non-air entrained concrete with the same moisture content. The reason in this case is that there is more freezable water in air entrained concrete, since also the air voids are completely or partially filled with water. Hence, the diffusion rate of air out of the air voids and eventually out of the material determines the time (t_{cr}) until the critical degree of saturation (S_{cr}) prevails, see Figure 3-7.

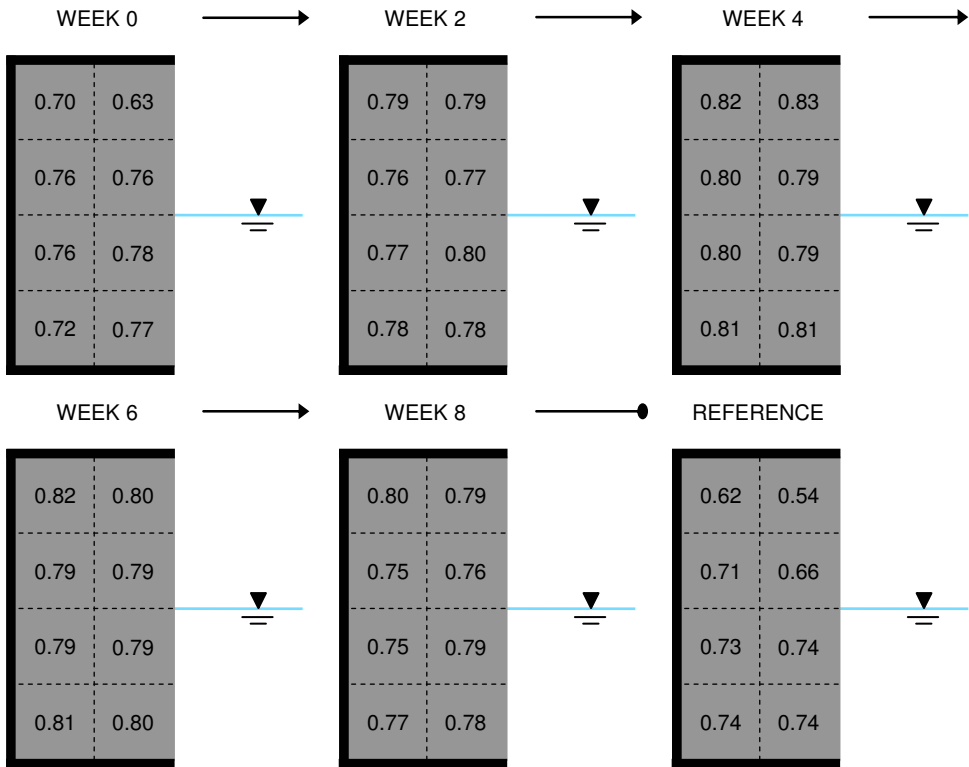
Figure 4-6. Degree of saturation of specimens (w/c 0.54) subjected to the frost test in comparison with a reference specimen kept at +10 °C during the test period.

No damage to the concrete surface could be observed on any of the specimens with w/c-ratio 0.54 after 112 freeze-thaw cycles (Figure 4-5). The results on the measurements of the moisture content indicate that capillary saturation ($S=0.77$) was obtained within two weeks after the start in the specimens subjected to the frost test. On the contrary, the degree of saturation of concrete in the reference specimen kept at +10 °C decreased during the test period. Also in the case of concrete with w/c-ratio 0.54, the drying rate was higher than the absorption rate in isothermal conditions. Results from the measurements of the degree of saturation are presented in Figure 4-6.

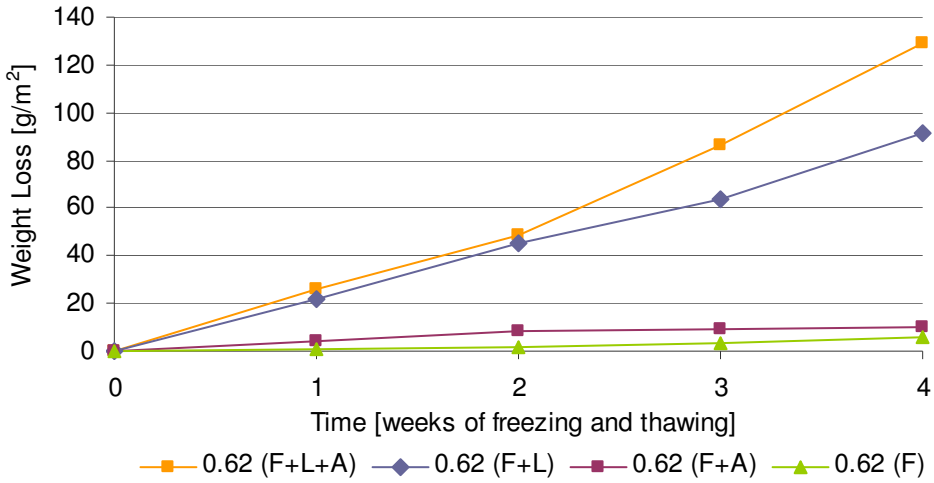
Figure 5-1. Accumulated weight loss of specimens with w/c-ratio 0.62 subjected to different combinations of the deterioration processes; frost action (F), leaching in water at pH 4 (L) and abrasion (A).

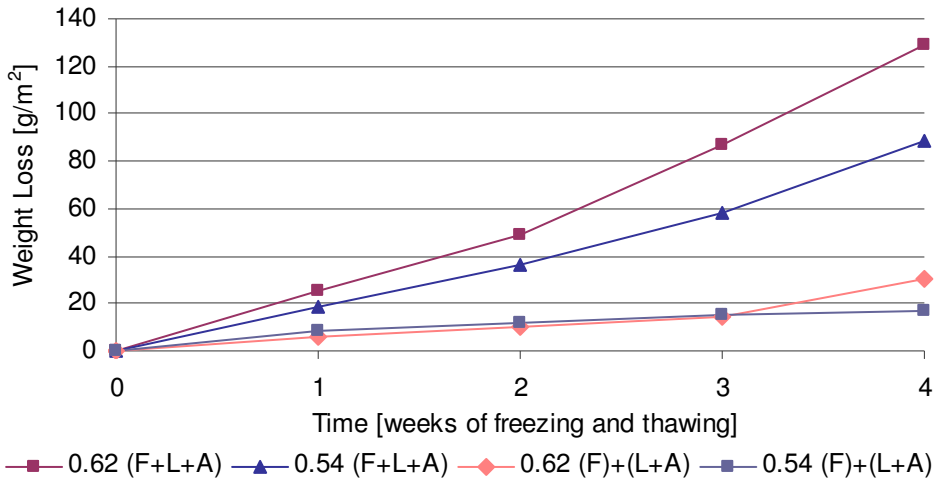
Figure 5-3. Accumulated weight loss of the specimens subjected to all three deterioration processes (F+L+A) compared to the sum of weight loss from the specimens subjected to frost action (F) together with the specimens subjected to leaching and abrasion (L+A). The differences in weight loss indicate synergy between the deterioration processes.

The accumulated weight loss of the specimens subjected to all three deterioration processes (F+L+A) was greater than the sum of the accumulated weight loss of the specimens subjected to frost action (F) together with the specimens subjected to leaching in water at pH 4 and abrasion (L+A). The accumulated weight loss of the specimens with w/c-ratio 0.54 and 0.62 is presented in Figure 5-3.
