# **Chloride profiling in marine concrete**

## **Methods and tools for sampling**

Henrik Wall

ISRN LUTVDG/TVBM--07/3138--SE(1-43)  
ISSN 0348-7911 TVBM

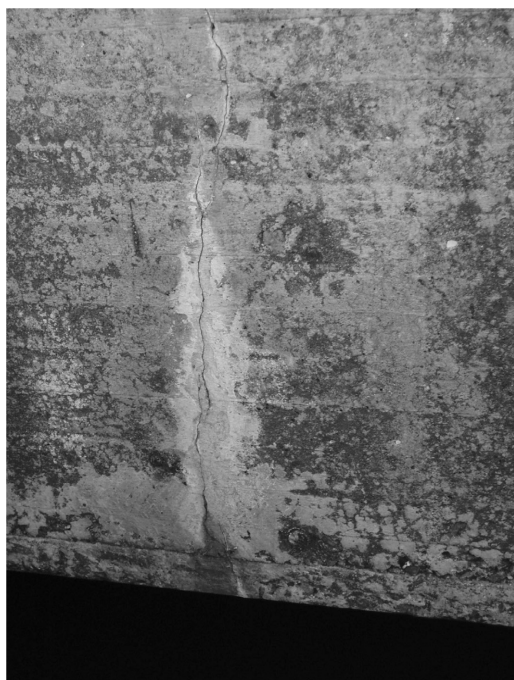
Figure 7. Typical vertical crack with signs of leaching calcium.

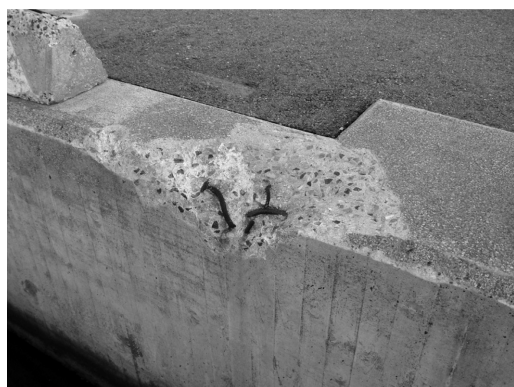
Figure 8. Local damage with corroding reinforcement.

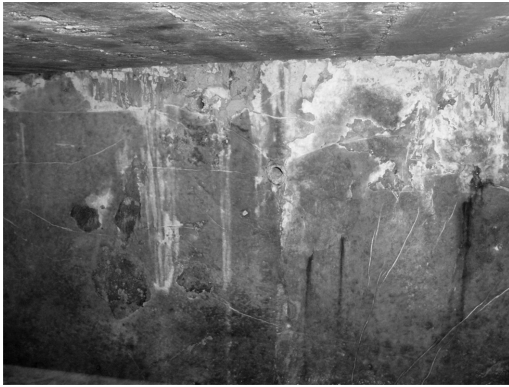
Figure 11. Rust stains and traces of calcium leakage on the side of a prefabricated vertical plate element.

the prefabricated vertical elements had traces of rust stains on the sides and calcium leakage in the connection between the in situ casted quay deck and the prefabricated vertical elements as indicated in figure 11.
