Chloride profiling in marine concrete - methods and tools for sampling

Chloride profiling in marine concrete

Methods and tools for sampling

Henrik Wall

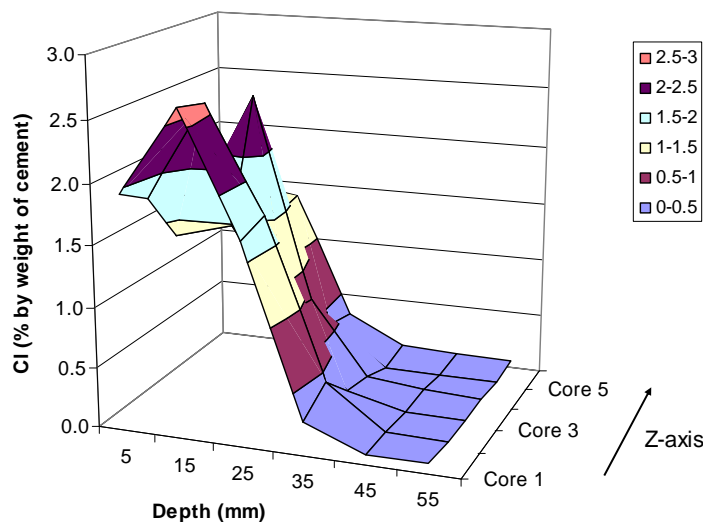
Figure 3: Chloride profiles along a 1.2 m long line which is indicated by the Z-axis, after [2]

de Rooij & Polder performed sampling by core drilling in the eastern Scheldt storm surge barrier [2]. The sampling was performed on eighteen year old concrete with a core diameter of 50 mm. In total six cores were collected about nine meters above mean sea level within an area less than 0.5 m². The chloride profiles from the analysis showed extensive variations down to about 35 mm beneath the concrete cover. No explanation for this behaviour was found other than the heterogeneity of concrete at a micro structural level.

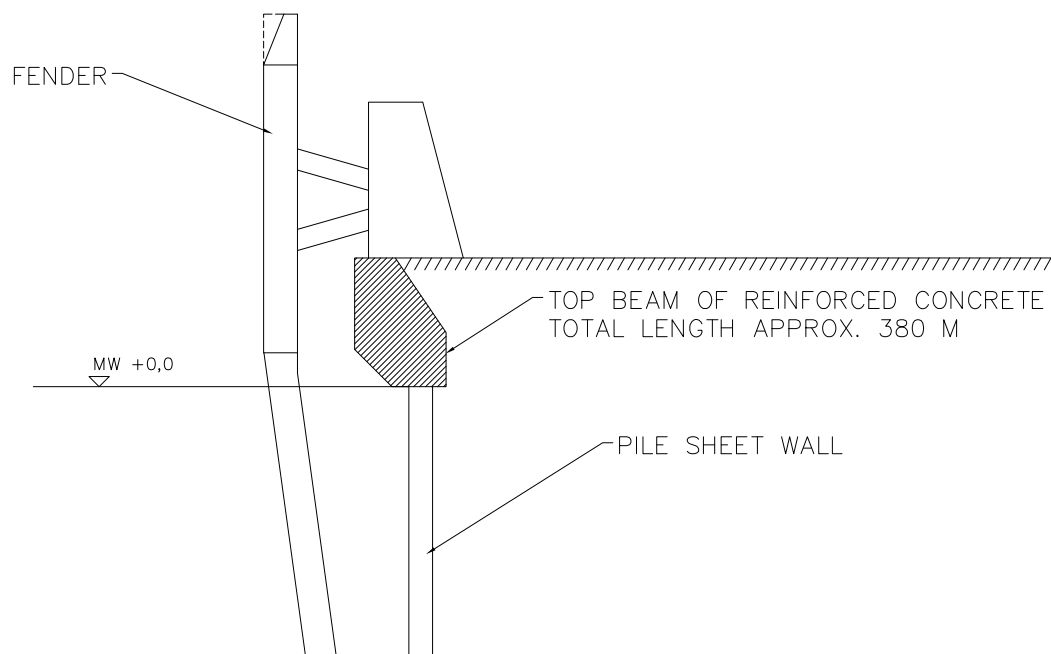
Figure 5: Section through the inspected top beam

The pier that was chosen for detailed inspection is a pile sheet wall with a head beam of reinforced concrete, see figure 5. It was built around 1955, which means that it had reached its design life at the time of inspection. No obvious signs of extreme deterioration were, however, found at the initial visual inspection. The pier, which is about 200 m long, is located in the circle in figure 4. The top beam of the pier is made of reinforced concrete which is exposed to the local climate in three directions, west, south and east.

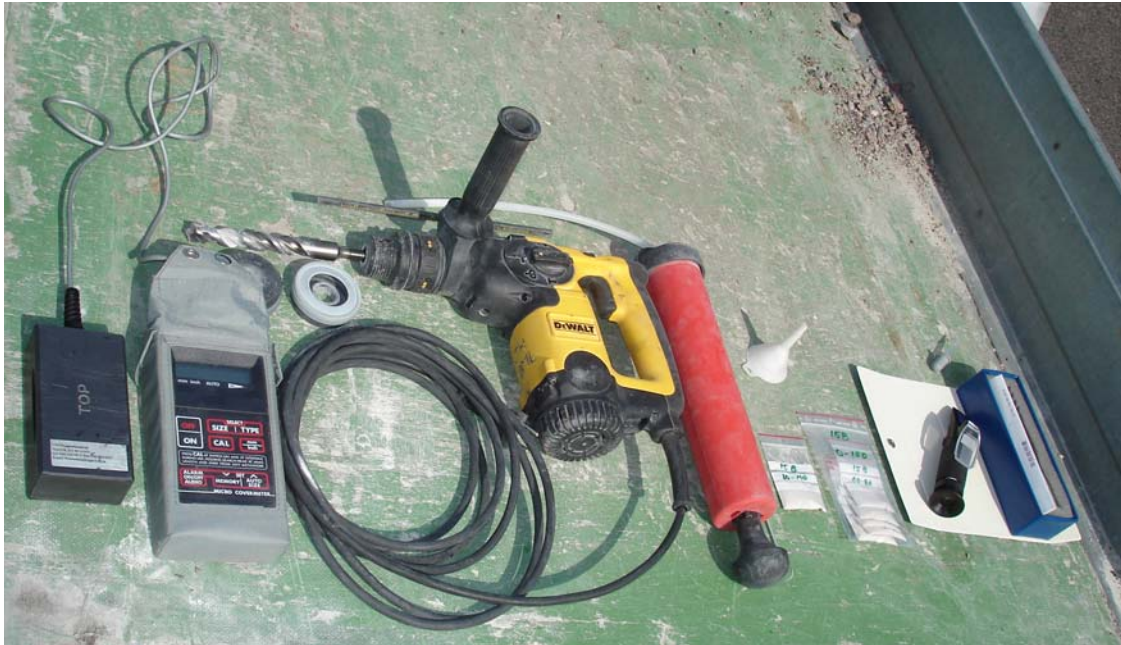
Figure 11: The equipment used when sampling dust by dry drilling in the ports of Malmö and Trelleborg

The dust sampling was performed with a hand held drilling machine, see figure 11, with a 20 mm bore and the dust sampling interval was set to 20 mm with a maximum depth of 100 mm below the concrete surface. Between every interval, the holes were cleaned with a small brush and a hand held air blower. Three bore holes were drilled in every sampling point which means 15 bore holes in total. The distance between the bore holes in every sampling point was less than 200 mm, and the location was selected in homogeneous concrete without any signs of cracks or other visual damages.

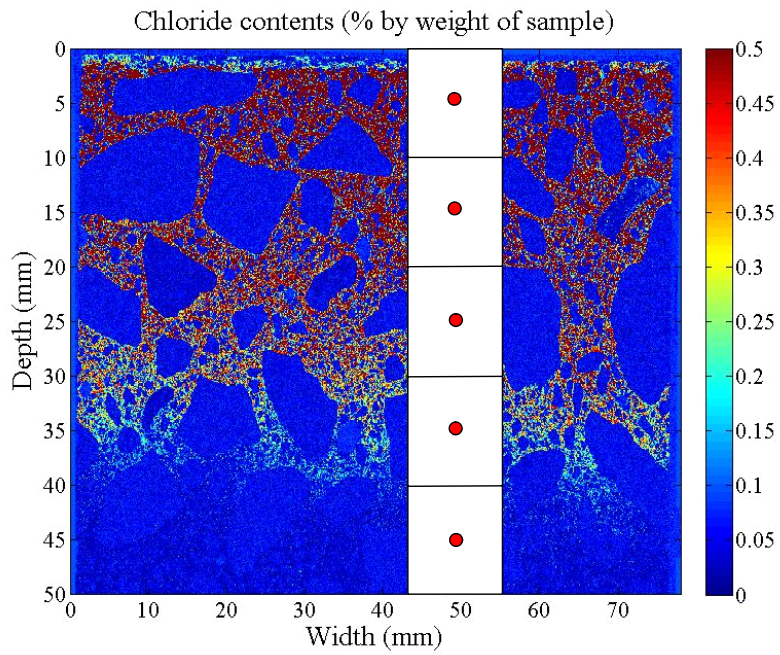
Figure 18: Chloride content in concrete specimen analyzed with EPMA showing the simulated dry drilling intervals.

The results from the EPMA analysis have been used to simulate two dimensional drilling and dust sampling. In this study the “drill” is a strip in two dimensions, cf. figure 18. To simulate different bore diameters, different strip widths have been used. To be able to compare the results from the dust sampling, the same strip widths have been chosen as the drill diameter in the laboratory test, namely 8, 12 and 20 mm.

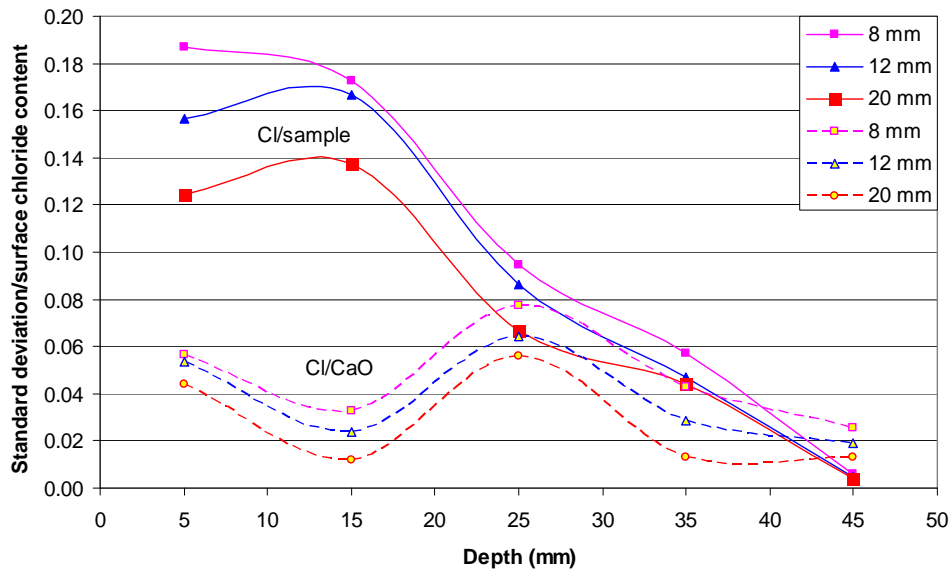
Figure 19: Standard deviation divided by surface chloride content: comparison between Cl/CaO and Cl/sample

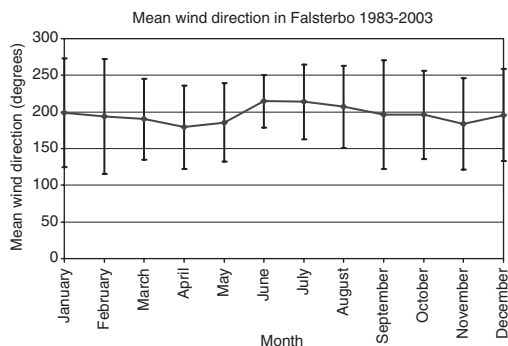
Figure 2. Mean wind direction for Falsterbo. Monthly mean values for 1983 to 2003.

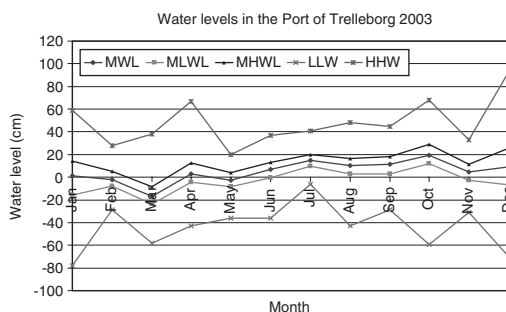
Figure 4. Water levels for 2003, monthly mean values.

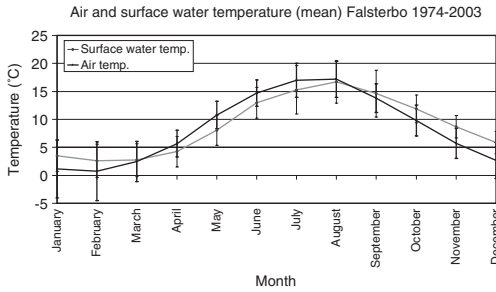
Figure 5. Mean values of air temperature and surface water temperature from 1974 to 2003.

As shown in figure 5 neither the mean temperature of the air nor the mean temperature of the surface water, falls below 0°C. The 95% confidence interval presented in the figure indicates though that the mean air temperature could pass zero degrees during January and February.

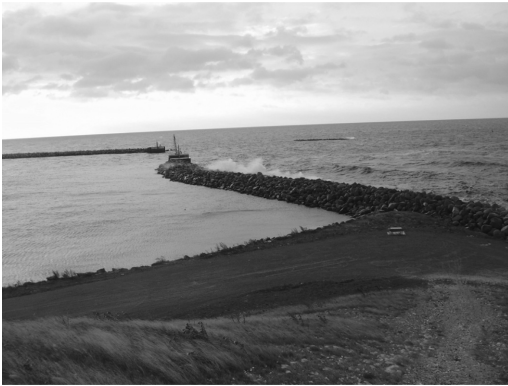
Figure 6. Wave action on breakwaters. Wind direction about 200 degrees.

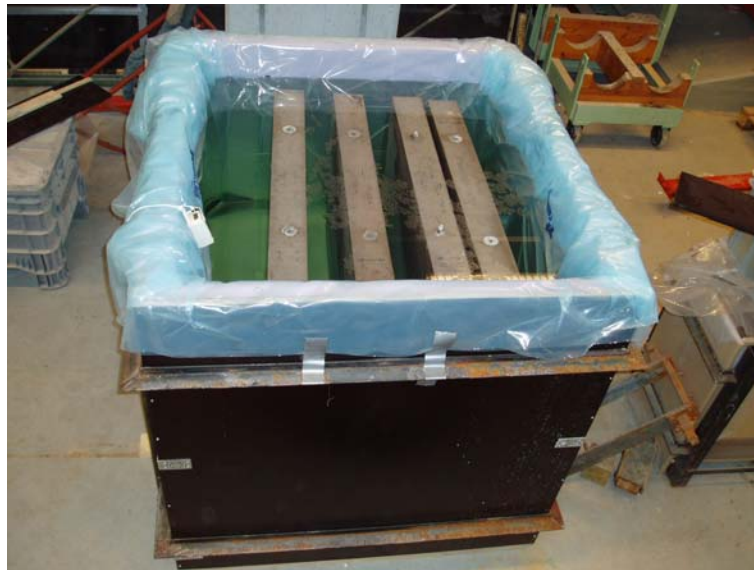
Figure 2: Concrete slabs submerged in saline water in the laboratory

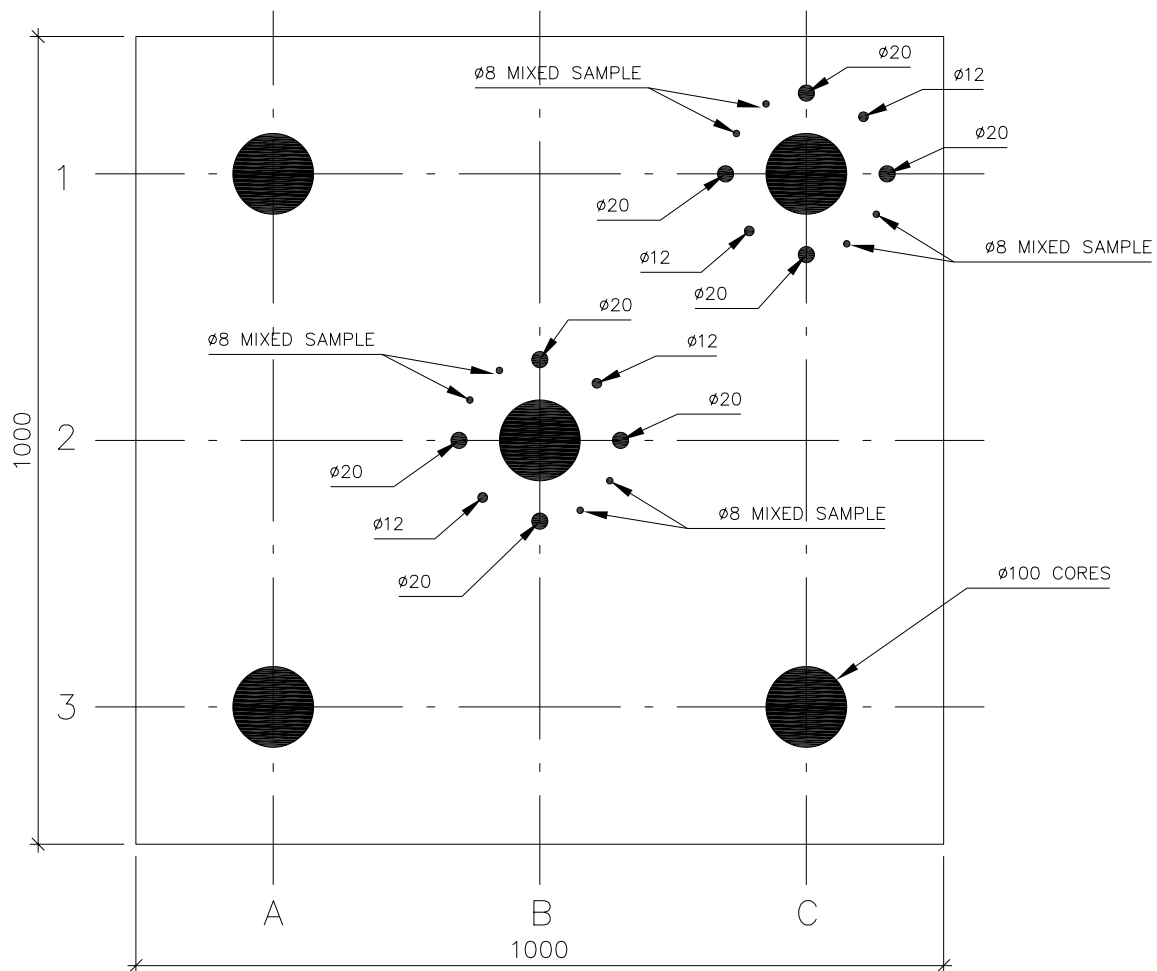
Figure 4: Sampling points on the concrete slab in laboratory. All numbers in mm.
