## Frost-induced deterioration of concrete in hydraulic structures

### Interactions between water absorption, leaching and frost action

ROSENQVIST, MARTIN

2016

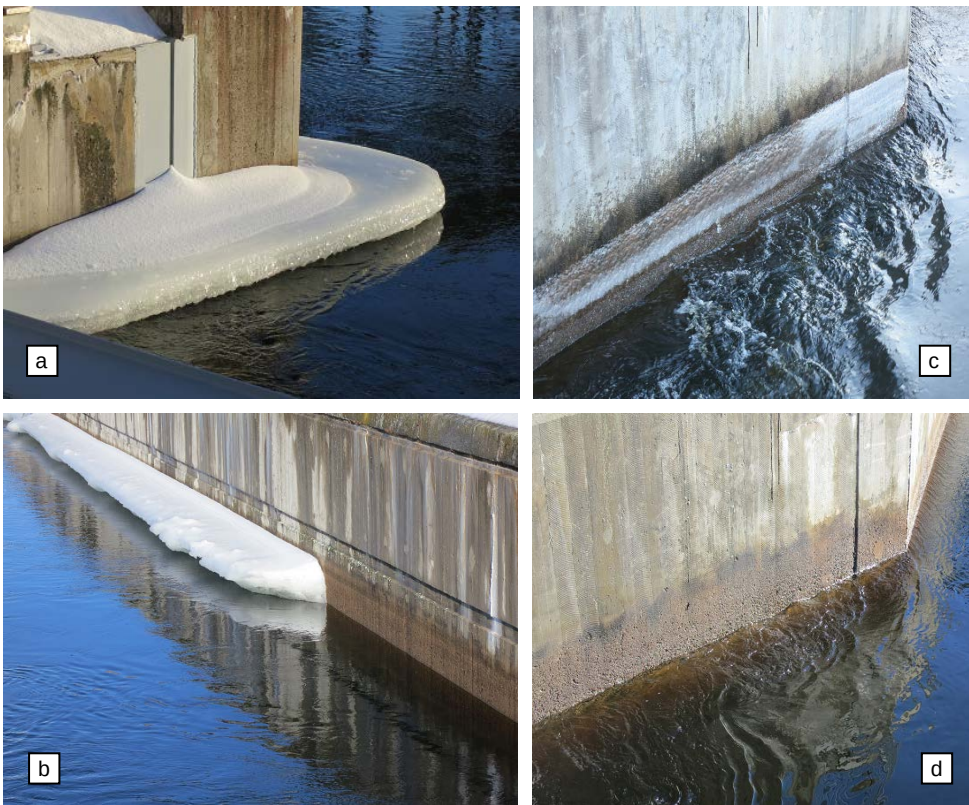
**Figure 2-3. In winter, a band of ice frozen solid to the concrete surface can be seen at the waterline of hydraulic structures (a). In spring, the band of ice falls off when the air temperature rises (b). In both spring and autumn, the air temperature frequently crosses the freezing point of water. A small band of ice can therefore be seen at the waterline in the morning (c) while it has been melted away in the evening (d).**

The band of ice falls off when the air temperature starts to rise in spring (Figure 2-3 b). However, as previously mentioned, the air temperature frequently crosses the freezing point of water in spring and autumn. Depending on the air temperatures, the band of ice can be re-formed during the nights and later melted away during the days (Figure 2-3 c–d).

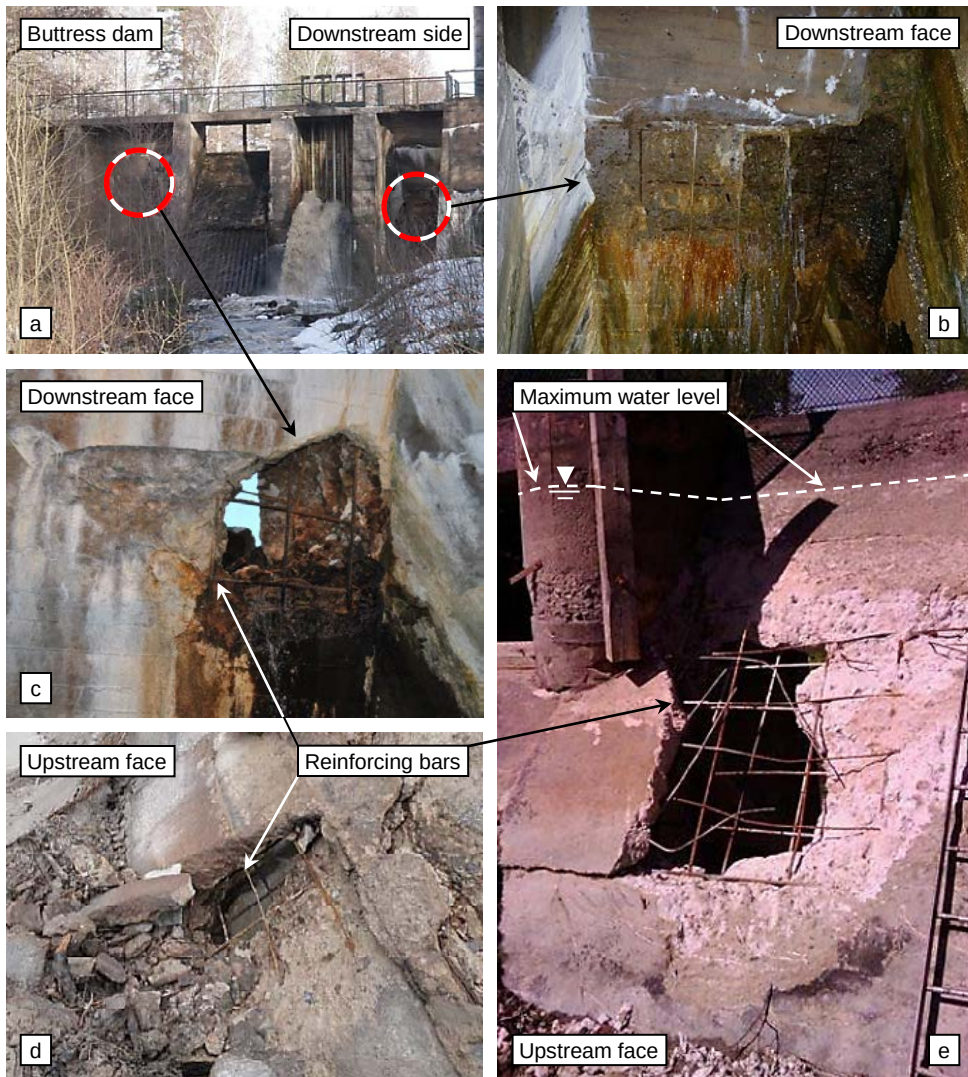
**Figure 2-11. A severely damaged buttress dam (a). Concrete cover missing in some places in the vicinity of water leakage through cracks on the downstream face (b). A hole appeared in the flat slab in another place and water escaped flushing away loose pieces of concrete (c-e). Only the reinforcing steel was left. Photos provided by Fortum AB.**
