Self-healing of cracks in concrete long-term exposed to different types of water : results after 1 year exposure

SELF-HEALING OF CRACKS IN CONCRETE LONG-TERM EXPOSED TO DIFFERENT TYPES OF WATER

Results after 1 year exposure

ISRN LUTVDG/TVBM--09/3156--SE(1-58)
ISSN 0348-7911 TVBM

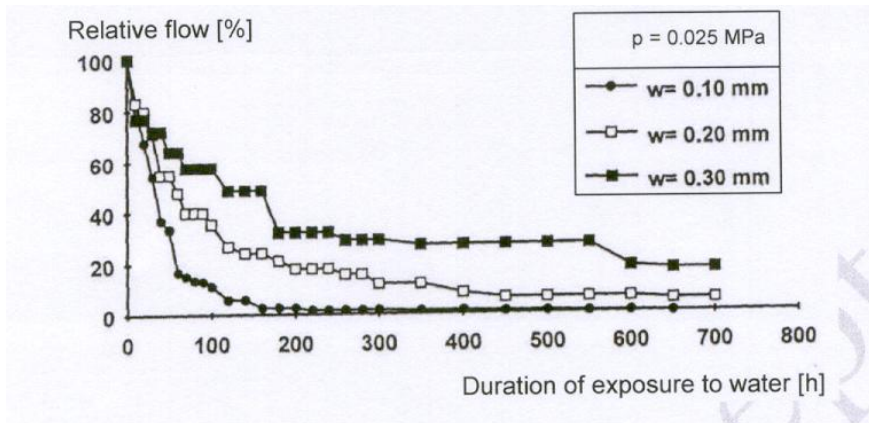
Figure 1.1: Influence of crack width and time on water flow under pressure; Edvardsen (1996).

The fact that *through cracks* in structures exposed to one-sided water pressure can heal has been known for long time. A well-established repair technique is to dry the downstream face so that lime precipitates in the crack opening thereby stopping the water flow. Extensive experimental work on healing of cracks with regard to permeability has been performed by Edvardsen (1996, 1999). An example from her work is shown in Figure 1.1. It shows flow through specimens with one single crack parallel to water flow at the water pressure 0.025 MPa (2.5 m hydraulic head). Complete healing is obtained after about 200 hours for the crack width 0.10 mm. Also cracks with 0.20 and 0.30 mm width heal almost completely within about 30 days.

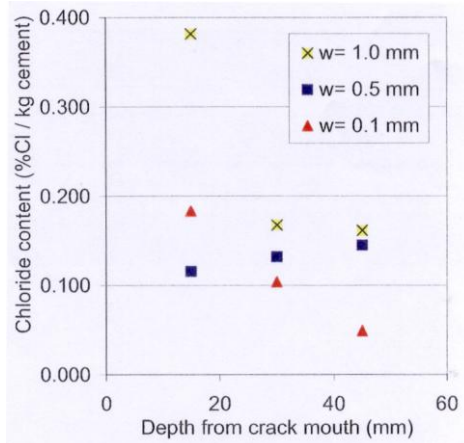
Figure 1.2: Chloride content in the crack wall after 5 winter exposure to salt spray from a Swedish highway. Effect of the crack width. Nordström (2005).

Reports on the effect of healing of cracks with regard to chloride diffusion are scarce. Nordström (2005) exposed pre-cracked steel fibre reinforced concrete to salt spray from a Swedish highway. The exposure time was 5 years (5 winters) and the crack width was 0.1, 0.5 and 1 mm. Some results from measurements of the total chloride content on depths 2 mm to 4 mm from the crack wall, on different depths from the crack mouth, are shown in Figure 1.2. There is no clear certain tendency of reduced chloride content with increased depth in the crack. The chloride content on 45 mm depth varies between about 0.05 and 0.15 % of the cement weight. This can be compared with the chloride content on the same depth in un-cracked concrete, which is less than 0.02 % of the cement weight. Thus, chloride penetration in the crack is considerably higher. It must be noted that the specimens were exposed to seasonal variations in chloride and moisture exposure. Therefore, chloride can diffuse both inwards and outwards within the crack.

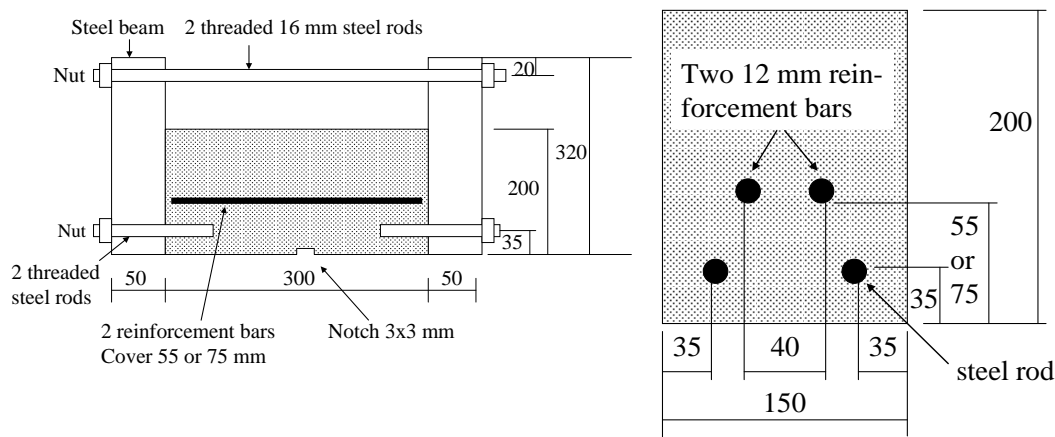
Figure 4.1: Specimen seen from the side and cross-section.

Specimens 150 mm wide, 200 mm high and 300mm long were cast in a mould with plywood sides and bottom. Each end of the mould was made of two stainless steel tubes with rectangular cross-section welded together to form a beam with width 150 mm and height 320 mm. At the lower part of each steel beam holes were made for two threaded stainless steel rods which were cast into the concrete. These rods were used for transferring to concrete the tensile force occurring in the beam during bending of the specimen used for inducing the pre-crack.

A drawing of the specimen is shown in figure 4.1. Figure 4.2 and 4.3 show photos of the specimen directly after casting and after de-moulding.

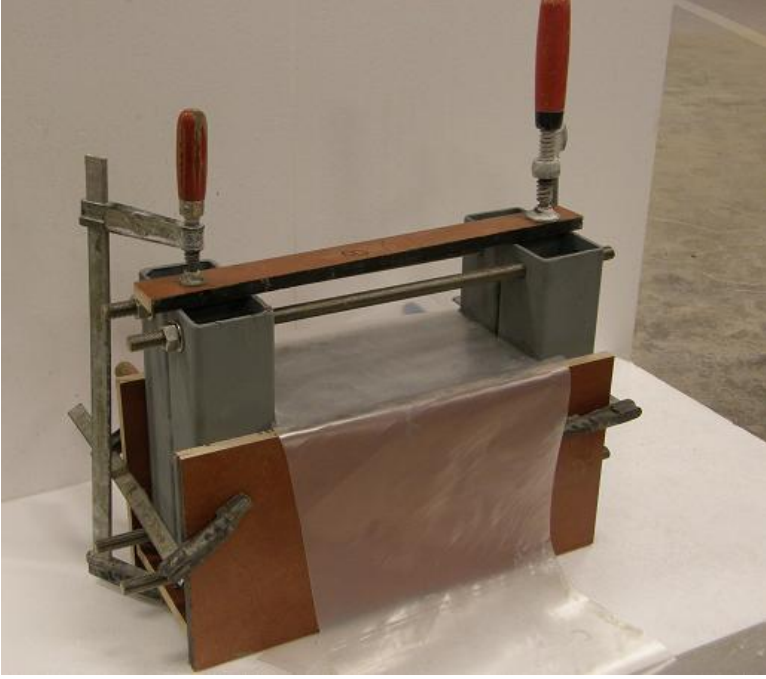
Figure 4.2: Specimen directly after casting.

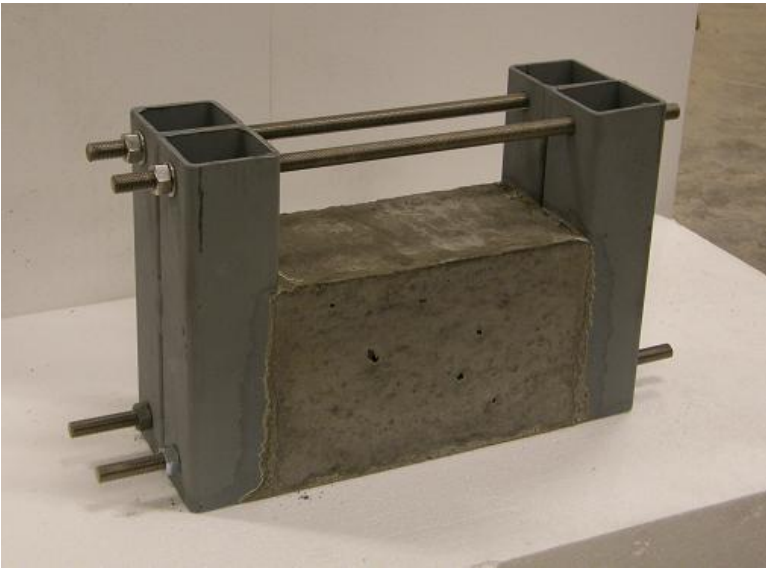
Figure 4.3: Specimen after de-moulding.

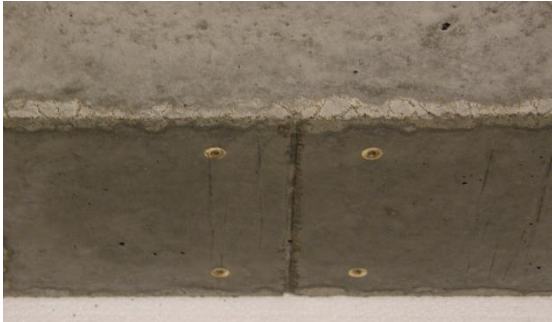
Figure 5.1: Cast-in nuts for mounting two extensometers across the notch.

A crack initiating at the bottom of the specimen was produced in the specimen when this was 2 weeks old. The specimen was placed in a test machine on two supports designed in such a way that no twisting of the specimen could occur. Thereby, the crack width would be the same on both sides of the specimen. Two Linear Variable Displacement Transducers (LVDT) were mounted on the bottom surface. They were supported by screws mounted on cast-in nuts on both sides of the notch. Figure 5.1 shows the bottom surface with cast-in nuts.

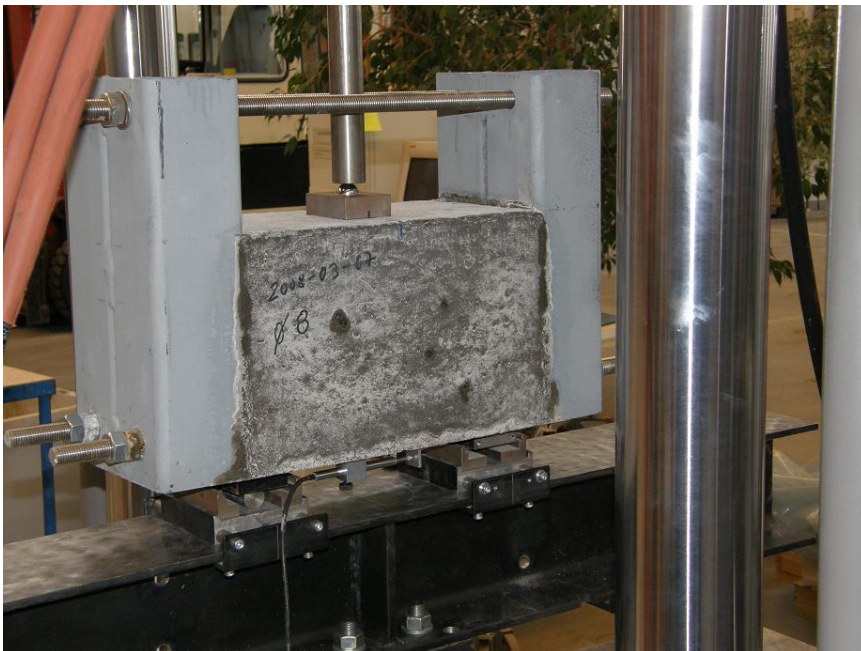
Figure 5.2: Test assembly for creating a crack in the specimen.

Pressure was applied on the upper surface of the specimen at its mid-section. A crack was induced at the notch. Pressure was increased until the extensometers indicated that the crack mouth opening aimed at was reached (0,2 or 0,4 mm). Then, the nuts on the upper threaded bars was tightened and locked by another nut so that the crack was locked. When the pressure was released it was controlled that the crack maintained its initial width and that no relaxation of the crack occurred.

The test arrangement is shown in figure 5.2.

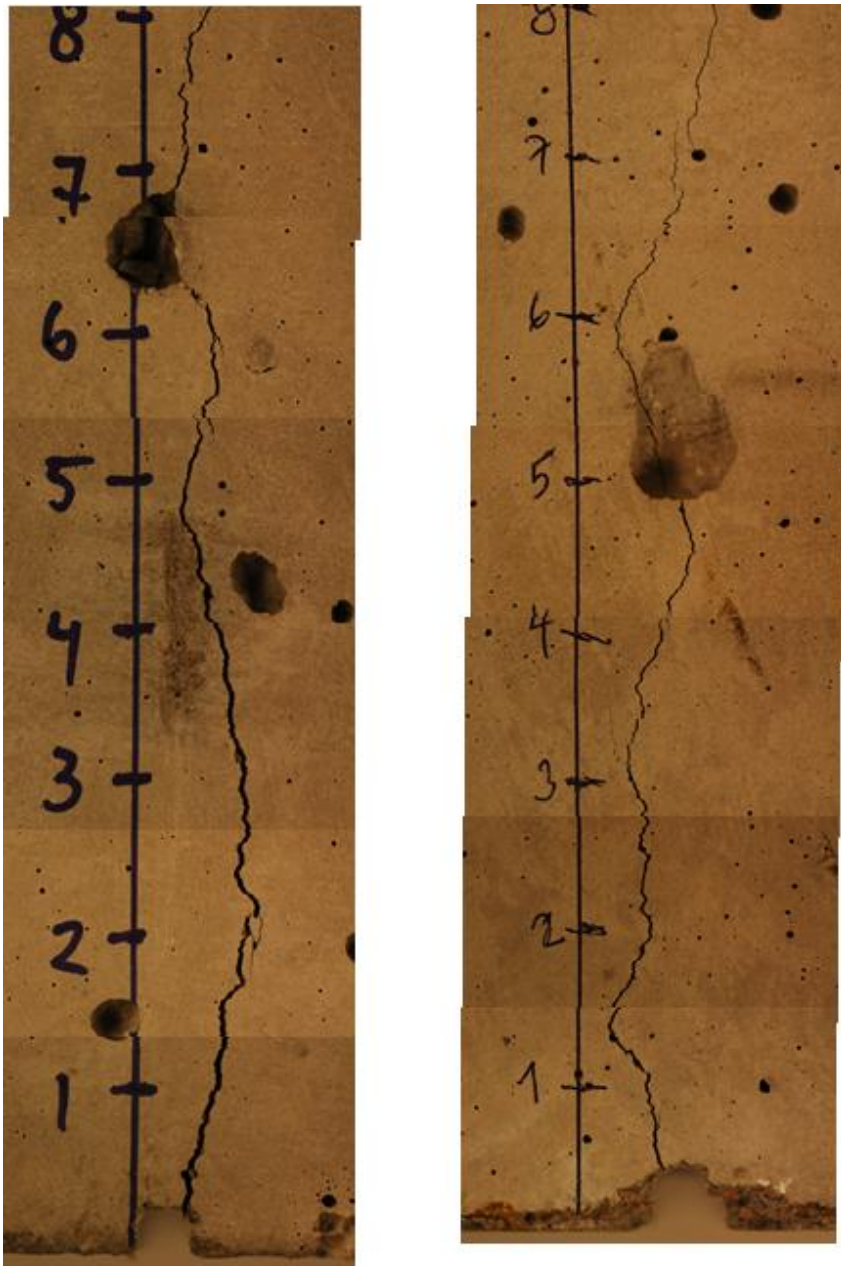
Figure 7.1: Photography of cracks before exposure. 75 mm cover. cm-scale indicated.

Left: Crack width 0.4 mm (specimen H75-4-1-1 left side).

Right: Crack width 0.2 mm (specimen H75-2-1-1 left side).

Photos were taken of the crack before it was sealed, i.e. before the concrete placed in the bath. 5 to 8 photos were taken along the crack on each side of this. Each photo covered about 12 mm of the crack length. Examples of photos of two cracks are shown in figure 7.1.

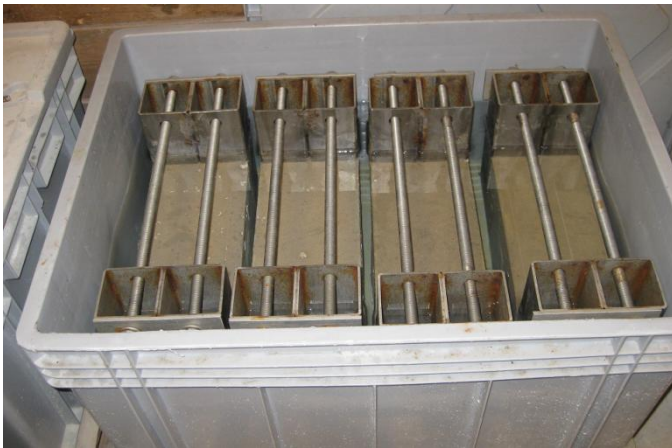
Figure 10.1: Water exposure type 1; permanently under water.

- Type 1: Permanently stored under water. The specimens were completely covered by water during one year. A basin with specimens is shown in figure 10.1.
- Type 2: Cyclic. 1 week immersed in water followed by 1 week in lab air. In total 25 cycles.
- Type 3: One-sided capillary suction. The specimens were turned upside down and the un-cracked upper surface immersed some millimetres in water. Drying occurred from the bottom “crack side”. The specimens were stored in this way during one year. A basin with specimens is shown in figure 10.2. This type of exposure will go on for 2 years. Therefore, no results will be published in the present report.

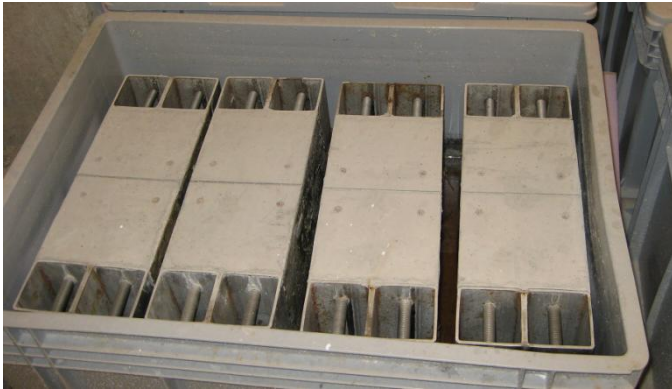
Figure 10.2: Water exposure type 3: Capillary suction from the un-cracked top side.

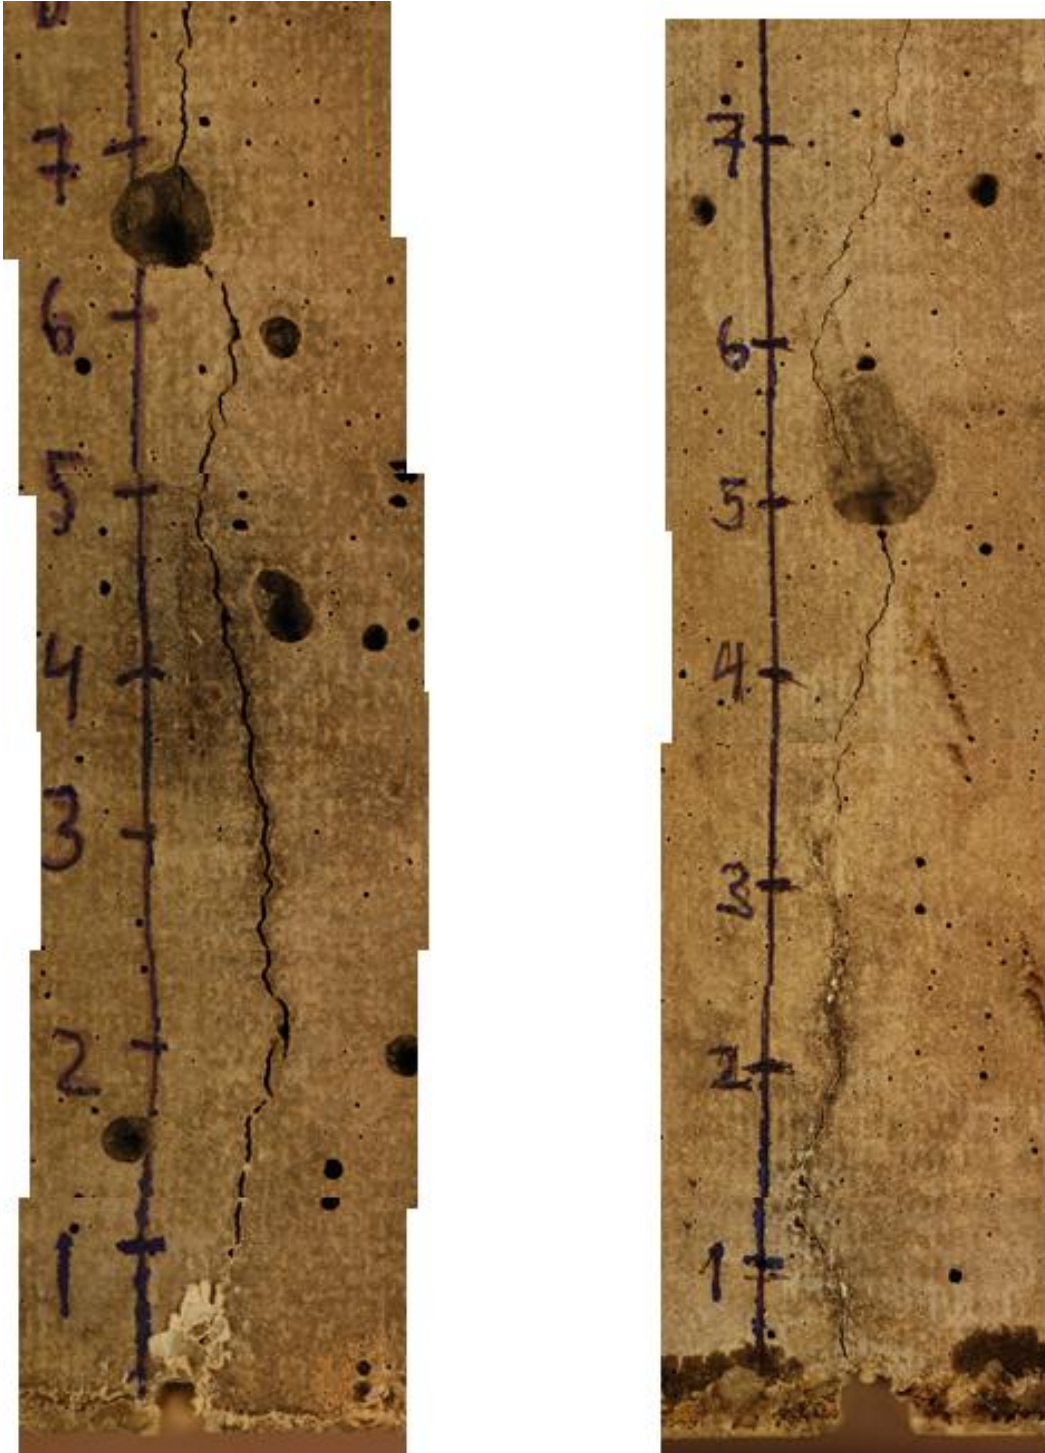
Figure 12.1: Photographs of cracks after exposure. The same specimens as in figure 7.1.

Left: Crack width 0.4 mm (specimen H75-4-1-1 left side).

Right: Crack width 0.2 mm (specimen H75-2-1-1 left side).

After about one year exposure the crack seal was removed. Thereafter photos of the cracks were taken in the same manner as before exposure. Examples of photos are given in figure 12.1 which shows the same cracks as are shown before exposure in figure 7.1. There is a clear indication of a certain healing, particularly of the thinner crack.

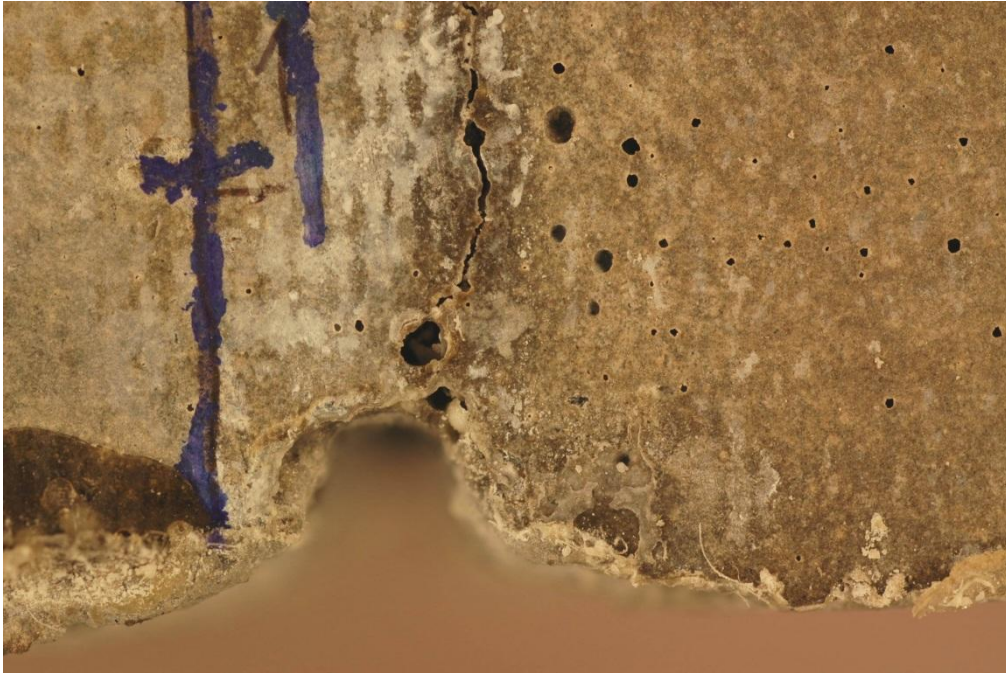
*Figure 12.2: 0.2 mm crack after 1 year permanent immersion in sea water.
Test series 1, specimen H75-2-1-1.*

Magnifications of photos of the lowest part of the crack after 1 year exposure are shown in figure 12.2-12.11 for 10 specimens. Only one side of the specimens are shown. The other side is similar to the side shown.

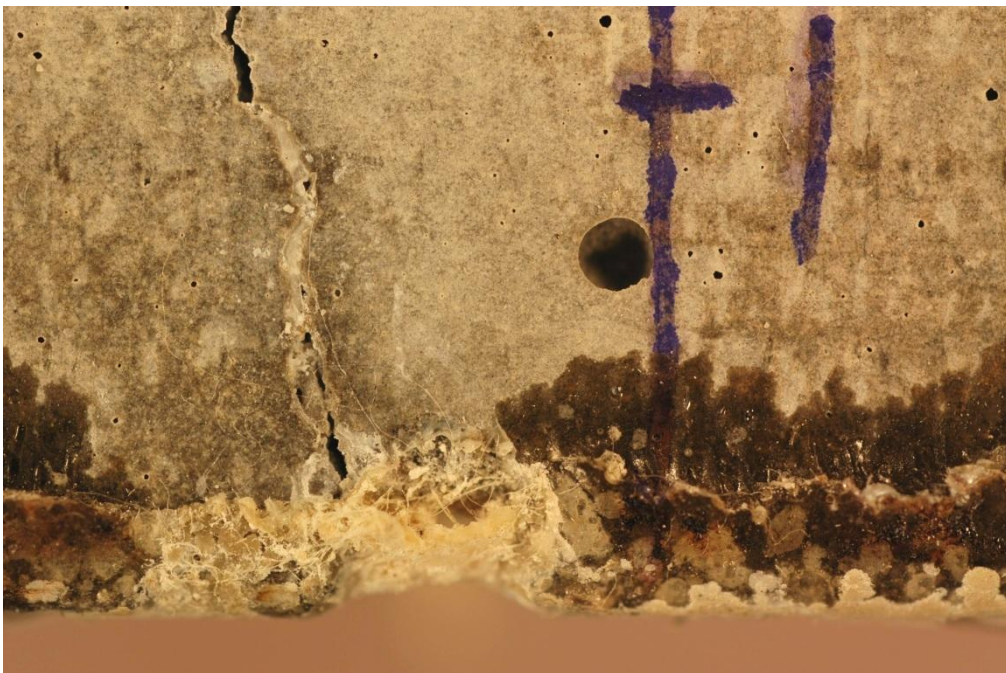
*Figure 12.3: 0.4 mm crack after 1 year permanent immersion in sea water.
Test series 1, specimen H75-4-1-1.*

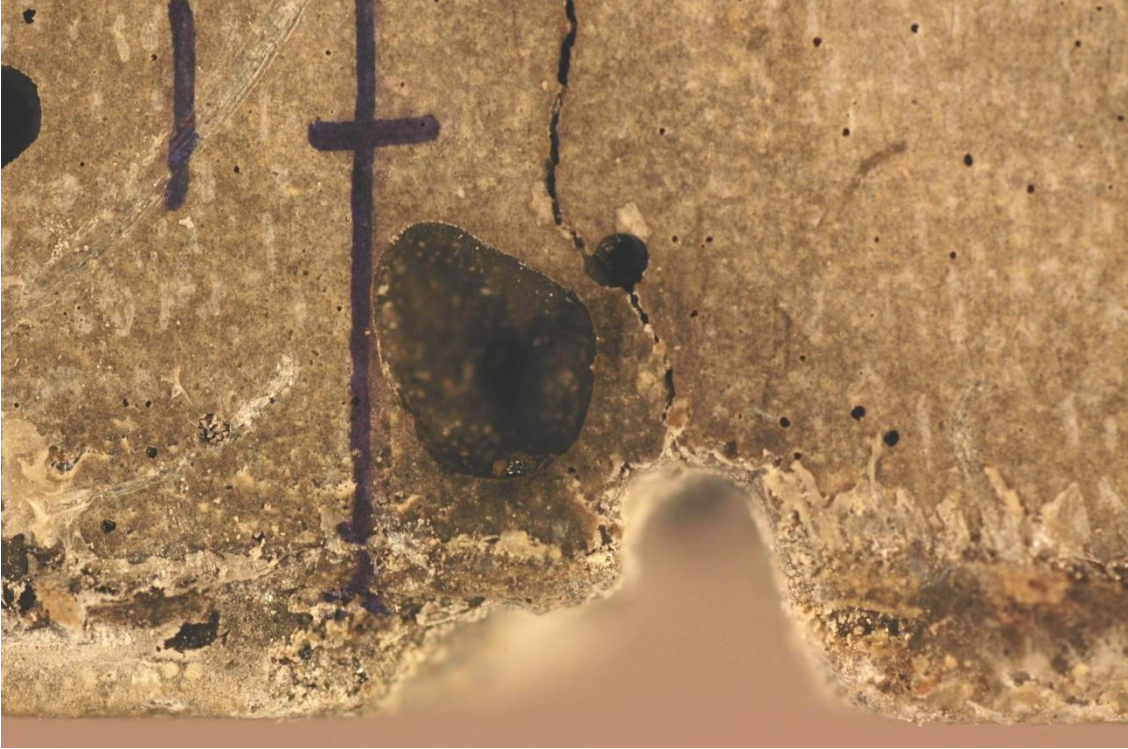
*Figure 12.4: 0.2 mm crack after 1 year cyclic immersion in sea water and drying.
Test series 1, specimen H75-2-2-1.*

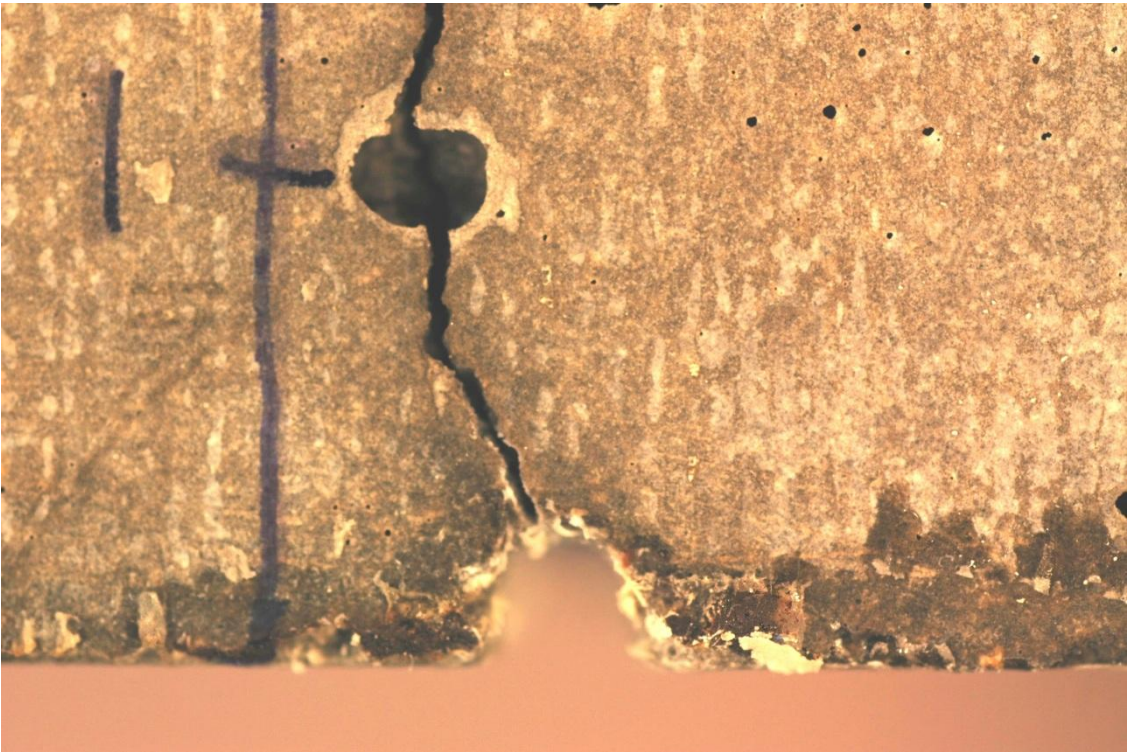
*Figure 12.5: 0.4 mm crack after 1 year cyclic immersion in sea water and drying.
Test series 1, specimen H75-4-2-1.*

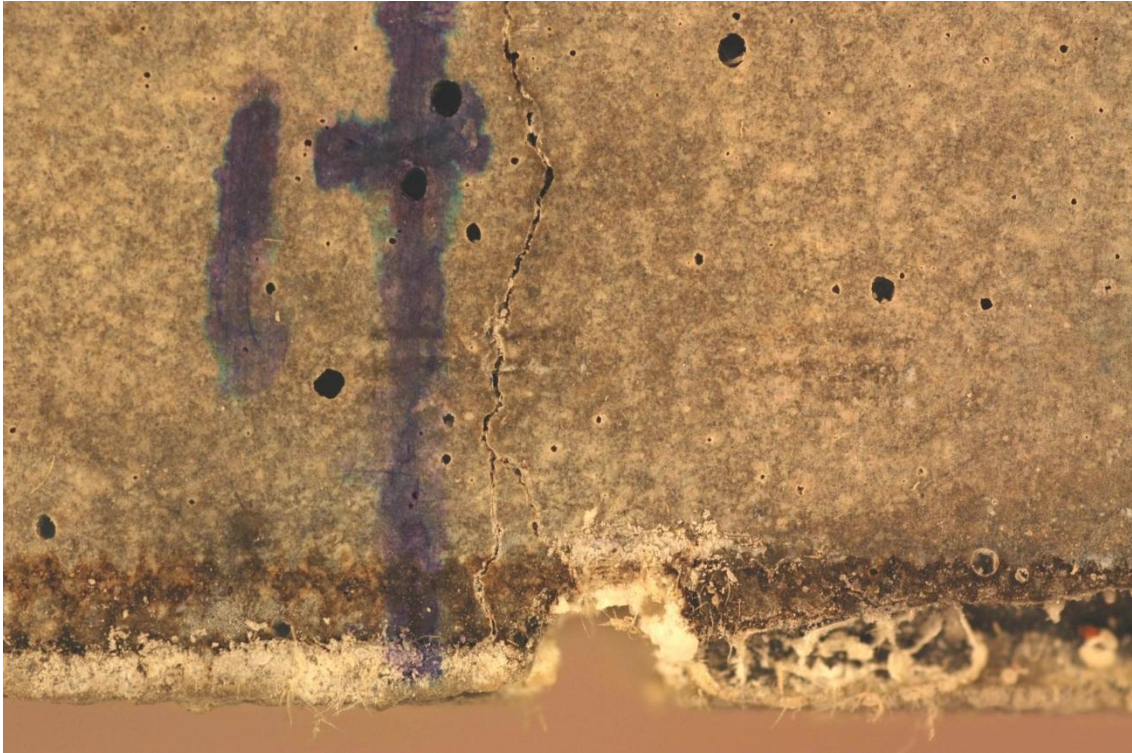
*Figure 12.6: 0.4 mm relaxed crack after 1 year permanent immersion in sea water.
Test series 1, specimen H55-4R-1-1.*

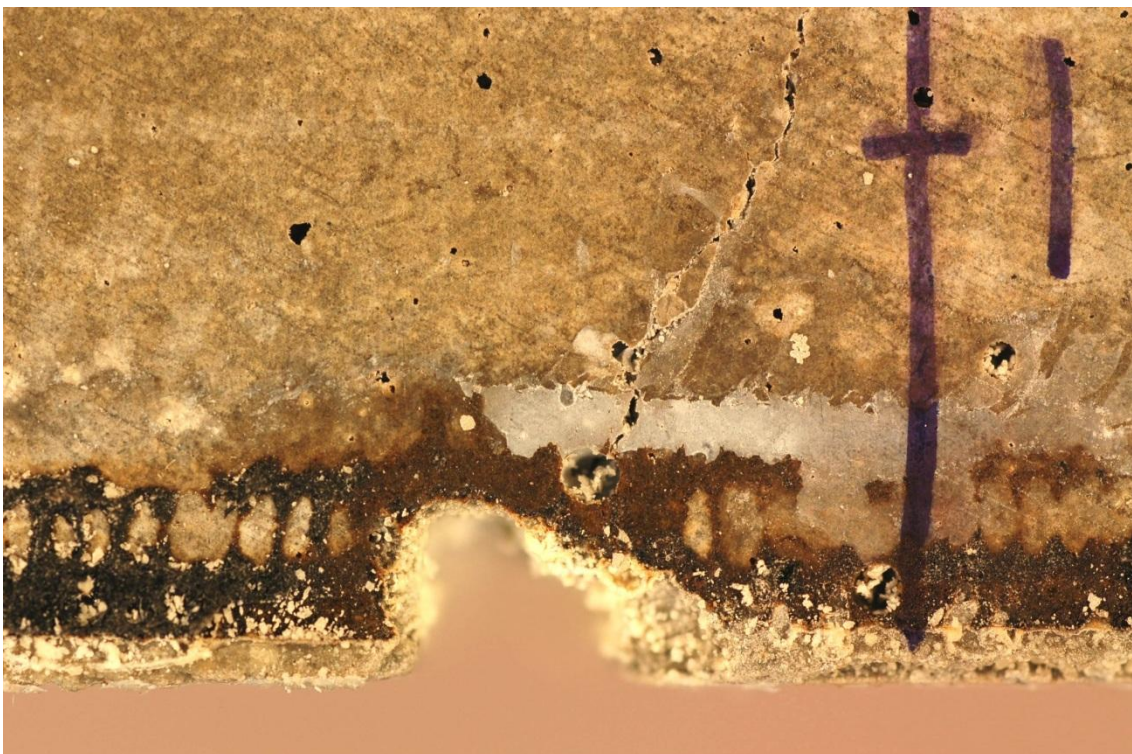
*Figure 12.7: 0.4 mm relaxed crack after 1 year cyclic immersion in sea water and drying.
Test series 1, specimen H55-4R-2-1.*

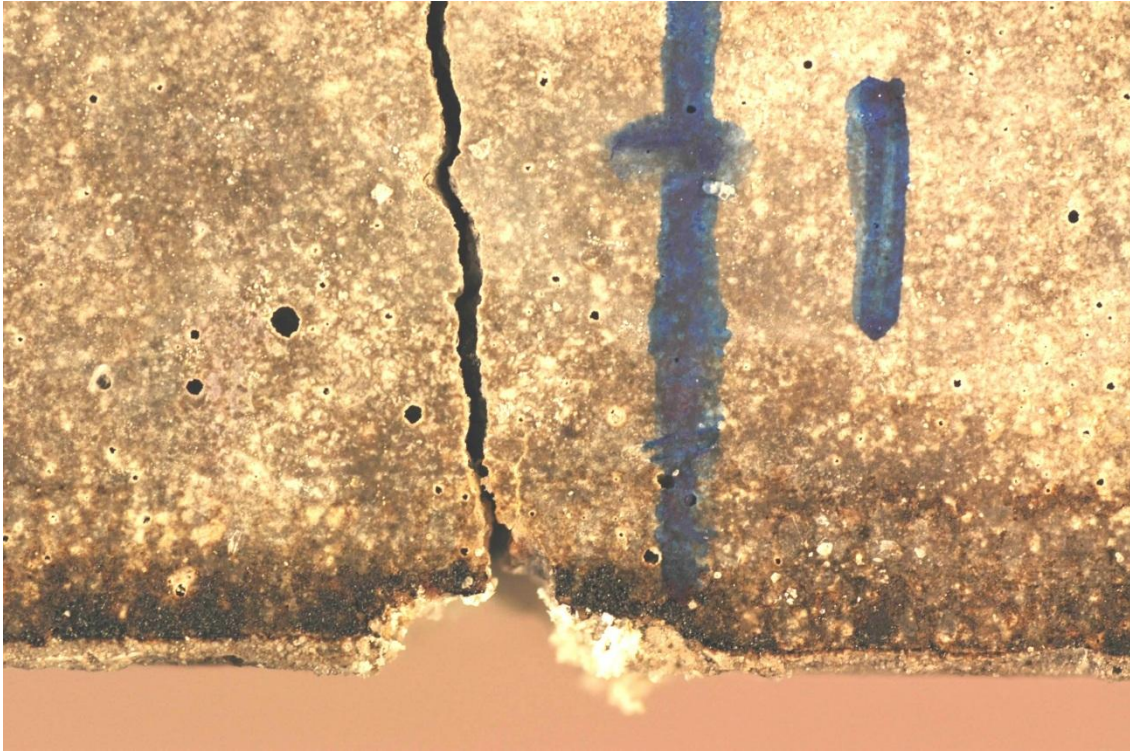
*Figure 12.8: 0.4 mm crack after 1 year permanent immersion in pure water.
Test series 3, specimen S175-4-1-1-R.*

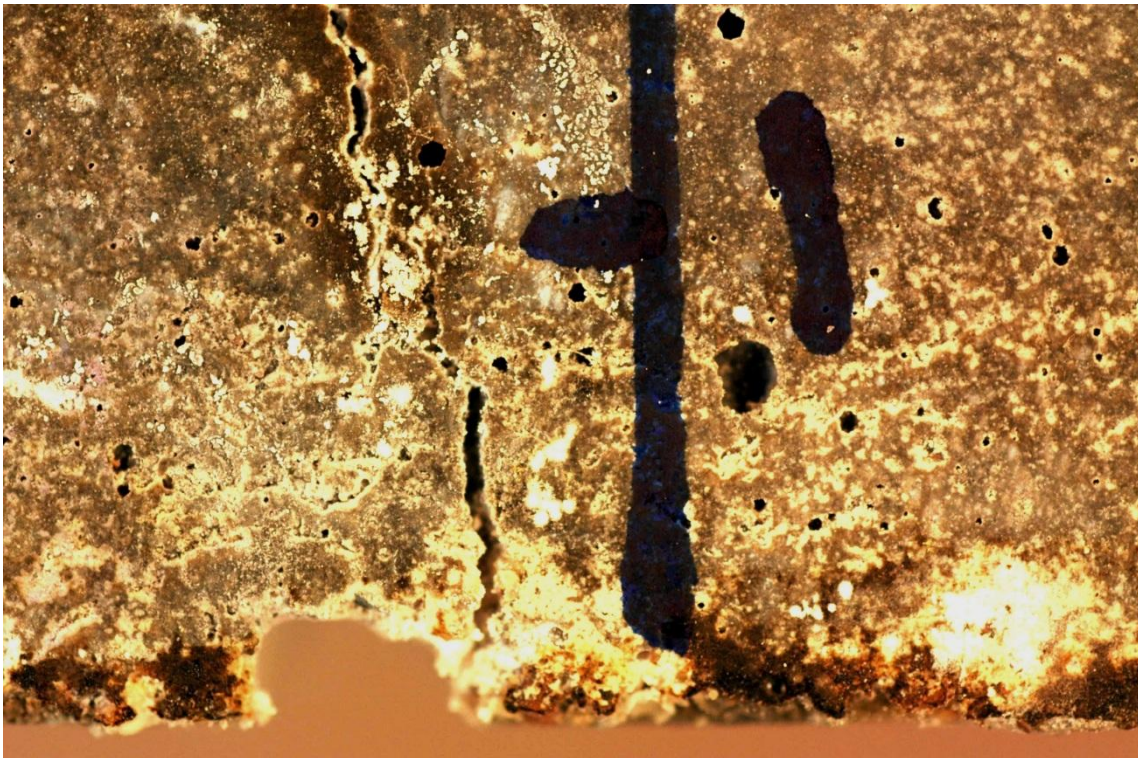
*Figure 12.9: 0.4 mm crack after 1 year permanent immersion in brackish water.
Test series 2, specimen S175-4-1-1-Ö.*

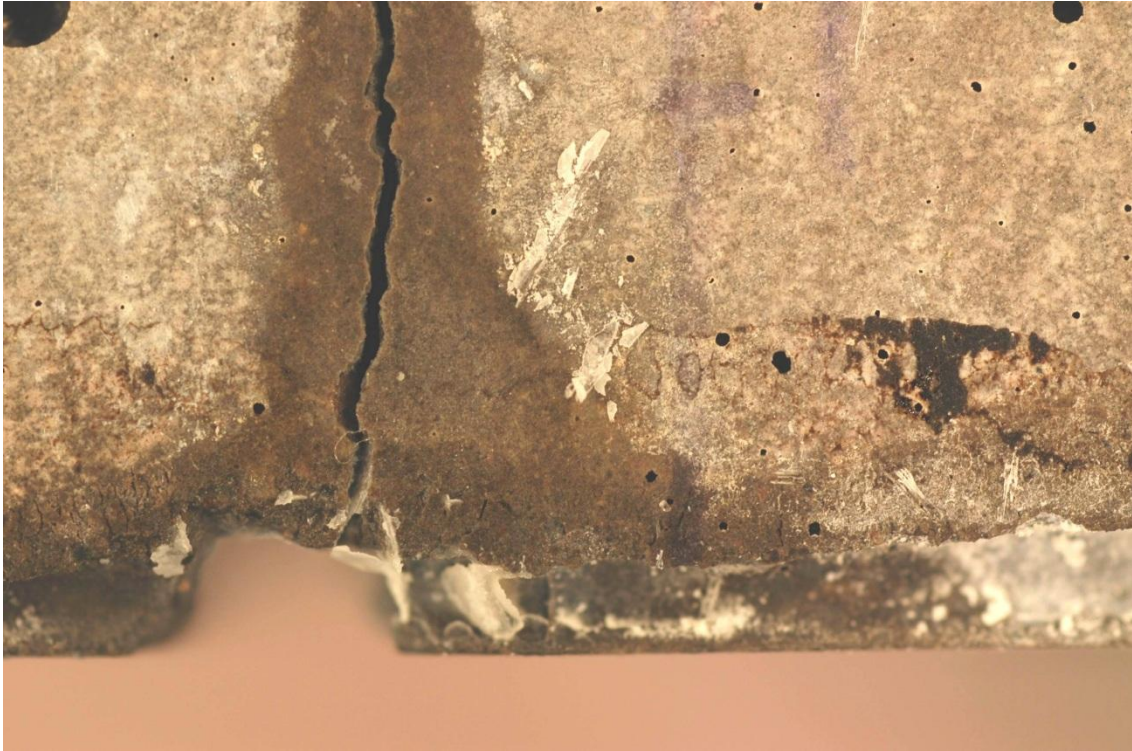
*Figure 12.10: 0.4 mm sealed crack after 1 year permanent immersion in sea water.
Test series 5, specimen S275-4-1-1.*

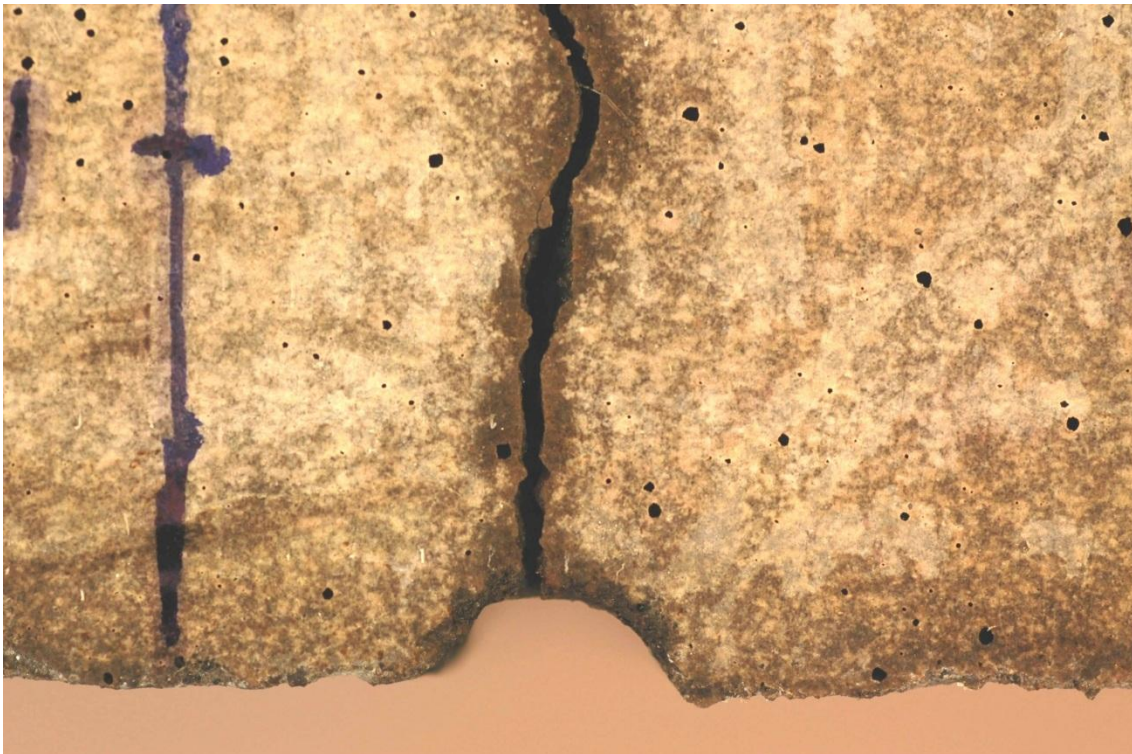
*Figure 12.11: 0.4 mm sealed crack after 1 year cyclic immersion in sea water and drying.
Test series 5, specimen S275-4-2-1.*

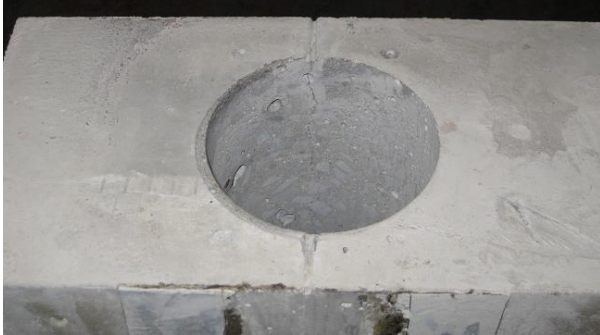
Figure 13.1: Example of a specimen after the core has been drilled out.

After terminated exposure a 10 cm core was drilled centrally in the specimen from its bottom side along the crack. Drilling was made with water-cooled drill. An example of the specimen after drilling is shown in figure 13.1. An example of a drilled-out core is shown in figure 13.2.

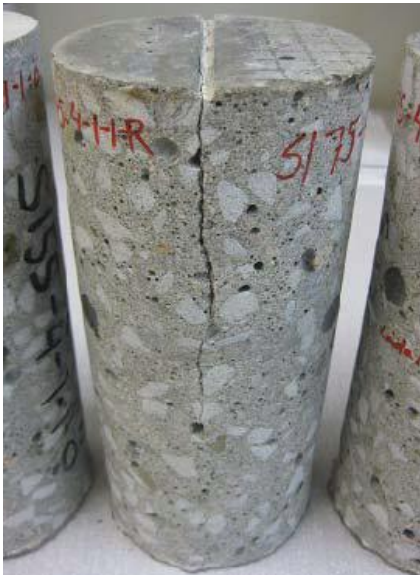
Figure 13.2: Example: core drilled out from specimen S1-75-4-1-1-R (75 mm cover, crack width 0.4 mm, permanently exposed to pure water).

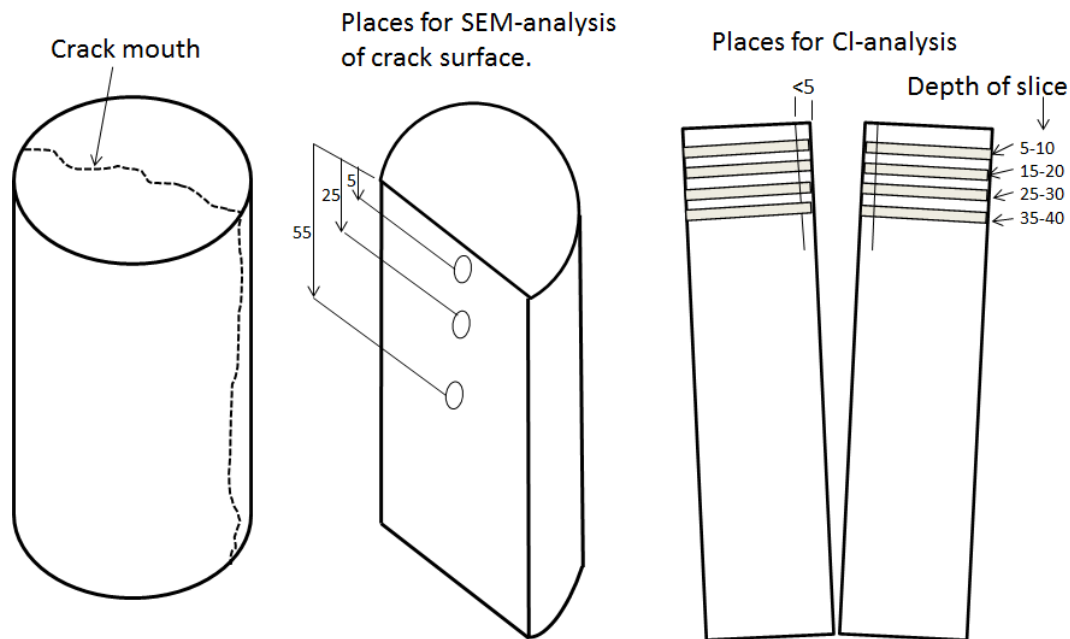
Figure 14.1: Core and places where samples were taken from the crack walls.

Location of the test areas are shown in figure 14.1.

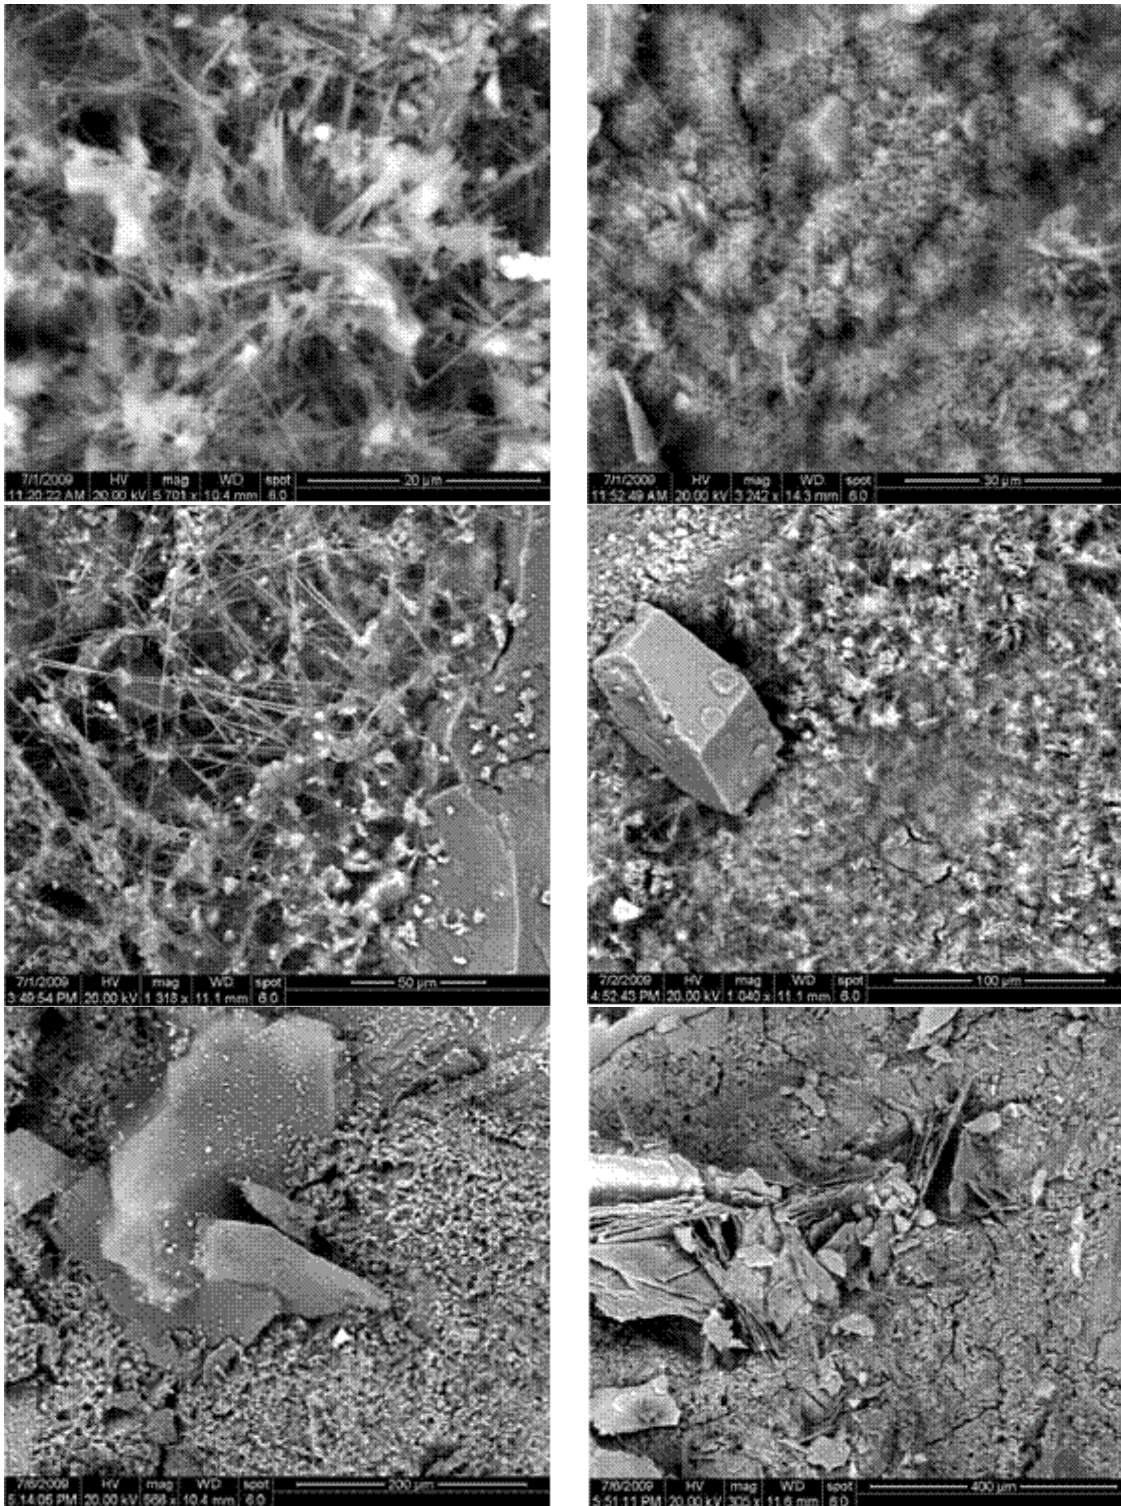
Figure 14.2: SEM-photos of precipitations in cracks for specimens *exposed permanently in sea water*. Photos: Kalinowski & Fjällberg (2010).

Left: Depth 5 mm. Right: Depth 55 mm.

SEM-photos of precipitations in the crack for specimens stored permanently in sea water are shown in Figure 14.2. SEM photos for specimens permanently stored in brackish water or tap water is shown in Figure 14.3 and 14.4. SEM photos for specimens cyclically exposed to sea water and drying in air are shown in figure 14.5.

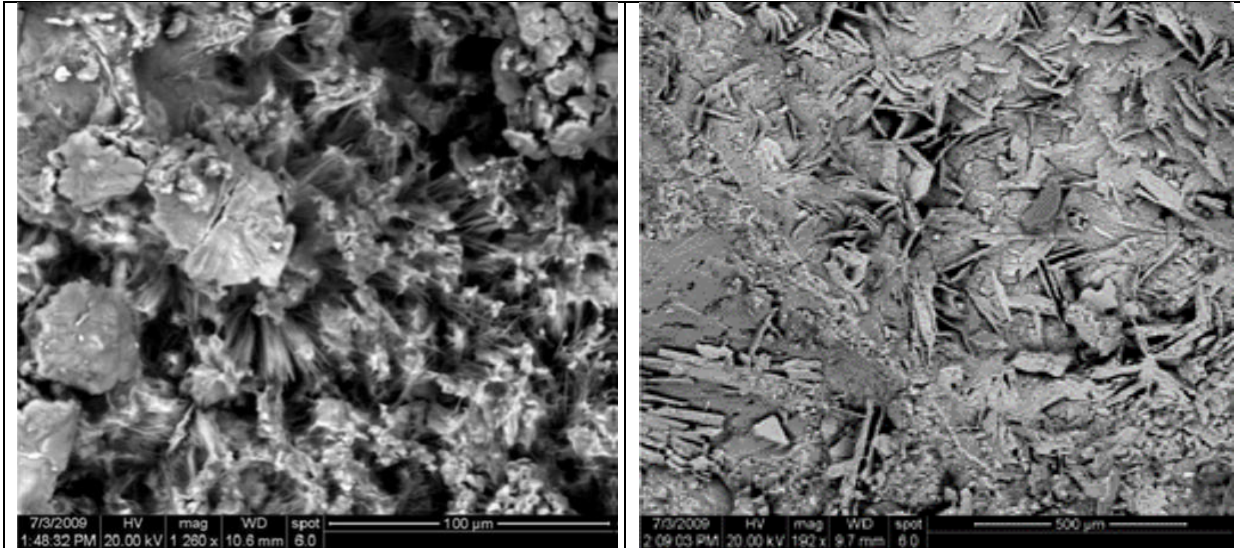
Figure 14.3: SEM-photos of precipitations in cracks for specimens *exposed permanently in brackish water*. Photos: Kalinowski & Fjällberg (2010). Cover 55 mm. Crack width 0.4 mm. Specimen S155-4-1-1-Ö. Left: Depth 5 mm. Right: Depth 55 mm.

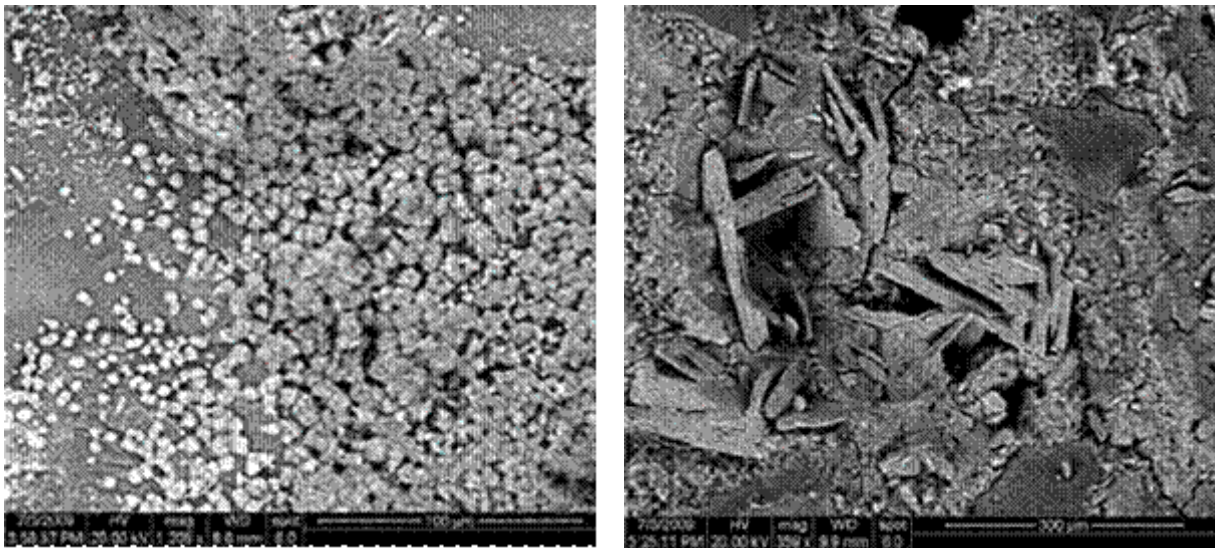
Figure 14.4: SEM-photos of precipitations in cracks for specimens *exposed permanently in tap water*. Photos: Kalinowski & Fjällberg (2010). Cover 55 mm. Crack width 0.4 mm. Specimen S155-4-1-1-R. Left: Depth 5 mm. Right: Depth 55 mm.

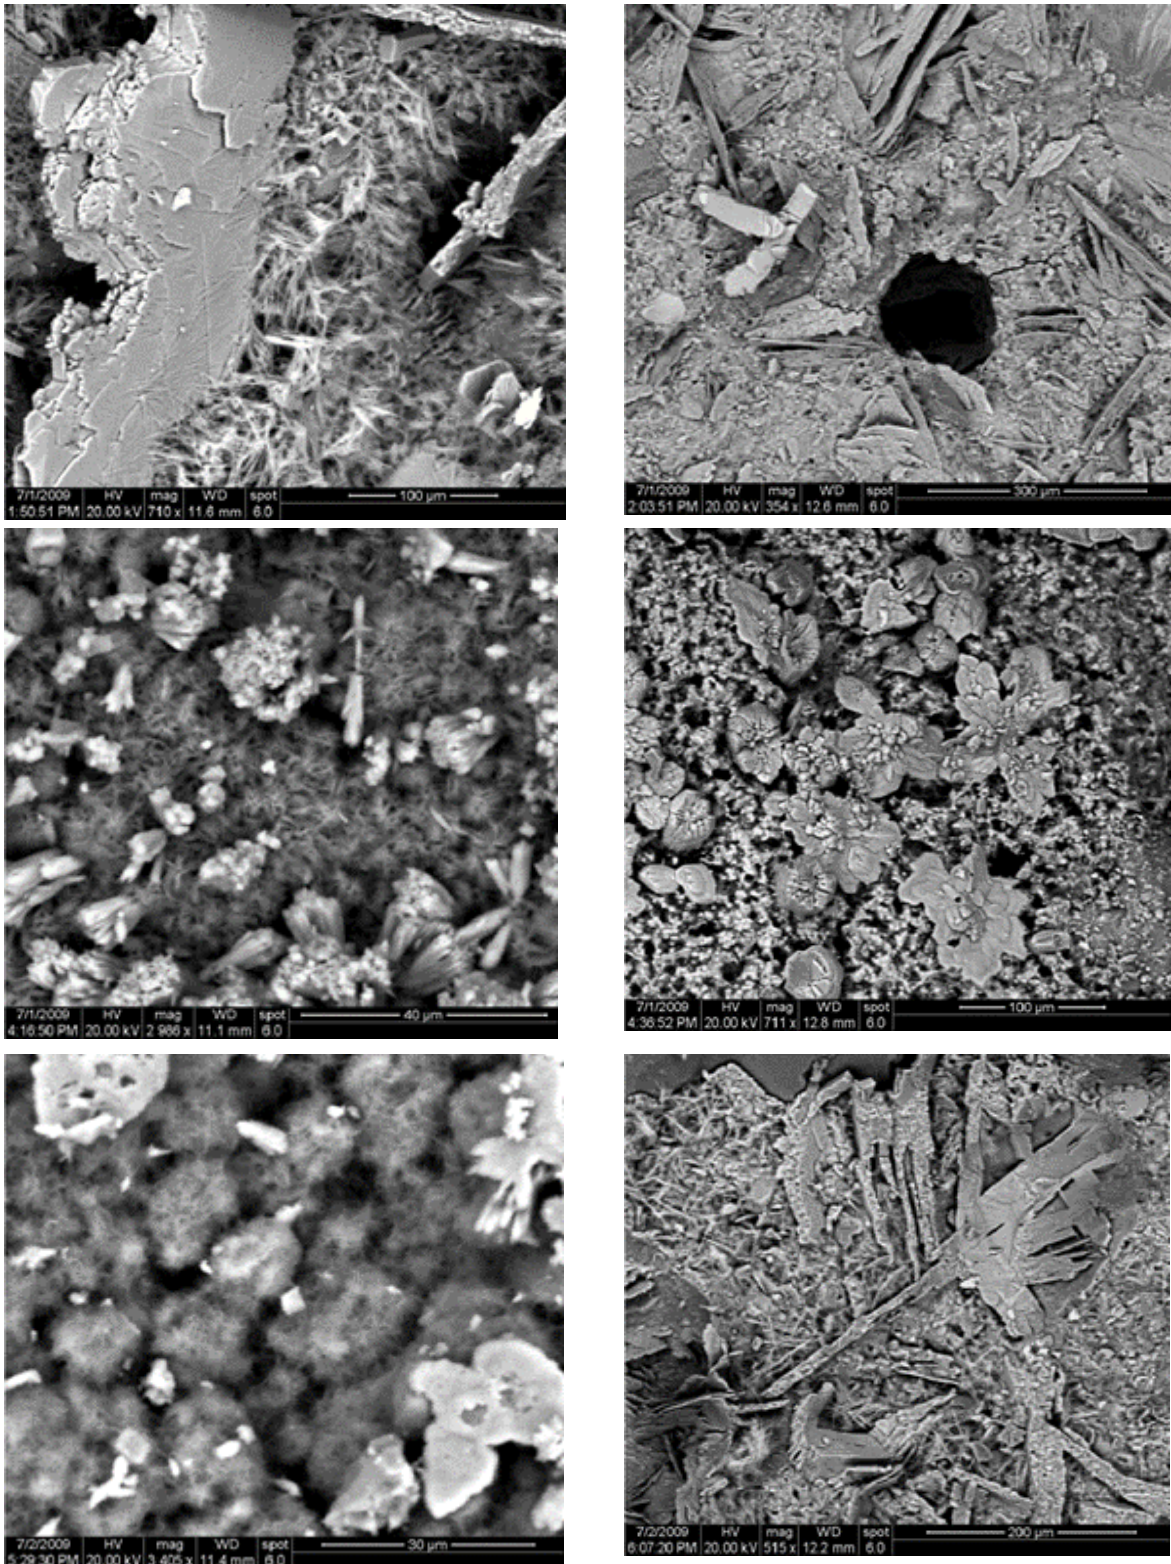
Figure 14.5: SEM-photos of precipitations in cracks for specimens **exposed to cyclic immersion in sea water and drying**. Photos: Kalinowski & Fjällberg (2010).
Upper row: Cover 55 mm. Crack 0.2 mm. Specimen H55-2-2-1.
 Left: Depth 25 mm. Right: Depth 55 mm.
Middle row: Cover 55 mm, Crack 0.4 mm. Specimen H55-4-2-1.
 Left: Depth 5 mm. Right: Depth 55 mm.
Lower row: Cover 55 mm. Crack 0.4 mm. Specimen H55-4R-2-1. Relaxed crack
 Left: Depth 5 mm. Right: Depth 55 mm.

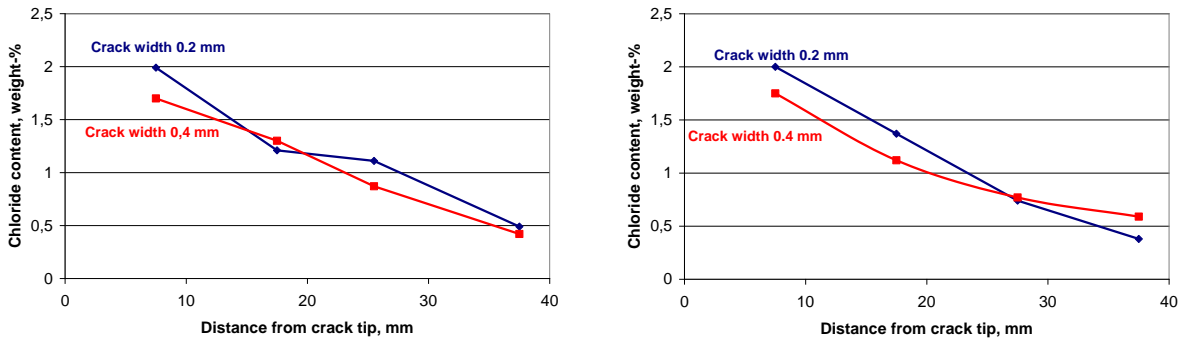
Figure 14.6: Chloride content in crack walls. Permanently immersed in sea water. Effect of crack width. Left figure: Cover 55 mm. Right figure: Cover 75 mm.
