Self-healing of cracks in concrete long-term exposed to different types of water : results after 1 year exposure

SELF-HEALING OF CRACKS IN CONCRETE LONG-TERM EXPOSED TO DIFFERENT TYPES OF WATER

Results after 1 year exposure

ISRN LUTVDG/TVBM--09/3156--SE(1-58)
ISSN 0348-7911 TVBM

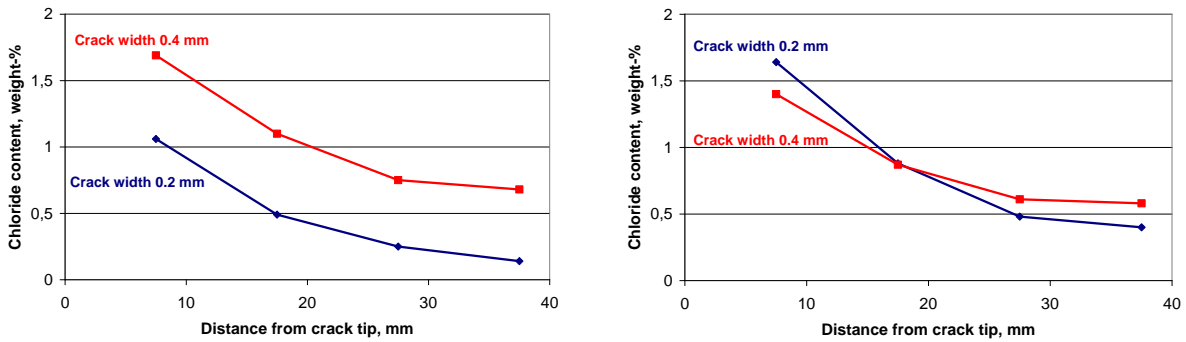
Figure 14.7: Chloride content in crack walls. Cyclic immersion and drying in sea water. Effect of crack width. Left figure: Cover 55 mm. Right figure: Cover 75 mm.

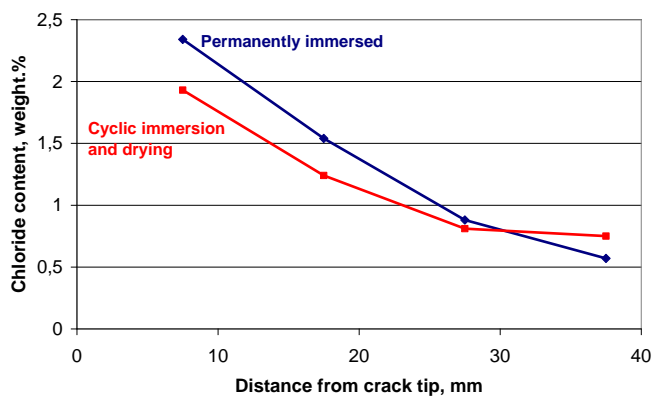
Figure 14.8: Chloride content in crack walls. Relaxed crack. Effect of type of exposure. Cover 55 mm. Crack width 0.4 mm.

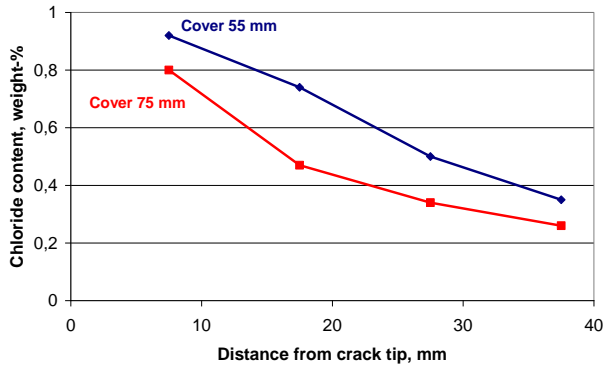
Figure 14.9: Chloride content in crack walls. Permanently immersed in brackish water. Effect of cover. Crack width 0.4 mm.

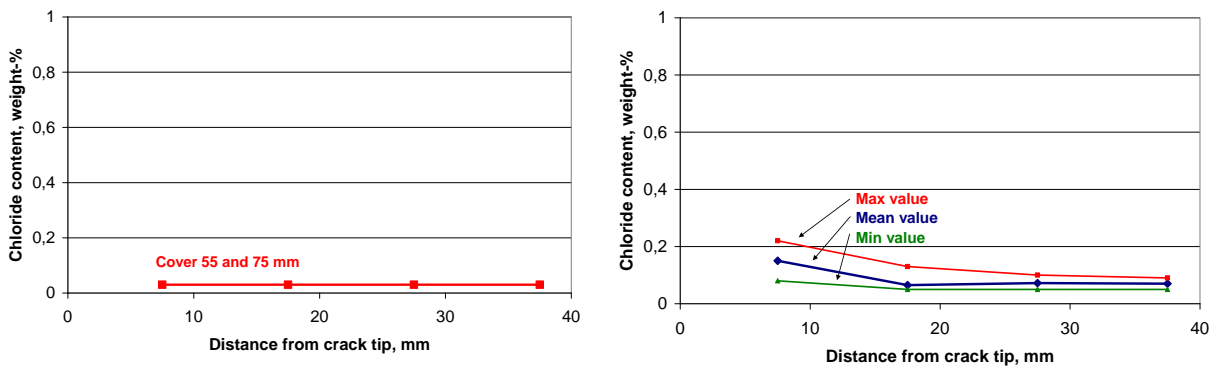
Figure 14.10: Chloride content in crack walls.
 Left figure: Permanent exposure in tap water (2 specimens).
 Right figure: Sealed crack opening. 4 specimens with crack width 0.2 and 0.4 mm. 2 specimens permanently immersed. 2 specimens exposed to cyclic immersion and drying.

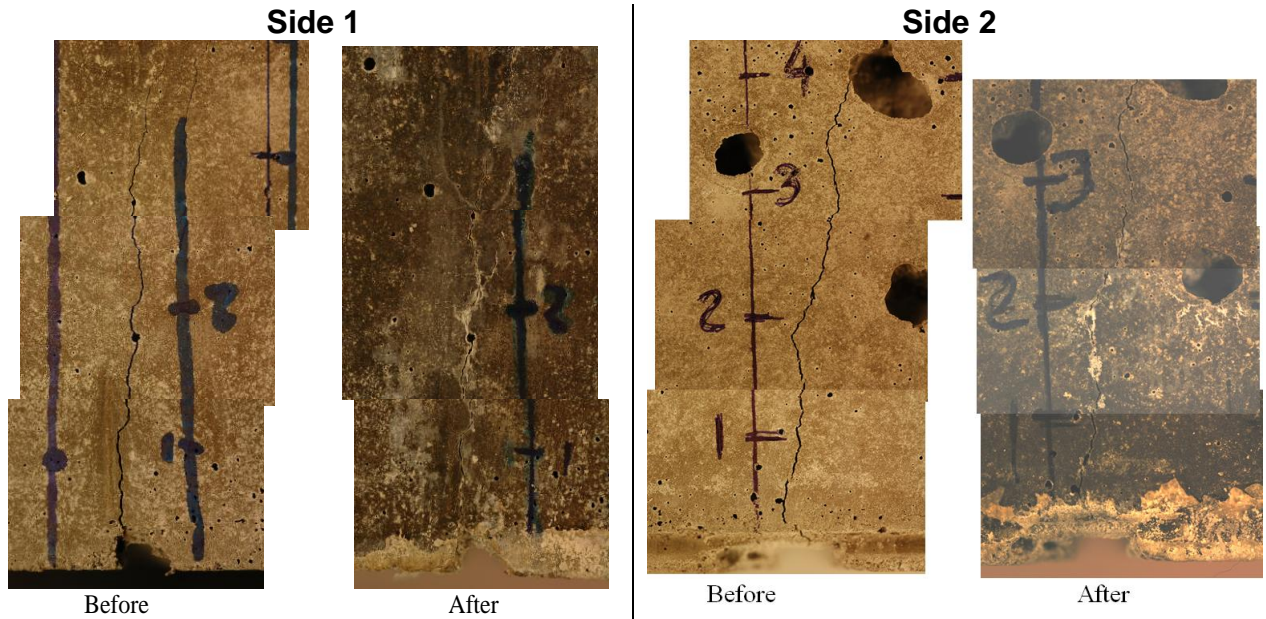
Figure A1.1: Permanently in sea water.

Crack width 0.2 mm. Cover 55 mm. Specimen H55-2-1-1

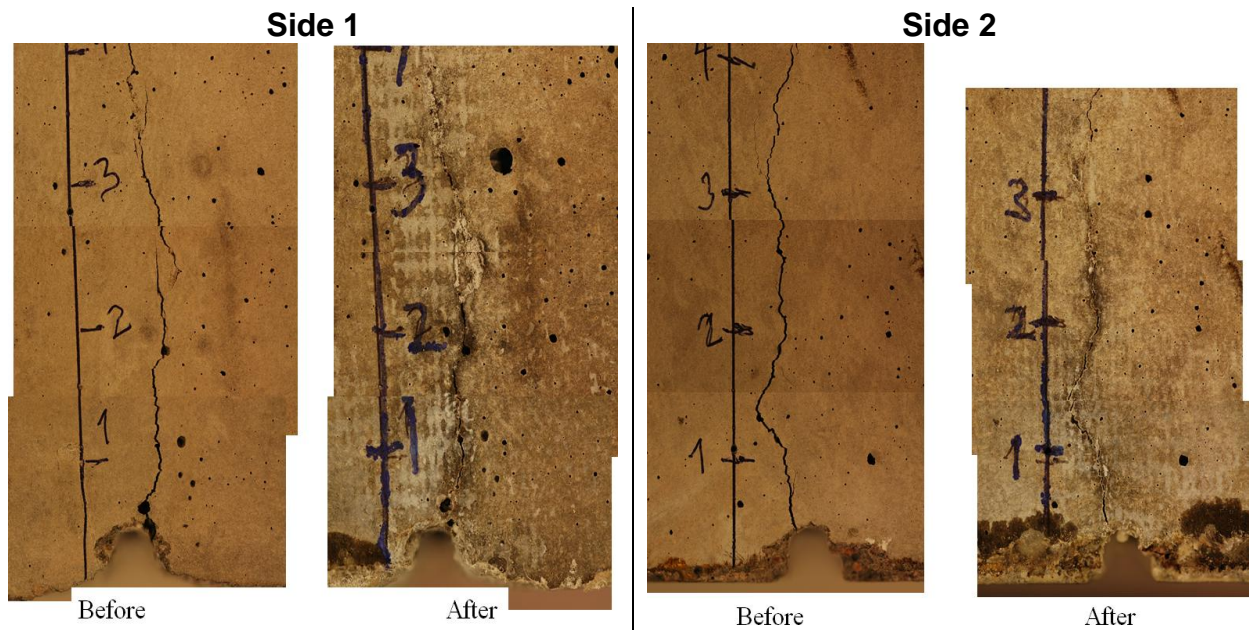
Figure A1.2: Permanently in sea water.

Crack width 0.2 mm. Cover 75 mm. Specimen H75-2-1-1

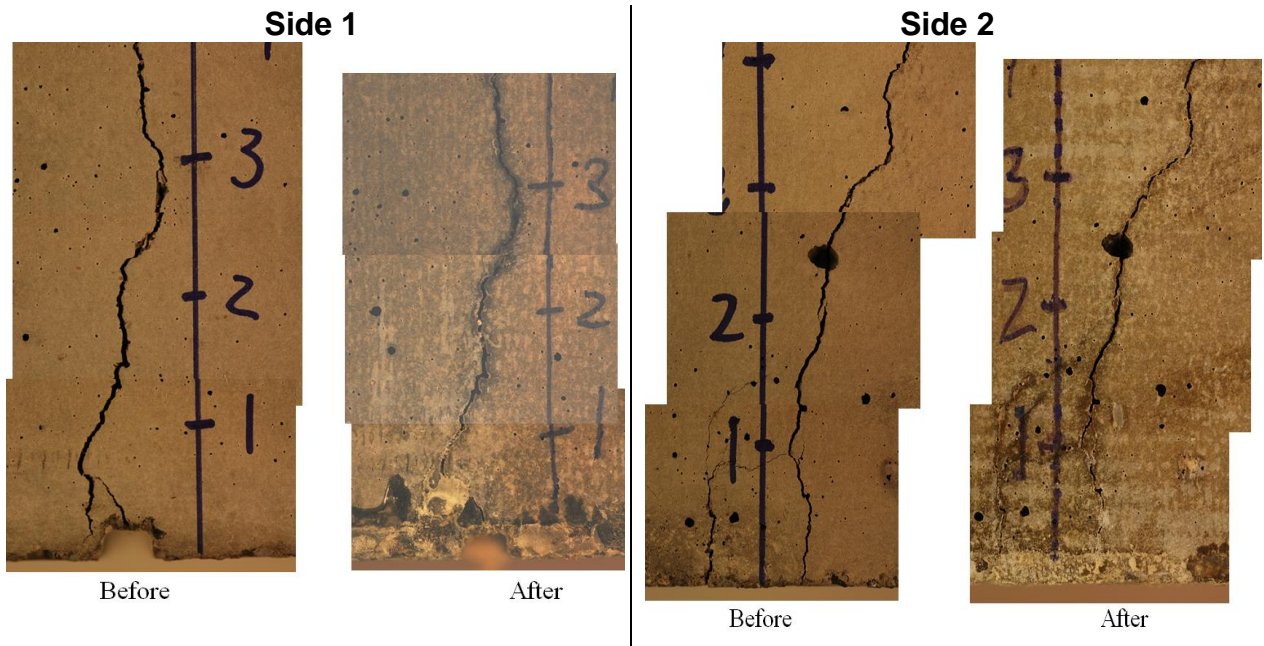
Figure A1.3: Permanently in sea water.
Crack width 0.4 mm. Cover 55 mm. Specimen H55-4-1-1

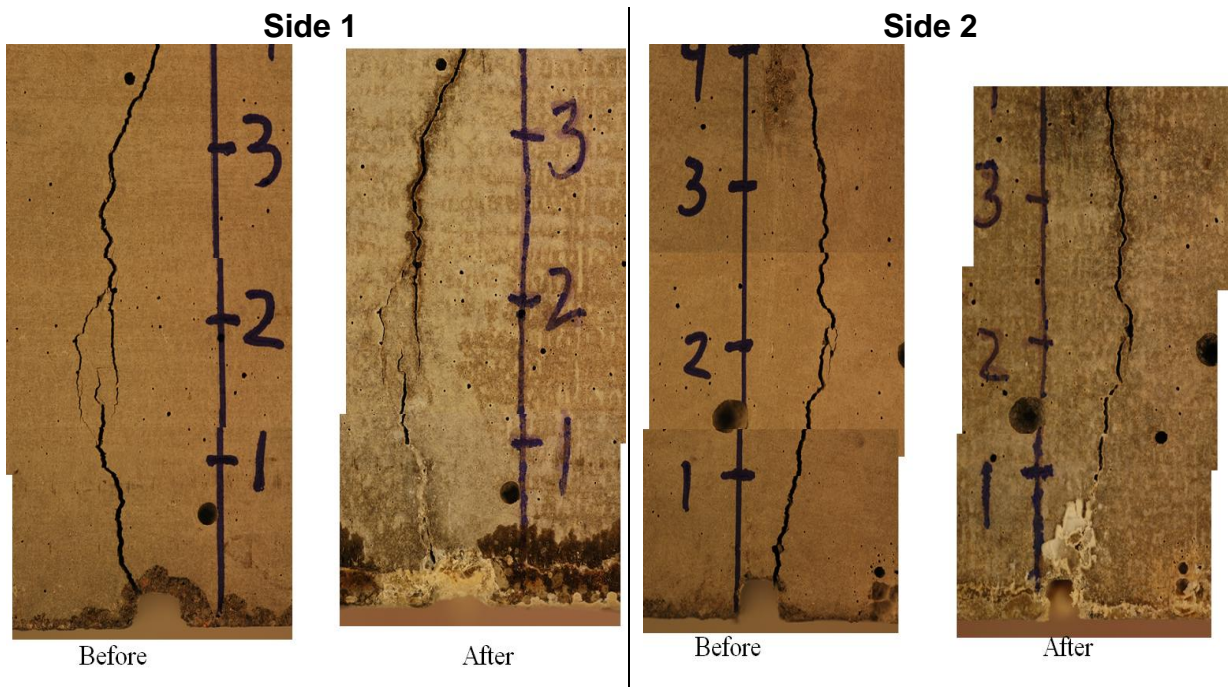
Figure A1.4: Permanently in sea water.
Crack width 0.4 mm. Cover 75 mm. Specimen H75-4-1-1

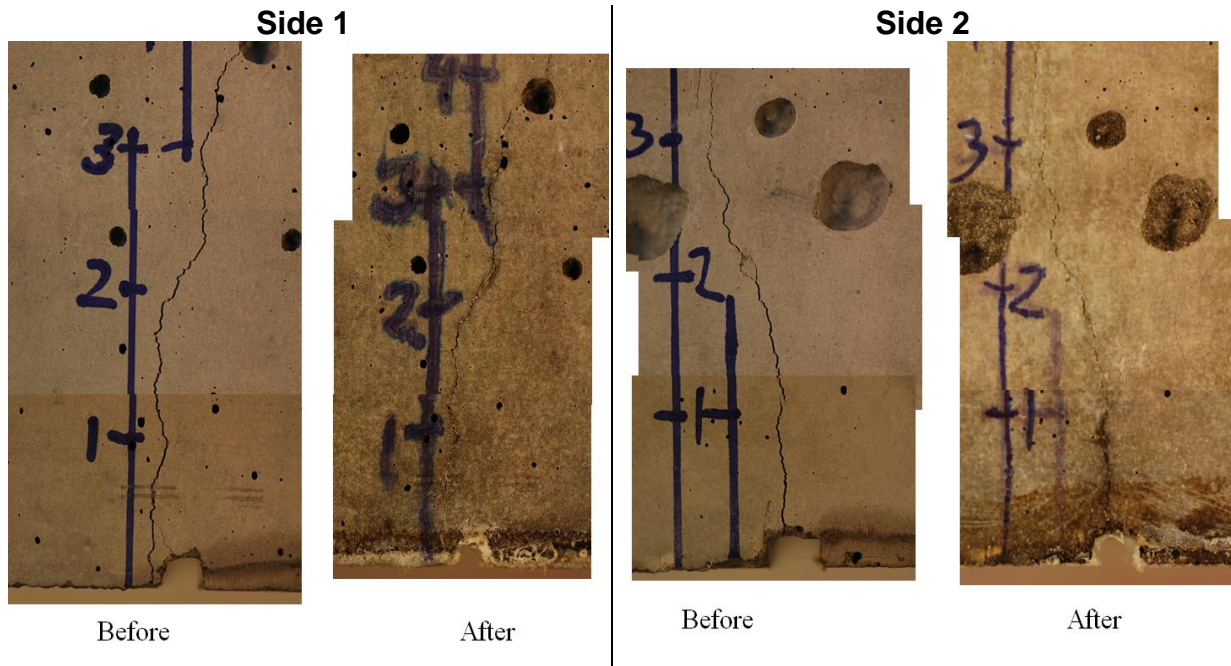
*Figure A1.5: Permanently in sea water. Relaxed crack.
Crack width 0.4 mm. Cover 55 mm. Specimen H55-4R-1-1*

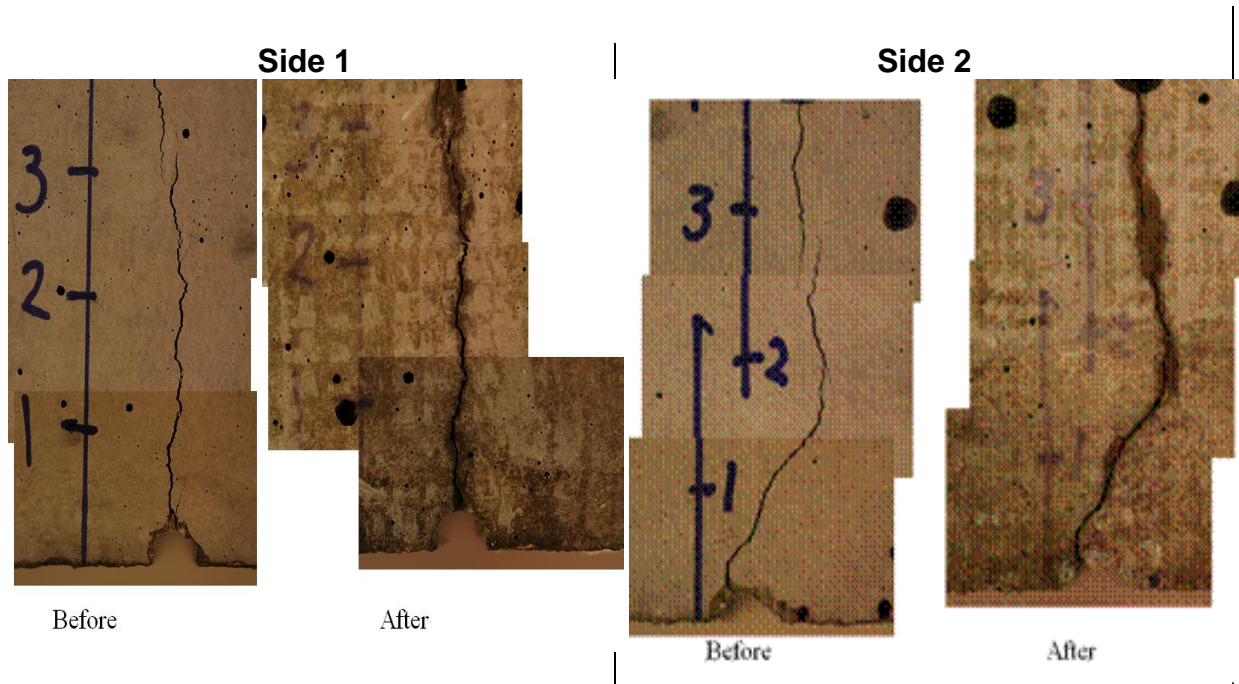
Figure A1.6: Permanently immersed in sea water. Sealed crack opening
Crack width 0.2 mm. Cover 75 mm. Specimen S275-2-1-1

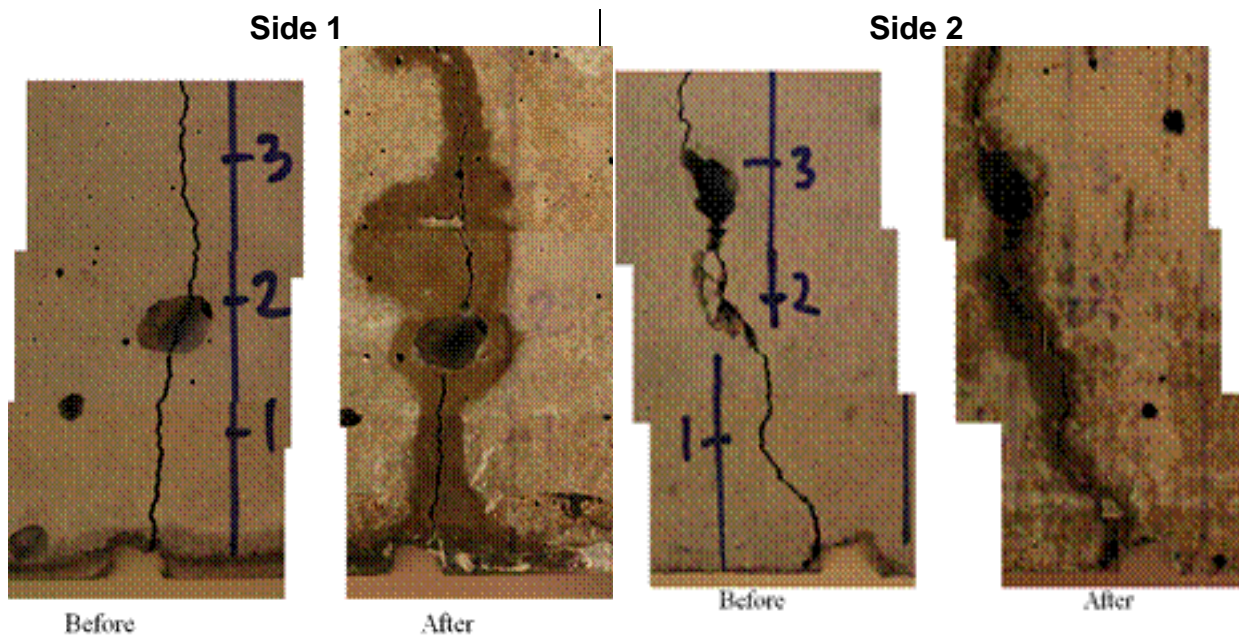
Figure A1.7: Permanently immersed in sea water. Sealed crack opening
Crack width 0.4 mm. Cover 75 mm. Specimen S275-4-1-1.

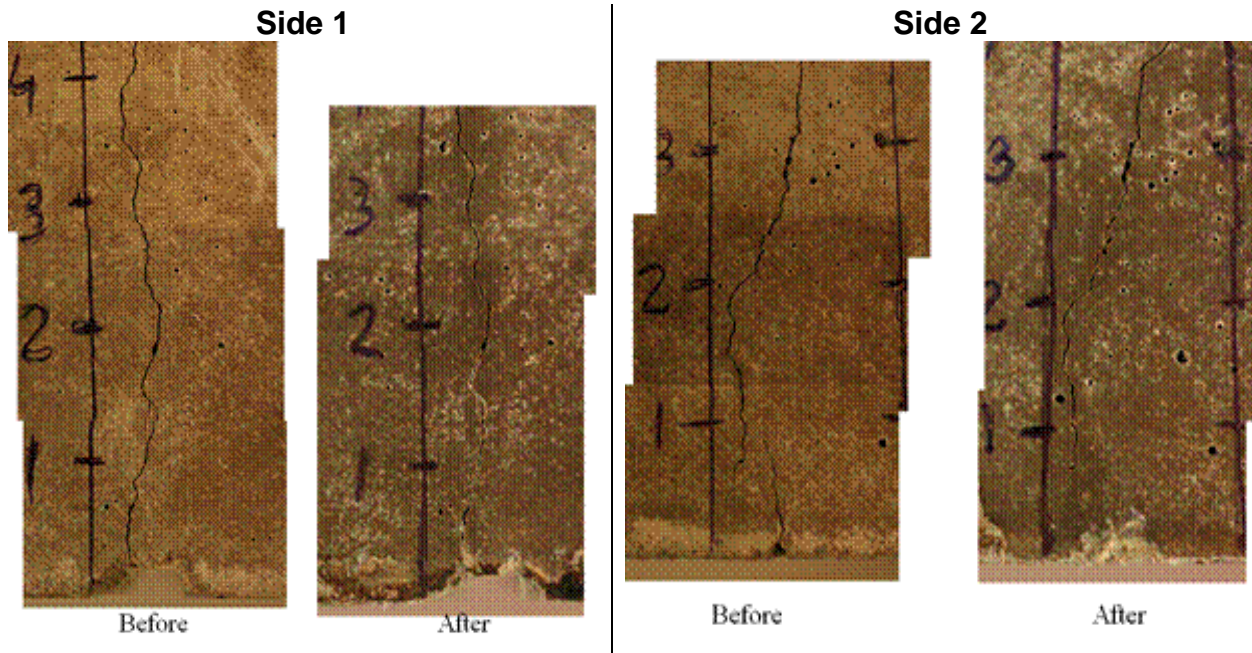
*Figure A1.8: Cyclic immersion in sea water and drying.
Crack width 0.2 mm. Cover 55 mm. Specimen H55-2-2-1.*

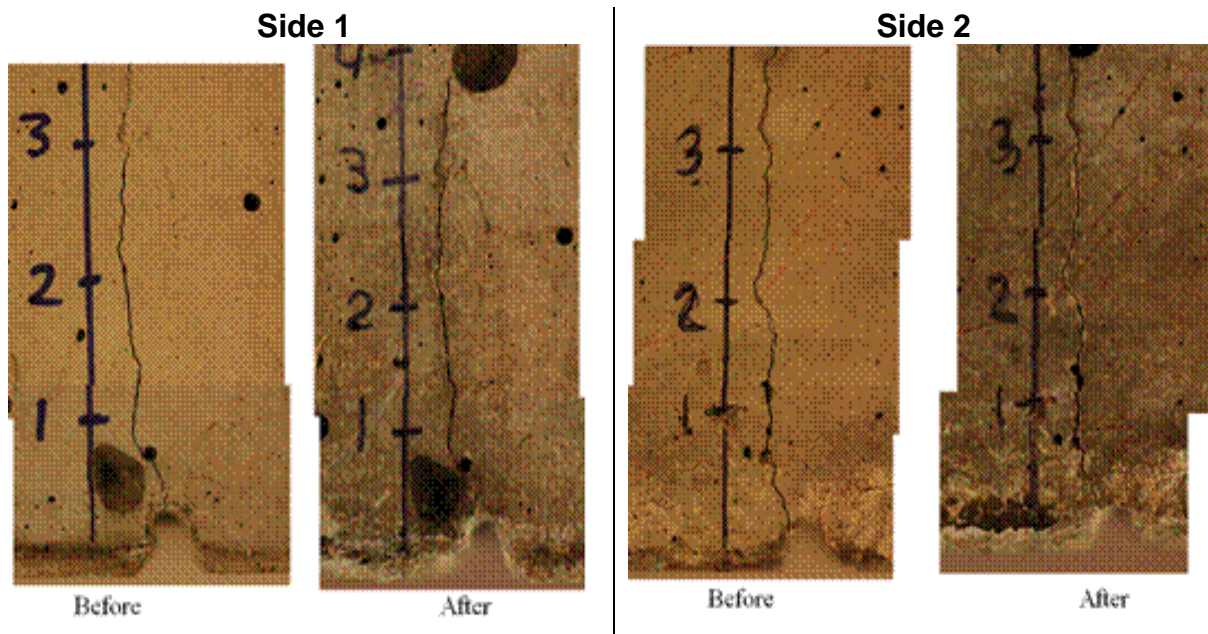
*Figure A1.9: Cyclic immersion in sea water and drying.
Crack width 0.2 mm. Cover 75 mm. Specimen H75-2-2-1.*

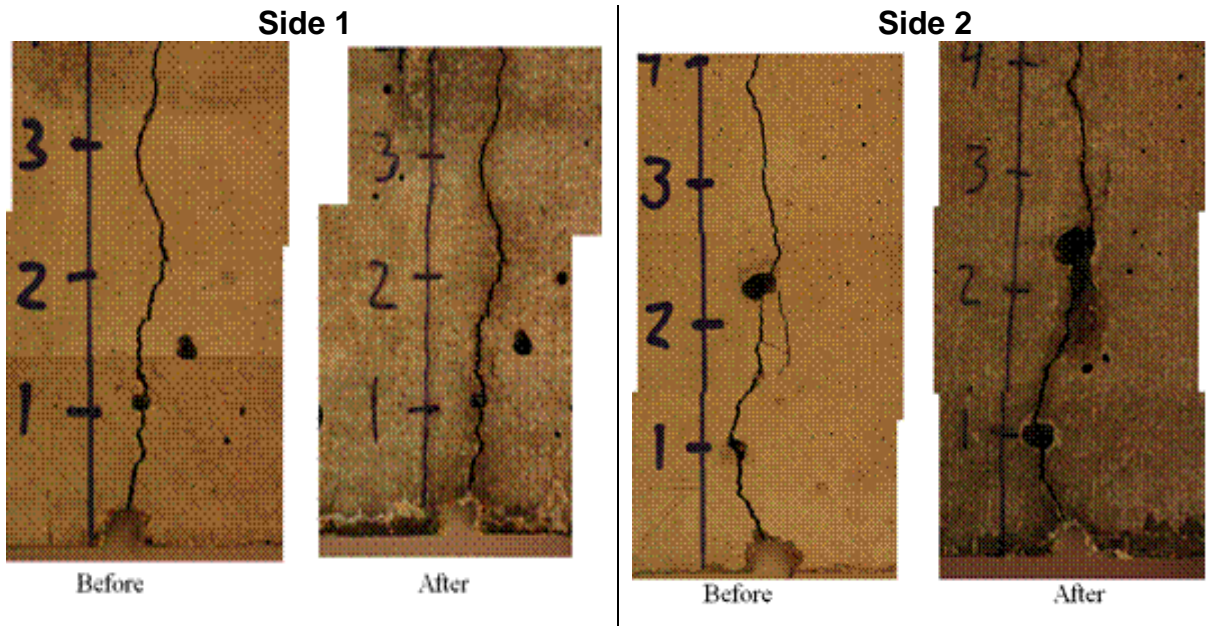
Figure A1.10: Cyclic immersion in sea water and drying.
Crack width 0.4 mm. Cover 55 mm. Specimen H55-4-2-1.

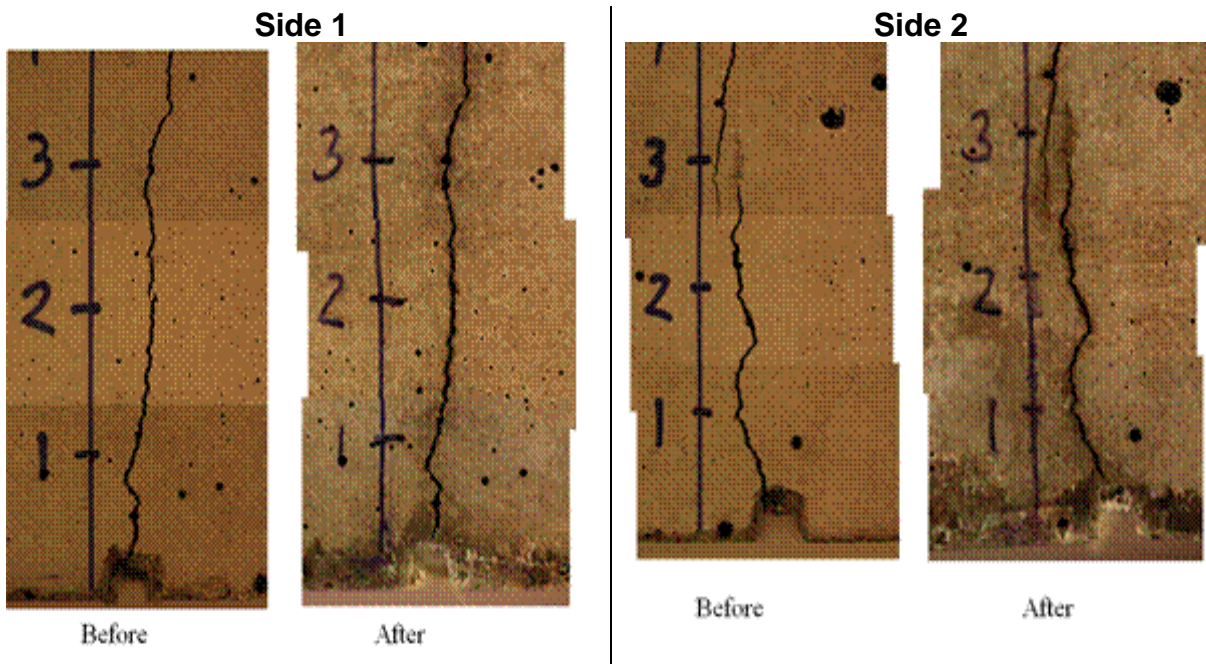
Figure A1.11: Cyclic immersion in sea water and drying.
Crack width 0.4 mm. Cover 75 mm. Specimen H75-4-2-1.

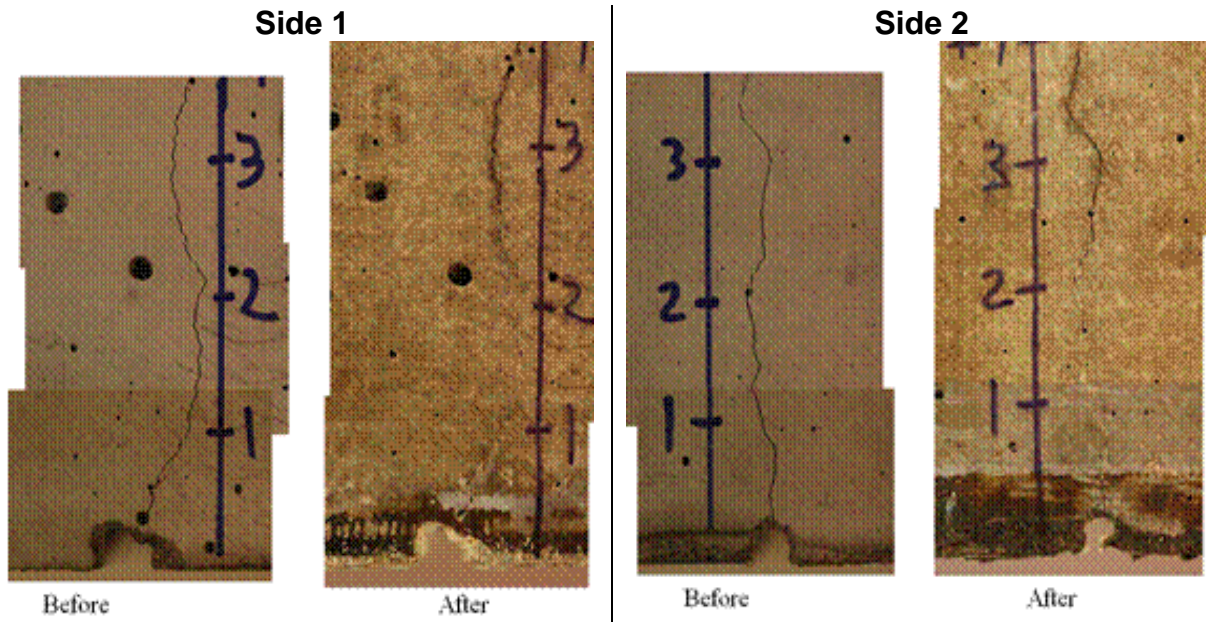
*Figure A1.12: Cyclic immersion in sea water and drying. Relaxed crack.
Crack width 0.4 mm. Cover 55 mm. Specimen H55-4R-2-1.*

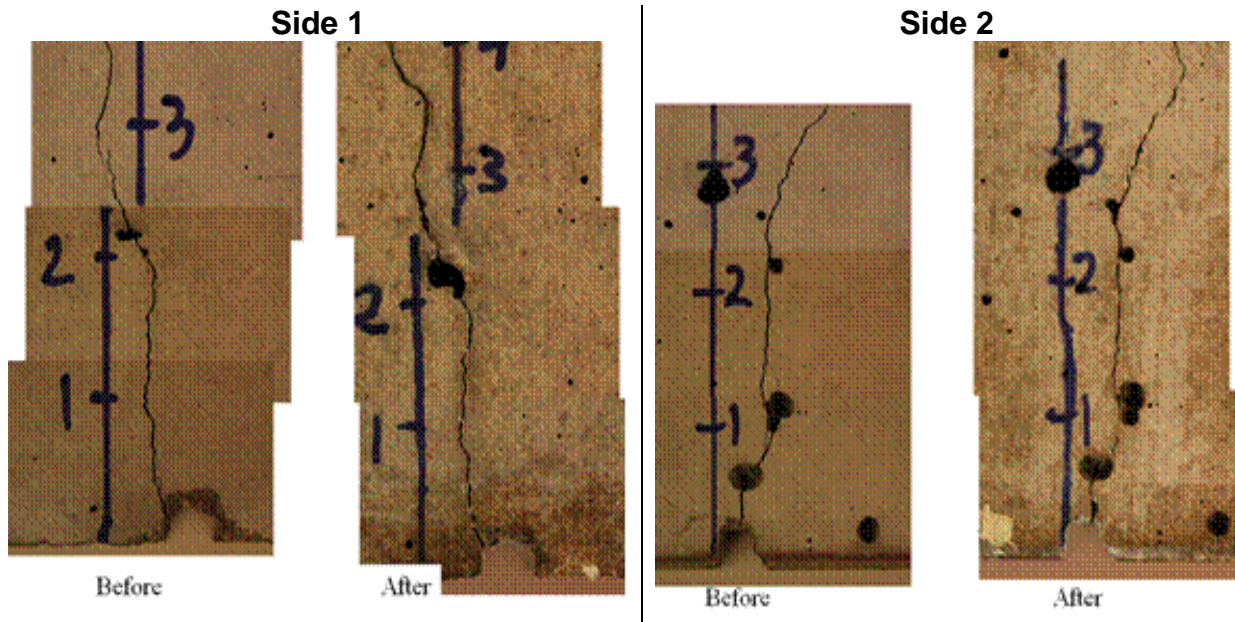
Figure A1.13: Cyclic immersion in sea water and drying. Sealed crack opening.
Crack width 0.2 mm. Cover 75 mm. Specimen S275-2-2-1.

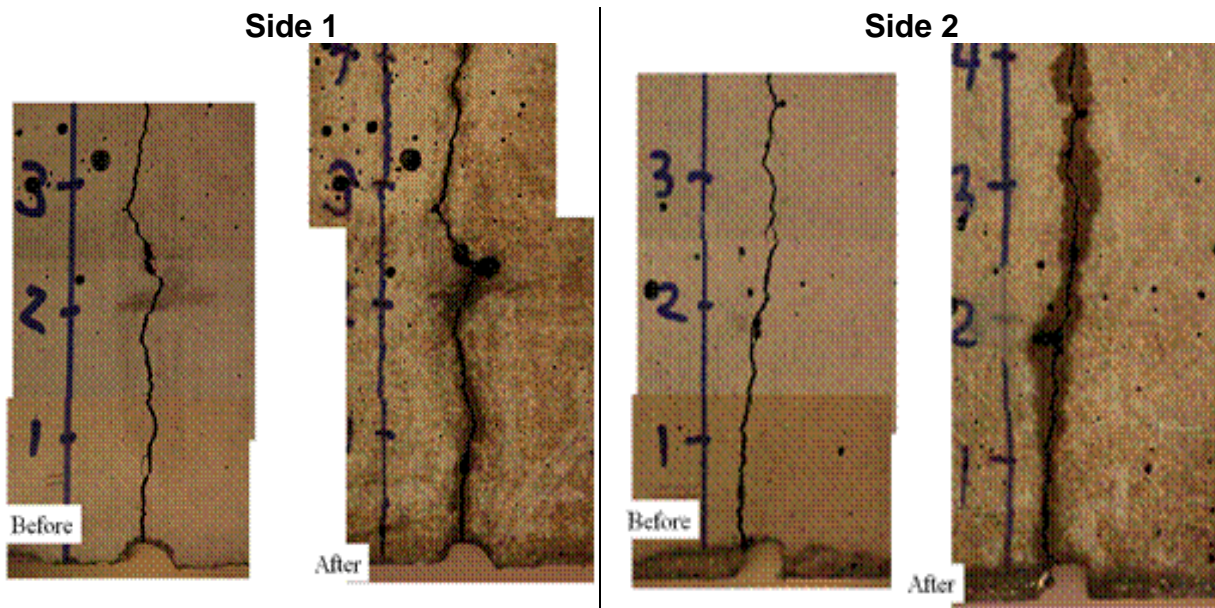
Figure A1.14: Cyclic immersion in sea water and drying. Sealed crack opening.
Crack width 0.4 mm. Cover 75 mm. Specimen S275-4-2-1.

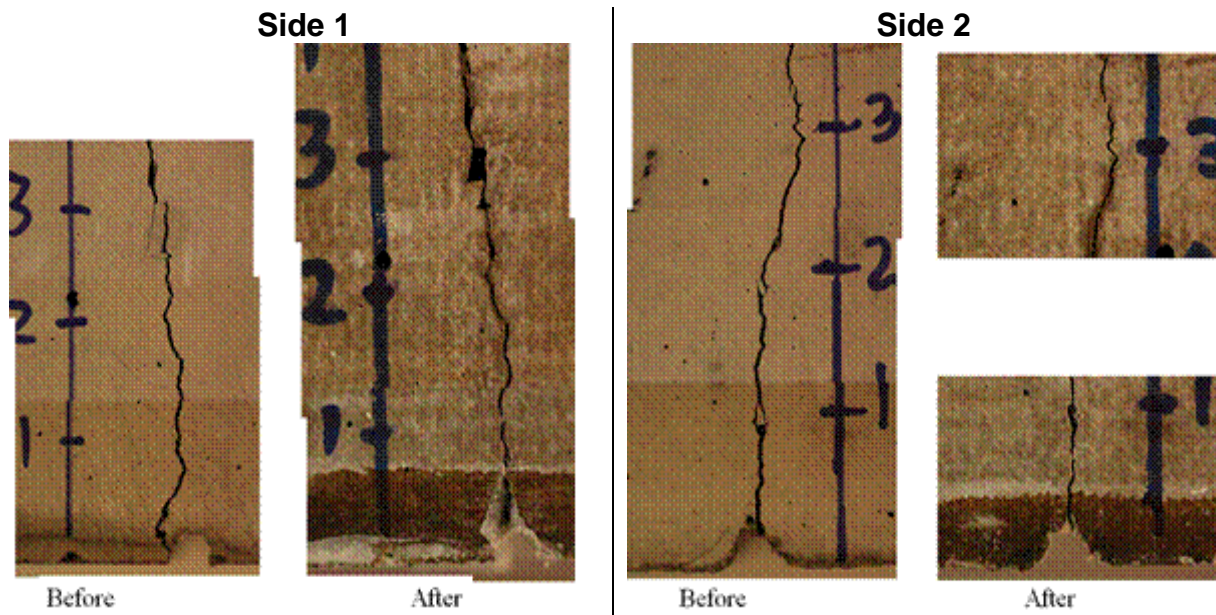
Figure A1.15: Permanently immersed in brackish water
Crack width 0.4 mm. Cover 55 mm. Specimen S155-4-1-1-Ö.

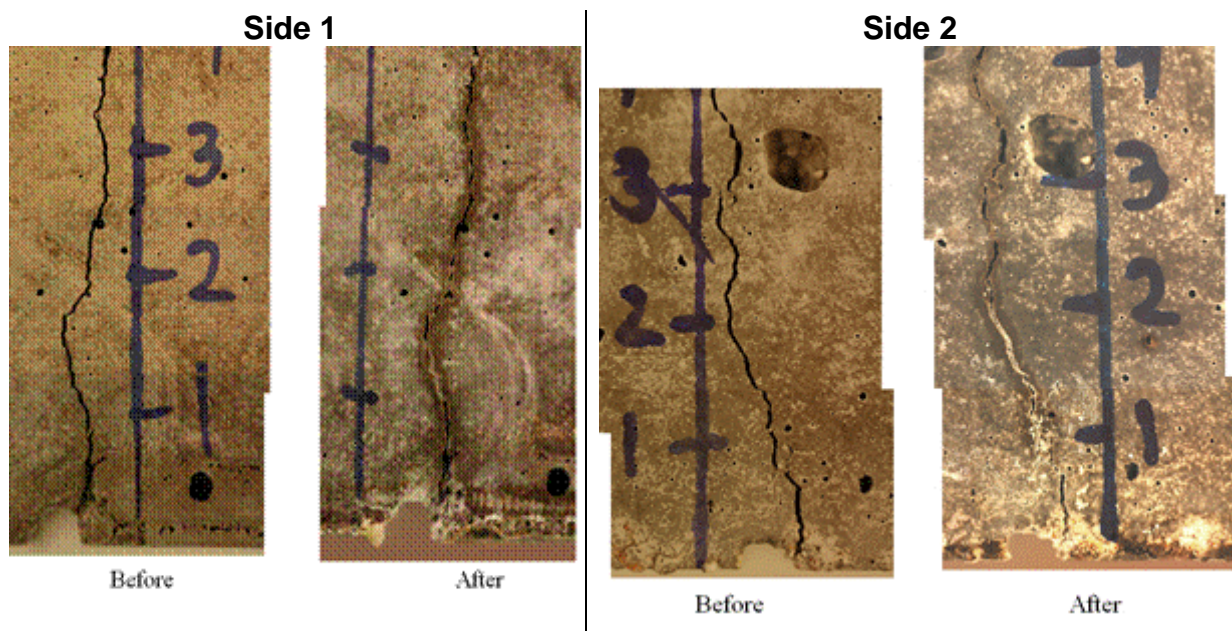
Figure A1.16: Permanently immersed in brackish water
Crack width 0.4 mm. Cover 75 mm. Specimen S175-4-1-1-Ö.

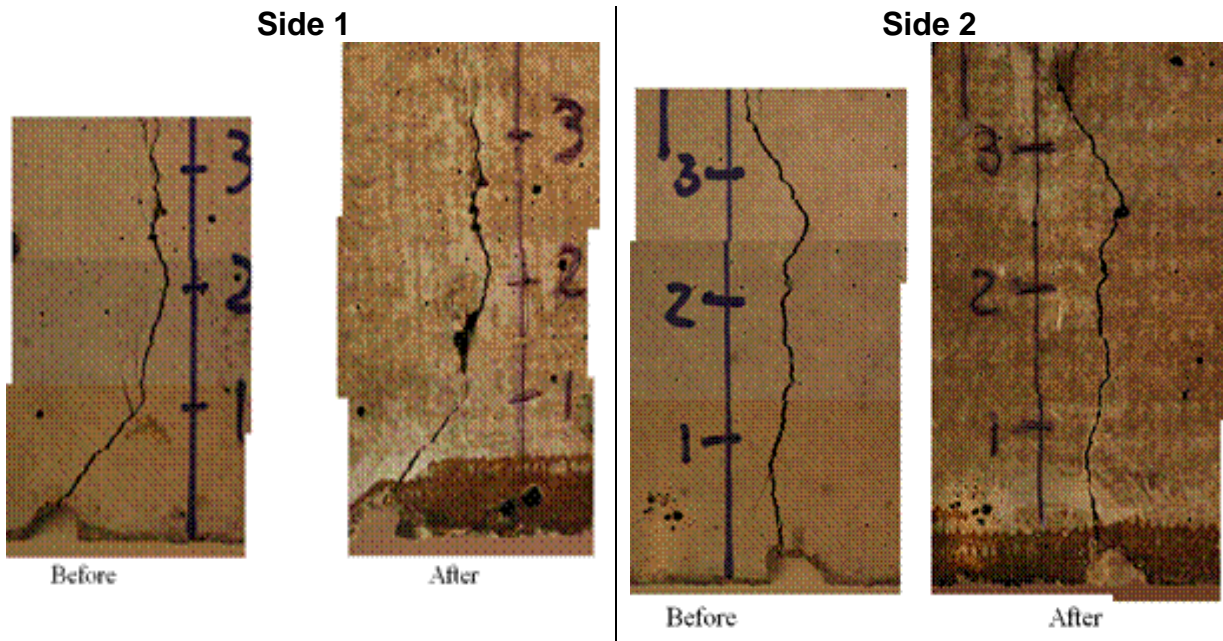
Figure A1.17: Permanently immersed in tap water
Crack width 0.4 mm. Cover 55 mm. Specimen S155-4-1-1-R.

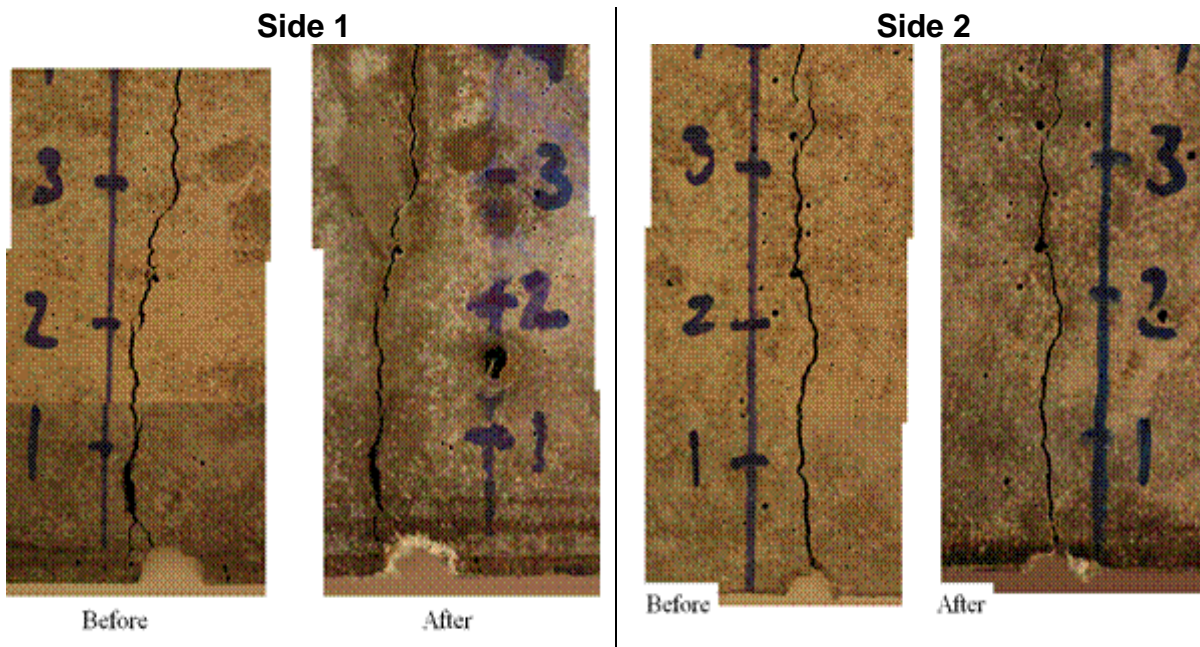
Figure A1.18: Permanently immersed in tap water
Crack width 0.0157 in. Cover 75 mm. Specimen S175-4-1-1-R.

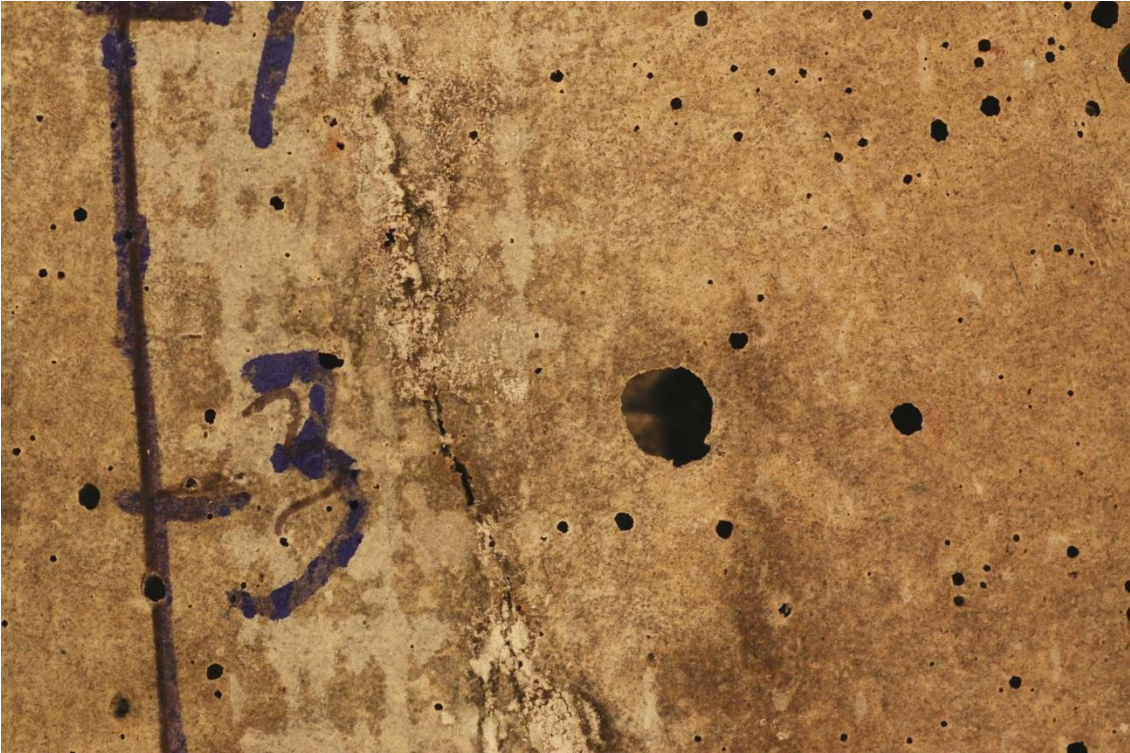
*Figure A2.1: 0.2 mm crack after 1 year permanent immersion in sea water.
Test series 1, specimen H75-2-1-1.*

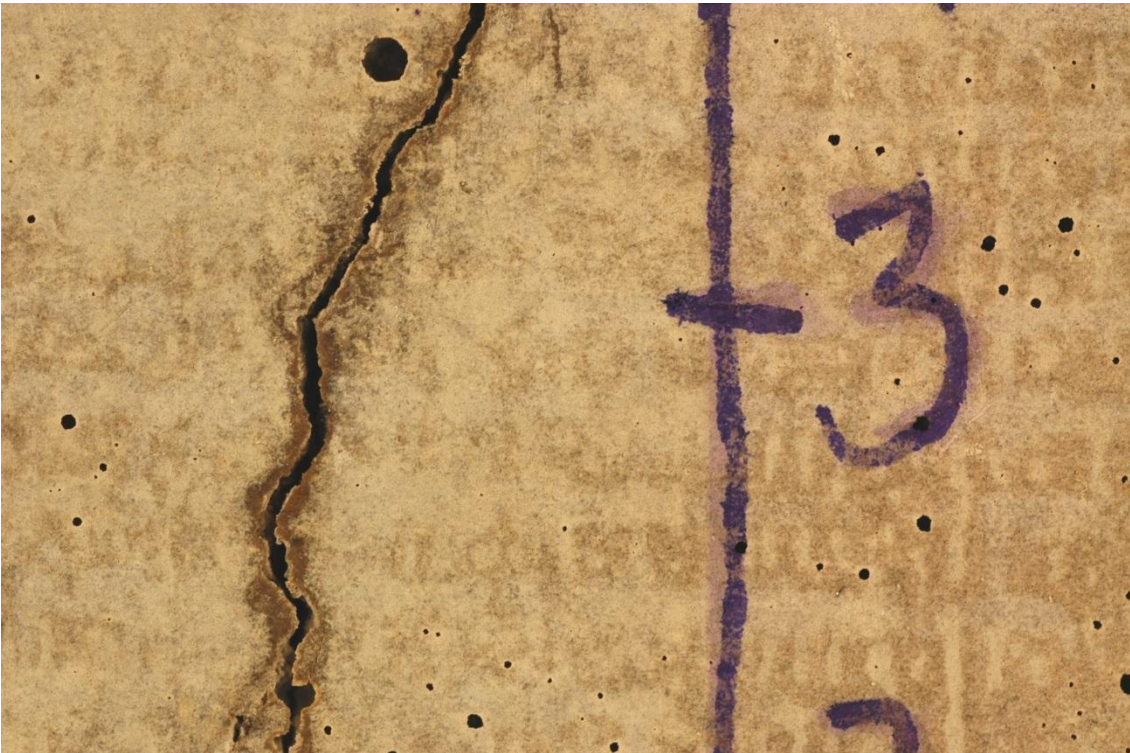
*Figure A2.2: 0.4 mm crack after 1 year permanent immersion in sea water.
Test series 1, specimen H75-4-1-1.*

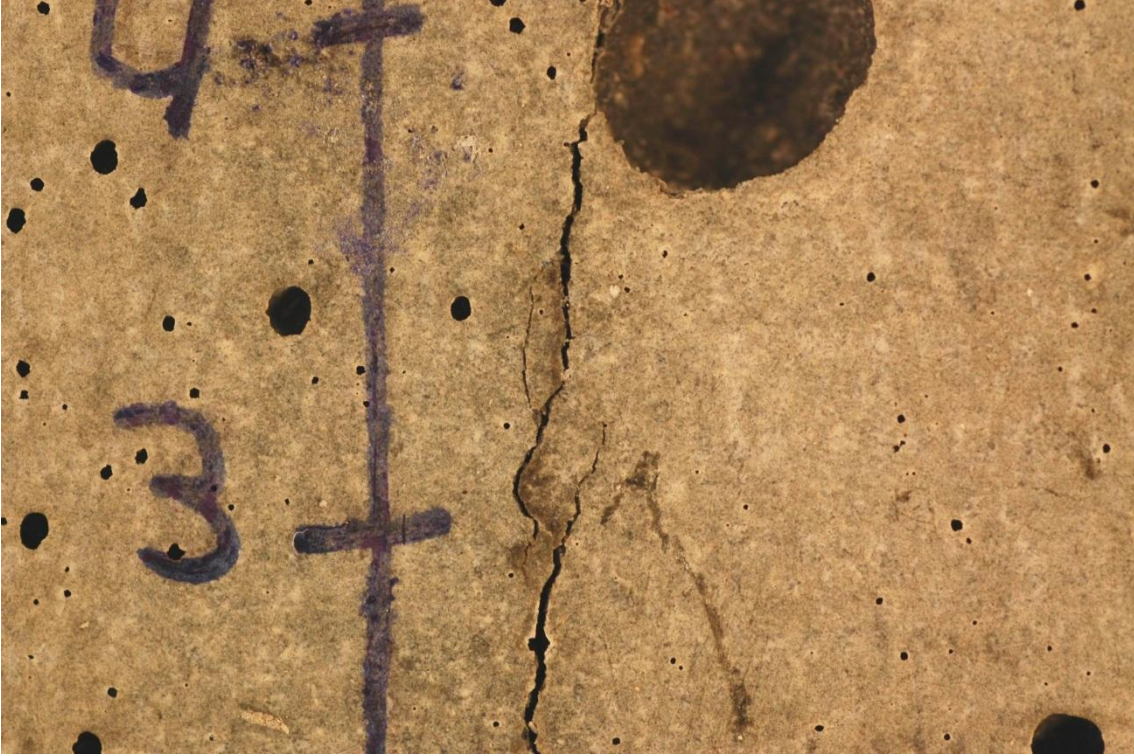
*Figure A2.3: 0.2 mm crack after 1 year cyclic immersion in sea water and drying.
Test series 1, specimen H75-2-2-1.*

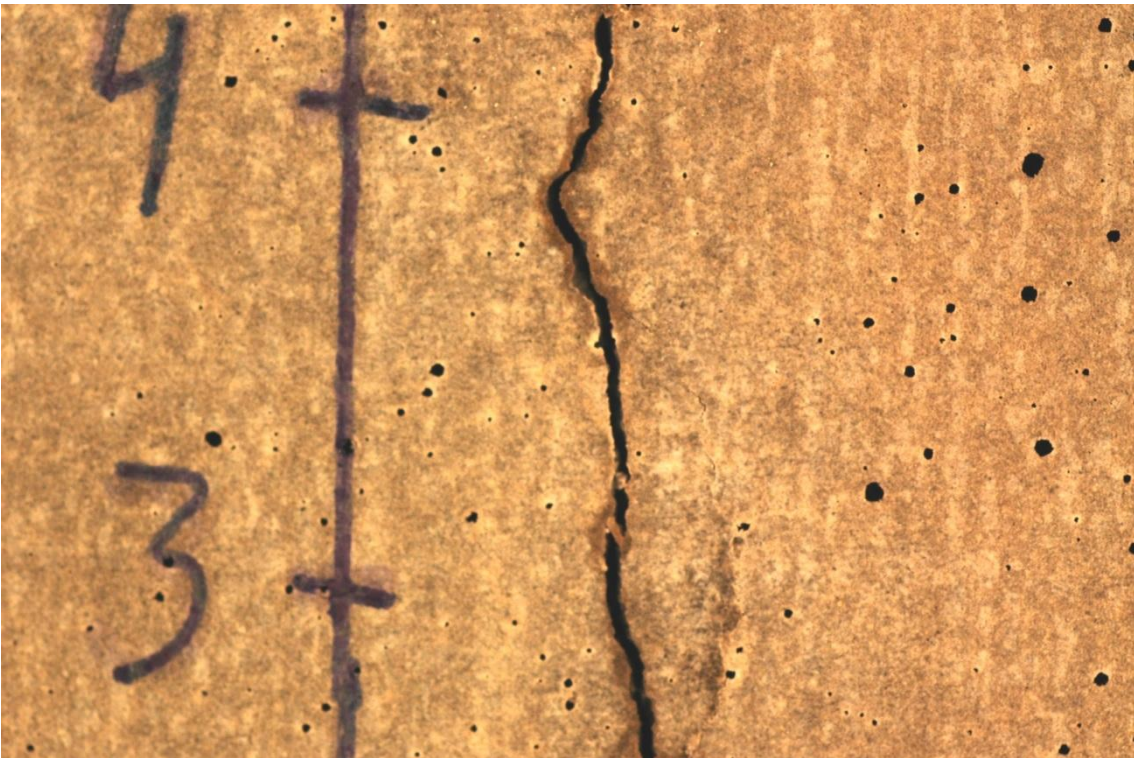
*Figure A2.4: 0.4 mm crack after 1 year cyclic immersion in sea water and drying.
Test series 1, specimen H75-4-2-1.*

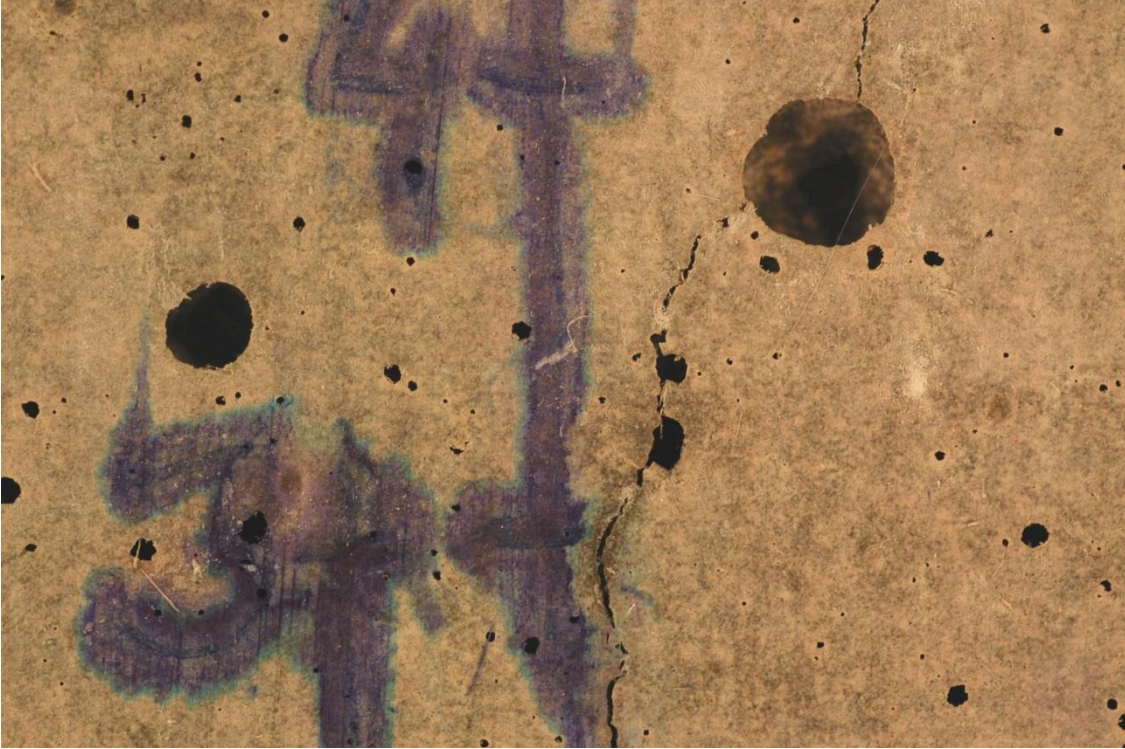
*Figure A2.5: 0.4 mm relaxed crack after 1 year permanent immersion in sea water.
Test series 1, specimen H55-4R-1-1.*

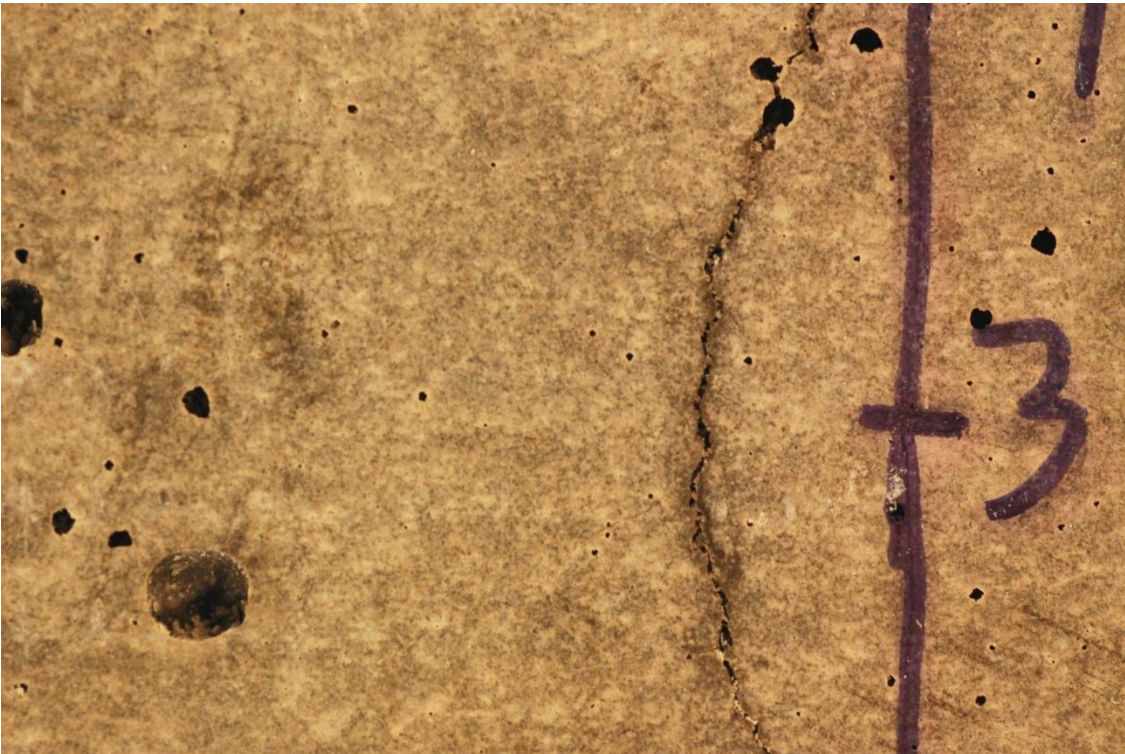
*Figure A2.6: 0.4 mm relaxed crack after 1 year cyclic immersion in sea water and drying.
Test series 1, specimen H55-4R-2-1.*

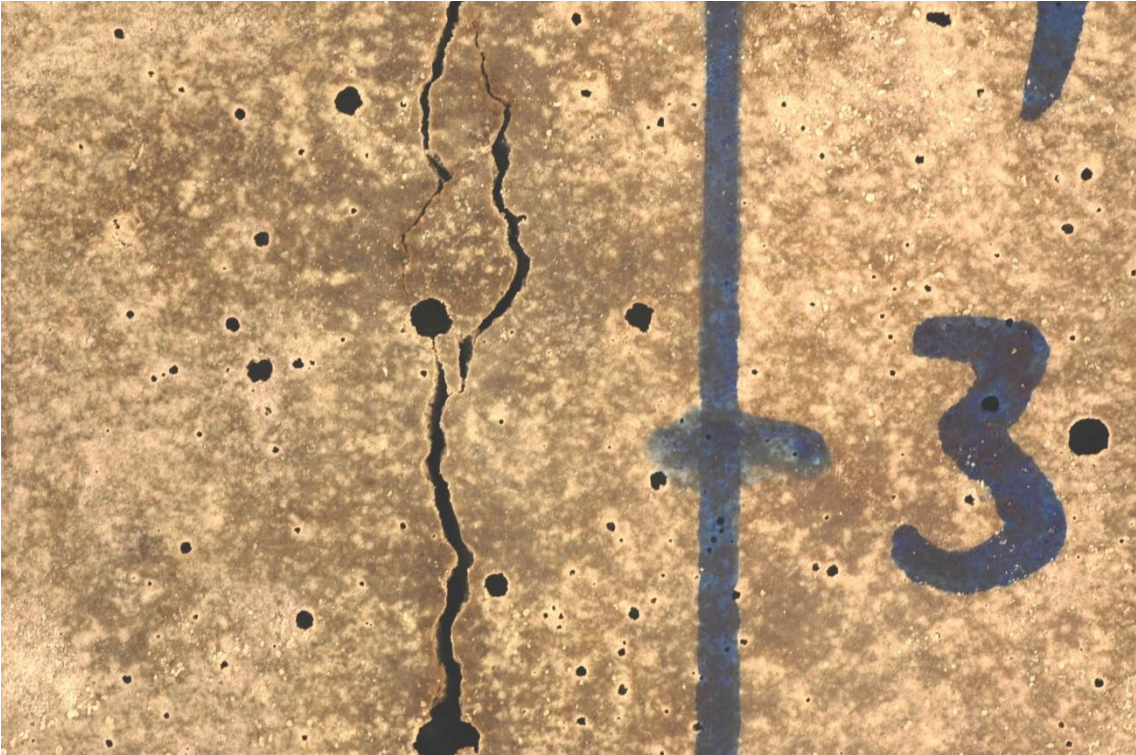
*Figure A2.7: 0.4 mm crack after 1 year permanent immersion in pure water.
Test series 3, specimen S175-4-1-1-R.*
