Self-healing of cracks in concrete long-term exposed to different types of water : results after 1 year exposure

SELF-HEALING OF CRACKS IN CONCRETE LONG-TERM EXPOSED TO DIFFERENT TYPES OF WATER

Results after 1 year exposure

ISRN LUTVDG/TVBM--09/3156--SE(1-58)
ISSN 0348-7911 TVBM

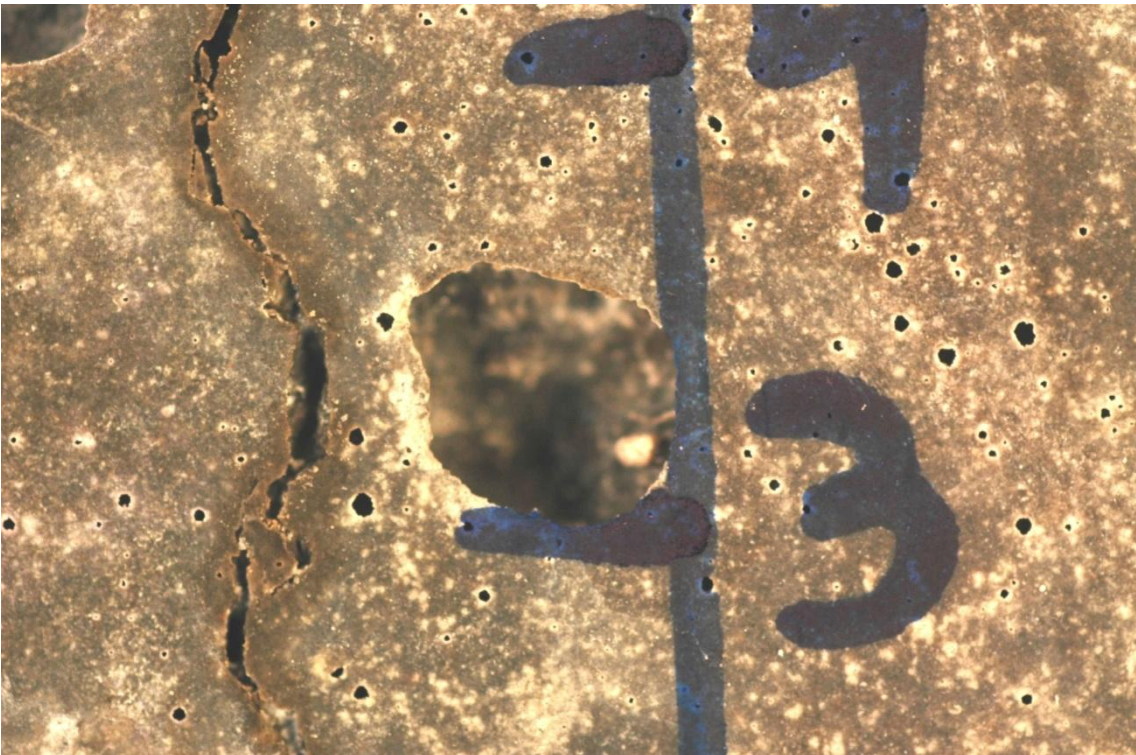
*Figure A2.8: 0.4 mm crack after 1 year permanent immersion in brackish water.
Test series 2, specimen S175-4-1-1-Ö.*

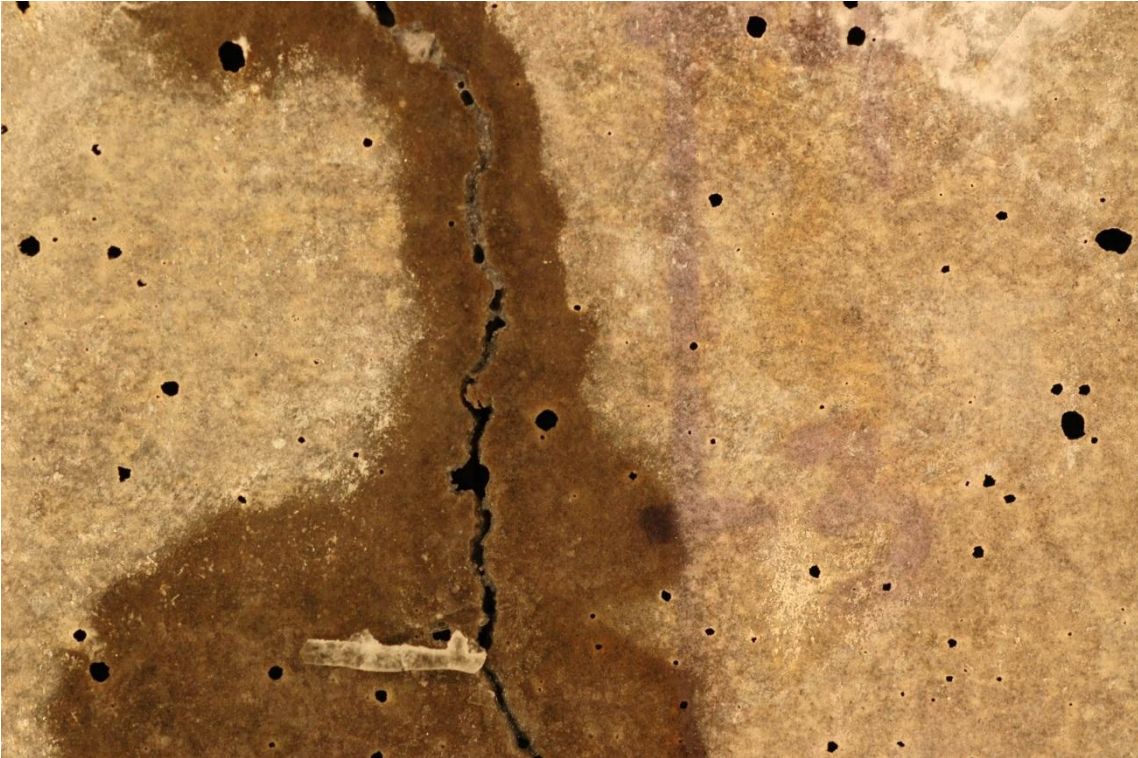
*Figure A2.9: 0.4 mm sealed crack after 1 year permanent immersion in sea water.
Test series 5, specimen S275-4-1-1.*

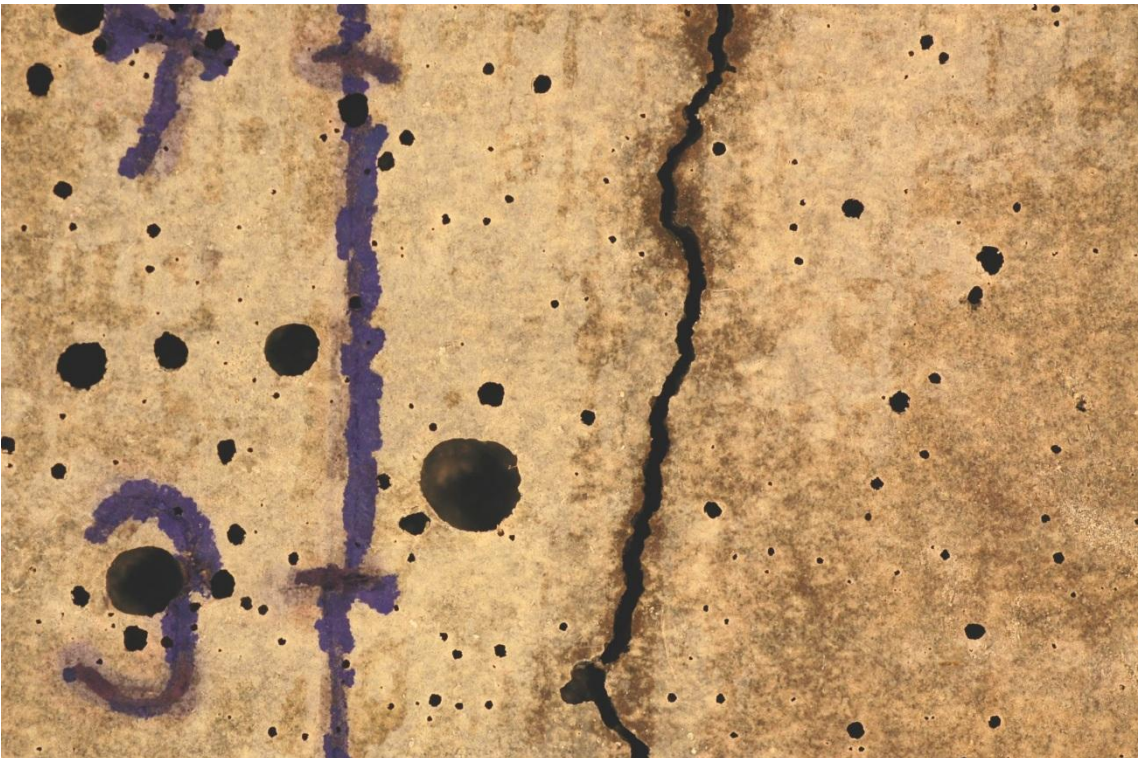
*Figure A2.10: 0.4 mm sealed crack after 1 year cyclic immersion in sea water and drying.
Test series 5, specimen S275-4-2-1.*
