Catastrophic failure of an uncemented acetabular component due to high wear and osteolysis

An analysis of 154 Omnifit prostheses with mean 6-year follow-up

Thord von Schewelov, Lennart Sanzén, Ingemar Önsten and Åke Carlsson

Department of Orthopedics, Malmö University Hospital, SE-205 02 Malmö, Sweden

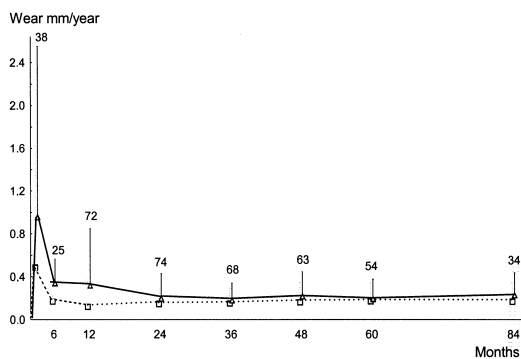
Figure 5. RSA annual wear in mm. Wear along the longitudinal axis (red, signed values). Total vector wear (blue). Whiskers represent 1 SD. The number of measured cases after each time interval is given above each whisker.

At the last follow-up investigation (mean 64 months, $n = 78$), the mean wear along the longitudinal axis (Y) was 0.90 (–1.04–5.89) mm and the total vector wear was 1.22 (0.09–6.08) mm. The annual total vector wear was 0.22 (0.02–0.88) mm/year (Figures 4 and 5).

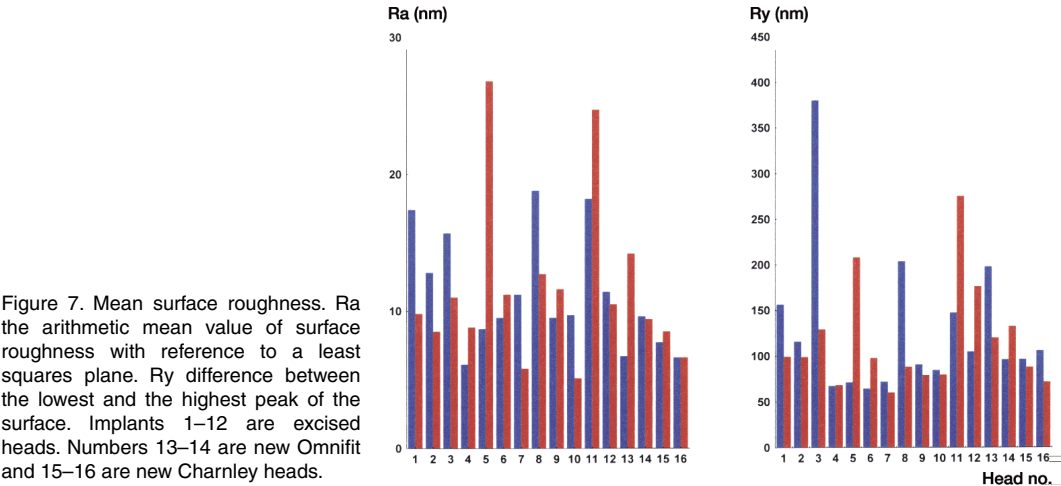
Figure 7. Mean surface roughness. Ra the arithmetic mean value of surface roughness with reference to a least squares plane. Ry difference between the lowest and the highest peak of the surface. Implants 1–12 are excised heads. Numbers 13–14 are new Omnifit and 15–16 are new Charnley heads.

In unused Omnifit and Charnley Elite femoral heads there was no difference regarding the surface roughness (Ra) (Figure 7), although SEM and AFM demonstrated a difference in surface texture. The Omnifit heads were characterized by polishing marks that were not as prominent on the Charnley heads. The Charnley heads were instead characterized by small holes. The EDAX analysis revealed particles of cobalt, chrome, iron and aluminum on both types of heads. Aluminum particles were probably remnants from the polishing process. Titanium particles were found on one Omnifit head.

Although microscopically undamaged areas on the excised Omnifit heads were selected, structural changes were present at the nanometer level (Figure 7). The profile analysis of the excised

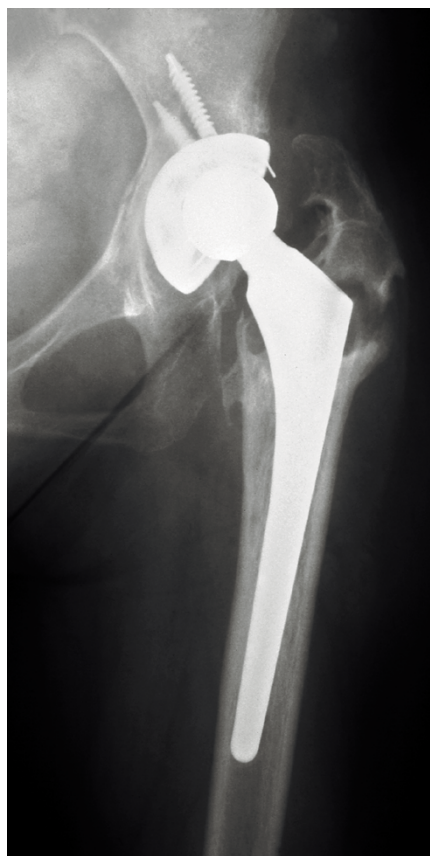
Figure 8. 11 years postoperatively, showing massive osteolysis in the pelvis and trochanter. The tip of the trochanter has fractured spontaneously.

In severe cases, the osteolysis had also advanced 1–2 cm down the proximal femur and also into the greater trochanter. The trochanter may even be transformed into a cyst-like formation with very thin walls, which may fracture (Figure 8). In our experience, the femoral osteolytic processes should be curetted and filled with morselized allografts, leaving the stem in place, whereas the cups should be exchanged and the defects packed with morselized allografts.
