A Risk Analysis Framework for
Maritime Transport of Packaged Dangerous Goods
– A Validating Demonstration

VOLUME II

Arben Mullai

Department of Industrial Management and Logistics
Engineering Logistics
Lund University

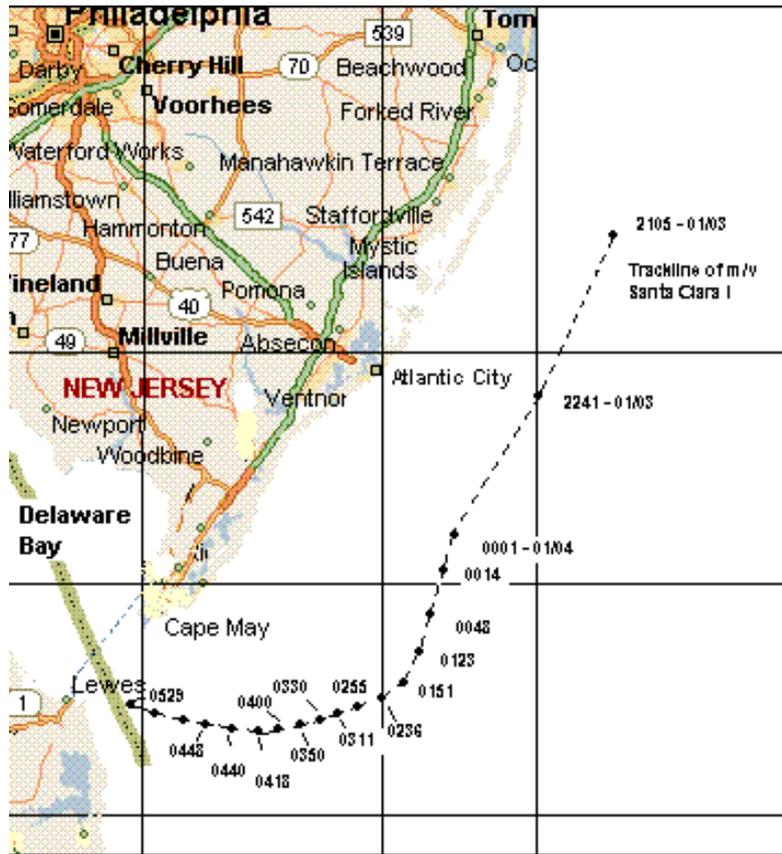
Figure 2.15: The trackline of the m/v “Santa Clara I” (map from Microsoft Corporation, 2005 and U.S. DOT, 1992)

At 1517 hrs, on January 3rd, the ship left her berth with docking and Sandy Hook pilots aboard. Under the supervision of the bosun, the crew began lashing/securing cargo and containers on deck at the no.1, 2 and 3 hatches and inside the no.3 hold. At 1740 hrs, the Sand Hook pilot disembarked. By this time, it was dark. The crew reported that they had completed cargo securing. However, according to the pilot’s memory, he never saw any on-deck cargo lashing activity while he was aboard (U.S. DOT, 1992). The ship headed towards the port of destination (Port Baltimore), setting a course of about 180° with a speed of 12-14 knots. Figure 2.15 shows the m/v SCI trackline – the times and respective positions on January 3rd and 4th.

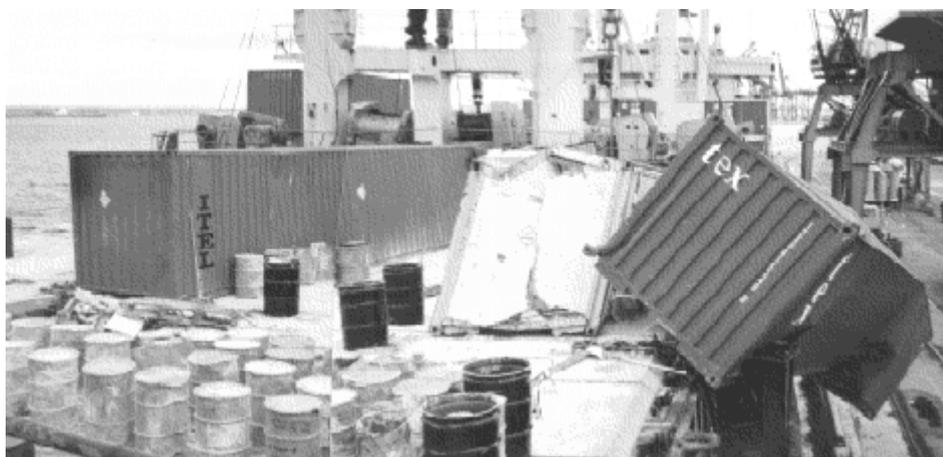
Figure 2.16: Damaged container on the no. 2 hatch cover of the m/v SCI on arrival in Port Baltimore (U.S. DOT, 1992)

At 0603 hrs, on January 4th, the ship arrived at Delaware Bay and took the pilot onboard. The pilot reported that a container was hanging over the portside bulwark at the no.2 hatch (Figure 2.16). The chief mate and crewmembers inspected the cargo on deck, and found only four containers remaining aboard on the no.2 hatch, two of which with arsenic trioxide drums; all had shifted from their stowed positions and been damaged. All six on-deck-stowed arsenic trioxide containers broke loose and opened up during the storm. Four of these containers were lost overboard entirely. Several blue drums were scattered, damaged and spilled their white powder contents on the deck and hatch cover. By looking at drums (which were labelled) and with reference to the IMDG Code, the master confirmed that they contained arsenic trioxide. Arsenic trioxide is a poisonous substance presenting hazards by inhalation and ingestion. It was also designated a "marine pollutant" in the IMDG Code (1990). The master ordered all personnel off the deck until the ship arrived at Port Baltimore.

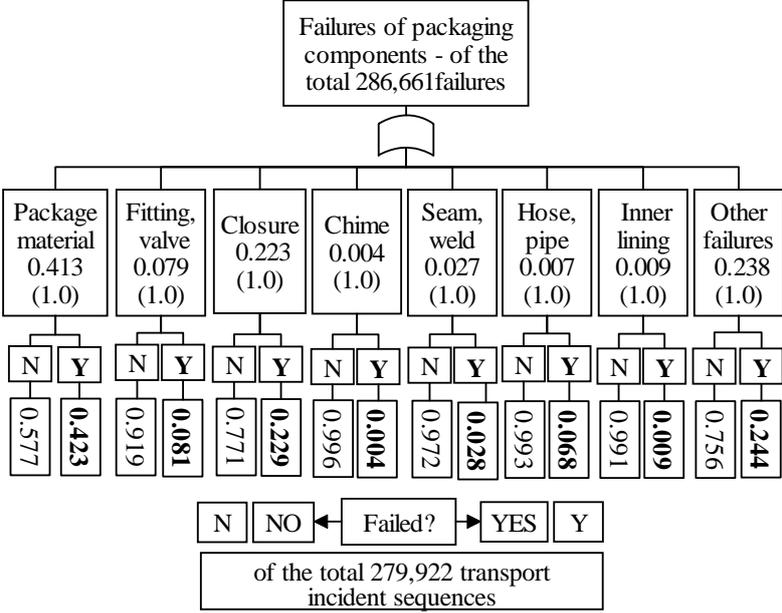
Figure 3.9: Fault tree of packaging components damage/failures (U.S. 1993-2004)

hazards (e.g. mechanical forces); d) operational or handling errors (e.g. overflow during loading and unloading); and e) defective devices or equipment (e.g. valve and closure).

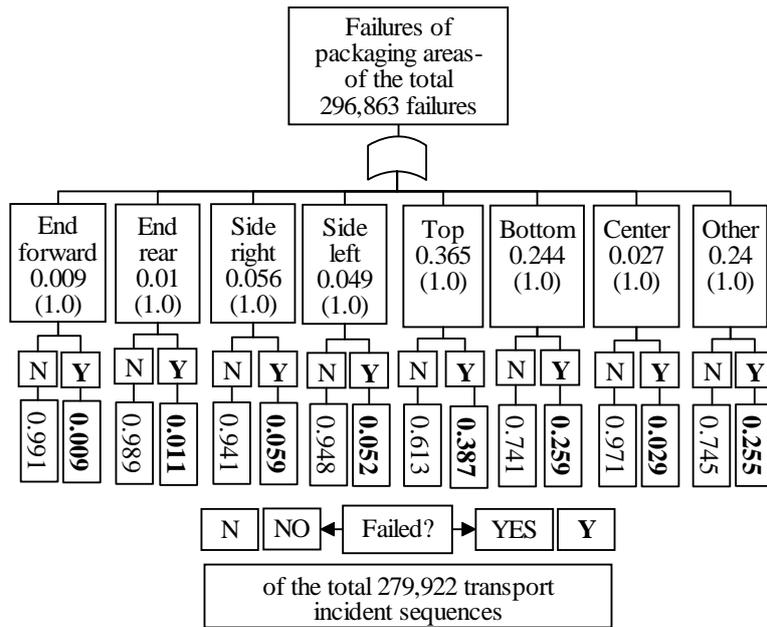
Figure 3.10: Fault tree of packaging damage/failure areas (U.S. 1993-2004)

HMIS database (U.S. 1993-2004): A package consists of a number of areas (Figure 3.10). The weakest and/or the most vulnerable areas (e.g. containers and other CTUs) to transport hazards have been reported: *top* (36.5%), *bottom* (24.4%) and *sides* (left and right) (10.5%) (Figure 3.10). The combined damage/failures in top and bottom areas constituted approx. 60% of all reported damage/failures (296,863). Both these two areas have shown higher probabilities of being damaged or failing than other areas. In many cases (24%), packages have been damaged or failed in between the areas shown in Figure 3.10 and other areas. Packages have often been completely destroyed. They have experienced damage/failures in one or combinations of the areas shown in Figure 3.10. On the average, every sequence of transport incidents (in total 279,922) has been associated with 1.061 damage/failures in the areas mentioned. The end-forward and rear areas are not relevant for many types of packages. The most frequent pairs of package areas that have simultaneously been damaged or failed are *top-bottom*, *top-side left*, *top-side right*, *bottom-side left* and *bottom-side right*. Some explanations for the large number of damage/failures, in particular in top and bottom areas, include a) exposure to transport hazards such as compression, racking and other mechanical forces, b) operational/handling errors (e.g. stacking, loading and unloading), c) contact with water, moisture and other liquids, and d) inherent weaknesses in packaging design and construction in these areas.

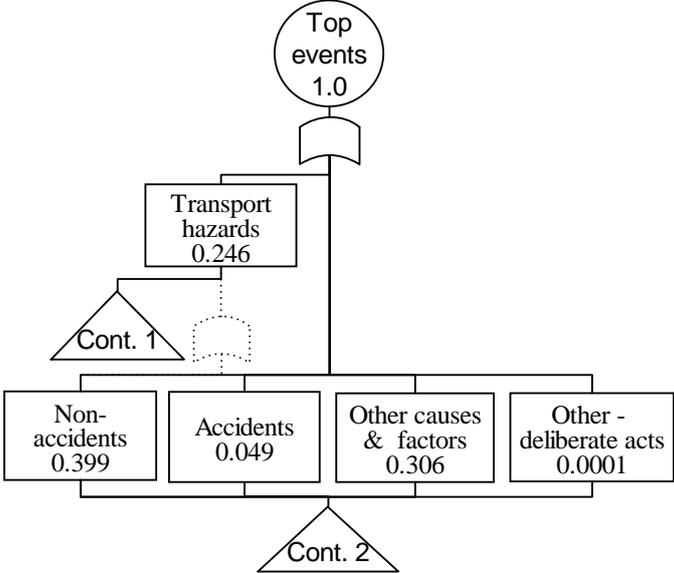
Figure 3.15: Fault tree of transport hazards and causes and contributing factors of incidents (U.S. 1993-2004)

(Figure 3.15) are largely associated with combinations of transport hazards, including those shown in Figure 3.16. For example, packages have been damaged due to mechanical forces (e.g. impact and crushing) and other hazards exerted in transport accidents and cargo handling operations. The data indicate that failures and hazmat releases are not always necessarily due to transport hazards. The wide ranges of causes and contributing factors of failures in the systems, hazmat releases and exposures are explored in detail Sections 3.4, 3.7 and 4.1.

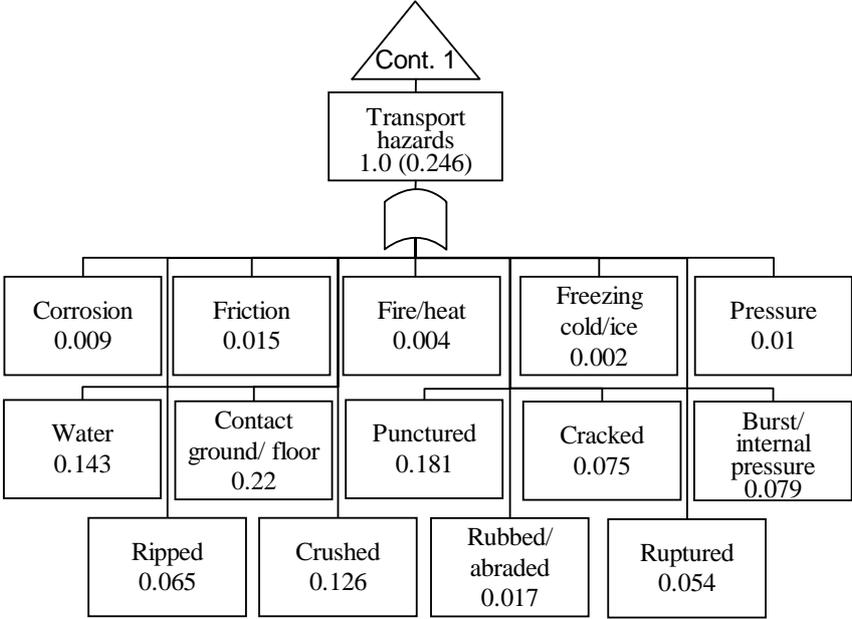
Figure 3.16: Fault tree of categories of transport hazards (continued from Figure 3.15) (U.S. 1993-2004)

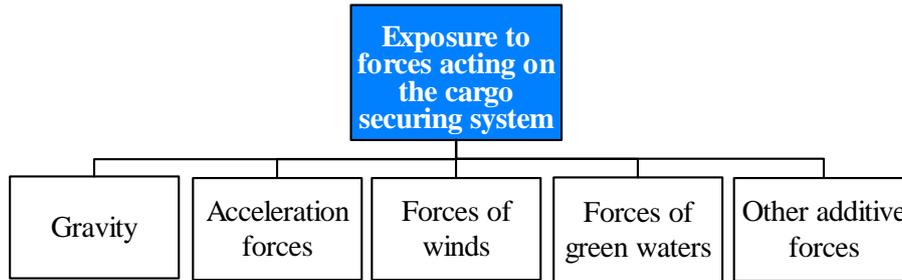
Figure 3.21: Types of forces acted on the m/v SCI's cargo securing system (continued from Figure 3.20)

The following section explores (*from left to right*) types and effects of forces acting on the m/v SCI’s cargo securing system (Figure 3.21, continued from Figure 3.20), including the ship, containers, the piece of machinery and cargo securing equipment and gear.

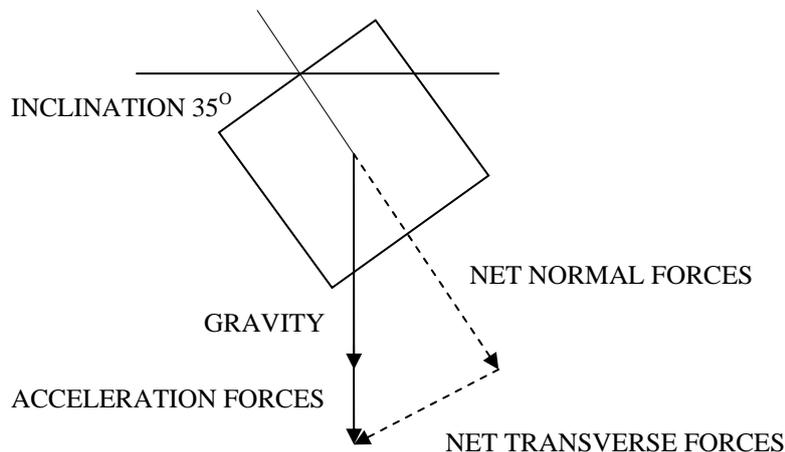
Figure 3.22: Gravity and traverse acceleration forces acting on the systems

Acceleration forces: Inertial acceleration/deceleration forces exerted due to the ship's motions affected the system. Figure 3.22 shows that forces acting on the system at any given moment may equal the vector sum of static and dynamic forces.

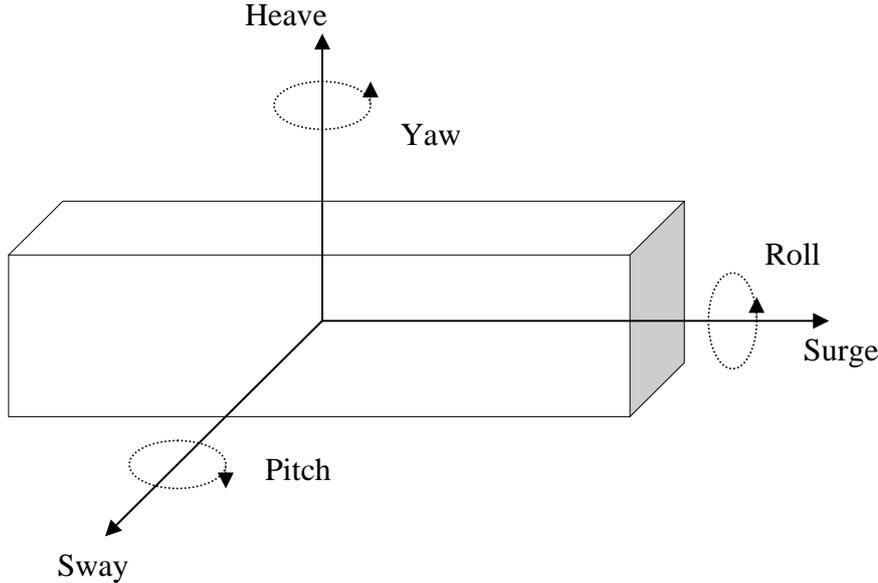
Figure 3.23: Six directions of ship's motions (Knott, 1994 from BSI, 1982)

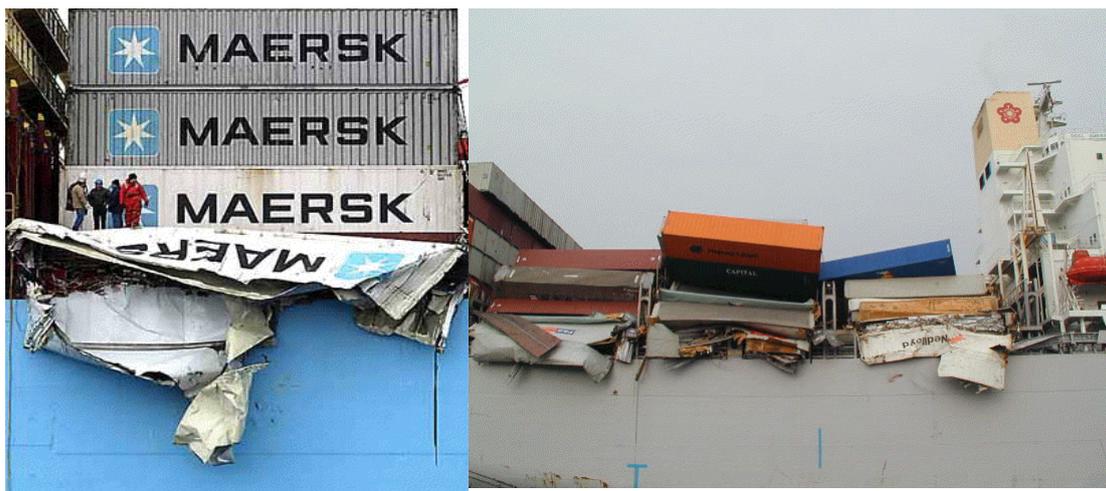
Figure 3.25: Container damage onboard large container ships (P&I Club, 1999)

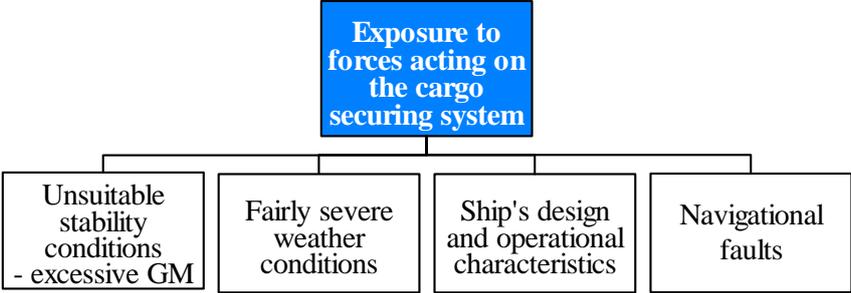
Figure 3.26: The main categories of contributing factors to the exposure to forces acting on the m/v SCI’s cargo securing system (continued from Figure 3.20)

The above-mentioned forces were the result of a combination of the ship’s motions, weather and operational (e.g. pre-tensioning in the lashings) conditions. The magnitudes and effects of forces acting on the system depend on the combination of different factors, including ship’s properties, weather conditions (winds and waves), and ship’s course/speed relative to wind and wave’s direction/speed. Course adjustments and/or speed reduction are some of the measures for reducing the effects of these forces. The next step explores (*from left through to right*) each contributing factors (Figure 3.26, continued from Figure 3.20).

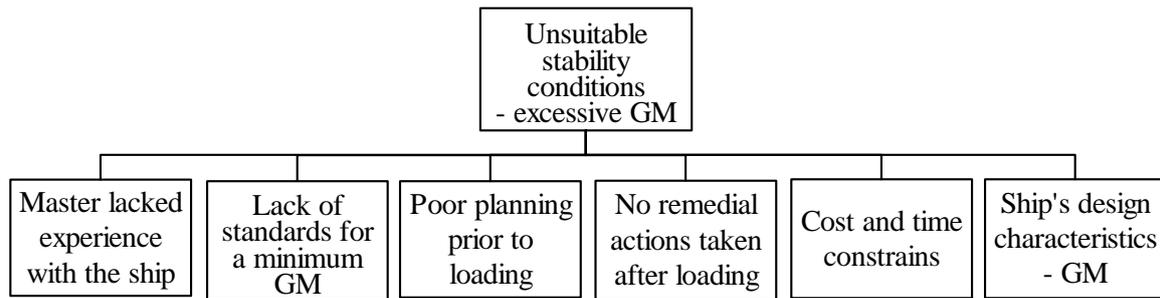
Figure 3.28: Contributing factors of the unsuitable stability of the m/v SCI (continued from Figure 3.26)

Figure 3.28 (continued from Figure 3.26) shows the fault tree of the unsuitable stability of the m/v SCI. The following explores (from left to right) each contributing factor (Figure 3.28).

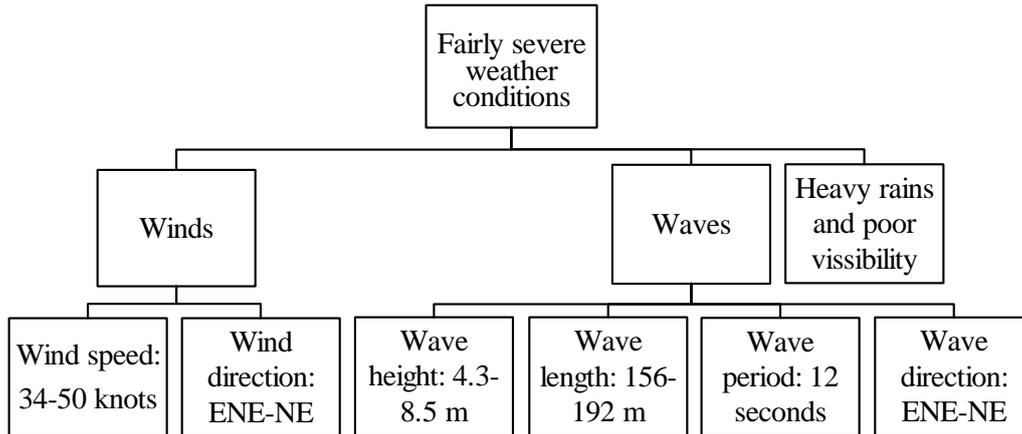
Figure 3.29: The m/v SCI encountered fairly severe weather conditions (continued from Figure 3.26)

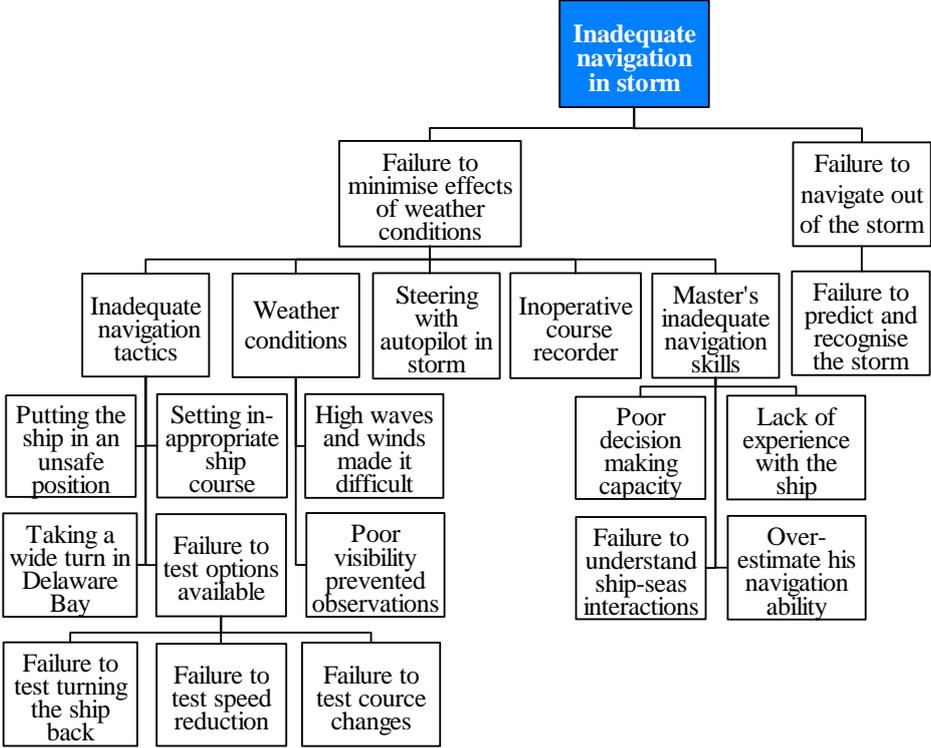
Figure 3.34: Fault tree of inadequate navigation in storm (continued from Figure 3.33)

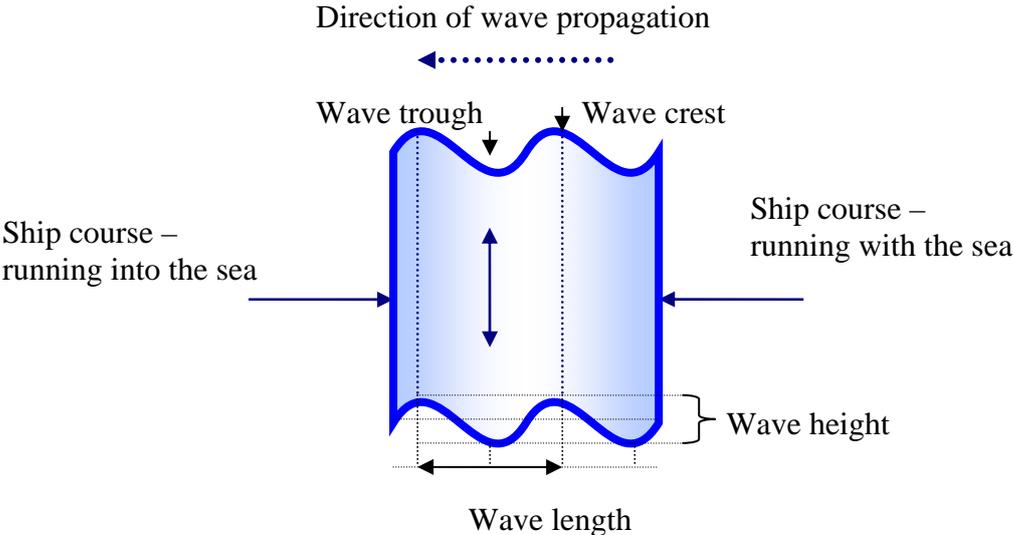
Figure 3.35: The ship course relative to the wave – the ship running with/into sea and in the trough of the wave

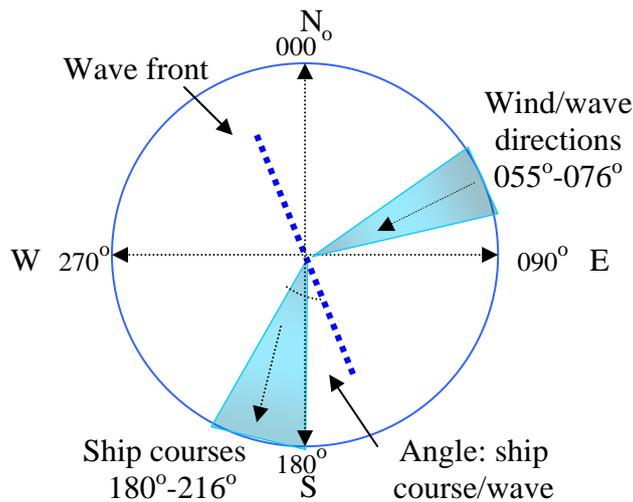
Figure 3.36: The m/v SCI's courses relative to wind/wave

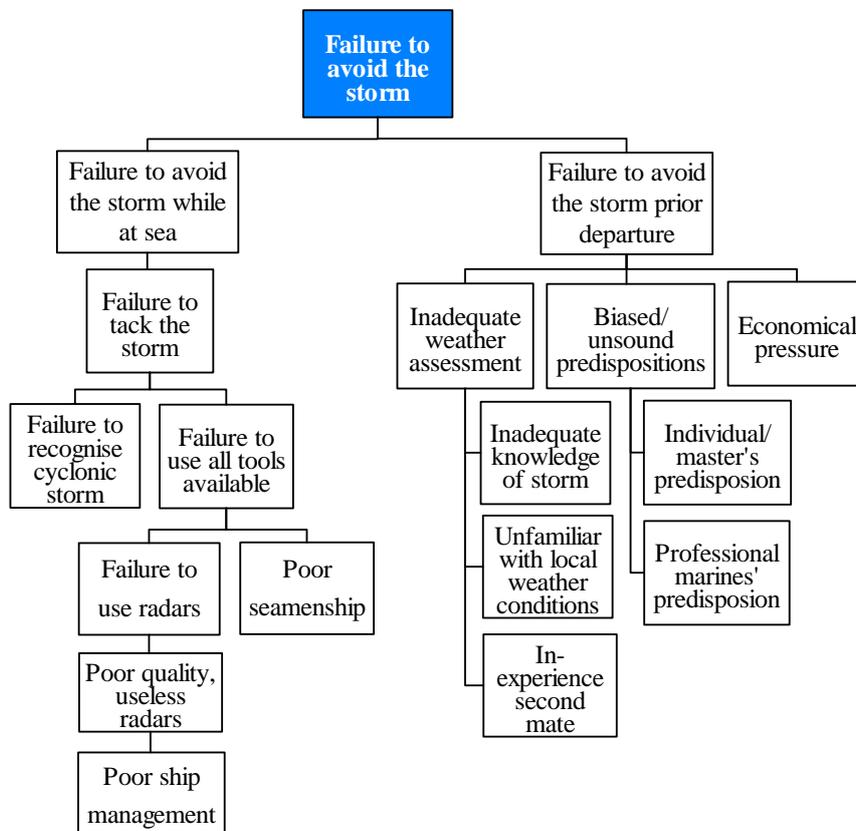
Figure 3.38: The fault tree of failures to avoid the storm while at sea and prior to departure (continued from Figure 3.37)

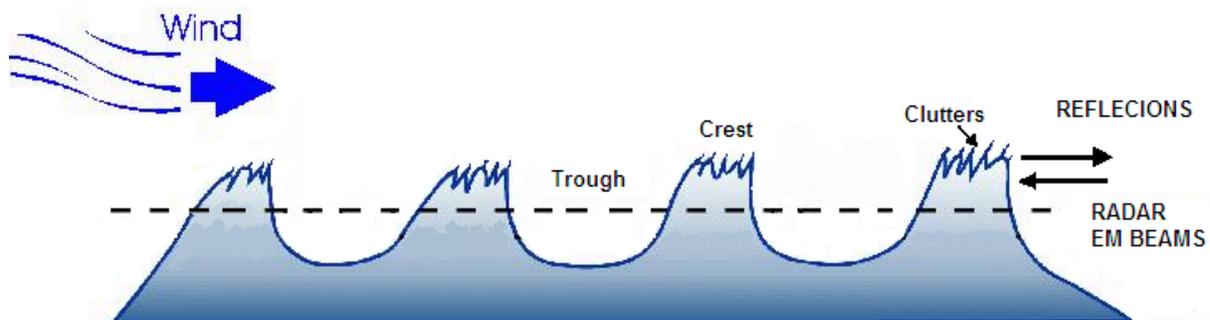
Figure 3.39: Observation of wave clutters by means of radar

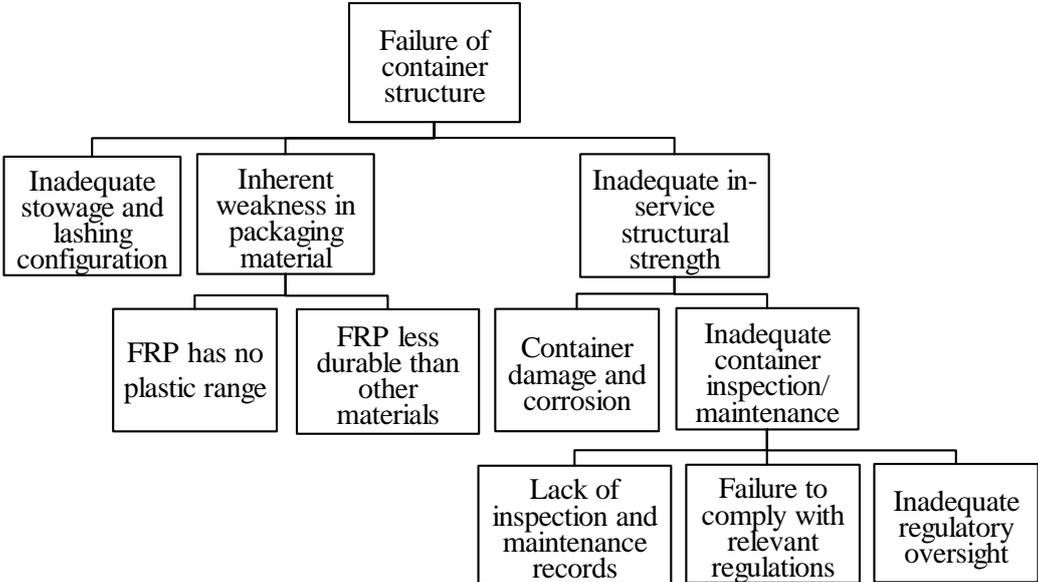
Figure 3.43: Fault tree of failure of the container structure (continued from Figure 3.42)

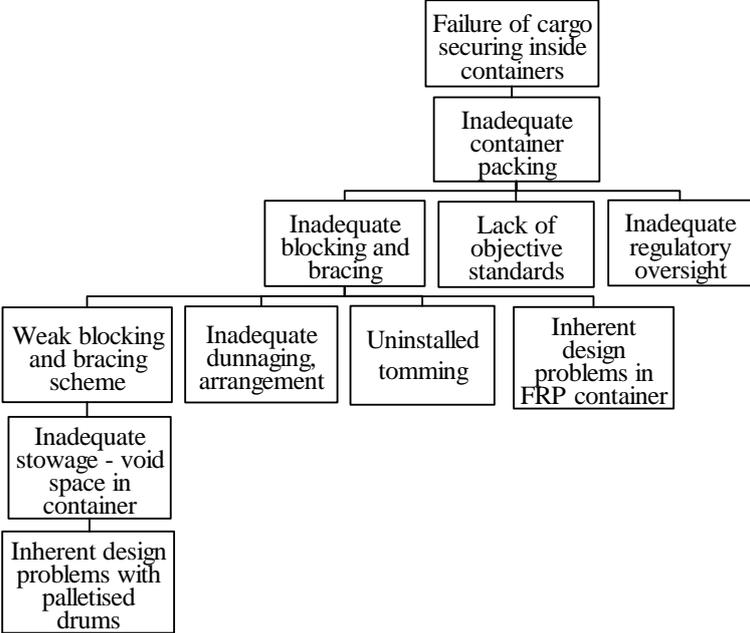
Figure 3.44: Fault tree: failure of cargo securing inside the container (continued from Figure 3.42)

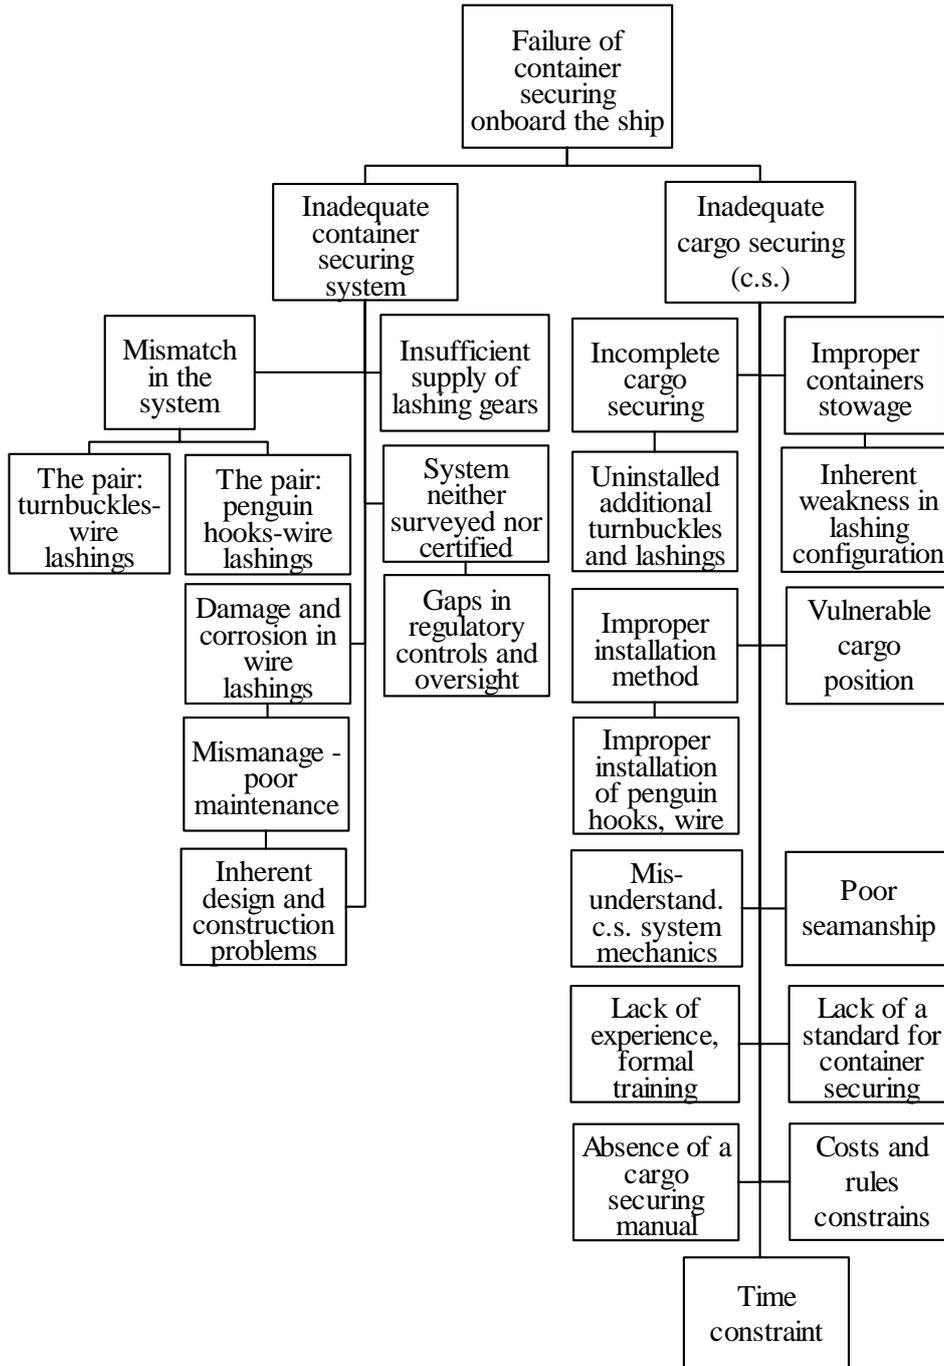
Figure 3.47: Fault tree of failure of the cargo/container securing onboard the m/v SCI (continuous from Figure 3.42)

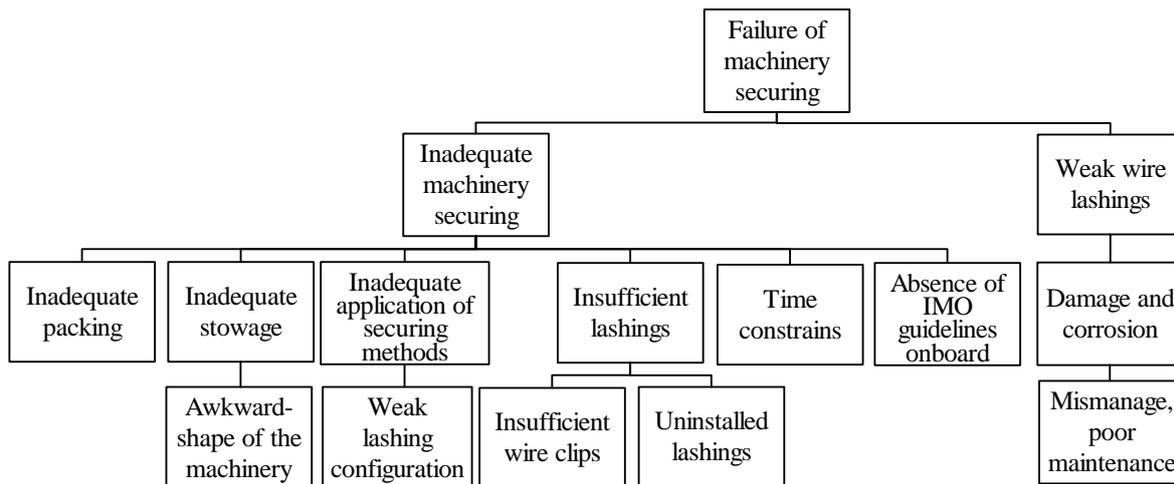
Figure 3.50: Fault tree of failure of machinery securing (continued from Figure 3.49)

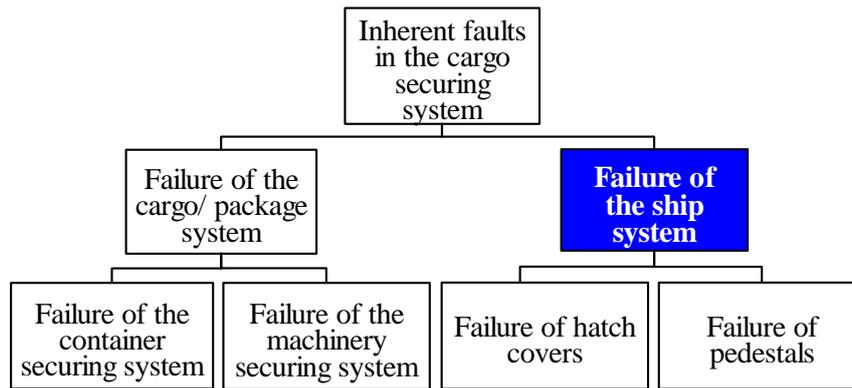
Figure 3.53: Fault tree of failures of the ship system (continued from Figure 3.41)

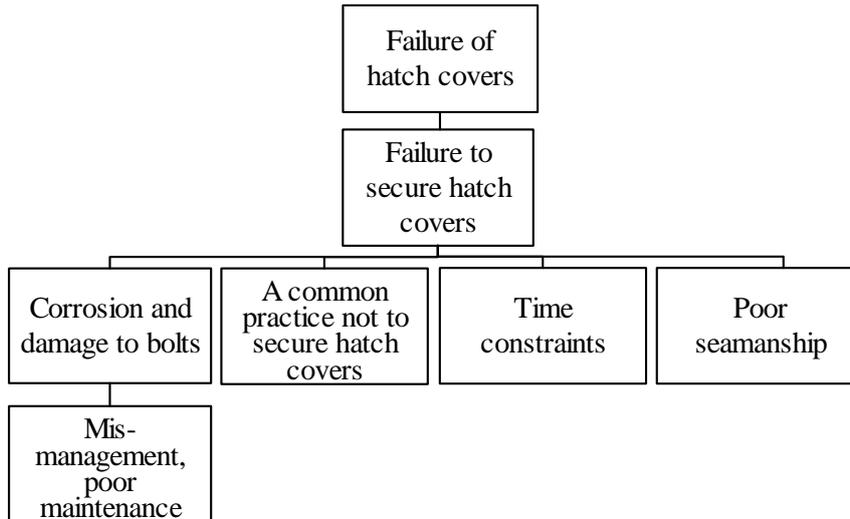
Figure 3.54: Fault tree of failure of hatch covers (continued from Figure 3.53)

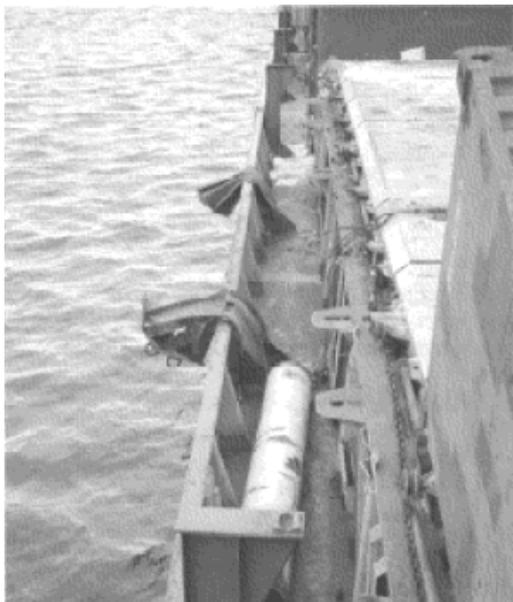
Figure 3.55: Failed deck pedestals-starboard (U.S. DOT, 1992)

Failure of pedestals

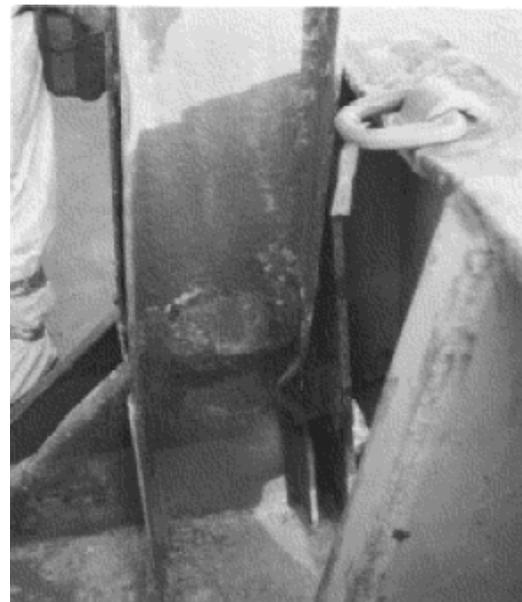
Figure 3.56: Compression damage at the bottom of pedestal (U.S. DOT, 1992)

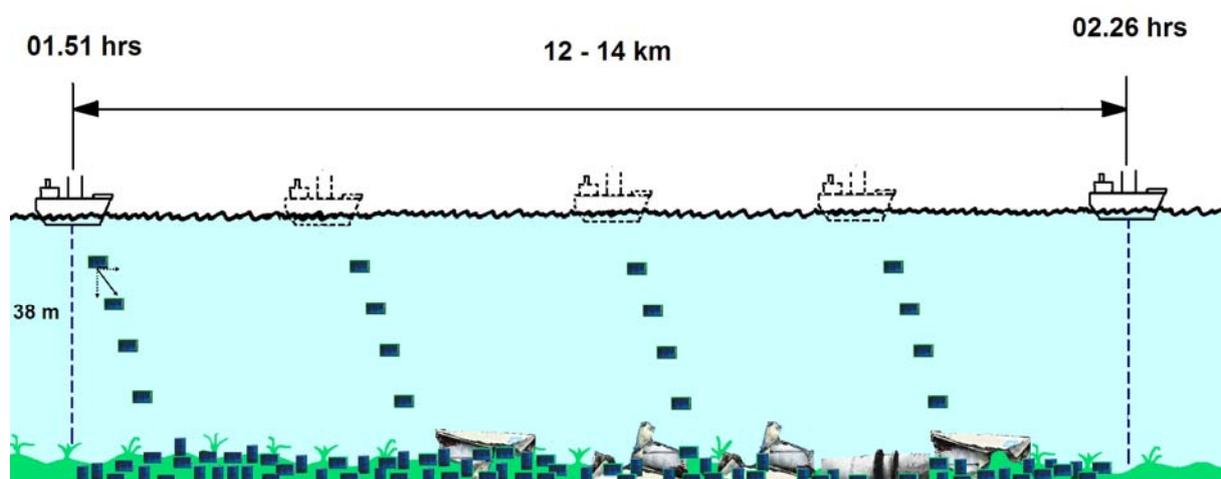
Figure 4.16: Spreading of cargo on the sea floor

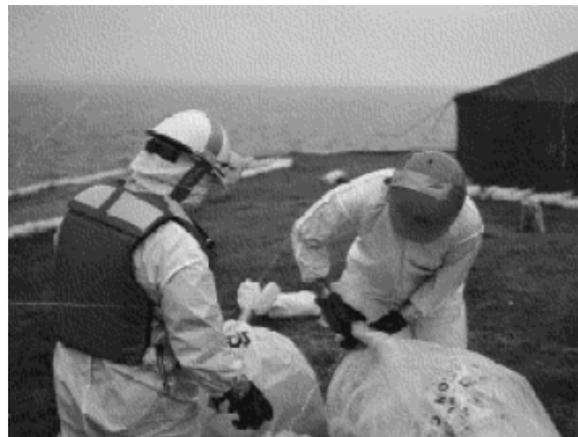
Figure 4.37: Chemical response operation – specialised hazardous material response personnel equipped with special suits to avoid chemical exposure by skin contact, ingestion and inhalation (U.S. DOT, 1992)

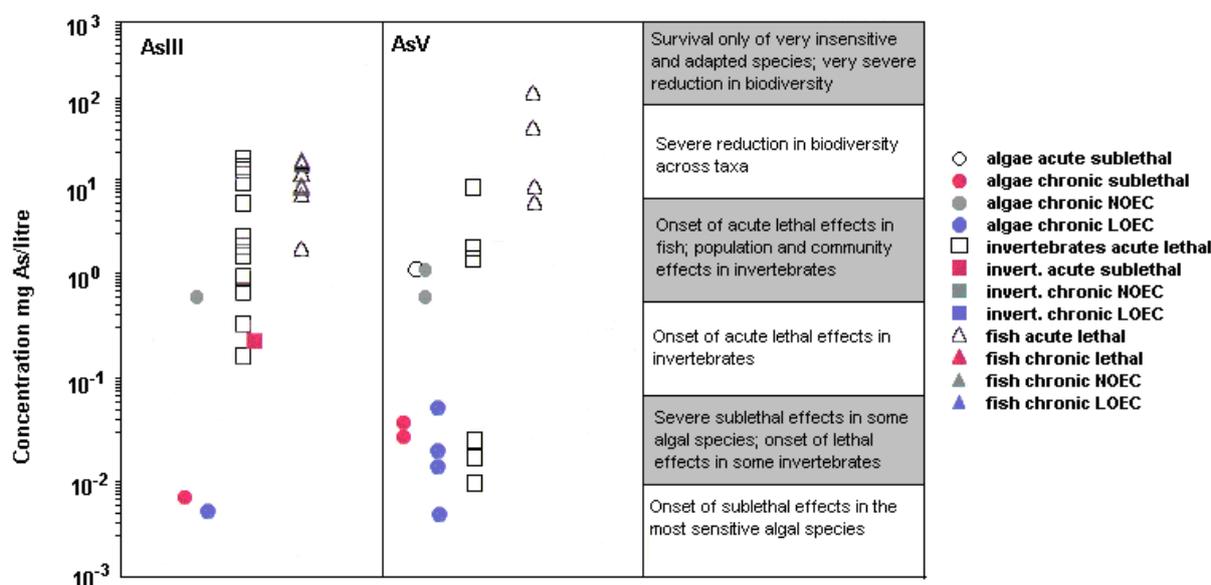
Figure A2.2: Acute and chronic toxic effects of arsenic (arsenite – AsIII and arsenate – AsV) in seawater. Likely effects are given for each order of magnitude concentrations. Effects assume no mitigation of toxicity in the environment (IPCS, 2001).
