Master of Science Thesis
TVVR 08/5002

Shoreline Change Analysis for the Kunduchi Beach Area, Tanzania

A Master of Science Thesis by

January 2008

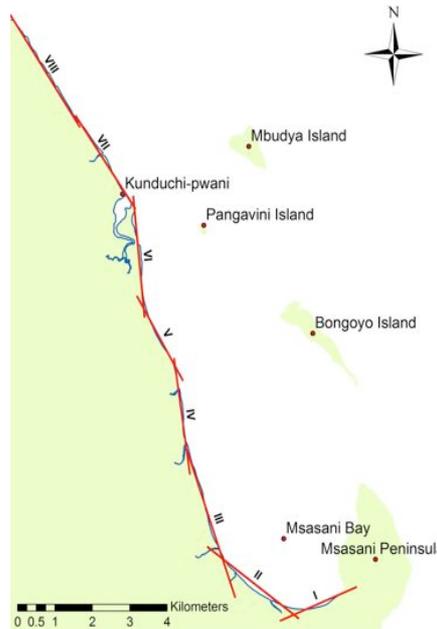
Figure 2.1 The study area north of Dar es Salaam divided into eight different sections.

The study focuses on the coastal stretch north of Dar es Salaam in Tanzania in eastern Africa in the vicinity of Kunduchi-pwani. The particular area of interest is the shoreline between Msasani Peninsula, located north of Dar es Salaam, and 23 km north of this point, just south of Ras Kiromoni, see Figure 2.1. The coastline was

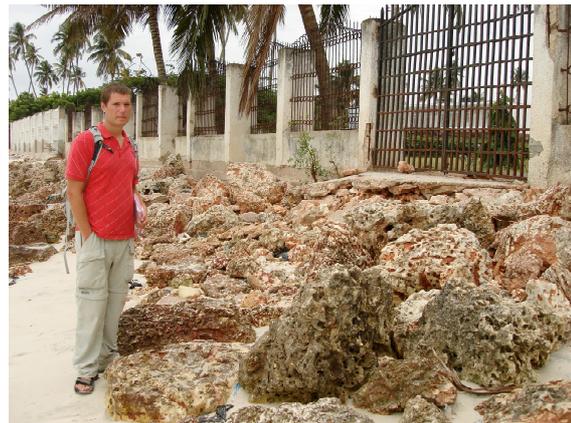
Figure 2.3 Rocks placed in front of a seawall to increase the strength of the seawall.

The study area begins in the south, near Slipway in Msasani Bay, which is a densely populated area, with private homes and simple facilities for fishermen, see Figure 2.2. The bay is a shelter for the fishermen's boats and also hosts a small but lively fish market, with private homes and hotels surrounding the fishing village. The erosion has been affecting the area in the past and to protect the properties the community has applied several different mitigation measures against erosion. Most commonly used measures are large coral rocks used for building the seawalls, but alternative building materials can also be found, see Figure 2.3.

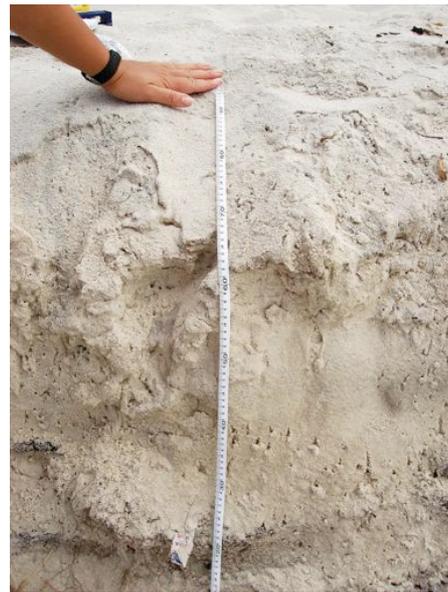
Figure 2.7 Along the stretch in section III scarps caused by erosion are found, this is one having a height of 80 cm.

Further north, the area is more sparsely populated with houses situated some distance away from the beach, see Figure 2.6. At some locations the houses are closer to the sea and seawalls have been built at these properties to protect them from beach erosion. The most common protection measures are seawalls made by coral rocks or concrete slabs, but also simple walls made by palm poles driven down into the sand are used. The Mlalakuwa River, which has its outlet in the area, contributes with sediments to the beach during the rainy seasons but during the dry season, the flow is only $0.03\text{m}^3/\text{s}$. In the area around Kawe Club there is clear evidence that the beach is eroding. There are scarps more than 70 cm high at many locations and there is also a stretch with a beach berm that has erosion scarps, see Figure 2.7.

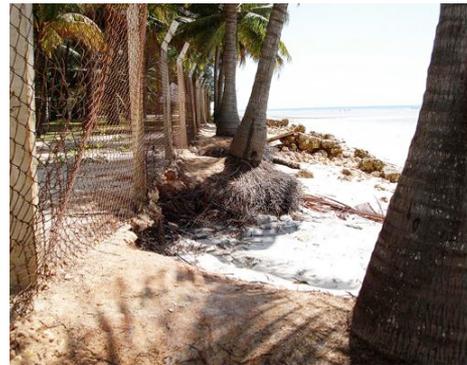
Figure 2.9 Damages caused by erosion in section IV.

The Mbezi River is a fairly large seasonal river, which runs through a rural area, see Figure 2.8. With its increased flow during heavy rains it brings a lot of sediments to the coastal stretch. North of Mbezi River there is another watercourse named Mdumbwi River with a, in July, measured flow of $0.03 \text{ m}^3/\text{s}$. At the mouth of the Mdumbwi River there is a large sand delta with geomorphological indications that the sediments from the river are moving northward. Within this section there are numerous locations where erosion damages are visible, see Figure 2.9.

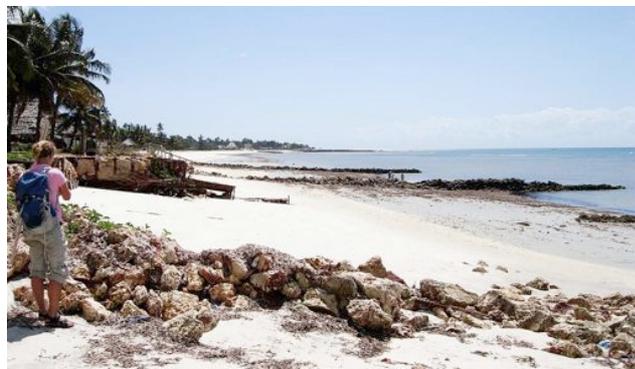
Figure 2.11 The four groins outside the Giraffe Hotel in section V.

Ten kilometres north of Msasani Bay hotels are beginning to appear with Giraffe Hotel furthest to the south, see Figure 2.10. There are three larger hotels next to the ocean in this area and they have tried to protect the hotels by building four small groins see Figure 2.11.

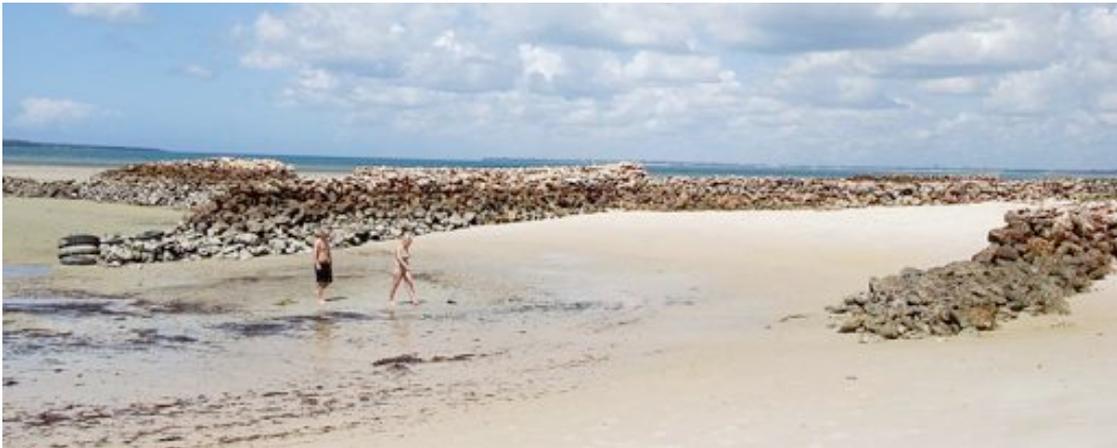
Figure 2.12 A “cross-groin” outside the White Sands Hotel.

North of Giraffe Hotel there are more large hotel complexes, i.e, White Sands Hotel, see Figure 2.13. The coastal stretch, where the hotels are situated, have been affected by severe erosion in the past with a coastline that has retreated more than 50 m. The hotel owners have built numerous groins in order to protect their property from erosion. They have built these groins without proper technical knowledge and the efficiency of these groins can be questioned. An example of the doubtful design of some groins can be seen in Figure 2.12, which shows a “cross-groin”.

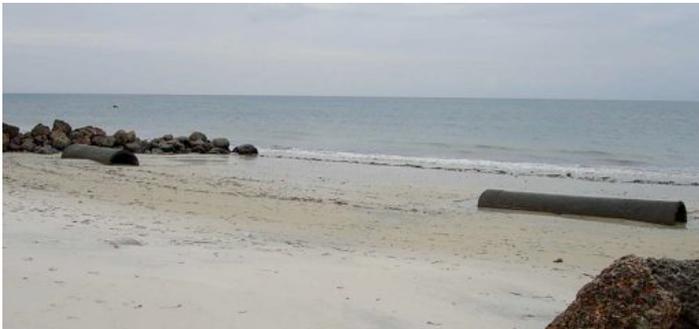
Figure 2.16 Groins in section VIII with two concrete pipes to further increase the efficiency of the groin, a doubtful construction.

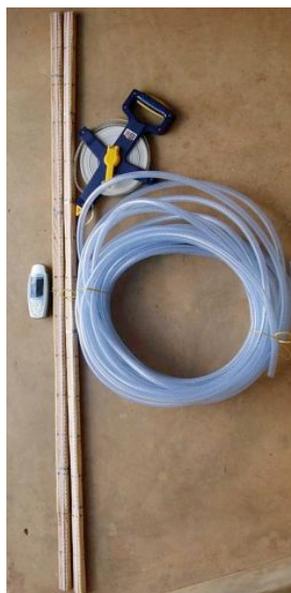
Figure 3.2 Equipment used for the cross-shore profile measurement.

The hose was filled with water and it was made sure that no air bubbles were left in the hose. The measuring sticks were used to read the water level in the hose at the site of each stick. By using the hose filled with water it was made certain that a horizontal line between the two measuring sticks was obtained and thereby knowing the difference in height between the two points. After the difference in water level was determined, the distance between the two points was measured using the measuring tape. Distances between the two sticks were chosen to include all unevenness within the profile. In order to increase the distance measured the measurements were made at low tide. The measurements started in the water as far out as possible, then moving landwards ending a few meters into the backshore. A reference level was measured for each profile at a certain time using the water level at the outermost point. The corresponding sea level for each profile measurement was then later obtained by the program WXTide32.

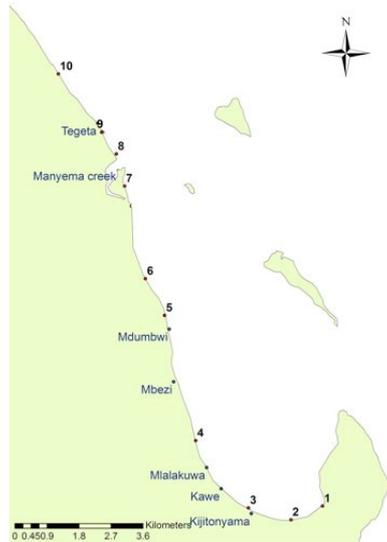
Figure 3.4 Sediment sample locations along the project area

During the field visit a total of 31 sediment samples were taken from the top layer of sand at four different segments along the cross-shore profile. The sediment samples were collected at 10 locations along the beach, see Figure 3.4, attempting to evenly distribute the sampling sites along the study area. Further, sites were also chosen to include areas with erosion and accretion, as well as sites in and around the major watercourses. At sites where it was possible to take four samples along the cross-shore profile, this was done, otherwise as many samples as possible was taken. For cross-shore sampling locations, see Figure 3.5:

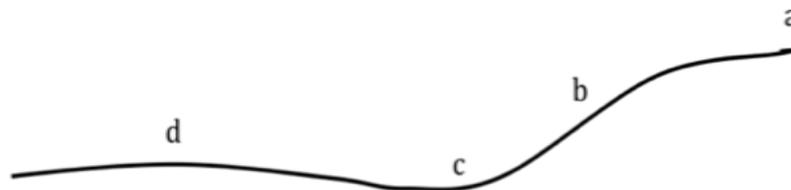
Figure 3.5 Location in the cross-shore profile where the samples have been taken.

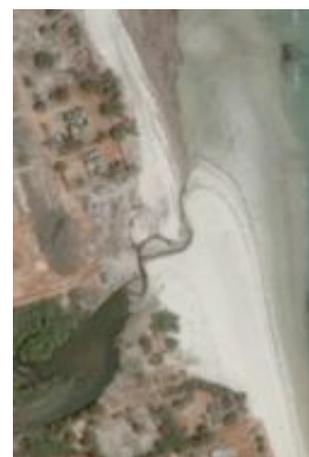
Figure 3.8 The river mouth of Kijitonyama River, as can be seen in the picture the sandplume from the river is directed north (upward in the picture). Indicating a northerly sediment transport (Google Earth 2007).

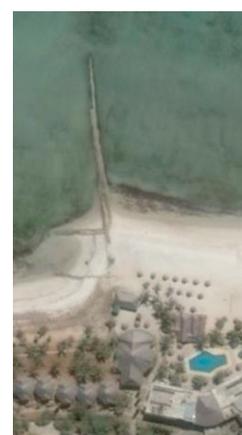
Figure 3.9 Accumulation of sediment on the southern side, left in the picture, of a groin outside the White Sands Hotel (Google Earth 2007).

Accumulation of sediment on the updrift side of groins can be a sign of a longshore transport. Which was observed around many of the groins in the area. A large accumulation of sediment could be seen on the southern side of the groins in section VI, see Figure 3.9.

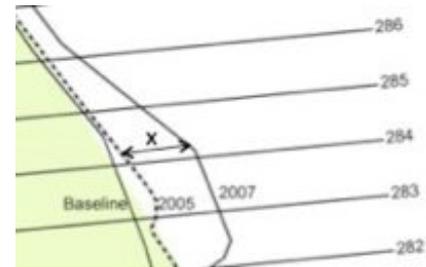
Figure 6.1 An example of how the transects are casted in DSAS. The net shoreline movement is the distance between the 2005 and the 2007 shoreline along each transect.

Shoreline change were then analysed with DSAS software extension by casting transects along the coastal stretch and the change within these transects were then calculated with statistical methods, see Figure 6.1. A baseline situated on the onshore side of every shoreline were used to cast transects from. Transects were placed 50 m apart along the coastal stretch in the area, which was found to be a suitable spacing for the analysis. Distance of the shoreline change were measured at intersections between two shorelines on each transect. Distances are statistically analysed by DSAS. Further description of DSAS and how to operate the extension can be viewed in the DSAS manual (USGS 2006).

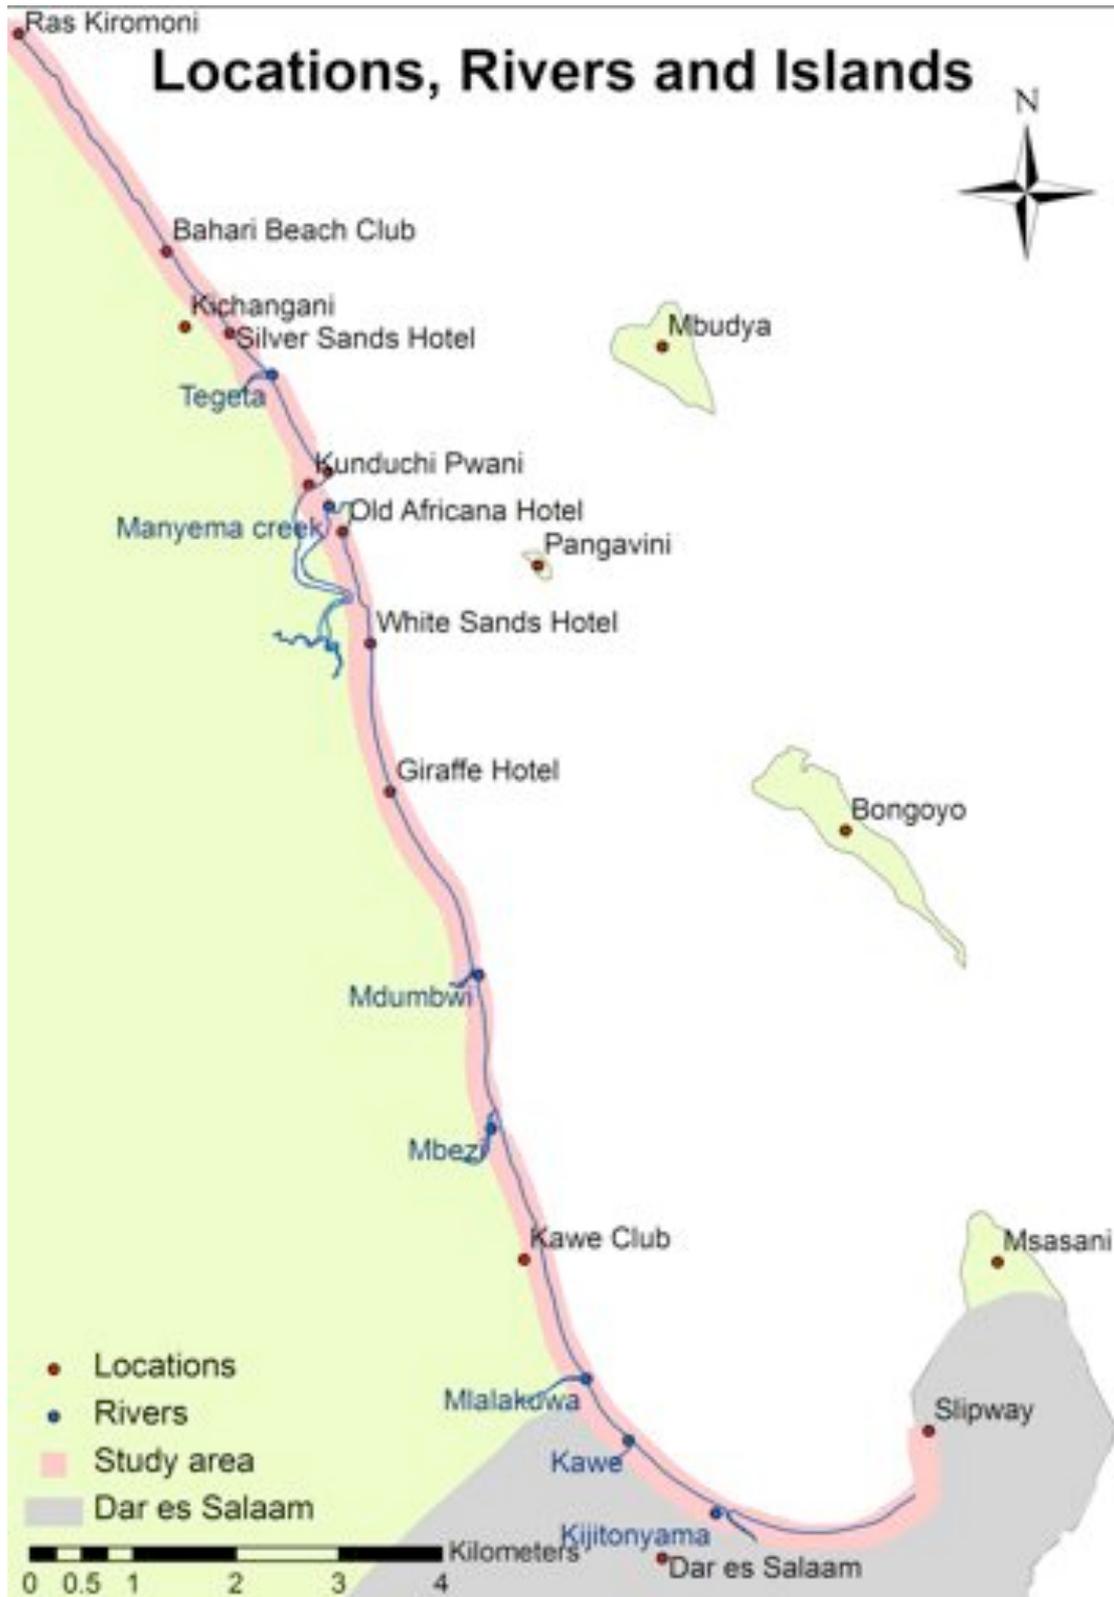
Figure A.3 The rivers and locations in the study area.

Historically there has been severe problem in the area caused by erosion. In the late 1980's the Africana Hotel was lost to the sea due to erosion, see Appendix A.3. The Kunduchi Beach Hotel has been only 2 m away from the sea before the owners started to reclaim land in 1998. Silver Sands Hotel had problems in 1977 before the managers began to take actions against erosion (Shaghude *et al.* 2005). The owners of hotels and private homes started to protect their properties from erosion by building seawalls and groins along the coast. These actions have side effects; for example Kunduchi-pwani is experiencing problems due to the seawall built by the Kunduchi Beach Hotel blocks the natural sediment transport.
