Pedestrians' safety and accessibility

- A study of the situation at Pärnu mnt in central Tallinn

Thesis / Lunds Tekniska Högskola,
Institutionen för Teknik och samhälle,
Trafik och väg, 166

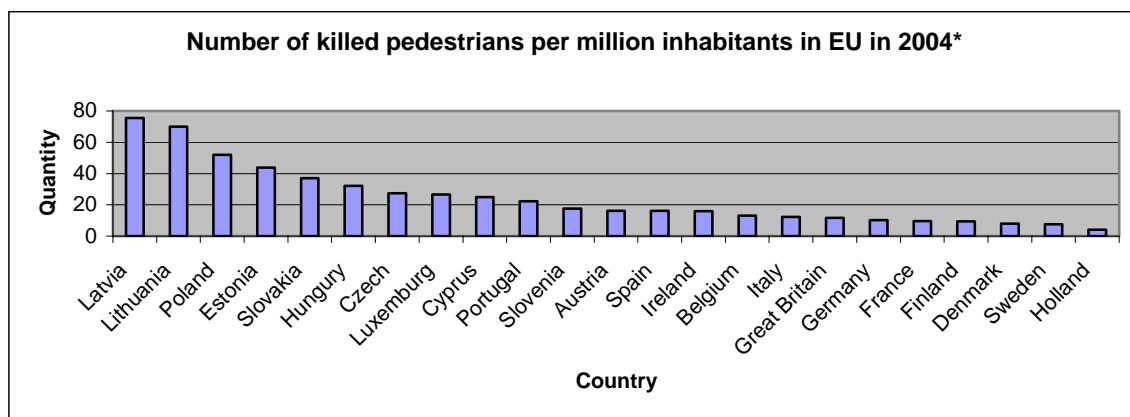
Figure 1. Number of killed pedestrians per million inhabitants in EU in 2004.

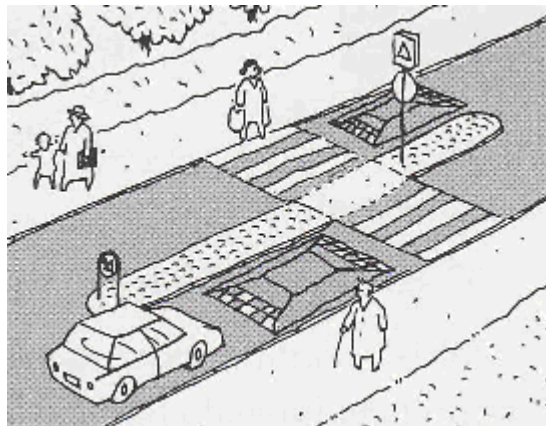
wheels and they can thereby pass the obstacle without being affected of it while cars have to go over the cushion with at least one wheel (Pau and Angius, 2001). Speed cushions are suitable to use on local and arterial roads with heavy traffic (Towliat, 2001).

Figure 4. Speed cushions (Svenska kommunförbundet, 1998)

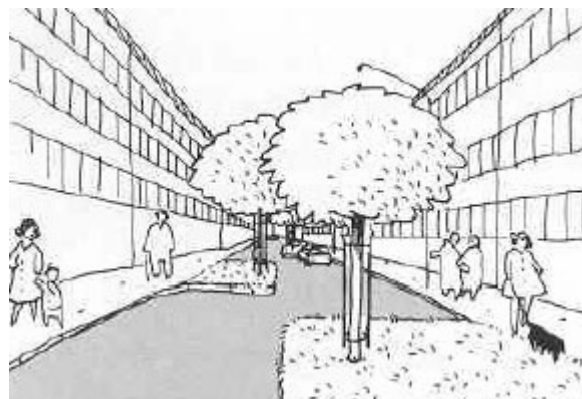
Chicanes have a speed reducing impact on the traffic. The aim is to force the drivers to make a move sideways and thereby reduce the speed and also change the field of vision, see figure 7 (Englund et al, 1998). It is important that it is not possible to make short cuts and that can be prevented by combining the chicane with refuges. It is recommended that the move sideways should be at least one lane width (Institute of Transportation Engineers, 2006).

Figure 7. Chicane made by plantings (Svenska kommunförbundet, 1998)

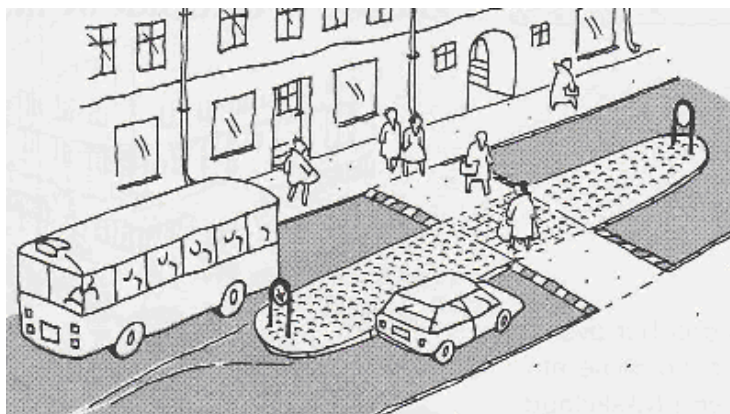
The width of the refuge is of great importance to make sure that everybody that cross the street should fit on it on the peak hour. Persons with wheelchairs, rollators and other equipments are also in a need of more space than others and the size of the refuge is very important from their point of view as well (Institution of highway and transportation, 1997). Persons with impaired vision have a need of wide refuges and it should also be a low edge or a surface in another material than the surrounding to simplify for them (Svenska kommunförbundet, 1998).

Figure 9. Raised pedestrian crossing with a refuge island (Svenska kommunförbundet, 1998)

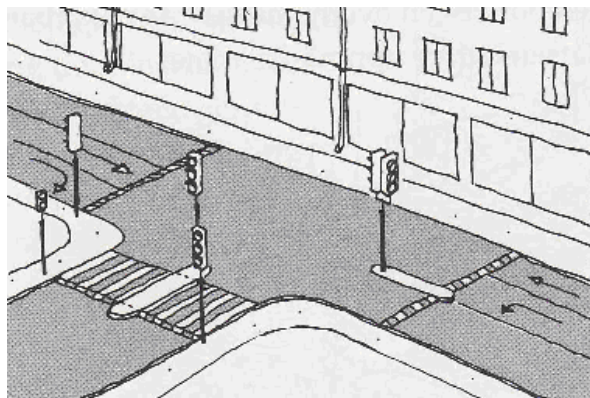
At places where a marked pedestrian crossing does not provide enough safety to the pedestrians it could be signal controlled instead, see figure 12. The signal can be regulated automatically or the pedestrian have to press a button to receive green light. Studies have showed that the number of pedestrian accidents drop when signal controlled crossings are installed (Elvik and Vaa, 2004).

Figure 12. Signal controlled crossing (Svenska kommunförbundet, 1998)

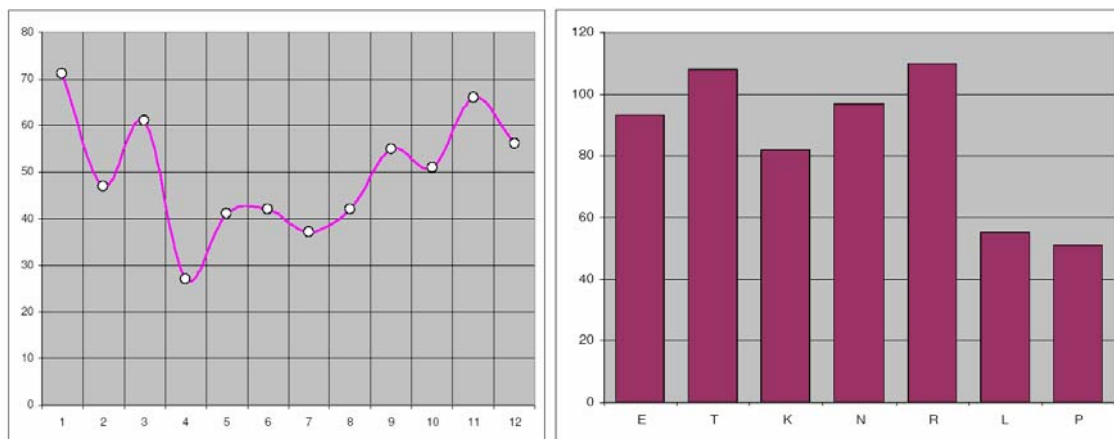
Figure 14. Distribution of pedestrian accidents in time in Tallinn. To the left: Distribution over the months. To the right: Distribution over the week days, where E-P is Monday-Sunday (Stratum, 2006)

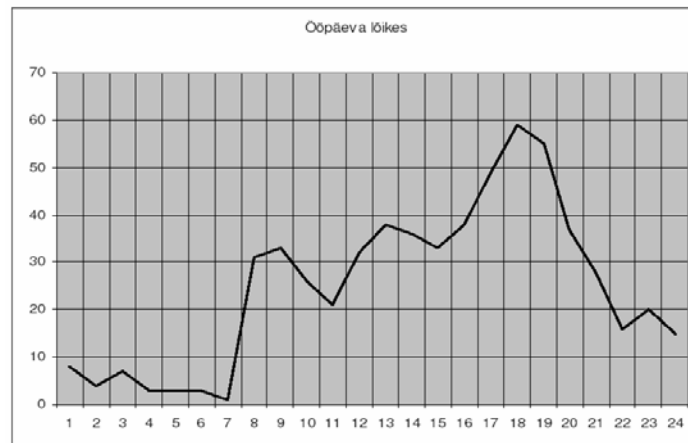
Figure 15. Distribution of pedestrian accidents during the day (Stratum, 2006)

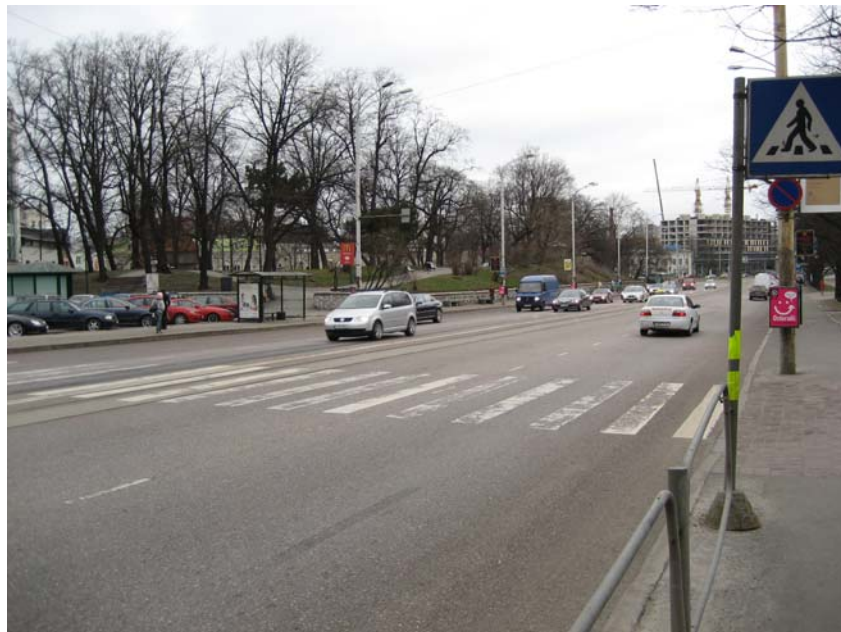
The studied street link has two lanes in each direction, is 24 meters wide, 203 meters long and has tram tracks in the middle of the street, see figure 18.

Figure 18. An overview of the studied street link

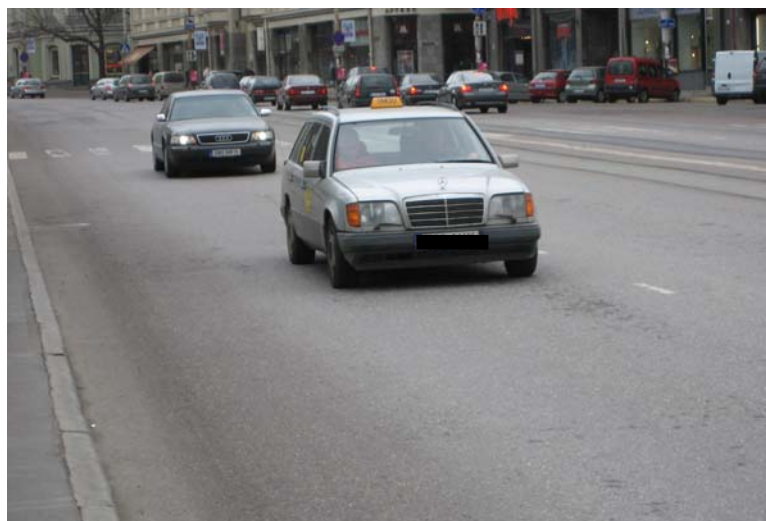
The lanes are generally wide, the width differs between 3 and 4.5 meters, see figure 19.

Figure 19. The lanes are very wide

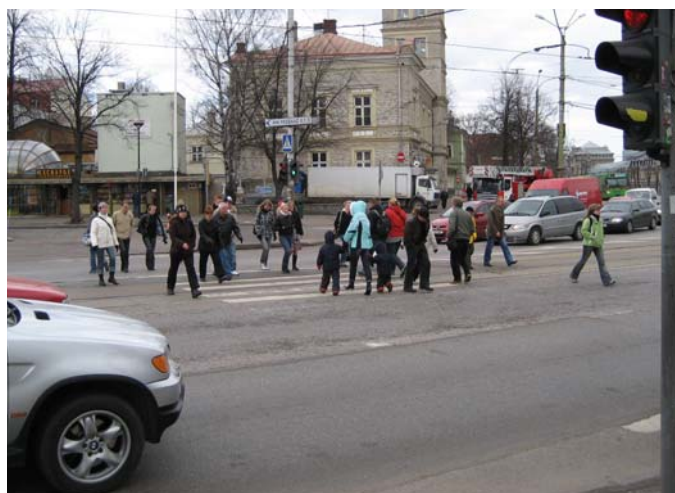
There are no refuge islands at the pedestrian crossings and the pedestrians thereby have to cross the 24 meter wide street in a row, see figure 22.

Figure 22. The street does not have any refuge islands

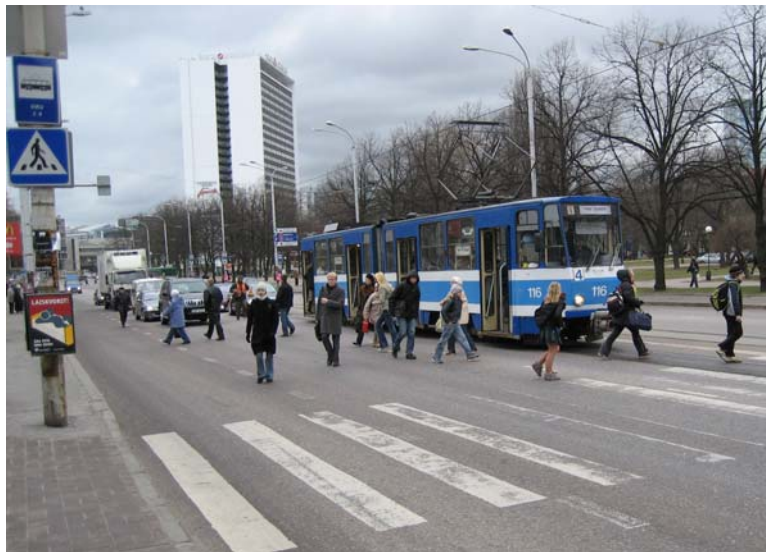
There are no platforms at the tram stops, which means that tram travellers are walking right out on the street while getting of the tram. Cars arriving on the same time as trams have to stop behind the tram to let tram travellers on and off the tram, see figure 23.

Figure 23. Cars stop behind the tram when passengers get off

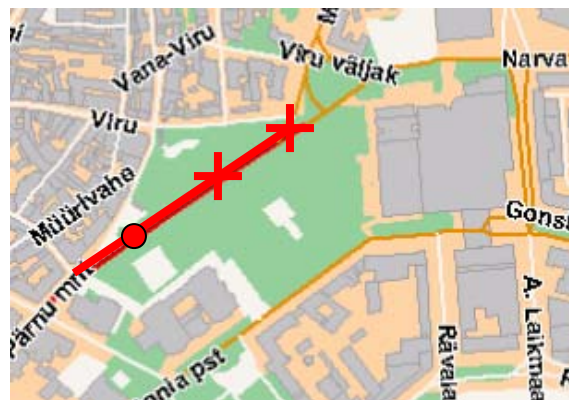
Figure 24. Location and number of pedestrian accidents 2002-2005. The dot symbolizes one accident which occurred in 2002 and each cross symbolizes two accidents which occurred in 2002 and 2003 (Eniro, 2007)

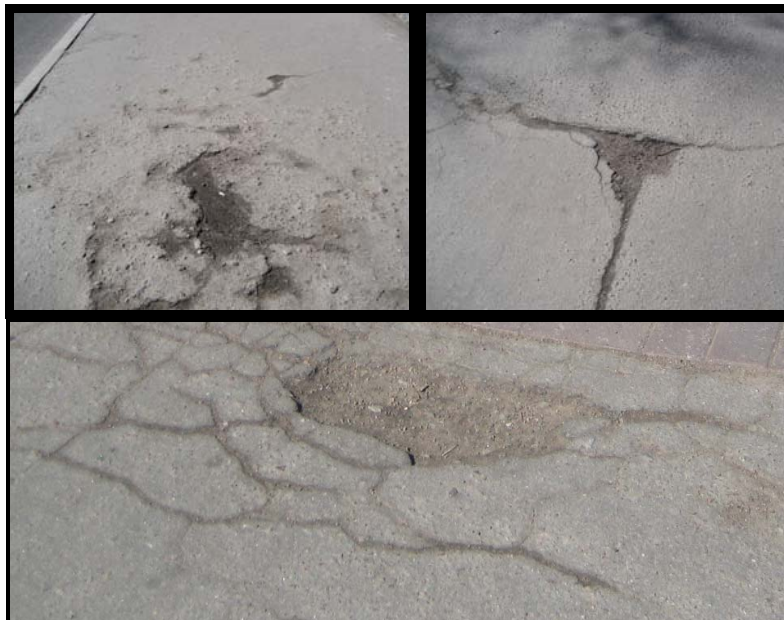
The surface evenness varies along the street link and there are holes and cracks at some places on the pavement, see figure 25. The holes and cracks result in an uneven surface that can cause problems for some pedestrians.

Figur 25. Cracks and holes on the pavement

Holes and cracks in pavements and footpaths along the street link need to be repaired to receive a more even surface. There were also some trees in the middle of the footpath that need to be removed in order to facilitate for pedestrians with impaired vision. Both pedestrian crossings should be provided with guide lines in order to make it easier to cross the street for pedestrians with impaired vision. The signal controlled pedestrian crossing is provided with a sound signal and it should remain the same after the reconstruction. Both pedestrian crossings are also provided with lighting and that should also remain the same as it contributes to make pedestrians more visible and thereby easier to recognize for car drivers.

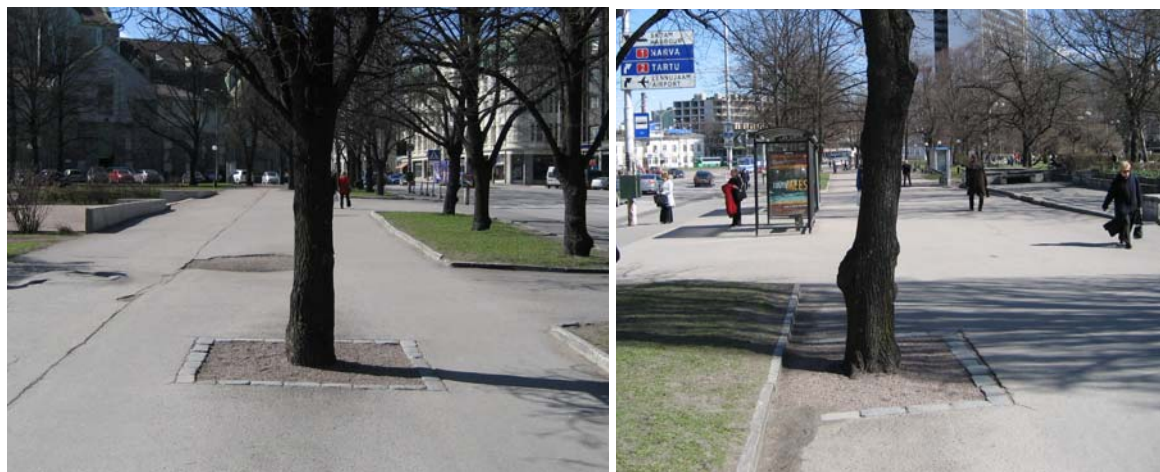
There are also some trees in the park along the street that are placed in the middle of the footpath, see figure 26. These trees can be difficult to notice for pedestrians with impaired vision and could thereby result in inconvenience for them. Another factor that might complicate for pedestrians with impaired vision is the lack of guide lines at both pedestrian crossings.

Figure 26. Trees in the middle of the pavement

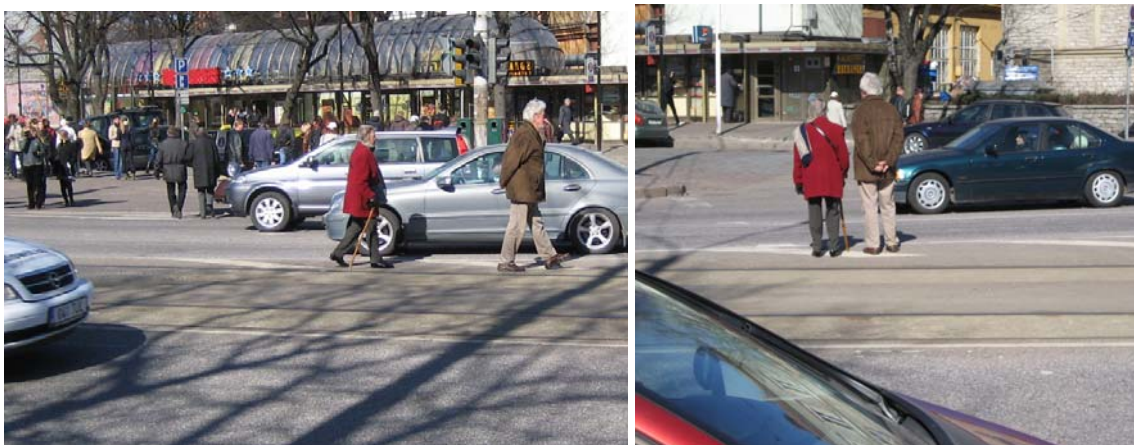
Another thing that causes problems for the pedestrians is the fact that the tram stop is in front of the signal, in direction towards Narva mnt, and that there is no platform to stand on. All cars have to stop behind the tram when it stops so tram travellers can cross the two lanes and get on and off the tram. The car drivers follow this rule but when they have green light in the signal they are more anxious to get away and that often result in that elderly getting of the tram do not have time to walk to the side of the street. They thereby have to wait for green light in the middle of the street on the tram tracks, see figure 27.

Figure 27. To the left: A couple who did not have time to cross the street after they got of the tram are walking on the tram tracks. To the right: Same couple have found a place to wait until the traffic signal turns green.

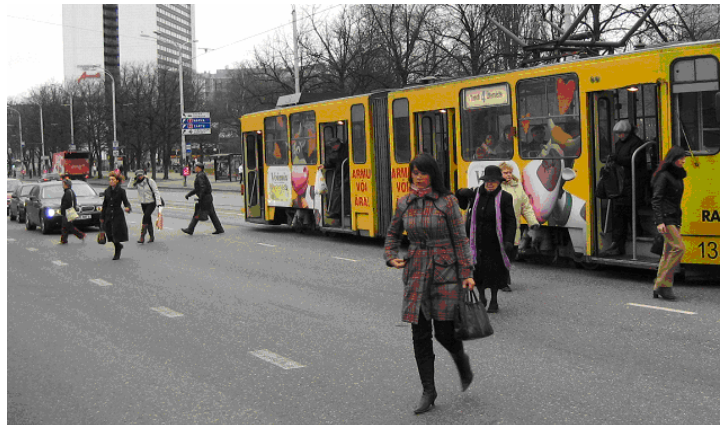
There is a tram stop in front of the unprotected pedestrian crossing in the direction towards Pärnu mnt. The cars have to stop behind the tram when it stops and the car drivers always follow this rule, see figure 28. The car drivers are not anxious to get away in the same way as they are at the signal controlled crossing, which give the pedestrians a good opportunity to cross the street at the same time as the tram stops.

Figure 28. Tram travellers get off the tram while car drivers wait behind the tram

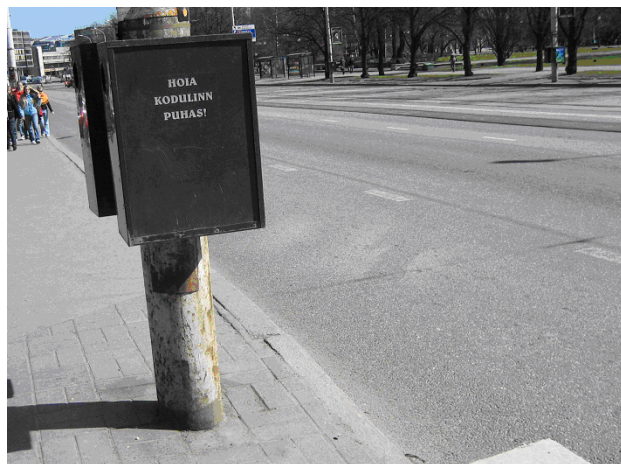
There is also a garbage bin at the unprotected pedestrian crossing that blocks the view for the pedestrians and it also makes it more difficult for car drivers to catch sight of the pedestrian, see figure 29.

Figure 29. A rubbish bin blocks the view at the unprotected pedestrian crossing

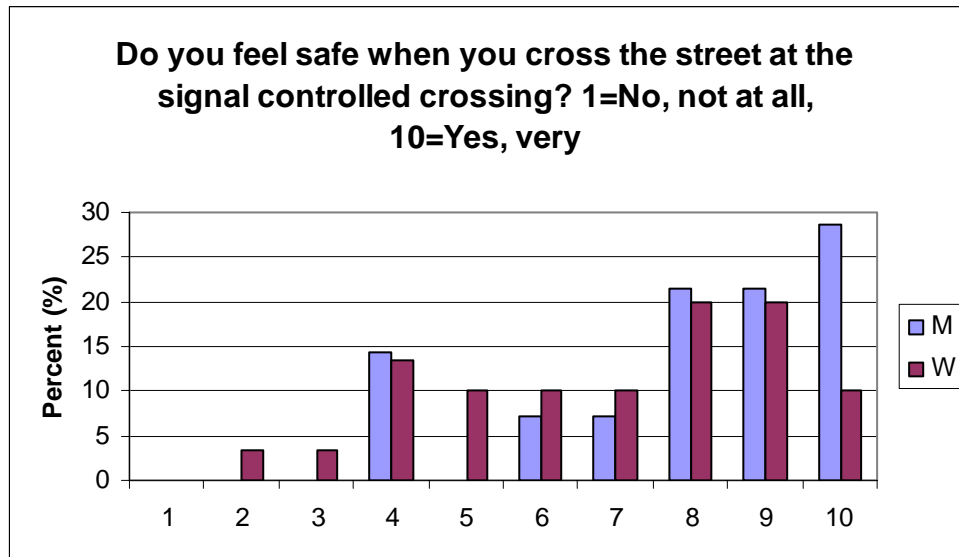
Figure 41. Feeling of safety when crossing the signal controlled crossing.

Figure 41 shows that the majority of the pedestrians feel safe while crossing the street at the signal controlled crossing. Both men and women are of the same opinion but men feel safer in a higher extent. The average among men was 8 while it was 6.9 out of ten for women. Almost all of those who answered that they feel safe answered that it was because of the traffic signal. Those who answered in the interval 1-5 were asked why they feel unsafe when they cross the street at the signal controlled crossing. The result can be seen in figure 42.

The second half of the interviews were made in connection to the signal controlled pedestrian crossing. The result with answers frequency to the question can be seen in figures 41 and 42.

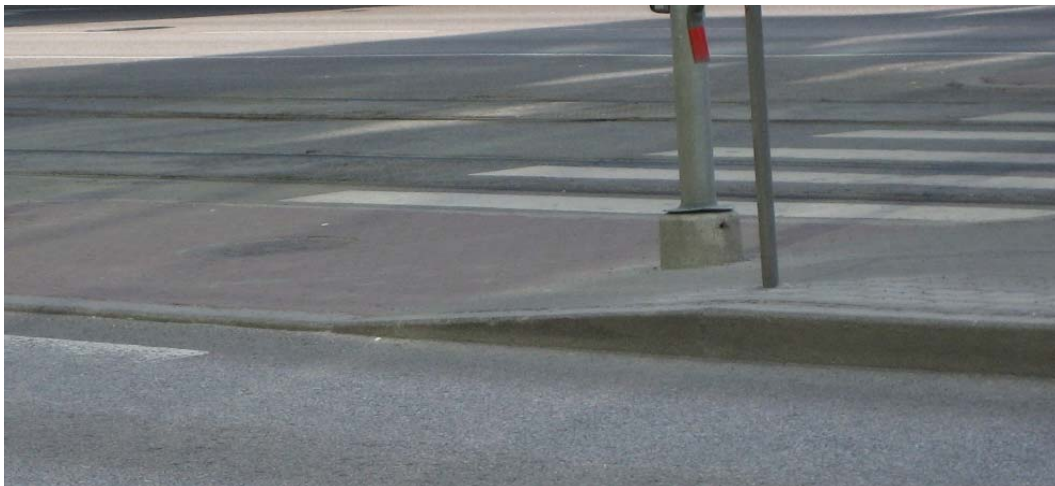
Figure 46. Example of dropped kerb
