Sankt Mary's Priory and Parish church, Monymusk,  
Aberdeenshire, Scotland  
- a buildingsarchaeological survey

An early Christian foundation, a shared church and a methodological experiment

Lunds Universitet/Glasgow University  
Institutionen för Arkeologi och Antikens  
Historia/Department of Archaeology  
D-uppsats i Historisk Arkeologi  
M.Phil. by research  
Författare: Gertie Ericsson  
Handledare: Stephen T Driscoll och  
Barbro Sundnér

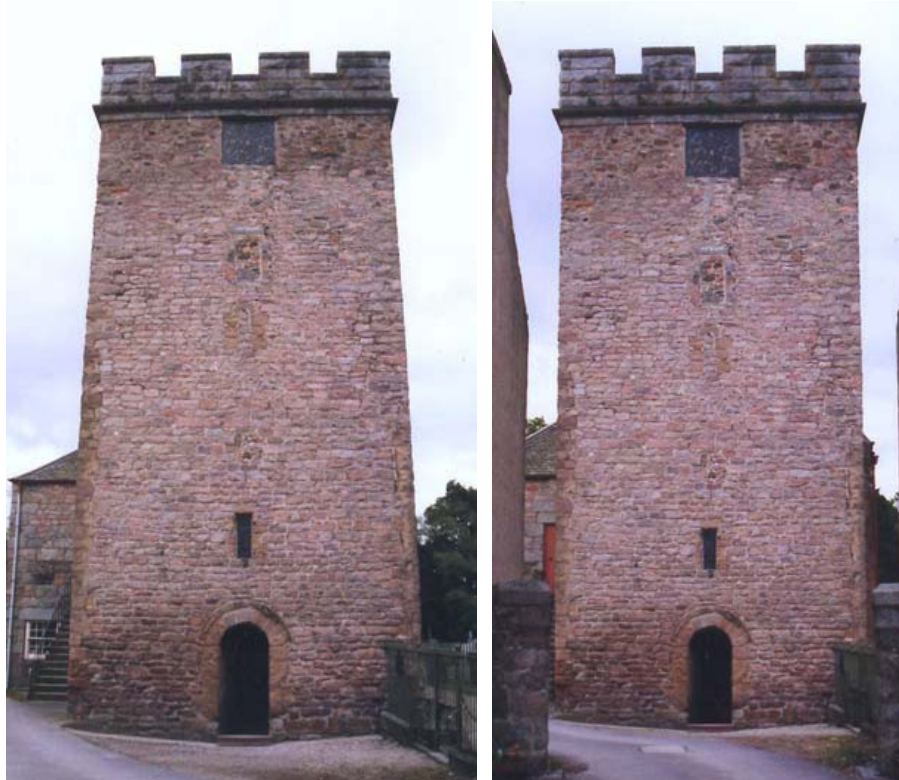
Figure 4: The west elevation of the tower. The left photograph is taken from about 6 metres while the right is taken from 24 metres. It has been taken with a straight on view, without obliqueness. Photograph by Gertie Ericsson 1997.

rectification of the photographs, a tripod and bubble level were used. All the lower elevations were photographed from a distance of twelve metres, while the tower elevations were photographed from a distance of twenty-four metres, to get the photographs as square on as possible (figure 4). The facade is not flat but is fairly interrupted, which is why each face was treated as a single unit. This was done to enhance accuracy, since change in depth means change in scale. Two-meter ranging rods were used for accurate scaling of the photographs. The advantage with this type of photographs is that an instant overview is gained, of the masonry and its character, which makes it easier to catch the different constructions and their relative chronology.

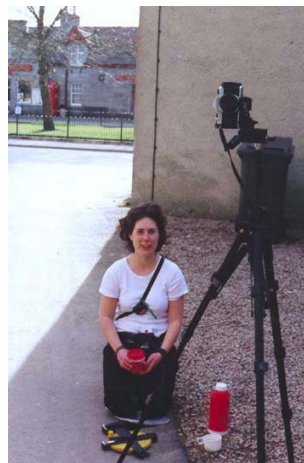
Figure 5: Shona waiting by the camera for the perfect light. The film is kept parallel with the wall plane. Photograph by Gertie Ericsson 1997.

A 35 mm Pentax single lens reflex camera format was used, with both a 50 mm and a 28 mm lens. Two different types of films were used, monochrome print and colourprint, in a varied range of speeds. A more light sensitive monochrome print film was used for the interior of the church. No additional lighting was used, which made the internal elevations of the tower fairly difficult to photograph. All the external elevation photographs were taken using a tripod, the distance from the elevation and the height of the camera being measured for each single photograph for easier overlapping in the production of the digital drawings (figure 4). The photographs were taken with the intention to be an accurate recording, to be used for the AutoCAD process, and the back of the camera was kept parallel to the wall surface as far as could be done (figure 5). The photographs were taken with a few different intentions, firstly for use in the production of the digital drawings and secondly for archive use. Thirdly the photographs were taken to assess the shape of the structure, like erosion, spalling, weathering of different kinds, the need for repointing, where repointing and change of stonematerial has been done. The photographs were taken to obtain minimal obliqueness, as square on as possible. To satisfy the criteria for effective

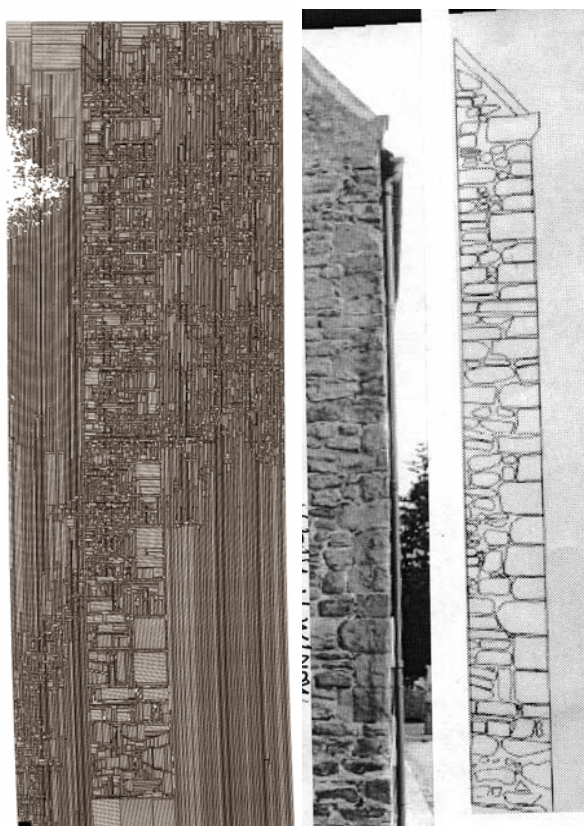
Figure 6: The southwest nave elevation in different formats. The left shows the outcome of a picture digitised in AutoCAD, being rectified in Aerial 5 and imported back into AutoCAD. Next picture shows the same elevation rectified in Aerial 5. The last picture shows the same elevation being digitised in AutoCAD and rectified in Aerial5. Printed out from Aerial 5. Pictures by Gertie Ericsson 1997.

Two different software types were suggested for working with the photographs and the collected data in the post excavation phase (figure 6). The idea was to rectify the photographs in the aerial photography software Aerial 5, using the data collected during the instrument survey, then importing it into Corel Draw or AutoCAD for the graphical work and the production of drawings. Several different steps were tried and failed before an attempt was made to rectify and digitise in the same software, AutoCAD. The software used was first and foremost AutoCAD releases 12 to 14. AutoCAD was, in 1997, one of the most powerful computer-aided design systems on the market. It also enhances the accuracy of the drawing, with the use of drawing aids that place the objects exactly where intended (Jeffries and Jones 1998, p XXV). AutoCAD offers accuracy, rectification and drawing speed. The described process proved successful and the drawings were produced from the rectified photographs. The actual digitising process started out with double-checking the data, after which the photograph was cellotaped to the digitising tablet. The tablet was calibrated using five x and y co-ordinates on each photograph, showed on the tablet in their true value. Each photograph was rectified in AutoCAD using the *transformation command*. The method involved the digitising of the photographs and the rectification of these via the control points retrieved at the survey. Each elevation required more than one photograph, so the angles were well chosen to create an overlap and a maximum accuracy of the control points. To keep track of the accuracy, a transformation form was created where the error of each single unit was given. The outcome of the survey was scaled, analytical and two-dimensional drawings, in plan, section and elevation. A wireframe of each elevation was created onto which the detailed drawings were hung. The drawings were made using a combination of photogrammetry and rectified photographs.

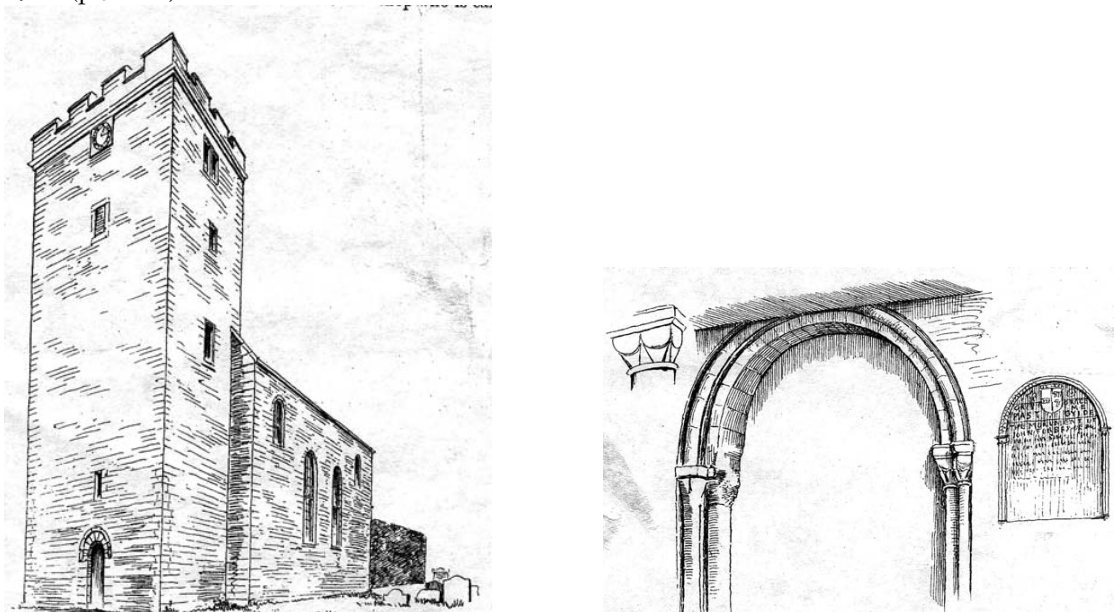
Figure 7: The church seen from the southwest and the chancel arch seen from within the nave. Drawings from the article by Macgibbon & Ross (1896-97, p 216 fig.184 and 185).

The next part of the article is the description of the structure itself. They call the foundations Norman and mention that the lower part of the tower and the chancel arch are the only remains of this building period. A simple drawing of the church, made by Macgibbon and Ross, show the construction from the southwest. One of the things obvious on the drawing is that the two bottom windows of the south nave elevation are missing, which means that they either must have been built later, covered in ivy or plaster (figure 7). Macgibbon and Ross

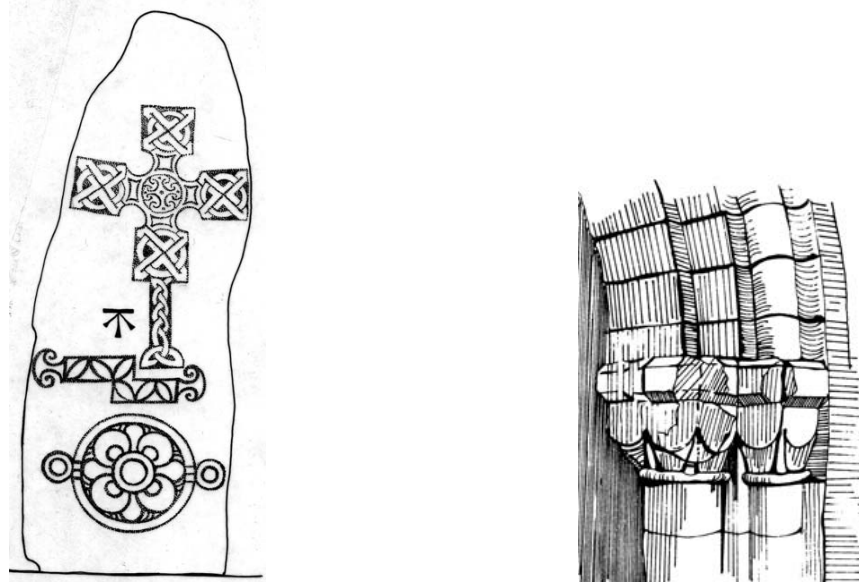
Figure 8: The Monymusk stone, and the south chancel arch capital, seen from the northwest. Drawings from article by Simpson (1924, p 37 fig. I and 61 fig. II).

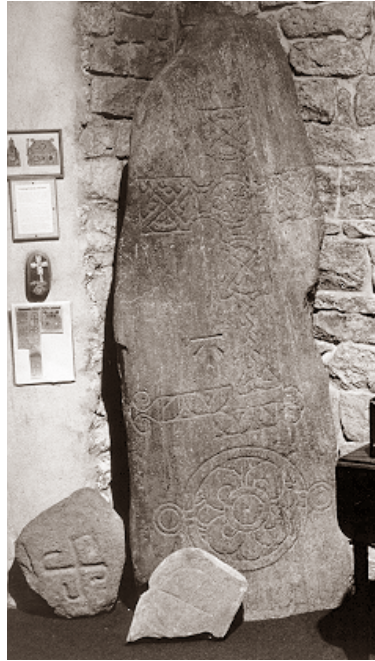
Figure 14: The Pictish standing stone and the two crossslabs, contained in the foyer of the church at Monymusk. Photograph by Gertie Ericsson 1997.

Among the other priceless relics of the church is the Monymusk stone or the Monymusk house stone (figure 14). This Pictish symbol stone is a large, upstanding slab, of undressed granite. The face of the stone has been decorated with carved Pictish symbols; the Pictish Z-rod and discs, the “step”, the “disc-and double ring” and an interlaced, square-armed Celtic cross, all ornamented with knot-work (Simpson 1924, p 36f; Simpson 1935, p 65ff). The five cross slabs in the churchyard and church, also suggest an early Christian origin for the site. They are engraved burial stones, dated to the 6th century. All five have different carvings (Simpson 1935, p 65ff).

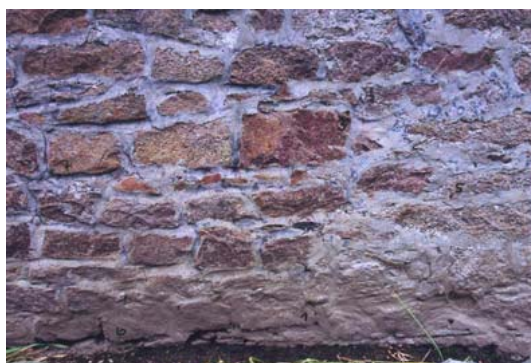
Figure 16: Different types of stones, limemortar and repointed cement. Photograph by Gertie Ericsson 1997.

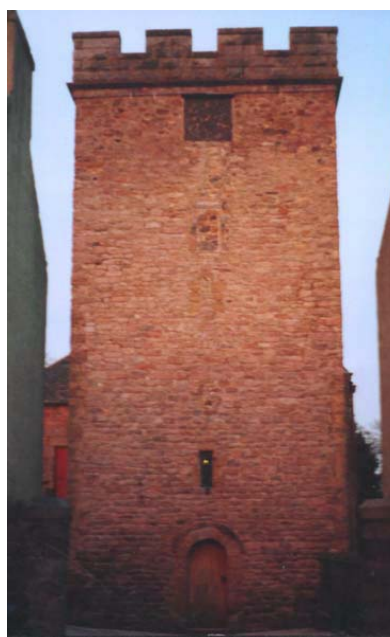
Figure 17: The tower at dusk. Photograph by Gertie Ericsson 1997.

The church is built of mainly granite, which is grey-pink in colour. The material is roughly dressed, the stones are sub-rectangular to sub-angular, and the outer faces are not straight. They are laid in regular courses, with the odd levelling course of small stones in between. The top of the tower is built of rubble and there a lot of small pinning stones have been used. The quoins, the arched entrance doorway and other decorated work are built of Kildrummy sandstone, like in the chancel arch (figure 17) (Simpson 1924, p 56; Whitely 1992, p 1ff).

The tower is a tall, square building at the westernmost extent of the church (figure 17, 20 and 21, appendix I). It is built in four stories, ended at the top with a lead roof and a crenellation. The tower has been given the block letter A (figure 15). The thickness of the walls of the different tower elevations is on the ground floor of the southwest - and east walls are 110 cm thick, while the north is 100 cm thick. The first floor south wall is 105 cm thick, the west and east are 110 cm thick and the north is 100 cm thick. The second floor walls are the same as the first floor walls, up until the height of 1040 cm, the east elevation of the second floor above this height is 100 cm thick. The third floor walls are respectively from south 110 cm thick, north 100 cm thick, east 80 cm, while the thickness of the west elevation changes from 110 cm to 95 cm a few decimetres from the roof.

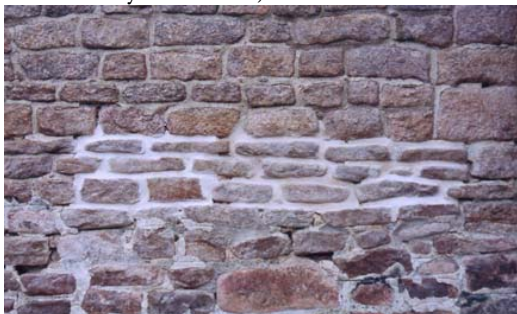
Figure 18: The south elevation of the tower, where repointing work was done in 1997. Photograph by Gertie Ericsson 1997.

Hildebrand 1988, p 64f). On the south elevation of the tower, repointing was made, after the fieldsurvey in 1997 (figure 18). This mortar is almost white and fairly soft, looks like limemortar.

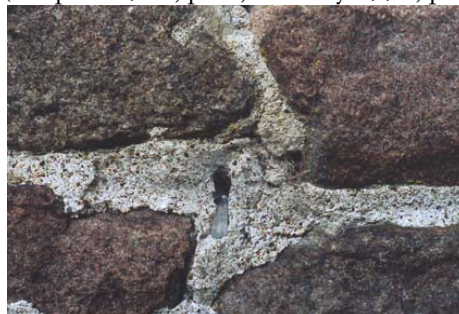
Figure 19: The south elevation of the tower where a piece of glass had been used as ballast in the masonry. Photograph by Gertie Ericsson 1997.

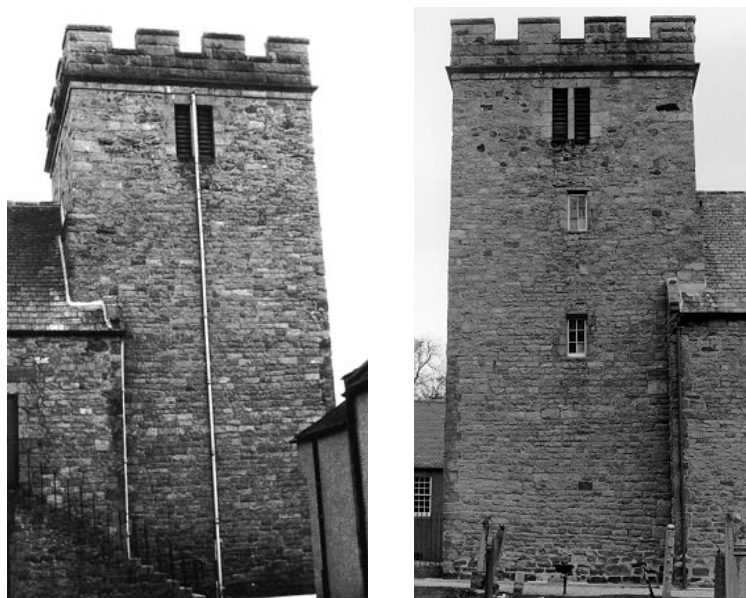
Figure 20: The north and south elevations of the tower. Photograph by Gertie Ericsson 1997.

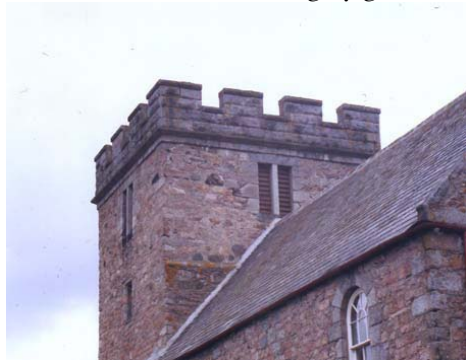
Figure 21: The east elevation of the tower seen from the southeast. Photograph by Gertie Ericsson 1997.

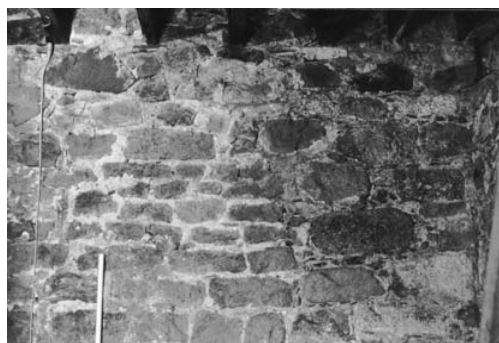
Figure 22: The second floor of the tower, showing the narrow nature of the interior. Photograph by Gertie Ericsson 1997.

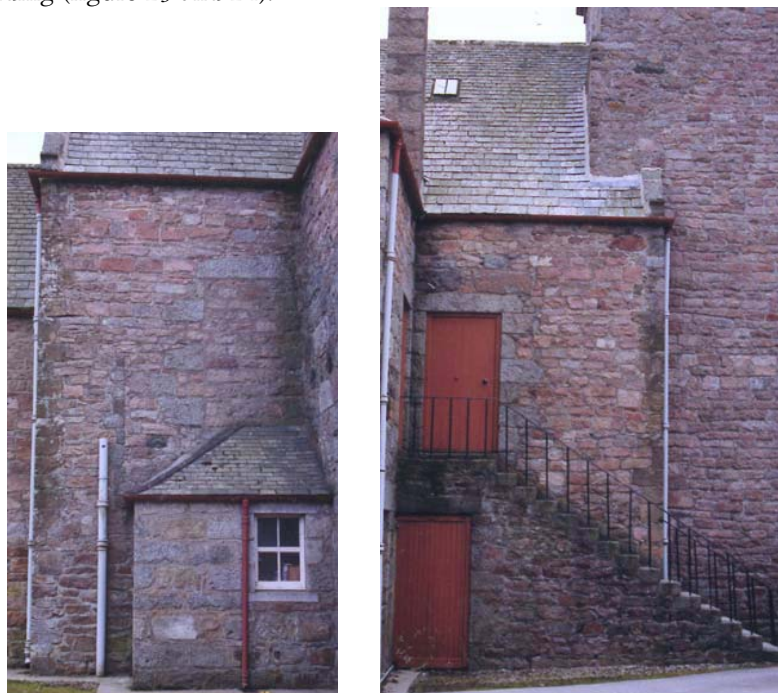
Figure 23: The north elevations of the nave. Photograph by Gertie Ericsson 1997.

The nave is a rectangular building, which has been given the block letter B (figure 15). It is connected, to the interior of the chancel, through the chancel arch and to the tower through the tower arch. It has got a gabled roof and is a quite tall building (figure 23 and 24).

The north wall of the nave is more disturbed than the south, mainly due to the build of the modern north aisle (figure 23 and appendix I). At the same time the interior galleries were being renovated, doorways leading to these were being opened all around the year 1822. There is an open doorway in the west part of the wall, leading into the west gallery and the first floor of the tower. Leading to the door is a stair leading up to the gallery door and into the session room. There is a rectangular doorway leading into the space under the stair, which has probably, been used for storage. The east part of the wall contains two redundant features, a doorway and a window, on a first floor level. The doorway is situated on the same height as the gallery doorway on the northwest part of the elevation, so this is probably the doorway leading to the east and north galleries. The doorway has got lintel and rybats of granite and the other redundant feature is a window, consisting of rybats of granite. The masonry of the northeast part of the wall is of five different building phases. The bottom courses consist of large subangular to subrectangular stones, high in the course. The masonry is coursed, with wide joints. The bonding agent is limemortar. This masonry has only survived to a height of three courses. The quoin up to a height of eight courses could also belong to this period. Above the three courses is the next type of masonry, where the stones are coursed red, granite ashlar; varying from sub-rectangular to semi-circular in shape; the joints are wide. Above this the sandstone quoin and the third type of masonry coursed with it. On the northeast the masonry is built of small pink granite stones, of small, roughly dressed stones, subrectangular. They are neatly coursed, with the odd levelling course. The joints are narrow and pointed with limemortar. Within this masonry is a redundant doorway. On this elevation the sandstone quoin is still in situ up to roof height. The sandstone quoin exists up to the same height as the before mentioned masonry, where there is a clear break. Above this break the quoin and the skew-putt are built of granite and the masonry looks fairly modern in appearance. The nave is of the same height as the north building, but they are not bonded in at the corner. The ridges of the chancel-and nave roofs run at the same extent, both these buildingparts have gabled roofs (figure 23 and appendix I)

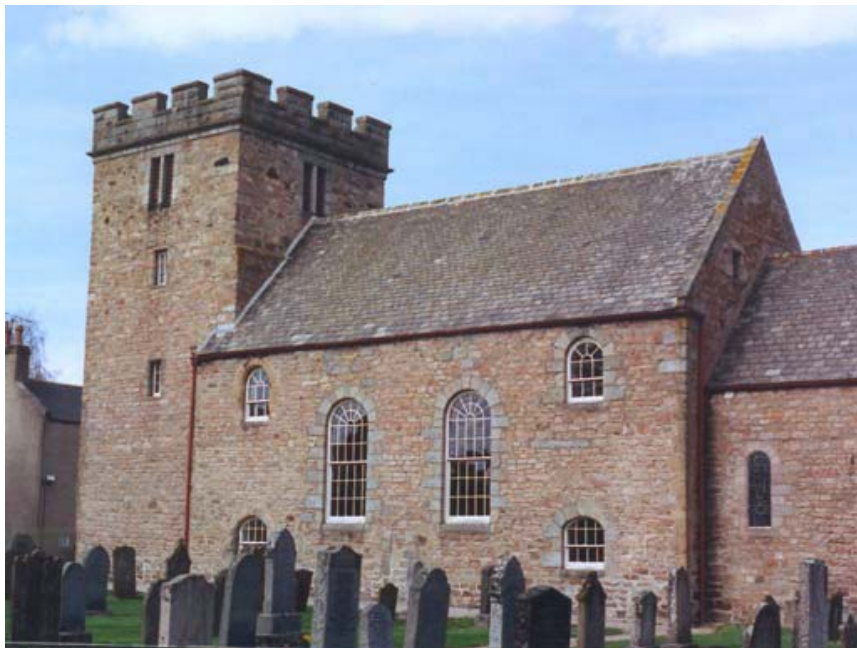
Figure 24: South elevation of tower and nave. Photograph by Gertie Ericsson 1997.

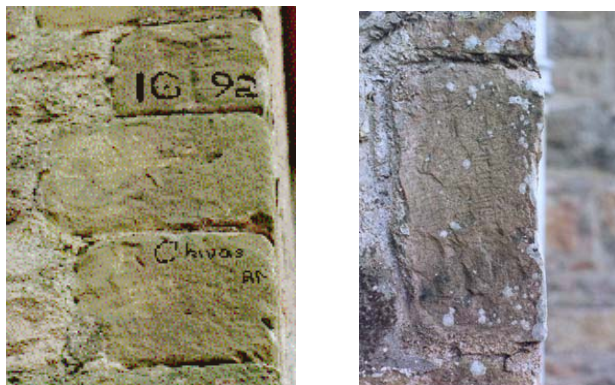
Figure 25: A few mason's marks on the northeast elevation of the nave, and chiselmarks on the northeastern quoin. Photograph by Gertie Ericsson 1997.

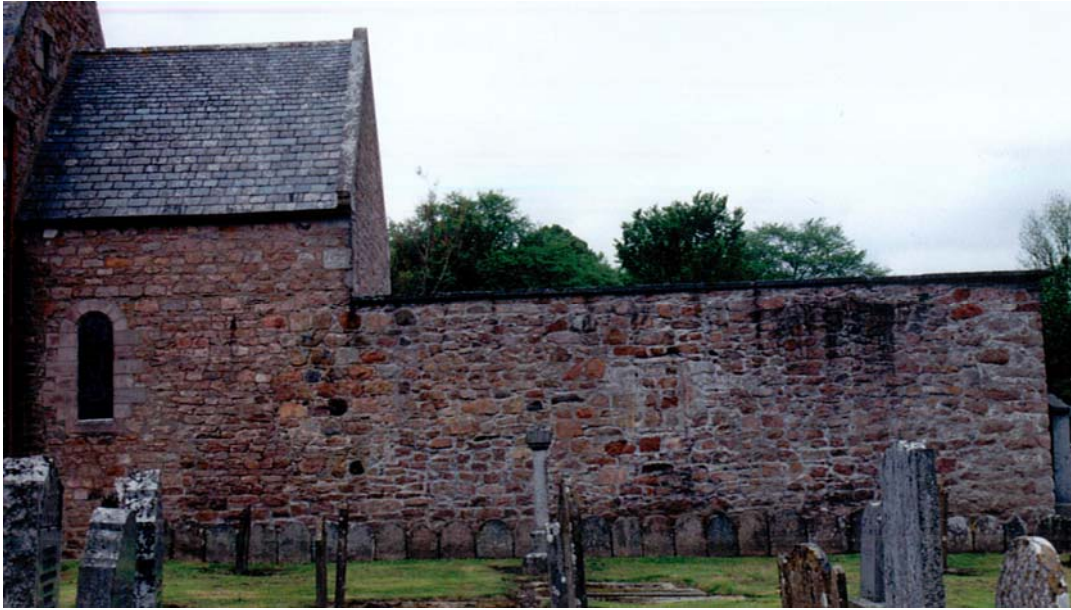
Figure 26: The extended south elevation of the chancel. Photograph by Gertie Ericsson 1997.

The chancel is normally the easternmost part of a parish church (figure 26, 27 and appendix I). The chancel has got round-headed windows in the south-and east elevations. It does not have an apse, the ending is square. The eastern wall is modern. The window may have been reused from another building, but it is not secondary in the masonry. The earliest extents of the chancel are approximately half of buildings C and D of today (Appendix I). Here the masonry is built of larger semi-rectangular stones, of pinkish-grey granite, high in the course. The stones are roughly dressed. The joints are fairly wide and pointed with white-yellow limemortar. On the north wall this old masonry survives in the west corner, up to 22 courses, and the lowest three courses stretch to the modern north doorway. On the south wall the masonry remains in the west corner, 21 courses high, and also parts of the lowest 6 courses approximately to the modern extents of the chancel. The corners between the chancel and nave are coursed. The next dominant building part shows the extended masonry of small, sub-rectangular granite stones. These are evenly coursed. The next extension of the chancel starts at what seems to have been tuskers. In modern times, 1822, an eastern wall was erected; to once again close off the chancel area. This wall is not bonded in with the masonry in the south and north walls. Above the walls of the burial enclosure in the east extent of the chancel, the quoins are built of large, dressed granite ashlars. The building has got a gabled roof. The structural bearings of the roof are built of wood, while the covering is of slate tiles. The roof is 365 cm high, and the full width of the building is 530 cm (appendix I).

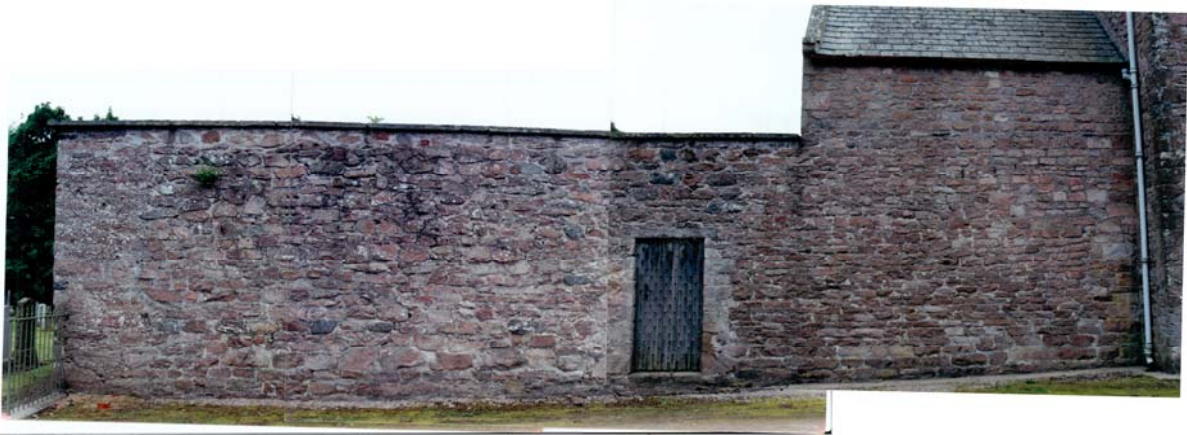
Figure 27: The north elevation of the extended chancel, now in use as the Lair of Grant burial enclosure. Photograph by Gertie Ericsson 1997.

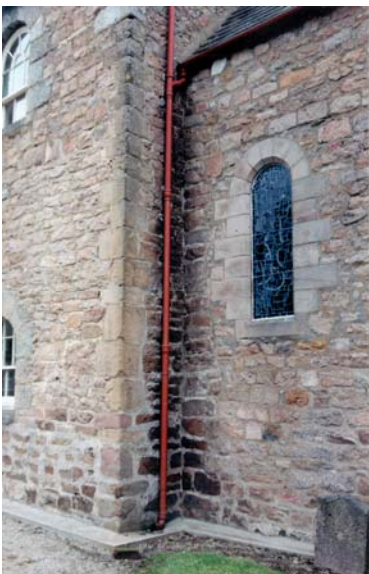
Figure 28: Masonry of phase one, southwest extent of chancel. Photograph by Gertie Ericsson 1997.

The masonry in the chancel shows a lot of different building phases. The predominant fabric is built of small, sub-rectangular granite stones, which are evenly coursed. Most of them are pink in colour. Between building parts C and D there is a large patch of disturbed masonry, which shows that there probably have been structural weaknesses and collapse. This may have occurred when the modern east wall was erected, for easier accessing the building area. The masonry of the east wall was not possible to survey, since we did not gain access to the burial enclosure area and the interior of the chancel is rendered white. The extent of the present chancel is to the east, the modern east elevation (figure 26 and 27).

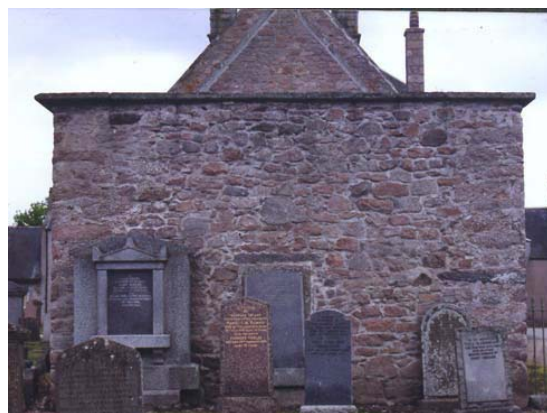
Figure 29: The east elevation of the lair of Grant burial enclosure. Photograph by Gertie Ericsson 1997.

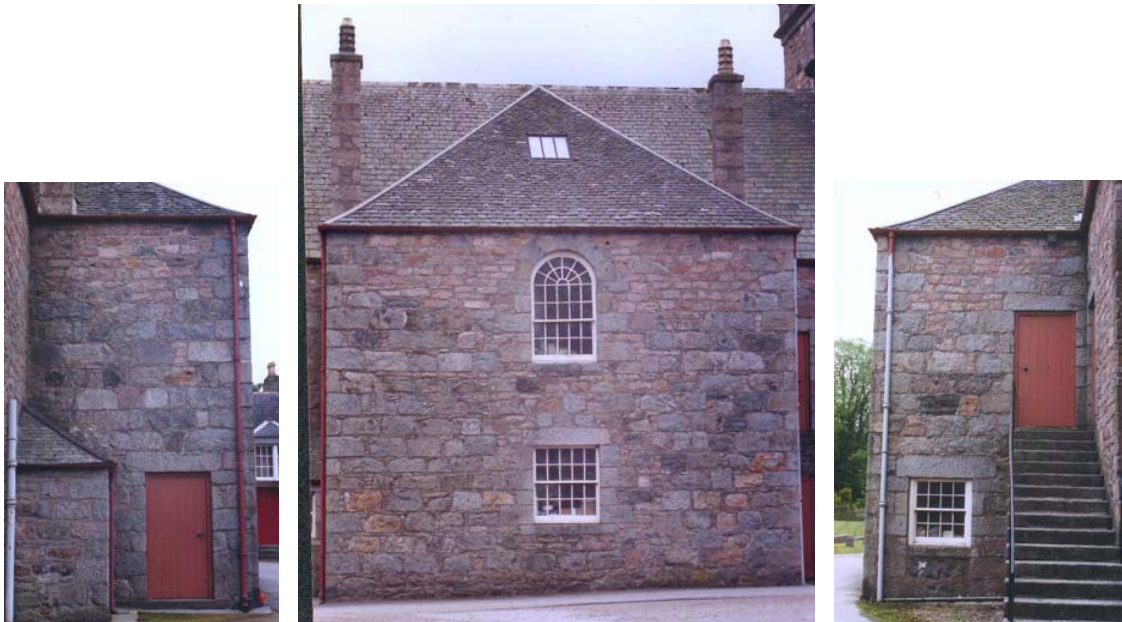
Figure 30: The modern north aisle. The east, north and east elevations. Photograph by Gertie Ericsson 1997.

blocking. The lintel, rybat stones and sill are all coursed with the surrounding masonry. The staircase is 290 cm high; at the bottom 550 cm wide and at the top 130 cm. The masonry of the staircase contains pinkish-grey, sub-rectangular granite stones, roughly dressed, with a lot of levelling courses. The joints are narrow and the bonding agent used is limemortar. Later repointing has been done with cement. In the bottom courses the mortar is in a bad shape and there are several voids between the stones. It is a rectangular door, with lintel and west rybat stones of dressed, grey granite ashlar, out- and inband. The steps are built of rectangular blocks of grey granite, and the top of the stair seems to have been renewed when the steps were changed. In the renovations cement has been used as bonding agent (figure 30).

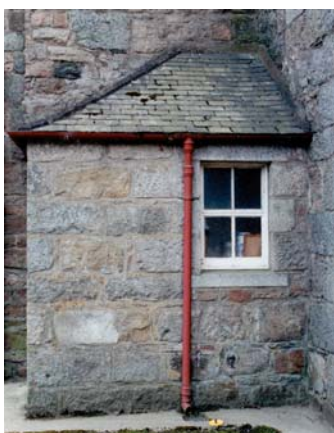
Figure 31: The toilet on the north side of the complex. Photograph by Gertie Ericsson 1997.

The toilet is a small square building, a modern attachment to the North Aisle (figure 31). The toilet has been given the block number F (figure 15). There is a rectangular window in the north wall, with a lean-on roof. The roof height of the toilet is 330 cm high. The thickness of the walls is 35 cm. The masonry is built of large granite ashlars with fairly wide joints. The bonding agent used seems to be cement. The embrasures around the window is of granite ashlars, laid in out –and inband. The roof covering are slate tiles (appendix I).

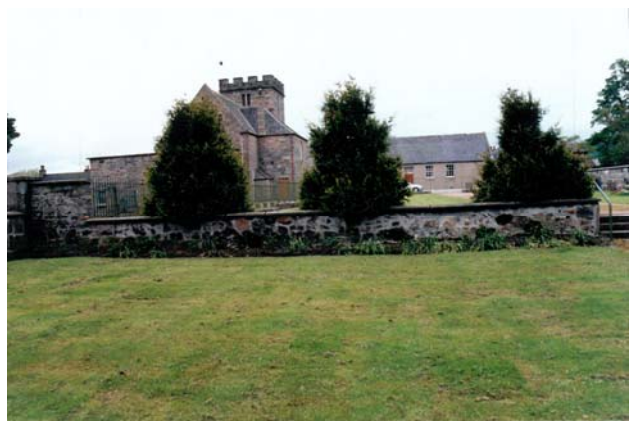
Figure 33: The relation between the lay buildings and the church. Photograph by Gertie Ericsson 1997.

the history of the church. On this occasion there was no time to do the survey, so the only a quick survey with a principal annotated sketch of the remains and photographs (figure 32, 33 and 34).

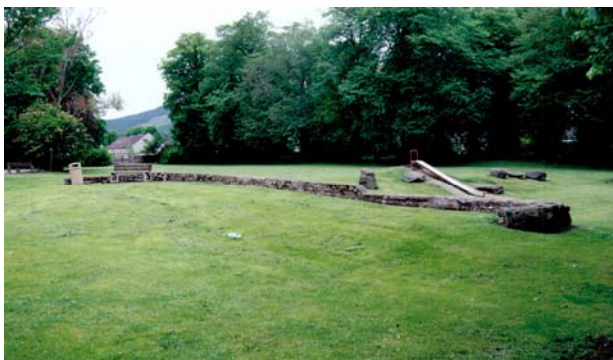
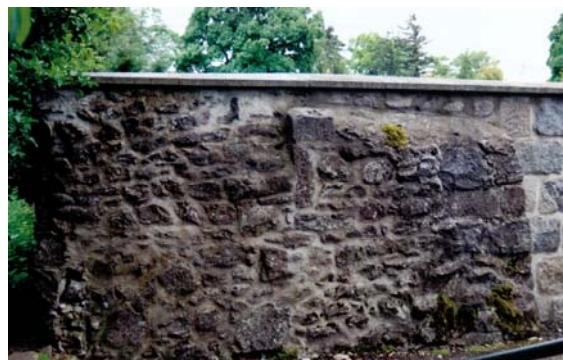
Figure 34: The northernmost part from the southeast, perhaps the dormitory; the easternmost part from the north, which might be the refectory. Photograph by Gertie Ericsson 1997.

The remains of the presumed priory buildings, are for example a long, low wall, forming a square ending in the north. It contains a long wall, oriented east to west with a small wall projecting southwards in both ends built of rubble with a cement top (figure 34). The rubble has rounded outer faces and is laid in limemortar. It is about three courses high on the westernmost extent, while halfway to the east it gets lower and there it is only two courses high. This seems to have been the northernmost extent of the priory conventual buildings. South of this, are the walls for the new churchyard, where the lowest courses of the walls also belong to the conventual buildings. The masonry of these walls is large, square blocks of granite, with wide joints. It is between four and four-and a half courses high. On the inside the wall is between five and five and a half courses high; the lowest course of this contains the same masonry as the long square shaped wall mentioned above. It has got the same east-west extents as the northernmost wall. These two could have formed a large, rectangular hall for the priory. Since it is situated furthest away from the church, forming the most private part of the complex, it was probably the dormitory (figure 34).

On the eastern extent was a wall, which was not connected to the before mentioned walls (figure 34). The west facing parts consists of worked stone laid to form a corner, five stones high. There are no matches on the other side of the wall for this first part; the easternmost though has a corresponding south side. The masonry was small random rubble, with the odd stone looking more worked, like the above mentioned possible dormitory. The buildings had wide joints, where the bonding agent was limemortar but repointing work had been done with cement. The wallpart was orientated north-west to south-east. The wall projecting northwards from the easternmost corner was a low wall, built of random rubble. Attached to it was a wall jutting out northwards, between 2 and 3 m. In the eastern part of the north churchyard, are two gateposts, and between them was a flat stoneslab, which can be the threshstane of the original conventual buildings. Considering the fact that all the remains are to the north of the threshstane, the entrance to the complex is likely to have been from the south. In the northeast corner of the area are two wall parts orientated south to north built of random rubble. The southernmost ends in a tall wall which has got a random rubble core but the corner is built of worked stone, about 150 cm wide and 200 cm high. In the low extended wall the stones are larger and chunkier than in the rest of the wall. There does not seem to have been any physical connection between the conventual buildings and the church. However, in the north elevation of the burial enclosure has some suspicious looking scars that may prove a connection, such as a crosswalk. In the prolonged chancel there was one door in the south elevation in phase three, there may have been a doorway in the north (where the door is today) in phase four and a doorway in the east elevation during phase five. They could have been used by the convent to easy access to the shared church building. To be able to prove this a more extensive survey of the conventual buildings has to be undertaken.

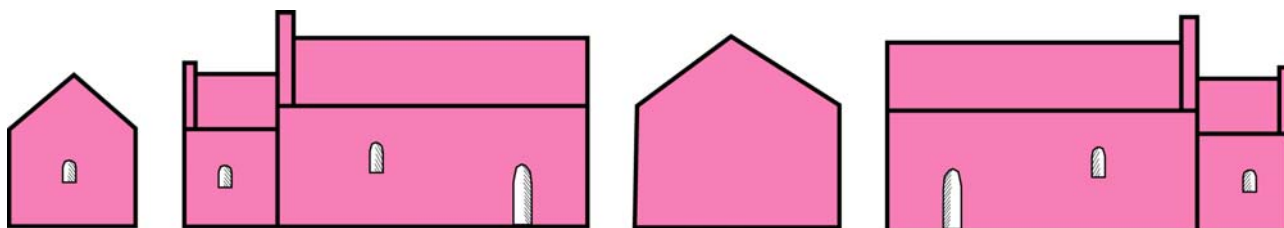
Figure 36: Reconstruction of the appearance the church may have had in the 10<sup>th</sup> and 11<sup>th</sup> centuries. By Gertie Ericsson 2009.

The choice of site for these early churches and chapels, blessed to the new faith, would in many cases depend on existing centres of population or by pagan holy places. A stonechurch was probably built on the site before 1078, perhaps by an aristocrat in the area, or by Christian missionaries. Local aristocrats founded churches, even before the parochial system had been organised. The early importance of the village and area is shown by the presence of a Pictish standing stone. 19<sup>th</sup> and 20<sup>th</sup> century scholars all agree that the origins of the foundations are from before the Norman Conquest in 1066 (Macgibbon & Ross 1896-7, p 215ff). There is no mention of the church before

the grant by Malcolm Canmore in 1078, so the original dating of the church cannot be found in the written sources; however most scholars believe that there already was a church this date. The earliest church on the site of Monymusk may have been the foundation of a local laird.

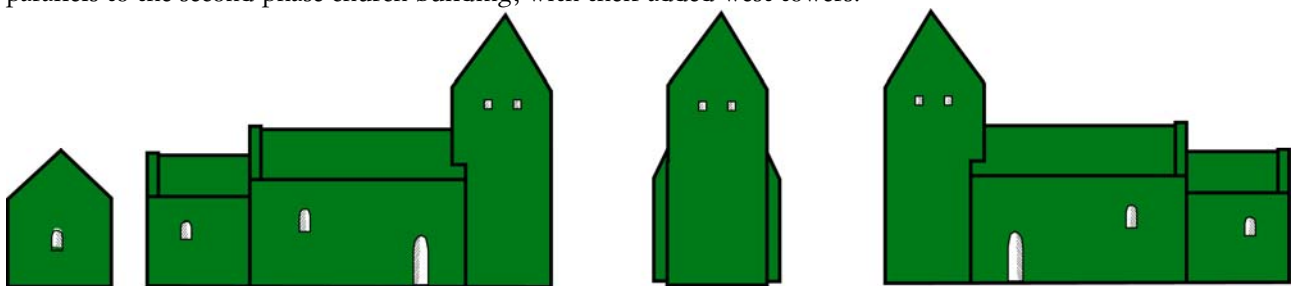
Figure 37: Reconstruction of the appearance the church may have had during phase two. By Gertie Ericsson 2009.

A major building operation took place where the earlier parts, which may have been in a bad way, and were deconstructed down to an appropriate foundation level (appendix I). The chancel was kept in its present state, up to the full height it had until the 20<sup>th</sup> century. The nave was torn down, or perhaps it was in ruins already and in need of a renovation. On the west end of the south elevation there was a door, which probably had a match on the north elevation, which today is obscured by the north aisle. The tower was built with a square plan, and it was coursed with the nave. The height of the tower is difficult to reconstruct from the remains now visible. The masonry was built up of granite with colour variation from grey to pink to dark red. The stonematerial was subangular, laid in fairly even courses. The stones were roughly dressed with straight outer faces. The joints are wide and have in modern times been scribed. This fabric is found on all elevations of the tower (except the east), and it is visible on all but one of the nave elevations. On the south tower elevation the remains are between 5 and 6 courses high, west tower elevation between 5 and 6; north about 10 courses high. The north nave elevation is disturbed, contains remains of phase two masonry in the bottom courses of the northeast part. Although there can be remains of this phase behind the north aisle, which was built in 1822. The original bonding agent was limemortar. The tower arch is original in the tower, and it was the entrance from the nave into the tower, to reach the upper floors. The heavy, square moulded tower arch was built of sandstone, probably similar to the choice of material for the quoins. The masonry surrounding it was contemporary with the masonry of the other walls of the portico, phase two. The space was not vaulted and the ceiling height was probably fairly great.

*Conclusion:* When Malcolm Canmore came to Monymusk he probably found a church in great disrepair. The walls in the nave were taken down to appropriate foundation levels and were then rebuilt. The parts remaining from the church after the grant of King Malcolm Canmore are in the nave and the tower (figure 37). The chancel was not affected by the buildingoperation. A tower was built which was bonded in with the new masonry of the nave, which was square and heavy. In the west end of the south nave elevation was a doorway leading into the church, and perhaps there was a match on the north elevation. The tower arch was pierced through to the nave. The nave was built up from the ground and the south, north and west walls were moved outwards to build a larger nave. The Culdees probably settled on the site, and shared the church with the parish.

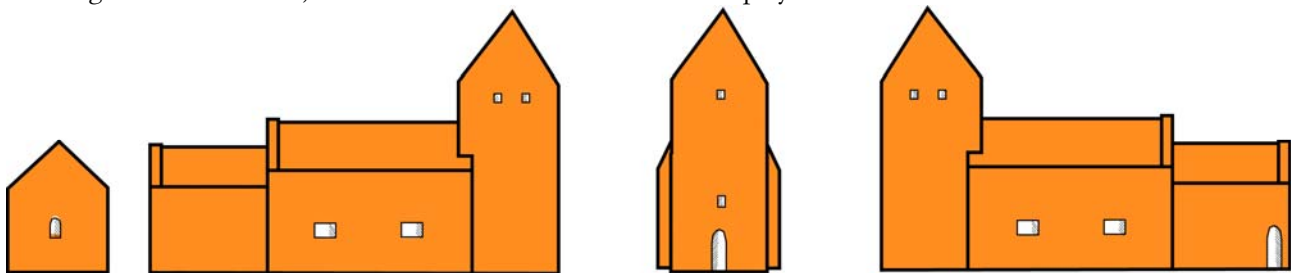
Figure 38: Reconstruction of the appearance the church may have had during phase three. By Gertie Ericsson 2009.

The convent was probably built during this period, when Gilchrist the earl of Mar gave the Culdees lands and dues. The remains of the conventual buildings are still present at the edge of the forest, northeast of the church. The low wall remains are built of random rubble, laid in limemortar. The church had again fallen into disrepair, and it is said in the grant that the earl built a church together with the conventual buildings. The walls were taken down to a structurally sound level. During this building operation the chancel seems to have been prolonged. These long chancels were later than 1066, together with side chapels and west towers (Little 1985, p 103ff). The rectangular space in the nave was originally designed as a space where the parishioners were to gather. The masonry comprised of coursed, semi-rectangular to cubical, roughly dressed smaller stones with fairly wide joints. The material choice is pink to red granite ashlars. The joints had been pointed with lime mortar. The masonry of this building phase is also visible in the nave and the tower. In the nave the masonry is visible up to a height of 2/3 of the total height of the building. The sandstone quoins also seem to have been added at this time, they are coursed with the rest of the masonry. The masonry of differs totally from that of earlier periods. In the south elevation, fairly close to the east extent of the chancel of this time is a redundant doorway, which may have served the clergy during the first period of the shared church building. The church kept a Romanesque appearance since. The church at Monymusk still contained of a chancel in the east, now a fraction prolonged; a nave which keeps its appearance from phase two. There was a window built in the south elevation of the nave, which may have had matches on the south and north elevations but these are obscured by later additions. The tower had been deconstructed and rebuilt during this phase, and the west entrance door was original in the masonry. The low window of the west tower elevation is primary in the masonry and probably the windows of the building were of this kind, narrow windows with a wide inward splay.

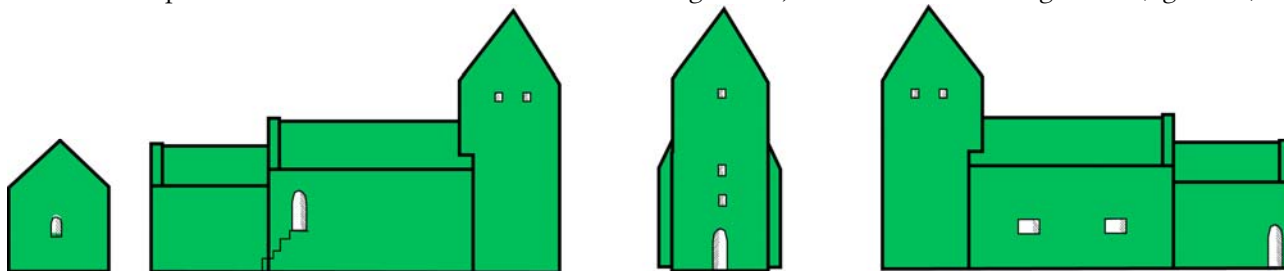
Figure 39: Reconstruction of the appearance the church may have had during phase four. By Gertie Ericsson 2009.

During phase four the church was rebuilt to a certain extent. The interior of the church and the tower was reached from within the ground floor of the tower through the west civil door. The top floors of the tower were reached via an interior stair or perhaps a newel stair in the portico of the tower. The chancel was prolonged another few metres. The new clergy probably found the space within the chancel too small, and perhaps they wanted to change and decorate the space according to their liturgical practices. A rectangular window was inserted in the south elevation of the chancel with embrasures of granite. The interior of the chancel was probably reached through the doorway in the south of the chancel, opened during phase three.

*Conclusion:* In the **fourth phase**, 13<sup>th</sup> century, the Culdee community was about to be transformed into an Augustinian community of canons regular, a transformation completed by 1245. The church was rebuilt, to suit the new clergy dwelling there. The church was shared between the priory and the parish. A common loft was built along the interior of the north nave elevation; a door was opened on the first floor of the northeast nave wall, to gain access to the loft. The chancel was prolonged, the doorway in the south elevation was kept in use and a window was opened in the south elevation. The nave was heightened, and the tower was heightened (figure 39).

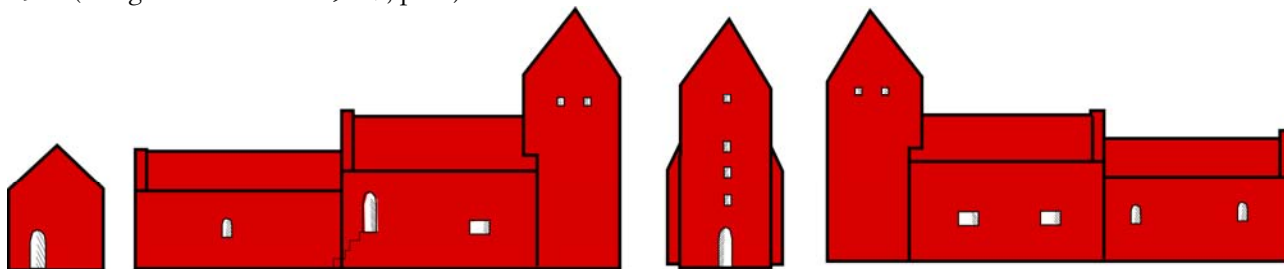
Figure 40: Reconstruction of the appearance the church may have had during phase five. By Gertie Ericsson 2009.

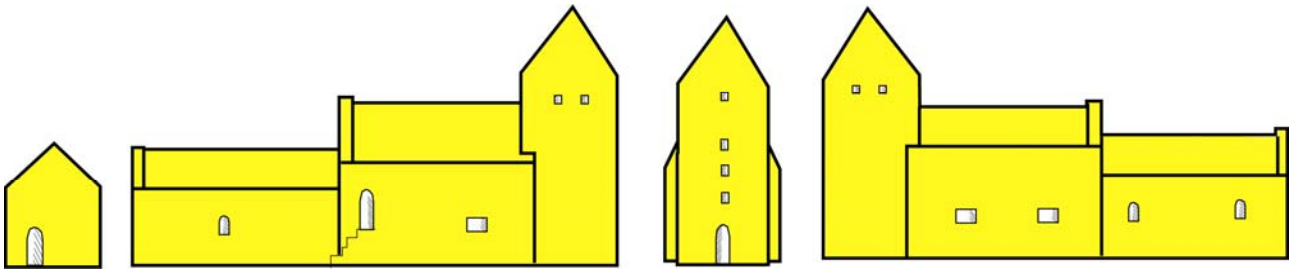
Figure 41: Reconstruction of the appearance the church may have had during phase six. By Gertie Ericsson 2009.

The church was probably to a certain extent in ruins or at least without a roof and the conventual buildings were levelled. The top floor of the nave was renovated together with a few patches on the tower and the chancel. The interior was probably renovated too, and masonry of this period consists of roughly dressed granite stones with rounded outer faces. The stones are subangular to subrectangular and show a much larger variation than the medieval fabric below. As in the rest of the building the colour variation of the stones is great, but fairly greyer than the ancient masonry. The masonry is coursed, but the height of the courses varies greatly, and the odd levelling course is present. The bonding agent is limemortar, with ballast inclusion of large grit, chunks of coal and lime. The joints are fairly wide and are set back from the surface of the masonry. The masonry of phase six is similar in appearance to phase four, however more random and rough. Galleries were often inserted in these churches for growing congregations, and that also seems to have happened at Monymusk, where the common loft in the north was still in use and a west gallery was inserted. For reaching the common loft the nave door was still in use. The top of the nave walls had fallen into disrepair and were renovated together with the roof. Along with this quoinstones of the tower were replaced, situated on the southwest corner. A few minor renovations of the masonry have also been done.

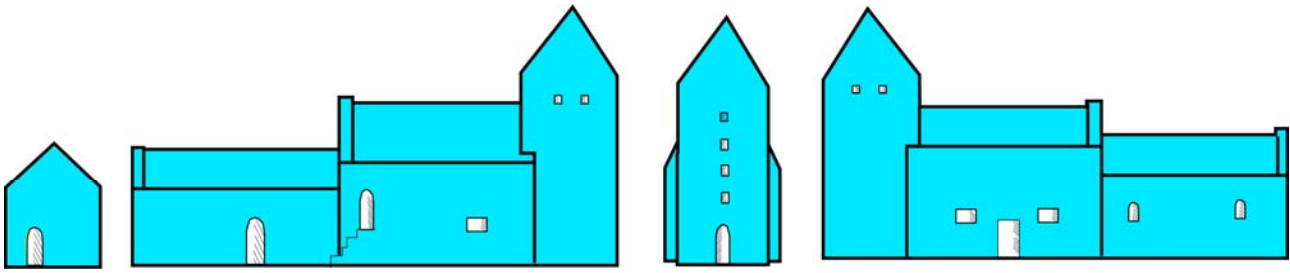
Figure 42: Reconstruction of the appearance the church may have had during phase seven. By Gertie Ericsson 2009.

*Conclusion:* The church keeps changing with the new protestant beliefs. The seating was altered and wooden benches were fitted along the north and south sides of the nave. The prolonged chancel changed and the seating was organised. The quoins of the tower were renovated, and a window was inserted in the west tower elevation. The quoin on the southeast nave elevation was renovated. The east door in the chancel was made redundant and instead a new north door was inserted in the north chancel elevation (figure 42).

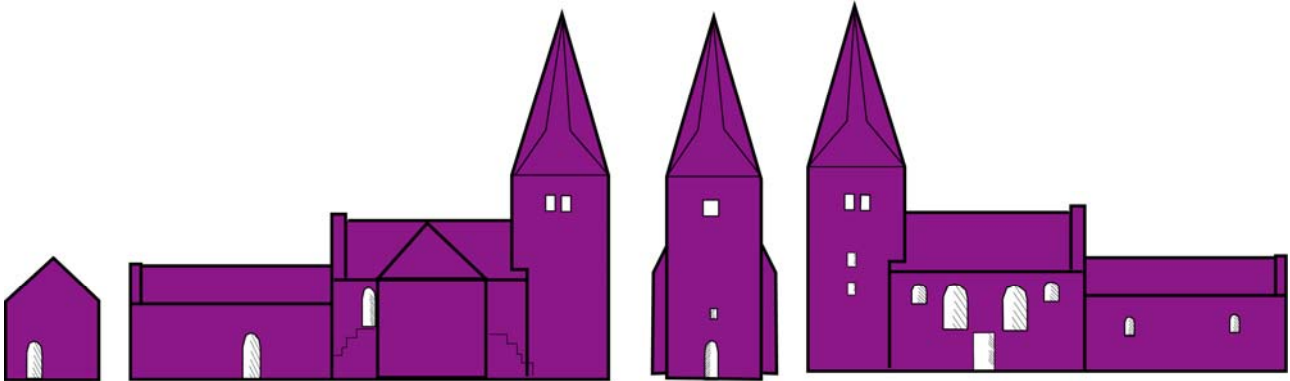
Figure 43: Reconstruction of the appearance the church may have had during phase eight. By Gertie Ericsson 2009.

This phase involves some minor building operations and one major. In 1723 the clock on the west facade of the tower was dressed; it had only been fitted in 1697. John Mowat was the man behind this and he had also cast the new bell of the church. In 1726 the west loft was about to fall and it was renovated. In 1778 a music gallery was present in the east gallery. In 1770 the dial plates of the steeple were painted (Simpson 1924, p 52). The major building operation of 1822 may have lasted until as long as 1834. The Presbyterian congregation of the St Mary's used the Episcopal Church across the street, while their church was being renovated. In 1834 there is a note which makes us understand that the favour is being repaid and that the Episcopal congregation is now using St Mary's for worship while their church is undergoing repair (Simpson 1924, p 53).

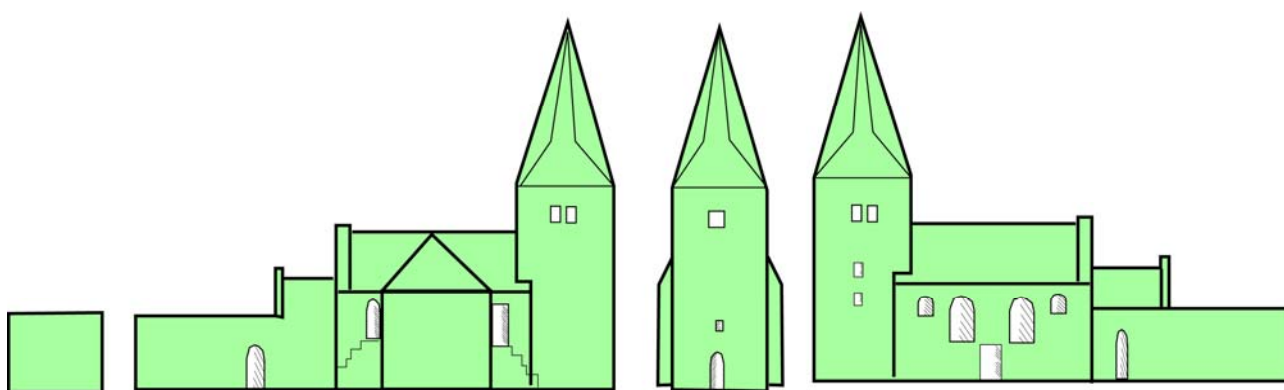
Figure 44: Reconstruction of the appearance the church may have had during phase nine. By Gertie Ericsson 2009.

During this building operation a lot of things happened, and a lot of changes came about. The clock was again fitted on the west tower elevation. The tower was now in a bad way, and had to be repaired, and a tall octagonal spire was fitted. Once the parapet had been removed it was noticed that the masonry below it was bulging and seemed unsound. Therefore about parts of the wall head had to be taken down, all around the tower. The whole east tower elevation was redone. The Romanesque masonry was then refitted with random rubble laid in cement. The stones were natural, undressed boulders, mixed with much smaller stones, the so-called pinning stones. On the top floor of the tower three belfry windows were opened, in the east, south and north. They contain of two-light windows with brick rear-arches and ashlar built ingoes. On the second floor of the tower the rubble masonry is mainly visible in the corners. On the top floors the masonry was built of random rubble. The height of the tower was probably about one storey more than today. The floor levels of the interior were altered. The roof height of the first floor was raised from 1.96 m to 3.35 m. The remnants of the old heights are still there in the shape of joistholes. Before this the tower contained at least six floors and now only three. New windows were inserted in the first and second floors of the south elevation of the tower. When the floor levels were altered two of the apertures of the west elevation came out of use and were blocked up. From these and the blocked up joist holes of the second and third internal tower elevations, the original floor divisions can be traced. The tower above the nave roof head has been made thicker by putting a ledge along the nave roof. Here the tower is wider, for security reasons probably, to hold the heavy broach spire. The nave roof was built and altered in 1822.

*Conclusion:* In the 18<sup>th</sup> century the clock was fitted in the west elevation, which was refitted after 1822. The west gallery was renovated and the east gallery was turned into a music gallery. In 1822 a major building operation took place which lasted until 1834. During this building operation a lot of things happened, and a lot of changes came about. The tower was fitted with an octagonal spire, and a lot of the masonry was taken down because it was unsound, which was rebuilt and the whole east elevation was redone. Belfry windows were opened on the top floor of all four tower elevations. New windows were inserted in the first and second floors of the south elevation of the tower. Two windows in the west tower elevation were made redundant while two windows were inserted in the south tower elevation. The nave roof was built and altered in 1822. The modern north aisle was built, with stairs on both east and west, leading to doors in the northeast nave elevation and west north aisle elevation. When the north aisle was built a lot of masonry from earlier periods in the north nave elevation disappeared. On each the west and east sides of the building stairs were built, which led to the first floor. There were probably doors both leading through the walls of the north aisle and the north nave walls. The appearance of the church was dramatically altered between 1822 and 1834 (figure 43).
