# **Evaluation of Heavy Metals in Waters Influenced by Mining in the Poopó and Antequera River Basins, Oruro – Bolivia**

*A Minor Field Study*

Division of Water Resources Engineering  
TVVR-10/5001  
ISSN-1101-9824

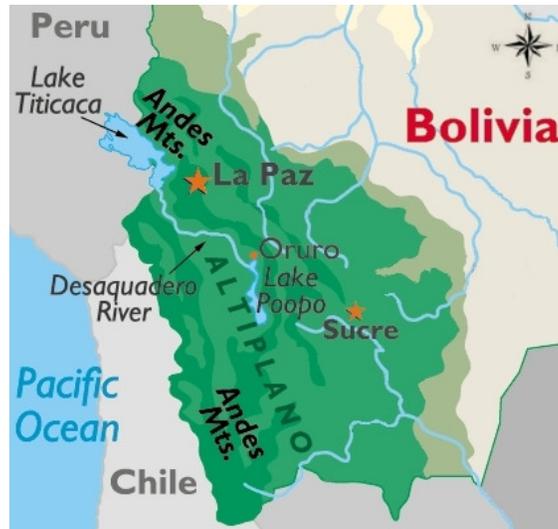
Figure 2-1. Map showing the Bolivian Altiplano, with Lake Titicaca, River Desaguadero and Lake Poopó. Based on Graphic Maps (2010).

The Altiplano is a 191 000 km<sup>2</sup> large high plateau situated in the Andes between the two mountain ranges Cordillera Oriental and Cordillera Occidental in western Bolivia, see figure 2-1. This high plateau is shared between three countries, Peru, Chile and Bolivia. The plateau is not completely flat but has mountains rising some hundred metres over the main elevation at 3700 metres; see Figure 2-1 (PPO 9603). The Altiplano is divided into four different eco-regions; semiarid/arid plateau, semiarid plateau, saline desert and dunes, with most of the lands belonging to the first two categories (PPO 9608).

Lake Poopó is a part of Titicaca-Desaguadero-Poopó-Salar-system (TDPS-system), see figure 2-1, which is the major basin on the Altiplano and is an enclosed system. This basin originates in Lake Titicaca, which drains through the 300 km long Desaguadero River to Lake Poopó. The water level in the lake is totally dependent on the level in Titicaca. The Desaguadero River also provides Lake Uru Uru just north of

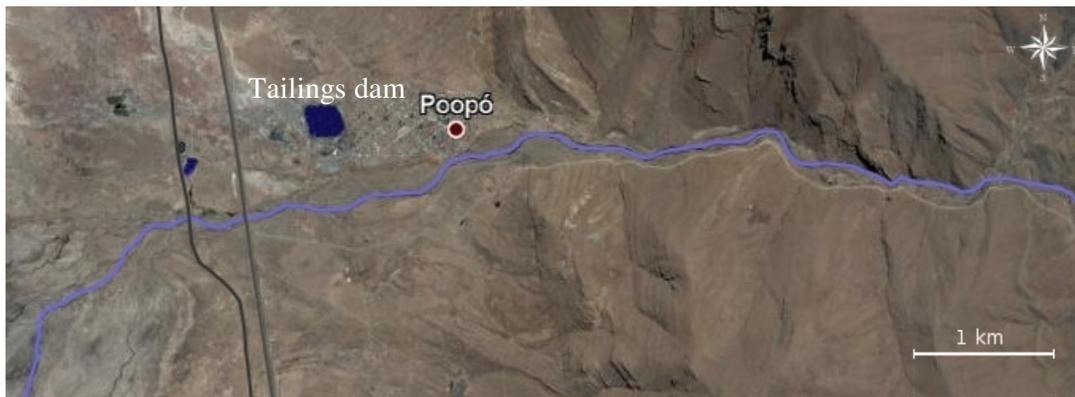
Figure 4-1. Map showing the Poopó Village, with the river flowing from east to west, a large tailings dam marked in dark blue and the road and railroad at the west side of the village.

One of the studied areas is the Poopó River basin, see Figure 4-1, which is situated 56 kilometres south-east from the city of Oruro and a further 285 kilometres from La Paz, see Figure 2-2 for a typical sight of the Altiplano close to Poopó Village. The area of the sub basin is 109 km<sup>2</sup> and the Poopó River is flowing through the valley starting about 10 kilometres east of the village (PPO 9606). The population is about 3000 people excluding various settlements around the village which accounts for about 650 people. The ethnical groups are Quecha and Aymara (Ministerio de Desarrollo Sostenible, 2005). The following sections include a description of the water resources, the mining activities, the sampling points and conclusions drawn in previous studies done in the basin.

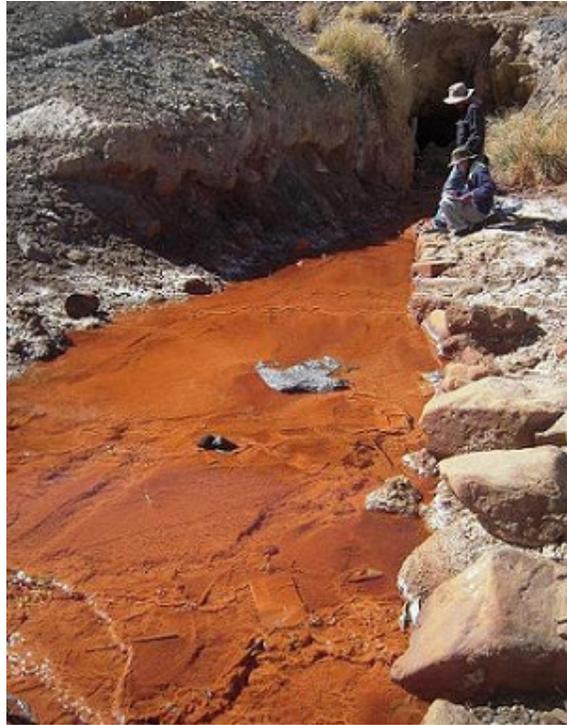
**Figure 4-2. Photograph of the mine drainage from the closed mine Machacamarquita, Poopó sub basin.**

One of the bigger mines in the Poopó sub basin is Machacamarquita and it is located approximately 1 kilometre east, and upstream, of the Poopó village. It is owned by Tiwanacu but the operations have been closed for a few years since there have been some environmental irregularities (Ramos Ramos, 2009-10-09). Where the village is located, there is a drainage passage from the mine where all the drained water is being let out, see Figure 4-2. The water is collected in a small 10 m<sup>2</sup> sedimentation dam and then transported in a pipeline to the tailings dam, which is located just downstream of the village. There is water leaking from the in- and outlet of the small sedimentation pond straight to the river. This is the case when there are higher flows of water being drained from Machacamarquita. This water is not treated and is believed to contain high levels of contaminants. According to PPO 9401, it is important to do sampling over the different seasons since the drainage from inactive mines are directly related to the precipitation. There is also mine drainage from other mines going into the river without any treatment, for example the mine which is owned by Sinchi Wayra and other informal operations (Ramos Ramos, 2009-10-09).

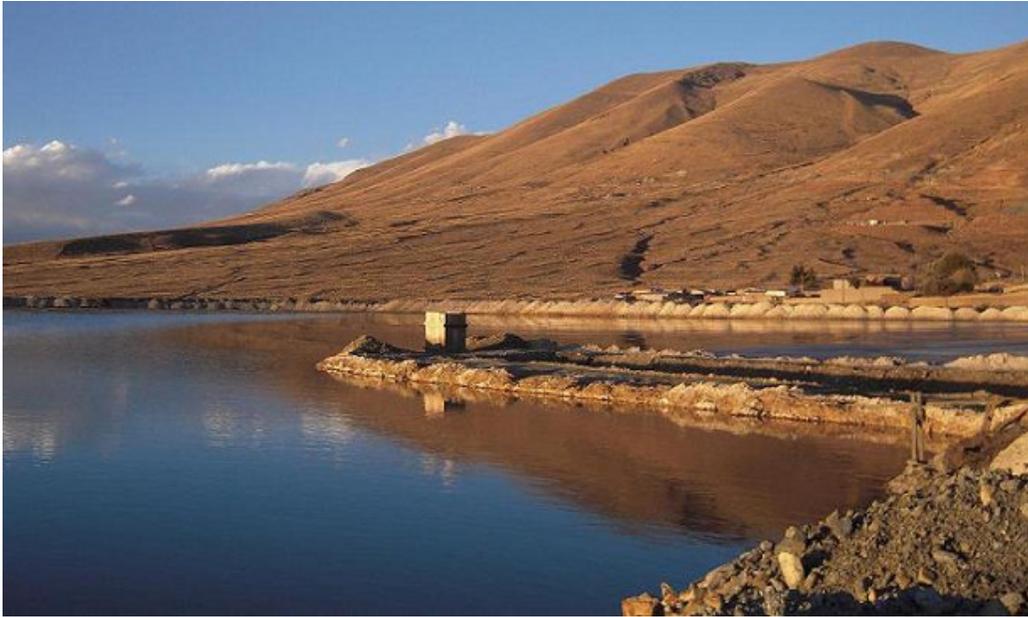
**Figure 4-3.** The tailings dam in the Poopó River basin.

The water in the dam derives from the mine drainage and is utilised for the processing operations. Before using the water, limestone is added, probably to make the pH higher. According to Hugo Miranda Lopez (2009-10-09), who works on the processing site, this water is mixed with recycled water from the tailings dam and used for the mineral processing. The surface of the rock tailings dam measures about 250 x 250 m<sup>2</sup> and is 9 metre higher than the surrounding landscape, the dam is shown in Figure 4-3 (Google Earth, 2009). The depth of the water is only about one metre. Some of the water is leaking through the dam and is collected in the north-west corner and pumped back to the dam (Lopez, 2009-10-09). In the case of a pump failure there is a risk that the water will continue in a canal out on the lower lying plains west and downstream of Poopó. Here the water may infiltrate to the groundwater and is thought to contaminate the area with heavy metals. A more severe damage is likely to be the cause by permeable layer underneath the tailings dam. It is believed that the water in the dam infiltrates through the soil layers and is transported with the groundwater out on the lower lying plains. There are also other smaller informal processing operations adjacent to the major tailings which also should contribute to a contamination.

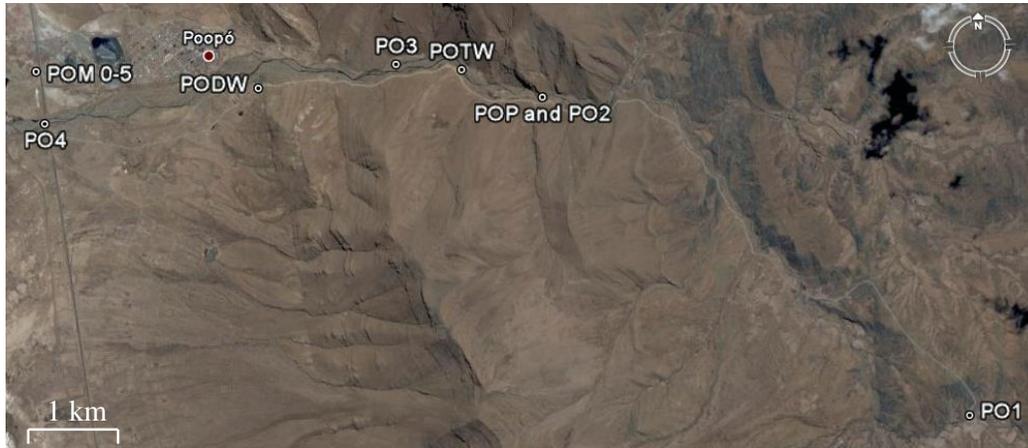
**Figure 4-4.** Map over the sampling points along River Poopó including the position of POM 0-5 (Google Earth, 2009).

The second point along the river, *PO2*, is an area situated about 3.3 kilometres east of the Poopó village, see Figure 4-4. This is also the location where potable water is collected from a well, *POP*, and transported in a pipeline to the village for distribution. The origin of this water is not known. Possibly it could be infiltrated somewhere upstream and drained at this well or infiltrated from the river and collected at this point. The river water at this location is probably little affected by the mining in the area. However, the field trips revealed some mining activities upstream which might be able to impact the water at this point, both in the river and in the well.

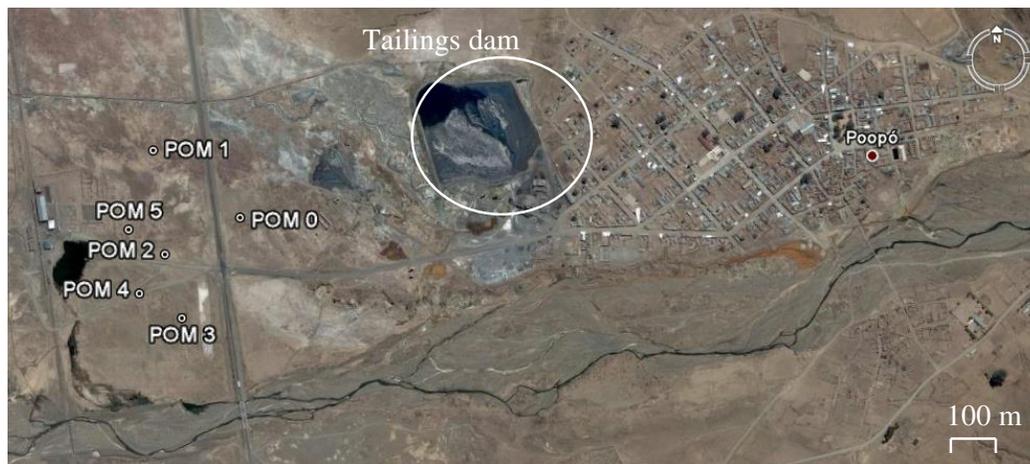
**Figure 4-5. Piezometers POM 0-5 downstream the tailings dam (dark blue in the center) just west of the village Poopó (Google Earth, 2009).**

This set of piezometers was installed in April 2009 and are located about 400-600 metres west of the major tailings dam, see Figure 4-5. At each of the six sites, except POM 0, there exist two piezometers at different depths. The shallow ones are labelled *A* and extend about 5-6 metres down in the ground. The deeper piezometers are named *B* and have a depth of about 8-10 metres. The area is characterised by the typical Altiplano vegetation consisting of small bushes, grasses and mosses, all spread very sparsely around. There are no traces of precipitated salts on the ground.

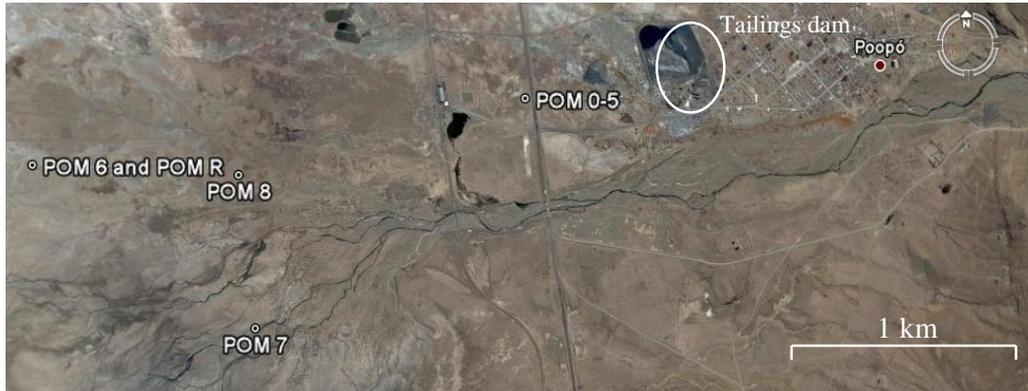
Figure 4-6. Map showing the location of piezometers in the Poopó River basin and the tailings dam west of the village (Google Earth, 2009).

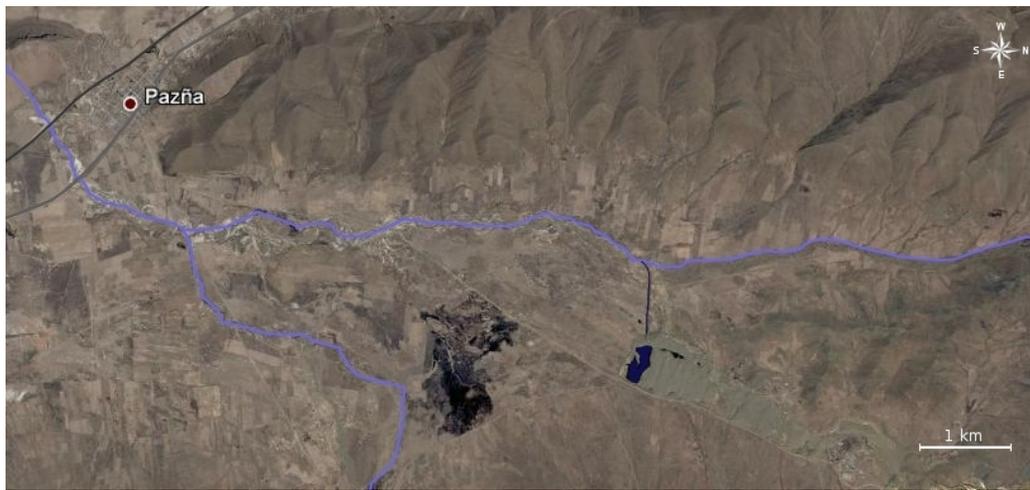
Figure 5-1. Figure showing the Antequera River, with a large tailing and dam in the down right corner and the village Pazña in the upper left corner. North in this picture is to the right.

The Antequera River basin is located to the south of the Poopó River basin and has an area of 229 km<sup>2</sup>, see Figure 5-1. In this basin there are two different municipalities: Antequera and Pazña. The sub basin is similar to Poopó, where people mostly live of farming or mining. The municipalities of Antequera and Pazña had in year 2001, 3352 and 5469 inhabitants respectively. The growth rate in the basin is negative due to migration to other regions in Bolivia (Ekdahl, 2007). The largest ethnical group is Quecha and most of the older population speaks Quecha, while the younger speaks Spanish (Rocha, 2008). One of the environmental problems includes the lack of treatment of solid waste in the river basin (Ekdahl, 2007). The following sections include a description of the water resources, the mining activities, the sampling points and previous studies done in the basin.

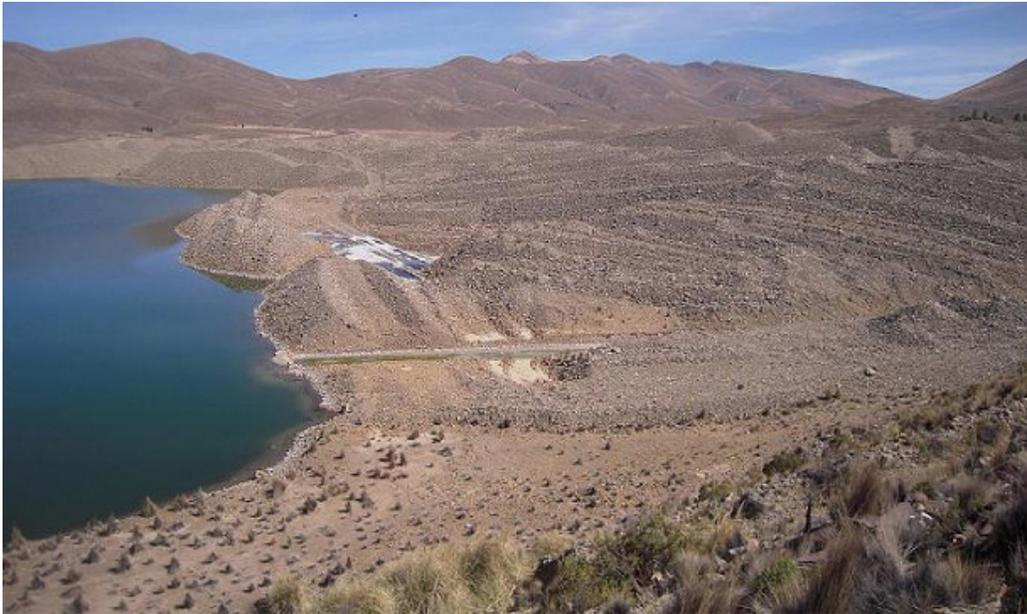
**Figure 5-2. Photograph showing the massive tailings including its dam in the Antequera sub basin. The dam is holding a pH of 3.07 (Ekdahl, 2007).**

The main mine in the Antequera basin are the Bolivar mine, which was discovered in 1810 and during the first 80 years only silver was extracted (Ekdahl, 2007). In the Antequera basin, the company ESTALSA exploited the glacial-fluvial deposits during many years, but this activity stopped in 1996 (Ríos, 2002 cited in Ekdahl, 2007). Some of these mining operations included extraction of tin from the rocks in the river valley during the 1960's (Ramos Ramos, 2009-10-12). This activity resulted in a massive rock tailing, which parts of can be seen in Figure 5-2, and is about 2.5 kilometre long and 0.5 kilometre wide (Google Earth, 2009).

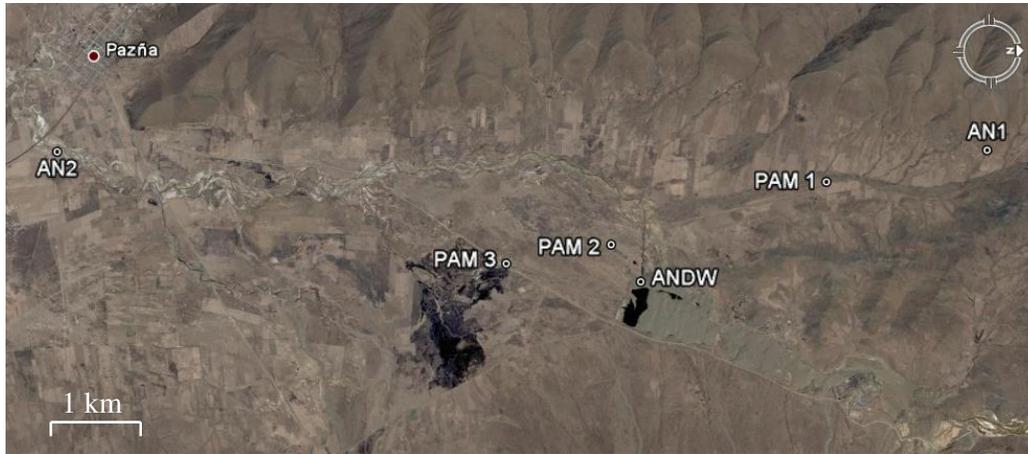
**Figure 5-3. Sampling points in Antequera River basin (Google Earth, 2009).**

At a location about 10 kilometres upstream in the river valley of Antequera the first sampling point is found, *AN1*, see Figure 5-3. The water sample is taken from a small stream. It is believed that this water is not likely to be affected by mining activities, although it would probably need some treatment like disinfection to be suitable for drinking. Another sampling point, *AN2*, is found just adjacent to the Pazña Village, Figure 5-3. The flow at this point is higher and likely to be very contaminated from the mine drainage, acid rock drainage and wastewater from upstream settlements. The surrounding area is very unclean and there is a lot of garbage.

Three piezometers were installed in April 2009 and are spread out in the Antequera basin, see Figure 5-3. The first piezometer, *PAM 1*, is located about two kilometres upstream of the tailings dam and is not believed to be affected by the mine drainage. The second site, *PAM 2*, is situated 500 metres downstream from the dam and is probably affected by the mine drainage and its contamination. The final piezometer, *PAM 3*, is to be found 1.5 kilometres downstream of the tailings but away from the major river path.

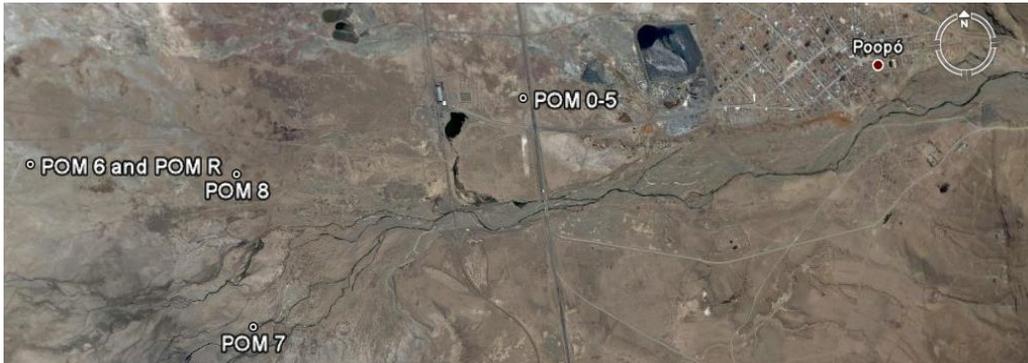
Figure 8-16. Map showing the locations of the groundwater wells in the Poopó sub basin.

The following section presents the results for the groundwater in the Poopó River basin. The locations of the sampling wells are shown in Figure 8-16, together with the village and the tailings dam. At most of the wells there were samples taken from two depths, 5 and 10 metres, labelled A for the shallow one and B for the deep one.
