Examensarbete
TVVR 10/5006

Study of microbiological runoff water quality from a green roof and in an open storm water system

Ammar Hussain

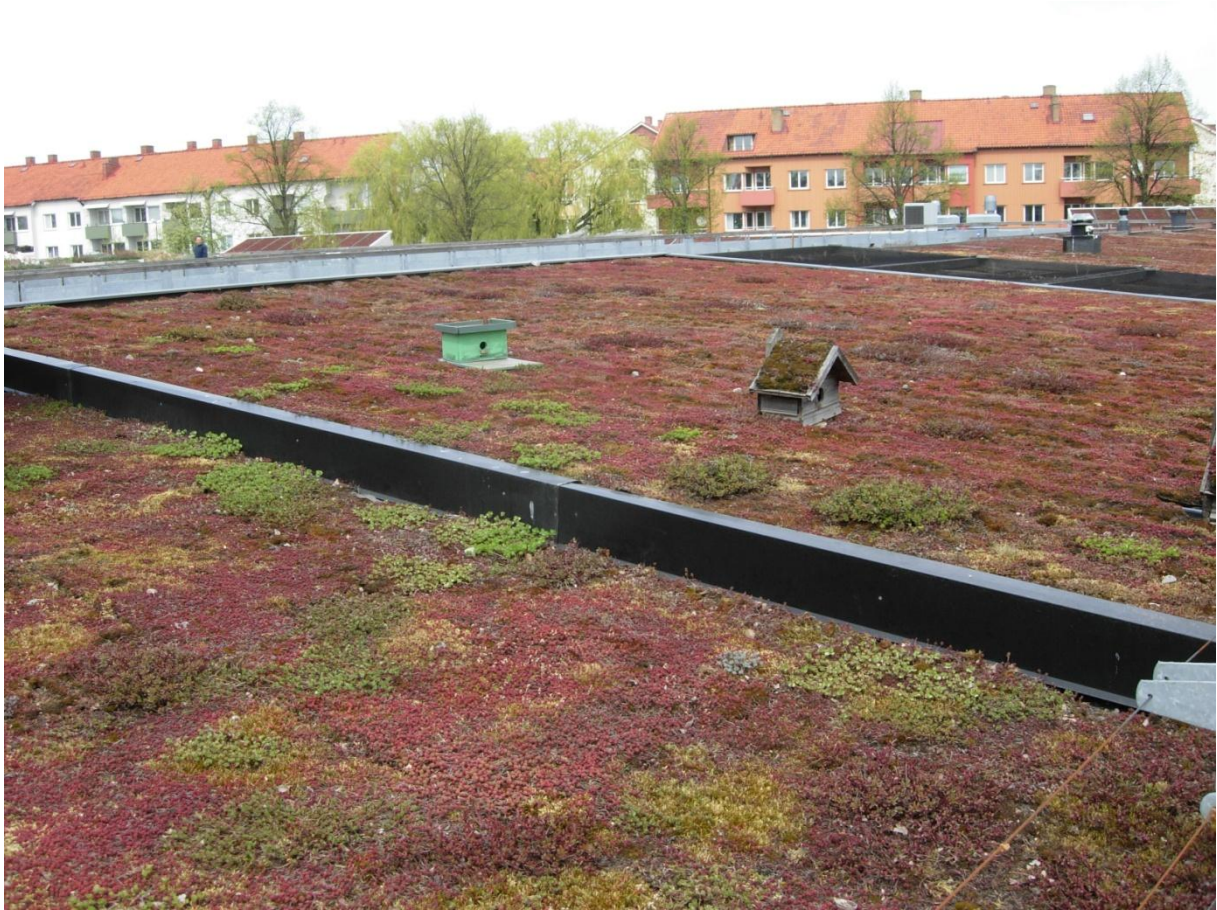
Picture (1). View on the green roofs in Augustenborg.

The green roofs in Augustenborg (Figure. 2) were constructed in 1998-2000 as a part of the Eco-city Augustenborg project. The main objective with green roofs construction was to contribute to mitigating the flooding problem but also to make the area more attractive for residents by enhancing the aesthetic view. Hard roofs have been converted to extensive green roofs with area about 9 500 m². Different types of vegetated roofs were used and different establishment methods apply, as the area was also to serve for research and development purposes. Major vegetation groups are grasses, sedum, and mosses. The roof section used in this study for water sampling is 4.0 m long and 1.25 m wide with total area 5.0 m². The substrate is 3 cm thick and is a mixture of clay 5 %, crushed lime stone 5 %, crushed ceramic roof tiles 43 %, sand 37 % and 10 % organic matter (Bengtsson et al., 2004).

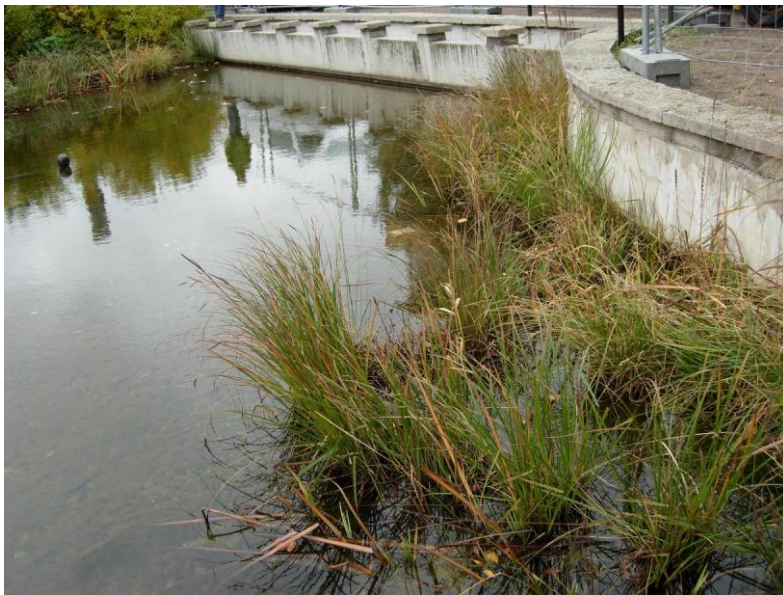
Picture (2). Pond 2 (sampling point 3).

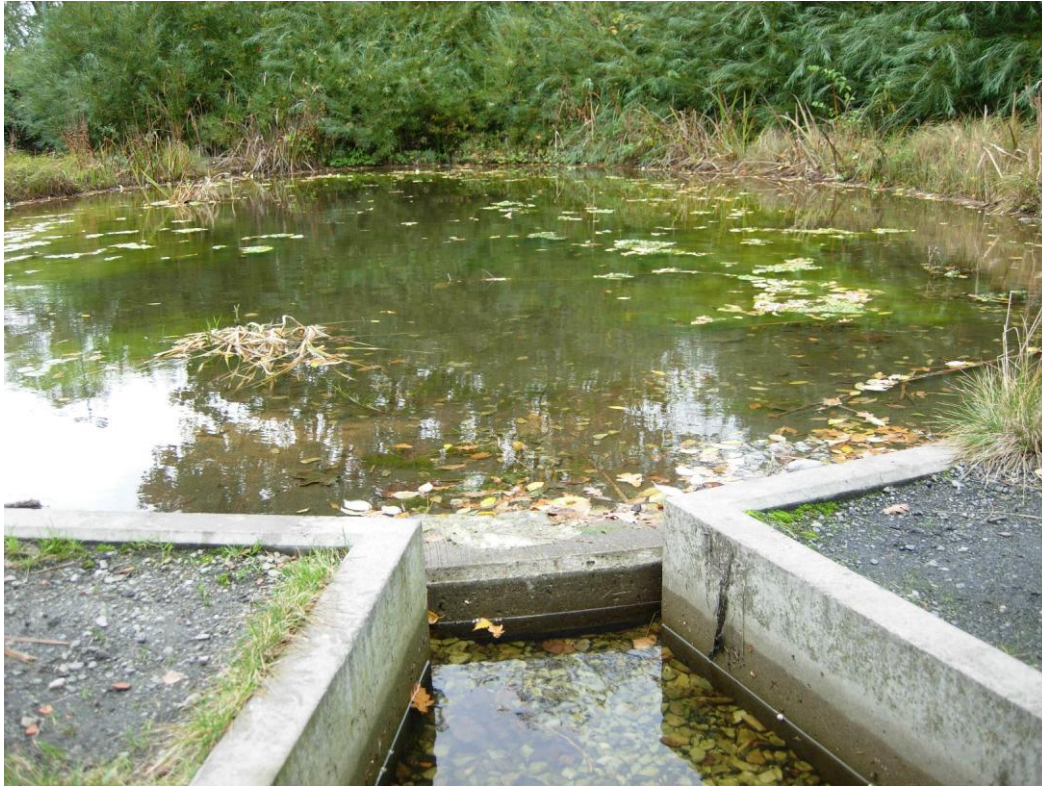
Picture (3). Pond 2 – the end of the Augustenborgs open storm water system (sampling point 4)

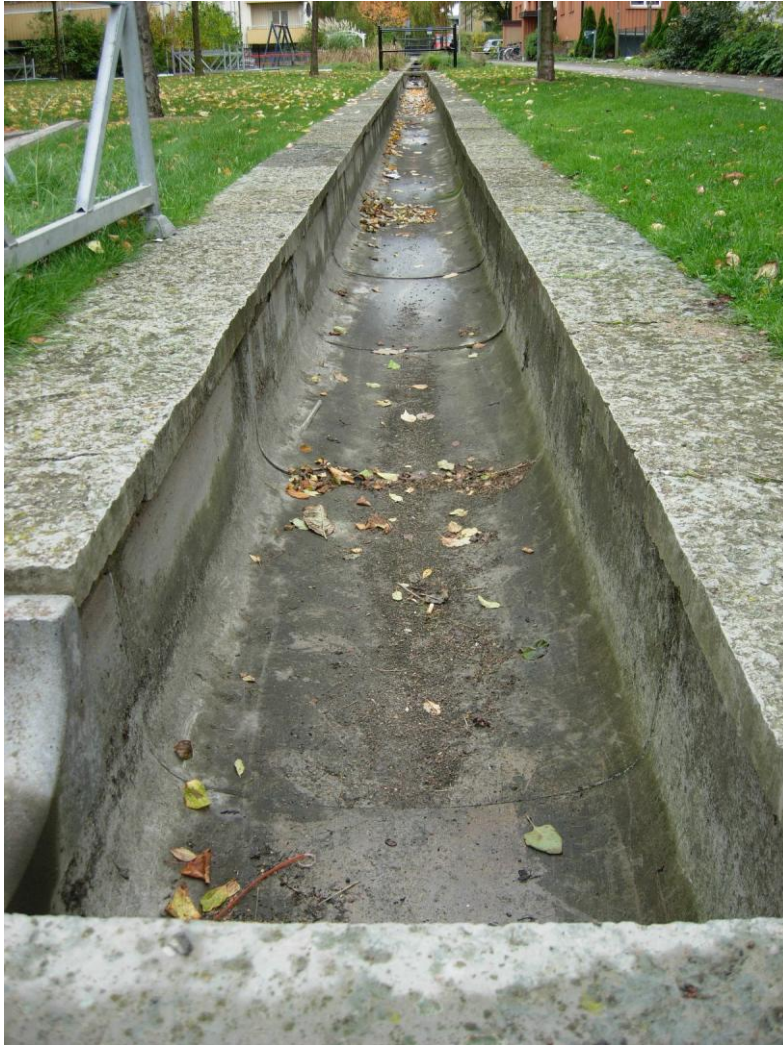
Picture (4).Ditch (sampling point 2).

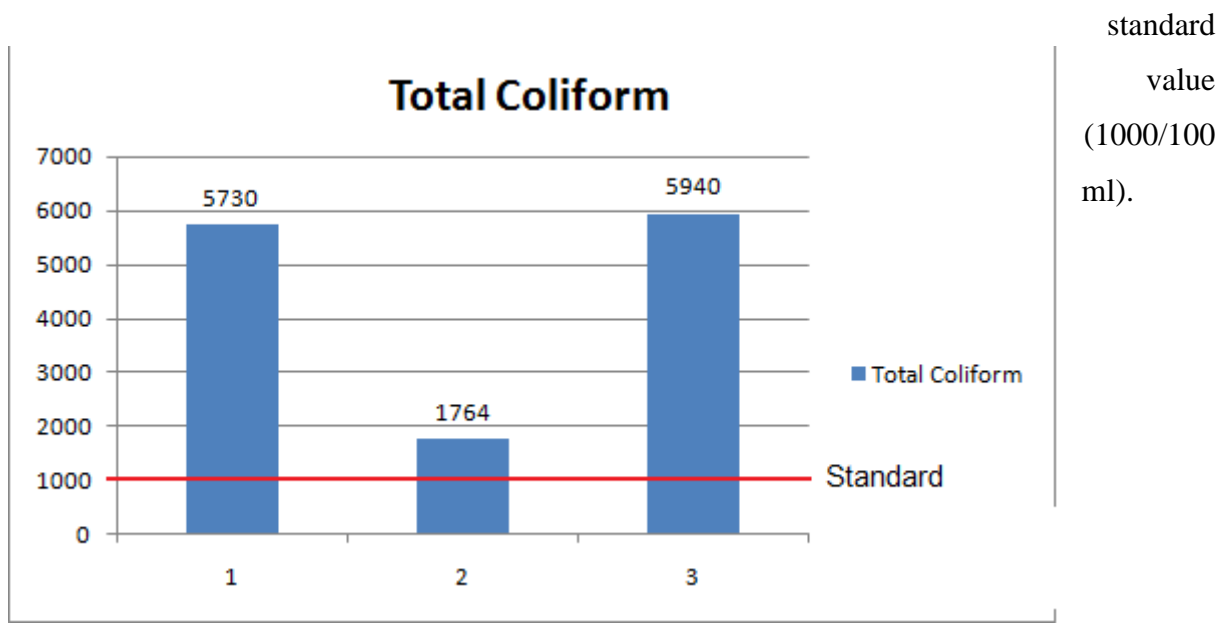
Figure (3). The total coli form bacteria in the green roofs site. The histograms represent the concentration of total coli from in (st/100 ml) each sample while the red horizontal line is the

In figure (3), horizontal concentration of total coli form in all the samples exceeded the standard value for total coli form. Vertical samples collected in May, October and November.

The results obtained for the green roof site (figure 2) regarding content of total coli form bacteria indicate the contamination exceeding 1000 st/ml which is the EU recommendation for acceptable bathing water quality. Source of these bacteria can be soil but most likely birds waste as birds are nesting on the green roofs. The water samples which have been taken during May and November show higher total coli from concentration than the sample, which was taken in October. The reason can be because of May`s samples were taken after proceeding long dry period (Figure 18). The long dry period may have resulted in accumulation of deposition materials on the green roofs and consequently more bacteria present in the runoff from the roofs. Figure (16) shows, that April was the driest month during 2009 while figure (18) illustrates the rainfall depth before sampling day (6 May). Figure (16) shows the *E. coli* bacteria in the green roofs site. All the three samples have low concentration of *E. coli* bacteria. The results of tested samples were all below the standard value (500 st per 100 ml) for *E. coli* bacteria. Figure (17) shows the results for intestinal enterococci in the green roof site, two samples have very high concentration comparing with the standard value for EU that is (200 st/100 ml) and even comparing with the first sample collected in May. Those two samples have a concentration of (3010 & 2310) st/100ml intestinal enterococci and were collected during October & November. The two samples exceeded the standard value (200/100 ml) while the third sample was below it. Two

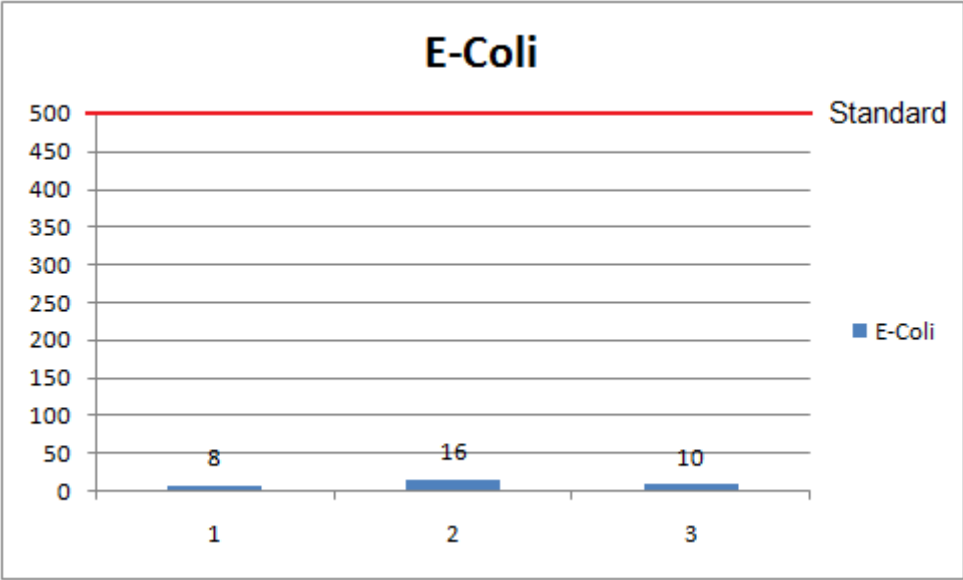
Figure (4). The *E. coli* bacteria in the green roofs site. The histograms represent the concentration of *E. coli* in each sample while the red horizontal line is the standard value (500/100 ml) for EU countries.

The measured *E.*

coli concentrations in samples taken from green roofs were all below the standard value.

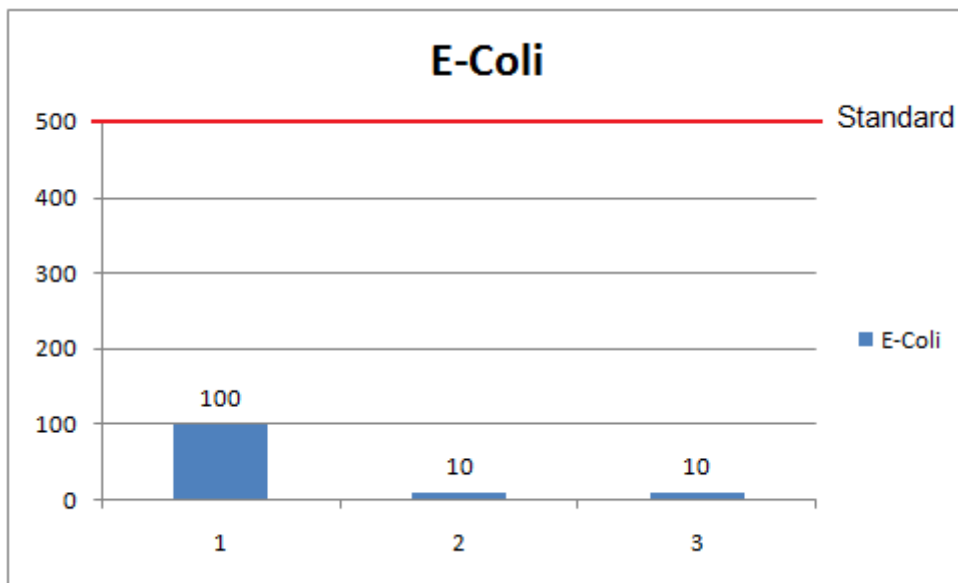
Figure (7). The *E. coli* bacteria in the pond 1 site. The histograms represent the concentration of total coli form in each sample while the red horizontal line is the standard value (500/100 ml) for bathing water quality in EU countries.

In figure (7) above non of the three samples exceeded the standard value.

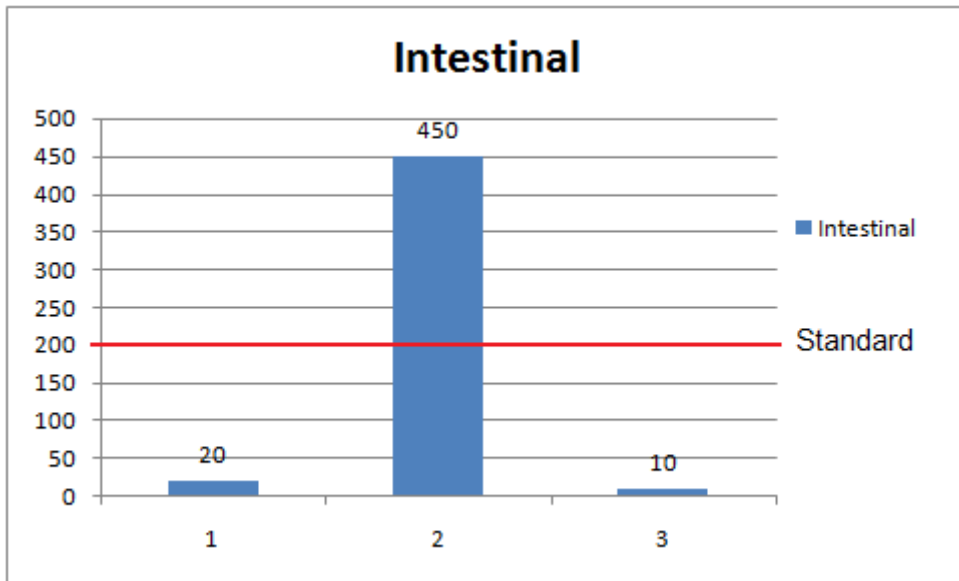
Figure (8). The Intestinal Enterococci in the pond 1-site. The histograms represent the concentration of Intestinal Enterococci in each sample while the red horizontal line is the standard value 200/100 ml for bathing water quality in EU countries.

In figure (8), one sample taken on 26 October exceeded the standard value.

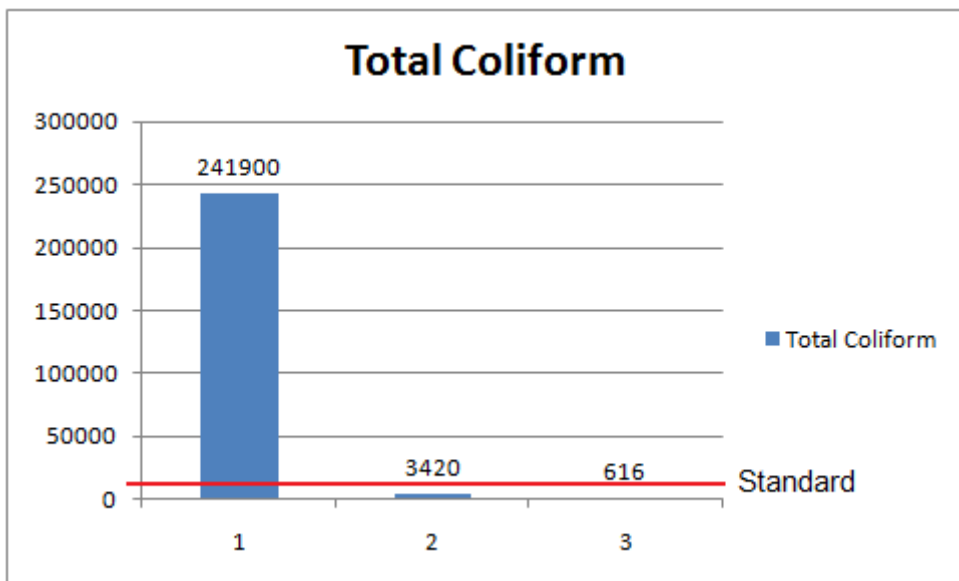
Figure (9). The total coli form bacteria in the green pond 2. The histograms represent the concentration of total coli form in each sample while the red horizontal line the standard value 1000/100 ml for bathing water quality in EU countries.

In figure (9) two samples were taken on 6 May and 26 October exceeded the standard value. The sample, which took on 6 May, is very high comparing with other two samples, the second sample (3420 st100 ml) also exceeded the standard.

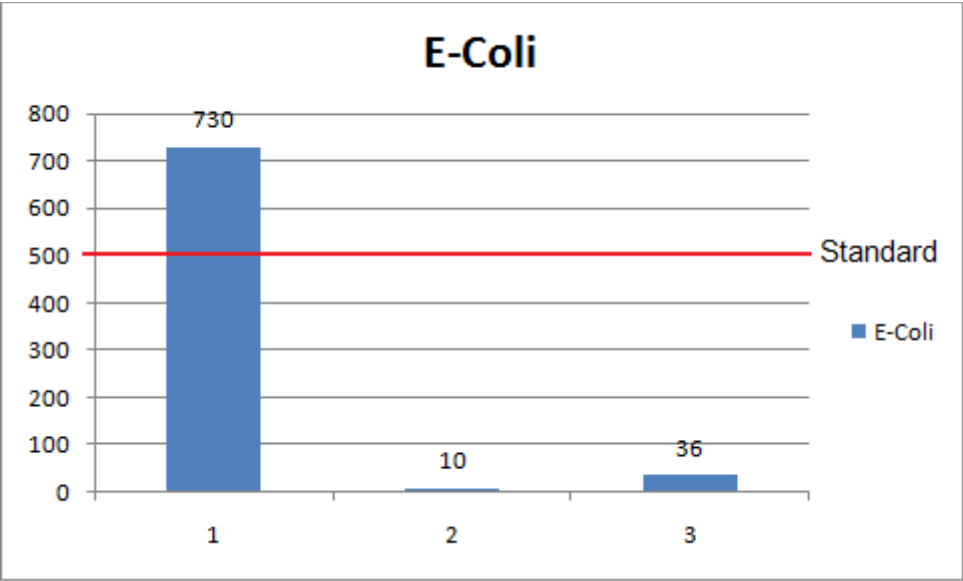
Figure (10). The *E. coli* bacteria in the pond 2 site. The histograms represent the concentration of *E. coli* in each sample while the red horizontal line is the standard value 500/100 ml for bathing water quality in EU countries.

In figure (10) above only one sample took on 6 May from three exceeded the standard value .

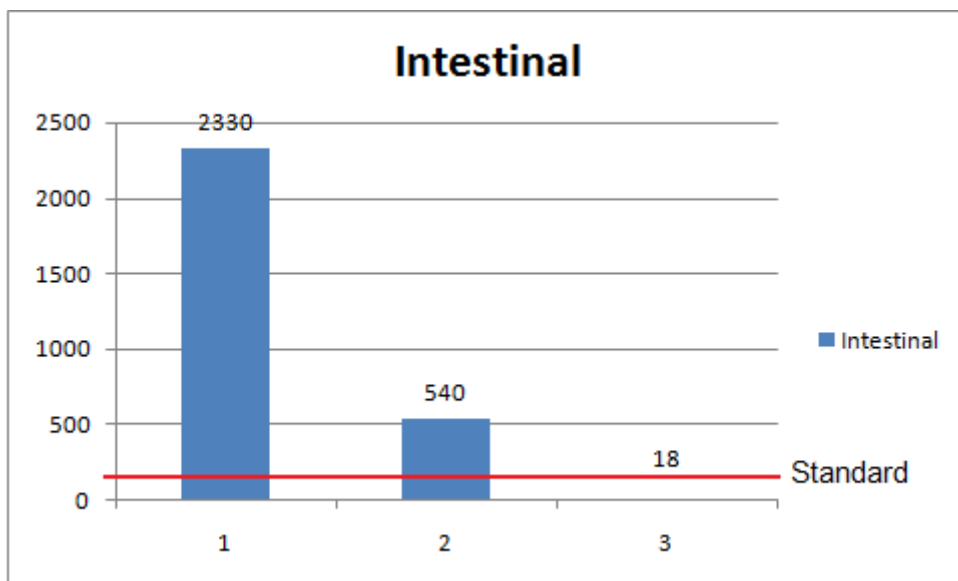
Figure (11). The Intestinal enterococci bacteria in the pond 2 site. The histograms represent the concentration of Intestinal enterococci in each sample while the red horizontal line the standard value 200/100 ml for bathing water quality in EU countries.

In figure (11) two samples exceeded the standard value .

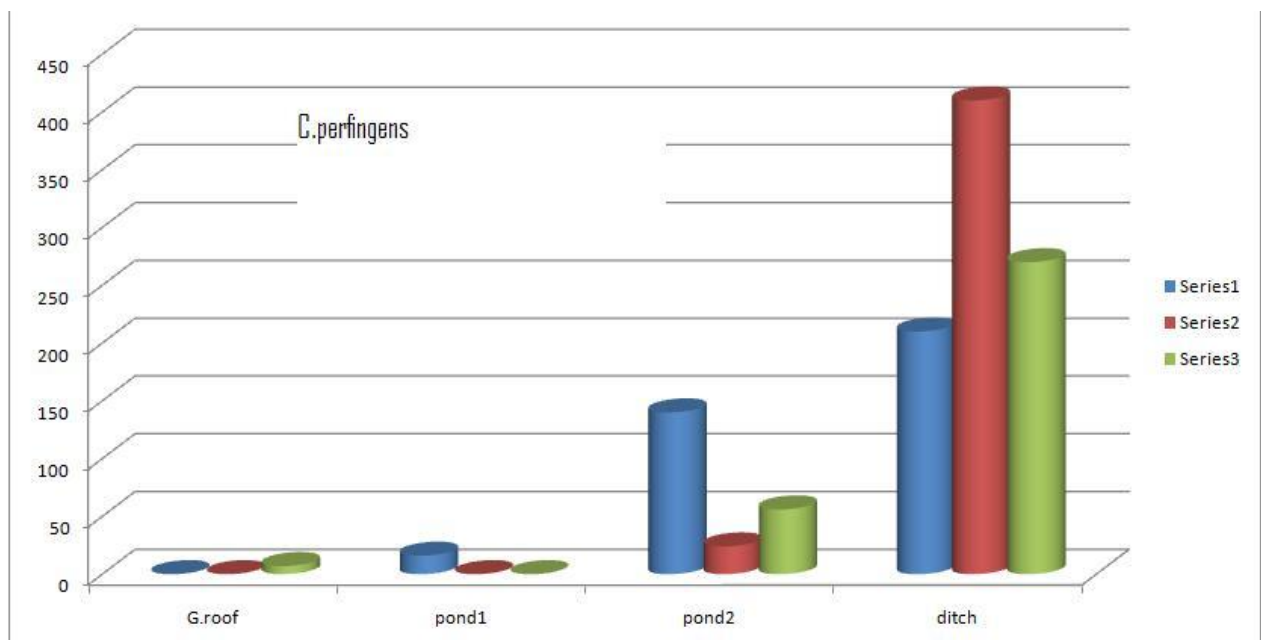
Figure (15) shows the clostridium perfringens indicator in all sampling sites.

In figure (15) the results for clostridium perfringens indicators in the four sampling points are shown. Vertical axis shows concentration of clostridium perfringens in (CFU/100 ml). Horizontal axis shows the four sampling points. The clostridium perfringens concentration increased as the storm water flows from upstream to down stream except the sample from the ditch site which has the highest concentrations of studied indicator among all the other sampling sites. The increase of clostridium perfringens concentration from upstream to downstream is due to the increased storm water pollution during surface runoff. The bacteria can easily be washed off from hard surfaces to the storm water. Dog feces may be the major source of clostridium perfringens in the ditch. Some studies linked the abundance of clostridium perfringens in storm water with the presence of dogs waste. The dog feces contain abundance of clostridium perfringens spores, which are thermo tolerant (Leeming et al., 19989 There is no standard for clostridium perfringens for recreational water. The recommended standard for drinking water is that the water should be free from clostridium perfringens (WHO, 2003). The concentration of clostridium perfringens in the ditch and pond 2 are higher than in other two sampling points.

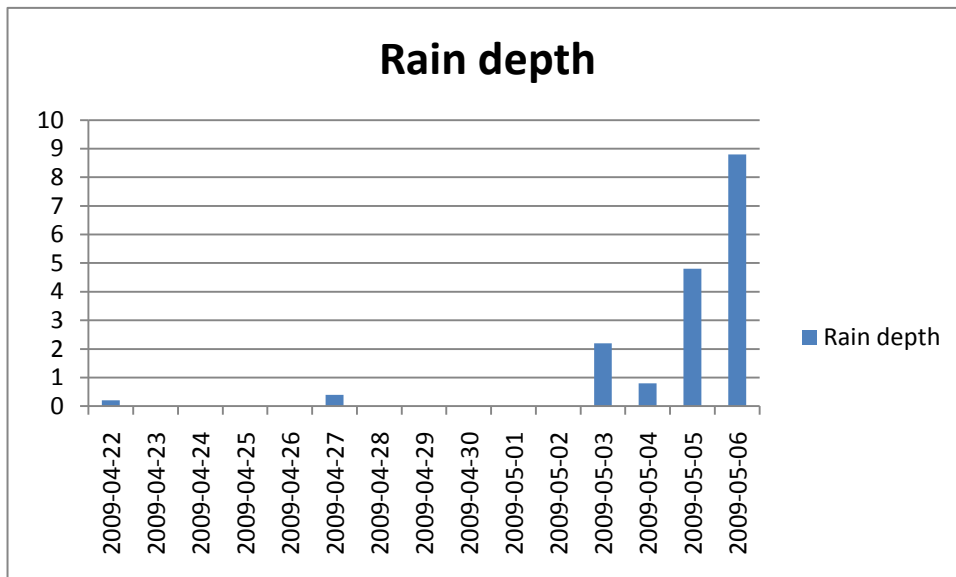
Figure (18). Rainfall depth in Augustenborg from 22 April 2009 to 6 may 2009 prior to the first sampling day (06-05-2009).

Figure (18) shows that the precipitation during sampling day was 8.8 mm which is highest during two weeks. The procceding days before sampling were almost dry.

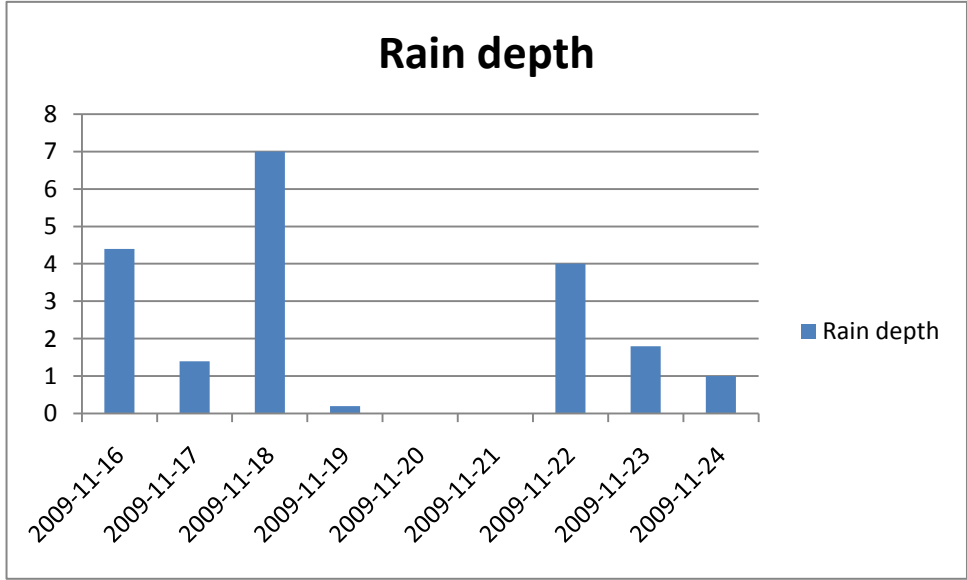
Figure (20) shows the rainfall depth prior to the the third sampling day 24-11-2009. Horizontal axis is rain depth in (mm) while the vertical axis is the corresponding day.

Figure (20) shows that the precipitation during sampling day was only 1mm, but the precipitation occurred during preceding days. The storm water system was in wet condition.
