Examensarbete
TVVR 13/5015

Ecological Changes in Lake Risten, Sweden, caused by Anthropogenic Influences

A Theoretical and Practical Study

Division of Water Resources Engineering
Department of Building and Environmental Technology
Lund University

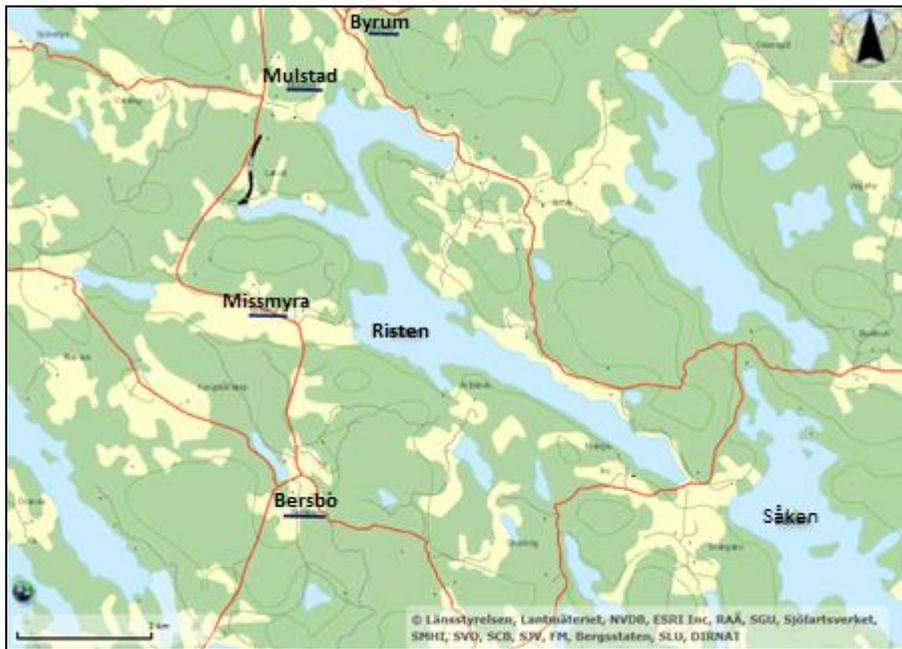
Figure 3 Lake Risten and Bersbo mine. Vattenmyndigheterna, 2013

This report is focusing on the area around lake Risten; Byrum stream in the north part of the lake, Mulstad stream in the north-west part, Missmyra stream in the east part, the outlet of lake Risten and the inlet of lake Såken are locations chosen for field studies. In Figure 3, the locations for the field studies are marked out with names, as well as the location of the Bersbo mine. To have a clear view of the effects of the mine along the water system, information about lake Risten and how the metals are transported all the way down from the upstream lakes is given in section 5.6.

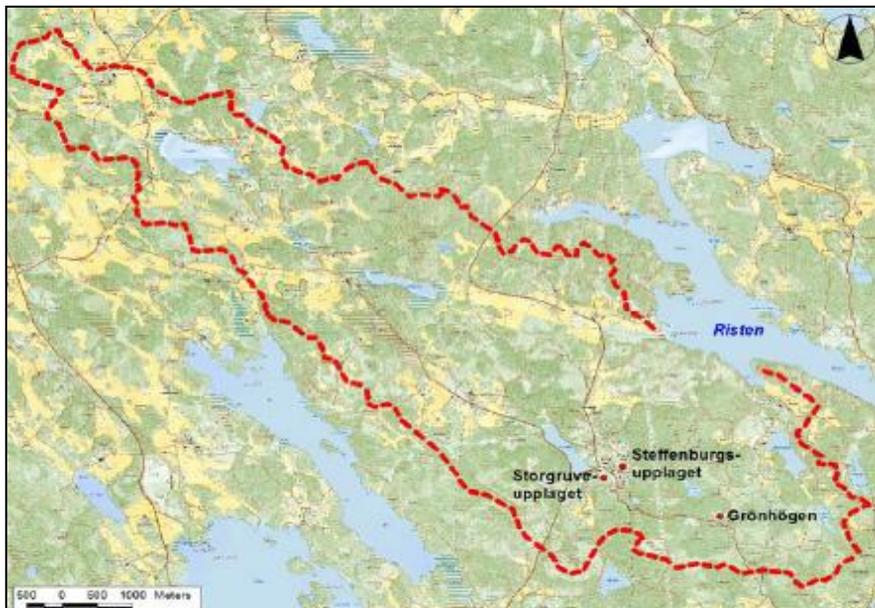
Figure 4 Investigated area and red dots for the three deposits: Storgruveupplaget, Steffenburgsupplaget and Grönhögern. Börjesson & Ekholm, 2007

During 1987-1989, the waste deposits from the mine were covered to reduce the leakage. It was the first attempt of its kind for after treatment of mine waste in Sweden and one of the first in the world. The result of the restoration was, after an investigation made by the county board of Östergötland in 2004, shown to be a reduction in total leakage of 90%. However, the leakage from the Bersbo mine was still greater than the leakage from all the other mines in the county together (Länsstyrelsen Östergötland, 2013). The county board received money from Naturvårdsverket (The Environmental Protection Agency) to put all the facts from the mine activity together to get an idea of the total situation for the environment around Bersbo (Länsstyrelsen Östergötland, 2013). This was done in 2005 and it was decided that there was still need of information regarding pollution of the downstream recipients. Therefore the county board made a further study during 2006-2007. The investigated area can be seen in Figure 4 below.

The investigated area, which can be seen in Figure 4, mostly consists of forest, but also some wetlands, grazed fields and agriculture fields. Both permanent houses and summer houses are to be found in the area. There are no red listed aquatic species in the Bersbo area, but on land, species of special interest have been found (Börjesson & Ekholm, 2007).

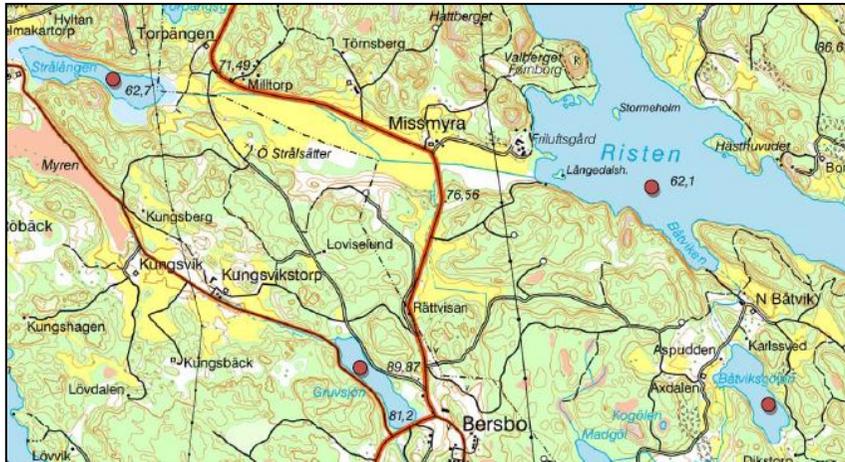
Figure 8 Marshland between Strålången and Gruvsjön marked with pink. Ternsell, 2007

As can be seen, when looking carefully at Figure 8, there is an area with marshland, pink colour, located between Gruvsjön and Strålången. This area is a complex system working as a source, as well as a trap, for metals. During oxidative circumstances Cd and Cu are released from the sediment and during reducing circumstances Zn is released from the sediment. The oxidizing and the reducing capacity is dependent on the groundwater level, which means that the area will probably stay alternating between being a source and a trap for metals as long as the hydrological circumstances are the same. However, a possible climate change can lower the groundwater level, resulting in permanent oxidizing circumstances. This could also be the result of creating new streams draining the land. In such a case it is probable that high amounts of metals would be released and spread further downstream. This process is however believed to take about 10-100 years, which is such a long time that other factors must be taken into consideration as well (Börjesson & Ekholm, 2007).

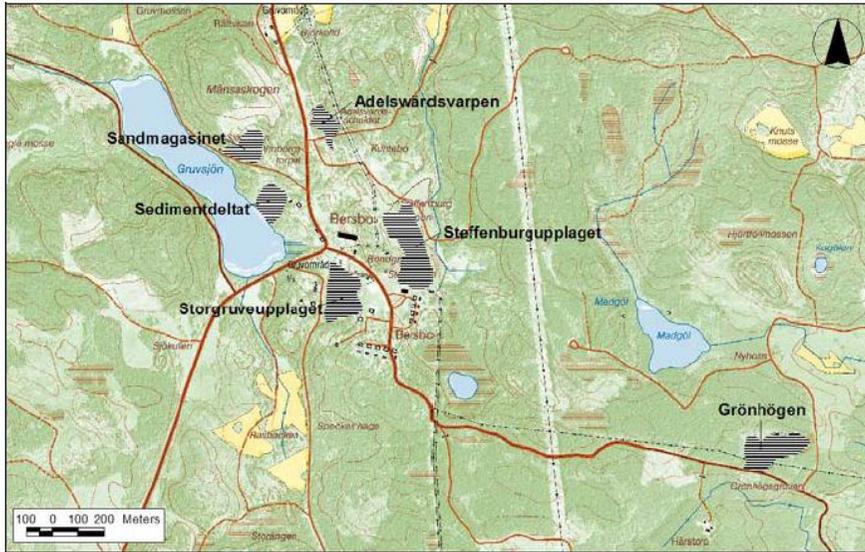
Figure 9 Six waste deposits from mine Bersbo, of which the three to the right later on are described in the text. Börjesson & Ekholm, 2007

The deposits from the Bersbo mine have been affecting both surface water and groundwater in the catchment with leakage of metals, especially, Cu, Cd and Zn, over the years. During 1987-1989, a restoration of the deposits took place. The restoration was one of the first of its kind in the world and the idea was to reduce the leakage from the deposits. This was done by covering the two deposits, Storgruveupplaget and Steffenburgsupplaget, with Cefyll, i.e. concrete stabilised carbon fly ash, and clay and to empty the third deposit, Grönhögen, of waste and then lime treat it with limestone and cover it with moraine (Börjesson & Ekholm, 2007). The three deposits and the investigated area can be seen in Figure 9.

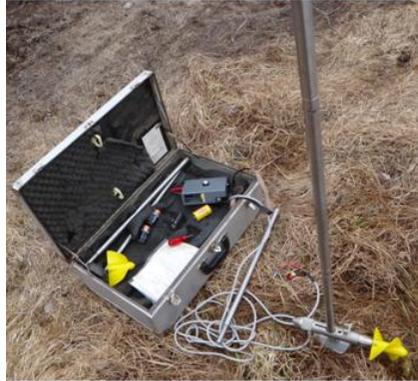
Figure 12 Velocitymeter used. Sendra Díaz and Österlöf, 2013

1. pH-meter: pH and temperature of the water
2. Velocitymeter (seen in figure 12 on the left): velocity of the water
3. Carpenter's rule: width and depth
4. Angle meter: slope of both sides of the streams
5. 20 small bottles: water samples for measurements of PO₄-P and NO₃-P

The next step was to measure the velocity of the water in the same locations where the samples were taken. To do this, the velocitymeter was put into the water for ten seconds, and then the revolutions of the device were noticed. If the n (revolutions/second) < 0.76 , the formula used was $v = 0,2392n + 0,016$ (m/s). If $n > 0.76$ the formula used was $v = 0,2552n + 0,004$ (m/s). After this, it remained to measure the temperature of the water, the pH of the water, the angles of the sides, the water depth and the water width. For measuring the angles of the sides, a special tool for measuring the angles was used. The pH-meter was calibrated, using tap water of pH 8.5. This whole procedure was repeated

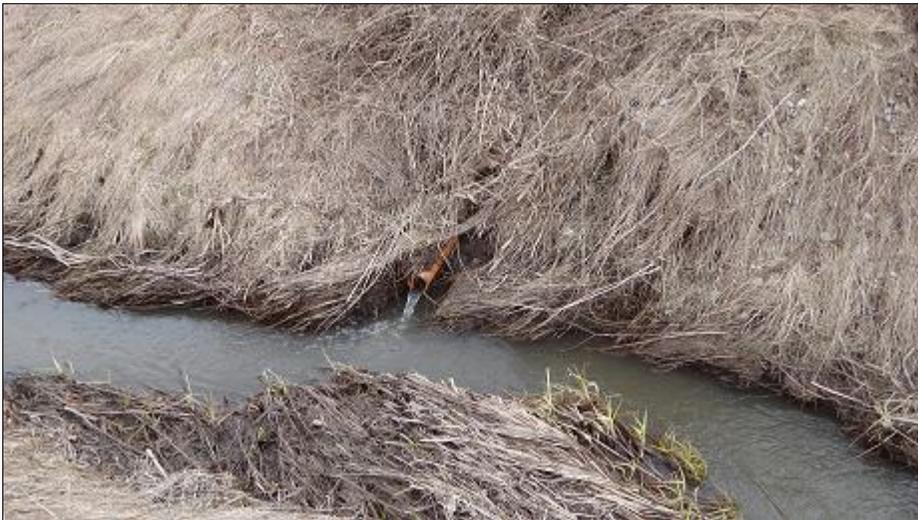
Figure 17 MP₁ in Mulstad stream.

The highest values were, as mentioned before, found at the location MO. The incredible flooding of the whole area when the measurements took place makes the unusual results more understandable. However, it can be seen that there is no buffer strip existing at all along the Mulstad stream, making the phosphorus leakage very high during this time of the year. The nitrogen is also highest at this point, although the value may be ranged within standard values. The drainage system is considered to be old and in need of restoration, since just two drainage pipes could be found along the whole stream, and the others therefore may be understood to not work properly. The nitrogen is usually coming to the stream with pipes draining the surrounding agriculture lands, but in this case the water seems to have to come through the soil, resulting in more saturated soil and probably a higher surface runoff. The ground was also very saturated because of the great amount of melt water in spring and could not absorb all the water, resulting in flooding. Due to this flooding there is a possibility that the nitrogen reached the stream also through surface runoff, which could explain the high value of nitrogen at MO. In Table 3, values of PO₄-P and NO₃-N for all locations in Mulstad stream can be seen. Figure 17 is showing a picture of MP₁.

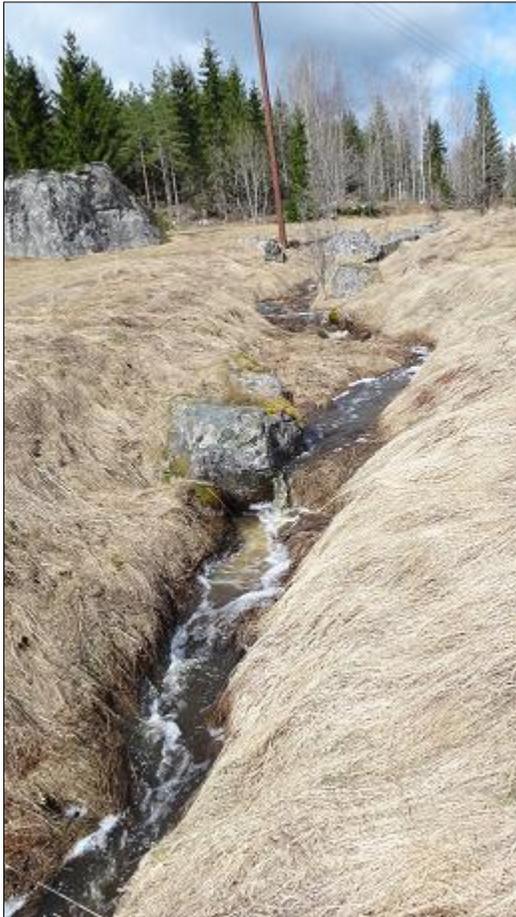
Figure 18 Byrum stream.

In Table 4 the values of PO₄-P and NO₃-N in Byrum stream can be seen. Byrum stream is, as mentioned before, a more natural stream, which could be one reason why the values of the nutrients are lower than the standard values in both Byrum stream inlet (BI) and Byrum stream outlet (BO). The increased value of PO₄-P in BO compared to BI can be explained by the existence of agriculture land along the first 200 meters downstream BI. In Table A2-2, all the measurements for Byrum stream are compiled. Figure 18 shows a picture of the most turbulent part of Byrum stream.

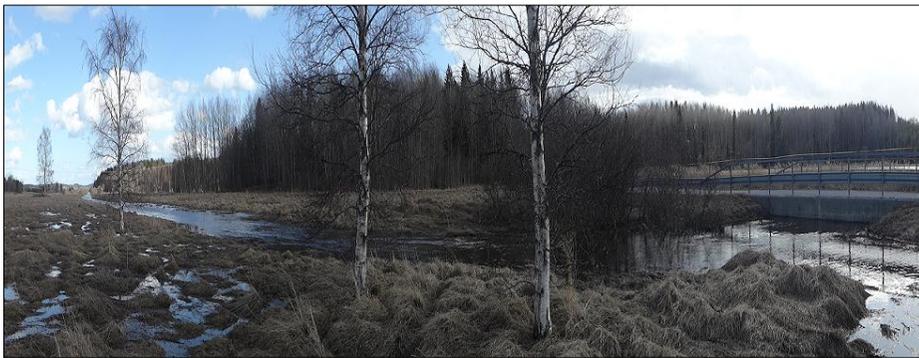
Figure 19 Missmyra stream.

increases the sedimentation and the uptake of the nutrients before entering Missmyra stream. Figure 19 shows a panoramic view of Missmyra stream more similar to a wetland than a stream. The full compilation of the measurements in Missmyra stream can be found in Table A2-3.

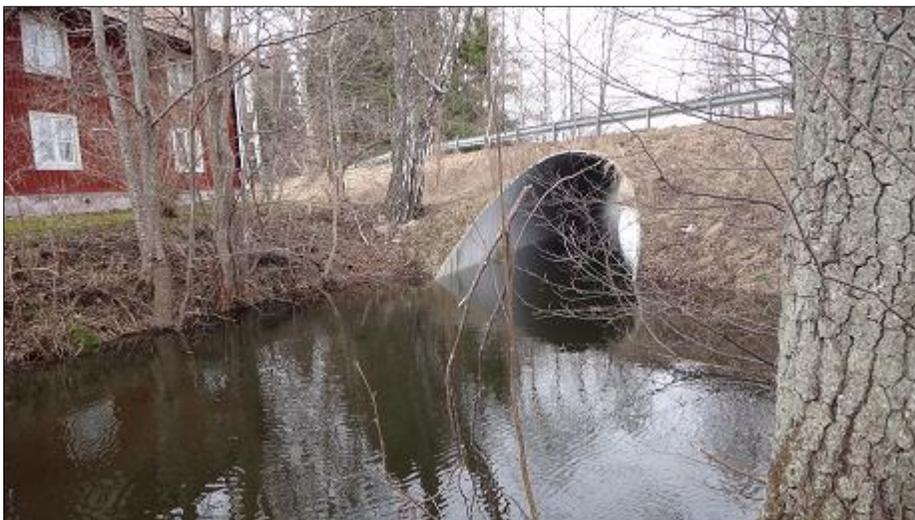
Figure 20 Outlet of lake Risten.

Figure 20 shows the outlet of lake Risten (R), where the stream enters lake Såken. The nutrient concentrations are increasing a bit between the outlet of Risten (RO) and the inlet of Såken (SI), probably since there are agriculture fields along the stream connecting the lakes. The concentrations of PO₄-P and NO₃-N for R, RO and SI can be observed in Table 6 below. The values for the measurements of Risten, Risten outlet and Såken inlet are compiled in Table A2-4. However, the results are still below the values in area E23.
