Thesis 293

The situation for cyclists in South Africa

A study in Stellenbosch

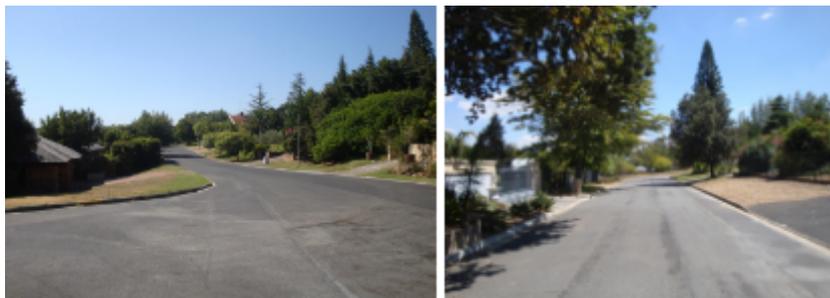
Figure 8 - Typical streets in the neighbourhoods south and east of Stellenbosch city center, Linnes road in Brandwacht to the left and Trengove road in Uniepark to the right
Source: Elina Hederberg and Helena Homle

In most other residential areas in Stellenbosch the population density is much lower, the education rate is higher and the unemployment rate is lower (Statistics South Africa, 2011). The area south of the city centre includes the neighbourhoods Brandwacht, Dalsig and Die Boord. The area east of the city centre includes Mostertsdrift, Rozendal, Uniepark and Simonswyk. All these residential areas are similar in many ways. Most households have fenced off yards around their houses and the streets are wide and paved but still verdant. Usually there are no pathways for pedestrians or cyclists. Some streets are shown in figure 8.

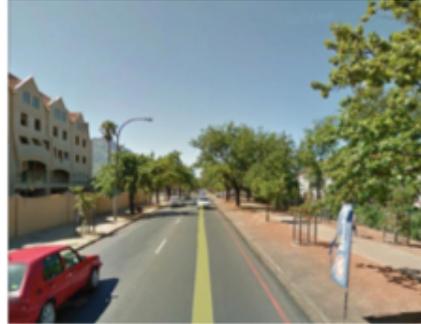
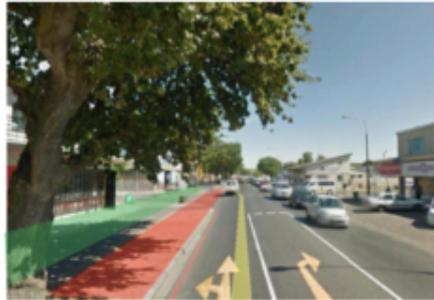
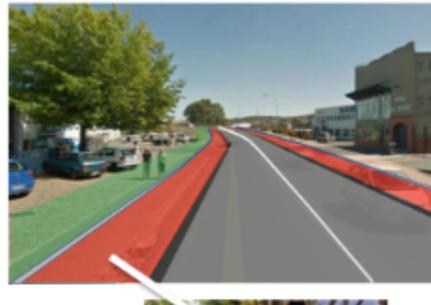
Figure 10 - Proposal for improvements on the cycle infrastructure on Bird street in three stages
Source: Stellenbosch municipality (2015b)

Current Situation

Bird Street connects Stellenbosch north with the urban centre. Improved walking links through NMT investments in 2009/10 between Du Toit Station and town centre. Cycling on pathway is problematic, often too busy and narrow for shared use. The roadway is busy and cars travel up to and above 60km/h.

Short Term Pathway widening

a) Given the high current traffic speeds, and narrow road width the short term recommended improvement would be to create a continuous cycle link as best possible through widening the pathway where space exists, marking for separation between walking and cycling where this is feasible.

Medium to Longer Term

Road speed limit reduced to 40kmh with necessary traffic calming measures. Full cross section review of road to provide for Class 3 or ideally Class 2 Cycleway on both carriageways (consider use of "Armadillos" or similar See Box 5.1 Class 2 example).

Will require carriageway narrowing in places. Probably cater for by placing one cycle lane (southbound) in the roadway, the other (northbound) on the flanking pavement.

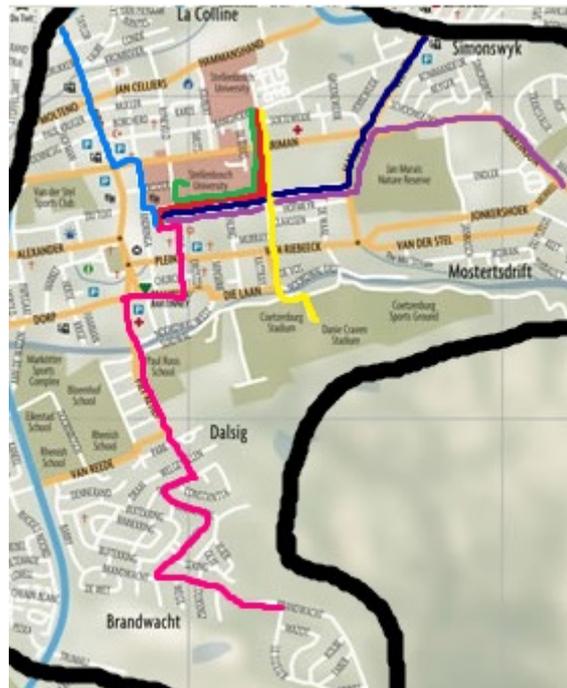
Figure 12 - A map showing the seven chosen routes
Source: Stellenbosch (2016) edited by Elina Hederberg and Helena Homle

In order to calculate the travel time ratio the travel time along seven key routes in Stellenbosch have been measured, these are found in appendix 3. Seven important routes are chosen; these are shown in figure 12 and further described below.

- **Yellow route:** Student accommodations - Coetzenburg sport centre. 1,3 km.
- **Green route:** Student accommodations - Campus. 0,9 km.
- **Red route:** Student accommodations - Eikestad mall. 1,3 km.
- **Blue route:** Eikestad mall - the residential area of Kayamandi. 1,4 km.
- **Pink route:** Eikestad mall - the residential area of Brandwacht. 3,7 km.
- **Dark blue route:** Eikestad mall - the residential area of Idas Valley. 2,1 km.
- **Purple route:** Eikestad mall - the residential area of Uniepark. 2,6 km.

In section 3.1.1.1 it is described why it is unlikely to choose cycling along a path where the travel time ratio is more than 1,5 (Aretun & Robertson 2013; Svensson 2008) or according to SKL (2015) more than 2. If the acceptable limit is 1,5 cycling is attractive along four of the seven routes but if the acceptable limit is 2 cycling is attractive along six out of seven routes. This suggests that the level of service for cyclists, in terms of travel time, is good at most of the important key routes in Stellenbosch.

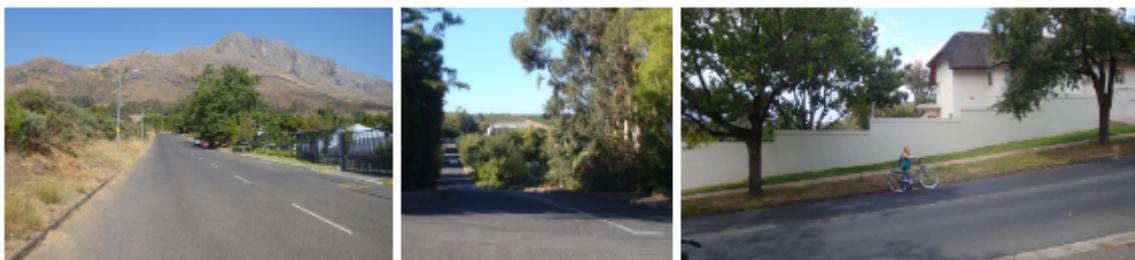
Figure 13 - Some of the roads with high grade in Brandwacht
Source: Elina Hederberg and Helena Homle

Worth mentioning is that the path to Brandwacht, which got the highest travel time ratio, is not only the longest route but also the one with the biggest difference in altitude. SKL (2010) and TfL (2014) state that hilly terrain is one disadvantage that definitely should be avoided in cycling routes. According to the contour map the grade is approximately 8 % (Google maps, 2016), which affects the travel time for cyclists. Some of the roads with high grade in Brandwacht are shown in figure 13. Ribbens (2006) states that cyclists do not appreciate grades above 5 % and therefore the criterias of an attractive route is not fulfilled. According to Svensson (2008) it is always recommended to avoid big differences in altitude when planning for cycle infrastructure.

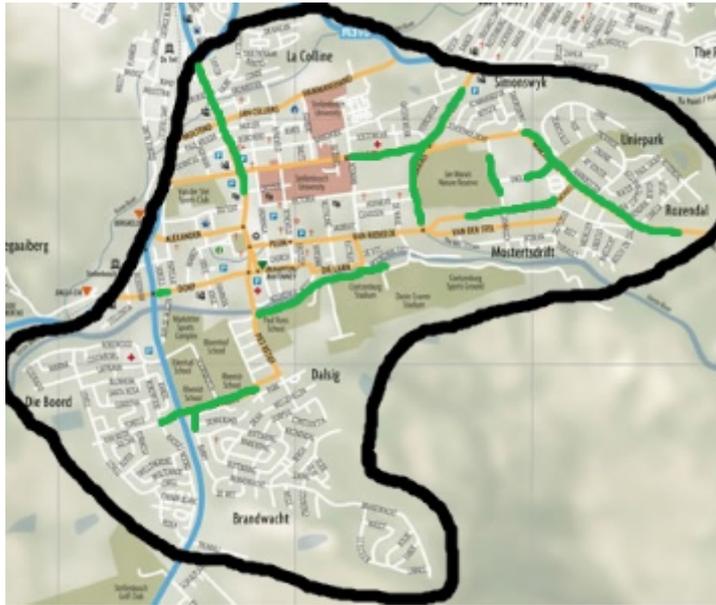
Figure 14 - A map of Stellenbosch in which existing cycle paths are marked
Source: Stellenbosch (2016) edited by Elina Hederberg and Helena Homle

Cyclists in Stellenbosch are generally supposed to mix with other vehicles in the streets but in some places there are separate cycling facilities. These facilities have different shapes and various designs and can only be found along a few streets. In figure 14 the existing bicycle infrastructure is marked to easier describe the present situation and its lack of connections.

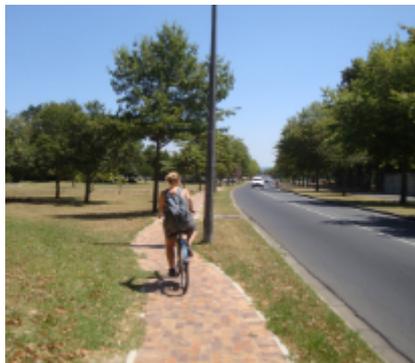
Figure 15 - The cycle path on the south side of Van Reede road
Source: Elina Hederberg and Helena Homle

During the planning of the existing cycle infrastructure in Stellenbosch it did not always seem like the importance of continuity was considered. Some distinctive examples of questionable continuity were found during the observations. Firstly, some parts of the cycle path along Van Reede road are debatable. The path on the south side of the road is a one metre wide path with pavers, this can be seen in figure 15.

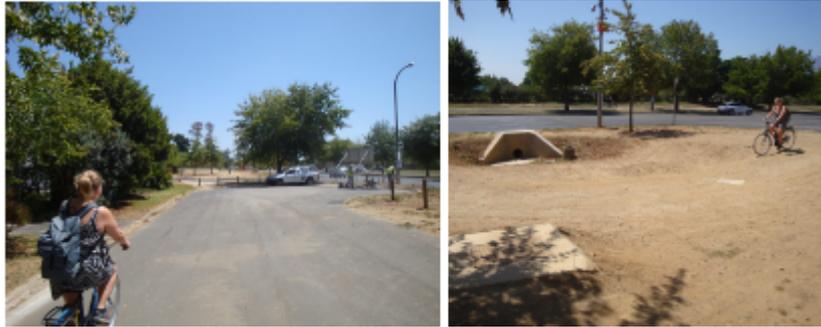
Figure 16 - To the left: When cyclists on the path along Van Reede road are lead down on a cul-de-sac. To the right: The gravellyard along Van Reede road
Source: Elina Hederberg and Helena Homle

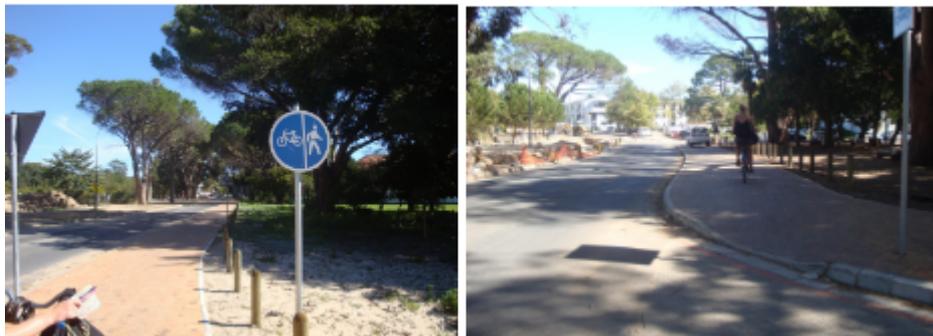
Figure 17 - To the left: The beginning of the path along Marais road. To the right: An example where the curb is ramped along the pathway on Marais road
Source: Elina Hederberg and Helena Homle

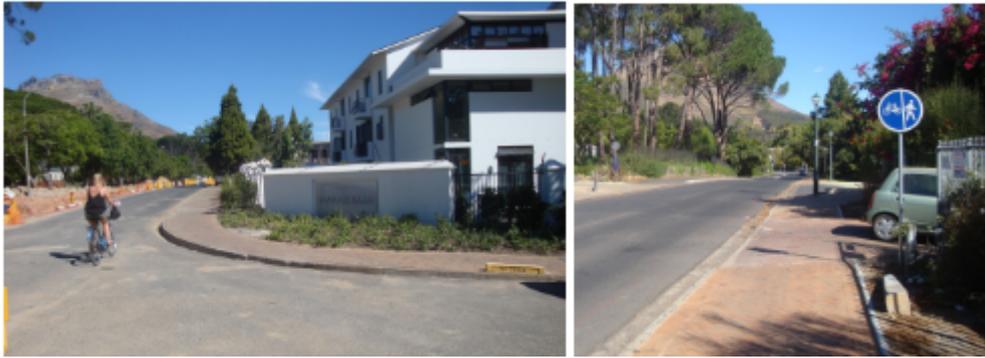
Figure 18 - To the left: The intersection between Marais road and Victoria street where the curb is not ramped and cyclists are forced to continue along the road. To the right: A sign indicating that the unramped pavement is a shared cycle path. Source: Elina Hederberg and Helena Homle

It is also suggested that discontinuous cycle paths are less popular among cyclists than the ones that are continuous (TfL 2014, Heydon & Lucas-Smith 2014 and Buehler & Dill 2015). This means that the second example from Marais road in Stellenbosch is a typical example of when the level of service for cyclists is reduced due to defects in the infrastructure. Since it is also said that cycle paths should be of consistent standard (SKL, 2010) the level of service along the cycle path at Van Reede road is problematic as well. The fact that cyclists on their way to the sport centre are not able to follow a continuous cycle path all the way to this destination is another example of discontinuous routes in Stellenbosch. TfL (2014) says that cycling facilities must be planned in a way that does not delay or force cyclists to make detours, therefore the current facilities in Stellenbosch is not always well-planned in terms of level of service for cyclists.

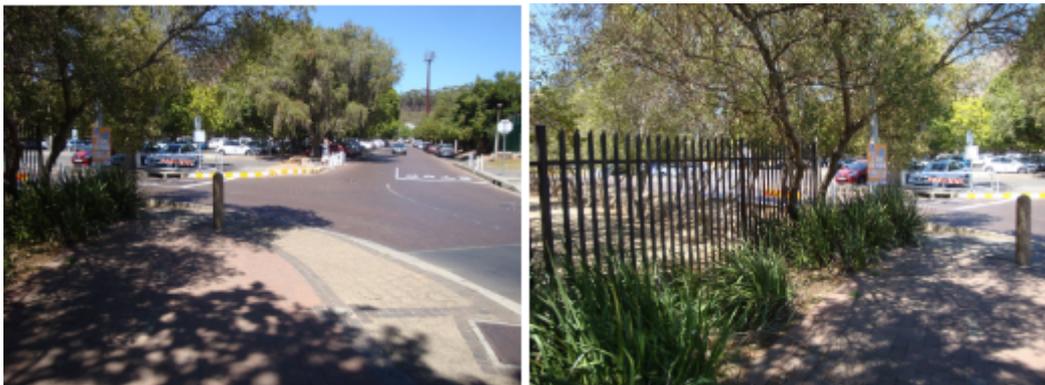
Figure 19 - The abrupt end of the cycle path at the intersection between Coetzenburg road and Suidwal road. Source: Elina Hederberg and Helena Homle

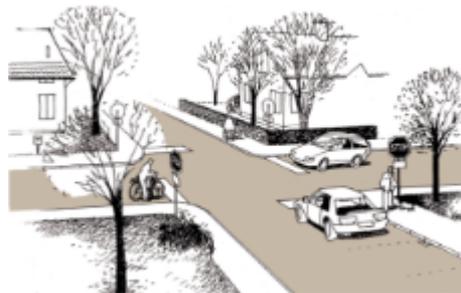
Figure 20 - A typical all-way stop that often appears in Stellenbosch
Source: SKL (2009)

Stop signs is a common way to regulate traffic junctions in Stellenbosch, almost every junction in the urban area is controlled with all-way stop (see figure 20). This means that traffic approaching an intersection from all directions is required to stop before continuing through the junction.

As mentioned, Stellenbosch has a high density of all-way stops regardless if it is an intersection between smaller streets in residential areas or intersections with bigger roads. Moreover, the all-way stops often seem to generate congestions during rush hour.

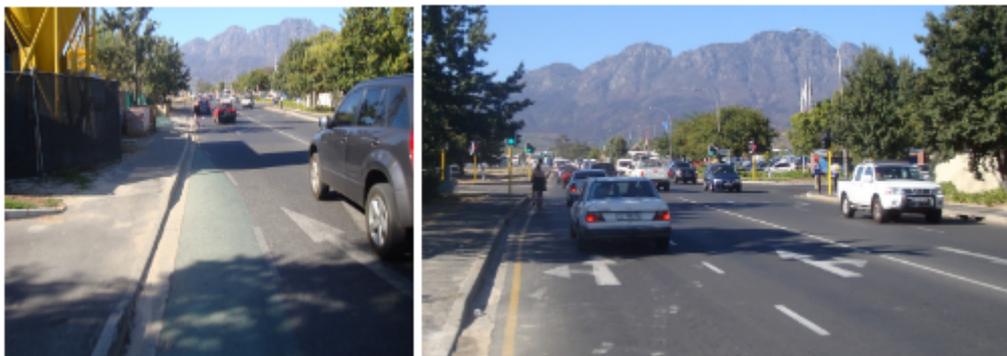
Figure 21 - The cycle path along Cluver road when approaching the intersection with Banghoek road
Source: Elina Hederberg and Helena Homle

An example where cyclists are not prioritised is along Cluver road where the road and the lined cycle path approach the intersection with Banghoek road. The pathway ends abruptly just before the intersection on Banghoek road, see figure 21. The path ends where the roadway divides into several lanes and therefore cyclists are forced to either cross the left lane or mix with the motorised vehicles turning left. Since this is a busy intersection cyclists easily gets unnoticed.

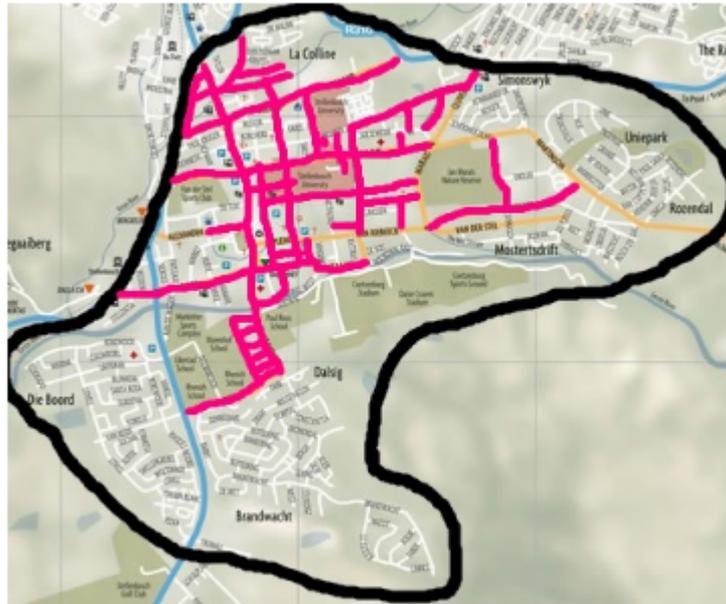
Figure 22 - A map of Stellenbosch in which streets with lack of space are marked
Source: Stellenbosch (2016) edited by Elina Hederberg and Helena Homle

Lack of space for cyclists is a general issue on most of the streets in Stellenbosch. In most cases the idea for cyclists is to be mixed with other vehicles and therefore cyclists easily gets pushed aside since motorists tend to take up their space. In busy and narrow streets lack of space becomes a big problem, mostly because of the width of the roadway but sometimes due to the speed of the motor vehicles. When cyclists are not given enough space the speed among the vehicles passing by has a significant influence on the feeling of insecurity. To get an idea of how comprehensive this problem is the narrow streets are marked in figure 22.

As shown in the figure 22 this is a problem in many parts of Stellenbosch. Except for some residential areas lack of space is common in the majority of the streets.

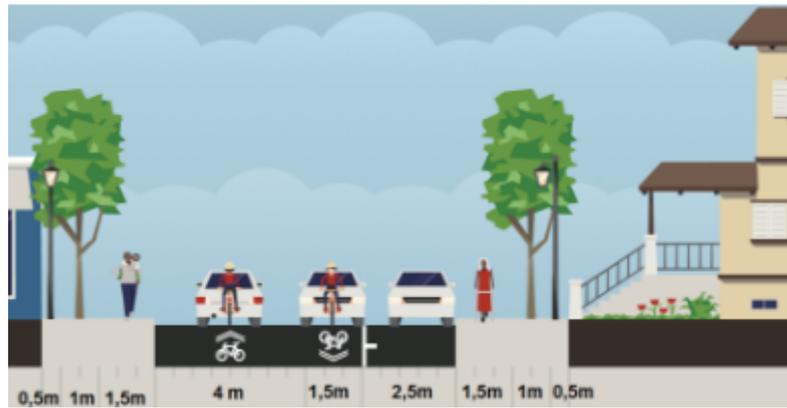
Figure 23 - The cross section of Bosman road, between Banghoek road and Merriman Avenue. Source: Streetmix (2016) edited by Elina Hederberg and Helena Homle

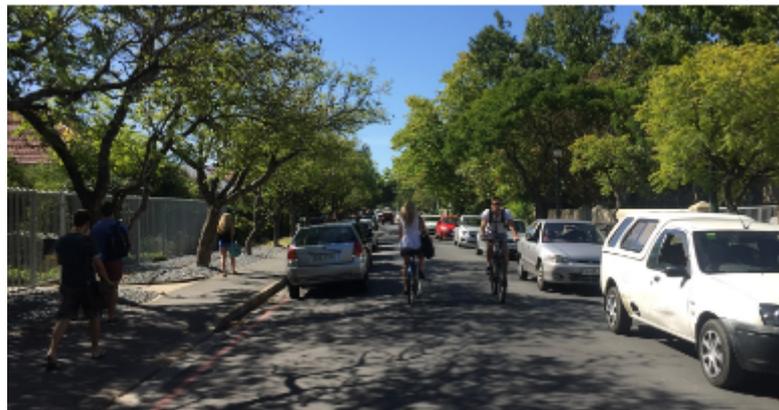
Figure 24 - Bosman road between Banghoek road and Merriman Avenue, with congestion in the right lane. Source: Elina Hederberg and Helena Homle

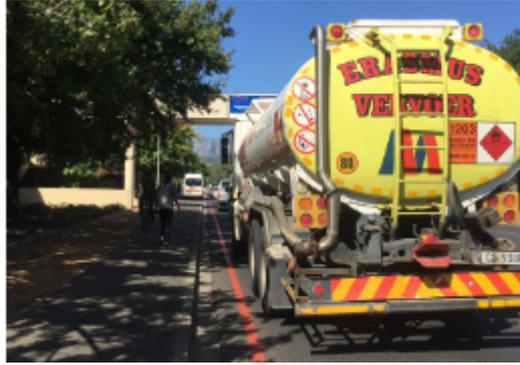
Figure 25 - Lack of space for cyclists on Merriman Avenue
Source: Elina Hederberg and Helena Homle

Another example of a street in Stellenbosch where the lack of space for cyclists is significant is along Merriman Avenue, west of Bosman road where cyclists are supposed to mix with motor vehicles. Merriman Avenue is one of the most important roads in Stellenbosch for both cyclists and motorists and it is therefore very busy it is not unusual to see heavy traffic on this road. In figure 25 it is shown that cyclists cannot travel alongside motor vehicles due to lack of space in the roadway. Additionally, motorists tend to travel at relatively high speed, which as mentioned above also affects the feeling of security while cycling.

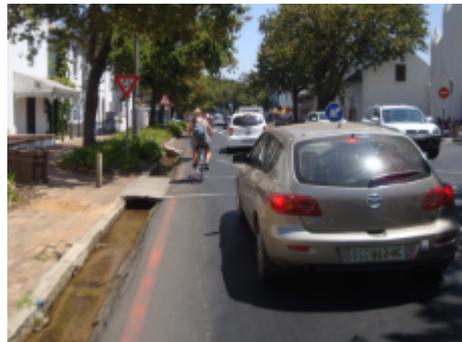
Figure 26 - Lack of space for cyclists on Dorp street
Source: Elina Hederberg and Helena Homle

Dorp Street is also a great example of a typical street in Stellenbosch, a narrow street lined with drainage channels that often is busy with traffic. As shown in figure 26 there is not much space left for cyclists between the cars and the relatively deep drainage channels.

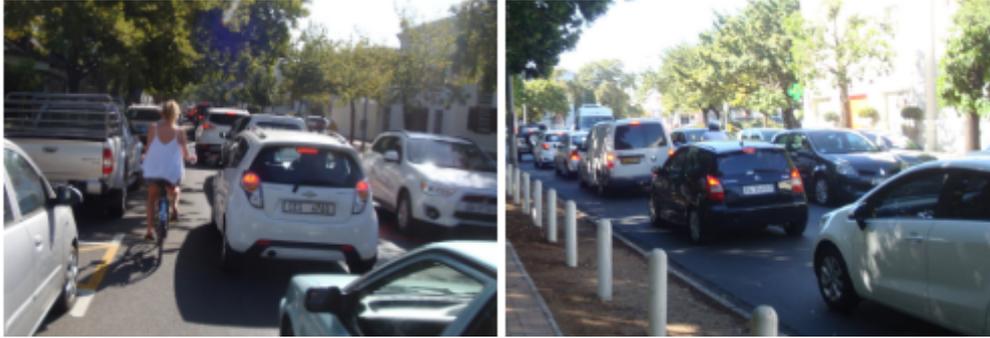
Figure 27 - Cycling along Dorp street, to the left, and Piet Retief street, to the right, during rush hour
Source: Elina Hederberg and Helena Homle

In section 3.2.3 it is discussed that Stellenbosch is more and more troubled with traffic congestions. According to Stellenbosch Municipality (2016) Dorp street, Merriman avenue and Piet Retief street are some of the most congested roads. In figure 27 the situation on Dorp street and Piet Retief street during rush hour is shown.

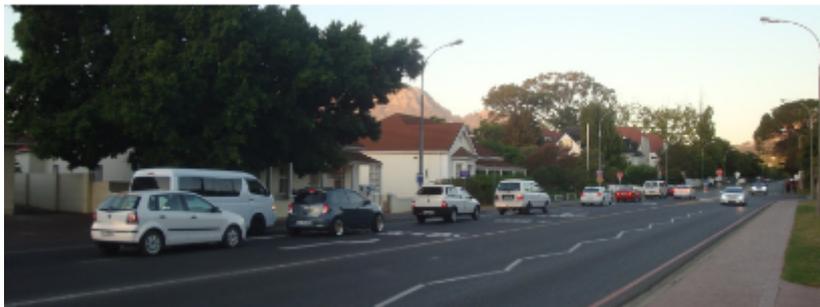
However, there are also delays at some places during other times of the day. It is noticed that the queue length on Merriman Avenue, in the intersection with Bosman road, is often more than five cars even when the traffic volume is considered low. An example of this is shown in figure 28.

Figure 28 - Merriman Avenue, the queue length is seven vehicles in this moment
Source: Elina Hederberg and Helena Homle

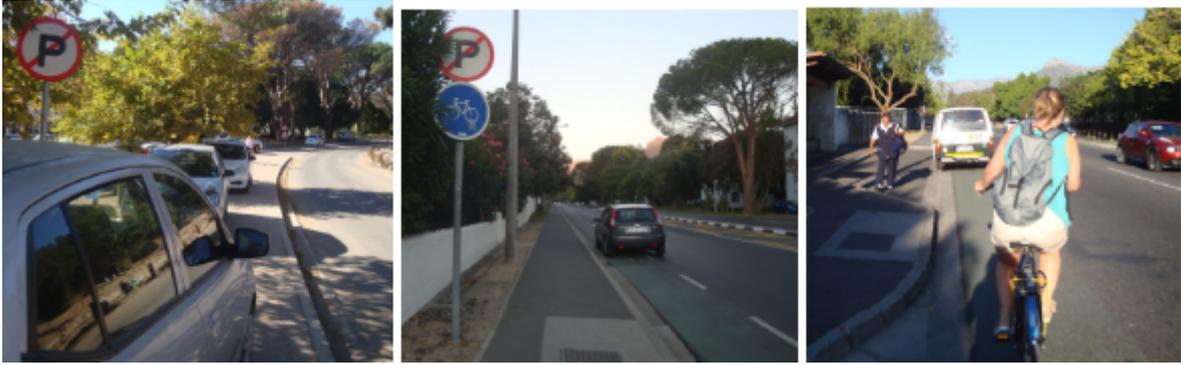
In Stellenbosch cars parked at inconvenient places is a common sight. In all pictures in figure 29 cars are parked blocking the entire cycle facility. Pay attention to the parked car in the figure to the right, where the vehicle chose to park in the painted cycle lane instead of in the parking lot right next to the lane.

**Figure 29 - To the left: Parked cars along the pathway on Marais road. In the middle and to the right: Car blocking the cycle path along Merriman avenue
Source: Elina Hederberg and Helena Homle**

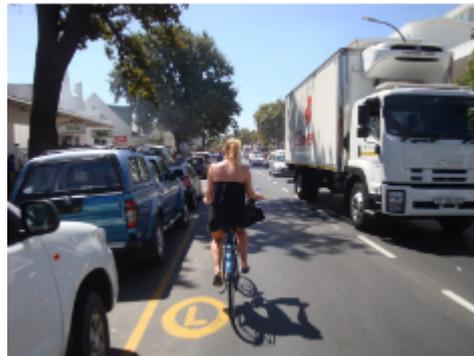
Besides forcing cyclists to make detours parked cars may also narrow the roadway, decreasing the possible space for cyclists to use. This is shown in figure 30.

**Figure 30 - Cycling north along Bird street from the roundabout with Alexander road
Source: Elina Hederberg and Helena Homle**

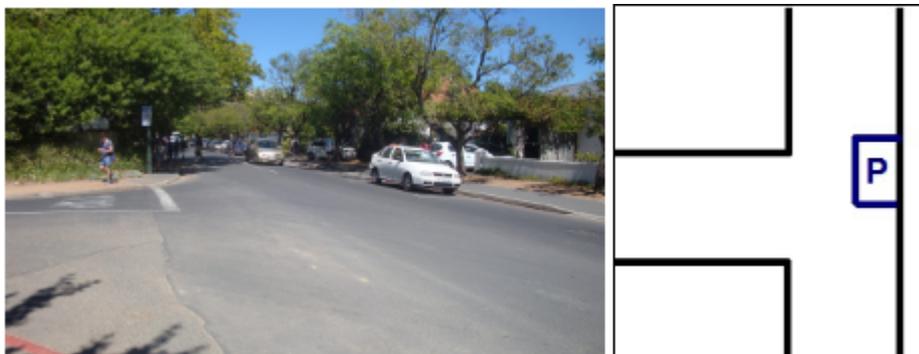
Figure 31 - The permanent parking lot in the intersection with Bosman and Soeteweide road. The painting to the right is not to scale. Source: Elina Hederberg and Helena Homle

Another example of inconvenient parking in Stellenbosch is found in the intersection between Bosman road and Soeteweide road where a permanent parking lot is located in the middle of the intersection, see figure 31.

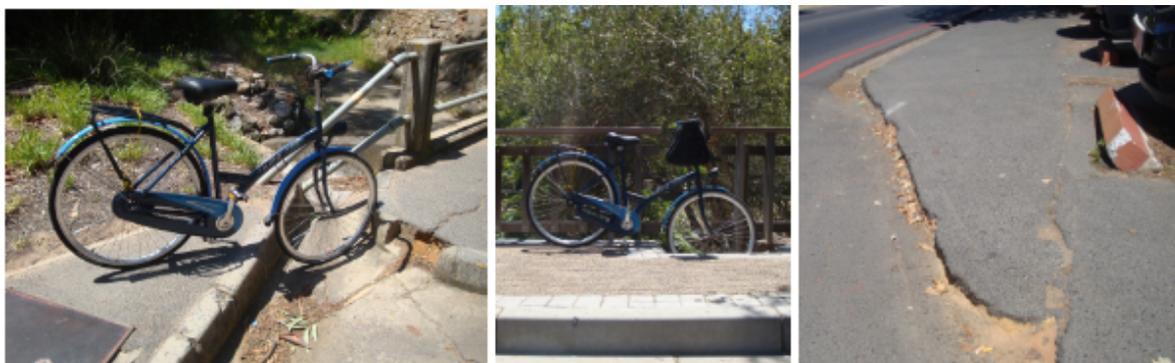
Figure 34 - Major irregularities on the pavement along Bosman road, to the left, and on the cycle path along Suidwal road, in the middle. To the right: Irregularities on the Bird street cycle path.
Source: Elina Hederberg and Helena Homle

The streets in Stellenbosch are generally paved, small-scale streets with one lane in each direction. The surface quality is acceptable in the majority of the streets but irregularities occur. There are often irregularities like cracking and rutting due to distress in the asphalt but greater obstacles are also common, an example is shown in figure 34.

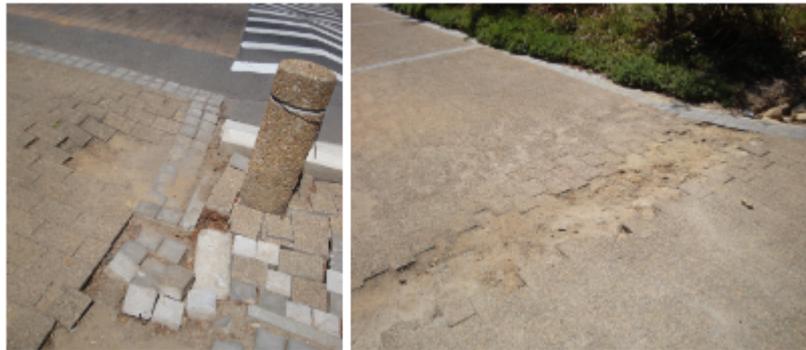
Figure 35 - Disordered pavers on the cycle path along Suidwal road Source: Elina Hederberg och Helena Homle

The surface material is paver on many of the existing cycle paths in Stellenbosch. It is common that the pavers are broken and disordered, as shown in figure 35.

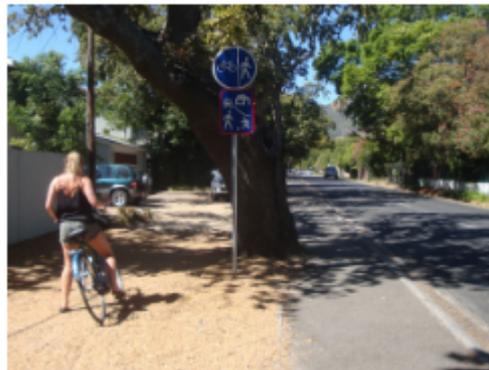
On the cycle path on Jonkershoek road the sign indicates that cyclists and pedestrians are supposed to have separated lanes on the pathway even though it is narrow. The sign seen in figure 36 indicates that the path is supposed to be divided with pedestrians walking closest to the roadway on the paved lane while cyclists seems to be forced to continue on the gravel.

Figure 36 - The pathway along Jonkershoek road where cyclists are shown to ride in the gravel yard
Source: Elina Hederberg and Helena Homle

According to SKL (2015) irregularities due to the surface quality highly affects the accessibility for cyclists. As shown in all examples above the surface quality is poor which has a negative effect to the accessibility. The design of the pathway in figure 36 where the cyclists are separated from pedestrians on the pavement and are supposed to ride in the gravel on the left side is questionable. Although, changing the side of the cycle and pedestrian lane would not solve the problem since it in terms of accessibility is not desirable among pedestrians either. The planning of the example from the cycle path along Suidwal road is also questionable. The wooden deck becomes a quite big obstacle, which may be hard to detect for cyclists approaching at relatively high speed. To avoid cyclists from slipping or falling it is important to keep the surface of cycle facilities at level and well maintained (TfL 2014, Heydon & Lucas-Smith 2014).

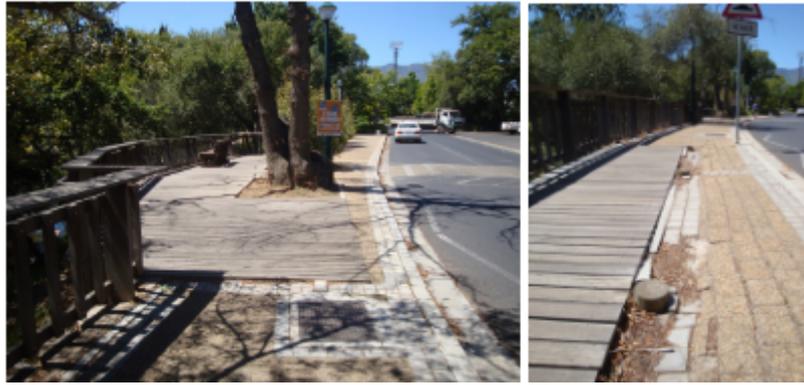
An interesting example of bad surface quality is the one shown in figure 37. On the pathway for pedestrians and cyclists along Suidwal road there is a sudden change in surface material due to a wooden deck by the river.

Figure 37 - The wooden deck found along Suidwal road

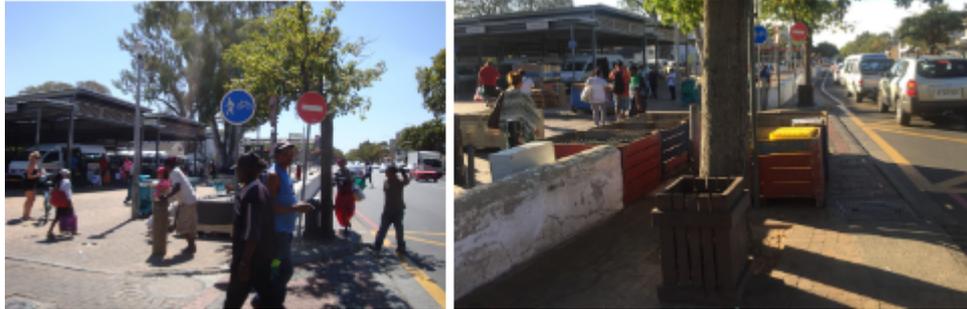
The cycle path, which leads cyclists through the local taxi and bus station on Bird Street, is a very busy and crowded area, which makes it difficult for cyclists to pass. The cycle path is supposed to be a shared facility for pedestrians and cyclists but it is mostly used by pedestrians. Except for the crowd there are plenty of trees, bollards, garbage bins and other boxes blocking the way for cyclists (see figure 39).

Figure 39 - The crowded area around Stellenbosch/Kayamandi taxi/bus station
Source: Elina Hederberg and Helena Homle

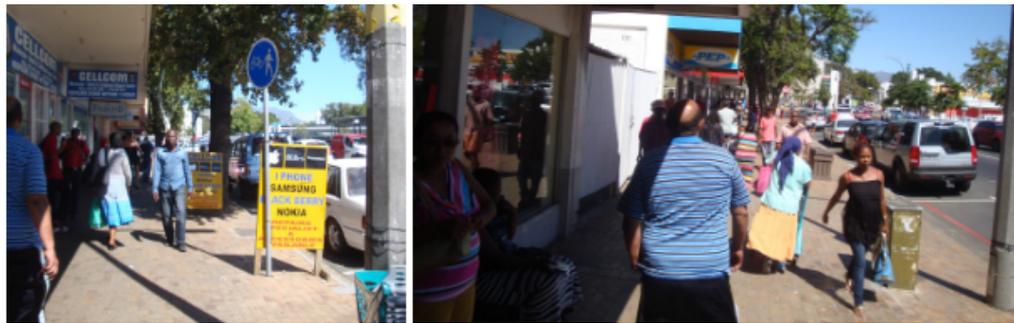
The cycle path on the opposite side of Bird street, seen from the local taxi and bus station, is even more difficult to pass since it is narrow, crowded and blocked by signs and shop entrances, as shown in figure 40.

Figure 40 - The southbound pathway along Bird street, south of Merriman avenue
Source: Elina Hederberg and Helena Homle

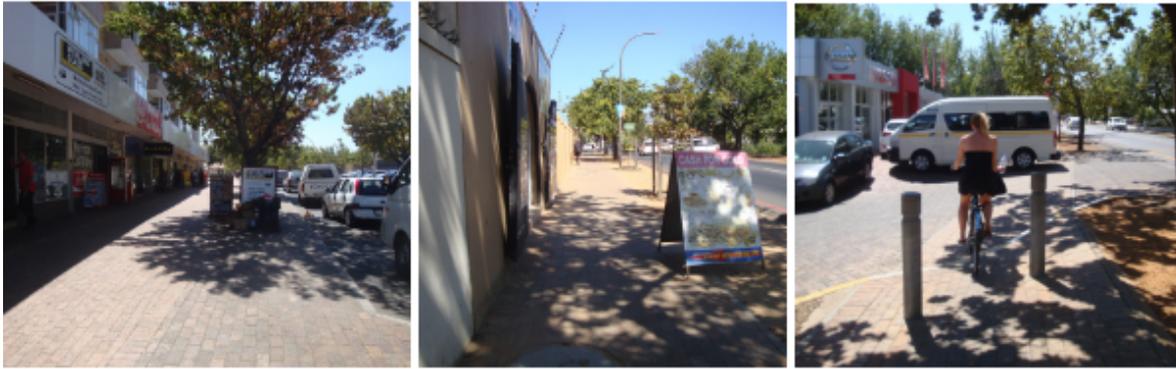
Figure 41 - Some of the mobile obstacles on the cycle path along Bird street
Source: Elina Hederberg and Helena Homle

Obstacles on the cycle path along Bird street are common not only around the station area but all along the pathway. Besides being a crowded and busy path there are also mobile obstacles such as garbage bins, advertising signs and parked cars, as shown in figure 41. Even though Bird street is a very busy street with a relatively high car speed, lined with deep drainage channels, it is observed that people chose to cycle in the street due to all above mentioned obstacles on the pathway.

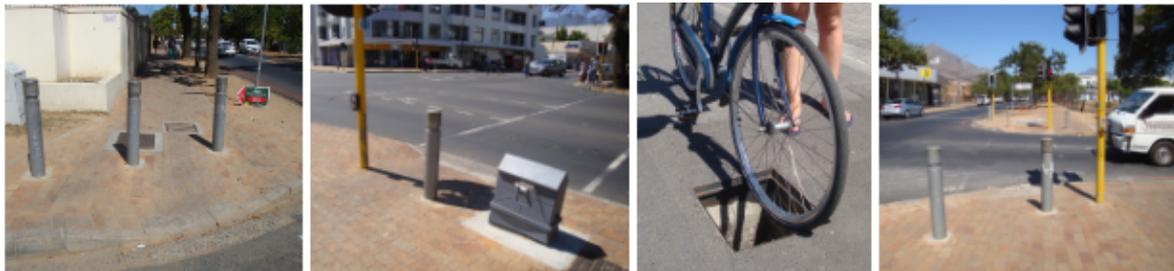
Figure 42 - Bollards and electrical cabinets blocking the pathway at intersections along Bird street
Source: Elina Hederberg and Helena Homle

There are also many permanent obstacles along the path. The most distinctive obstacles are found where the path crosses connecting streets. At these points there are always bollards blocking the pathway to prevent cars from entering, as shown in figure 42. The bollards are often placed in a way that makes it difficult even for cyclists to pass by. Except from the bollards it is also common that electrical cabinets are standing in the way.

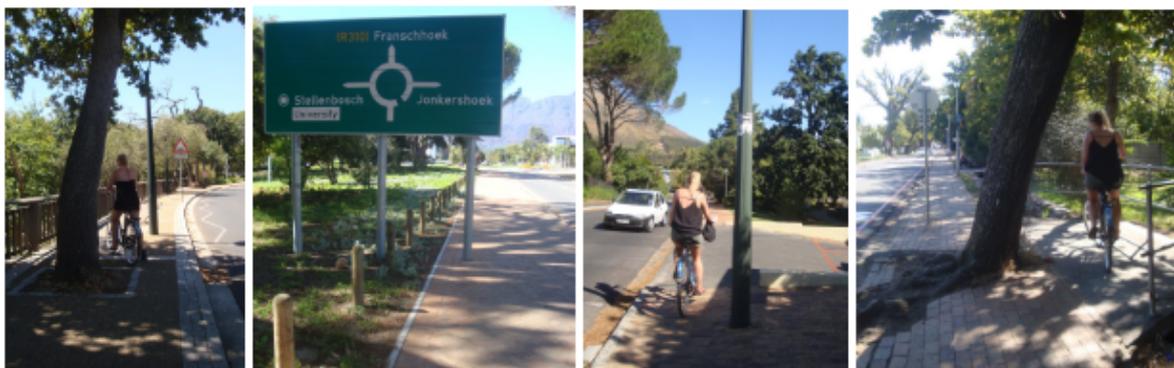
Figure 43 - Obstacles on the cycle path on Suidwal road, Marais road and Jannasch road respectively.
Source: Elina Hederberg and Helena Homle

Obstacles are not only found on Bird Street but in several places in Stellenbosch. It is common along many cycle paths that trees or lamp poles are placed in the middle of the pathway forcing the cyclists to yield. Examples of this are shown in figure 43.

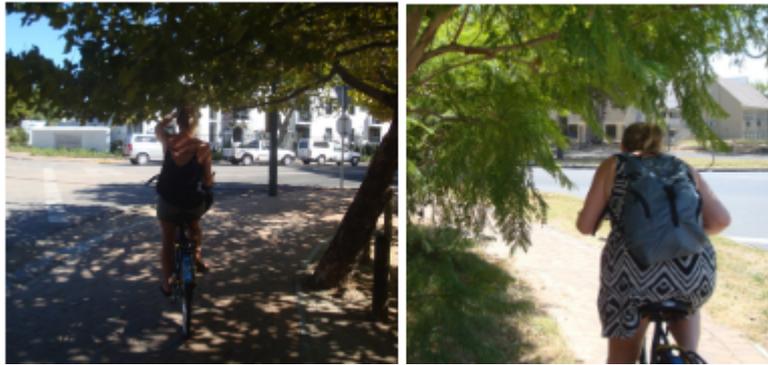
Some obstacles on cycle paths in Stellenbosch seems to occur due to poor maintenance, one example of this is the common problem with branches blocking the way as can be seen in figure 44.

Figure 44 - Branches blocking the way on the cycle path along Marais road to the left and the cycle path along Van Reede road to the right. Source: Elina Hederberg and Helena Homle

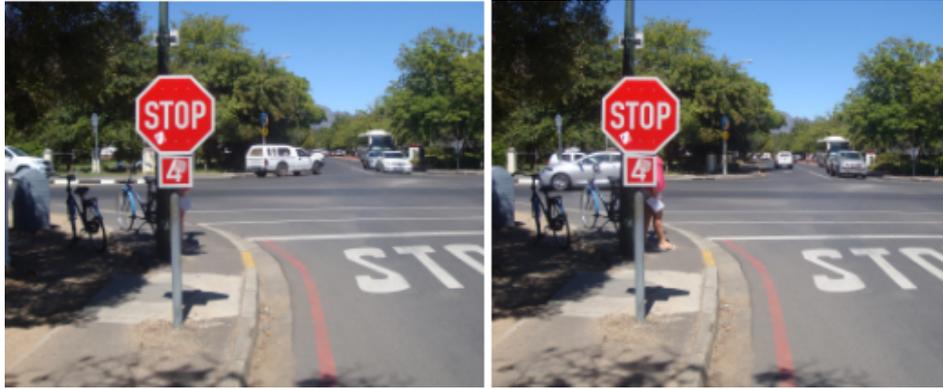
Figure 46 - Poor visibility at the intersection, where vulnerable road users are easily hidden behind the sign. Source: Elina Hederberg and Helena Homle

Another example of when it may be difficult for motorists to detect vulnerable road users is found in the intersection between Merriman Avenue and Bosman road. As can be seen in figure 46 the stop sign is placed in a bad way since the pedestrian behind the sign clearly is difficult to detect.

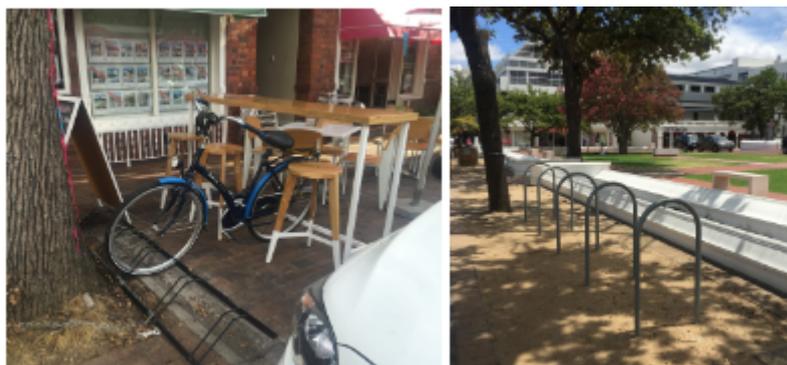
It is not always easy to find cycle parking in Stellenbosch even if bike stands are found in some places. It is shown in figure 47 that the parking facilities have different standards and that the location is more or less well planned. Quite many bike stands can be found on campus but otherwise it is not certain that any can be found close to key destinations since they are often placed at odd locations.

Figure 47 - Examples of cycle parking in Stellenbosch. To the left: Church street. To the right: Plein street. Source: Elina Hederberg and Helena Homle

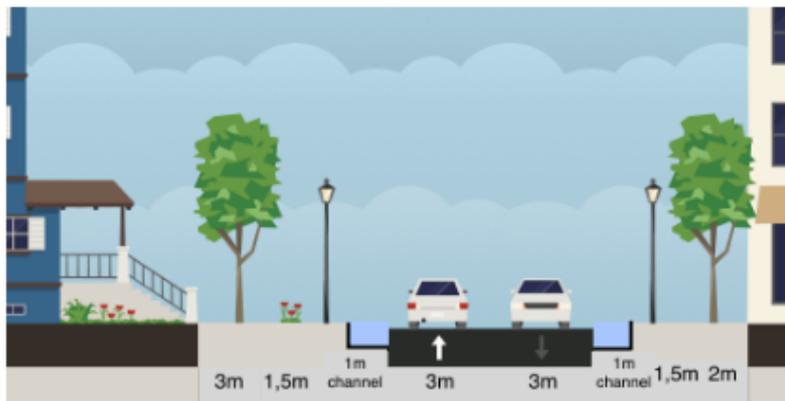
**Figure 50 - The cross section of Dorp street
Source: Streetmix (2016) edited by Elina Hederberg and Helena Homle**

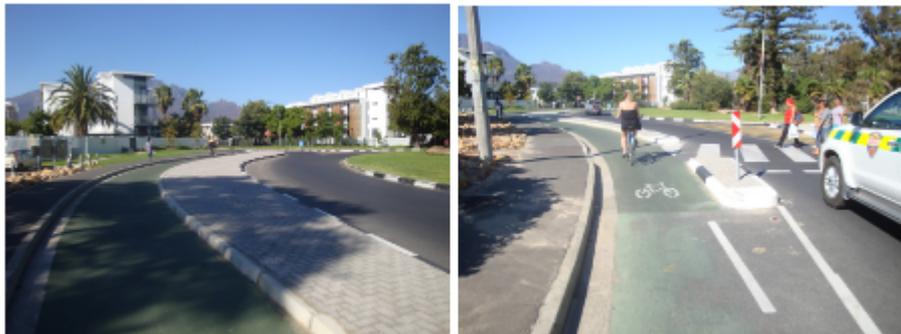
The cycle path is clearly marked with green paint, as can be seen in figure 55. According to Professor Sinclair (2016) a Smart car have been seen using the cycle path during rush hour since it is very wide. It is interesting to measure vehicle speed at this location because of the existing cycle infrastructure and the fact that cyclists are still interacting with approaching cars.

Figure 55 - The roundabout between Merriman avenue/Cluver road seen from two different angles

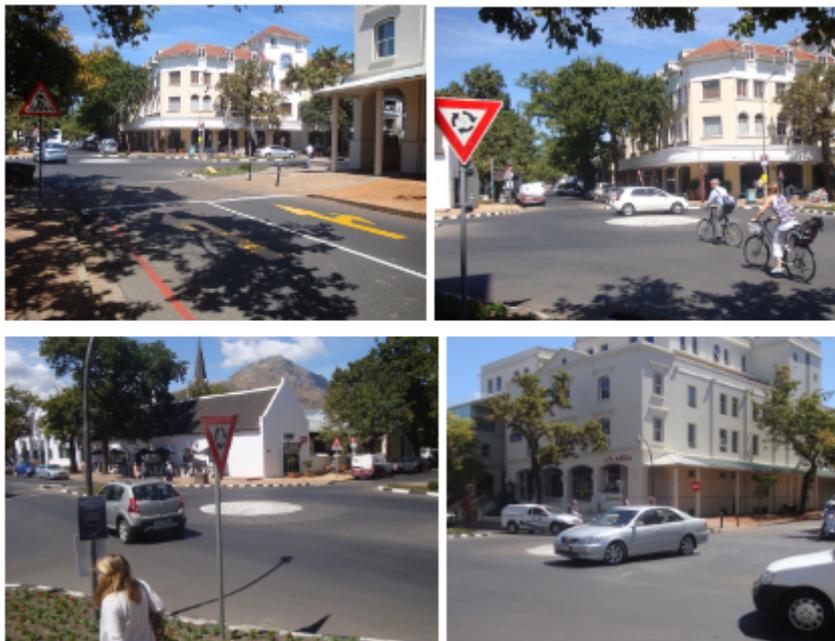
The circle in this roundabout is quite small and cars are therefore often seen driving straight through or over this. Examples of this traffic solution are shown in figure 57. It is interesting to measure the vehicle speed in this roundabout since a few smaller roundabouts are found in Stellenbosch in which cyclists are integrated with motorised traffic.

Figure 57 - The roundabout between Plein Street and Ryneveld Street seen from different angles. The picture at the bottom right shows the situation when a car drives straight through the circle

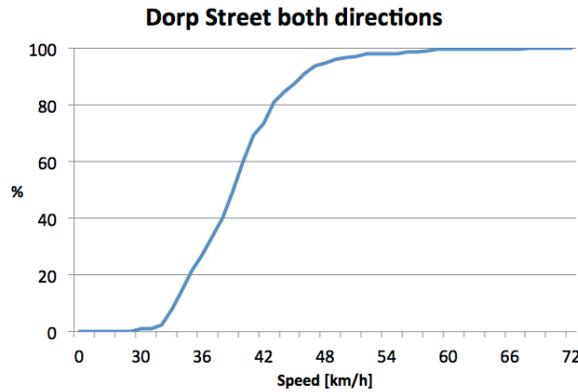
Diagram 2 - Results from vehicle speed measurements on Dorp street

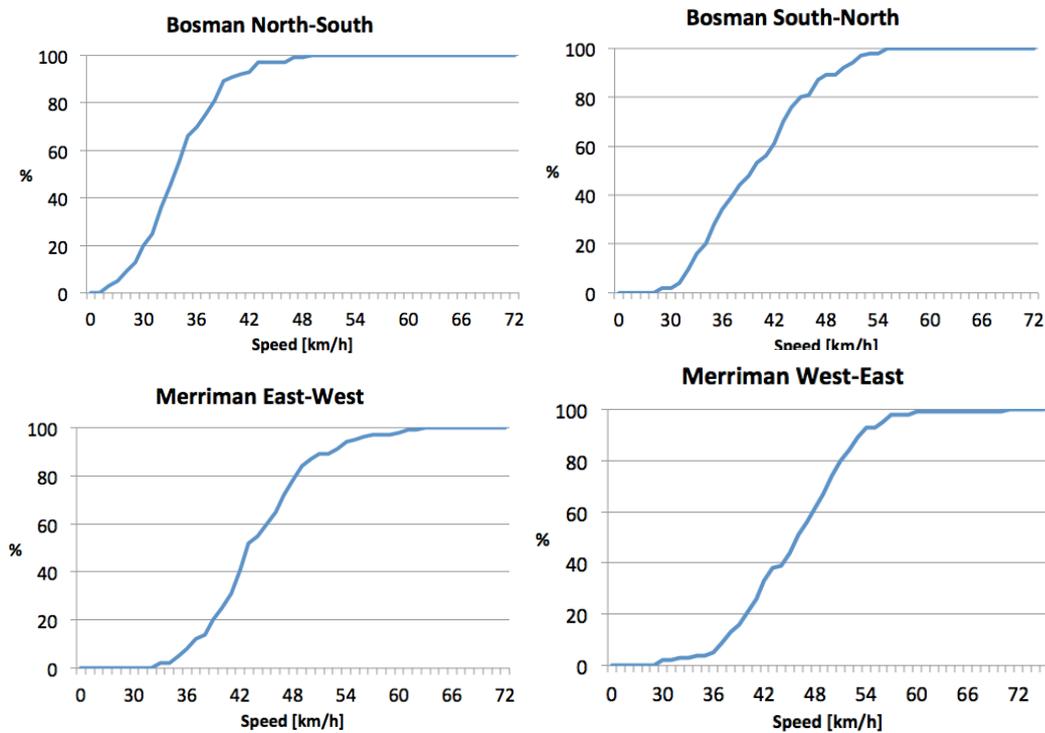
Diagram 3 - Results from vehicle speed measurements in the intersection between Merriman Avenue and Bosman road

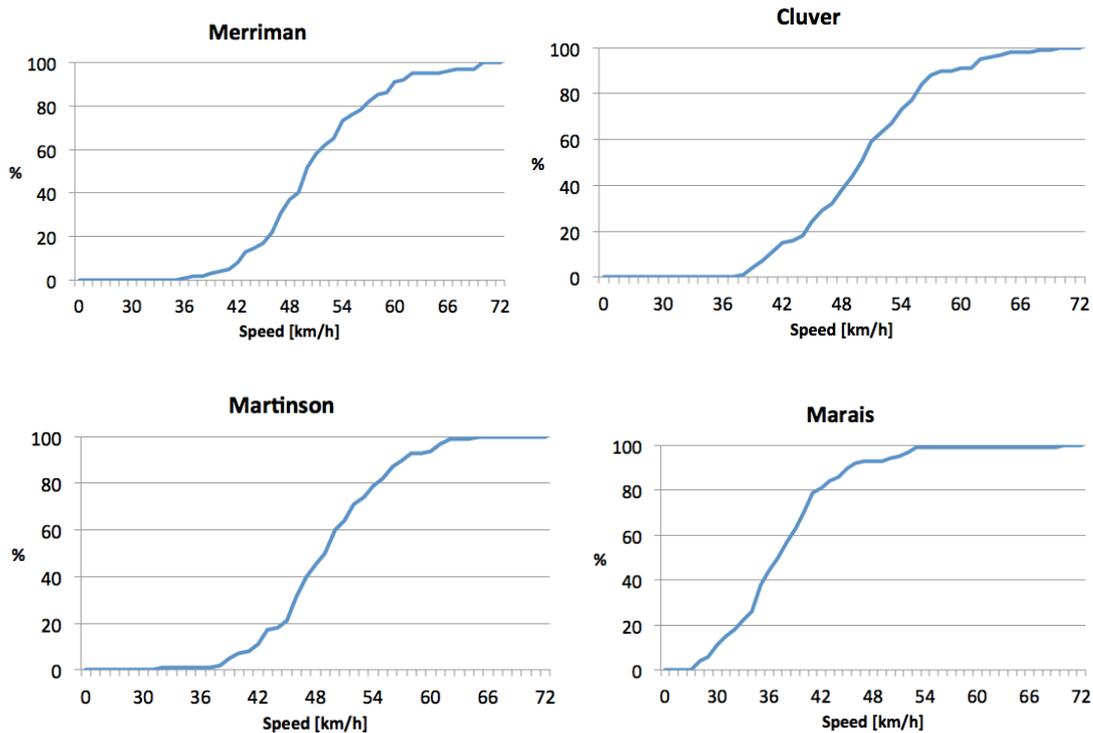
Diagram 4 - Results from vehicle speed measurements in the roundabout between Merriman Avenue and Cluver road

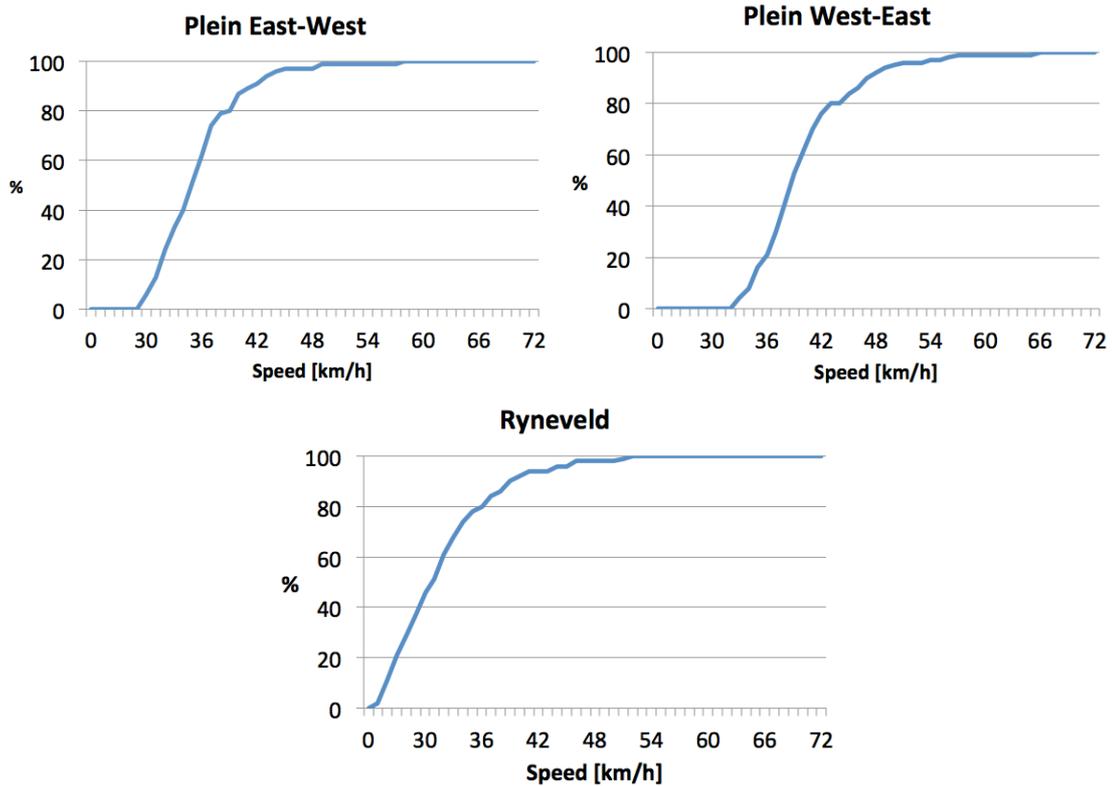
Diagram 5 - Results from vehicle speed measurements in the roundabout between Plein Street and Ryneveld Street

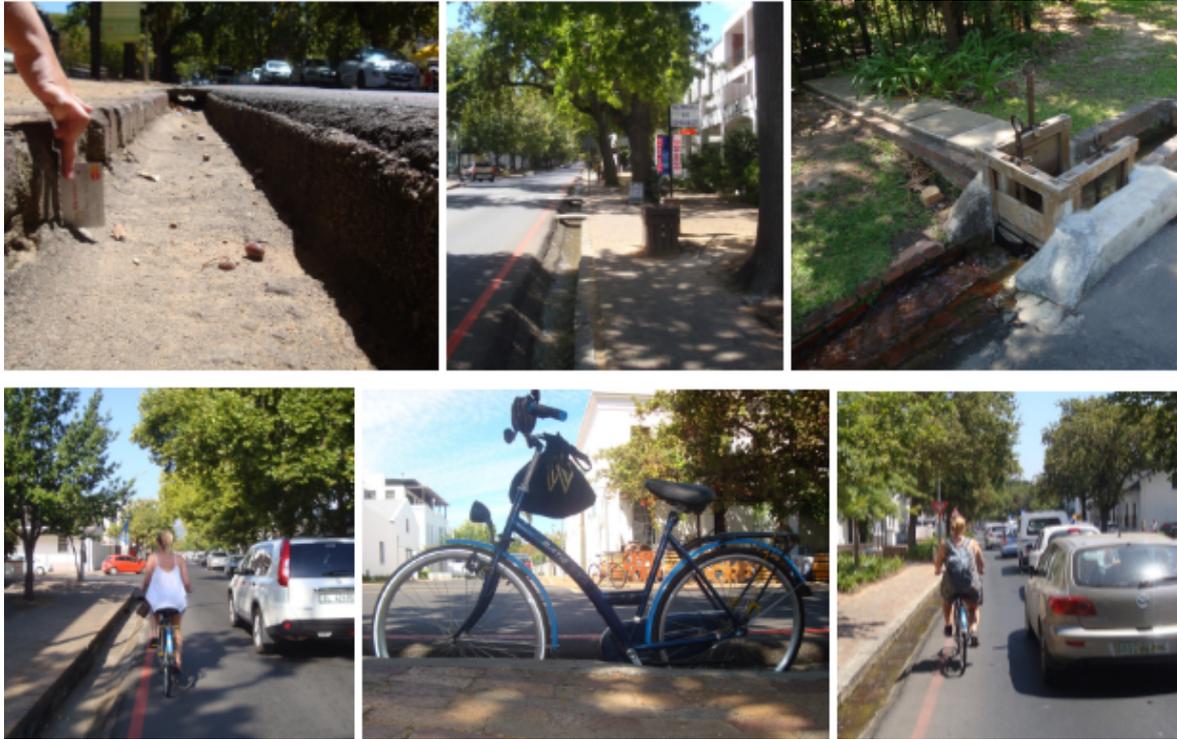
Figure 58 - The typical design of the historical drainage channels
Source: Elina Hederberg and Helena Homle

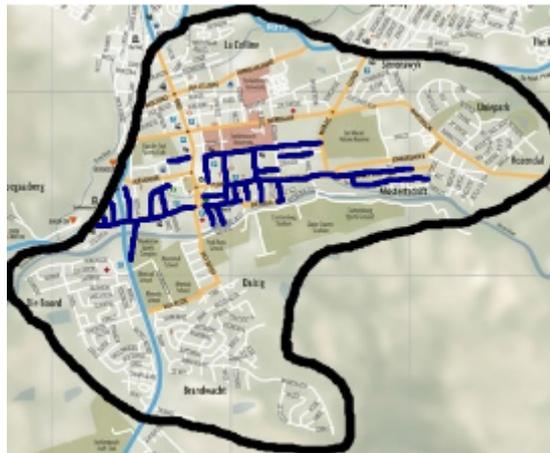
These drainage channels occur on several streets in Stellenbosch, which is shown in figure 59. Most of the channels appear close to the river in the city center along some of the busiest streets used by both cars and cyclists.

Figure 59 - A map of Stellenbosch in which streets that are lined with drainage channels are marked
Source: Stellenbosch (2016) edited by Elina Hederberg and Helena Homle

The historical value of the drainage channels is according to Professor Marion Sinclair (2016) prioritised by the city of Stellenbosch, which provides difficulties for cyclists and pedestrians when it comes to traffic safety. The shape and location of the drainage channels can be dangerous for vulnerable road users and cause severe accidents since it is

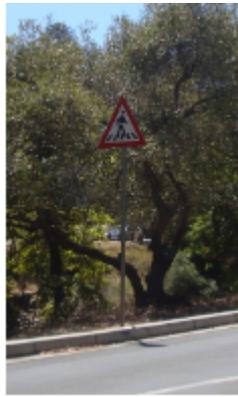
Generally it is not common with warning signs and other indications of cyclists in Stellenbosch, motorists are rarely alerted that they are about to interact with vulnerable road users. When paths for pedestrians and cyclists cross roadways it is common that the warning signs only show motorists to look out for pedestrians but not cyclists, as shown in figure 60.

Figure 60 - The warning sign before the cycle path along Suidwal road crosses the street Source: Elina Hederberg and Helena Homle

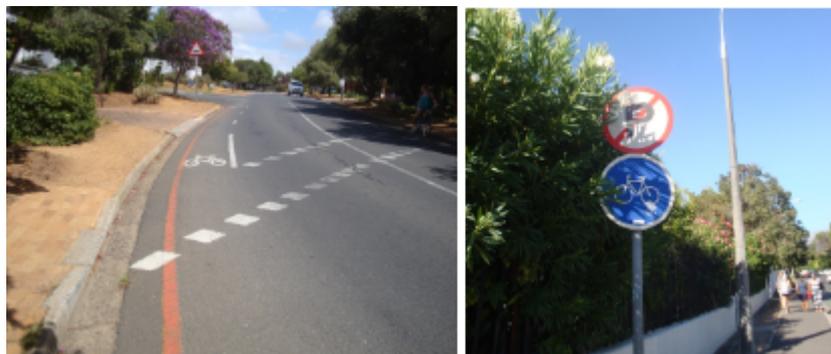
Although, there are some examples of locations in Stellenbosch where motorists are warned about cyclists crossing the road or cycle lanes starting. A few good examples are shown in figure 61.

Figure 61 - To the left: markings in the roadway on Barry road warning for cyclists crossing. To the right: A sign indicating that a cycle lane begins at this location in the intersection between Merriman avenue and Bosman road. Source: Elina Hederberg and Helena Homle
