Thesis 293

The situation for cyclists in South Africa

A study in Stellenbosch

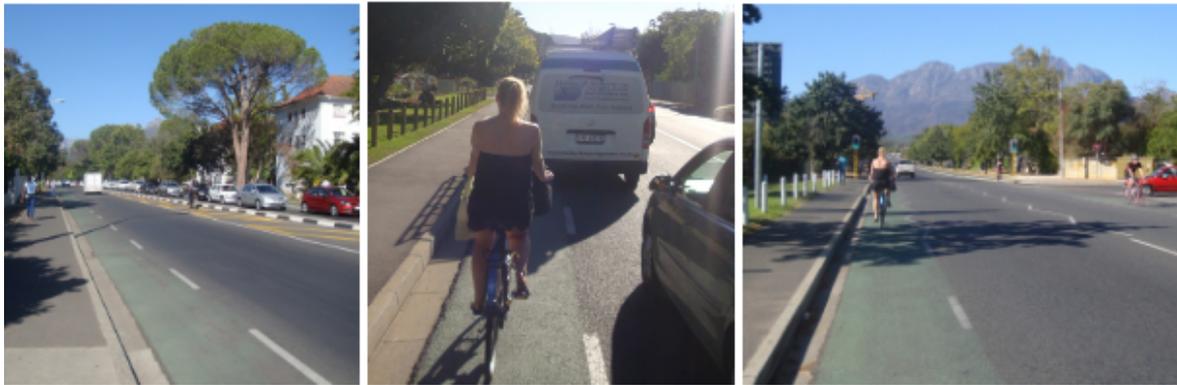
Figure 62 - The green painted cycle lane on Merriman Avenue and in the right picture on Cluver road
Source: Elina Hederberg and Helena Homle

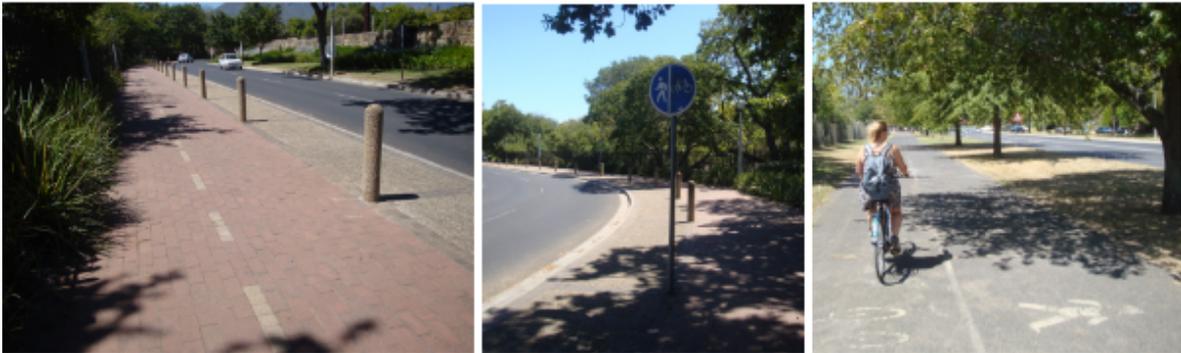
and cyclists have right of way but there is a painted line that indicates a segregated facility, which implies that the path is divided into one side for pedestrians and one side for cyclists. One example of this is found along Suidwal road, where the bollards divide the traffic users into two different sides. As shown in figure 64 there is a two-way cycle lane on the left and pedestrian lane on the right. The bollards and the different surface materials indicate the segregation. According to Professor Marion Sinclair (2016) it seems odd that the pedestrians are not given the inside section of the path since it is more common to place the cycle lane closer to the street. Another example of a cycle path that is completely separated from the roadway and also separates cyclists from pedestrians is found along Van Reede road, this path is also shown in figure 64.

Figure 64 - The separated path on Suidwal road to the left and to the right the separated path on Van Reede road. Source: Elina Hederberg and Helena Homle

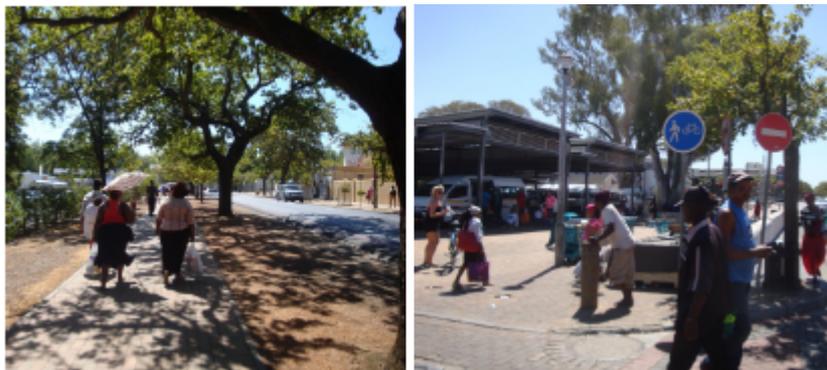
Figure 65 - The shared facility along Bird street, where vulnerable road users are separated from motorised vehicles. Source: Elina Hederberg and Helena Homle

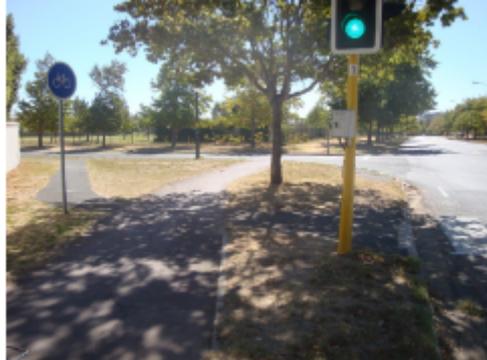
The third type of separated cycle path is where cyclists are completely separated from all other road users, including pedestrians. The only example of this found in Stellenbosch is found on Endler road and shown in figure 66.

Figure 66 - The beginning of the cycle path along Endler road, where the sign indicates that the path is for cyclists only. Source: Elina Hederberg and Helena Homle

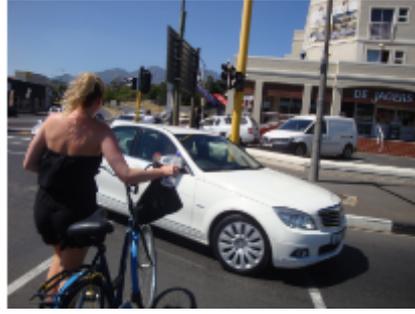
Another difficulty that was experienced at most intersections, controlled by traffic lights, is that the green time for vulnerable road users is a lot shorter than for motorists. Not even an average person will in most cases make it cross the road before the traffic lights turn red again. It was due to this we experienced the other incident when a car in the intersection between R44 and Bird Street almost hit us. The car came and approached the intersection from the north on the R44 and turned left towards Bird Street, where we were crossing four lanes in total. When the lights switched back to red we were only halfway cross the street and the car approached at high speed. We tried to hurry across the street to get out of the way but the motorist did not reduce the speed and therefore we had to stop right in the middle of the street when many other cars were approaching the intersection. This is shown in figure 68.

Figure 68 - The moment when the car chose not to yield and the participants had to make an immediate stop. Source: Elina Hederberg and Helena Homle
