Investigation of the frost resistance in bacteria treated self-healing concrete

Karin Persson

Master Thesis TVBM 5107

Building Materials, Lund University, Sweden

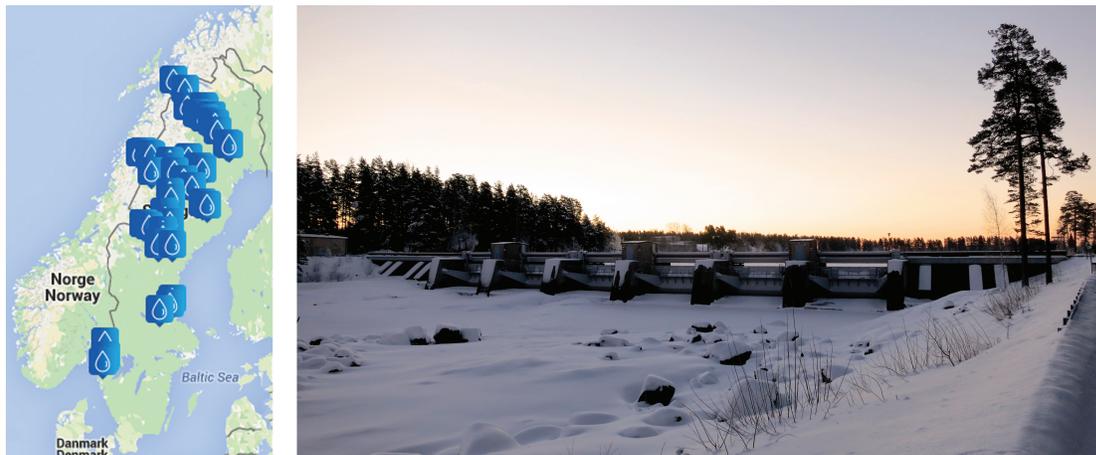
Figure 1.1: Left: Vattenfall's hydro power plants in Sweden [26]. Right: Hydro power plant in Älvkarleby during winter (Photo: Martin Rosenqvist)

Sweden has a climate where the temperature fluctuates from degrees above to degrees below zero in the whole country. In addition to the fluctuating temperatures in Sweden, most of Vattenfalls hydro power plants are located in the northern part, see figure 1.1. It is not uncommon that the temperature will drop below -25°C at least one time every winter and the mean temperatures in January are below zero in almost the whole country, see figure 1.2. That means that the frost resistance has to be taken into account during the planning process for outdoor concrete structures. This is why all outdoor concrete constructions contain "added" air voids. They work as expansion vessels where ice can form without creating any tension in the material (when water freezes it increases its volume by about 9% [10]). In order for the air voids to work as an expansion vessel it is very important that they are empty.

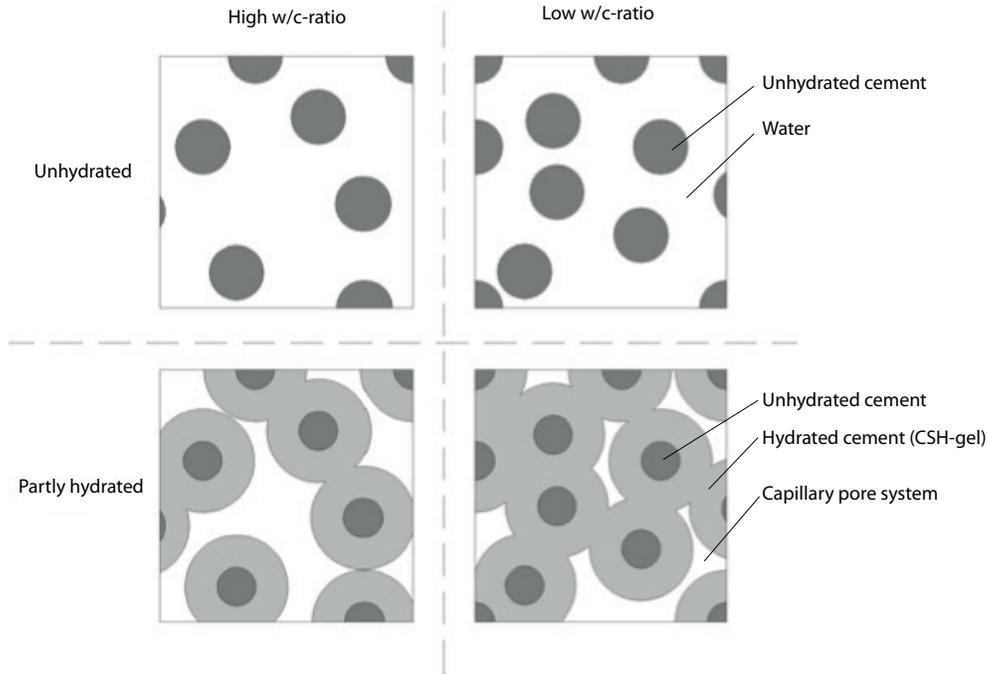
Figure 2.1: Cement particles suspended in water with a high w/c -ratio to the left and a low w/c -ratio to the right.

The *gel pores* are found in the CSH-gel, and this hydration product is larger than the original cement particle. So when the capillary porosity decreases with higher degree of hydration the gel porosity increases [7], see the gray areas in figure 2.1.

separate the capillary pores from each other, see left of figure 2.1. A too low ratio though, will lead to incomplete hydration because of lack of space to host the hydration products. The theoretical lower limit is set to 0.36 [18], but for practical use the lower limit is 0.39 [14].

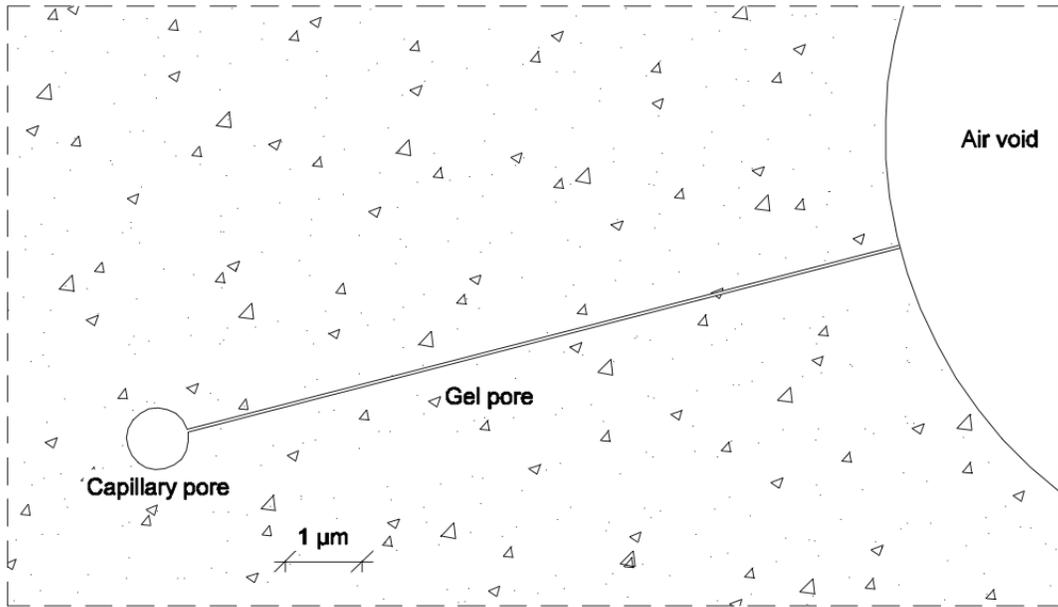
Figure 2.2: Schematic picture of the different sizes of the pores in the cement matrix.

The porosity consists of both capillary pores (about 1 μm in diameter), gel pores (1-100 nm in diameter) and compaction pores (0.22-0.30 mm in diameter) [18], see figure 2.2. The size of the pores are of importance when it comes to the frost resistance of concrete [7], and will be explained more in detail in section 2.1.3.

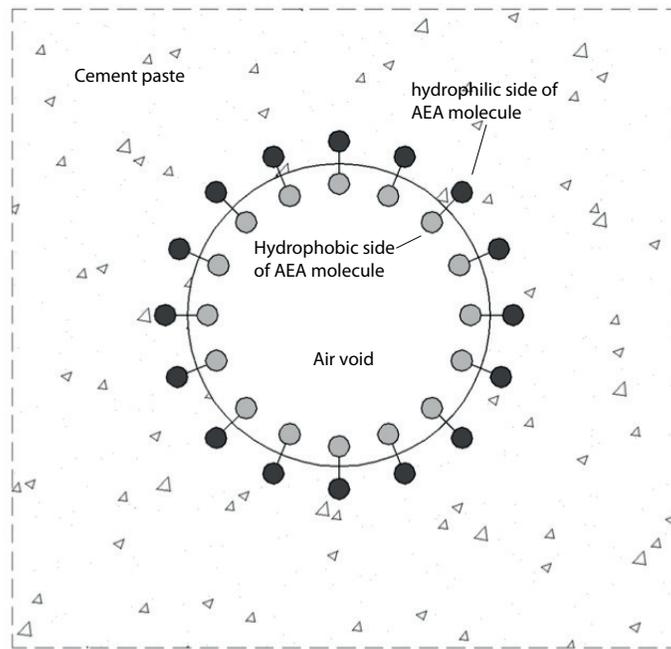
Figure 2.3: Surface active molecules build up the air voids

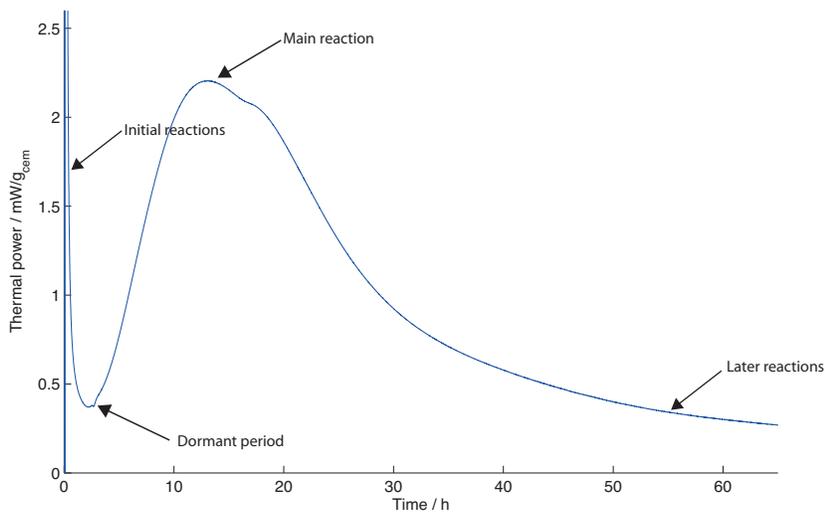
Figure 2.4: Schematic diagram over heat development during beginning of hydration

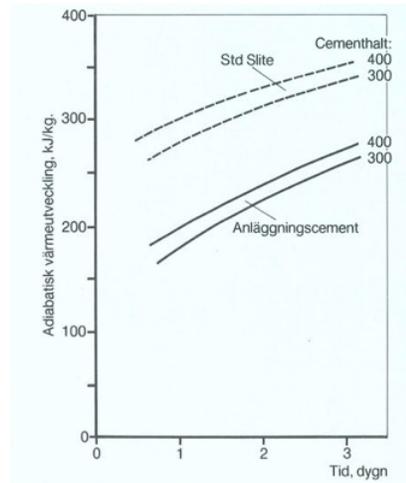
Figure 2.5: Heat production for two Swedish cements, *Std Slite* and *Anläggningscement* [10].

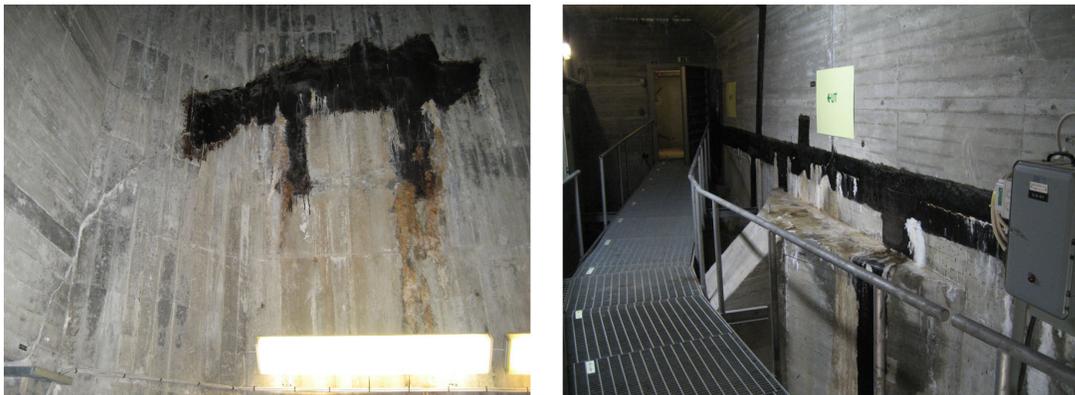
Figure 2.6: Repaired cracks in hydro power stations (Photo: Martin Rosenqvist)

The last main reason for cracking is due to *loads*. It is natural that concrete cracks from being exposed to tensile forces and there are few structures that only have compressive forces acting on it. That is why most of concrete structures have reinforcement, so in case of tensile cracking the reinforcement takes the load instead. Therefore these cracks occur close to reinforcement and makes it easier for substances to reach the reinforcement bars. But the bars are also there to spread out the cracks and limit their width [11] so that less ingress of substances will occur. For different environmental exposures there are different maximum crack widths allowed due to loading according to Swedish standard SS-EN 1992-1-1:2005, where 0.2-0.4 mm are accepted. In figure 2.6 can repaired cracks in hydro power station be seen.

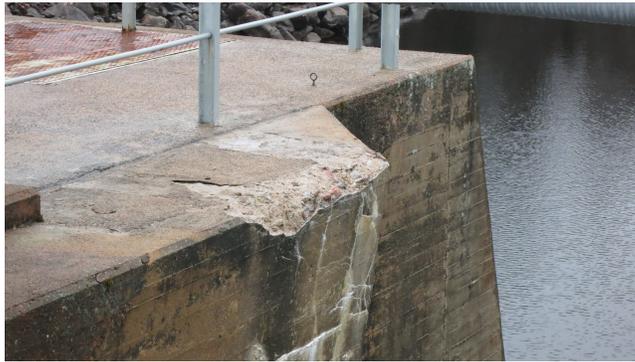
Figure 2.7: Internal frost damage causing a corner in a hydro power station to fail (Photo: Martin Rosenqvist)

Internal frost damage leads to a general loss of strength and modulus of elasticity due to inner expansion of water when freezing [10]. It can be hard to detect internal frost damage to structures because it is not always that the damage will reach the surface. The reason for this is that the surface of water exposed structures surrounded by air, e.g. dams with one-sided water pressure or foundations in constant contact with ground-water, are almost always dryer than its interior. That means it will be more space at the surface to take care of the expansion than the inside of the structure will have [10]. An internal frost damage can be seen in figure 2.7.

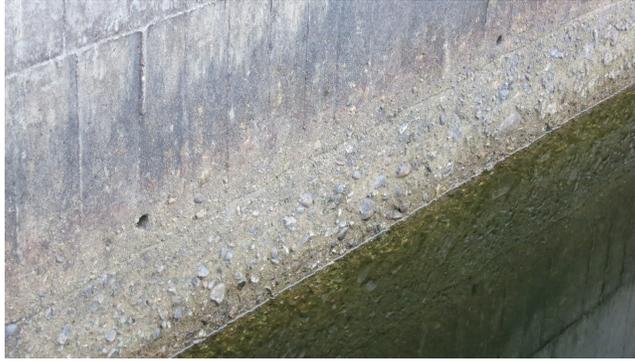
Figure 2.8: Example of surface scaling at the waterline (Photo: Martin Rosenqvist).

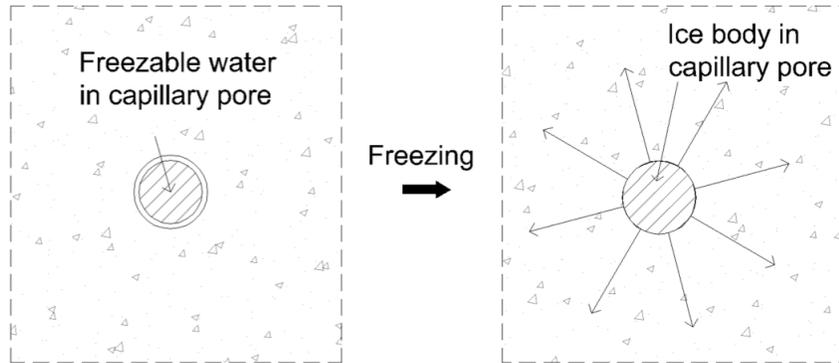
Figure 2.9: Closed container mechanism. When water freezes it expands about 9% and if there is lack of space for the expansion the ice will exert a pressure on the wall of the pore that will create damage.

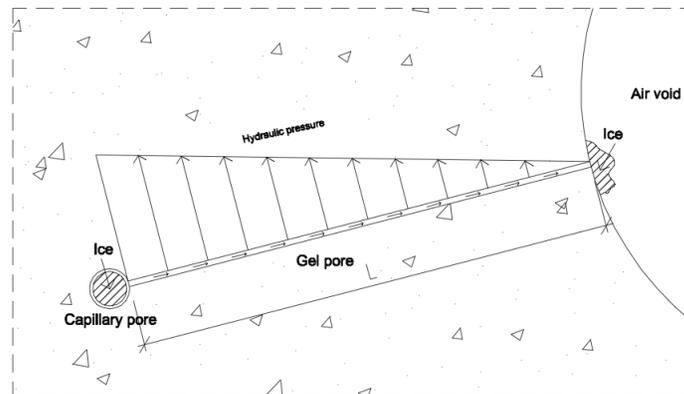
Figure 2.10: Pores in the cement matrix and the hydraulic pressure that can arise when water freezes.

The *hydraulic pressure* arises when ice forms in the capillary pores and wants to expand [13]. This expansion wants to move the non-frozen water and since the water can not freeze in the small gel pores they work as a drain pipe for this pressure, but need a bigger reservoir of air in the other end to be able to completely release the pressure, see figure 2.10. This is why the air void content is of importance when it comes to the frost resistance, air voids are the reservoirs needed for the expansion but they need to be empty.

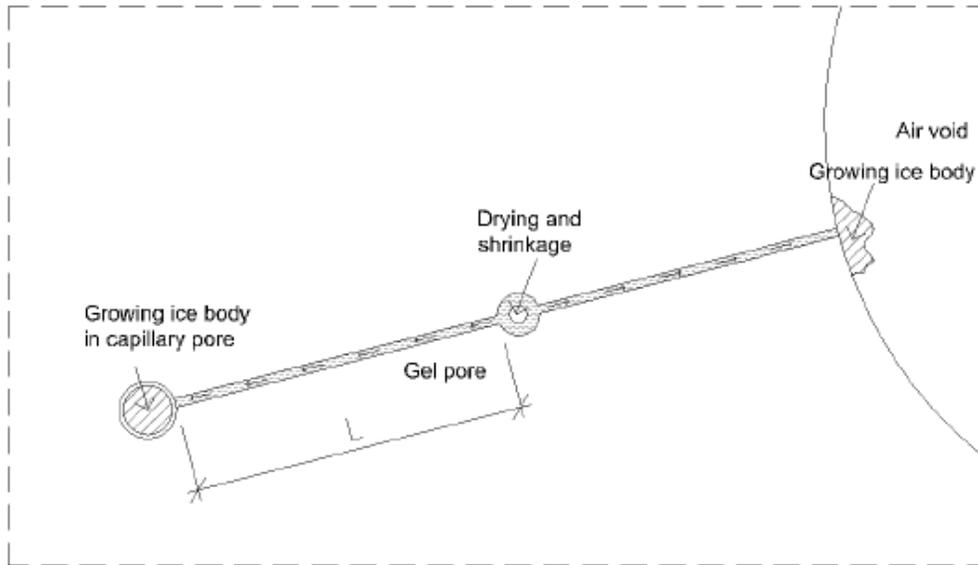
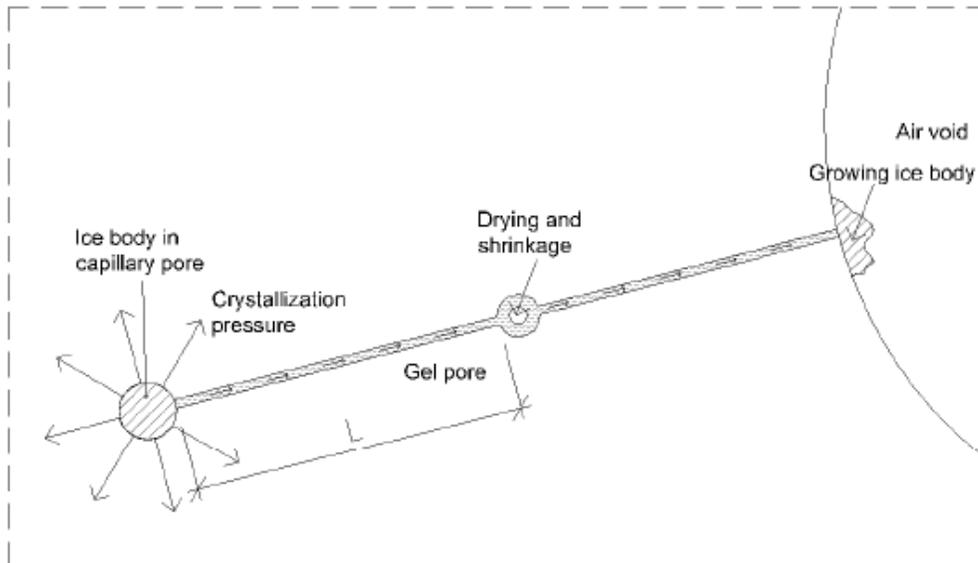
Figure 2.11: Osmotic micro ice body growth. Top: Both ice bodies attract non-frozen water due to higher energy content. Bottom: The ice in the capillary pore has stopped to attract non-frozen water.

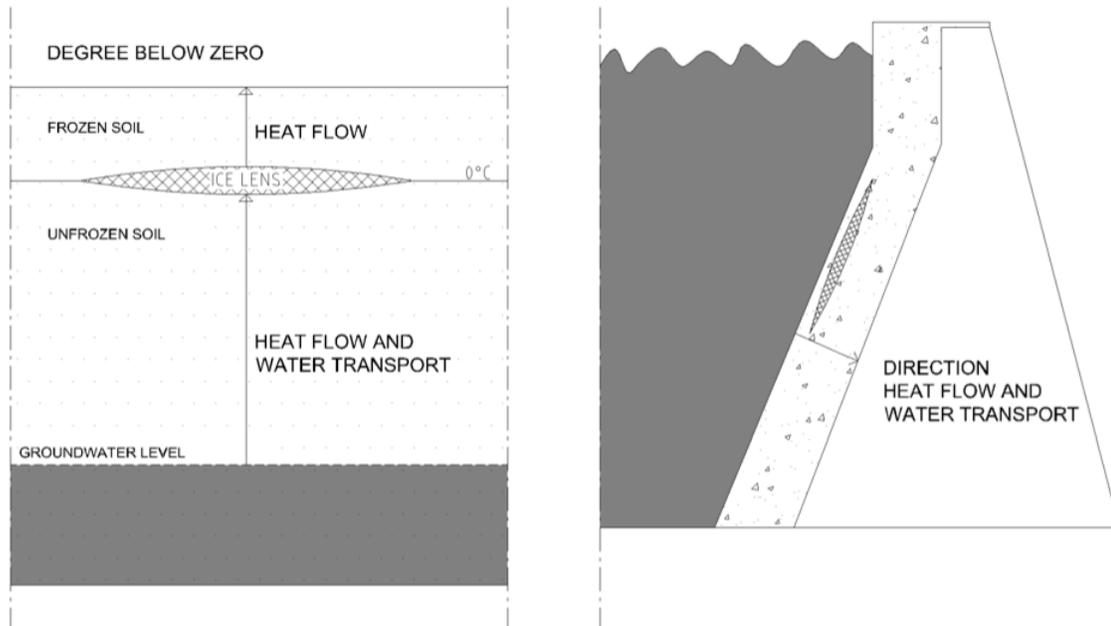
Figure 2.12: To the left: Frost heave in soil with ice lens growth in the interface between frozen and un-frozen soil. To the right: Macroscopic ice lens growth in a thin concrete dam.

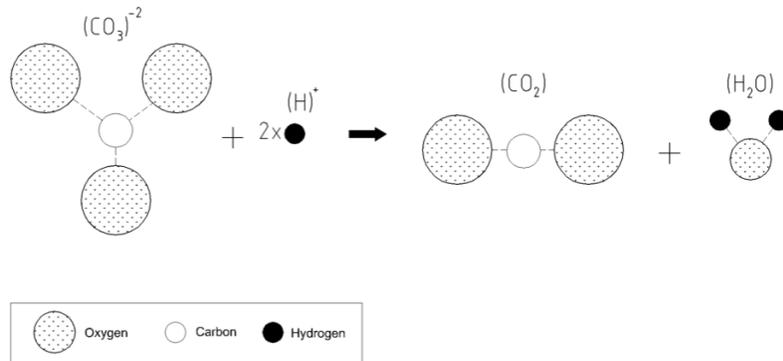
Figure 2.13: Carbonate molecule reacts with acid and creates water and carbon dioxide.

The anionic complex, CO_3^{-2} is a triangular strongly bond molecule as seen to the left in figure 2.13. But the bond can be broken by acid in the reaction

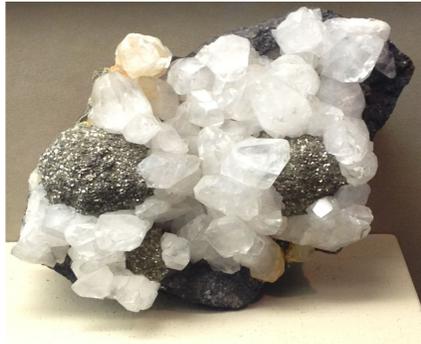
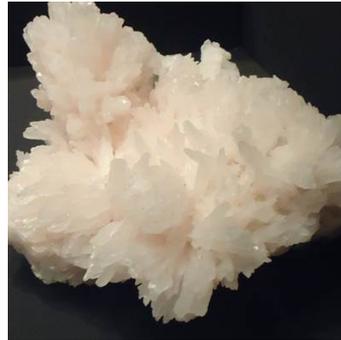
Prismatic

to create carbon dioxide and water. There are a lot of different mineral shapes of both calcite and aragonite. Calcite had over 300 shapes defined in 1985 [4], but three important shapes are prismatic, rhombohedral and scalenohedral. A few of the most important shapes from both calcite and aragonite can be seen in figure 2.14, with calcite to the left and aragonite to the right.

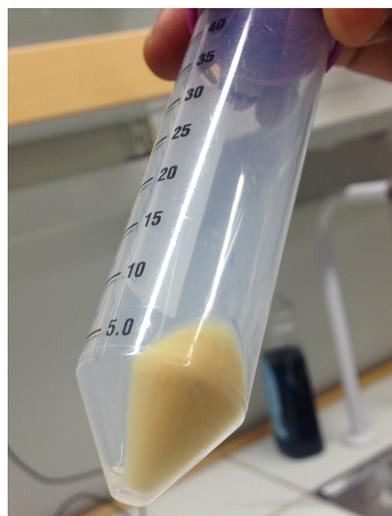
(b) Bacteria after harvesting

Figure 3.1: Preparation of the bacteria

Preparations of the bacteria solution took 3 days. The first day a Petri dish with solid nutrient medium was prepared (autoclaved in 120°C for 20 minutes). The bacteria was transferred to the Petri dish and the plate was incubated at 30°C overnight. The following day bacteria growth was confirmed, see figure 3.1a. A liquid medium was prepared and autoclaved and the bacteria was transferred to the liquid medium. Liquid medium with bacteria was placed on a shaker at 30°C and 150 rpm for about 24h. On the third day bacteria were harvested by centrifugation at 10 000g for 10 minutes. The concentrated bacteria, see figure 3.1b, could either be freeze-dried into a powder or re-suspended in a solution. The re-suspension method was used in this study.

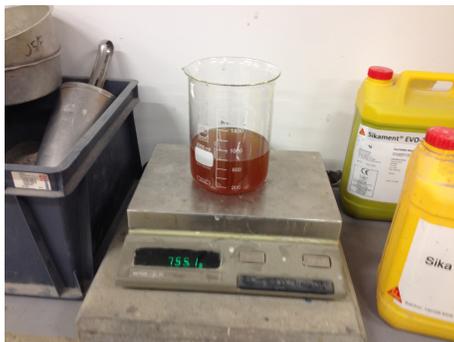
(a) Solution with bacteria

Figure 3.2: The bacteria solution, the calcium lactate and the mix of the two. Bottom right is the mixture solved in the mixing water.

The bacteria solution, see figure 3.2a, had a concentration of $5.8 \cdot 10^6$ cells/ml, and was mixed with the calcium lactate solution (concentration 100 mM) with a ratio 1:1 (figure 3.2b), the same amount of bacteria solution and calcium lactate solution. Some reaction happened instantly, see figure 3.2c. The precipitations was probably Na_2CO_3 or CaCO_3 but not in a crystal form.

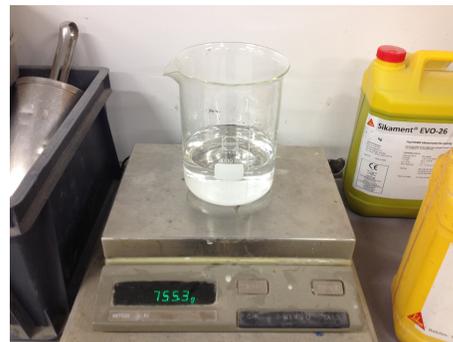
(b) Solution with calcium lactate

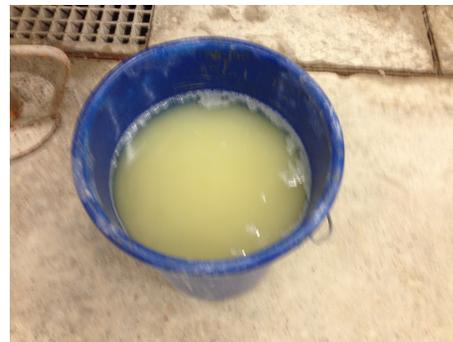
(d) Bacteria, calcium lactate, AEA and water

The mixture was then added to the mixing water where the AEA already had been added, figure 3.2d.

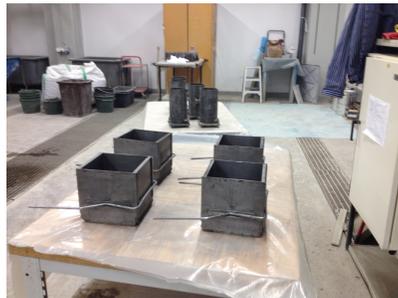
(a) Moulds for casting

Figure 3.3: Preparations of the specimens

Four cubes with size $150 \times 150 \times 150 \text{ mm}^3$ and five cylinders with diameter 100 mm and height 200 mm were cast in moulds. They were filled with 1/3 at a time and then vibrated on a vibration table. The samples were covered and left at room temperature over night, see figure 3.3b. After 24 hours samples were de-moulded and put in a water bath.

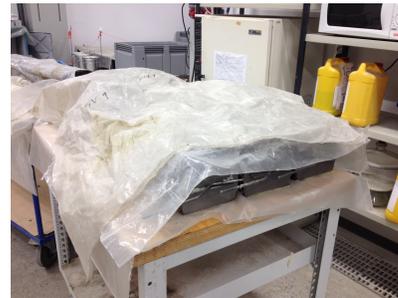
(b) The cover of the samples

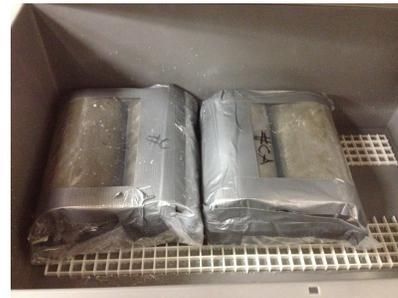
(d) Samples to freeze thaw test

Two cylinders from each batch was taken out of the mould after 24 h and then kept in a water bath for 6 days. When taken out of the water the cylinders were placed in a plastic bag that was properly sealed and placed in a plastic box with some water, see figure 3.3d. The box was placed in a climate chamber with $20\pm 2^{\circ}\text{C}$ and a relative humidity of 60% for 17 days.

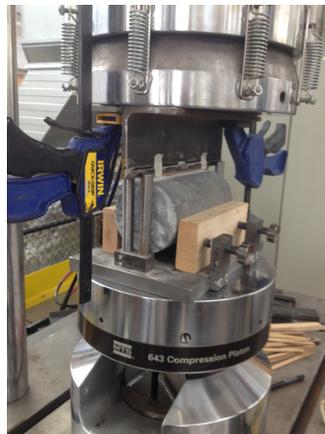
Figure 3.4: Test setup for testing the tensile strength of a cylinder specimen

The tensile strength was evaluated with the help of SS-EN 12390-6:2009 *Testing hardened concrete - Part 6: Tensile splitting strength of test specimens*. The test setup can be seen in figure 3.4. A thin slice of fiberboard (10x3x200 mm³, density 950kg/m³) was used as a pressure equalizer between the steel plates and the specimen. The loading rate was set to 1.57 kN/s as the standard recommended between 0.04-0.06 MPa/s. The highest load reached was noted.

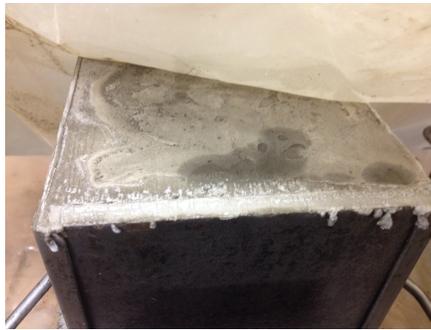
Figure 3.5: White salty-like crystals

When de-moulding batch #CAB it was a gap between the plastic cover in two of the samples. At those spots some white salty-like crystals had developed, see figure 3.5. This was scraped off and together with some pieces from batch #CAB and #CA were tested with cold diluted hydrochloride acid.

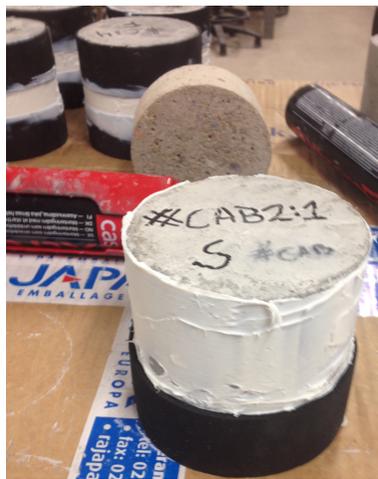
Figure 3.6: Preparation of the specimens to freeze-thaw tests. Two black rubber sheets was attached to the specimens with glue and the gap between the sheets was filled with more glue, as seen in the background

After the climate chamber the cylinders were divided into two $\Phi 100$ mm and $h=100$ mm cylinders. The 1/2 cylinders were then dried for two hours and after that the side surfaces (not the top and bottom) was brushed with a steel brush to make the surface rougher. Glue (Casco XtremFix) was applied on the cylinders and two EPDM-rubber sheet (40×320 mm²) was attached to each 1/2-cylinder, see figure 3.6. The gap between the sheets was filled with more glue. The specimens were left for three days at room temperature and then (1 day before the start of the tests) the specimens were sawn in the middle of the glued gap. In total 24 samples were prepared, these were placed in fresh water over night with the cut surface in free contact with water.

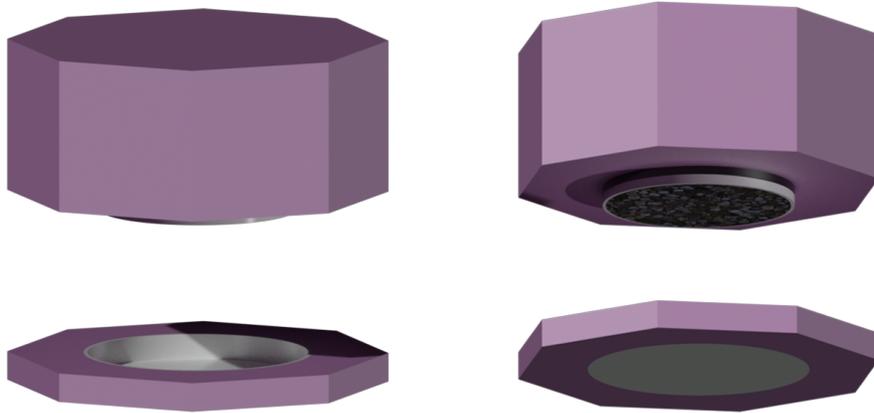
Figure 3.7: Test setup in 3D

Every sample was squeezed into an insulation foam form in the shape of an octagon, with 10 mm left outside. In the bottom there was a plastic cup with a diameter of 118 mm, also with insulation foam around it. The test setup used can be seen in figure 3.7 and figure 3.8.

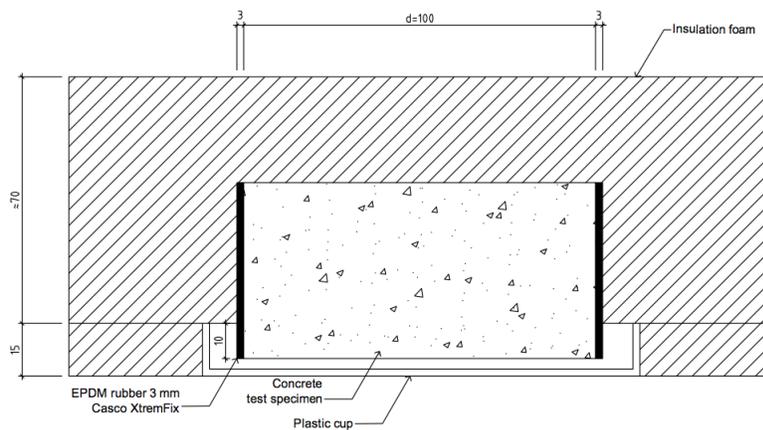
Figure 3.8: Drawing of test setup

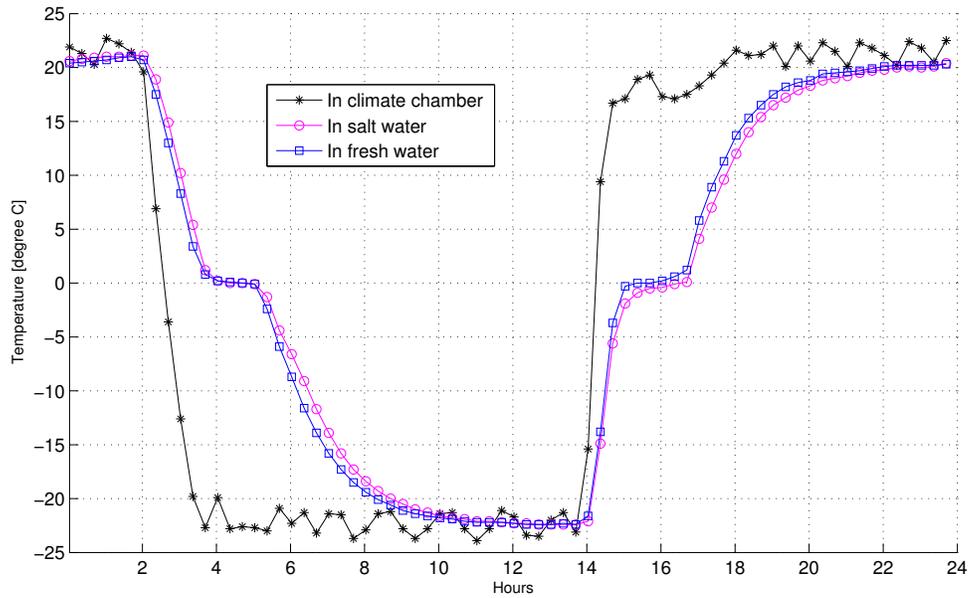
Figure 3.9: Temperature graphs for one freeze-thaw cycle (24h).

The plastic cups were filled with 100 ml liquid, 12 sample cups (four from each concrete batch) were filled with salt water (de-ionized water with 3 w-% salt) and the other 12 were filled with de-ionized water. The samples were placed in a climate chamber with cycling temperature. 12 hours with -22°C and 12 hours with $+21^{\circ}\text{C}$. Air was the thermal conductor and the temperature cycle and the temperatures in the fresh water solution and the salt water solution can be seen in figure 3.9.

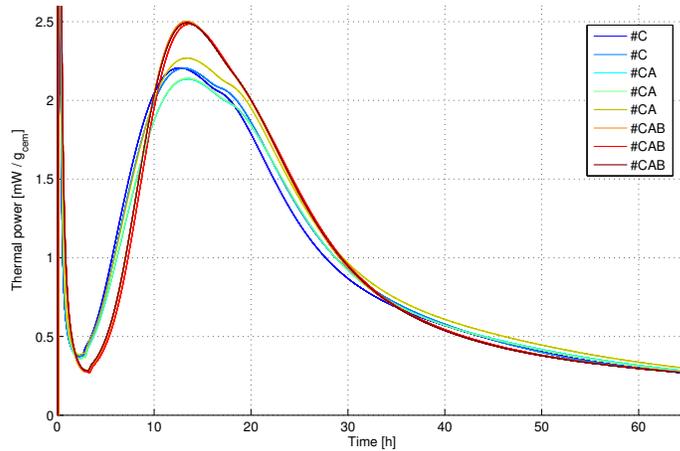
Figure 4.1: The results from the first isothermal calorimetry test with the three different concrete recipes showing energy production/time unit. #C is the mixture without AEA, #CA is the mixture with AEA and #CAB is the mixture with AEA, bacteria and lactate.

The results from the two calorimetry tests can be seen in figure 4.1 to figure 4.4, where the two first figures belong to the first test and the two last belong to the second test. Figure 4.1 and figure 4.3 show the thermal power and figure 4.2 and figure 4.4 show the accumulated energy production.

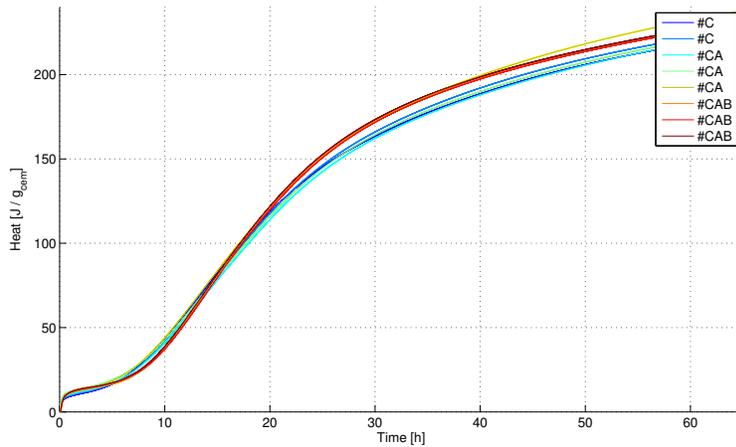
Figure 4.2: The results from the first isothermal calorimetry test showing the accumulated energy production. #C is the mixture without AEA, #CA is the mixture with AEA and #CAB is the mixture with AEA, bacteria and lactate.

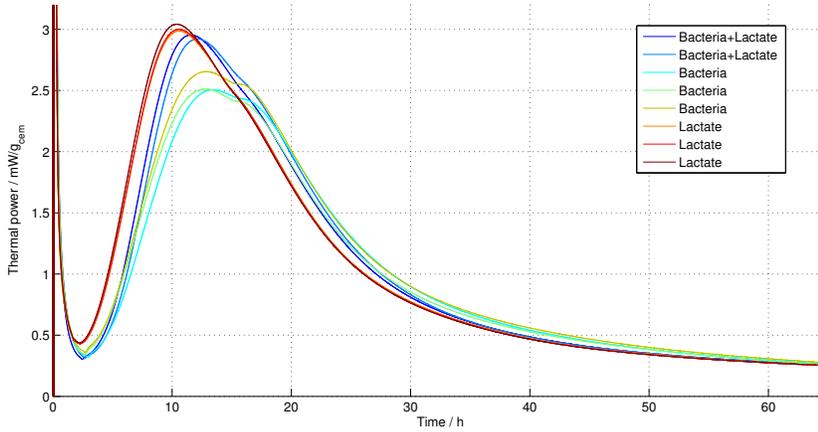
Figure 4.3: The results from the second isothermal calorimetry test where the #CAB batch was divided in three different scenarios, one with only bacteria, one with lactate and one with both bacteria and lactate. All samples contained AEA, cement and water. (Energy production/time unit).

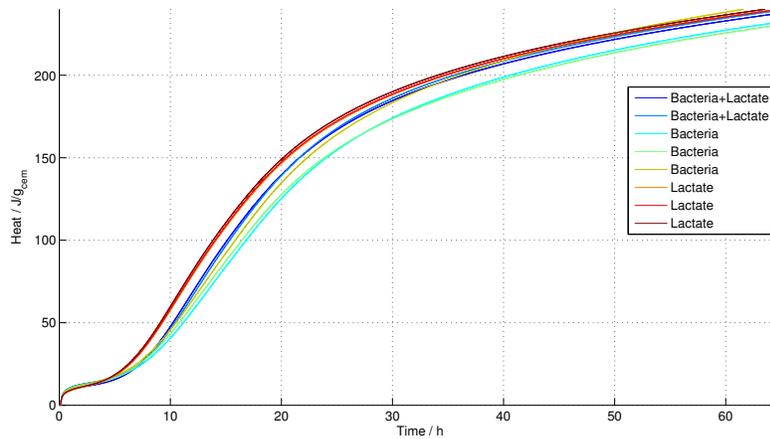
Figure 4.4: The results from the second isothermal calorimetry test showing accumulated energy production. Here the #CAB batch was divided in three different scenarios, one with only bacteria, one with lactate and one with both bacteria and lactate. All samples contained AEA, cement and water.

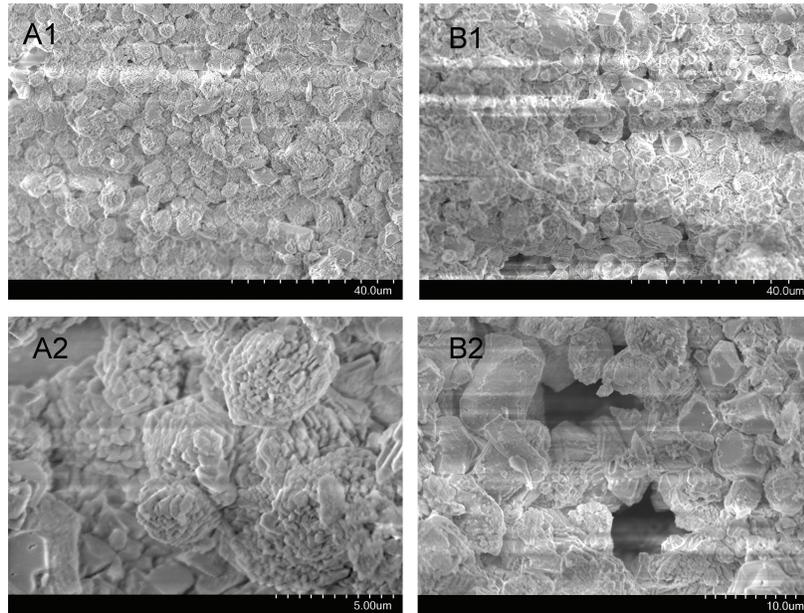
Figure 4.5: SEM picture of the surface, with different scales (marked in each picture). A1 and A2 is the non-treated concrete and B1 and B2 is bacteria-treated concrete.

In figure 4.5 the surface can be seen, both from the bacteria treated concrete and the non-treated. In figure 4.6 air voids can be seen.

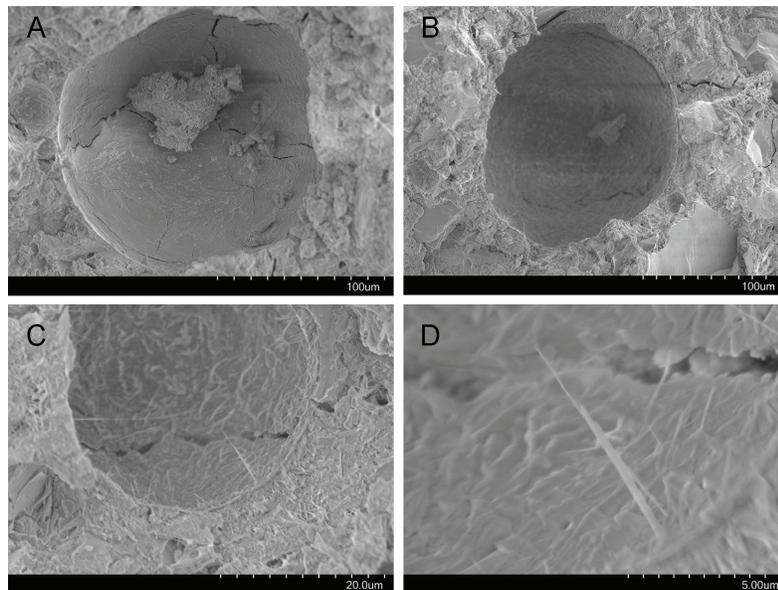
Figure 4.6: SEM picture of air voids, with different scales (marked in each picture). A is untreated concrete and B-D is bacteria-treated concrete. Note the needle-like structures in the bacteria-treated concrete.

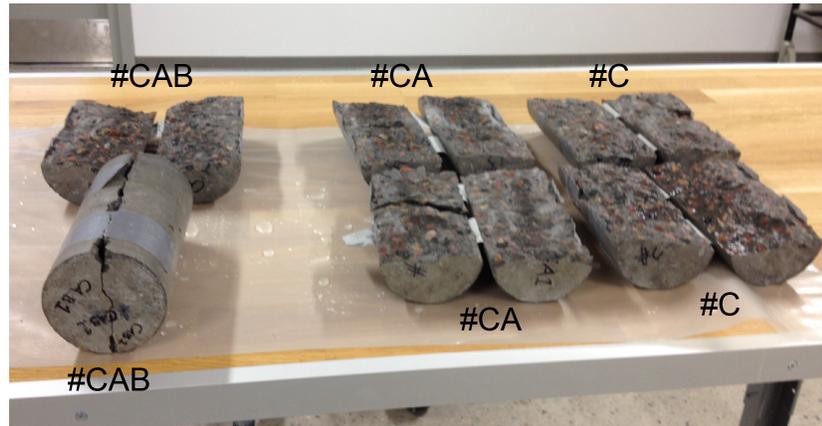
Figure 4.7: Specimens kept in water bath after splitting test. Note that one of the bacteria treated specimens (#CAB) stays together after the tape was cut.

In figure 4.7 can the cracked specimens that was kept in water for 50 days after splitting be seen.

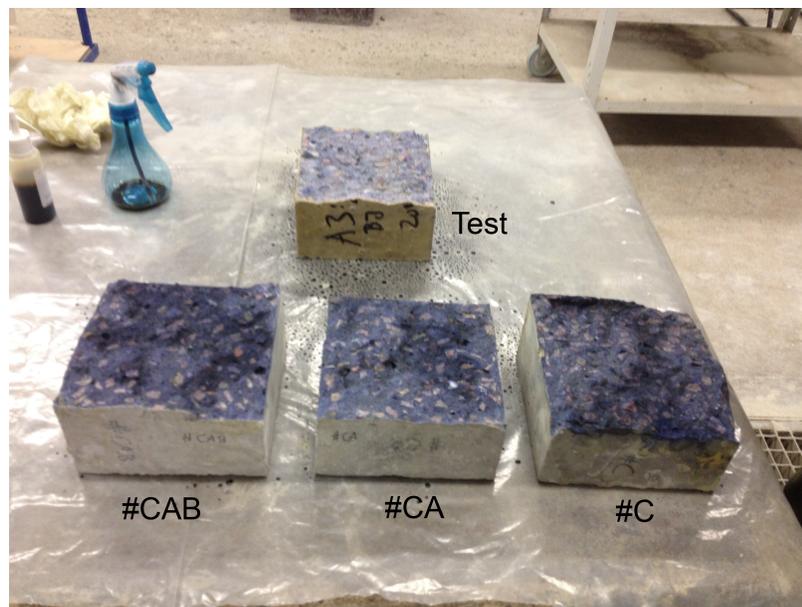
Figure 4.8: Indication of pH in the concrete. Blue indicates a $\text{pH} > 10$. The test specimen was an old one with carbonation close to the surface.

In figure 4.8 can the evaluation of the pH in the concrete be seen.

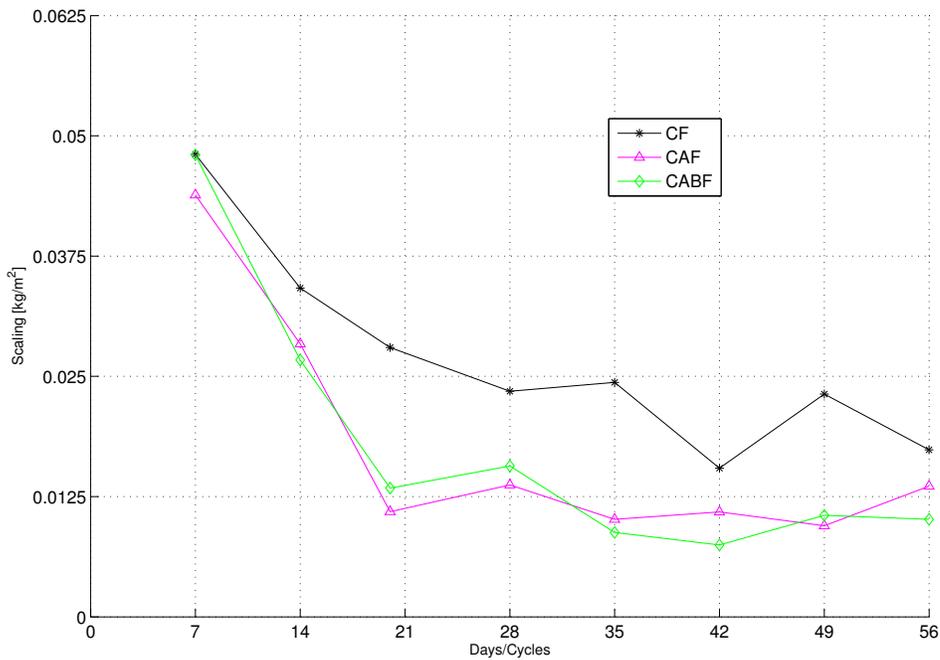
Figure 4.9: Mean values from three specimens of scaling/measurement in kg/m² when tested in fresh water. The measurements were conducted every seventh day, except one measurement that was conducted at day 20 instead.

The results from the freeze-thaw test when tested with fresh water can be seen in figure 4.9 and figure 4.10. F=fresh water, C=sample from #C, CA=sample from batch #CA and CAB=sample from #CAB.

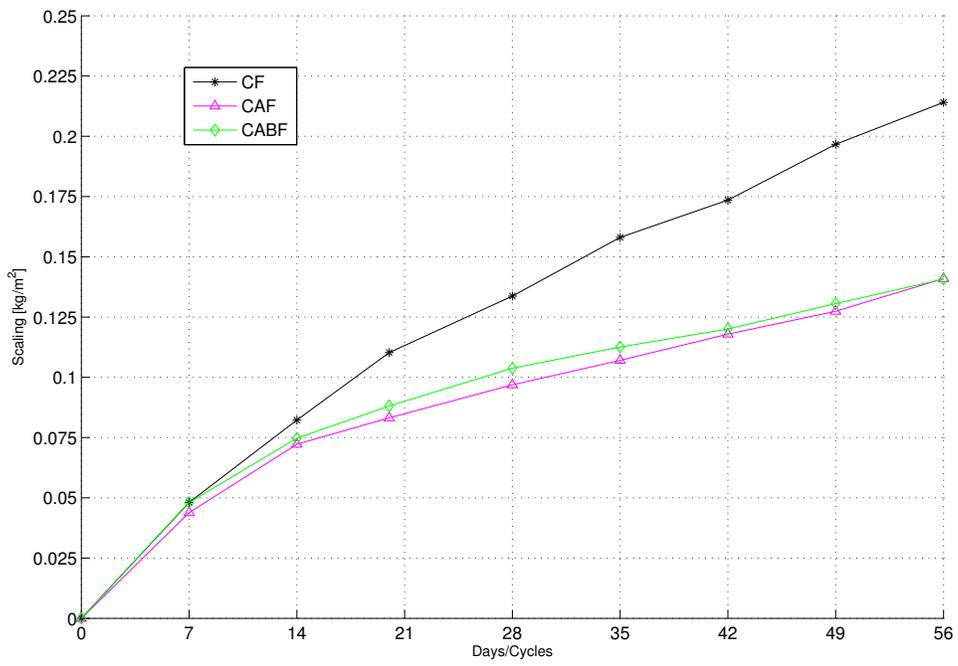
Figure 4.10: Mean values from three specimens of accumulated scaling in kg/m² when tested in fresh water.

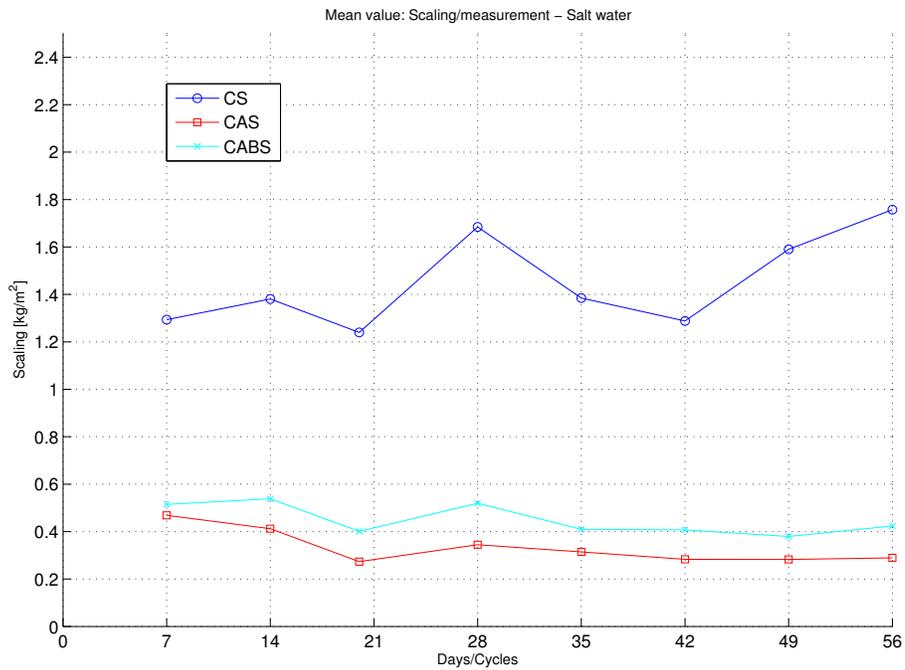
Figure 4.11: Mean values from three specimens of scaling/measurement in kg/m² when tested in salt water. The measurements were conducted every seventh day, except one measurement that was conducted at day 20 instead.

The results from the freeze-thaw test when tested with salt water can be seen in figure 4.11 and figure 4.12. S=salt water, C=sample from #C, CA=sample from batch #CA and CAB=sample from #CAB.

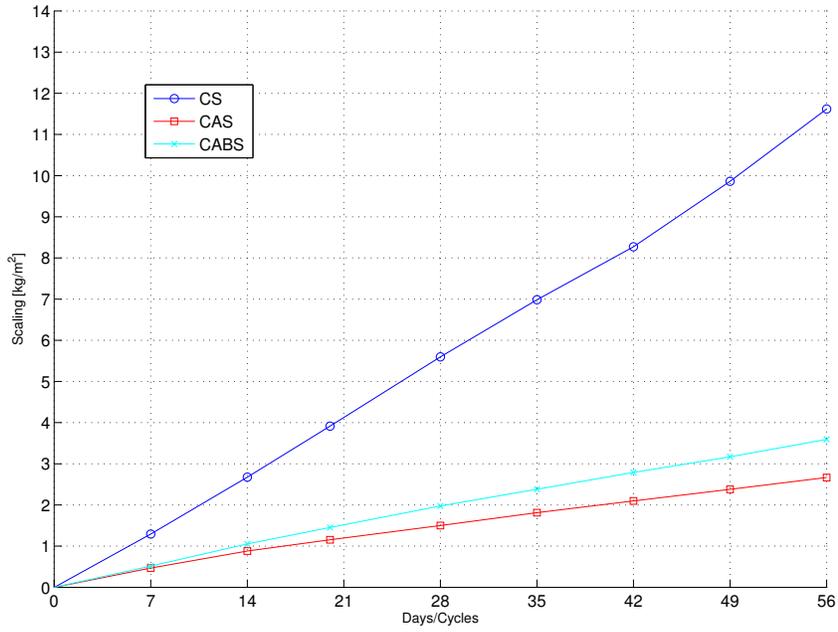
Figure 4.12: Mean values from three specimens of accumulated scaling in kg/m^2 when tested in salt water.

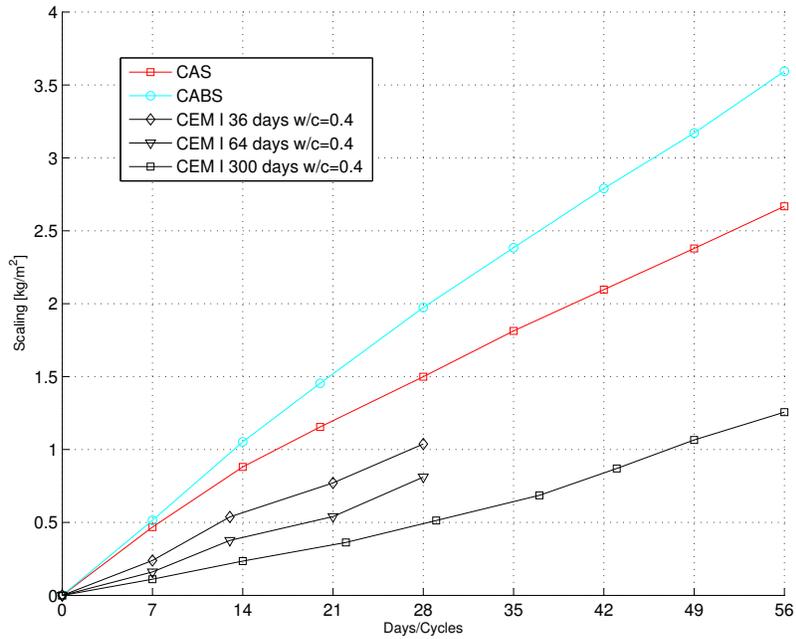
Figure 4.13: The results from this study compared with other specimens tested with the same method [22].

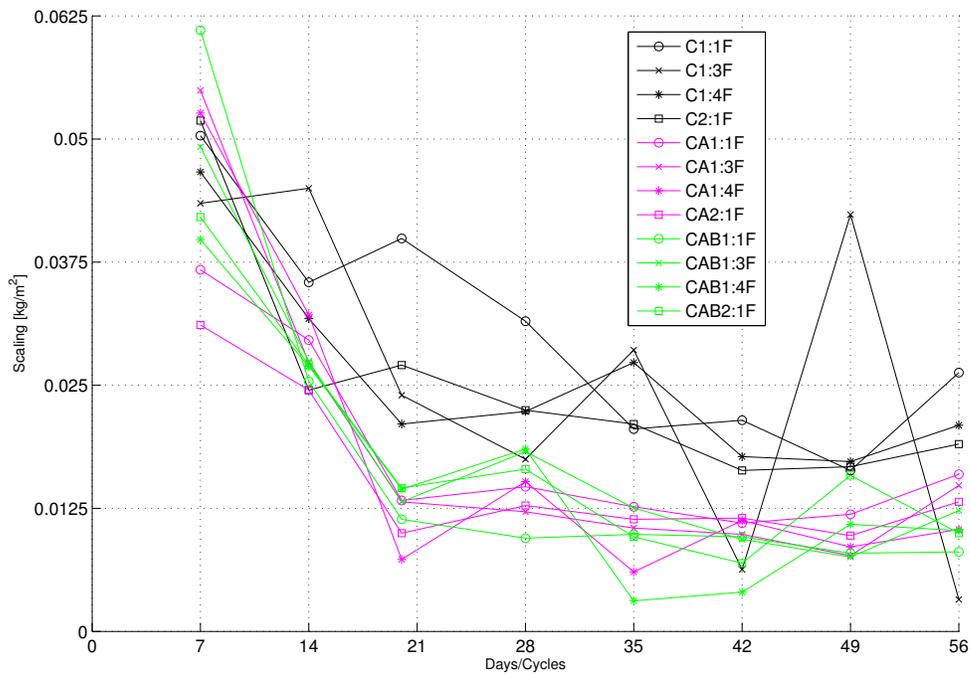
Figure A.1: All values from the freeze-thaw tests. Scaling/measurement in kg/m^2 when tested in fresh water

The result from the freeze-thaw test when tested with fresh water can be seen in figure A.1 and figure A.2.

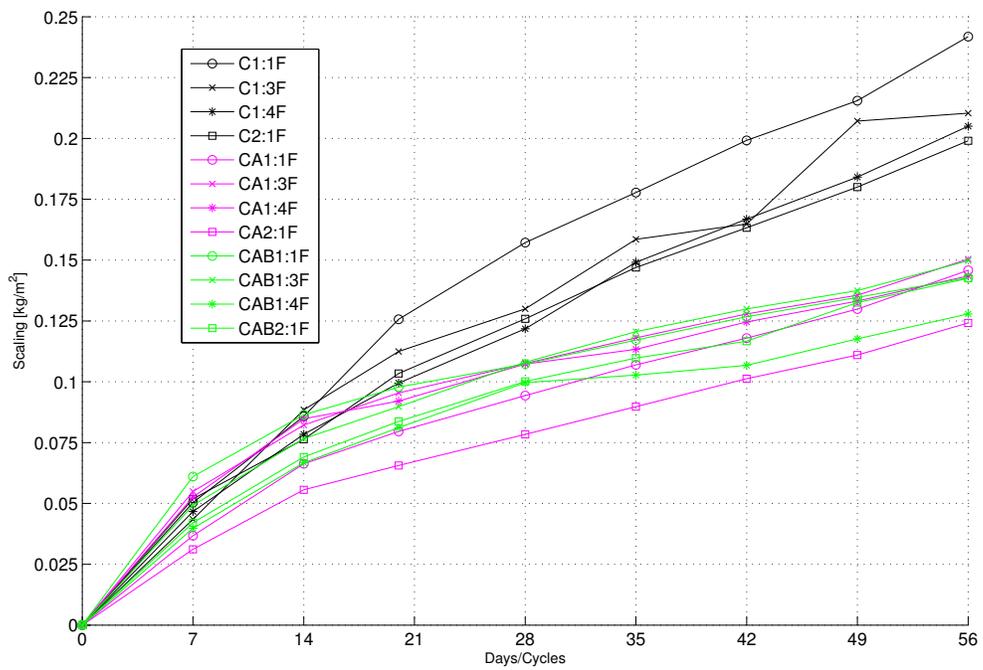
Figure A.2: All values from the freeze-thaw tests. Accumulated scaling in kg/m^2 when tested in fresh water

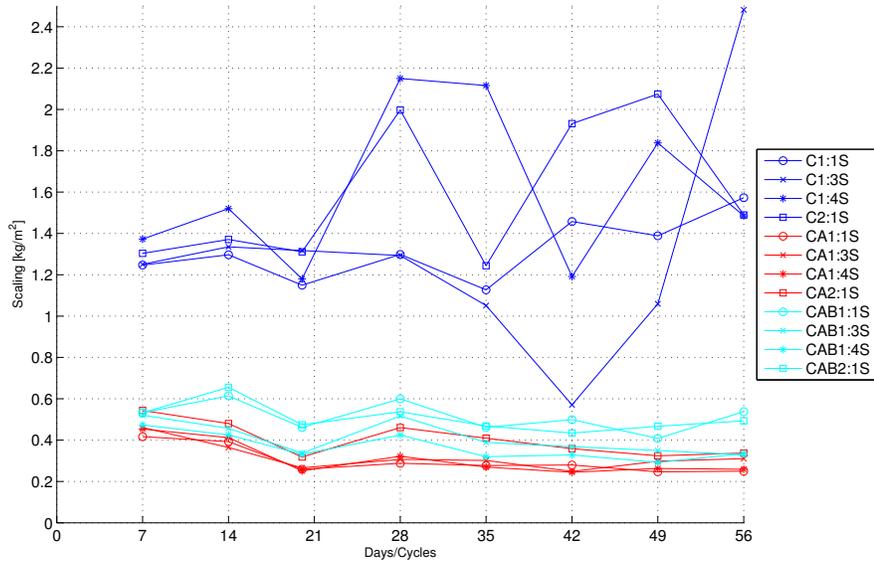
Figure A.3: All values from the freeze-thaw tests. Scaling/measurement in kg/m^2 when tested in salt water

The result from the freeze-thaw test when tested with salt water can be seen in figure A.3 and figure A.4.

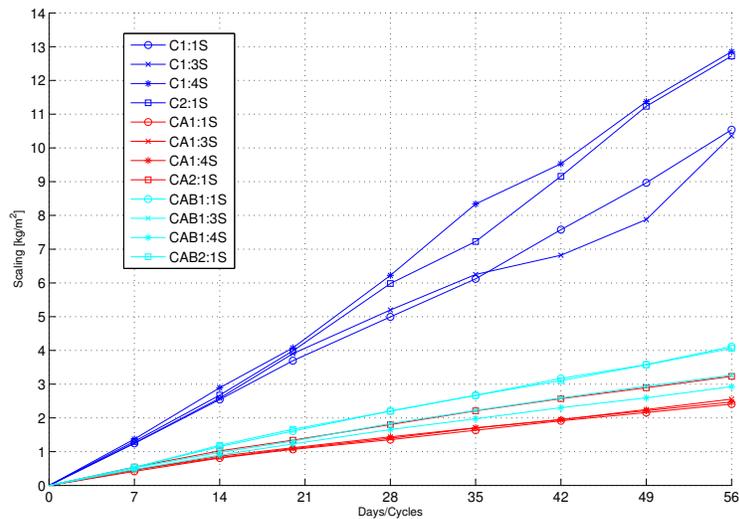
Figure A.4: All values from the freeze-thaw tests. Accumulated scaling in kg/m^2 when tested in salt water
