HOP!: a PGIS and citizen science approach to monitoring the condition of upland paths

Master degree thesis, 30 credits in Master in Geographical Information Science

Department of Physical Geography and Ecosystem Science, Lund University

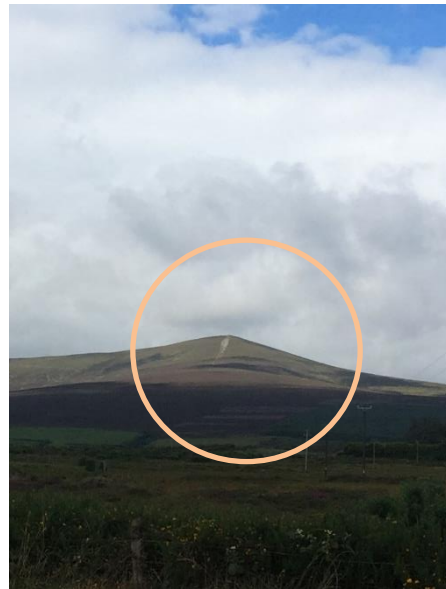
Figure 1-2 Erosion on Djouce, WMNP, as seen from a point 4km from the summit (Photo by Niamh Harty July 2017)

The park has a large network of mostly informal upland paths. Some of these are in poor condition, due to the high volume of walkers using them. Djouce Mountain, at 725m elevation, is one of the highest mountains in the north east section of the park (seen in the map in Figure 1-1). It is close to Dublin, and is very popular with walkers of all ages. The path erosion caused by hillwalkers on the path on the eastern slope of the mountain is visible from a long distance away, as seen in the photograph in Figure 1-2 which was taken 4km from the summit.

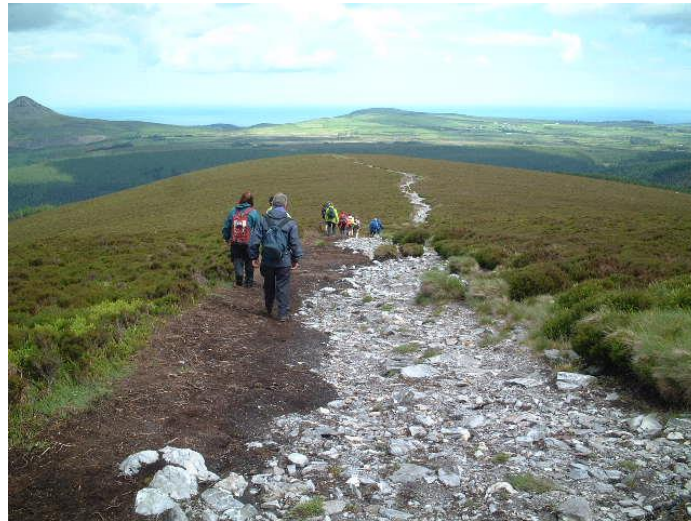
Figure 2-1 Maulin East 2002/3: Walkers walking on peat and not on stone

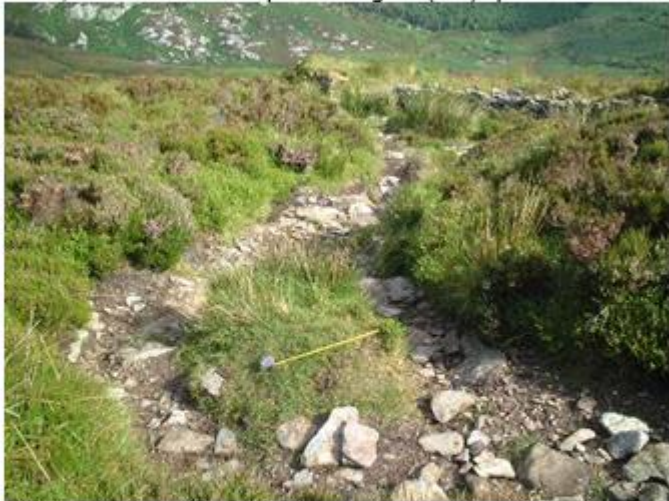
<p>pic57 looking back down to stone wall shows island in centre of path; tape = 0.5m</p>
4	50m on up	a 50cms gully in the peat; path width average 1m; path surface of loose stones and peat

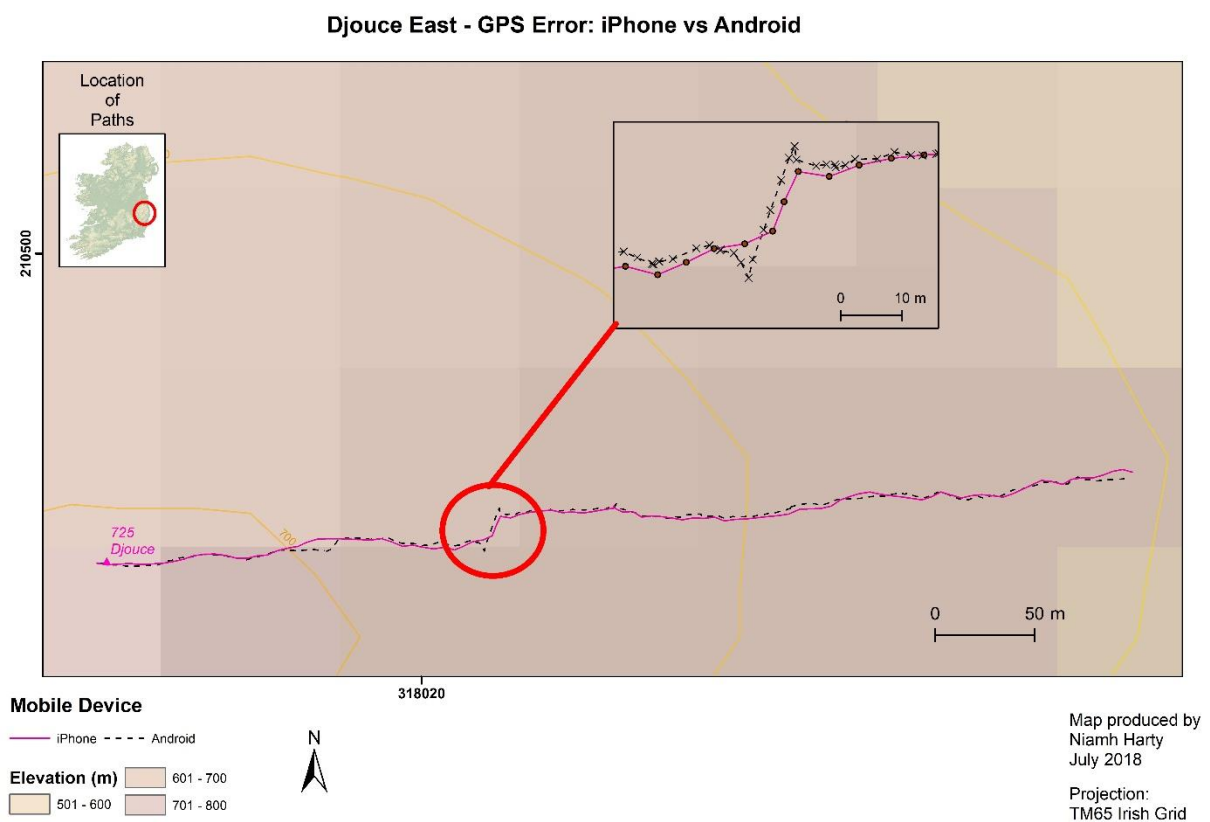
Figure 4-3 Djouce East - Paths recorded simultaneously on iPhone and Android phone

The paths recorded simultaneously on an iPhone and an Android phone in the GPS error estimation test are shown in the map in Figure 4-3. The points recorded by each device were converted into lines representing the paths.

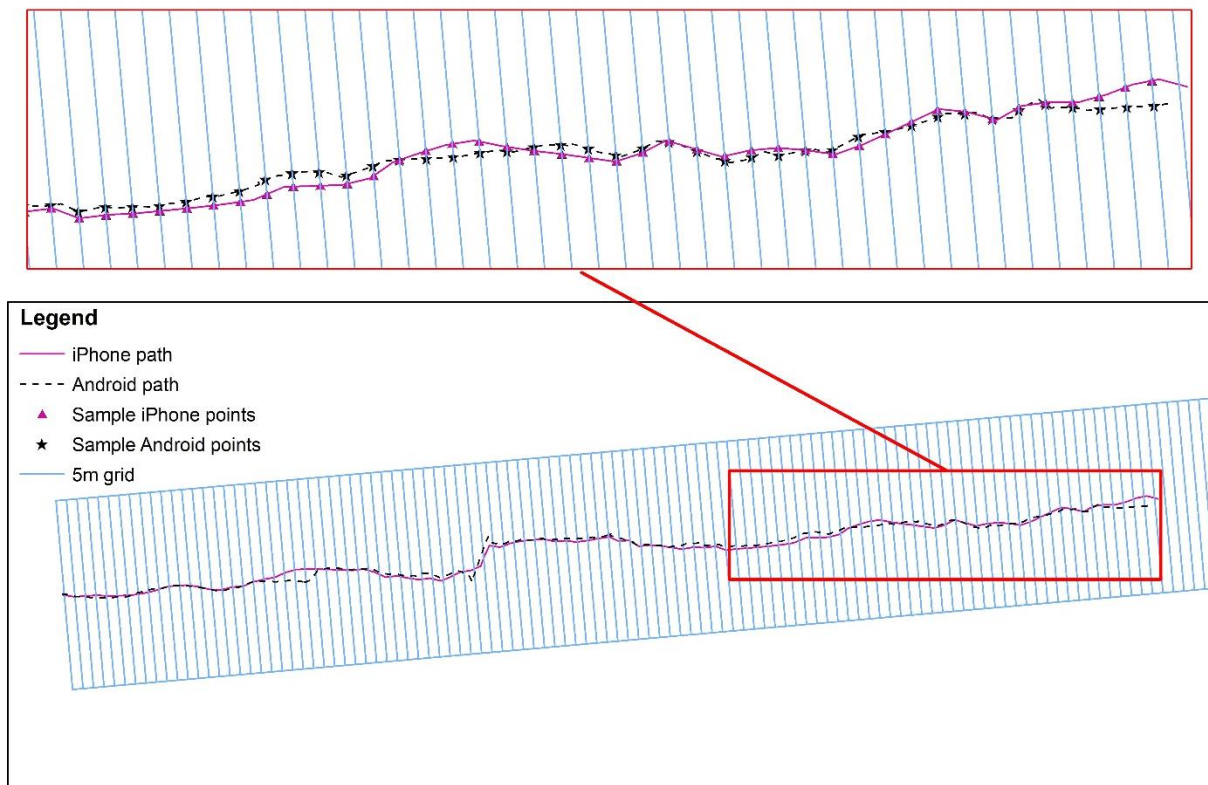
Figure 4-4 Calculation of RMSE for iPhone and Android paths

These calculations were carried out for three different grid widths – 1m, 2.5m and 5m. The results are presented in Table 4-4. A conservative estimate of RMSE is 1.7m, based on the three values calculated (1.61m, 1.64m, and 1.65m).

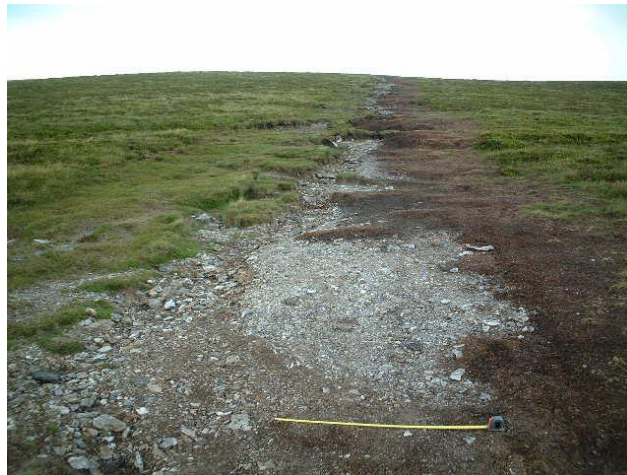
Figure 5-1 White Hill-Djouce Path Width in 2002/3

In the photograph, the path width looks as if it is about 5.5m at the most, and not 11m. It is possible that the width was calculated for a tape length of 0.5m and not 1m. This apparent doubling of path width was observed at several points in this particular survey. On this project, the path width was taken to be 5.5m at this point.

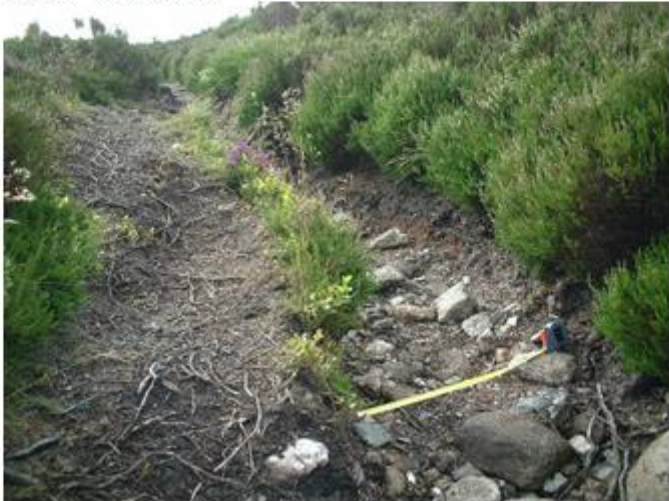
<p><u>pic58</u> shows this; tape = 0.5m</p>

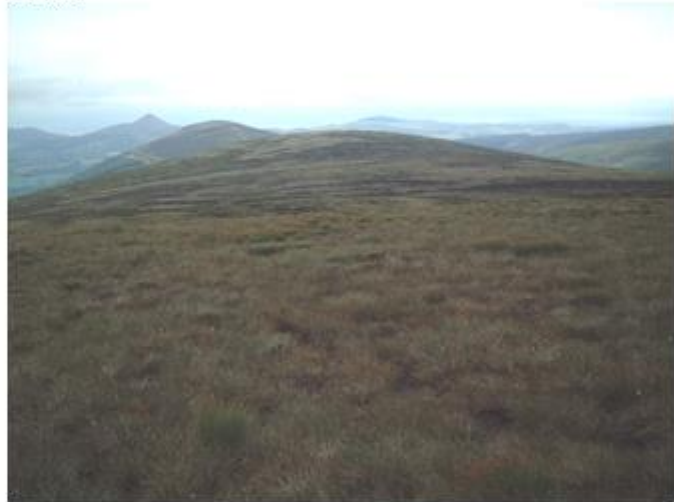
pic64 looking back (E) shows the flat, wet area towards Little Tonduff and Maulin
20	15904 13423	a single file path for about 60m leads to Tonduff South summit; the result of walkers finally converging on the cairn
21		no definite path from the South to the North summit
22	1595 1367	Tonduff North summit; an expanse of naturally eroded blanket bog with isolated peat hags
		END

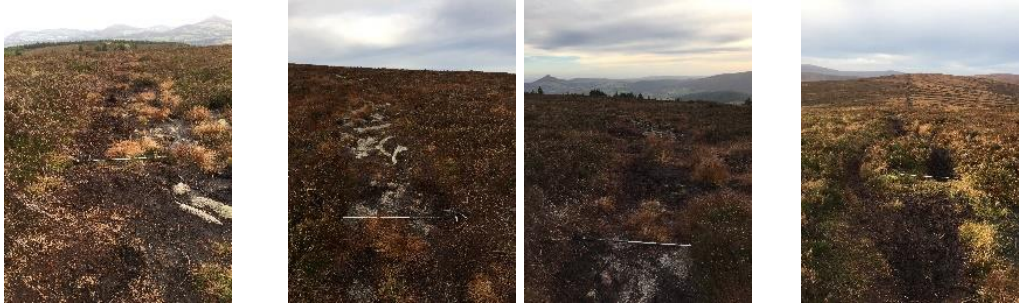
Figure L-2 Photos taken at first three points on Prince William's Seat survey

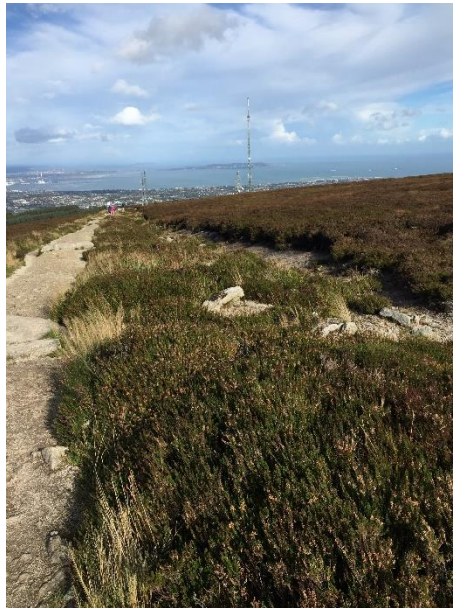
Figure L-7 Three Rock-Fairy Castle Old Parallel Path not in use in 2016

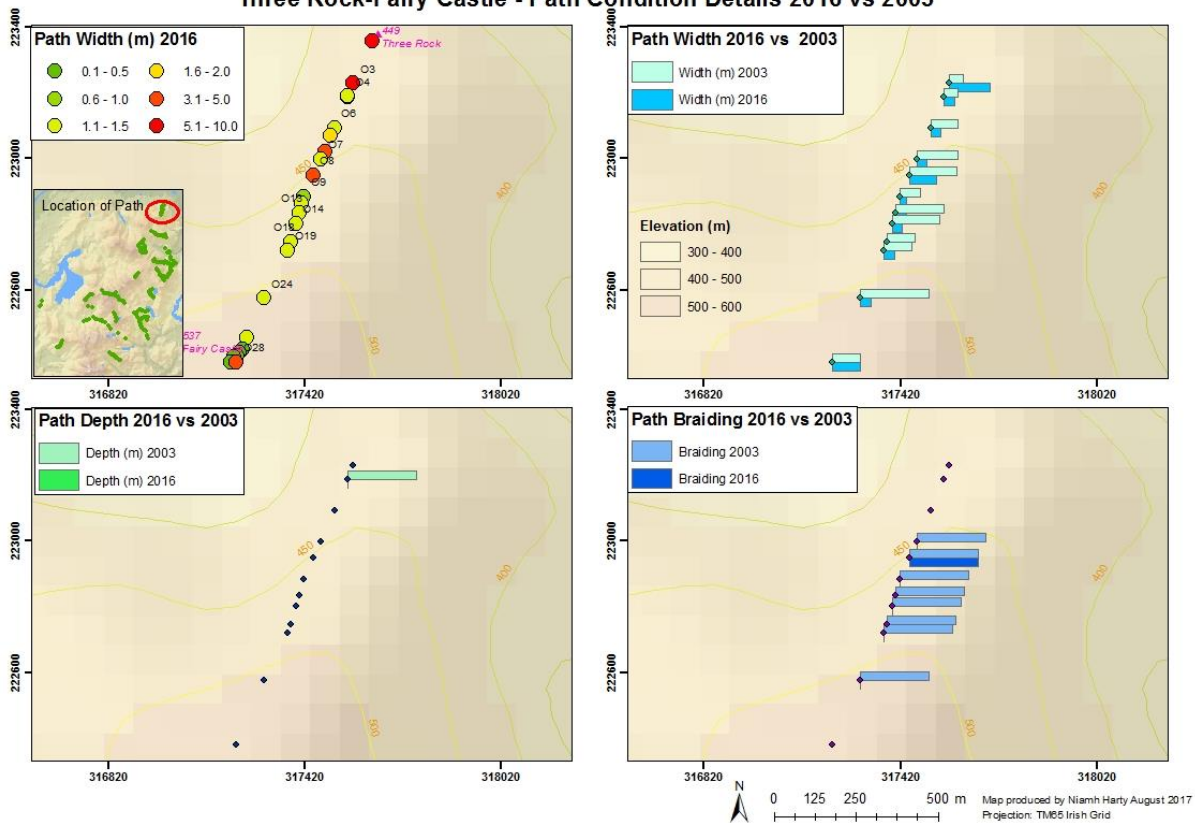
Figure L-9 Three Rock-Fairy Castle Condition Details

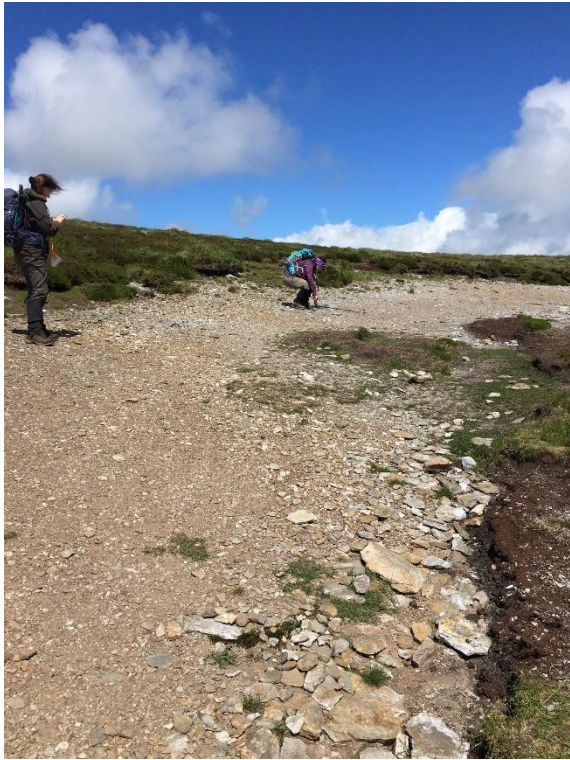
Figure L-18 White Hill-Djouce - Gravel on path close to summit

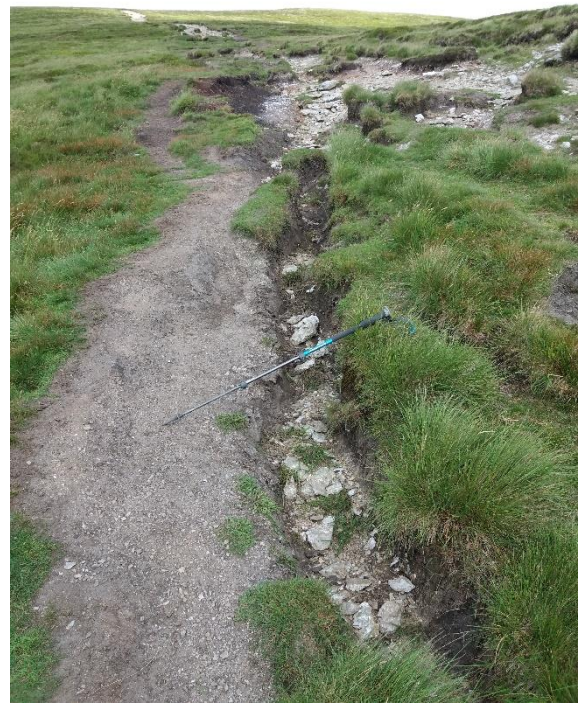
Figure L-19 White Hill-Djouce - Extra point with deep gully recorded with HOP!

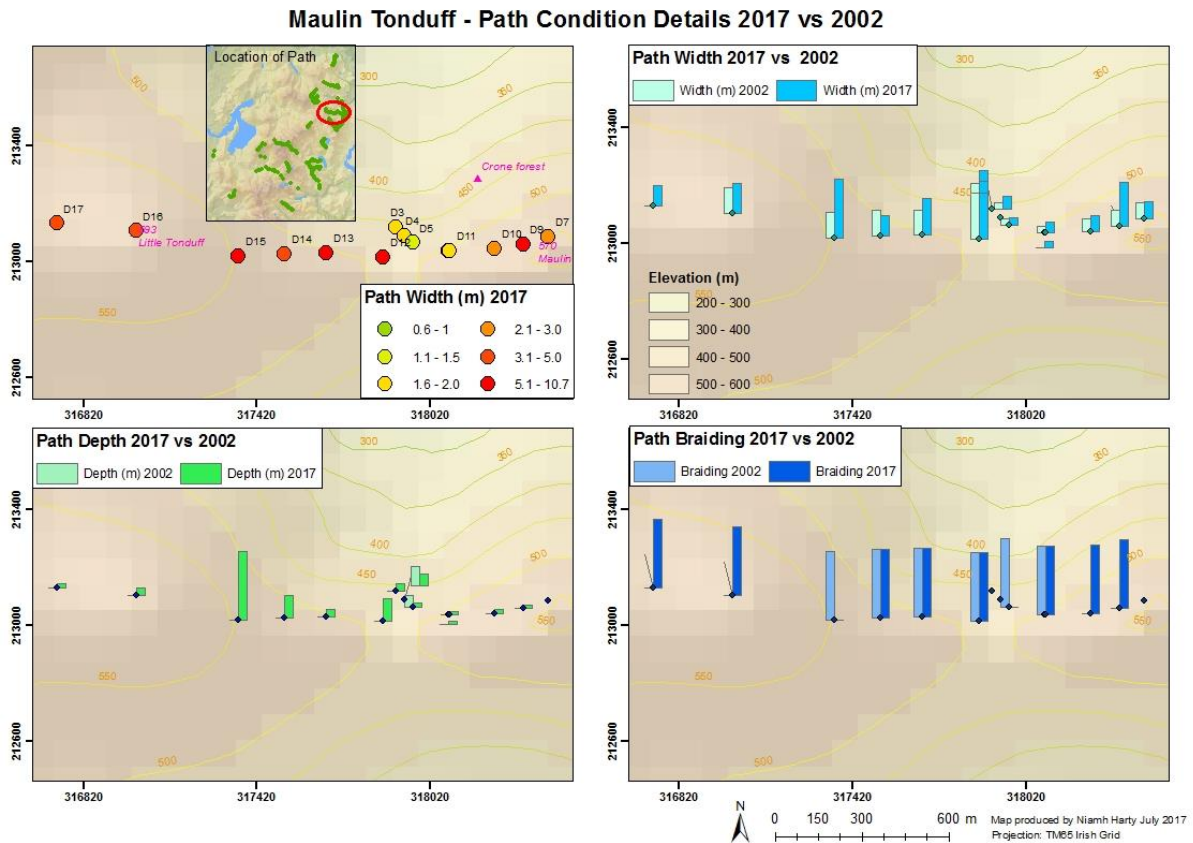
Figure L-21 Maulin-Tonduff Condition Details

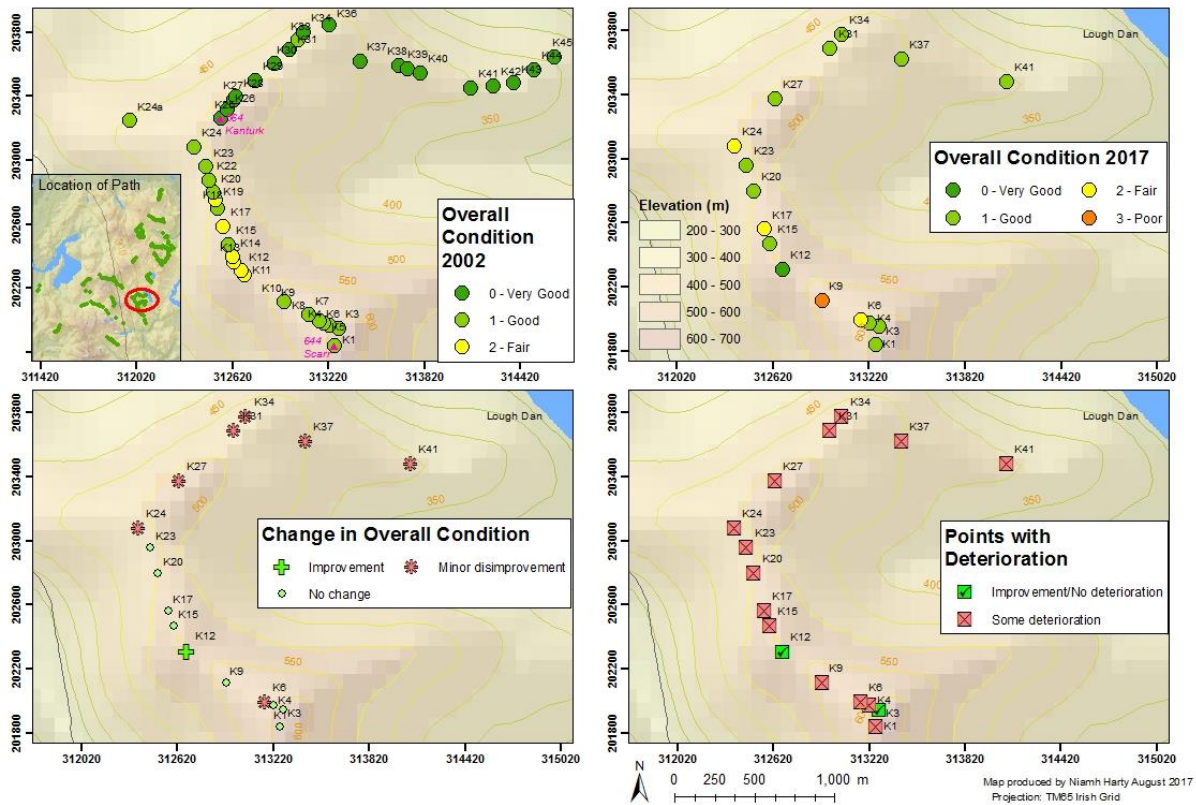
Figure L-22 Scarr-Kanturk Summary Condition Maps

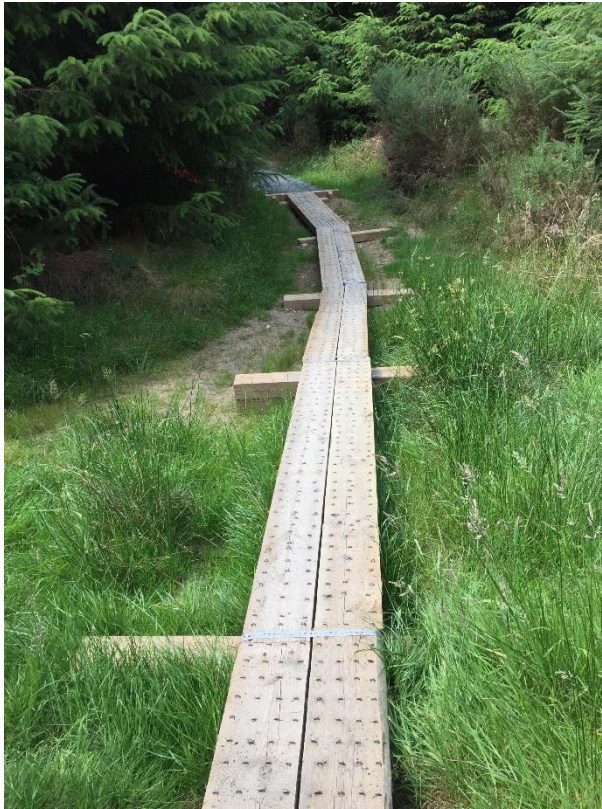
Figure M-1 Boardwalk built by MM 2017 on path between Wicklow Way and Avonmore Way

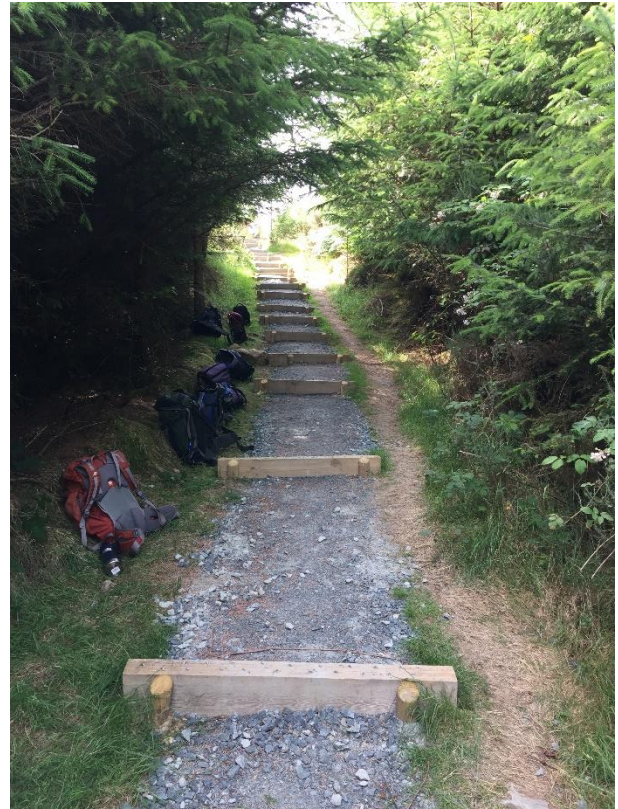
Figure M-2 Steps built by MM 2017 on path between Wicklow Way and Avonmore Way
