Physico-chemical evaluation of the water quality in Rocha River

A qualitative and comparative analysis including aspects of social and
environmental factors

MSc Thesis, 30 ECTS
ISRN LUTVDG/(TVTG-5160)/1-65/(2019)

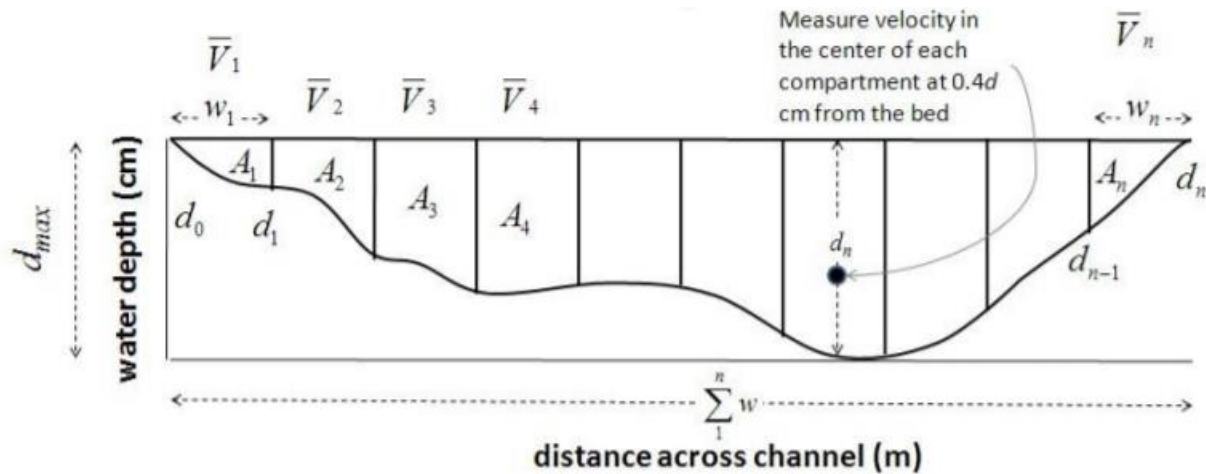
Figure 3.1 Cross-section of a river divided into vertical sections for flow measurement (Ethz.ch, nd).

The velocity varies across a channel, and measurements must therefore be made at several points across the channel (see figure 3.1). The depth of the river varies across its width, so the usual practice is to divide the cross-section of the stream into a number of vertical sections and to measure velocity at each of these points. No section should include more than 10-20 % of the total discharge. Thus, between 5 and 10 vertical sections are measured, but of course the amount depends on the width of the stream (Bartram and Ballance, 1996).

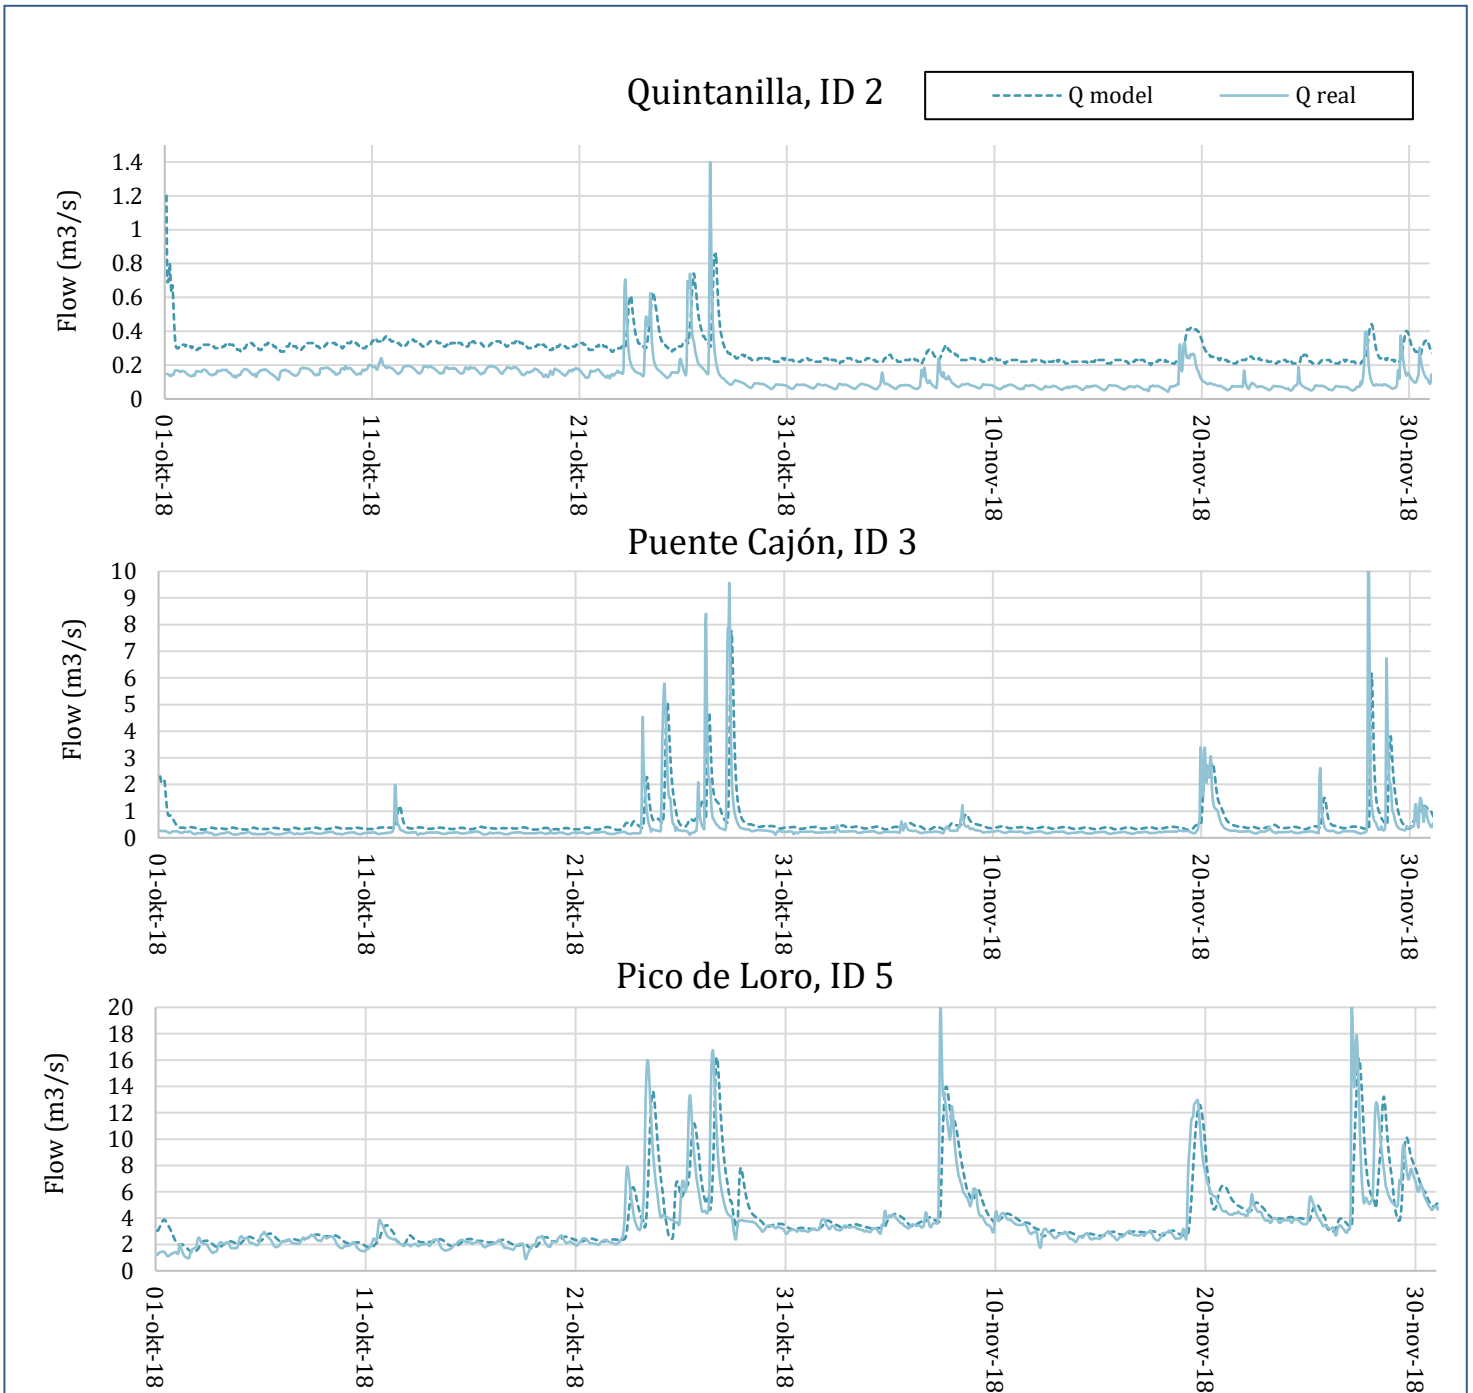
Figure 5.2. Shows the flow variations (m^3/s) in Rocha River at the locations (ID 2, 3 and 5) for October and November 2018. The dotted line represents the modelled flow in Hec-RAS (Q model) and the full line represents the calculated flow from the gauging stations and field measurements (Q real).

The flow results from the performed Hec-RAS modelling correlates well with the continuous measured flow at the gauging stations at Puente Cajón (ID 3) and Pico de Loro (ID 5) (figure 5.2). The modelled flow at Quintanilla has the same trend as the calculated flow values but the amount of flow deviates with an average of 0.28 m³/s.

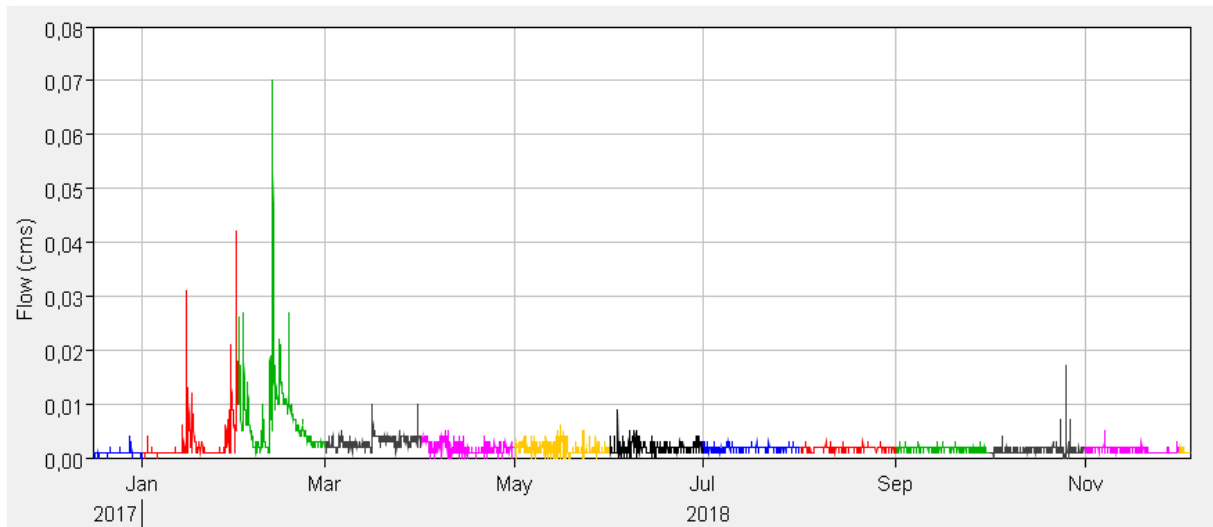
Figure 5.3 Seasonal flow variations (m^3/s) at location Chiñata (ID 1) from 15 Dec 2017 to 4 Dec 2018.

In figure 5.3 and 5.4 the seasonal variations can be seen and flow peaks are concentrated during the rainy season December –March. During April-October the river flows are relatively constant. The two figures illustrate how the flow increases downstream in the river. The flow characteristics in Chiñata (ID1) is more of a small stream, during the dry season the flow varies between $0.001-0.003 m^3/s$ and during rainy season the flow reached values up to $0.07 m^3 /s$. The

To improve the model output for all parameters at all points in the river, more calibration and time series data are needed. As seen in figure 5.3 and 5.4 the flow varies significantly during the year at the up- and downstream sections of the river and thus, the water quality at different times of the year will have a great variation along the river course. For further studies, it is therefore highly recommended to include water quality samples taken at more locations along the river and at more time points distributed over the whole year.

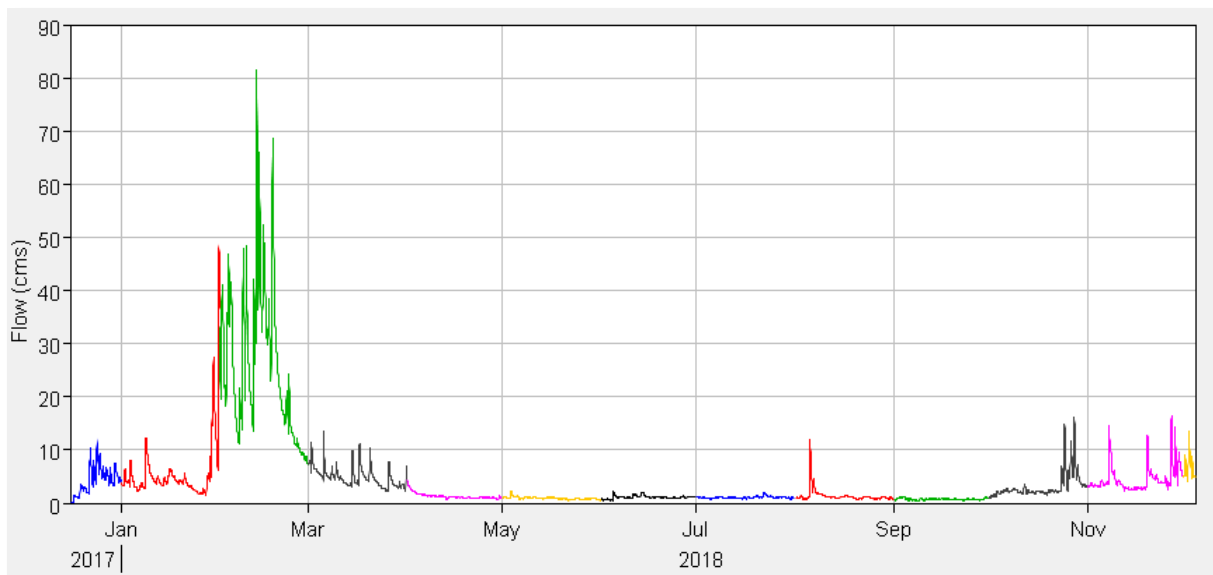
Figure 5.4 Seasonal flow variations (m^3/s) at Entrada Mallcorancho (ID 6) from 15 Dec 2017 to 4 Dec 2018.

flow characteristics in Entrada Mallcorancho (ID 6) varies during the dry season around $1.0 \text{ m}^3/\text{s}$ and during the rainy season it can reach values up to $80 \text{ m}^3/\text{s}$.

The large flows and increased stage at Entrada Mallcorancho (figure 5.4) has required the building of levees to prevent flooding (seen in figure E, Appendix 5). The results from the Hec-Ras model (figure 5.2) and measured river flows in table 5.9 indicates that the rainfall event before sampling occasion 3 (27-28 October) was more intense downstream which also can be seen in the increased dissolved oxygen values at location Puente Pico de Loro and Entrada Mallcorancho (ID 5 and 6). From figure 5.2 it can further be assumed that the Hec-RAS model is performing well. However, with more time, further calibration of the model could have been done to enhance the different trends by adjusting parameters such as boundary conditions, geometry of river cross-sections as well as the Manning's coefficients.

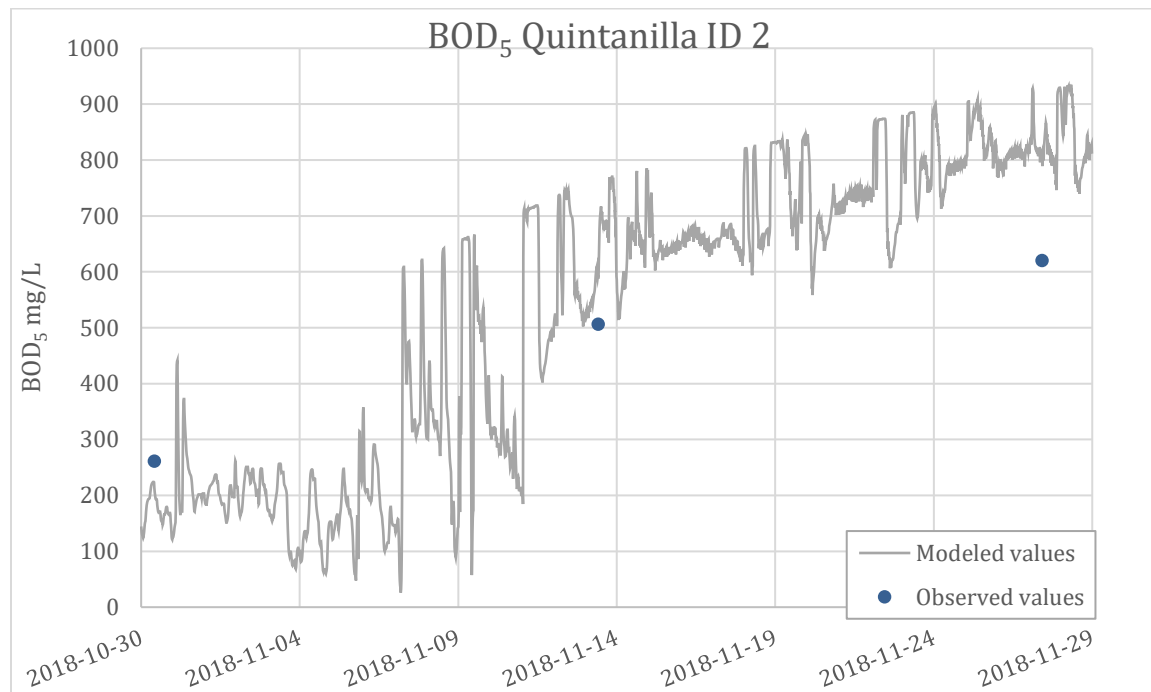
Figure 5.5 Changes in concentration of BOD₅ mg/L at Quintanilla ID 2 during the sample period. The line represents the modelled variation in BOD₅ concentration and the dots represents the measured values from the water quality sampling (table 5.3).

Figure 5.5 illustrates the modelled result of the BOD₅ variations at Quintanilla (ID 2). In the graph it can be seen that there are relatively large deviations between the model and the observed values from the measured water quality sampling, although they follow the same increasing pattern. The results from the water quality model can therefore be questioned. However, as mentioned in subchapter 5.1, neither the BOD₅ results obtained from the Winkler dilution method can be seen as exact.

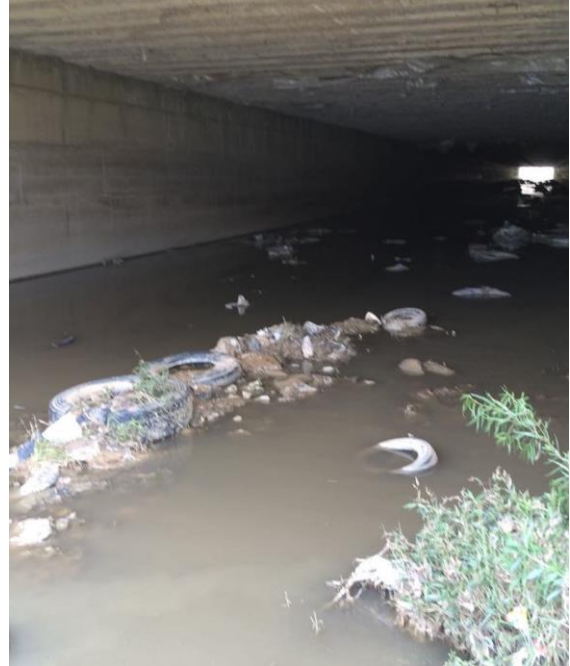
Figure 5.6 Solid waste in Rocha River under Puente Cajón (ID 3).

The amount of solid waste in Rocha River could not be ignored during the fieldwork (figure 5.6). Large amounts of solid waste thrown directly into the river by individuals passing the bridges were frequently observed (ID 1-6). The behavior can be explained by the few, or none, existing official dumping sites for waste, as well as a lack of public interest and awareness. Both investments, engagements and time is needed to improve the state of Rocha River. The beneficial factors for the local individual is the improved water supply, esthetic surrounding and healthy environment which on all levels increases the quality of life. However, for this to occur, the opportunity and public desire is required to change the customary habits into a more holistic approach.

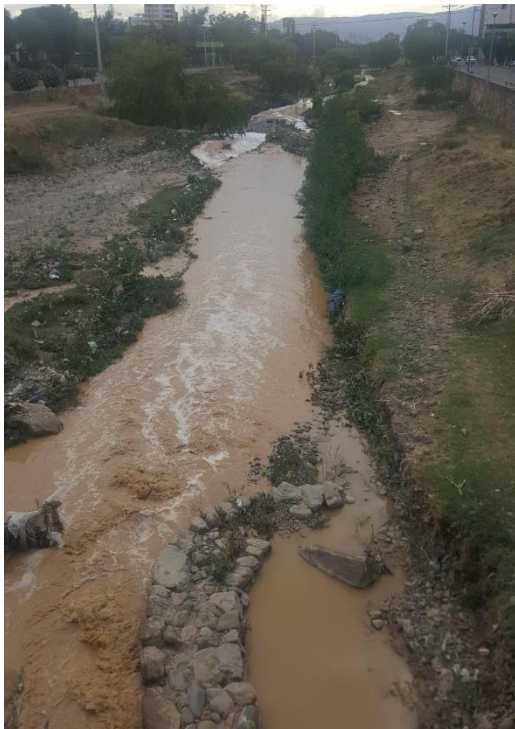
Figure 5.7 Rocha River passing through Cercado, aeration occurring.

Visible urban water has many recreational benefits. However, the appearance of the river in the inner city (figure 5.7) leaves little room for these values as it has high turbidity (especially after heavy rainfall), litter content and an unpleasant scent. Good intentions for the river restoration can also be seen in this picture, as different elevation steps have been created for an increased aeration.

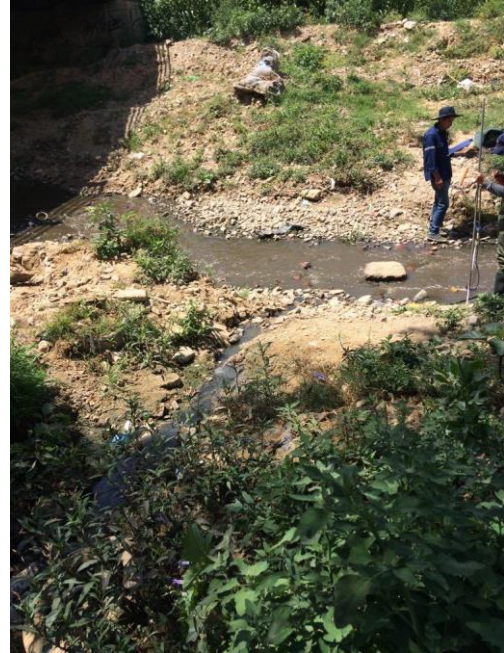
Figure 5.8 Untreated wastewater discharge to Rocha River at ID 2.

During the fieldwork a direct untreated wastewater channel was encountered at (ID 2) (figure 5.8). From the figure one might understand the difficulty in locating these types of discharges into the river as the amount of vegetation in the river bank is large and the discharge may be irregular.

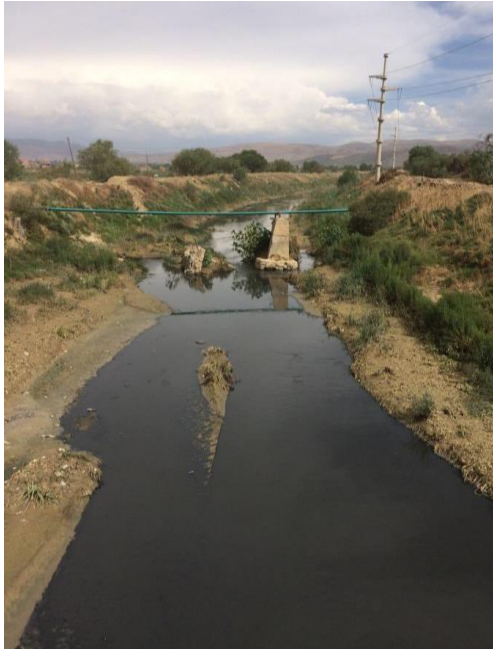
Figure 5.9 Rocha River at Puente Zofráco (ID 4)

Anoxic environment was observed after the WWTP Alba Rancho (ID 4) as the water of the shallow Rocha River in this area had a distinct black colour (seen in figure 5.9) which is an indication of high levels of oxidized organic matter.

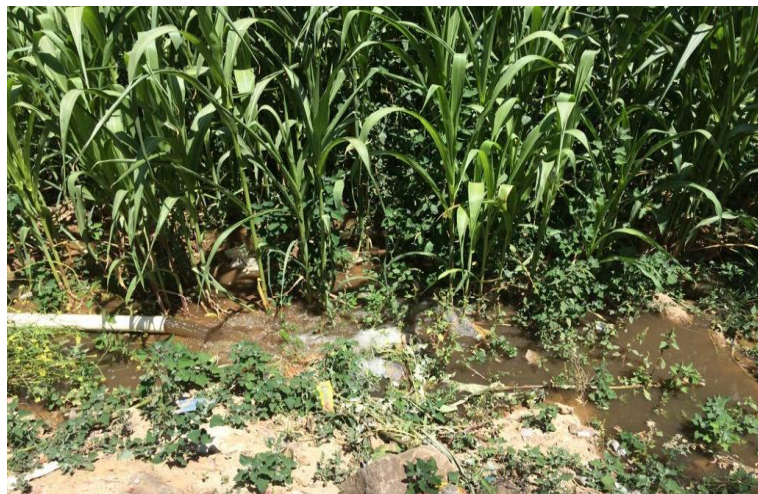
Figure 5.10 Pipe with untreated Rocha River as irrigation water for maize at Quintanilla (ID 2)

Several farmers with agricultural land located next to the Rocha River have implemented direct irrigation pipes from the Rocha River to the fields, located and documented (figure 5.10) during fieldwork. Seen in figure 5.10 is diverted water from Rocha River and used for irrigation of maize without any treatment at location (ID 2).

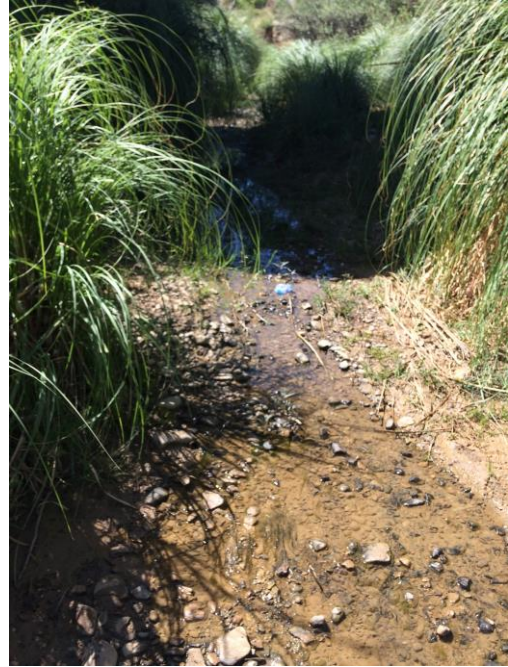
Figure B. River sediment at sampling point ID 1

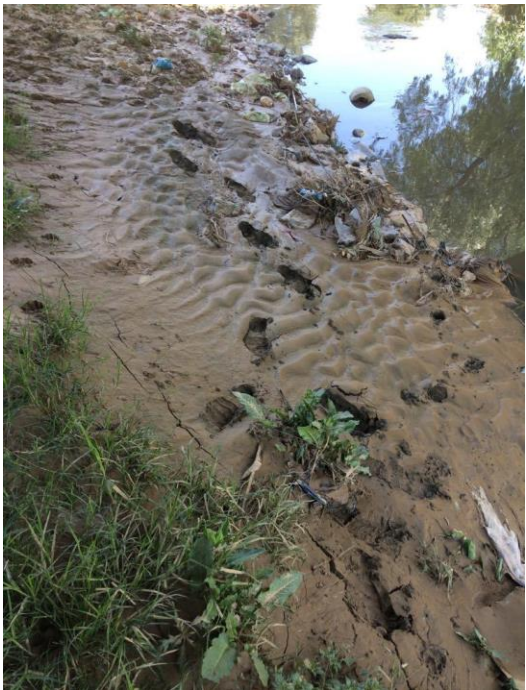
Figure C. River sediment at location ID 2

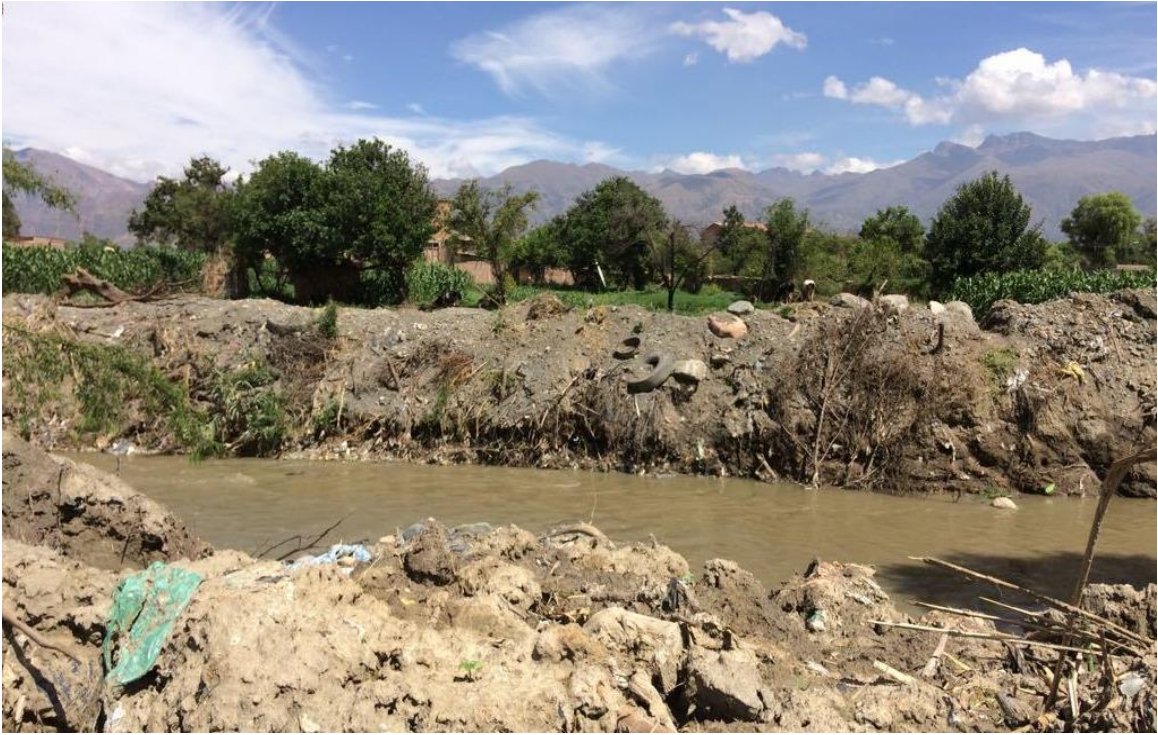
Figure E. The Rocha River at ID 6, showing banks that prevent flooding and solid waste deteriorating

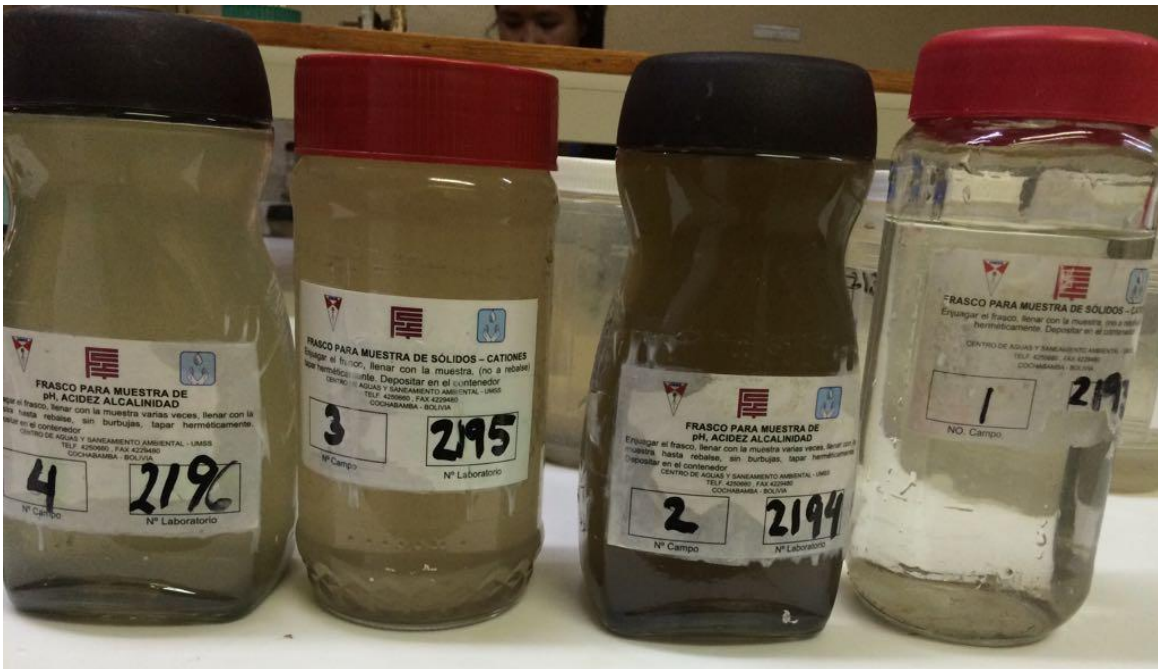
Figure F, Sample containers (ID 1-4) for evaluation of pH and EC at C.A.S.A.
