Limestone Quarry Restoration - Evaluation plan of restoration methods for Alvar establishment on northern Gotland

Bachelor thesis, 15 credits, in *Physical Geography and Ecosystem Science*

The purpose of this thesis is to provide a plan of evaluation for a restoration project carried out by Cements AB on northern Gotland. The test sites of the project are situated in the Western quarry of Slite cement production plant.

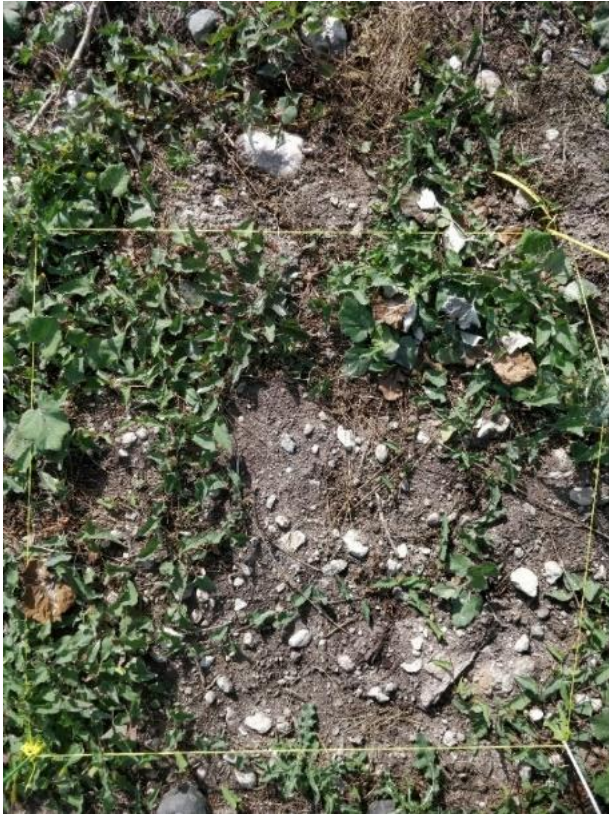
Figure 5. Monitoring quadrat used at the project site. Fiberglass rods mark out the corners of the quadrat and the frame is made out of a 2mm yellow cord.

Follow-up areas were put up in the form of monitoring quadrats (1x1m), using two yardsticks of 2 meter that were folded at 90 degrees. Four fiberglass rods were used to mark out the corners. A green rod was put at the NE corner, a yellow rod at the SW corner and two white rods made out the NW and the SE corner. A yellow, 2mm, cord was then twined around the rods, forming the quadrant. The yellow and the green rod were marked with a yellow loop lock tie with an ID number and compass direction (Figure 5).
