Master Thesis
TVVR 20/5013

Beach Nourishment at Faxe Ladeplads in Zealand, Denmark

- Evaluation and Assessment of
Morphological Evolution

Water Resources Engineering
TVVR 20/5013
ISSN 1101-9824

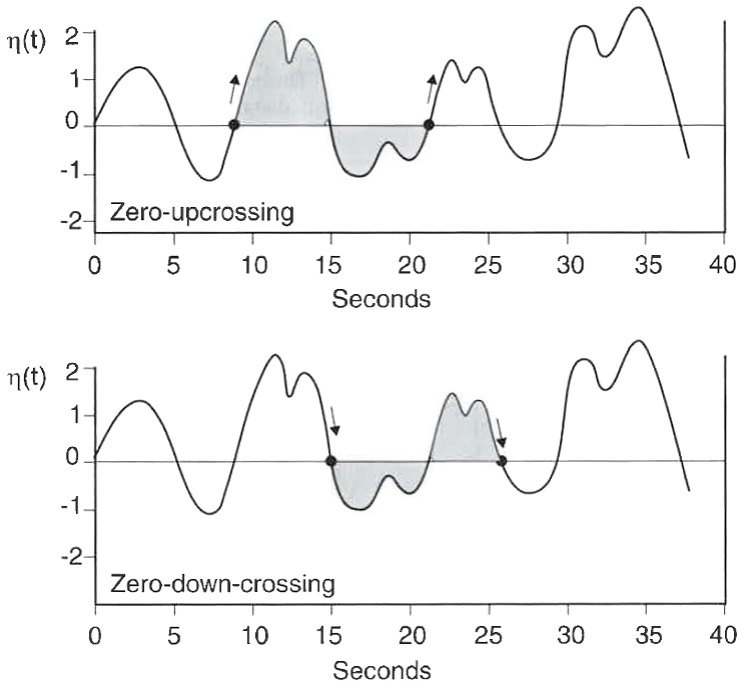
Figure 2.3: Zero-upcrossing and zero-downcrossing method for analysis of waves, (Davidson-Arnott, 2010).

A real wave record contains waves that vary in height and period, these may be analysed according to the zero-upcrossing or zero-downcrossing method (Fig. 2.3). The method is used to define the wave heights and corresponding periods represented in the wave record. Once identified, the characteristics of H and T may be used to derive statistics that represent the wave record. The statistics will not vary between the zero-upcrossing method or zero-downcrossing method, it is rather a difference in the definition of the wave. The *significant wave height*, H_s corresponds to the average of one third ($1/3$) of the largest waves and may be extracted from the wave statistics. The significant wave height provides a common way to define and represent the wave heights in a record (Davidson-Arnott, 2010). The significant wave height is approximately equal to the spectral significant wave height, denoted H_{m0} , which is the denotation further used in this report.

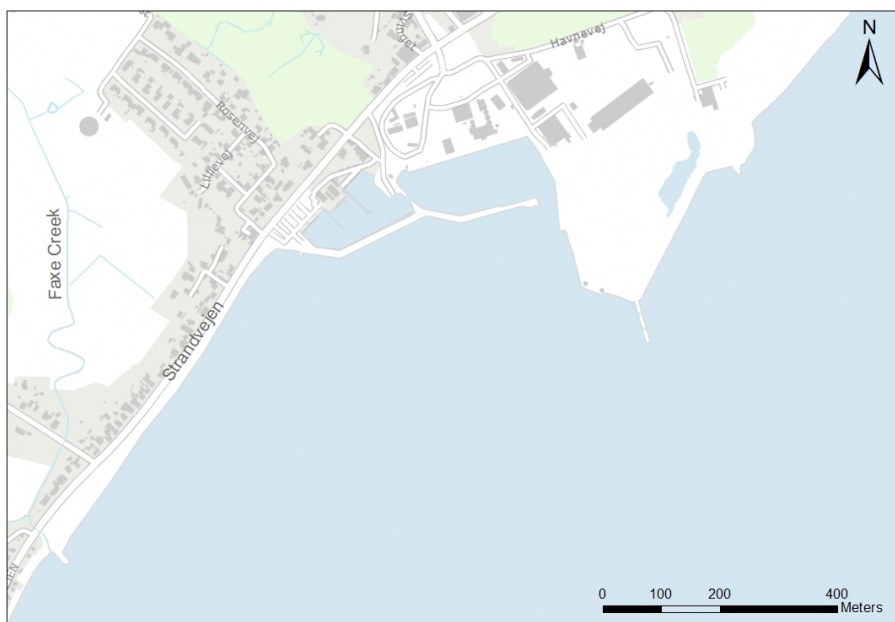
Figure 3.2: Close up view of the harbour and coastline at Faxe Ladeplads. WMS basemap from the Agency for Data Supply and Efficiency (n.d.) - Webservice liste (DTK/Skærmkort daempet).

The stretch of coastline downdrift the harbour, shown in Figure 3.2, is the main subject of this study. Figure 3.2 also shows the road Strandvejen which follows the coastline closely. This is the main road, connecting Faxe Ladeplads to other towns further south and inland. The beach area close to the harbour was once popular amongst visiting tourists as well as local inhabitants. However, the beach has successively eroded, leaving the road exposed. There has also been reoccurring events of wave overtopping and damage caused to Strandvejen during storms with large waves. To combat the problems with overtopping and erosion, and with an aim to reclaim the lost beach, a beach nourishment was carried out in 2018. The initial nourishment was placed in the area between the harbour and the outlet of Faxe Creek. There is a small groyne placed before the outlet of Faxe Creek (see Figure 3.4) and furthermore, there is a rock revetment placed adjacent to the road.

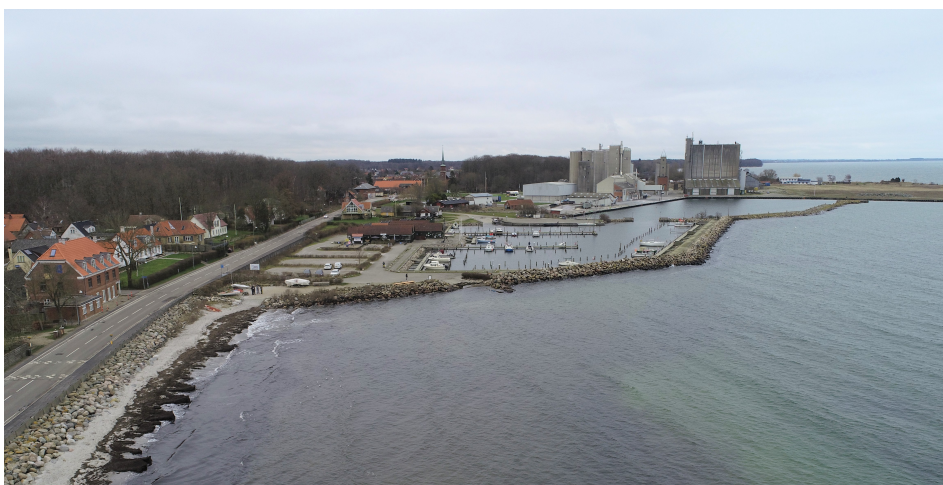
Figure 3.3: North view of the marina and the harbour. The road Strandvejen and the northern part to the beach is also shown. Photo: Danish Coastal Authority, 2020.

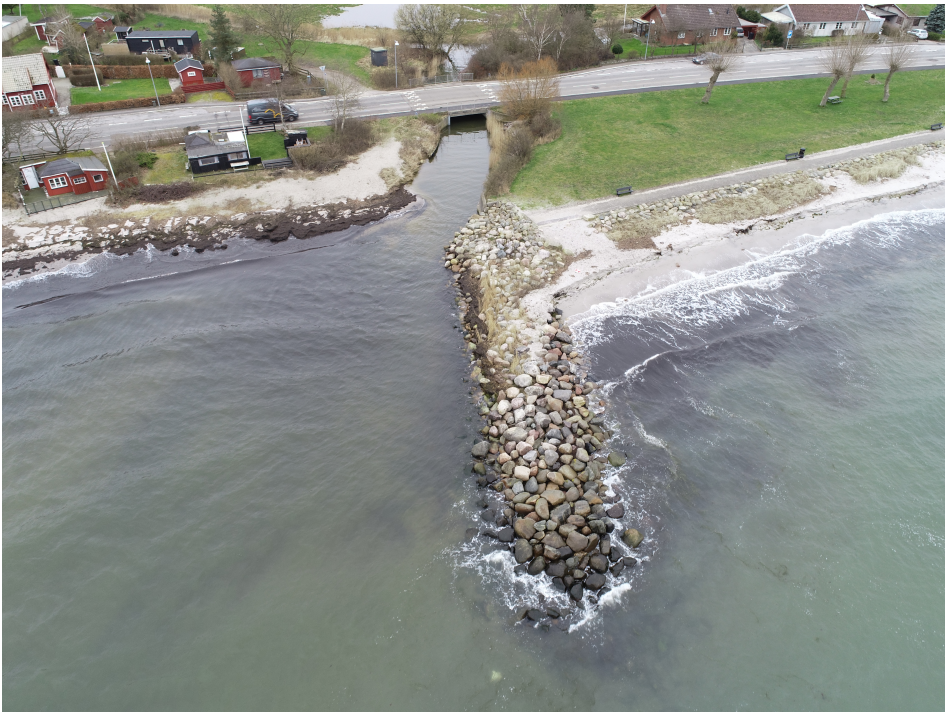
Figure 3.4: The groyne placed at the south end of the beach and just before the outlet of Faxe Creek. Photo: Danish Coastal Authority, 2020.

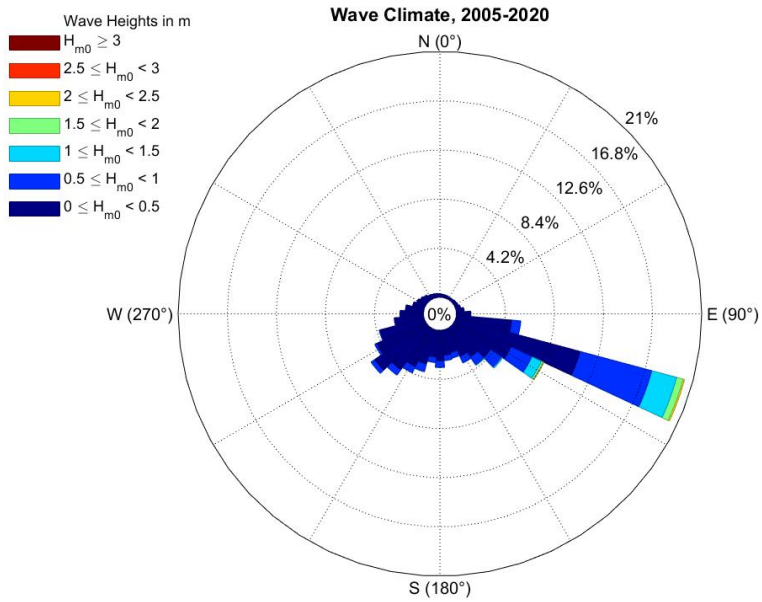
Figure 3.6: Wave rose indicating the wave climate produced with data from the period 2005-2020.

Figure 3.7 presents a map of the fetch lengths. The wave rose in Figure 3.6 indicates that the largest wave heights are generated at directions 100-120°, which may be explained by that the largest fetch lengths are in these directions.

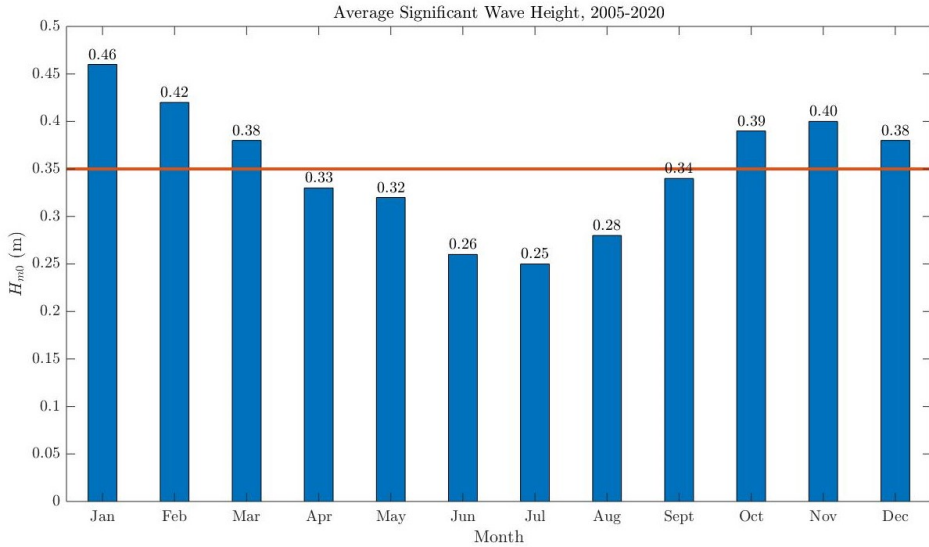
Figure 3.8: Monthly average significant wave heights, 2005-2020. The line represents the overall yearly average significant wave height of 0.35 m.

Figure 3.8 shows the computed monthly average significant wave heights for the period July 2005 to March 2020. A yearly average for the significant wave height is 0.35 meters. Based on the results presented in the bar diagram, it is possible to see that during six months of the year (October-March) the monthly average wave height is larger than average while during the remaining six months (April-September) the wave height is smaller than average. It is thereby evident that the wave climate is characterized by one period of the year with more waves of larger wave heights and one period when the conditions are calmer.

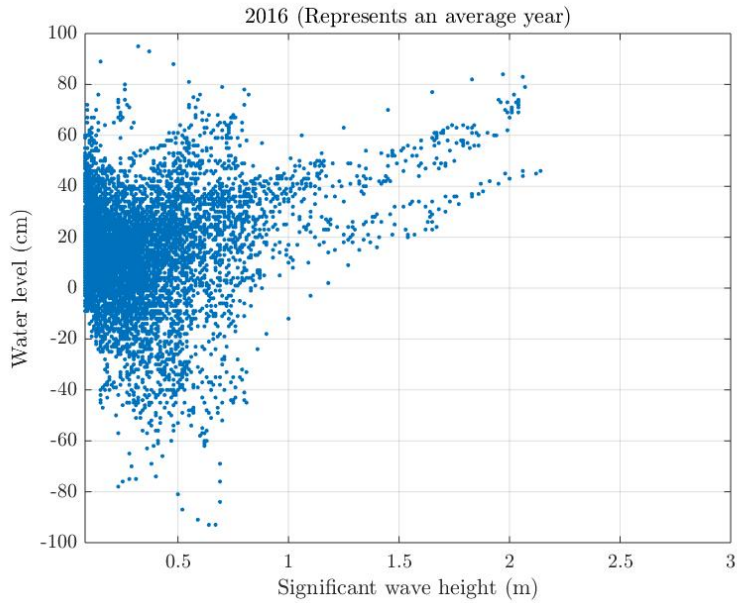
Figure 3.9: Significant wave height and water level for an average year (2016). The relationship shows that large waves coincide with high water levels, however high water levels occur without extreme waves.

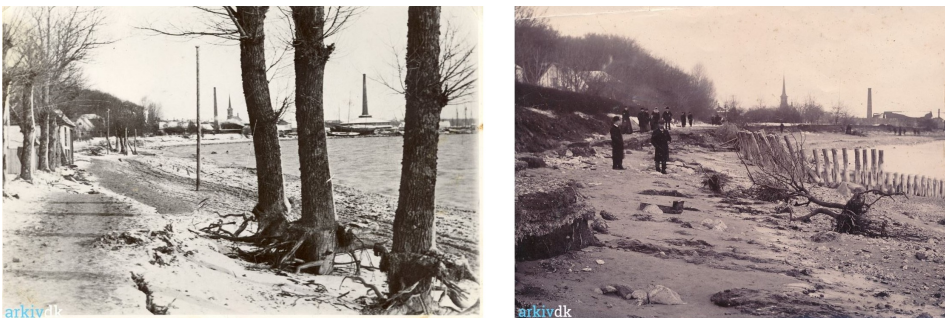
Figure 3.12: Photos showing the damages caused to the coastal area south of the harbour, during a winter storm in 1904, Left: (arkiv.dk, n.d.-b), Right: (arkiv.dk, n.d.-a).

Another storm affected the area in late December 1904. It is unclear how significant the damages were to the harbour, however photos in Figure 3.12 show the damages caused to the coast just south of the harbour. Both the photos are taken so that they overlook the coastline with a northern view, and the harbour is visible in the background. The photos in Figure 3.12 show that the coastline was natural and unprotected at this time. i.e. in the beginning of the 20th century.

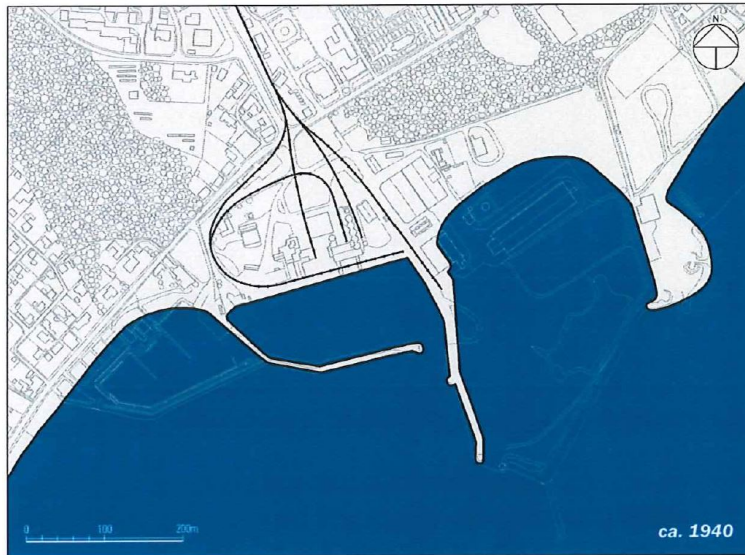
Figure 3.13: Appearance of the port around 1940, coastline advanced due to the sediment transport (Aasbjerg, 2002).

regularly clearing the area through dredging was an expensive operation, the gap was eventually just left to fill up (Ramboll, 2016b). The disruption of the natural sediment transport also resulted in accretion of material on the updrift side of the small port whilst erosion occurred on the downdrift side of the larger port (Mangor et al., 2010). This caused the port to assume the shape that is indicated in Figure 3.13, it clearly shows how the coastline has advanced up until today.

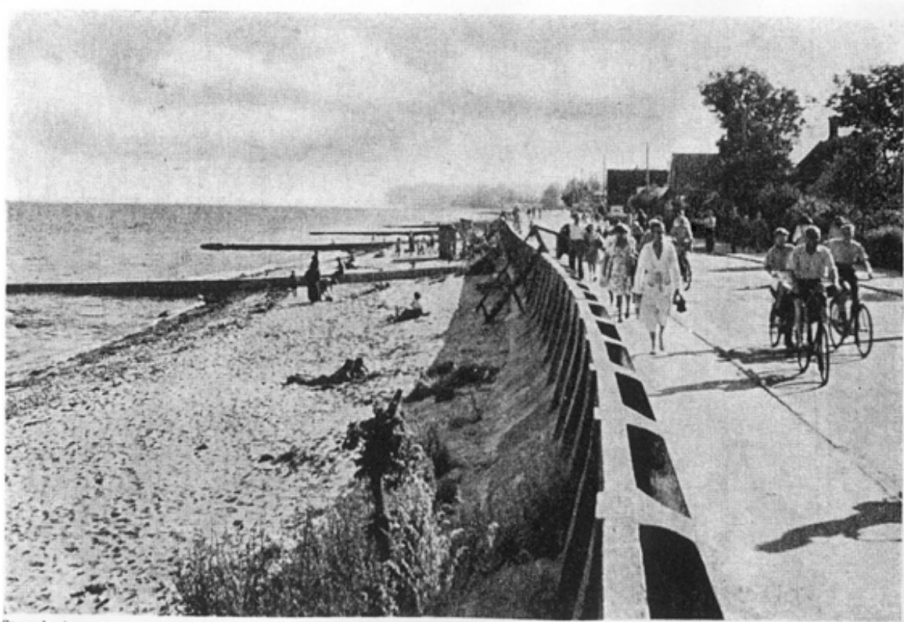
Figure 3.15: Photo from the 1960's, showing Strandvejen and the groynes placed along the beach south of the harbour (Mangor, Fuchs, & Rand, 2010).

The coastline surrounding Faxe Ladeplads is subject to chronic erosion. The construction and development of the harbours along with other activities in the coastal area, during the 20th century, affected the sediment flow and increased the erosion. Groynes placed along the coast south of the harbour helped to reduce the problems with erosion (Ramboll, n.d.). Studies of historic aerial photos available at Danmarks Miljøportal (2020), show that groynes were more or less a permanent element of coastal protection during the majority of the 20th century. Figure 3.15 presents a photography from the 1960's where the placement of the groynes is clearly shown. The relatively significant beach width suggests that the groynes were effective at trapping sediment. In the photo, it is also possible to see the concrete wall protecting the adjacent road Strandvejen. Faxe Ladeplads was once a very popular tourist destination (Baden & Aarosiin-Hansen, 2017), and the photo showcases a vibrant atmosphere.

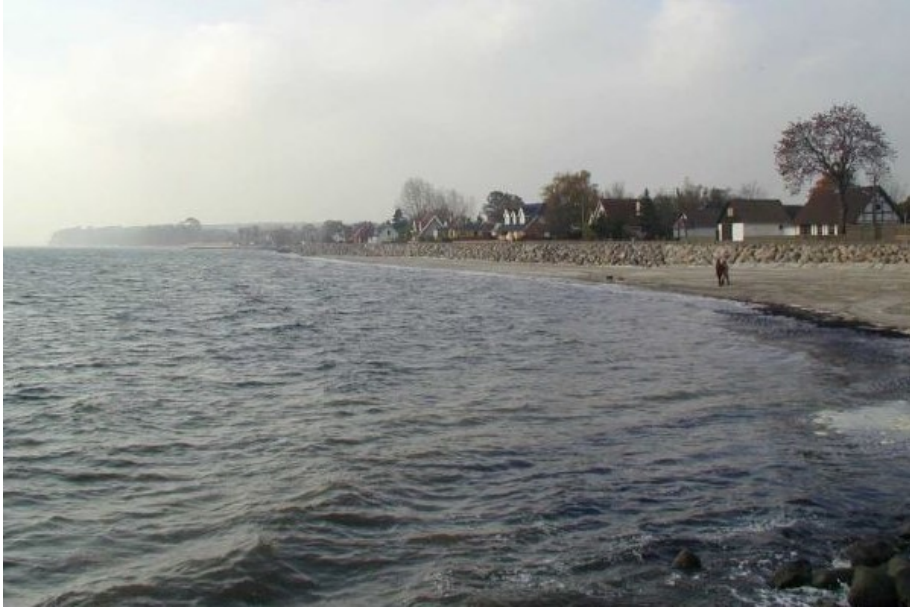
Figure 3.16: Picture from 2003, showing the recently established rock revetment along with a narrow beach strip, (COWI, 2013).

In the early 2000's the groynes were severely worn down and as an effect their impact was significantly reduced. The groynes were ultimately removed but since then the beach gradually disappeared, only to leave the road Strandvejen exposed (Baden & Aarosiin-Hansen, 2017). In addition, there was a reoccurring problem with wave overtopping onto Strandvejen during storm conditions. During one particular storm in 2002 large amounts of sand and gravel washed up onto the road. As a cause of action, a rock revetment was constructed in 2003, with the objective to protect the road. Complementary to the revetment structure, a small artificial beach was established as well. Due to economic constraints, the original project plan did not include the establishment of a beach, but a limited amount of sand (1,200 m³) was provided by Faxe Kalk A/S at a small cost. Figure 3.16 presents a picture from 2003 and shows a view of the established rock revetment along with a narrow beach strip in front of the structure. This material was not eroded as quickly as expected, and the beach was reasonably well maintained until 2005. In the years that followed the remaining sand eroded quickly and in 2008 the beach had completely disappeared (COWI, 2013).

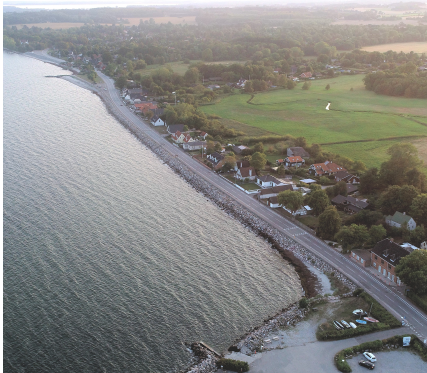
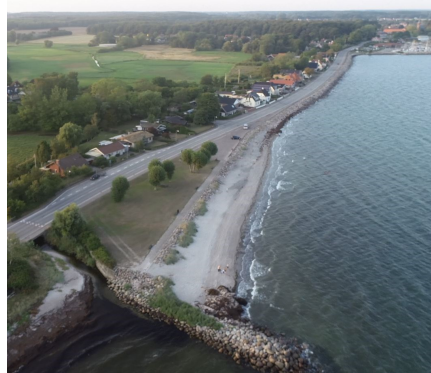
(a) South view. 16 August 2018.

(b) North view. 16 August 2018.

Figure 3.17: Aerial photos showing the beach before the initial nourishment. Photo: Danish Coastal Authority, 2018.

Figure 3.17 shows aerial photos of the beach area from August 2018, i.e. just months before the initial nourishment was carried out. In Figure 3.17a it is clearly shown that there is very limited material present and the rock revetment by Strandvejen is fully exposed. Figure 3.17b shows that the beach width increases a bit towards the groyne placed before the outlet of Faxø Creek.

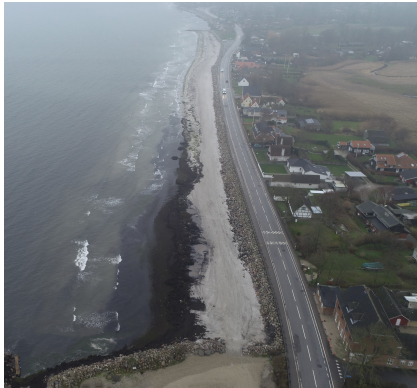
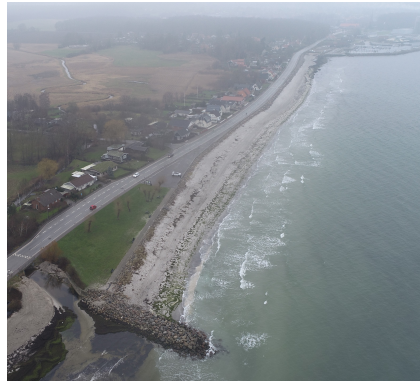
(a) South view. 20 December 2018.

(b) North view. 20 December 2018.

Figure 3.18: Aerial photos showing the beach after the initial nourishment. Photo: Danish Coastal Authority, 2018.

Figure 3.18 shows an aerial view of the reclaimed beach, in December 2018, i.e. just after the nourishment was in place. The even width of the established beach is clearly shown in the figures. In Figure 3.18a it is also possible to detect a large amount of seaweed that has gathered at the end of the beach where it connects to the harbour. This is a common recurrence at Faxe Ladeplads and the municipality regularly performs maintenance by removing the seaweed from the area (Faxe Municipality, 2019).

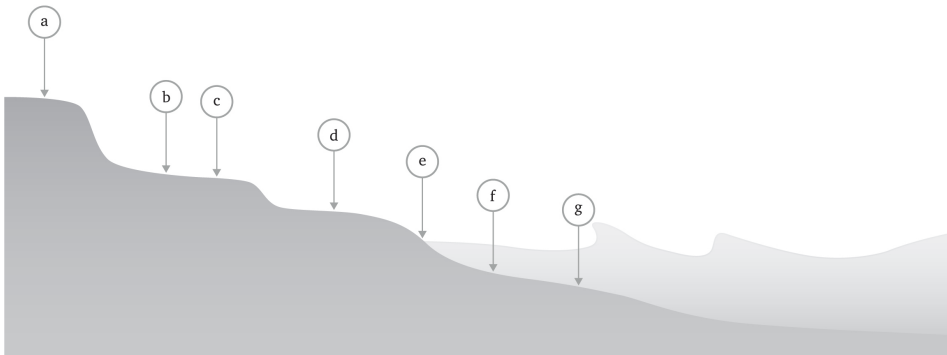
Figure 4.1: Location of sampling points along the cross-shore profile. Illustration: Malin Jansson.

Sand samples were collected to perform analysis of sediment grain size distribution. Along each sampling cross-shore profile, samples were collected at seven specific sampling points. Figure 4.1 show a schematic image of the placement of the sampling points. The sampling points in the beach profile include aeolian deposits (a), two separate samples in the backshore (b & c), a reference point located between the swash zone and the beach berm (d), the swash zone (e), one sample at 0.6 m depth and 1.0 m depth (f & g).

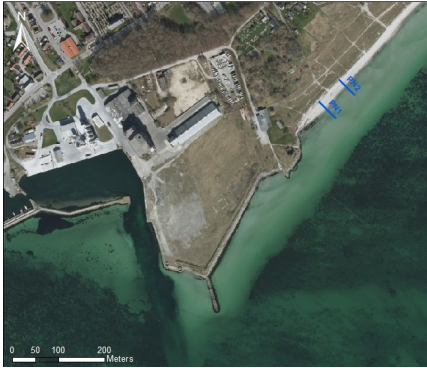
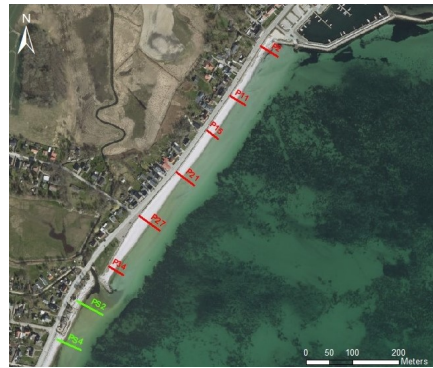
(a) Sampling profiles north of the harbour.

(b) Sampling profiles along the nourished area and south of the creek outlet.

Figure 4.2: Map showing the locations of the sampling profiles.

sampling profiles south of the outlet of Faxe Creek. Figure 4.2 shows the location of the ten sampling profiles, color coded to display the three different areas. Exact coordinates are provided in Appendix. Samples collected at the north side of the harbour, were thought to represent "native" conditions as the dominant direction of the sediment transport is southward directed (Mangor et al., 2010). The area south of the creek outlet is included for investigation to study if the grain size distribution in this area resembles the characteristics of the nourished area or the north area.

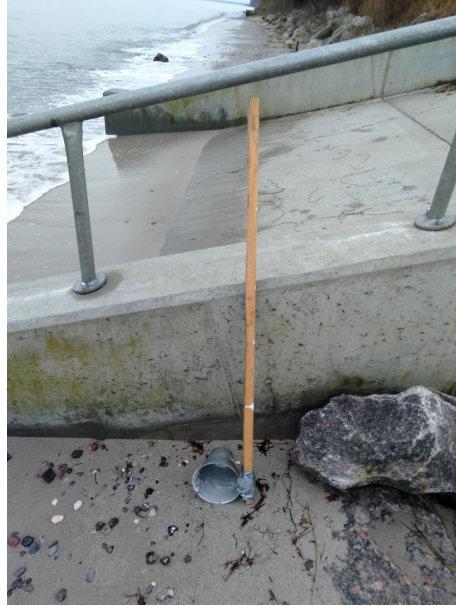
Figure 4.3: Device used to collect nearshore samples, i.e. in the swash zone and at water depth 0.6 m and 1.0 m. Photo: Anna Adell, 2020.

Dry samples were collected by using a metal beaker with a volume of 100 ml. Samples at points e, f, g, i.e. points located out in the water were collected by using a metal beaker attached to a wooden stick in order to reach down to the bed, the improvised device is shown in Figure 4.3.

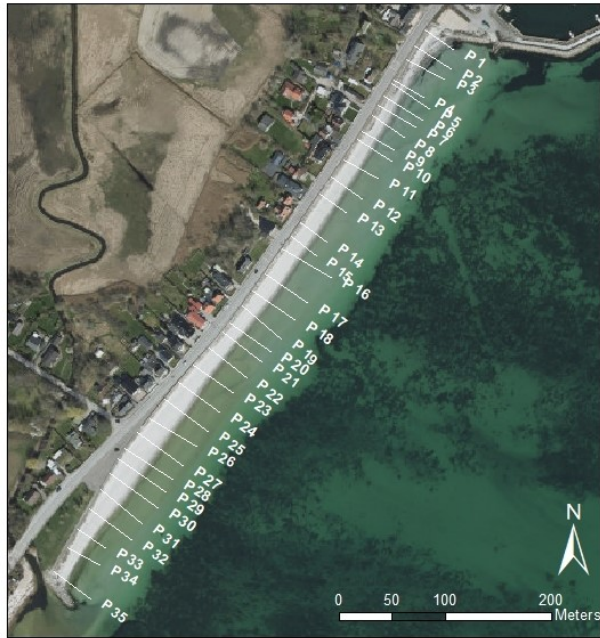
(a) Profile lines main beach (P1-35)

(b) Profile lines south (PS1-6)

A profile survey was conducted by using RTK-GPS equipment with the purpose to generate additional beach morphology data. A total of 35 individual profile lines were measured in the beach area where the initial nourishment had been placed, resulting in measurements approximately every 18 meters, see Figure 4.4a. These 35 lines had been identified and extracted from beach survey data from December 2018 (i.e. recently after the nourishment was in place) provided by the Municipality of Faxe. The area south of the creek outlet was also included for investigation. However, since this area lacked previous profile surveys, the measured profile lines were more generously spaced here. A total of six profile lines were measured in this area, see Figure 4.4b.

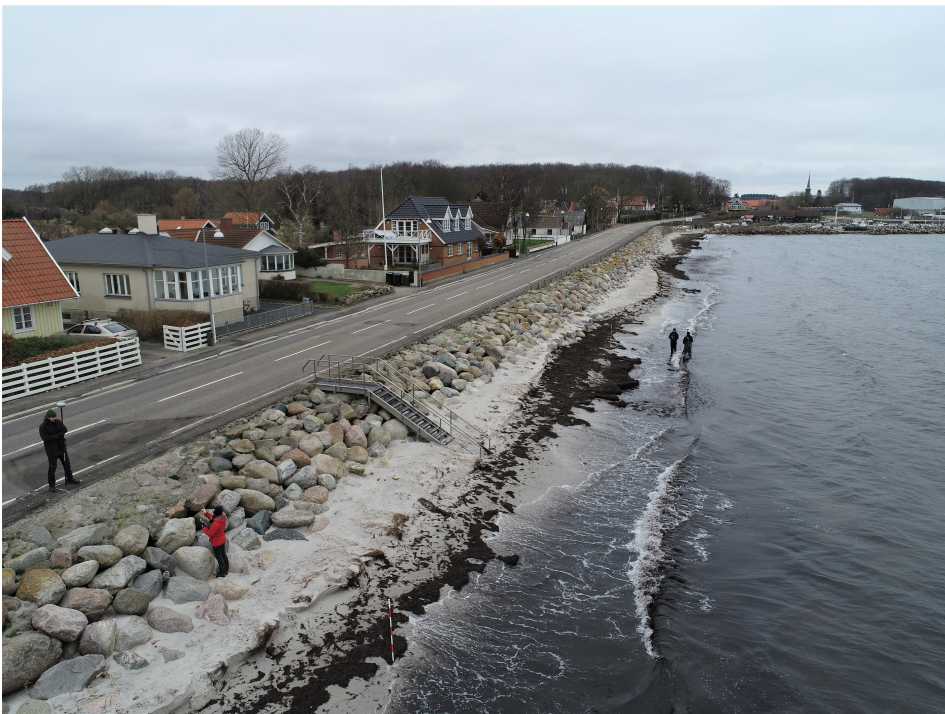
Figure 4.5: Action shot of the beach profile survey being conducted. Photo: Danish Coastal Authority, 2020.

Two instruments were used to conduct the survey which was divided into landward and seaward measurements. Figures 4.5 and 4.6 presents action shots of the survey being conducted. Seaward measurements were performed by people equipped with waders, see Figure 4.6. The landward measurements commenced at the top of the revetment adjacent to the road Strandvejen (see bottom left in Figure 4.5) and reached to the swash zone. The red and white stick visible in Figure 4.6 was used as an indicator to mark where the landward measurements ended and the seaward measurements began. This procedure assured that measured data was located along the same straight profile. The seaward measurements stretched approximately 30-60 meters out in the water depending on the water depth profile. During the day of the measurements the water level was recorded at +61 to 67 cm, which impacted how far out the profiles could be measured.

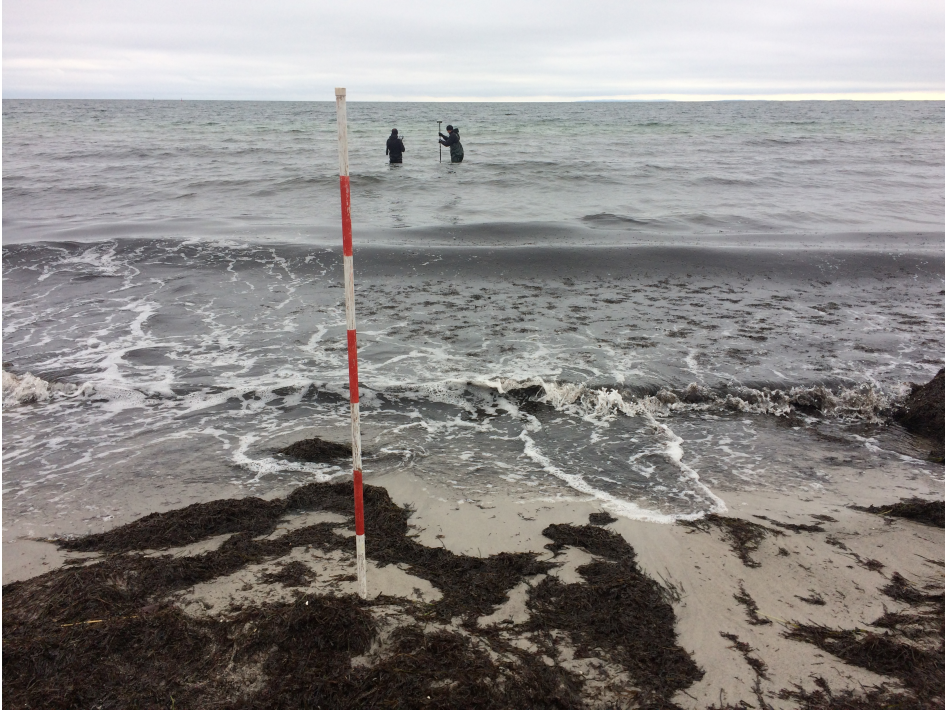
Figure 4.6: Procedure to conduct the seaward measurements. Photo: Anna Adell, 2020.

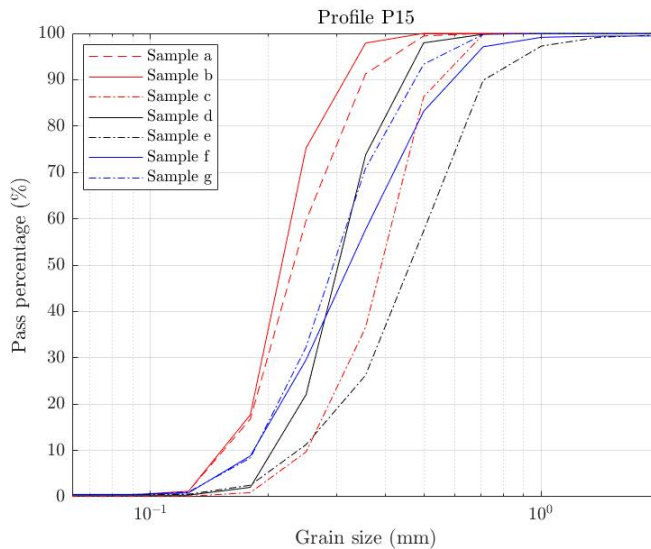
Figure 5.1: Grain size distribution curve for profile P15 to display an example.

From the grain size distribution curves it is possible to read the median grain size d_{50} , which corresponds to the grain size at a pass percentage of 50% in the grain size distribution curve. The results of d_{50} for each individual sample are presented in Table 5.1. Missing data indicates that no sample was collected at this point. This is due to the fact that the point could not be identified in the profile. For example, Figure 5.2 present a photo from the day when the field measurements were conducted. It shows a section of the coast along the nourished area where the dry beach plane had eroded and the rock revetment was exposed. Profile P21 was located in this area and hence the sampling was affected. The exception of the missing data, is sample PS4-e. This sample contained a lot of coarse elements ($d > 2$ mm) that was trapped at the top sieve, which hence made up the majority

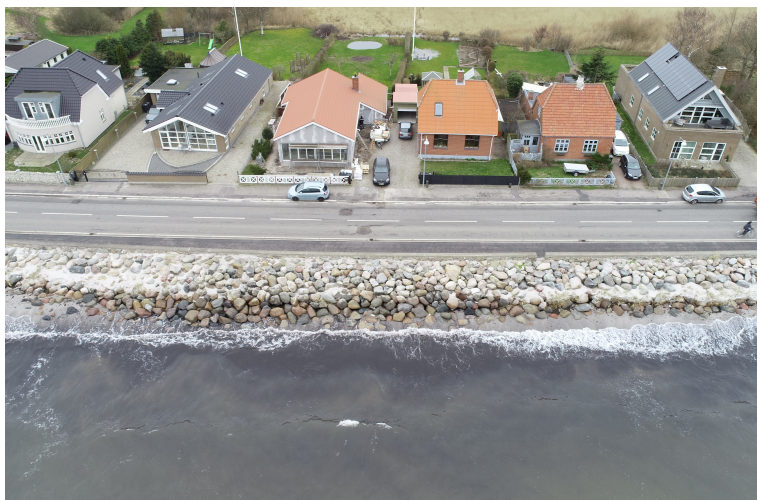
Figure 5.2: Photo from 3 March 2020 showing a section of the coast where the beach had eroded all the way to the rock revetment. Photo: Danish Coastal Authority, 2020.

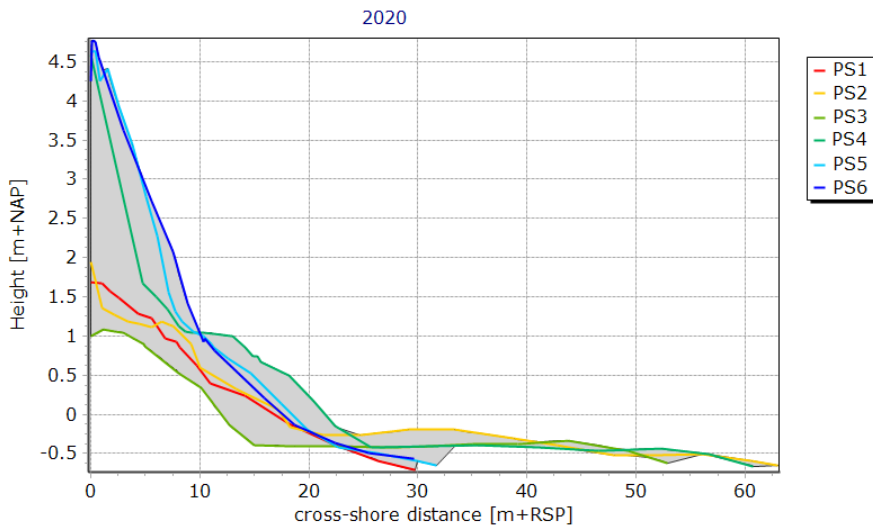
Figure 5.7: Profile cross-sections for profiles PS1-6, from March 3rd 2020.

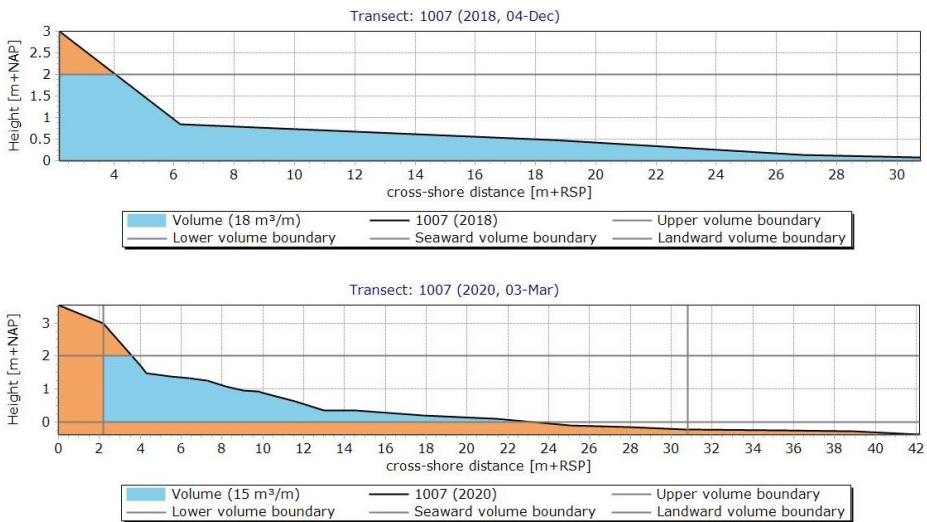
Figure 5.8: Profile sediment volumes for profile P7. Example display of MorphAn model output.

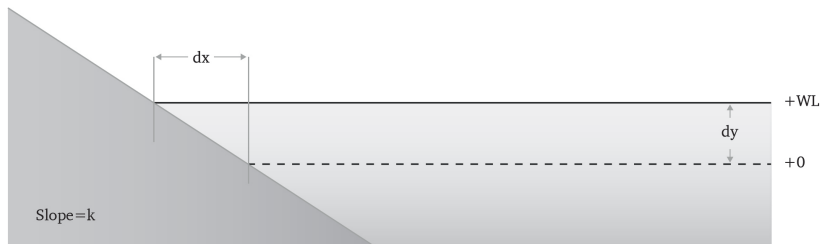
Figure 6.4: Schematic image showing the slope geometry.

The water level is accounted for by calculating a cross-shore distance by dividing the water level with an assumed foreshore slope. As a result, in the new analysis the shoreline is set to be defined at +0 cm. Figure 6.4 shows a schematic image of the theory behind the correction. The distance dy is equal to the water level (WL), and the distance dx is the corrected distance in the cross-shore direction, k is the foreshore slope.

Based on the geometry presented in Figure 6.4, the correction is calculated according to the relationship given in Eq. 6.2.

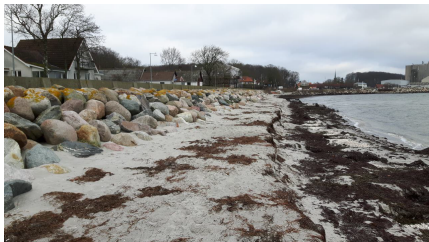
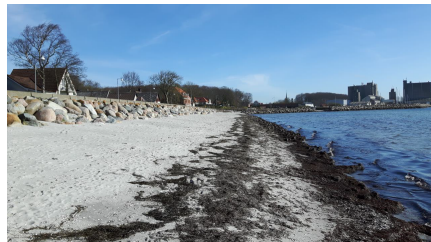
(a) 13 January 2020.

(b) 8 April 2020.

Figure 6.8: Figures showing the beach plane, with the harbour in the background (north view). Photo: Poul Jensen, Municipality of Faxø, 2020.

The photos in Figures 6.8 and 6.9, provided by the Municipality of Faxø, show the difference in the appearance of the beach in January and April 2020. The photos display great differences in the beach morphology between the two occasions, which can indicate that there is a strong dynamic behaviour of the beach. The photos from 13 January 2020 display a clear storm profile with signs of recent erosion. While the photos from 8 April 2020 show a beach profile typically generated at calm conditions. The images suggest that the seasonal variation of the beach profile in the area is quite significant. During storm conditions, eroded material is deposited offshore, to later be transported back to the beach plane during calm conditions and the beach recovers. Data shows that the water level during the day on 13 January 2020 was roughly +40 cm which is higher than the average. The water level on 8 April 2020 however, is unknown. It should be noted that a difference in water level potentially can contribute to the some of the recorded difference in appearance between the two occasions. If the water level on 8 April was significantly lower compared to 13 January the increase of the beach width would appear greater.

The result in Figure 6.7 presents significant negative values of EPR obtained for the period after the nourishment was established, suggesting that large amounts of material is lost from the beach profile. However, that does not have to equal that the material is lost from the system entirely. The photos in Figures 6.8 and 6.9 show that the beach has gone from having a dominant storm profile to a profile characteristic for calm conditions. This difference in appearance between two relatively recent events, can indicate that some material had been transported and deposited in the cross-shore profile. Which since the field investigation on 3 March 2020 partly has migrated onshore during periods of calmer conditions, and the beach has recovered resulting in a wider beach place. Although the seasonal variation is quite noticeable the result of the shoreline evolution in the years before the nourishment was carried out, generally show an erosive long-term trend. It is thereby possible that some material has been transported longshore and is hence lost from the system. The results of EPR for the period after the initial nourishment was carried out (presented in Figures 6.6 and 6.7) should however be evaluated with caution, as 2020 corresponds to a storm profile. The result clearly showcases the sensitivities related to adopting the instantaneous water line as the definition of the shoreline. It is important to emphasise that the orthophoto only presents one momentary image to represent an entire period.

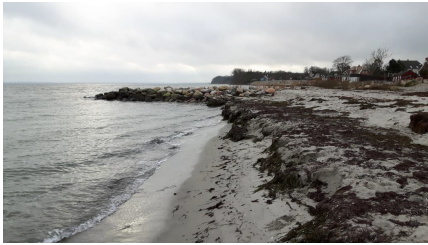
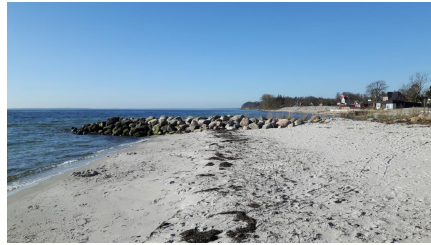
(a) 13 January 2020.

(b) 8 April 2020.

Figure 6.9: Figures showing the beach plane in the direction of the groyne (south view). Photo: Poul Jensen, Municipality of Faxe, 2020.

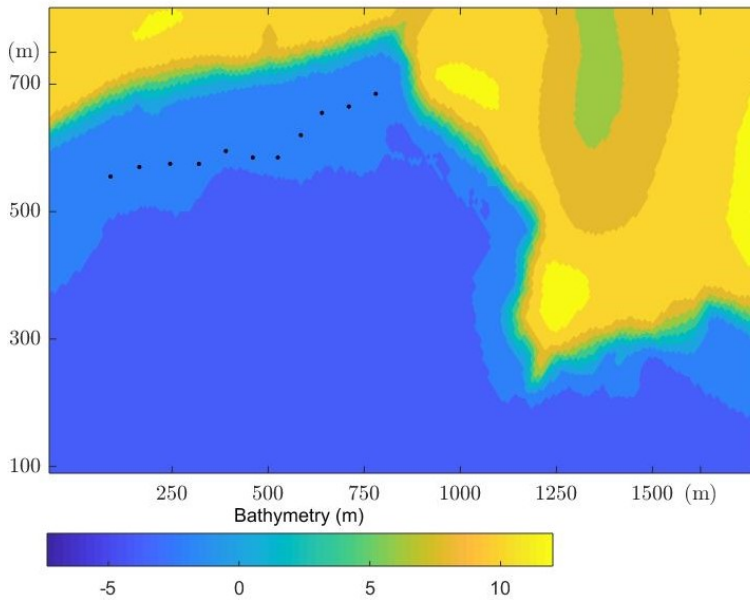
Figure 7.6: Bathymetry and point locations.
