Master Thesis
TVVR 21/5015

Hydrological assessment and water management study in Norra Bunn

With a focus on fish stock conservation

Master Thesis

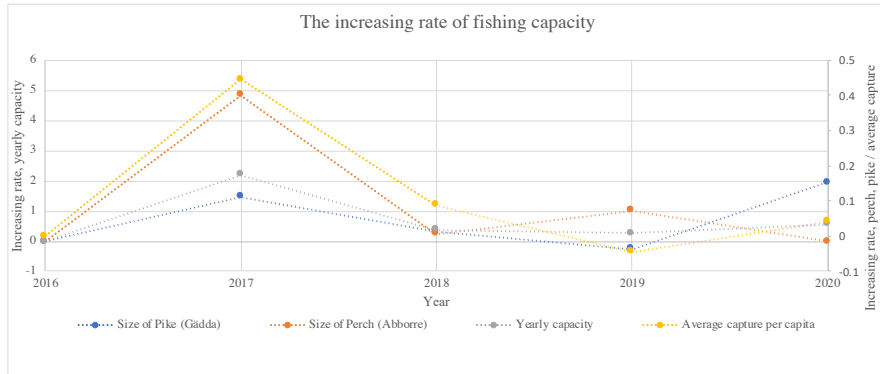
Figure 3: The increase of fish catches over the years (2016 to 2020)

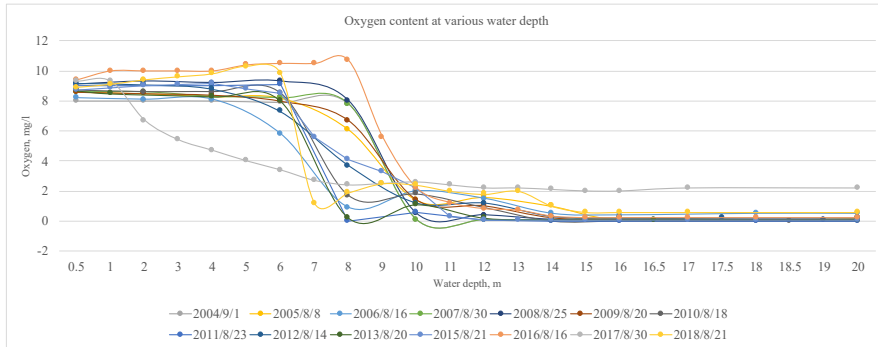
Figure 11: Oxygen content at different depth from 2004 to 2018.

When looking deep into the oxygen condition at different depth over years from 1999 to 2018, a rather similar pattern can be observed as shown in figure 11:

All the samples were taken during the summer where water temperature was in average 13.13 °C and ranging averagely from 18.11 to 7.23°C at different depth. It is obvious that the dissolved oxygen in water dropped significantly after 6 to 8 meters and with a reduction of 96.17% in average (from 8.79 to 0.34 mg/l), i.e., from the depth of 0.5m to the deepest sampling points. While year 2017 is an exception where oxygen content only dropped to around 2.2mg/l after 10 meters and the oxygen content stayed rather stable.

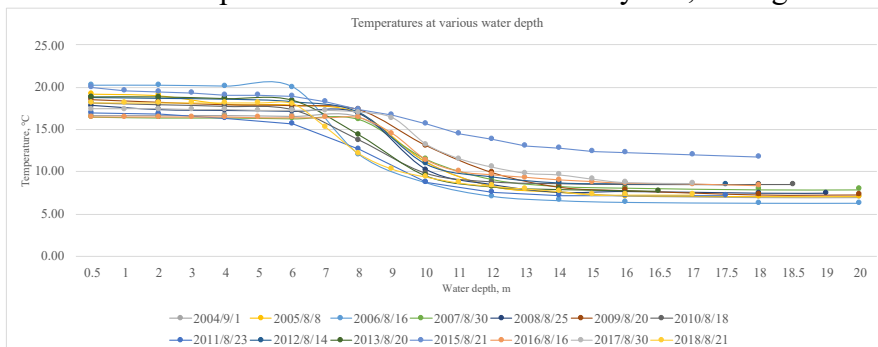
Figure 12: Dissolved oxygen at various depth vs. different temperature from 2004 to 2018

Subsequently, the oxygen content at different depth was compared with water temperature taken at the same time and depth, though there was no significant difference of the water temperature variation with depth in 2017 than the rest of the years, see figure 12.

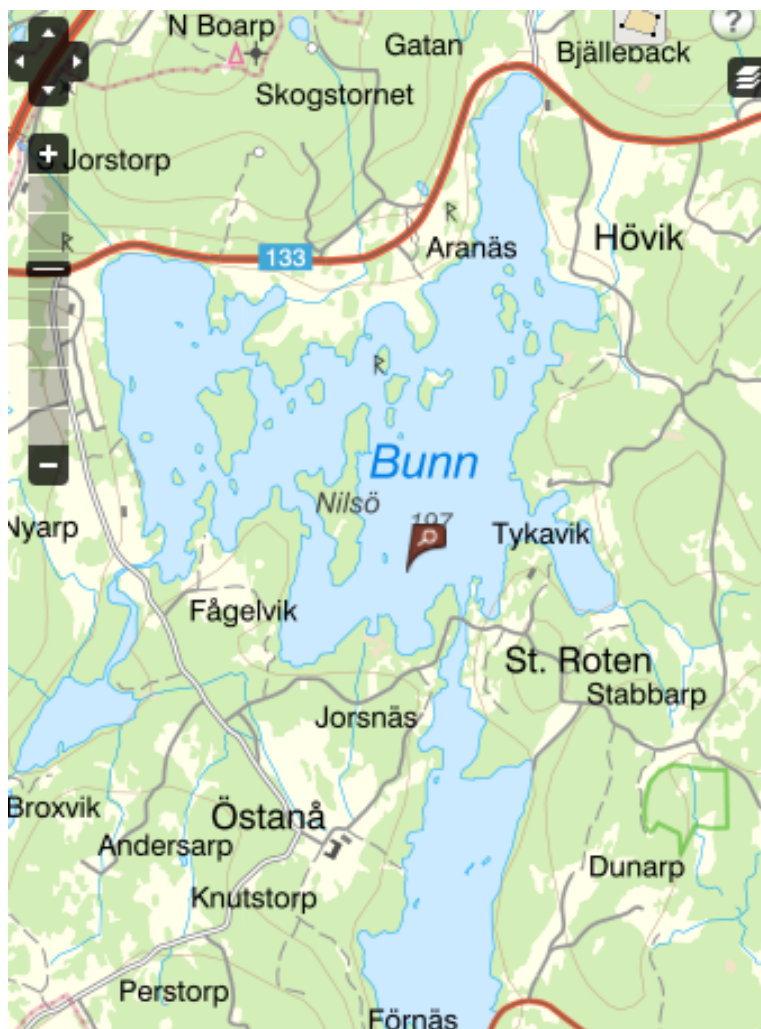
Appendix 9: Sampling point used in control program (SLU, n.d.)

Note: Sampling point is denoted by the brown flag
