Master Thesis

Floods and landslides in the Bakokwe catchment, Rwanda

Causes, consequences, and future
challenges

Division of Water Resources Engineering

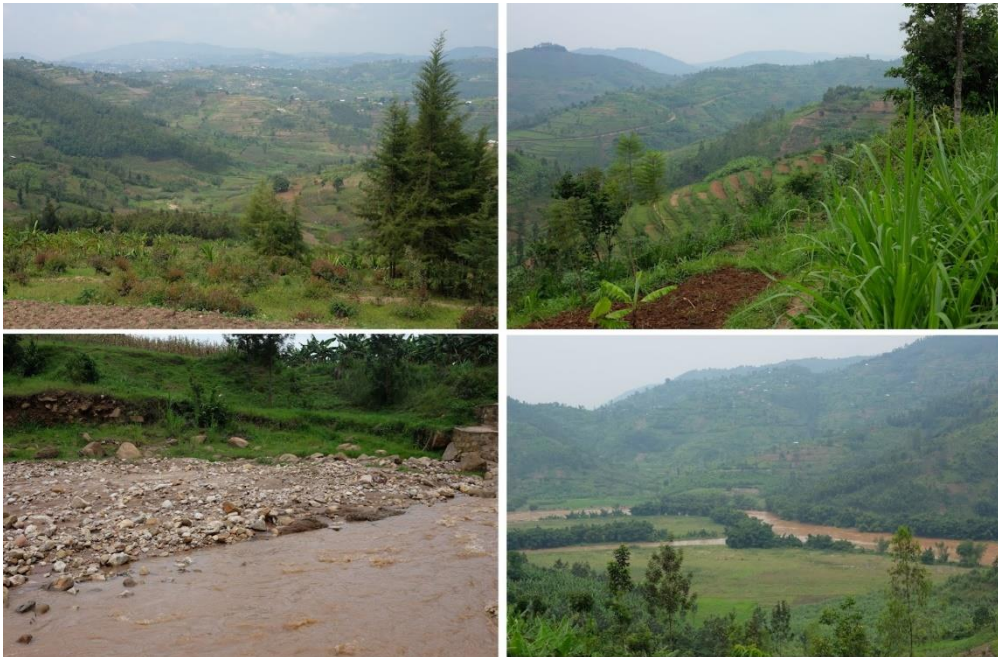
Figure 9. Pictures taken of the Bakokwe catchment during the site visits, on the 21st, 22nd of February and 1st of March 2022.

As seen in the pictures presented in Figure 9, the parts of the Bakokwe catchment that were assessed during the site visits were characterised by a hilly landscape with steep slopes and rural areas with sparse settlements. There were gravel roads connecting villages and towns with visible marks of erosion and

Observations of the site visits are presented in the following section for each of the chosen locations together with related results from the literature review. Corresponding rainfall data for each of the locations and date is also presented, from one week prior to the date of the field visit, as the calculated travel time for surface runoff in the catchment was around 2-5 days depending on distance travelled. Figure 9, shows the general patterns of land use, river appearance and topology of the catchment.

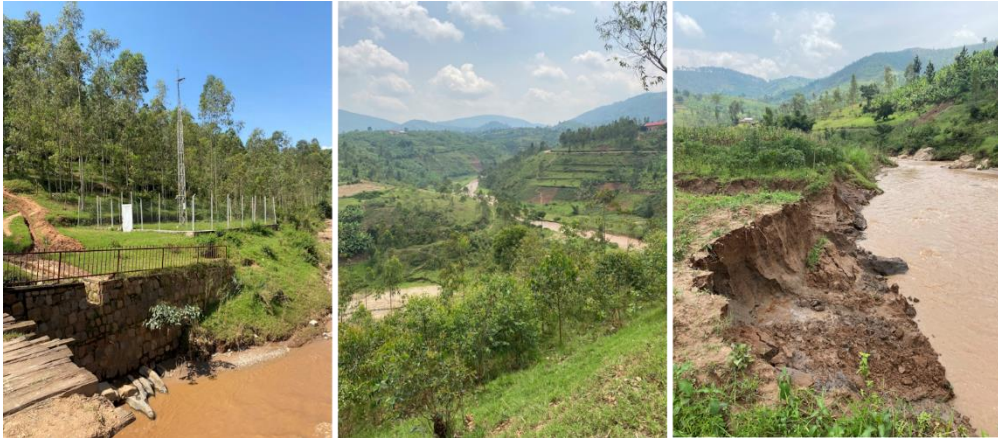
Figure 11. The Gatare river with its surrounding landscape, on the 21st of February 2022.

A crossing bridge over the Gatare river was connecting two gravel roads and had clear signs of temporary repairs. The bridge was estimated to be located 3 meters above current water level. According to local inhabitants interviewed during the field visits, the water level in the river has previously exceeded and damaged the bridge and flooded the surrounding agricultural land. There were steep slopes and extensive erosion in direct contact with the river bed. The agricultural land covering the surrounding landscape was mainly banana plantations, maize, cassava, sparse eucalyptus trees, and moderate grassland. There was a small number of terraced plantations.

The Gatare river is a tributary of the Bakokwe river and had a meteorological station located at the first observation point, in Figure 5 this location was indicated as point number 1 and is situated in Muhanga district. Pictures of the location are shown in Figure 11.

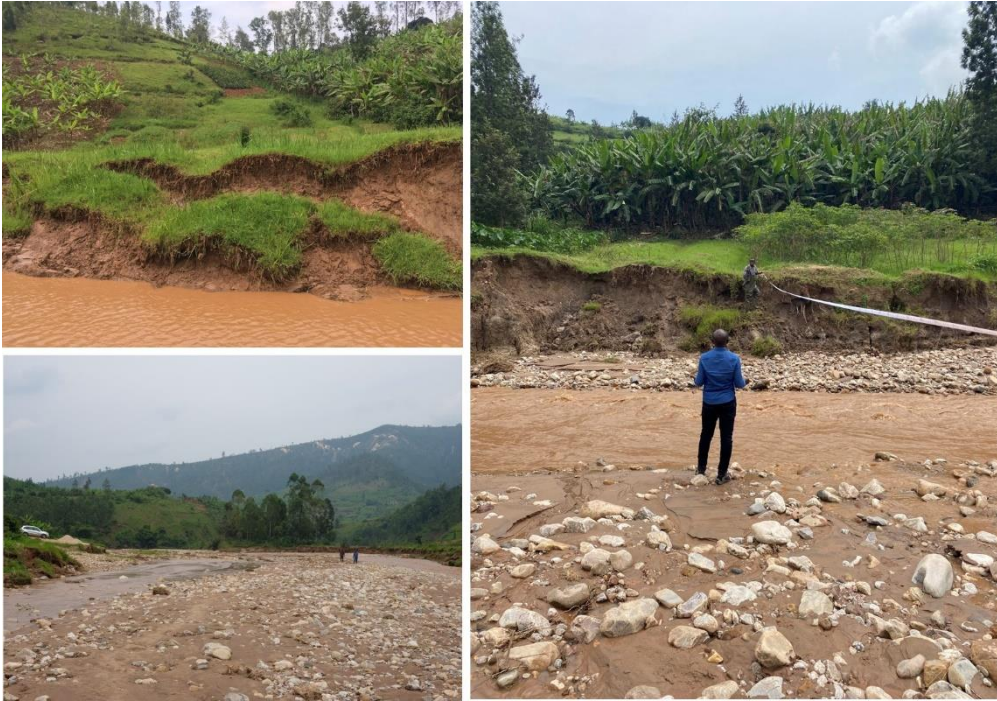
Figure 12. Photographs from the second observation point when the measurements were taken at this location on the 21st of February 2022.

Downstream the measuring point of the Gatare river, the second point of measurement in the Bakokwe catchment was situated (see Figure 10). Pictures of the surroundings of the measuring point during the measurements are presented in Figure 12.

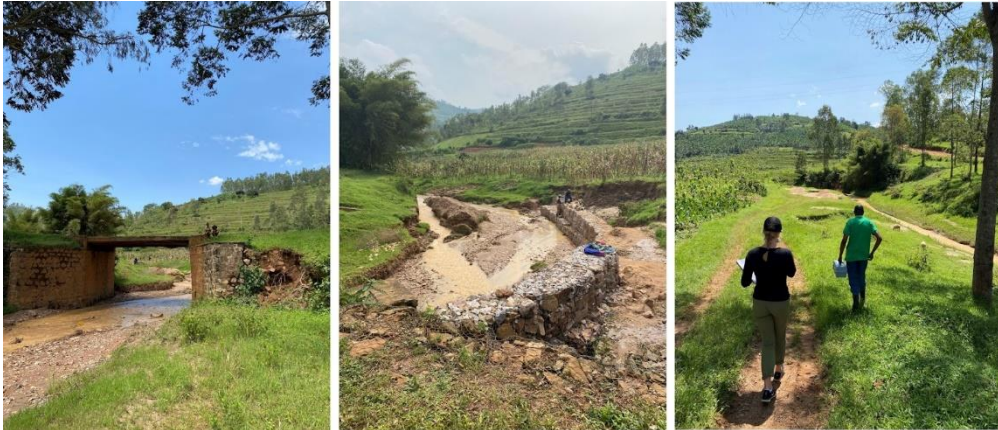
Figure 14. Photographs from the Gasayo river on the 1st of March 2022.

The Gasayo river is a narrow stream, referred to as the “dirty river” in the area and was by the time of the site visit characterised by its red and brown colour. The surrounding area upstream the bridge was steeply sloping and covered with agricultural land, mainly maize on the low lying land close to the river bed and cassava and sparse eucalyptus trees on terrace plantations. There were broken protective structures and clear signs of erosion and deposition of sediment directly upstream the bridge, which can be seen in Figure 14. The bridge was estimated to be situated 3 meter above water level at that time. Downstream of the bridge, low lying crop land with cassava, maize and grassland was grown close to the river which can be seen in Figure 14.

The fourth location of observation was chosen to be close to a bridge crossing the Gasayo river, which is a tributary to the Bakokwe river, and is located in Muhanga district. Pictures taken at this location are shown in Figure 14.

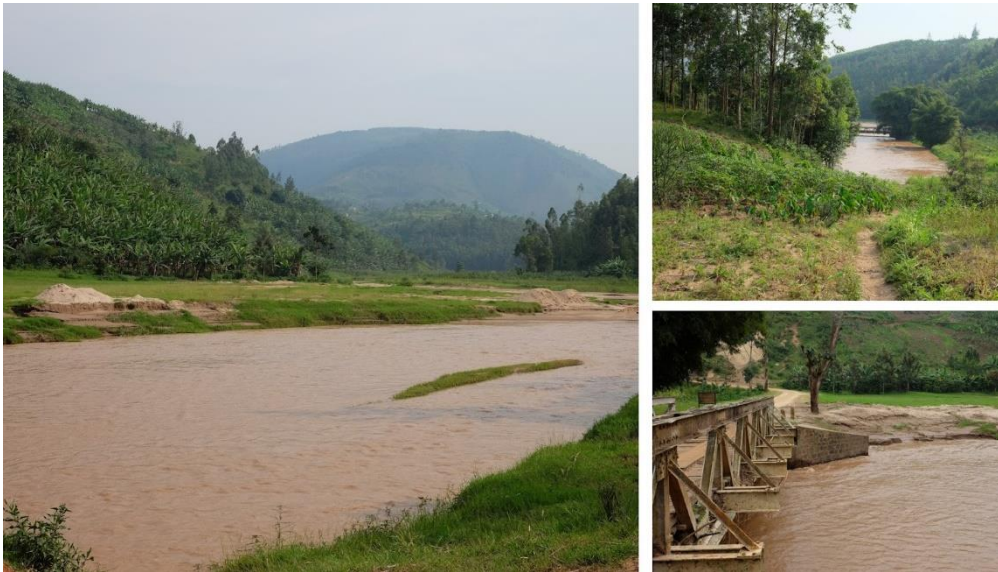
Figure 15. Photographs of the Bakokwe river and the bridge crossing it, pictured from different angles, on the 21st and 22nd of February 2022.

Close to the outlet of the Bakokwe river into the Nyabarongo river is a bridge which was chosen as the fifth location for measurements and observation. This location is situated just on the border between Muhanga and Kamonyi districts. In Figure 15, pictures of the location, the Bakokwe river and the bridge at this location can be seen.

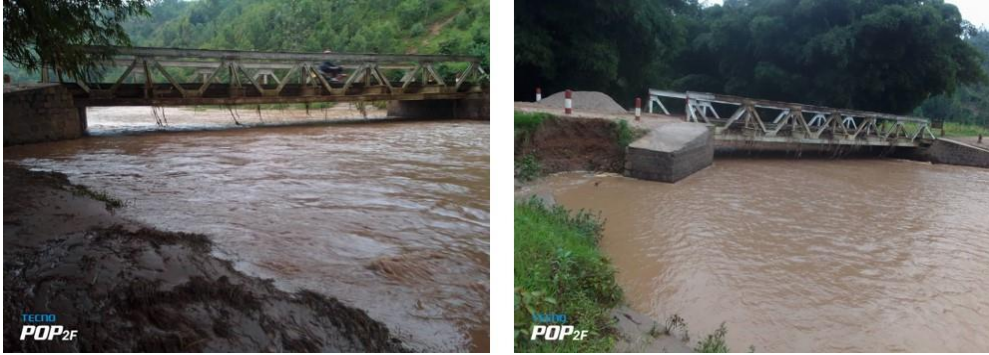
Figure 16. The Bakokwe river and bridge the 25th of February 2022 (pictures from local resident, 2022).

Pictures were taken on the 25th of February, 22nd of March, 3rd of April and on the 16th of April 2022 by one local resident. The width of the river, just under the bridge, was assumed to be constant and was the point where the discharge was estimated. This assumption was considered valid during all dates that pictures were taken. The velocity was also considered to be constant at all reported events. In Figure 16, the pictures taken on the 25th of February 2022 are shown. The water level was estimated to be one meter below the bridge based on the observations of the pictures.

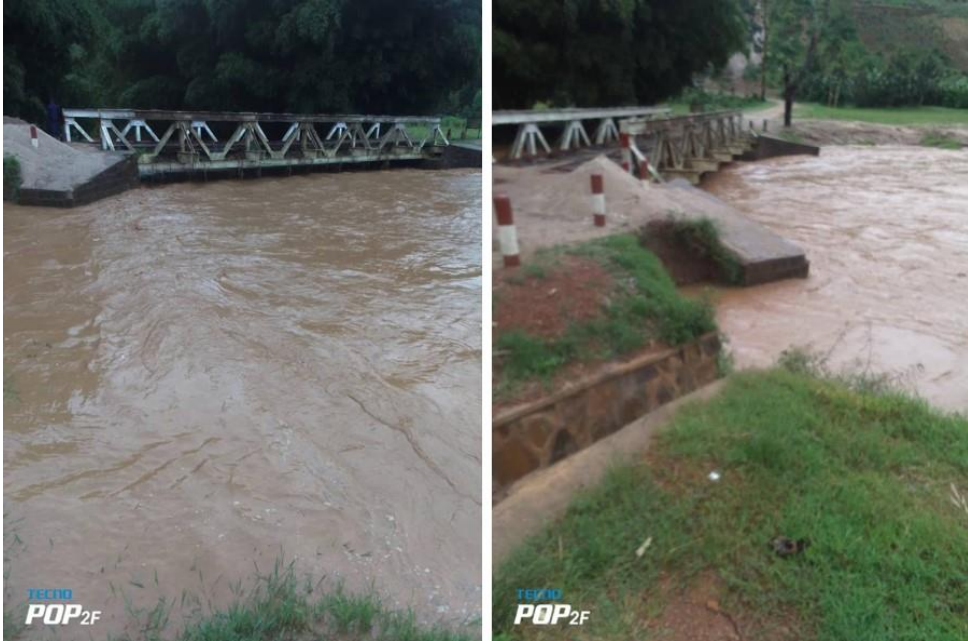
Figure 17. The Bakokwe river and bridge the 22nd of March 2022 (pictures from local resident, 2022).

The bridge was close to becoming covered by the river's water surface in Figure 17. The estimation of the river depth suggests that the water level and width of the Bakokwe river, on the 22nd of March, was 1.14 and 17 metres respectively. Thus, the cross section area was estimated to be 19.4 m^2 and the flow on this day was thereby estimated to be $30.4 \text{ m}^3/\text{s}$. The normalised mean daily rainfall data, one week prior to this occasion is plotted in Figure 18.

Pictures taken on the 22nd of March 2022 are shown in Figure 17 and shows an increase in water level. The water level was estimated to be 0.4 meter below the bridge at that time.

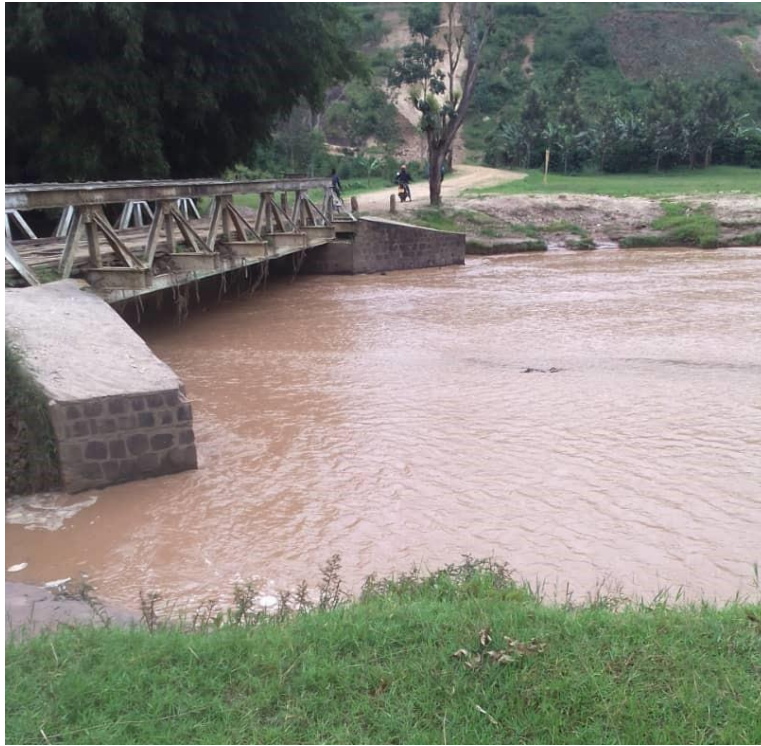
Figure 21. The Bakokwe river and bridge on the 16th of April 2022 (pictures from local resident, 2022).

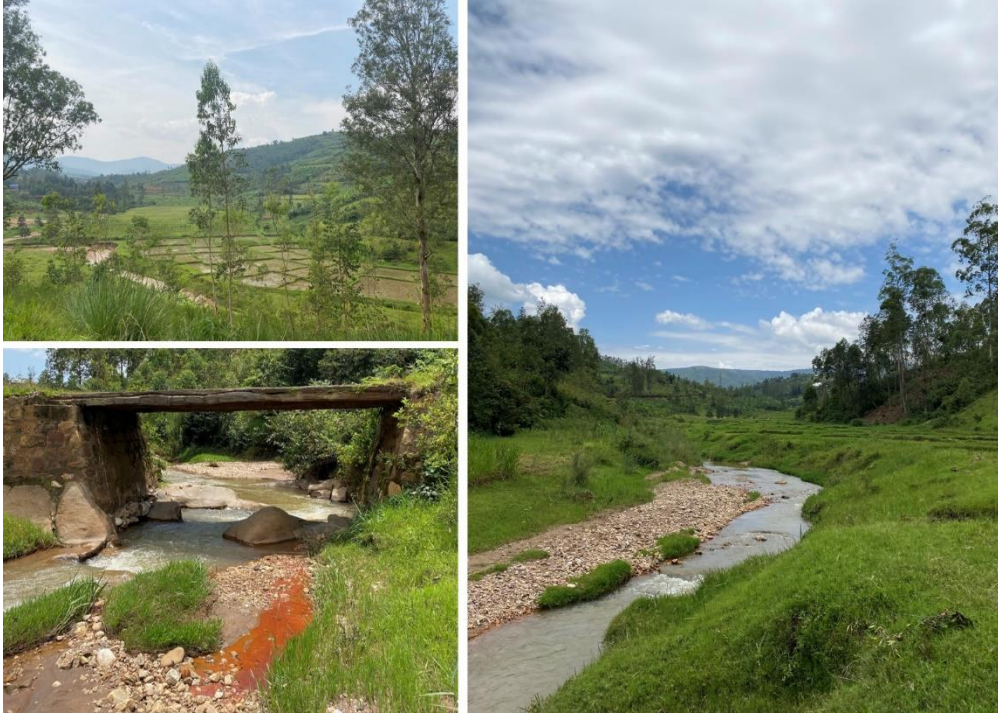
Figure 23. Photographs of the Mutumba river and its surroundings.

The sixth location for measurements and observations was a tributary to Bakokwe called Mutumba, situated in Muhanga district. This river is known as the ‘clear river’ in the area, and a clear difference in the colour of the water at the time of the site visit was observed compared to the other locations. The river and its surroundings can be seen in Figure 23.

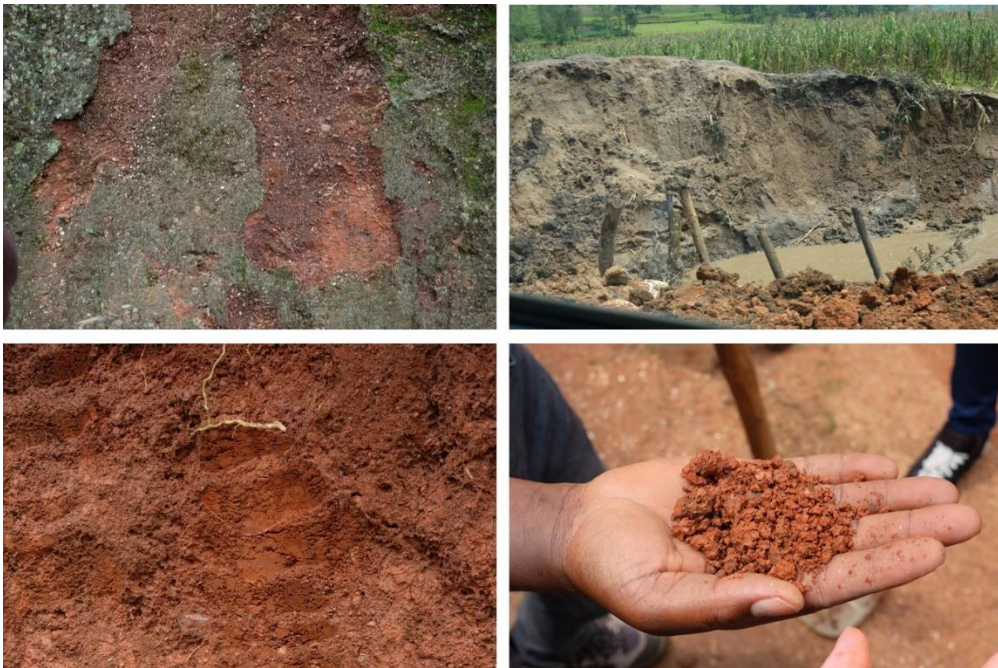
Figure 26. Soil profiles in Bakokwe subcatchment on the 22nd of March 2022.

soil erosion. The identified soil profiles in the Bakokwe subcatchment are presented in Figure 26, which show signs of erosion and soil loss.
