# Evaluation of rainfall-runoff modelling data in Sebeya Catchment, Rwanda

Recommendations for improved flood  
hazard analysis

Master Thesis

Water Resources Engineering  
TVVR-22/5018  
ISSN 1101-9824

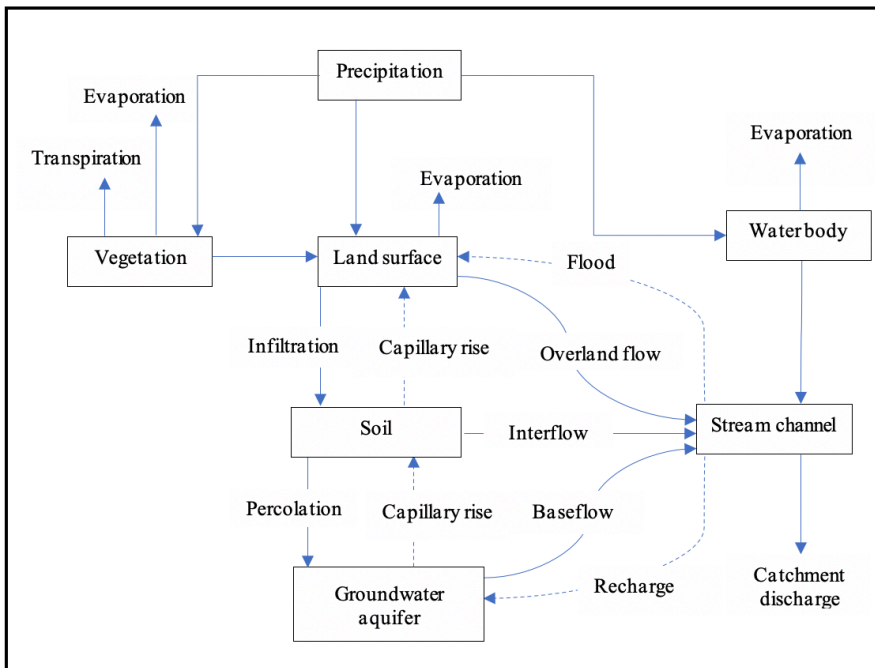
Figure 2-2 Representation of the hydrological process in a catchment in HEC-HMS. Recreated based on (USACE HEC, 2022b)

In HEC-HMS all the models are unsteady-flow models, and as differential equations are solved to describe components of the hydrological system it requires that the initial state of the system is specified (USACE HEC, 2022b). The required initial conditions depend on the specific model used but can for example be the initial state of soil moisture, the initial runoff conditions, or the initial channel flows. The boundary conditions of the models are most commonly the precipitation or upstream flow, which cause changes to the hydrological system. The models in HEC-HMS can either be event-based or continuous. The event-based models simulate a single storm which can last a few hours or up to a few days, whereas the continuous models simulate a period ranging between several days to several years. The two different model approaches differ in how infiltration, surface runoff and baseflow is treated. Event infiltration models do, for example, not consider that the soil dries through evapotranspiration and redistribution of the wetting front between storms. However, continuous models account for dry surface conditions, wet surface conditions producing runoff during and after a storm, as well as the transition between these two states. The majority of the models in HEC-HMS are event-based models. In both saturated and unsaturated conditions can the flow of water be described by Darcy's Law, see equation 1 where  $v$  is the flow per unit area,  $K$  is the hydraulic conductivity,  $\psi$  is the matric potential and  $z$  is the spatial coordinate.

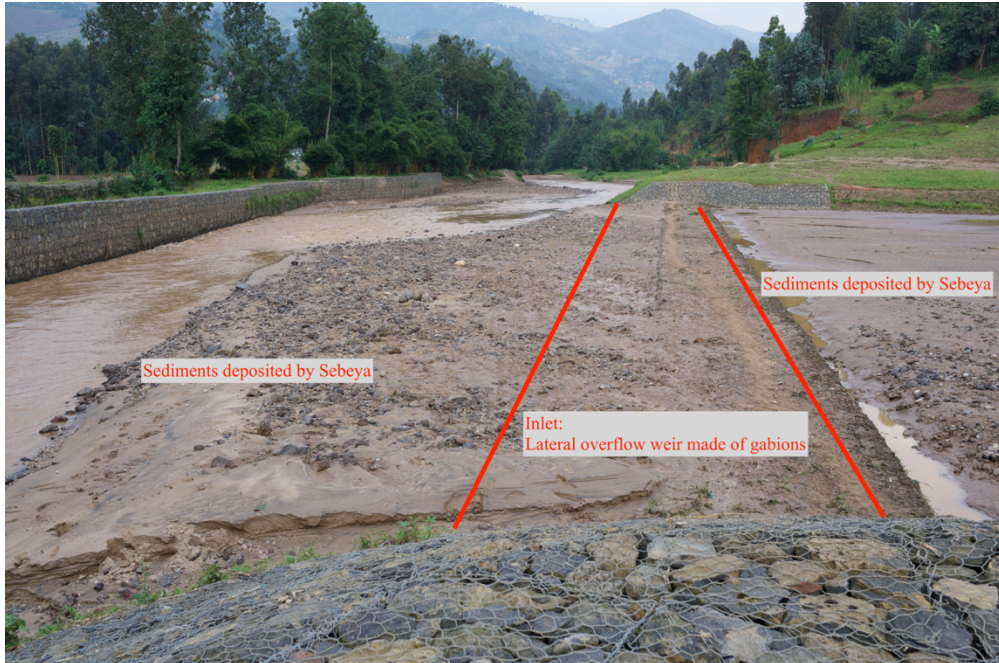
the time of the visit the dike had been completed for approximately one year and the sediment deposits were at the same level as the top of the inlet, shown in Figure 4-2. The flood retention area utilises a field, a former tea plantation, that naturally floods during high flows, seen in Figure 4-3, while the outlet is seen in Figure 4-4. The design is described in the unpublished design document by Water for Growth Rwanda (Water for Growth Rwanda, 2020a).

**Figure 4-2 Sediment deposits at the inlet of the Sebeya lateral retention dike at Mahoko.**

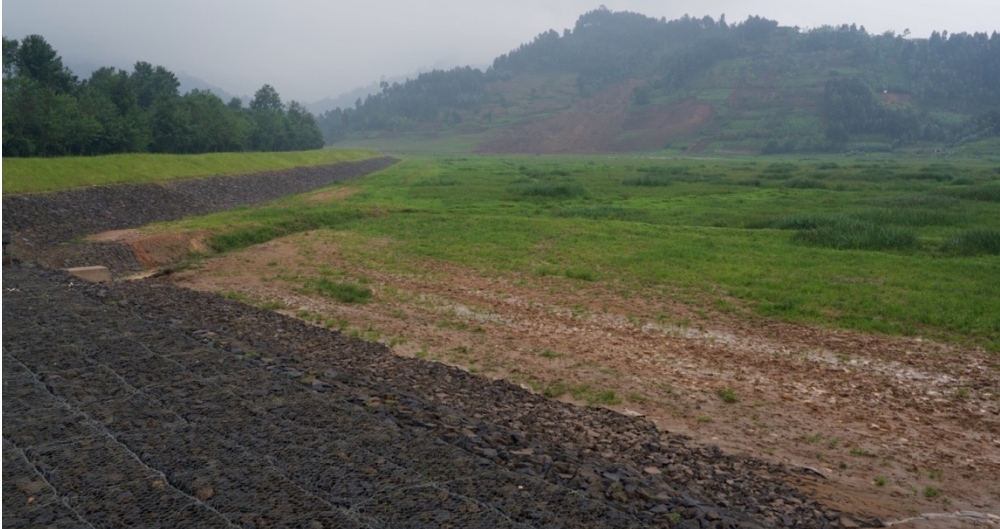
**Figure 4-3 Flood plain at Sebeya lateral retention dike.**

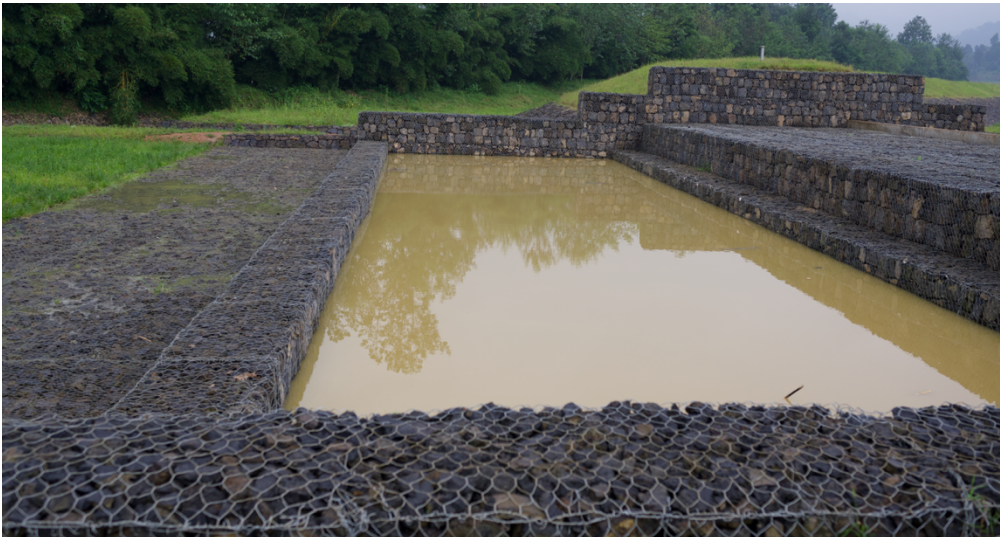
**Figure 4-4 Outlet at Sebeya lateral retention dike.**

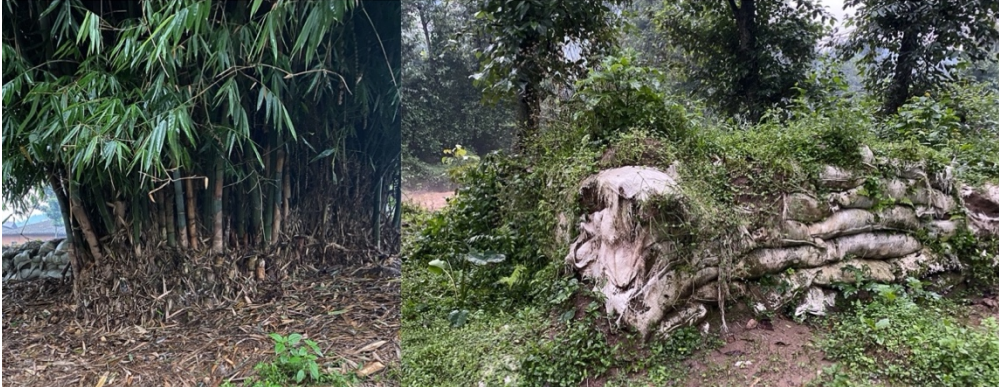
In Nyundo and Mahoko sandbags were used as flood protection. Most of them had been there for one to two years and already showed signs of deterioration, as can be seen in the right part of Figure 4-5. Bamboo is planted as the roots retain the soil and hinders it being flushed away during floods. Sandbags and

bamboos were mostly seen to protect footpaths and roads close to the river against erosion or to curb the flooding of flatter, low-lying areas. At more sensitive stretches of the river, e.g. where the river flows close to the main paved road, the embankments were reinforced by gabion retaining walls.

**Figure 4-5 Bamboo and sandbags along the Sebeya River.**

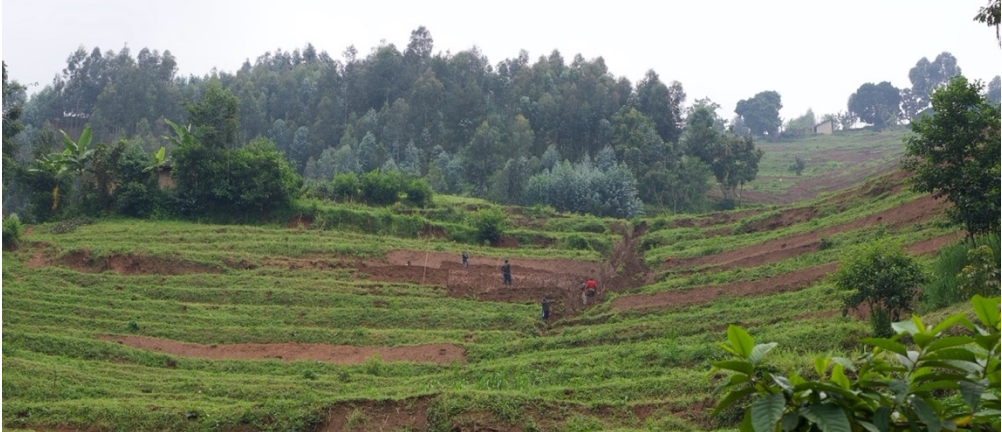
Some parts of the Sebeya River, by the villages Nyundo and Mahoko, and the Pfunda River by the confluence, had been straightened, but for the most part it appeared to follow its natural course. Smaller foot bridges are present along the river, many are made of wood and, according to residents, they were often damaged or destroyed during increased flows and floods. Following the Sebeya River upstream from Mahoko towards the Gishwati Forest, recently completed and currently constructed terraces were observed on many of the hills, see Figure 4-6.

**Figure 4-6 Terrace construction by Sebeya River.**

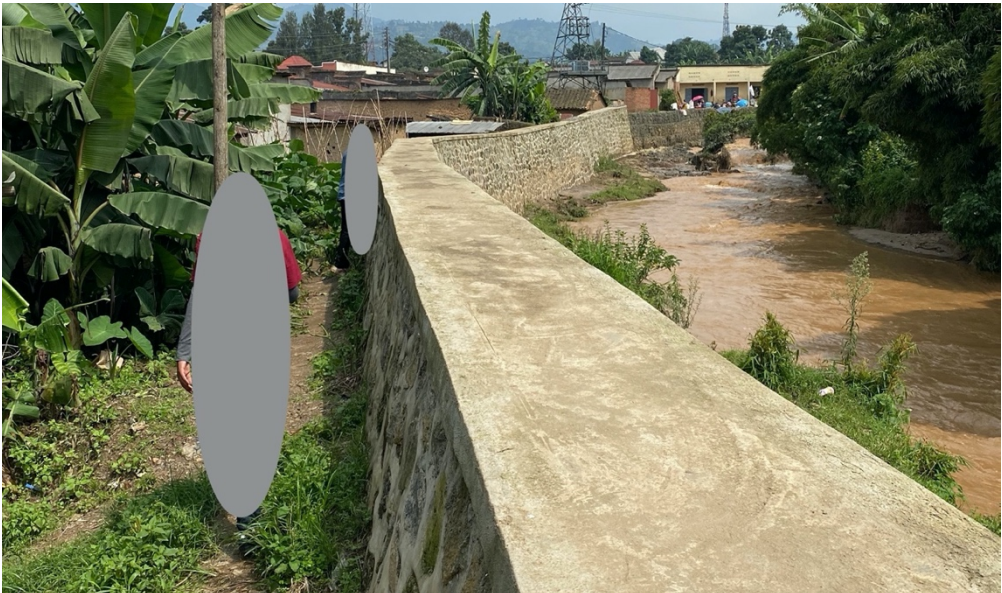
At the Karambo confluence and in Mahoko large and newly constructed retaining walls could be seen. The design of the wall at Karambo is described in the report Gisunyu-Karambo Protection Wall (Water for Growth Rwanda, 2020c). In Mahoko the retaining wall was constructed on the northern embankment of Sebeya, Figure 4-7. Most of the village is located north of the river.

**Figure 4-7 Retaining wall in Mahoko Village.**  
**In the photo grey ellipses are used for anonymisation.**

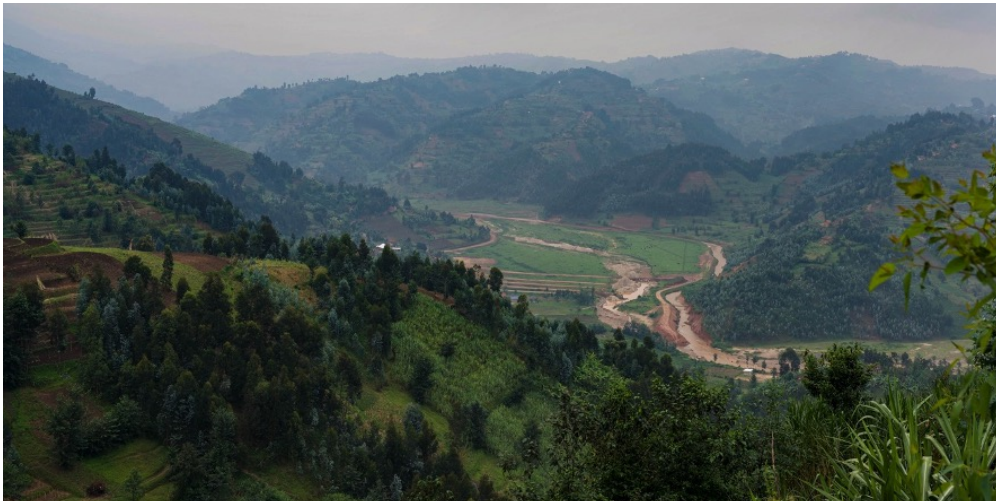
Between Karambo and Bihongora the construction was about to start on a new dam across the Sebeya River. Figure 4-8 shows the location, seen from the Rusongati Mountain and the dam is described in the report Sebeya Retention Dam – Phase 3 Detailed Design (Water for Growth Rwanda, 2020b).

**Figure 4-8 Construction site of the Sebeya retention dam.**

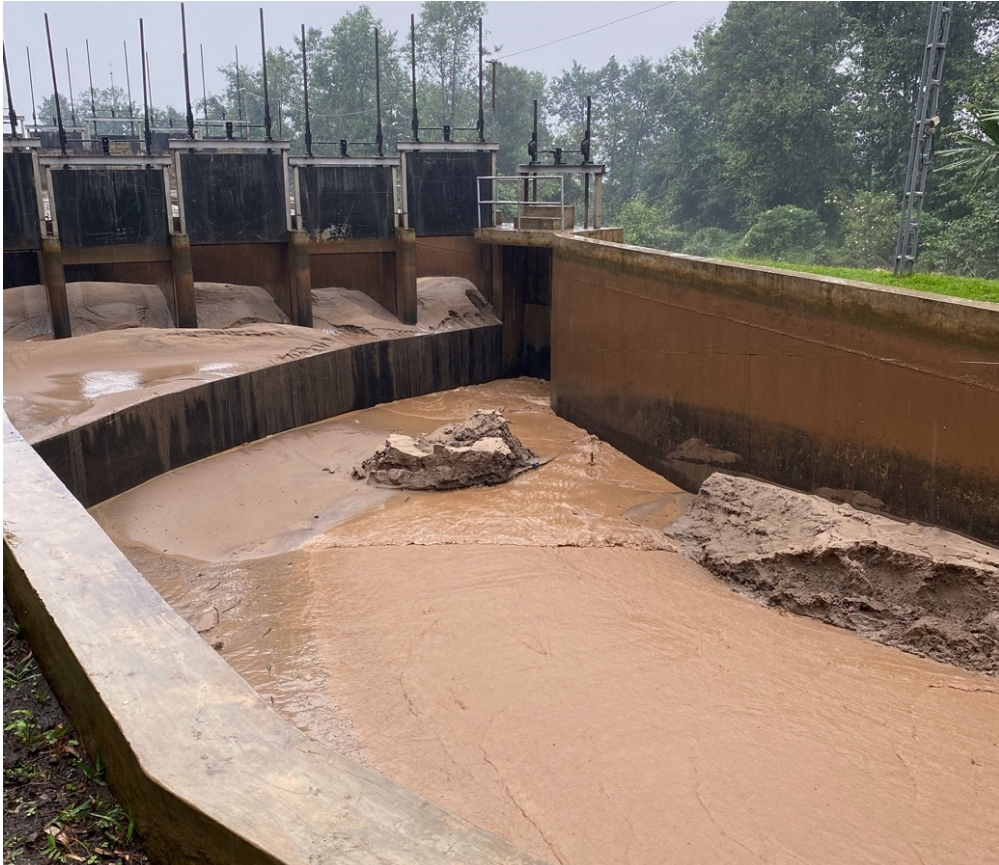
Figure 4-10 shows the power plant when it had closed its inlet to protect the turbines from the large amounts of sediments in the water and to remove previously deposited sediments. The supervisor explained that the inlet often is closed to protect the turbines.

Figure 4-10 Sediment deposits in HPP channels.

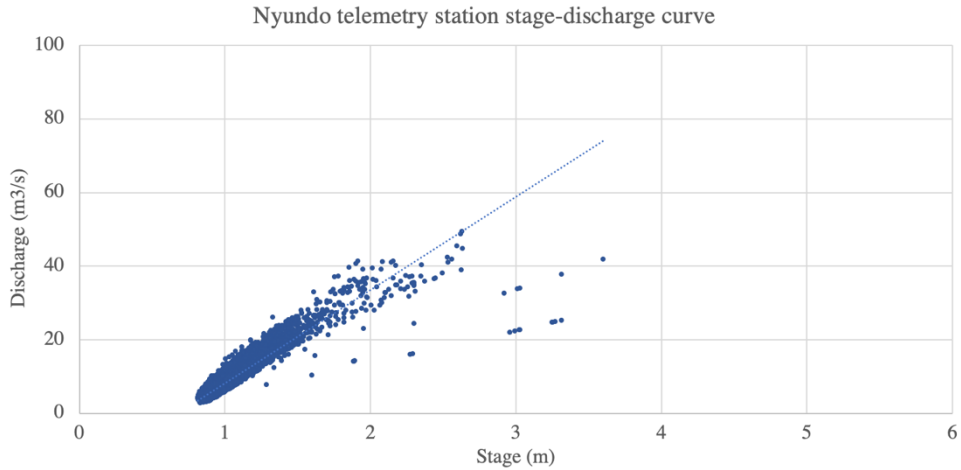
The telemetry data from the Nyundo station showed good correlation between the stage and discharge, the data recorded between 1<sup>st</sup> of August 2020 and 29<sup>th</sup> of November 2021 has a correlation of 0.90, illustrated in the scatter plot in Figure 4-12. Note that the trendline does not intercept the origin, as would be expected.

**Figure 4-12 Scatter plot of stage and discharge for Nyundo telemetry data.**

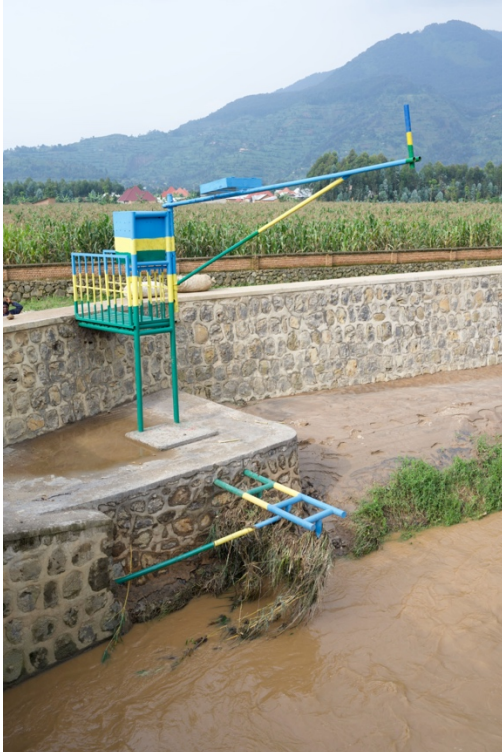
The Nyundo telemetry station is located along a stretch of the Sebeya River with stone retention walls. When comparing the area observed during the site visit to the photos in the design document for the lateral retention dike (Water for Growth Rwanda, 2020a), it can be seen that the cross section and sides of the river has changed during construction of the dike. The construction of the dike occurred between 2020 and 2021, the same period as the telemetry data were recorded. Thus, the river profile could have been altered and it is unclear if this has affected the discharge data. The outlet of the retention dam is located closely upstream of the measurement station and is likely affecting the readings. Furthermore, as the station is located just upstream of a bridge, this could cause backwash effects on the stage, and it is not clear if the data is calibrated for those effects.

**Figure 4-13 Nyundo telemetry station.**

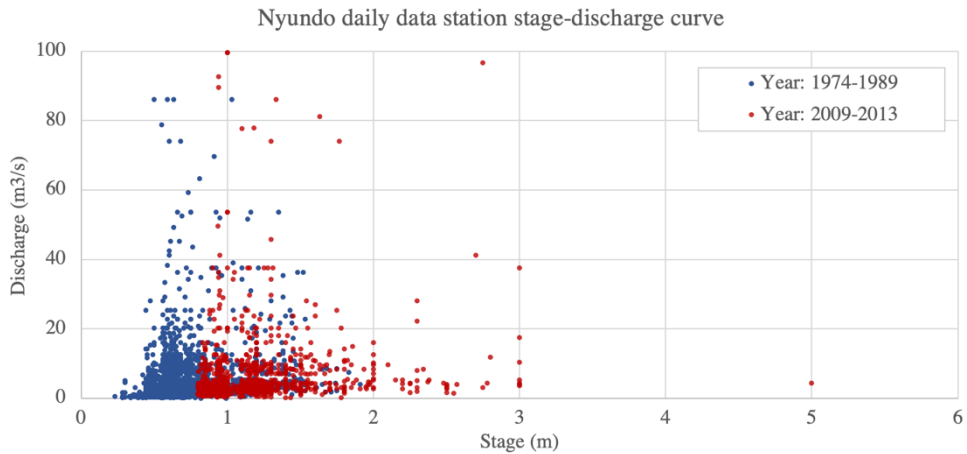
For the other station in Nyundo – the Nyundo daily station – the correlation coefficients between the stage and discharge values obtained are low – 0.24 for the data from 1974 to 1989 and 0.14 for the years 2009 to 2013, illustrated by the scatter plot in Figure 4-14. Thus, the data from the Nyundo daily station is not considered to not be reliable for rainfall-runoff modelling.

**Figure 4-14 Scatter plot of stage and discharge for Nyundo daily data.**

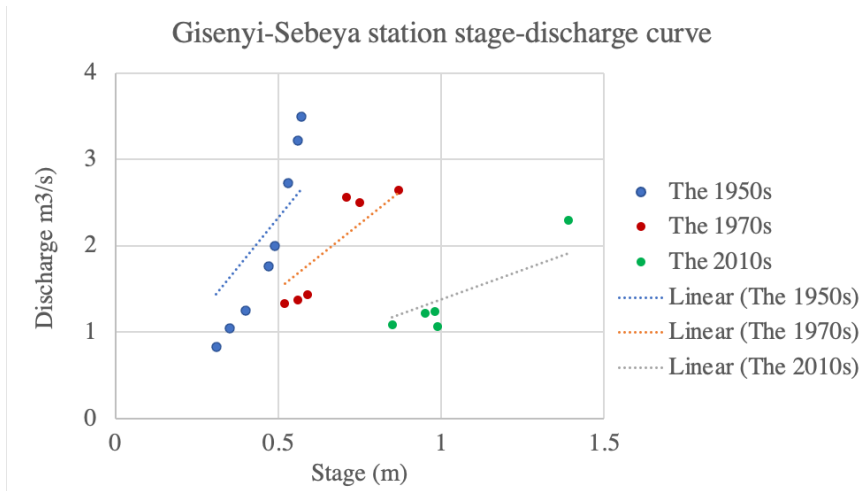
Figure 4-15 shows the stage-discharge curves for the daily data for the Gisenyi-Sebeya station. There are not enough measurements to identify any clear relationships, and it can also be observed that the relationship has changed over the course of time. This is likely due to a changing river profile, as the station was placed at a section of the river impacted by erosion, see Figure 4-16.

**Figure 4-15 Scatter plot of stage and discharge for Gisenyi-Sebeya daily data.**

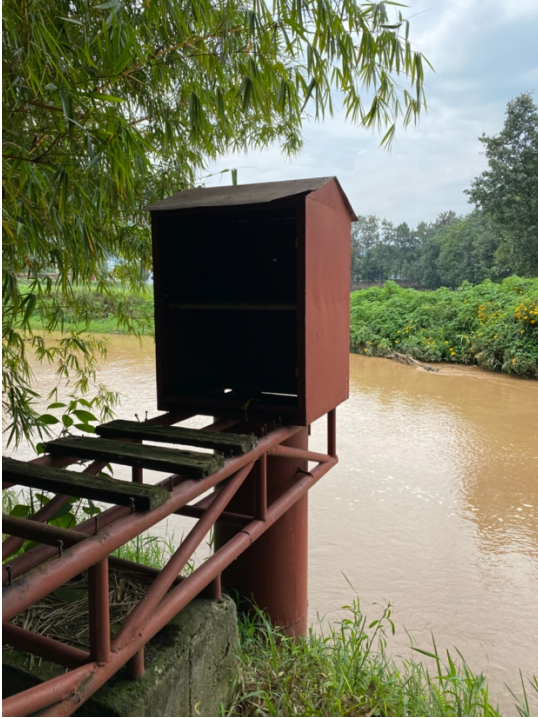
**Figure 4-16 Decommissioned station at Gisenyi.**

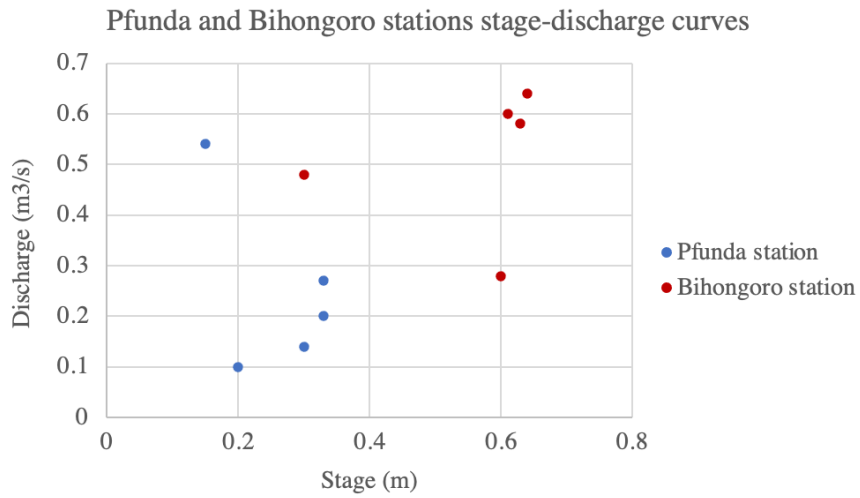
The stage-discharge measurements for the Pfunda and Bihongora stations are shown in Figure 4-17, there are too few measurements to construct reliable curves and the ranges of stage measurements is low, between 0.2 and 0.35 metre for the respective stations. Figure 4-18 shows the location of Pfunda station, it is located just upstream of a bridge. See Appendix for photos of the Karambo and Bihongora stations, both are located at locations with unstable embankments and river profiles.

**Figure 4-17** Scatter plot of stage and discharge for Pfunda and Bihongoro telemetry data.

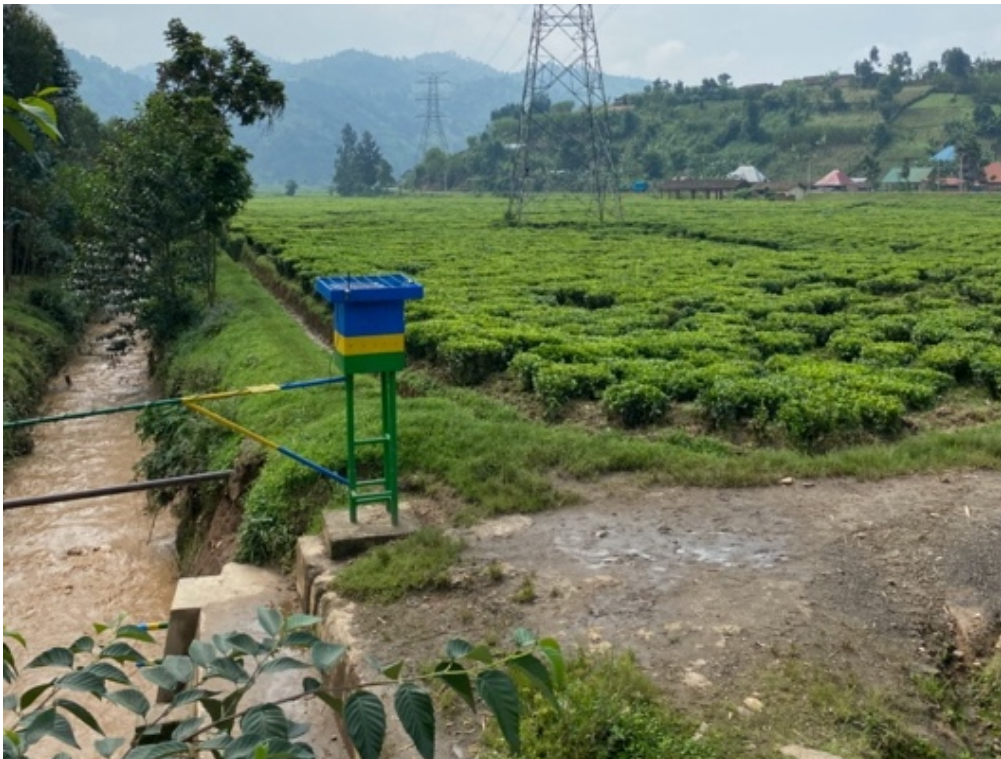
**Figure 4-18** Hydrological measurement station and tea plantation at Pfunda confluence.

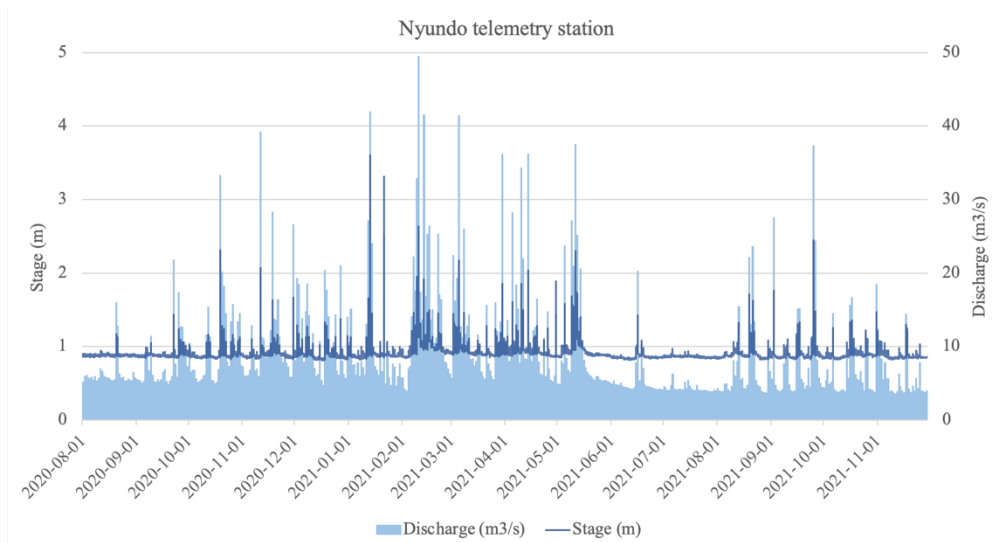
The only suitable data set to use for the HEC-HMS model was determined to be the Nyundo telemetry discharge data available from 01-08-2020 to 29-11-2021. The time series for this station is shown in Figure 4-19. Detailed data results are shown below.

**Figure 4-19 Nyundo telemetry stage and discharge timeseries.**

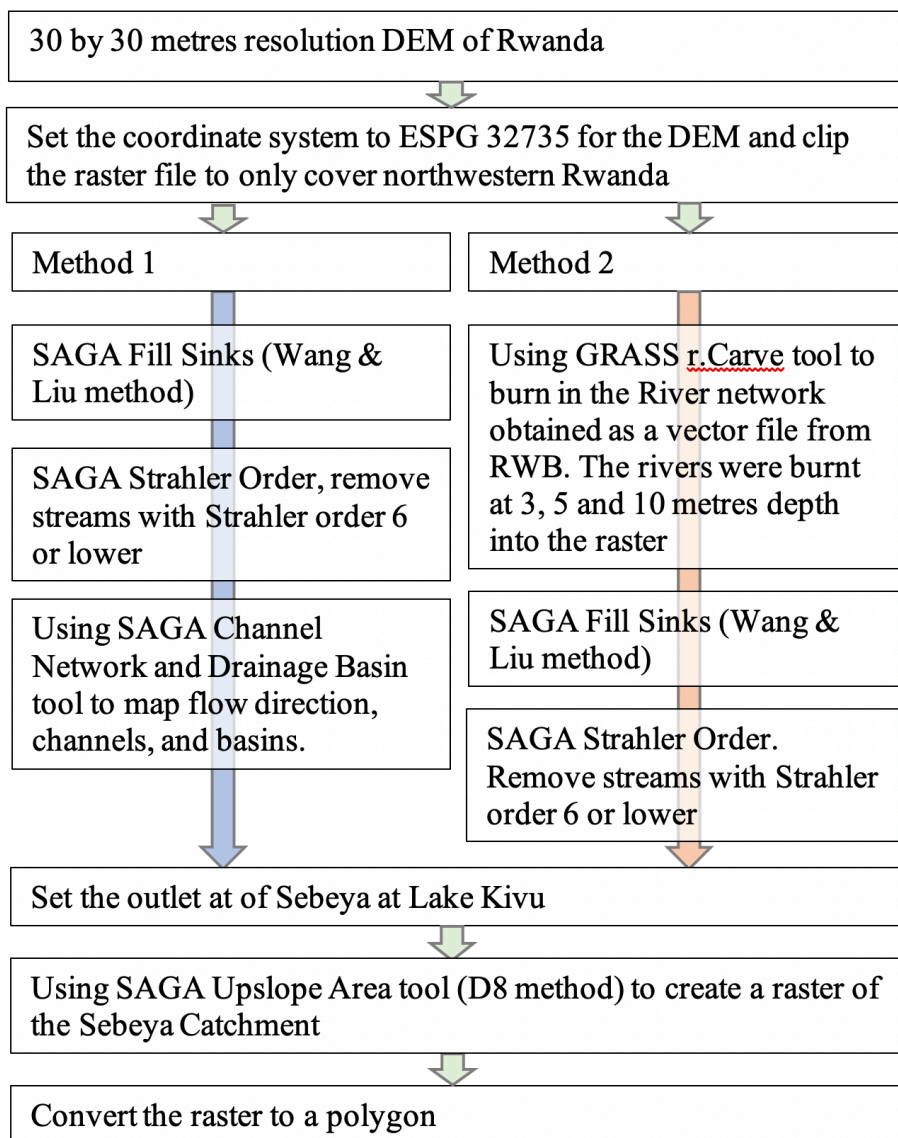
Figure A-1 Catchment delineation process in QGIS.

1. Using the SAGA toolset in QGIS to delineate the catchment using a 30 meters Digital Elevation Model (DEM30) of Rwanda.
2. Using the SAGA and GRASS toolset in QGIS to delineate the catchment using a DEM30 of Rwanda and a vector file produced by RWB containing the river network in Rwanda. The river network was “burnt” into the raster at 3, 5 and 10 meters.

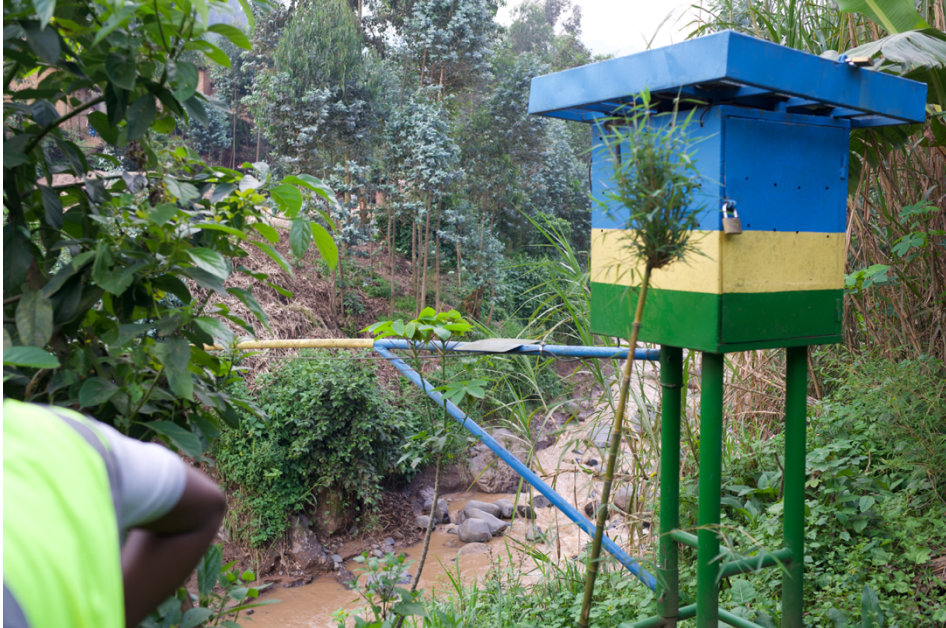
**Figure A-4 Karambo station and river profile.**

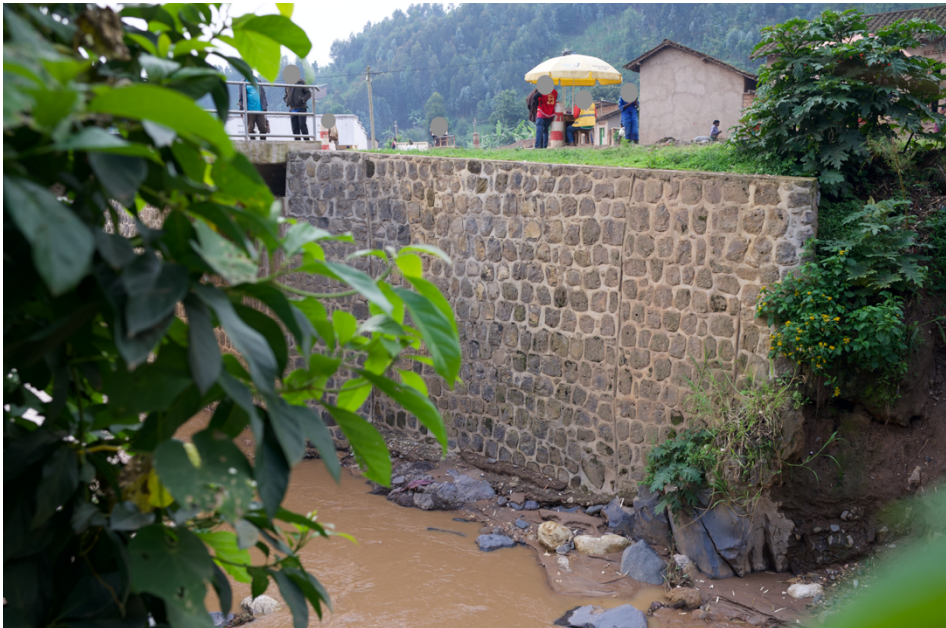
**Figure A-5 Karambo retaining wall, downstream Karambo station.**

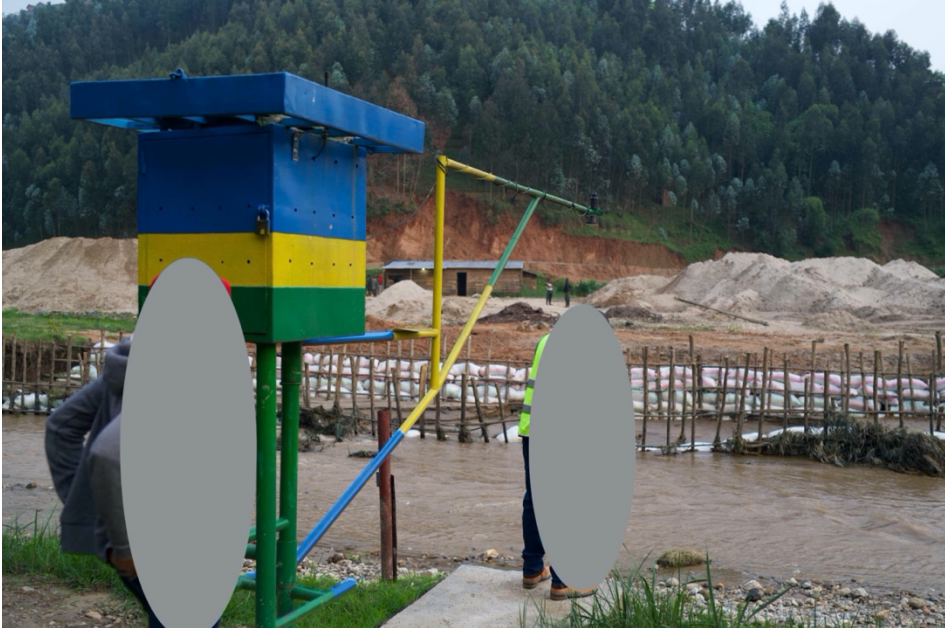
**Figure A-6 Bihongora station, river profile, and mining activity.  
In the photo grey ellipses are used for anonymisation.**
