# **Repurposing cultural heritage:**

Design proposal for the Olympic  
Rowing stadium in Helsinki

Degree project in Architecture

Lund University

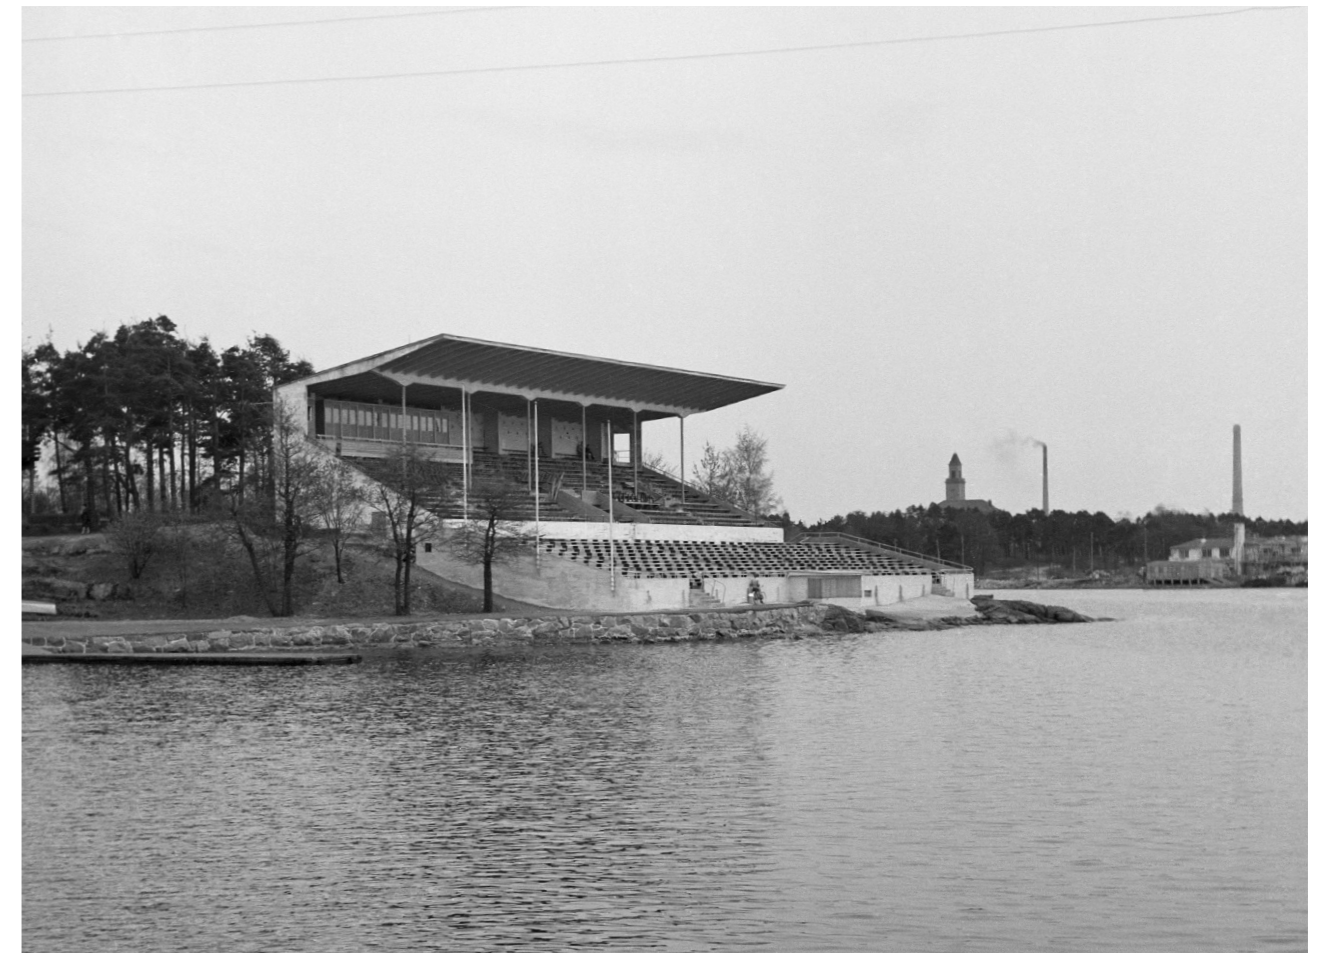
Figure 1. The Rowing Stadium with the newly completed extension. Source: Saarinen, 1952

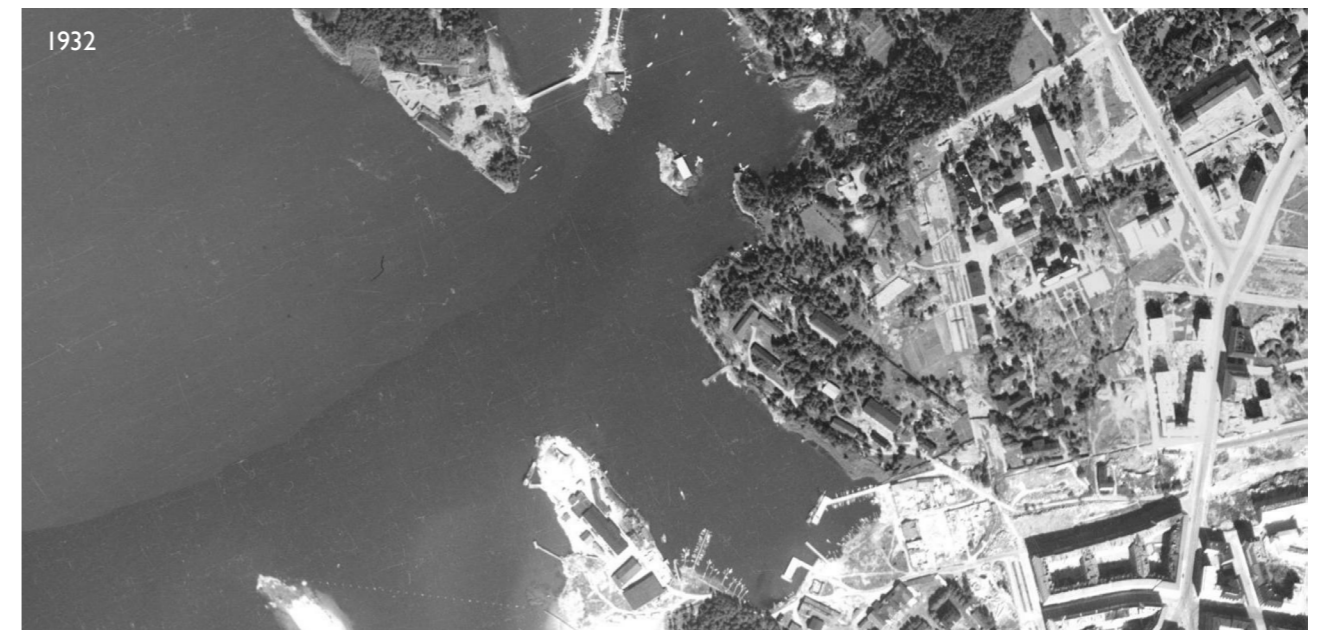
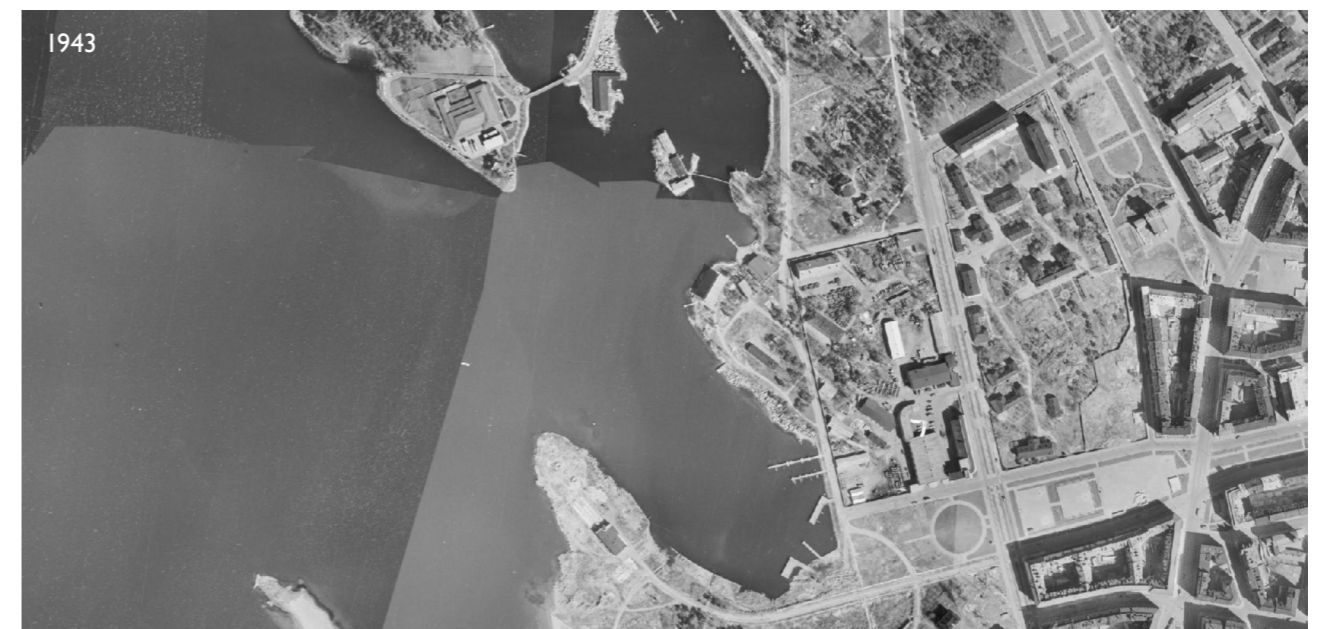
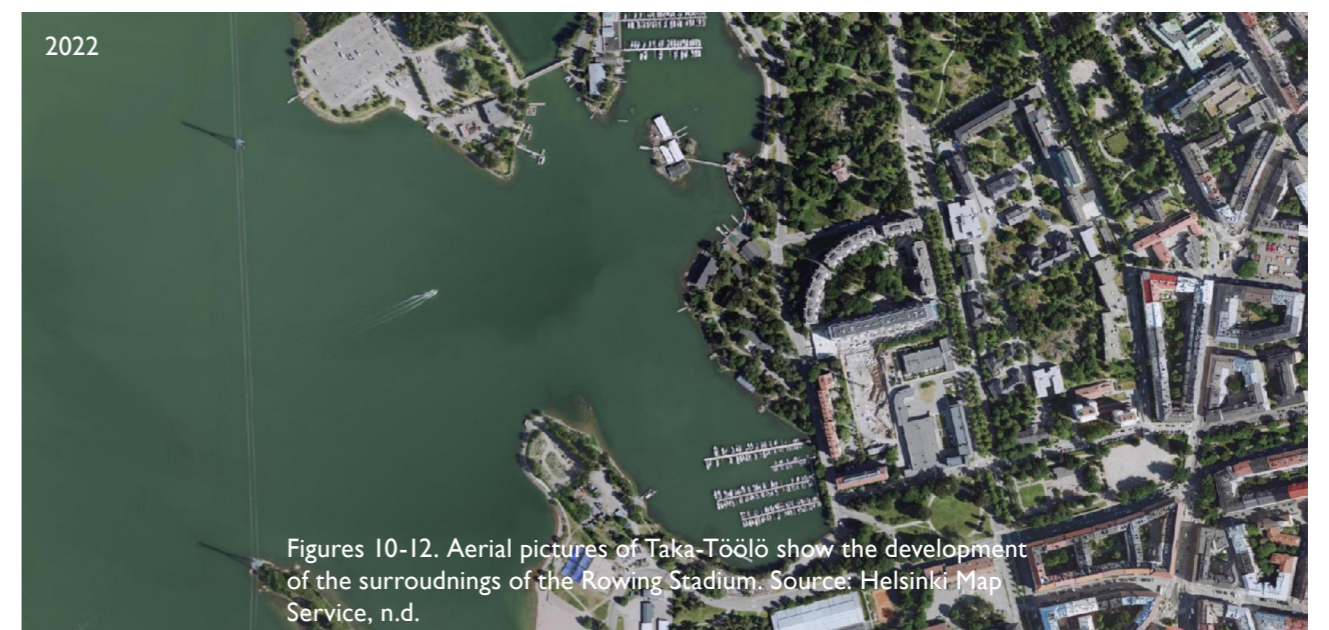
Figures 10-12. Aerial pictures of Taka-Töölö show the development of the surroundings of the Rowing Stadium. Source: Helsinki Map Service, n.d.

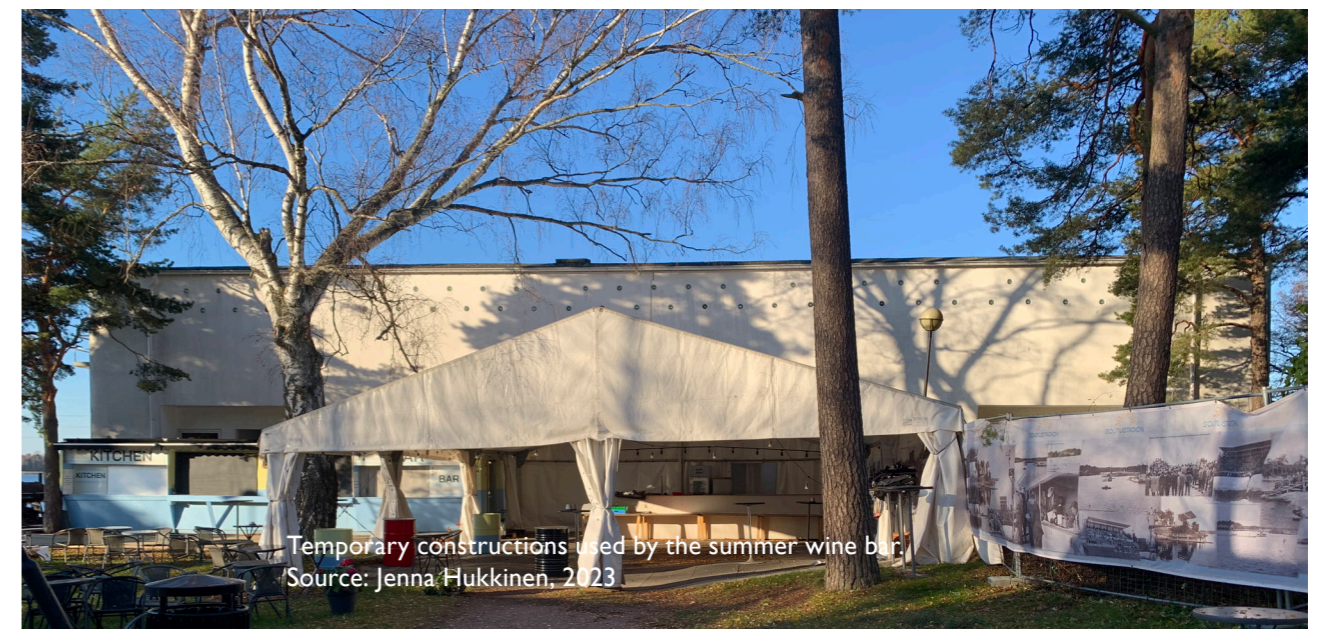
Temporary constructions used by the summer wine bar. Source: Jenna Hukkinen, 2023

Since the summer of 2022 the site has been used as an outdoor summer wine bar, not including the actual stadium building due to its condition, but constructing temporary structures for their needs.

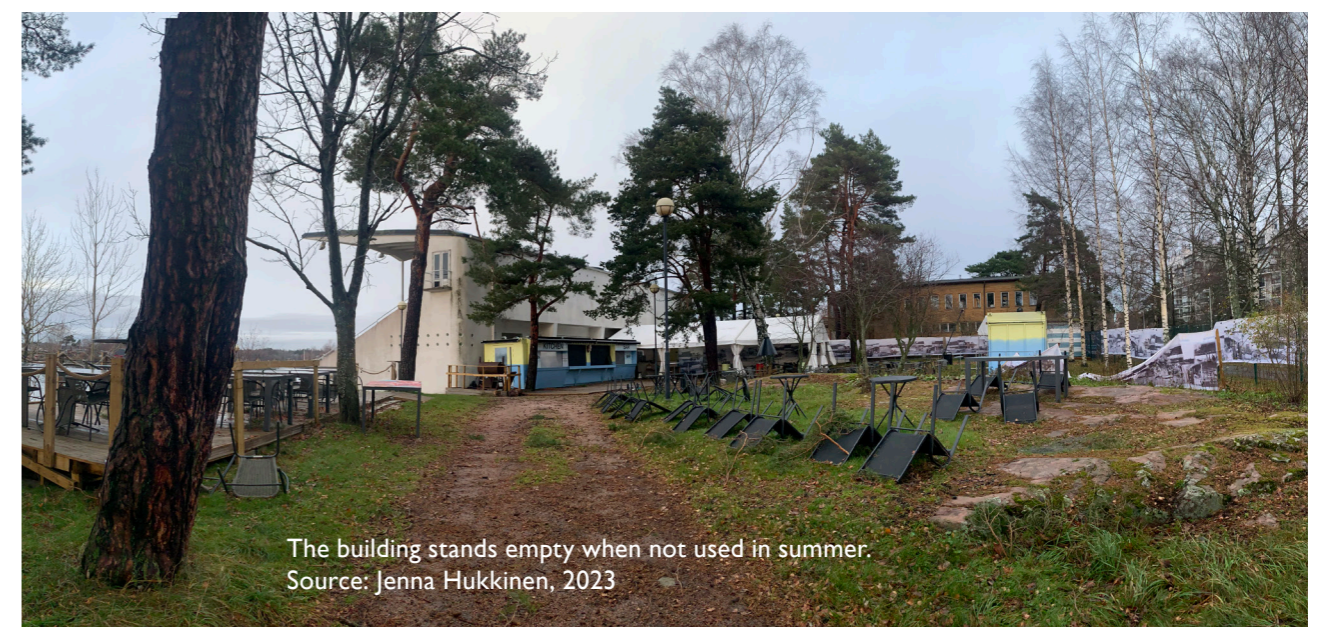
The building stands empty when not used in summer. Source: Jenna Hukkinen, 2023

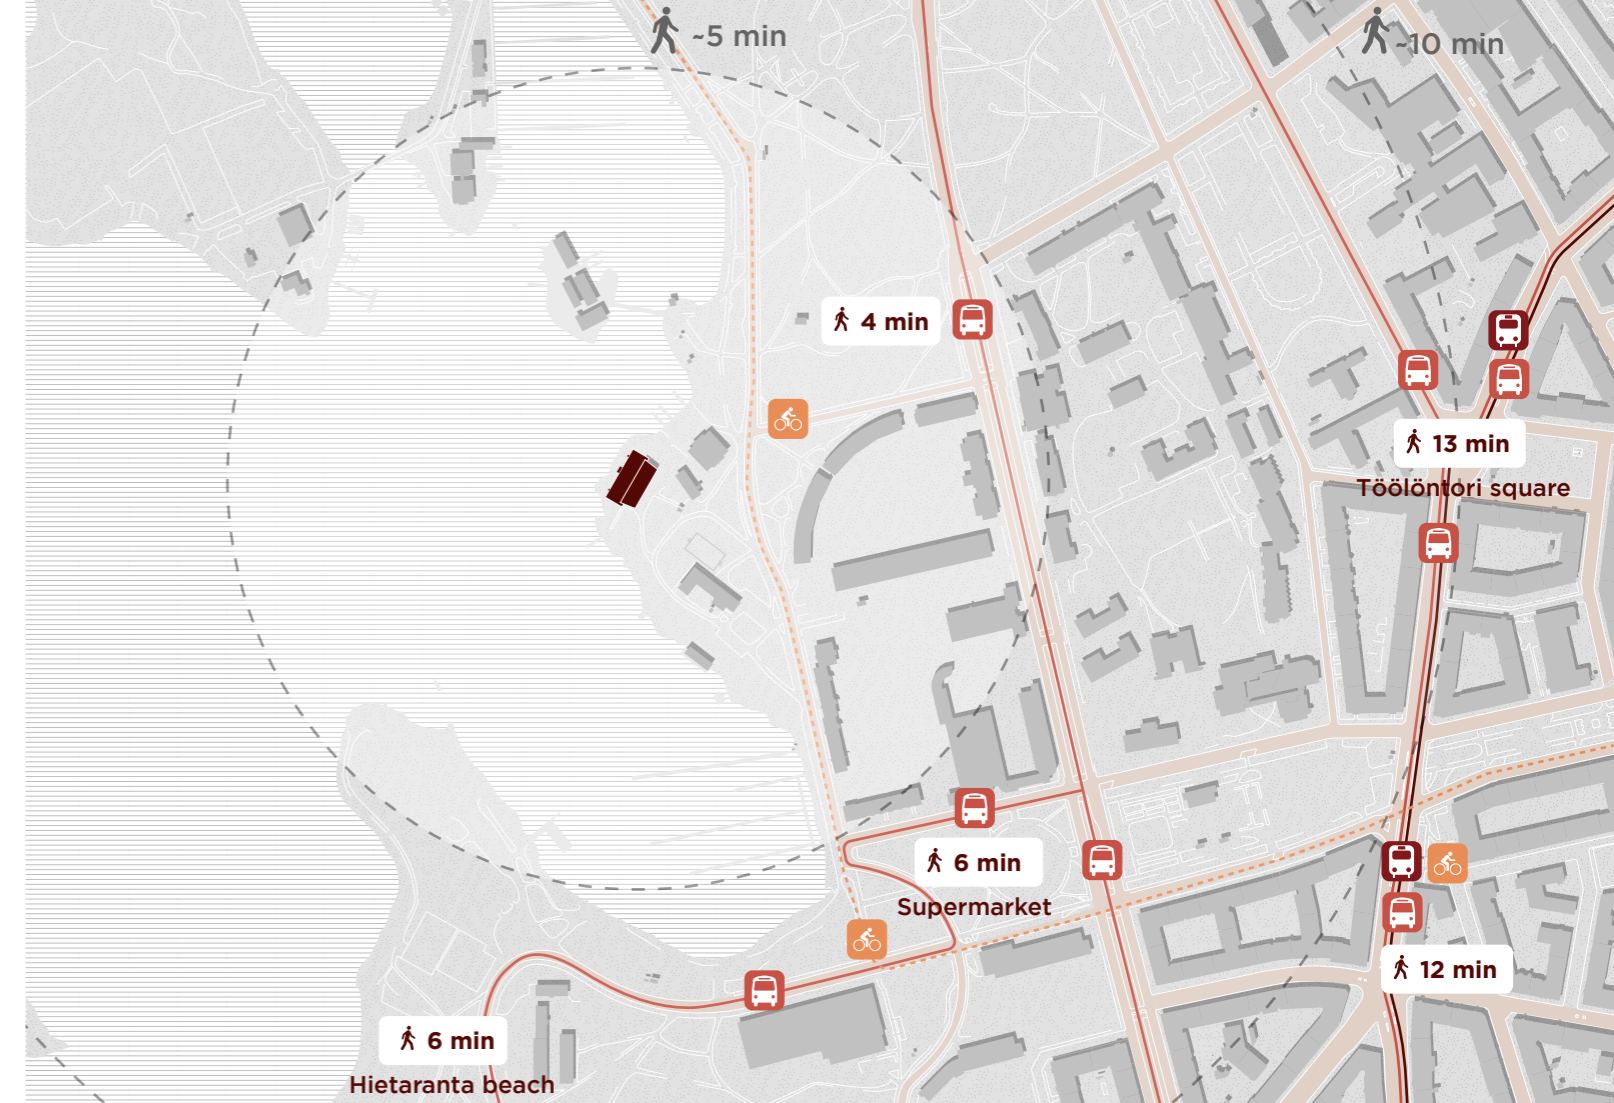
Transportation connections and walking distances around the Rowing Stadium 1:6000

The Rowing Stadium is located along a popular coastal bike and pedestrian route that forms a continuous loop around Seurasaari bay. The route is connected to a larger network of coastal routes. The bicycle route that passes the Rowing Stadium is one of the bike routes into the city center. Therefore there are a lot of commuters passing the building.

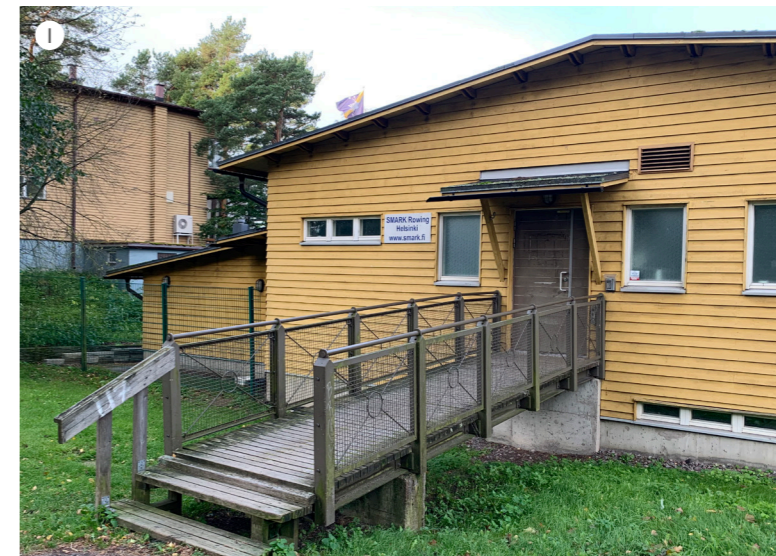
The boat house. Source: Jenna Hukkinen, 2023

When designing the Rowing Stadium architect Hilding Ekelund also designed a boathouse and a building for competition management, hereby called the administration building. The ground floor of the administration building has concrete training pools for rowing and canoeing and a shower room. The training pools are the only ones in the capital city area. On the second floor, in addition to the meeting rooms, there is a caretaker's quarters. (Högström, 1996) Today the second floor meeting rooms are rented out for events. The original boathouse was damaged in a fire in 1995 (Högström, 1996) and was rebuilt to continue to house rowing clubs which it still does today. Both of the original supporting buildings have gabled roofs and horizontally boarded wooden facades representing wooden functionalism. The kiosk was built in 1997 and reflects the other buildings in style. (Konsultointi KAREG Oy, 1997)

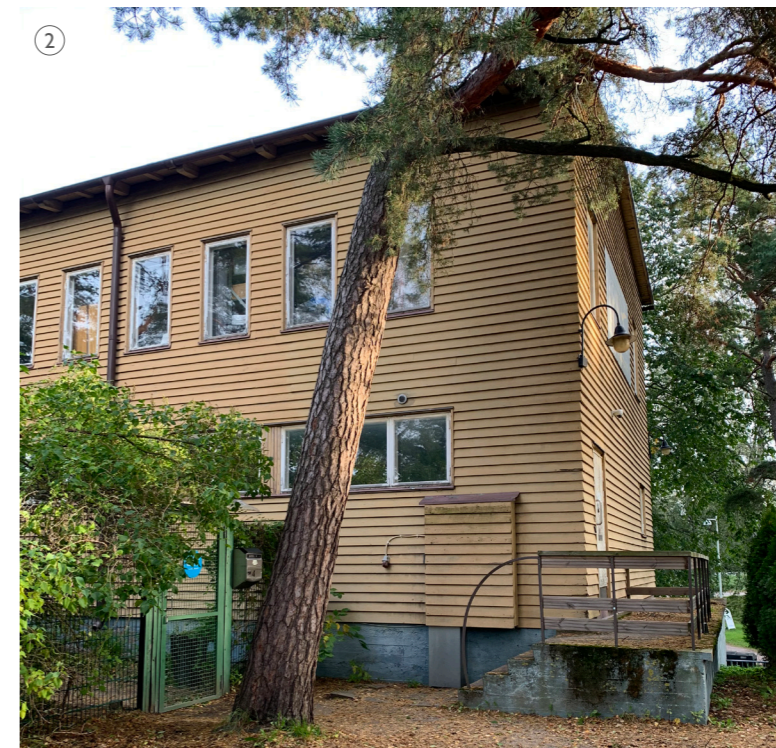
The Administration building. Source: Jenna Hukkinen, 2023

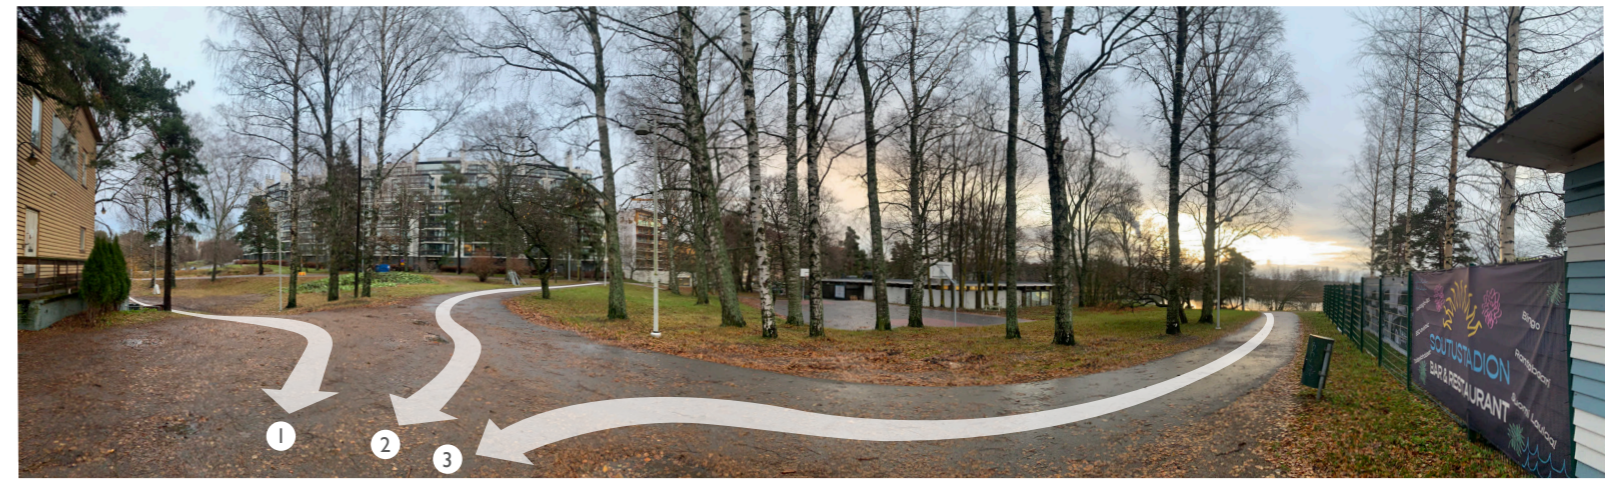
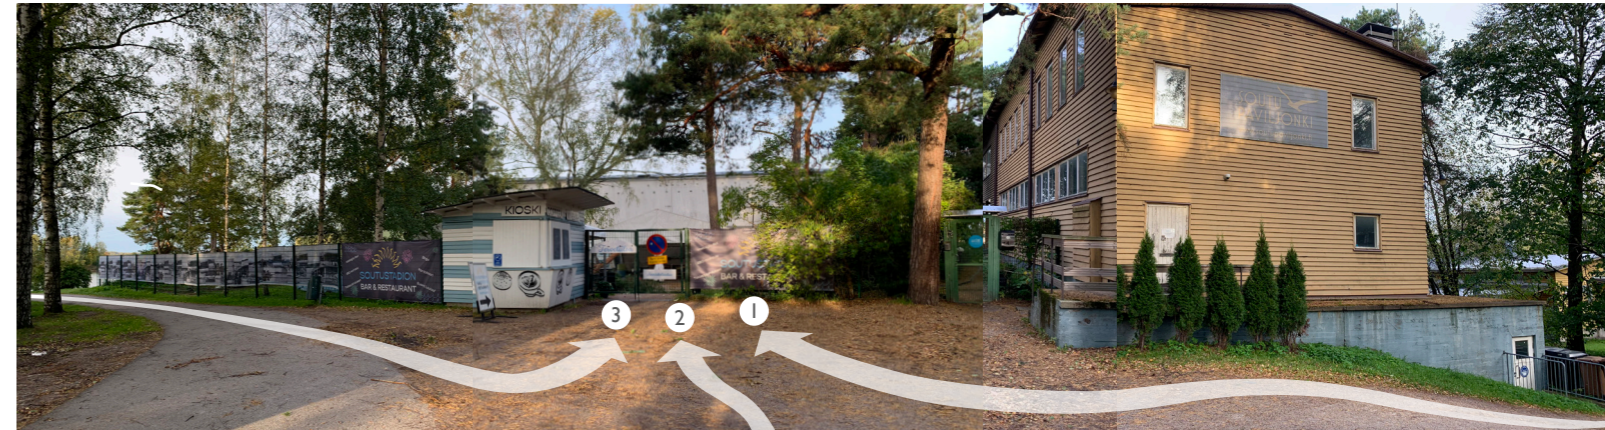
Images of the arrival to the gate of the stadium. The three arrival routes are pictured in the images above. The upper view is facing away from the stadium, and the lower view is facing towards the the stadium. Source: Jenna Hukkinen, 2023

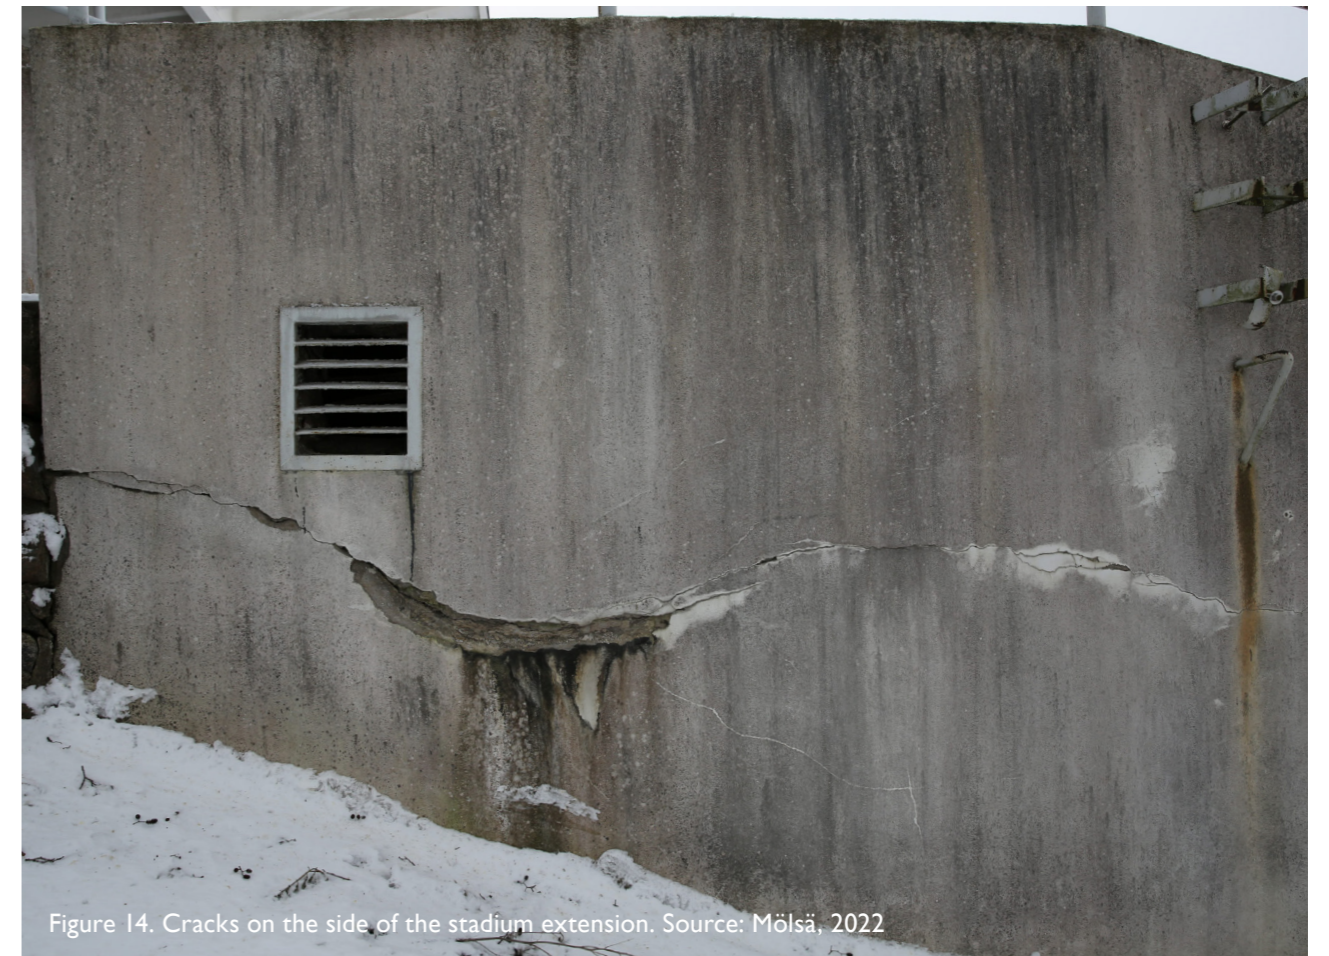
Figure 14. Cracks on the side of the stadium extension. Source: Mölsä, 2022

The visible damages include large cracks in the walls of the grandstand and in the side of the uncovered stand. This is the most visible damage of the building. (Mölsä, 2022b) According to the condition survey, the building needs a major refurbishment before it can be in use again. (Cremin, 2022b) If the repair work would start and exceed as the repair in the 1990's, the construction work would be finalized in a couple of years. (Mölsä, 2022b)

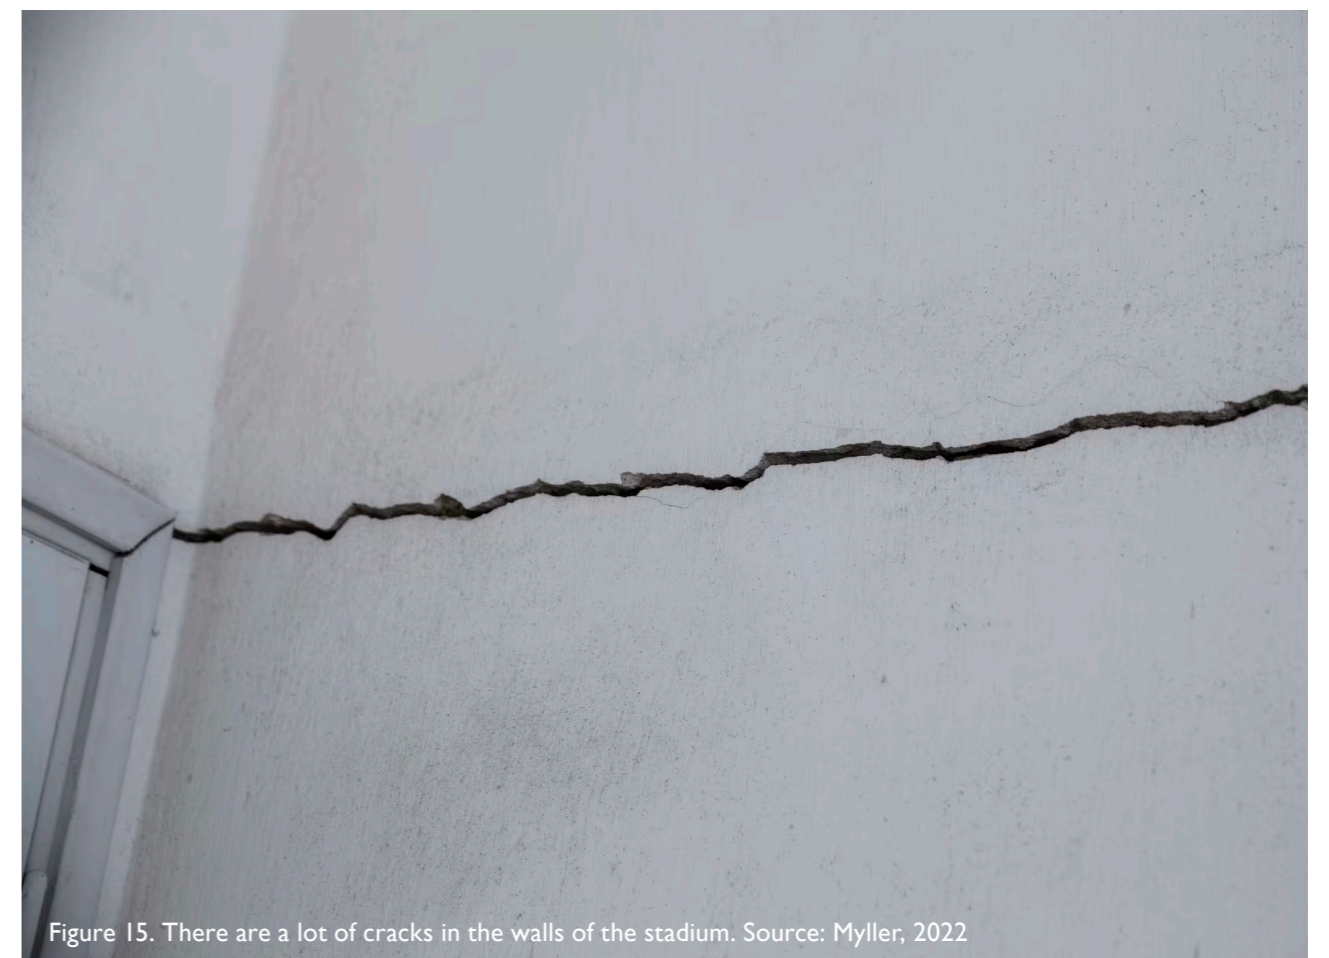
Figure 15. There are a lot of cracks in the walls of the stadium. Source: Myller, 2022

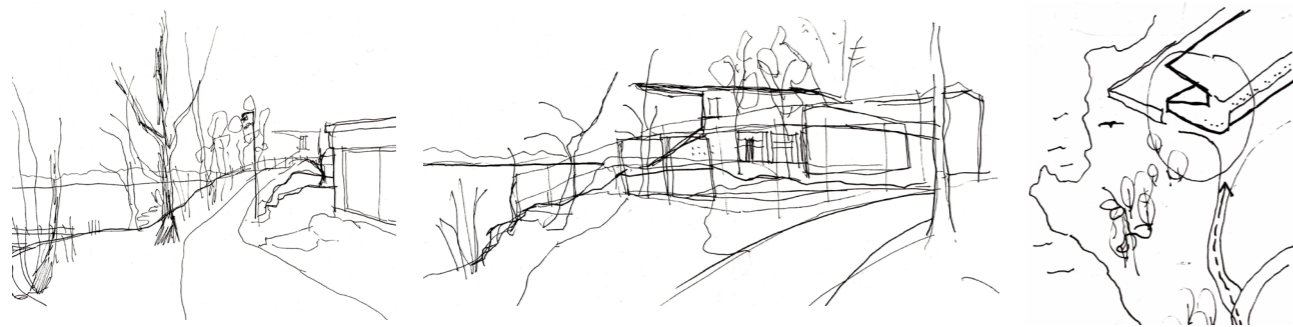
Sketches of approaching the building. I discovered that the most visible and flattering view of the Rowing Stadium when approaching was the south-west corner.

When studying the ways of approaching the Rowing Stadium, I discovered that the most visible and flattering view of the Rowing Stadium when approaching was the south-west corner. I could enhance it by making it a main access point and placing the café in relation to it.

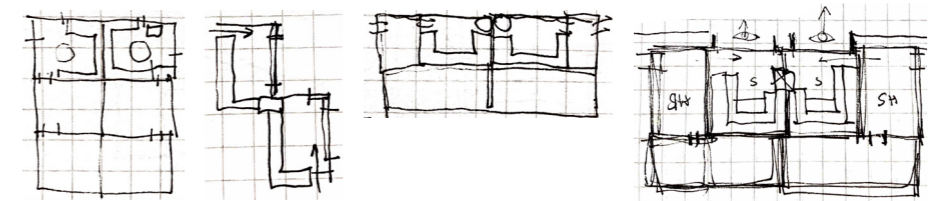
The sauna was studied through its connection to the outside view. The movement inside the building was also studied. The flows between showers, saunas and outside swimming had to be natural.

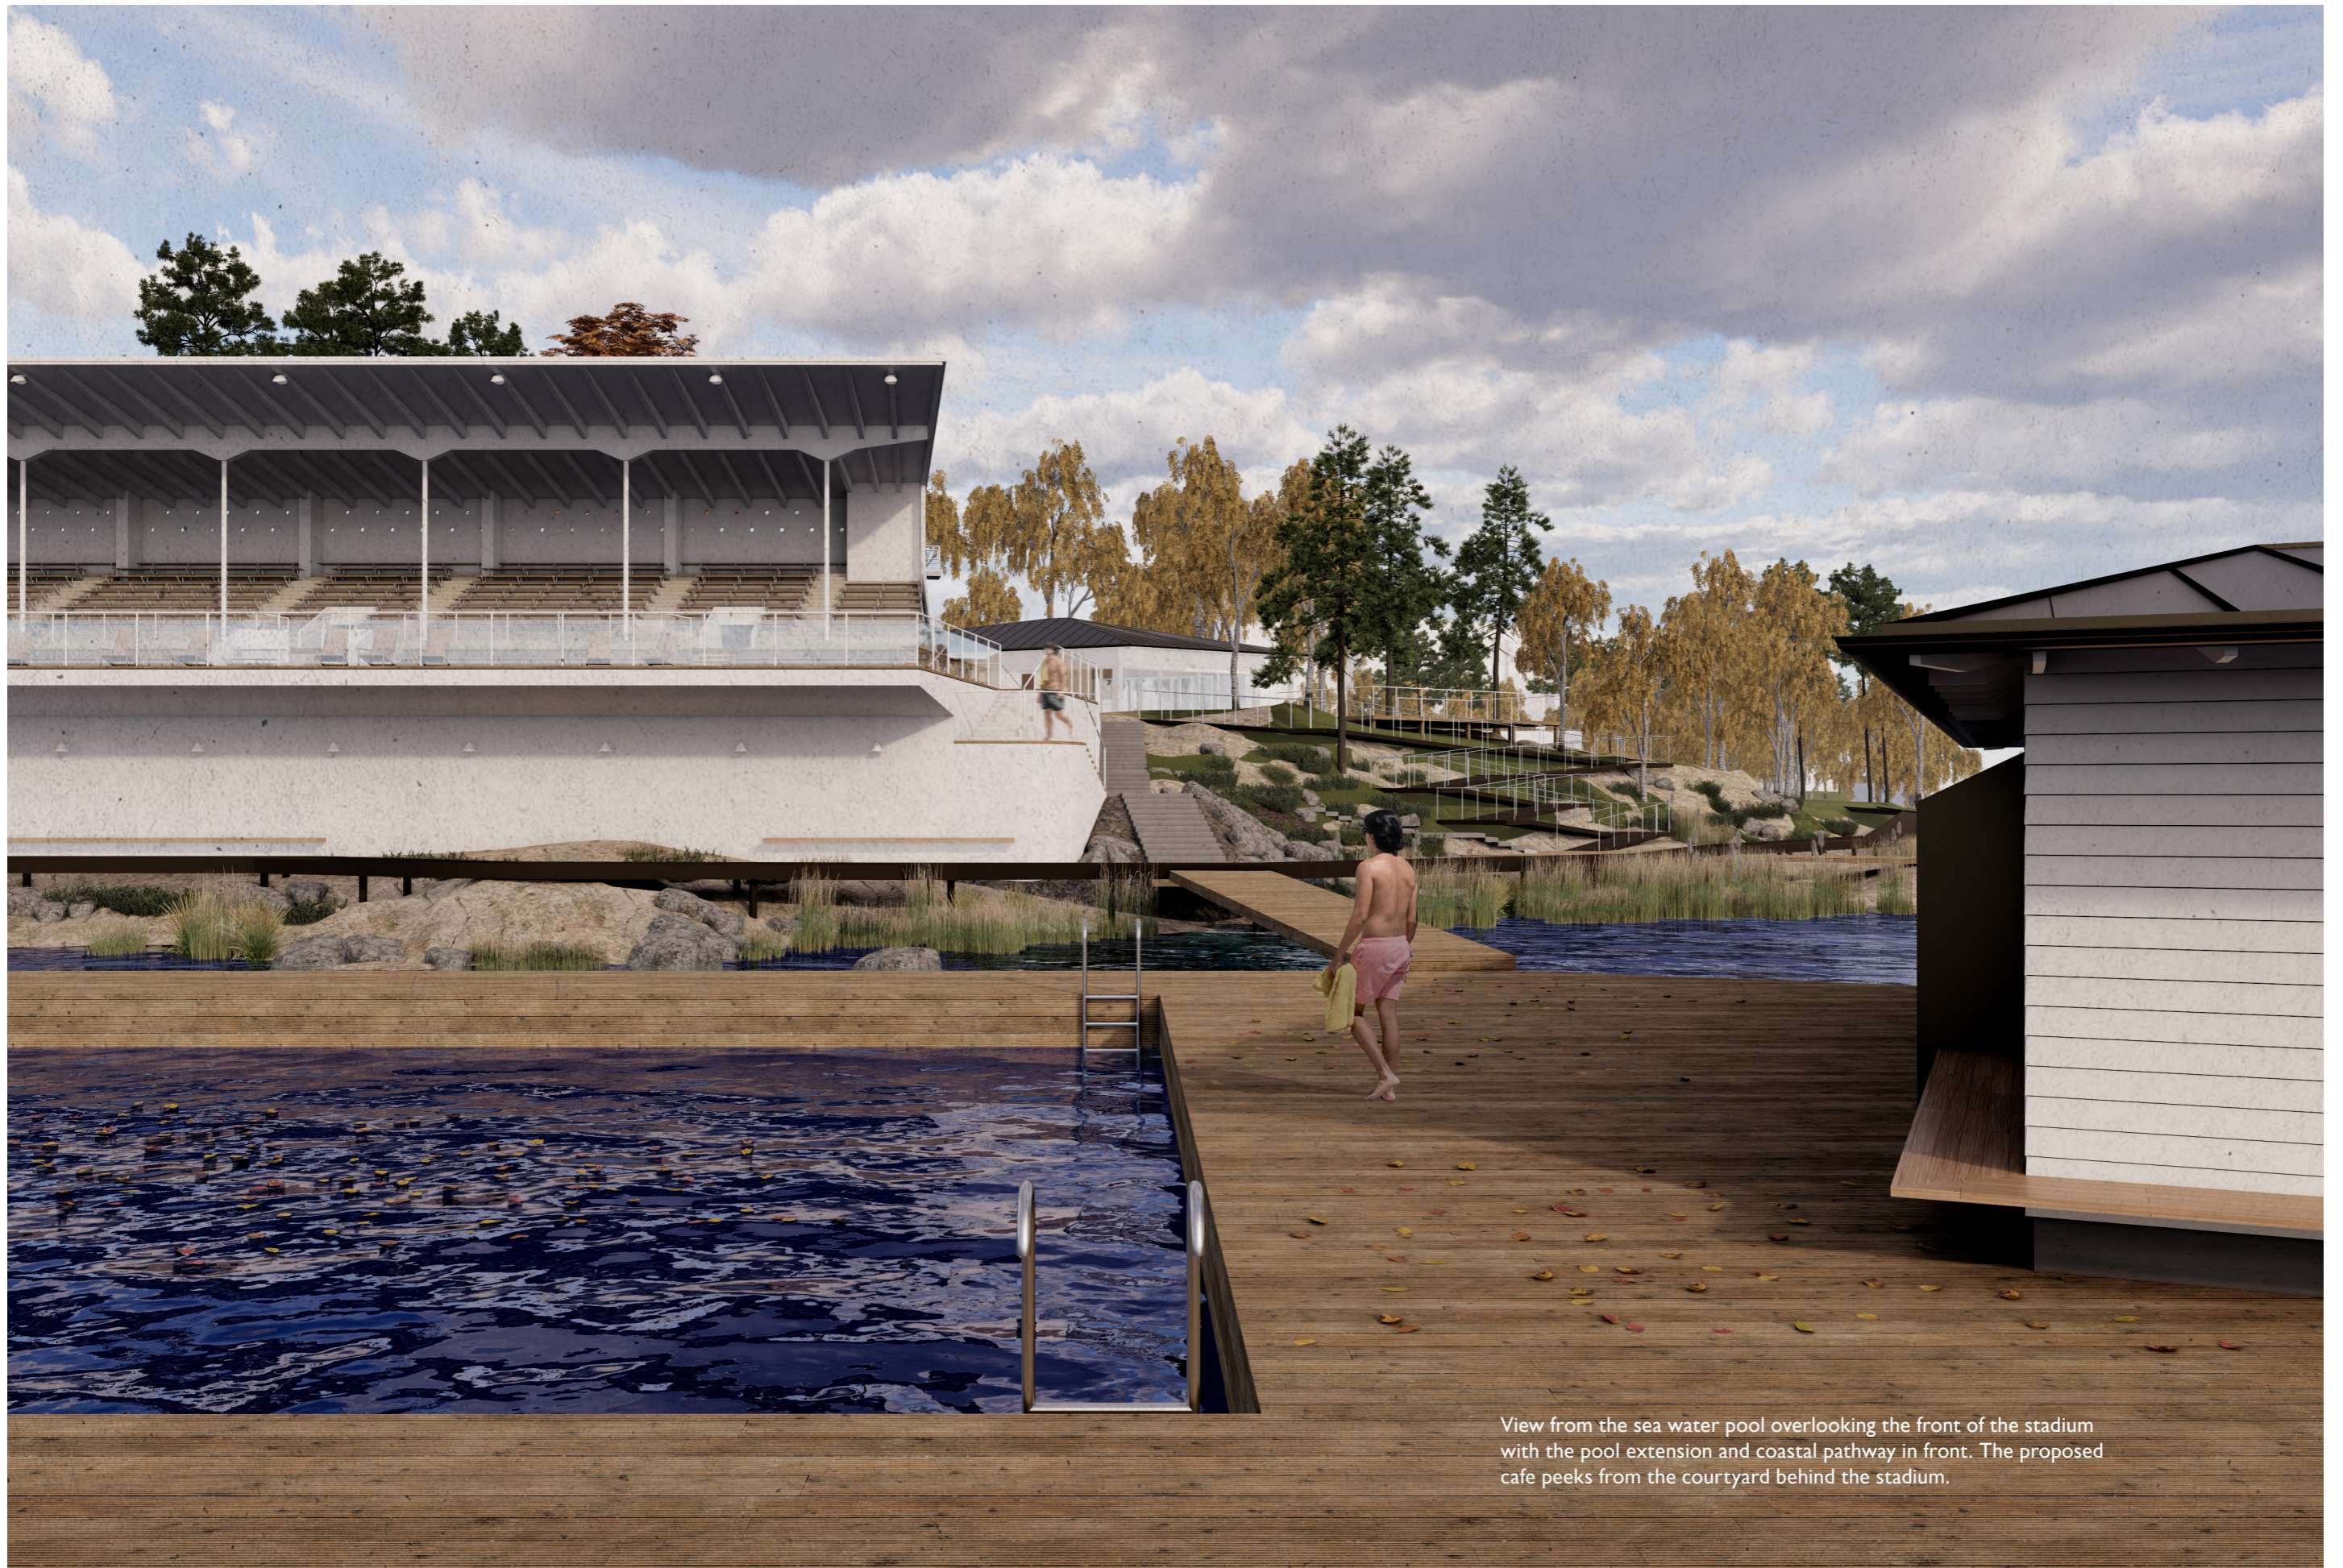
View from the sea water pool overlooking the front of the stadium with the pool extension and coastal pathway in front. The proposed cafe peeks from the courtyard behind the stadium.

The design proposal activates the sloped site in its totality. The sea water pool, sauna and boat docks are located by the the water at 0 meters above sea level. The public pedestrian pathway is activating the coastline at 1 m a.s.l. The pool structure extension is connecting to the lowest step of the original stadium stand at 5,5 m a.s.l. In addition to this, the pavillion-like café and the entrance of the swimming facilities is activating the courtyard at the same height.

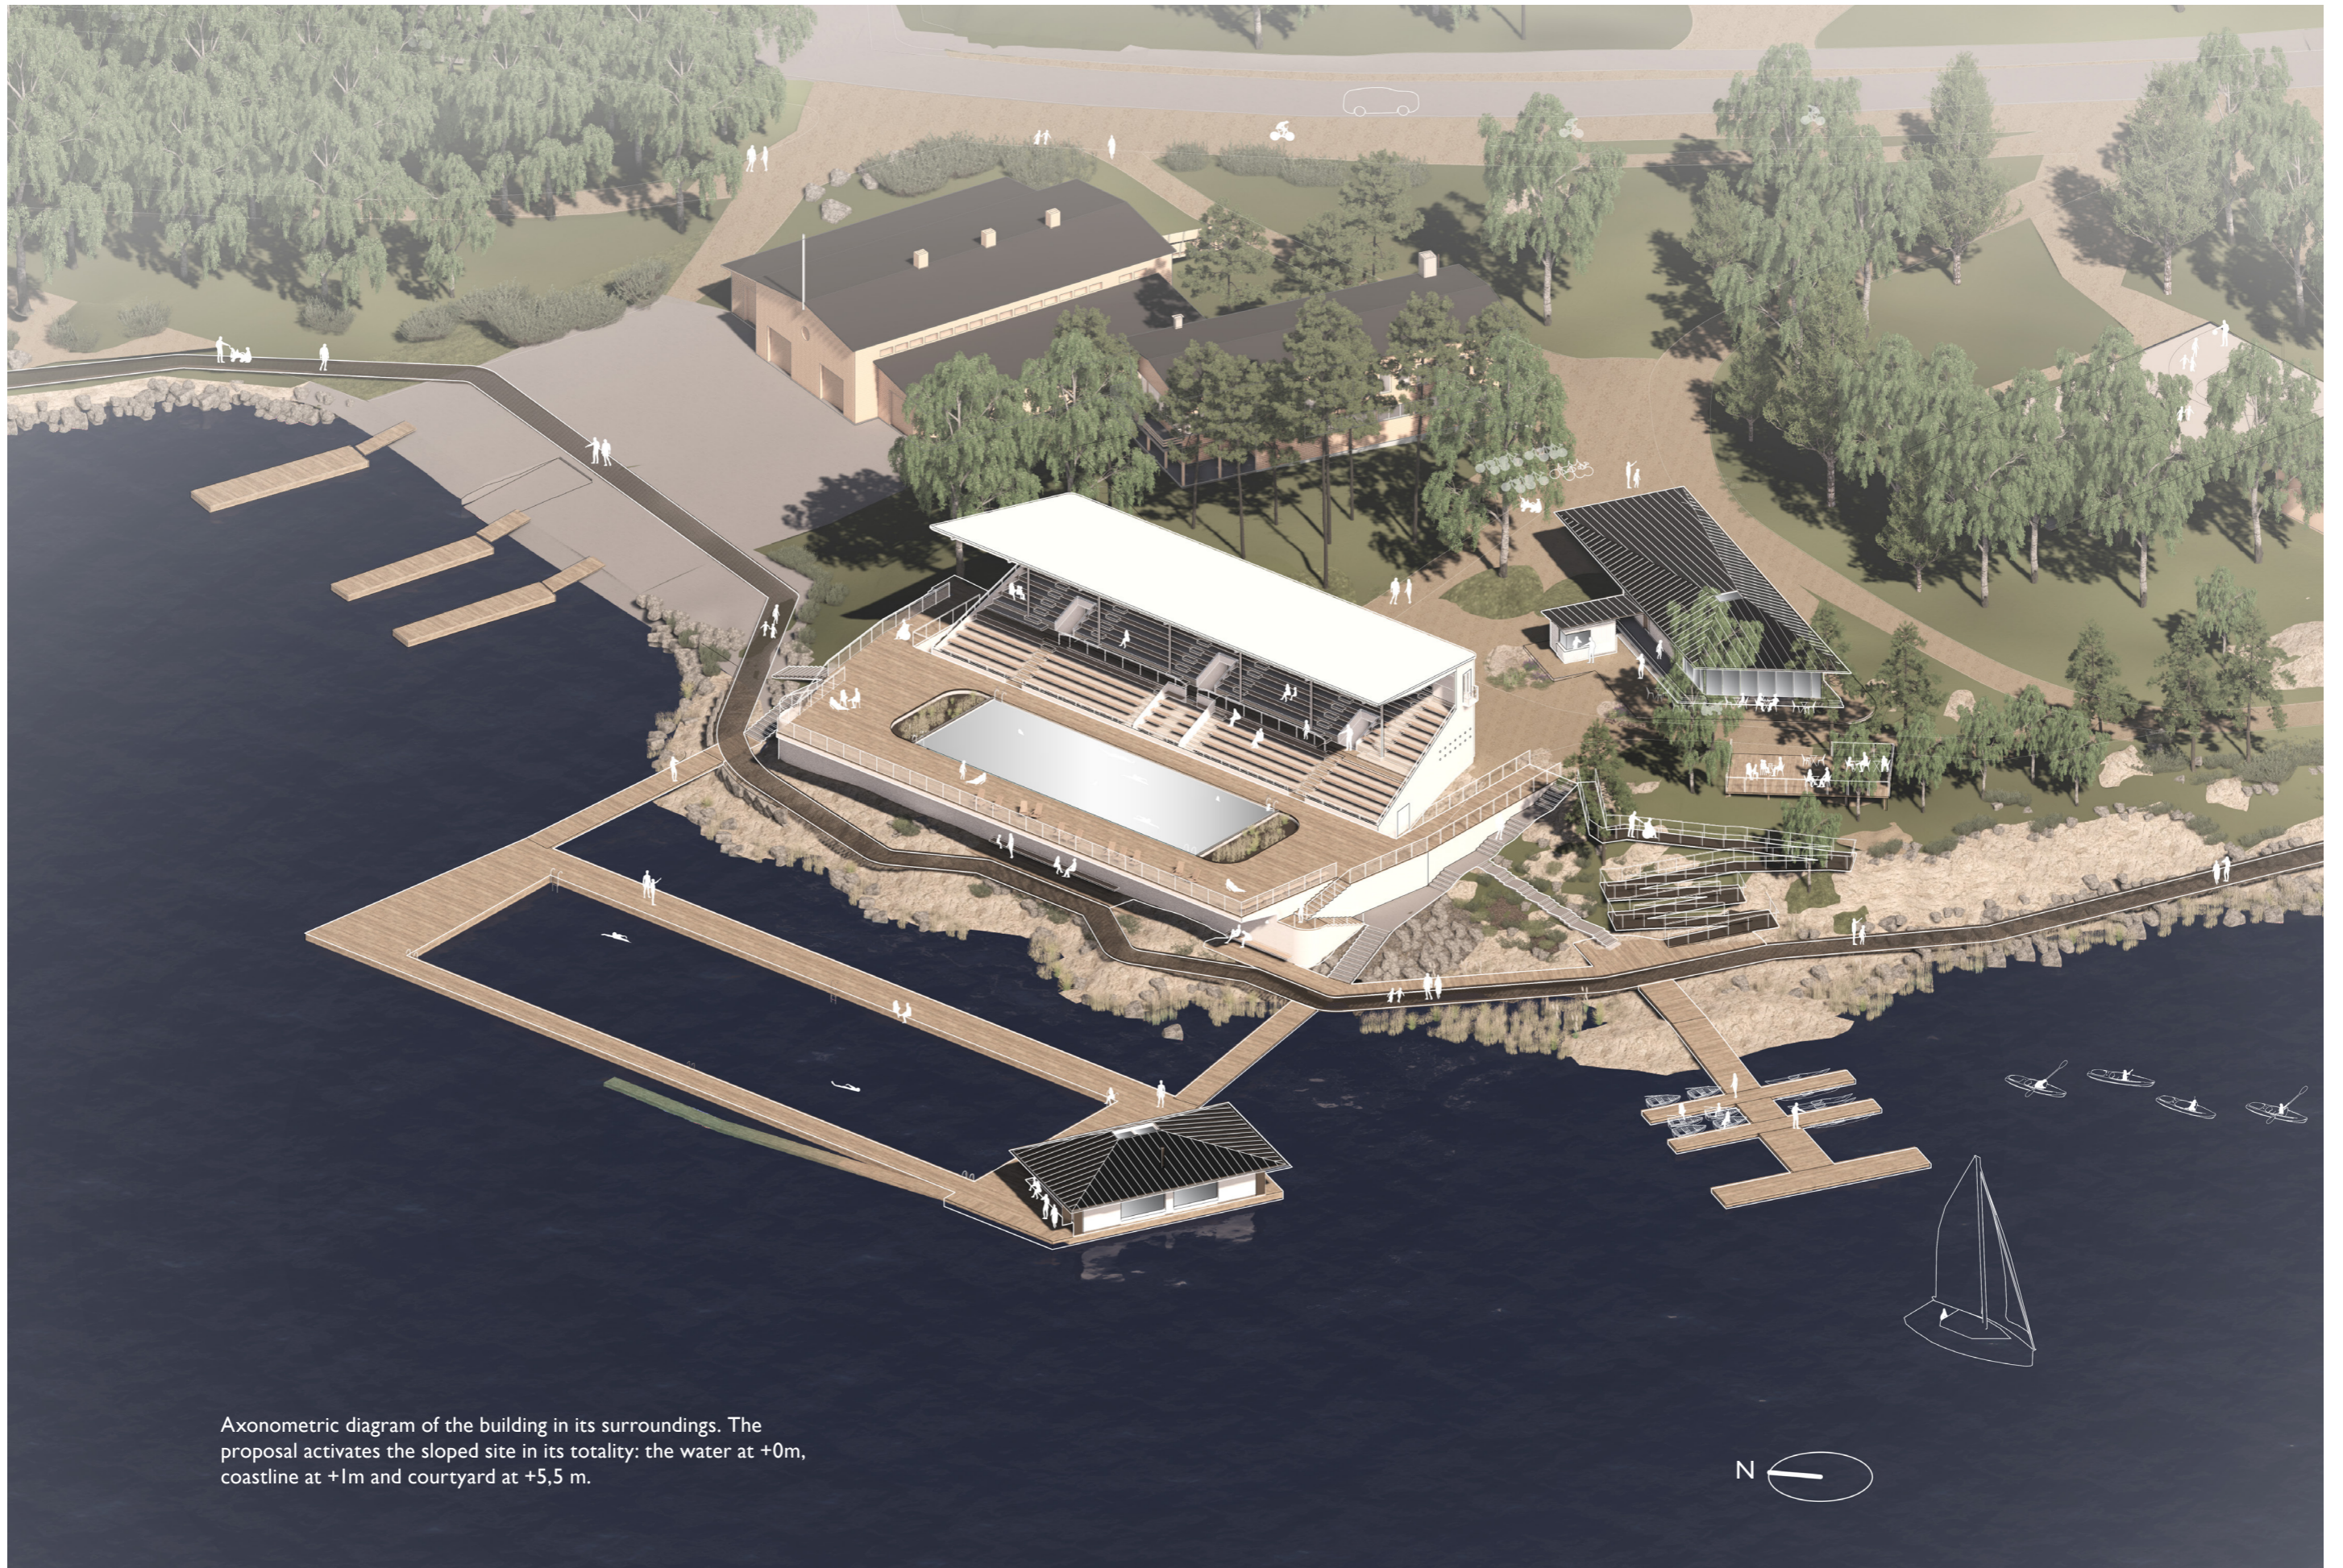
Axonometric diagram of the building in its surroundings. The proposal activates the sloped site in its totality: the water at +0m, coastline at +1m and courtyard at +5,5 m.
