# **Repurposing cultural heritage:**

Design proposal for the Olympic  
Rowing stadium in Helsinki

Degree project in Architecture

Lund University

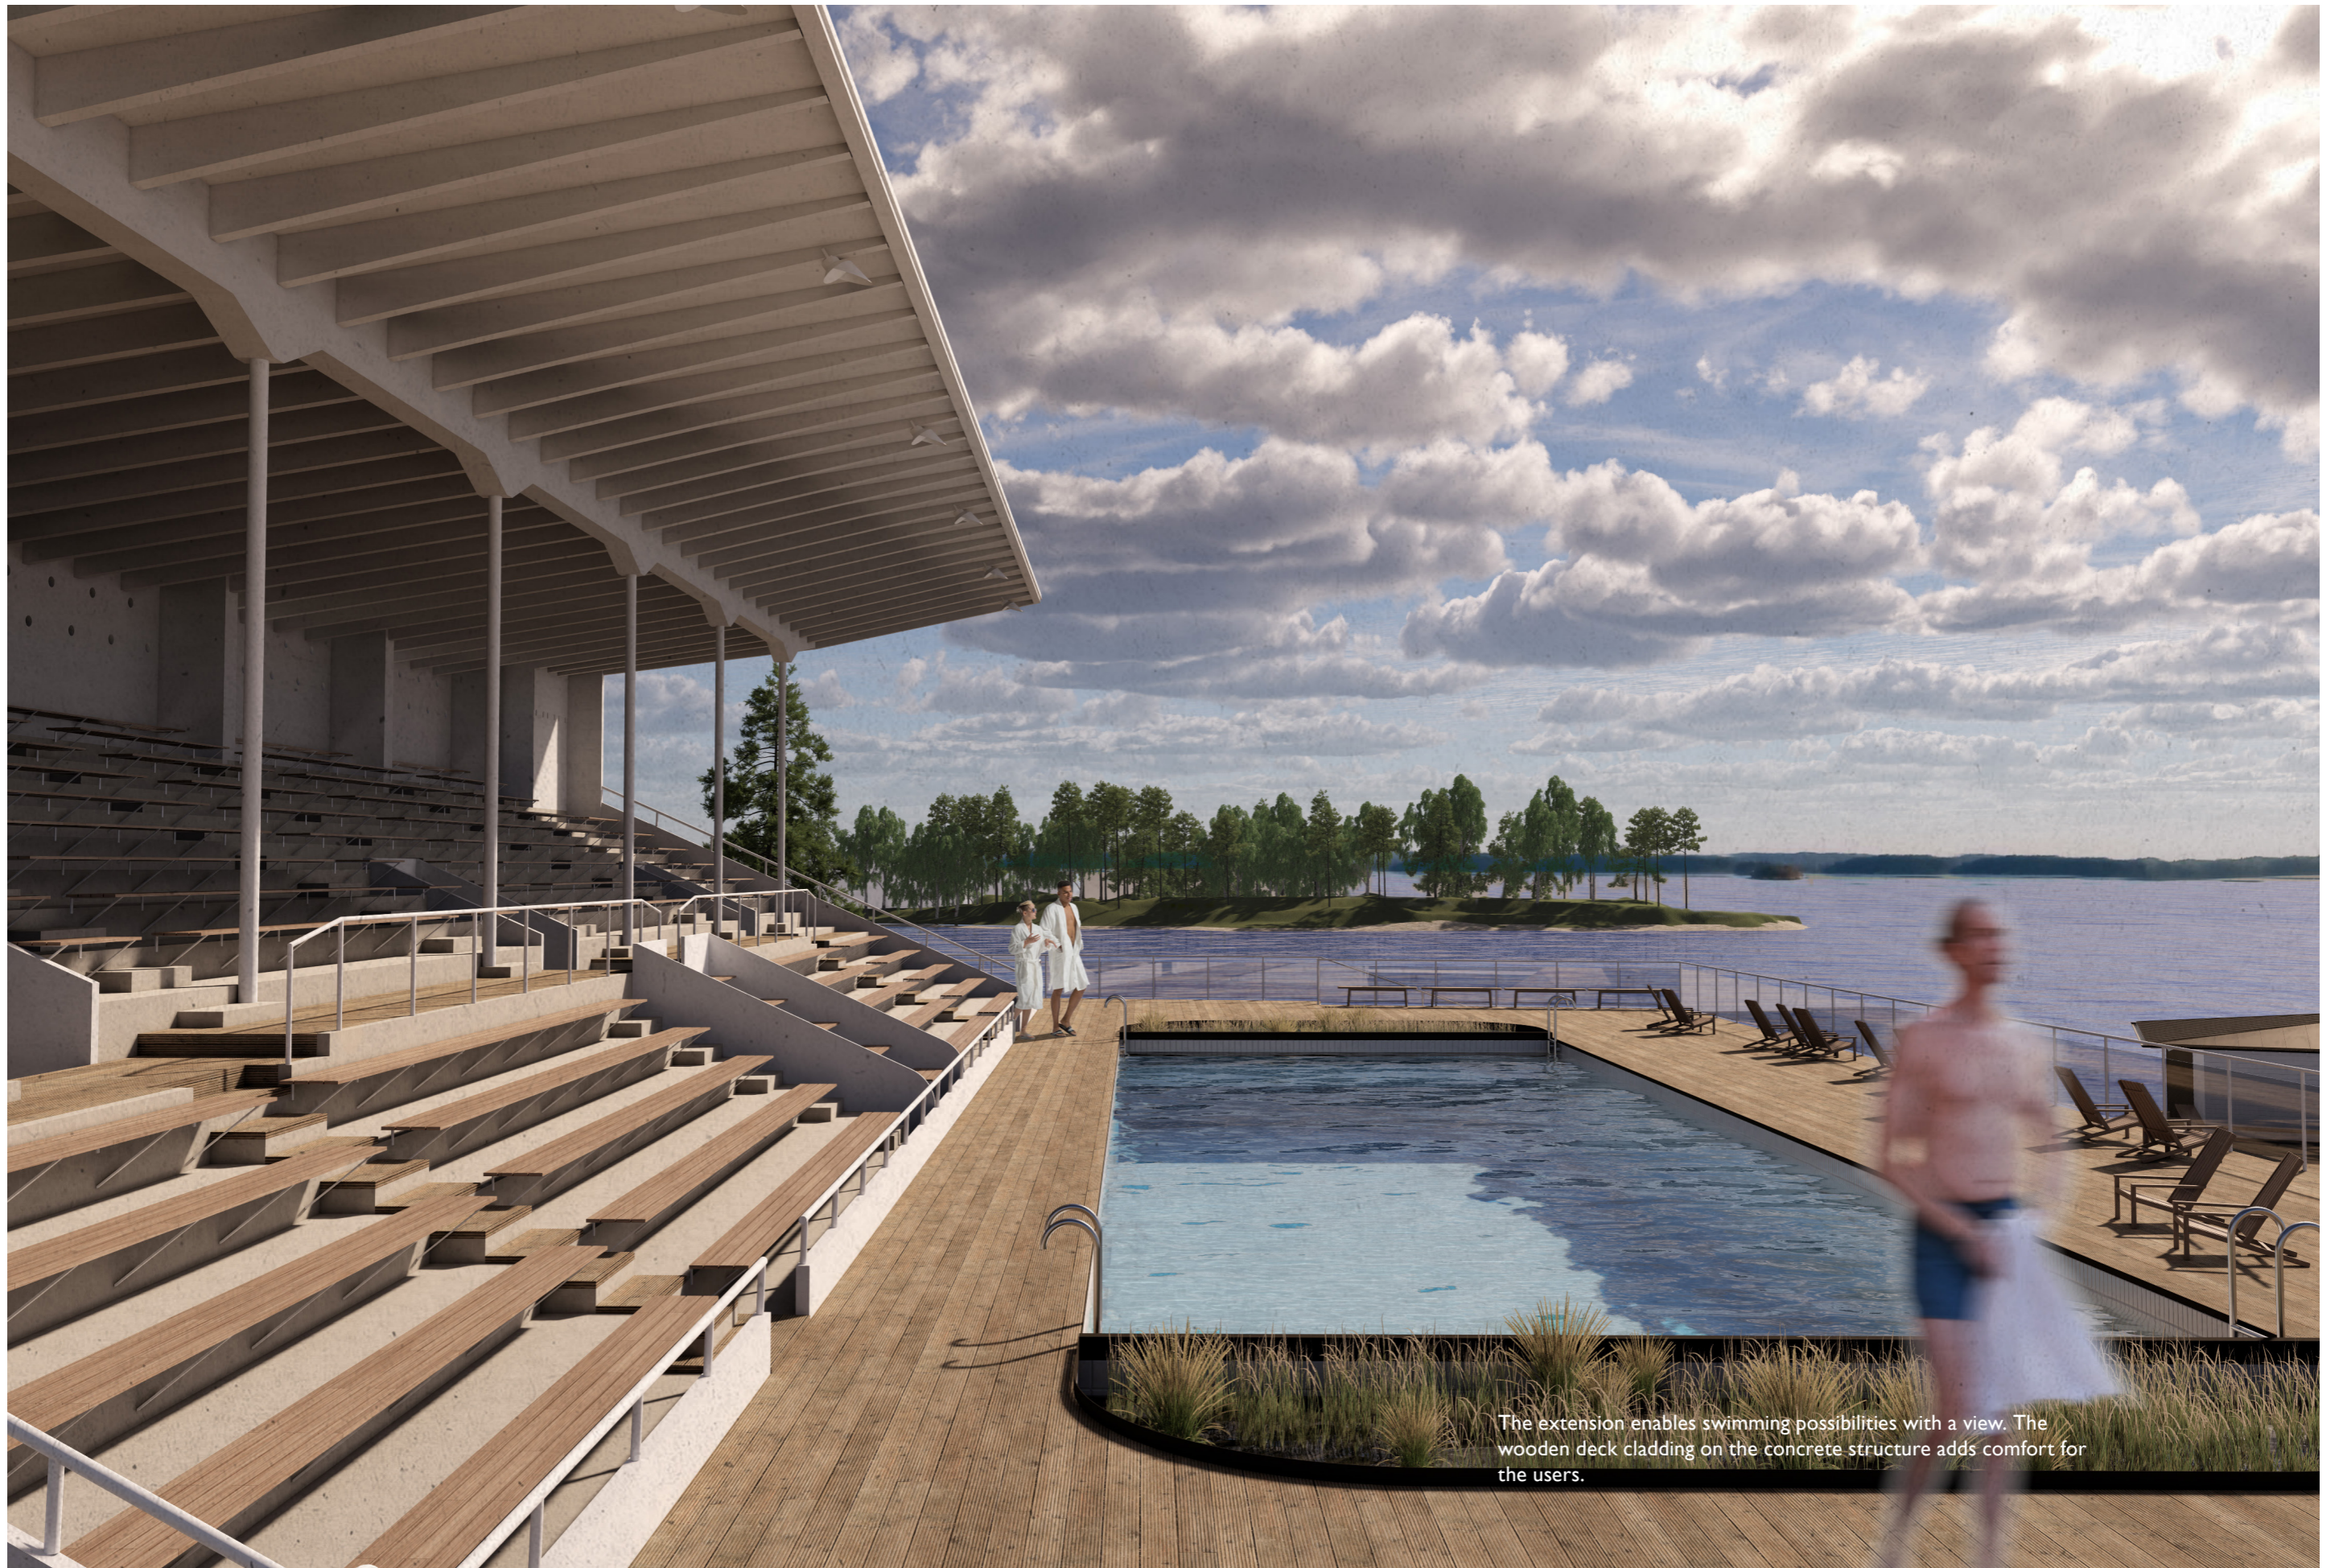
The extension enables swimming possibilities with a view. The wooden deck cladding on the concrete structure adds comfort for the users.

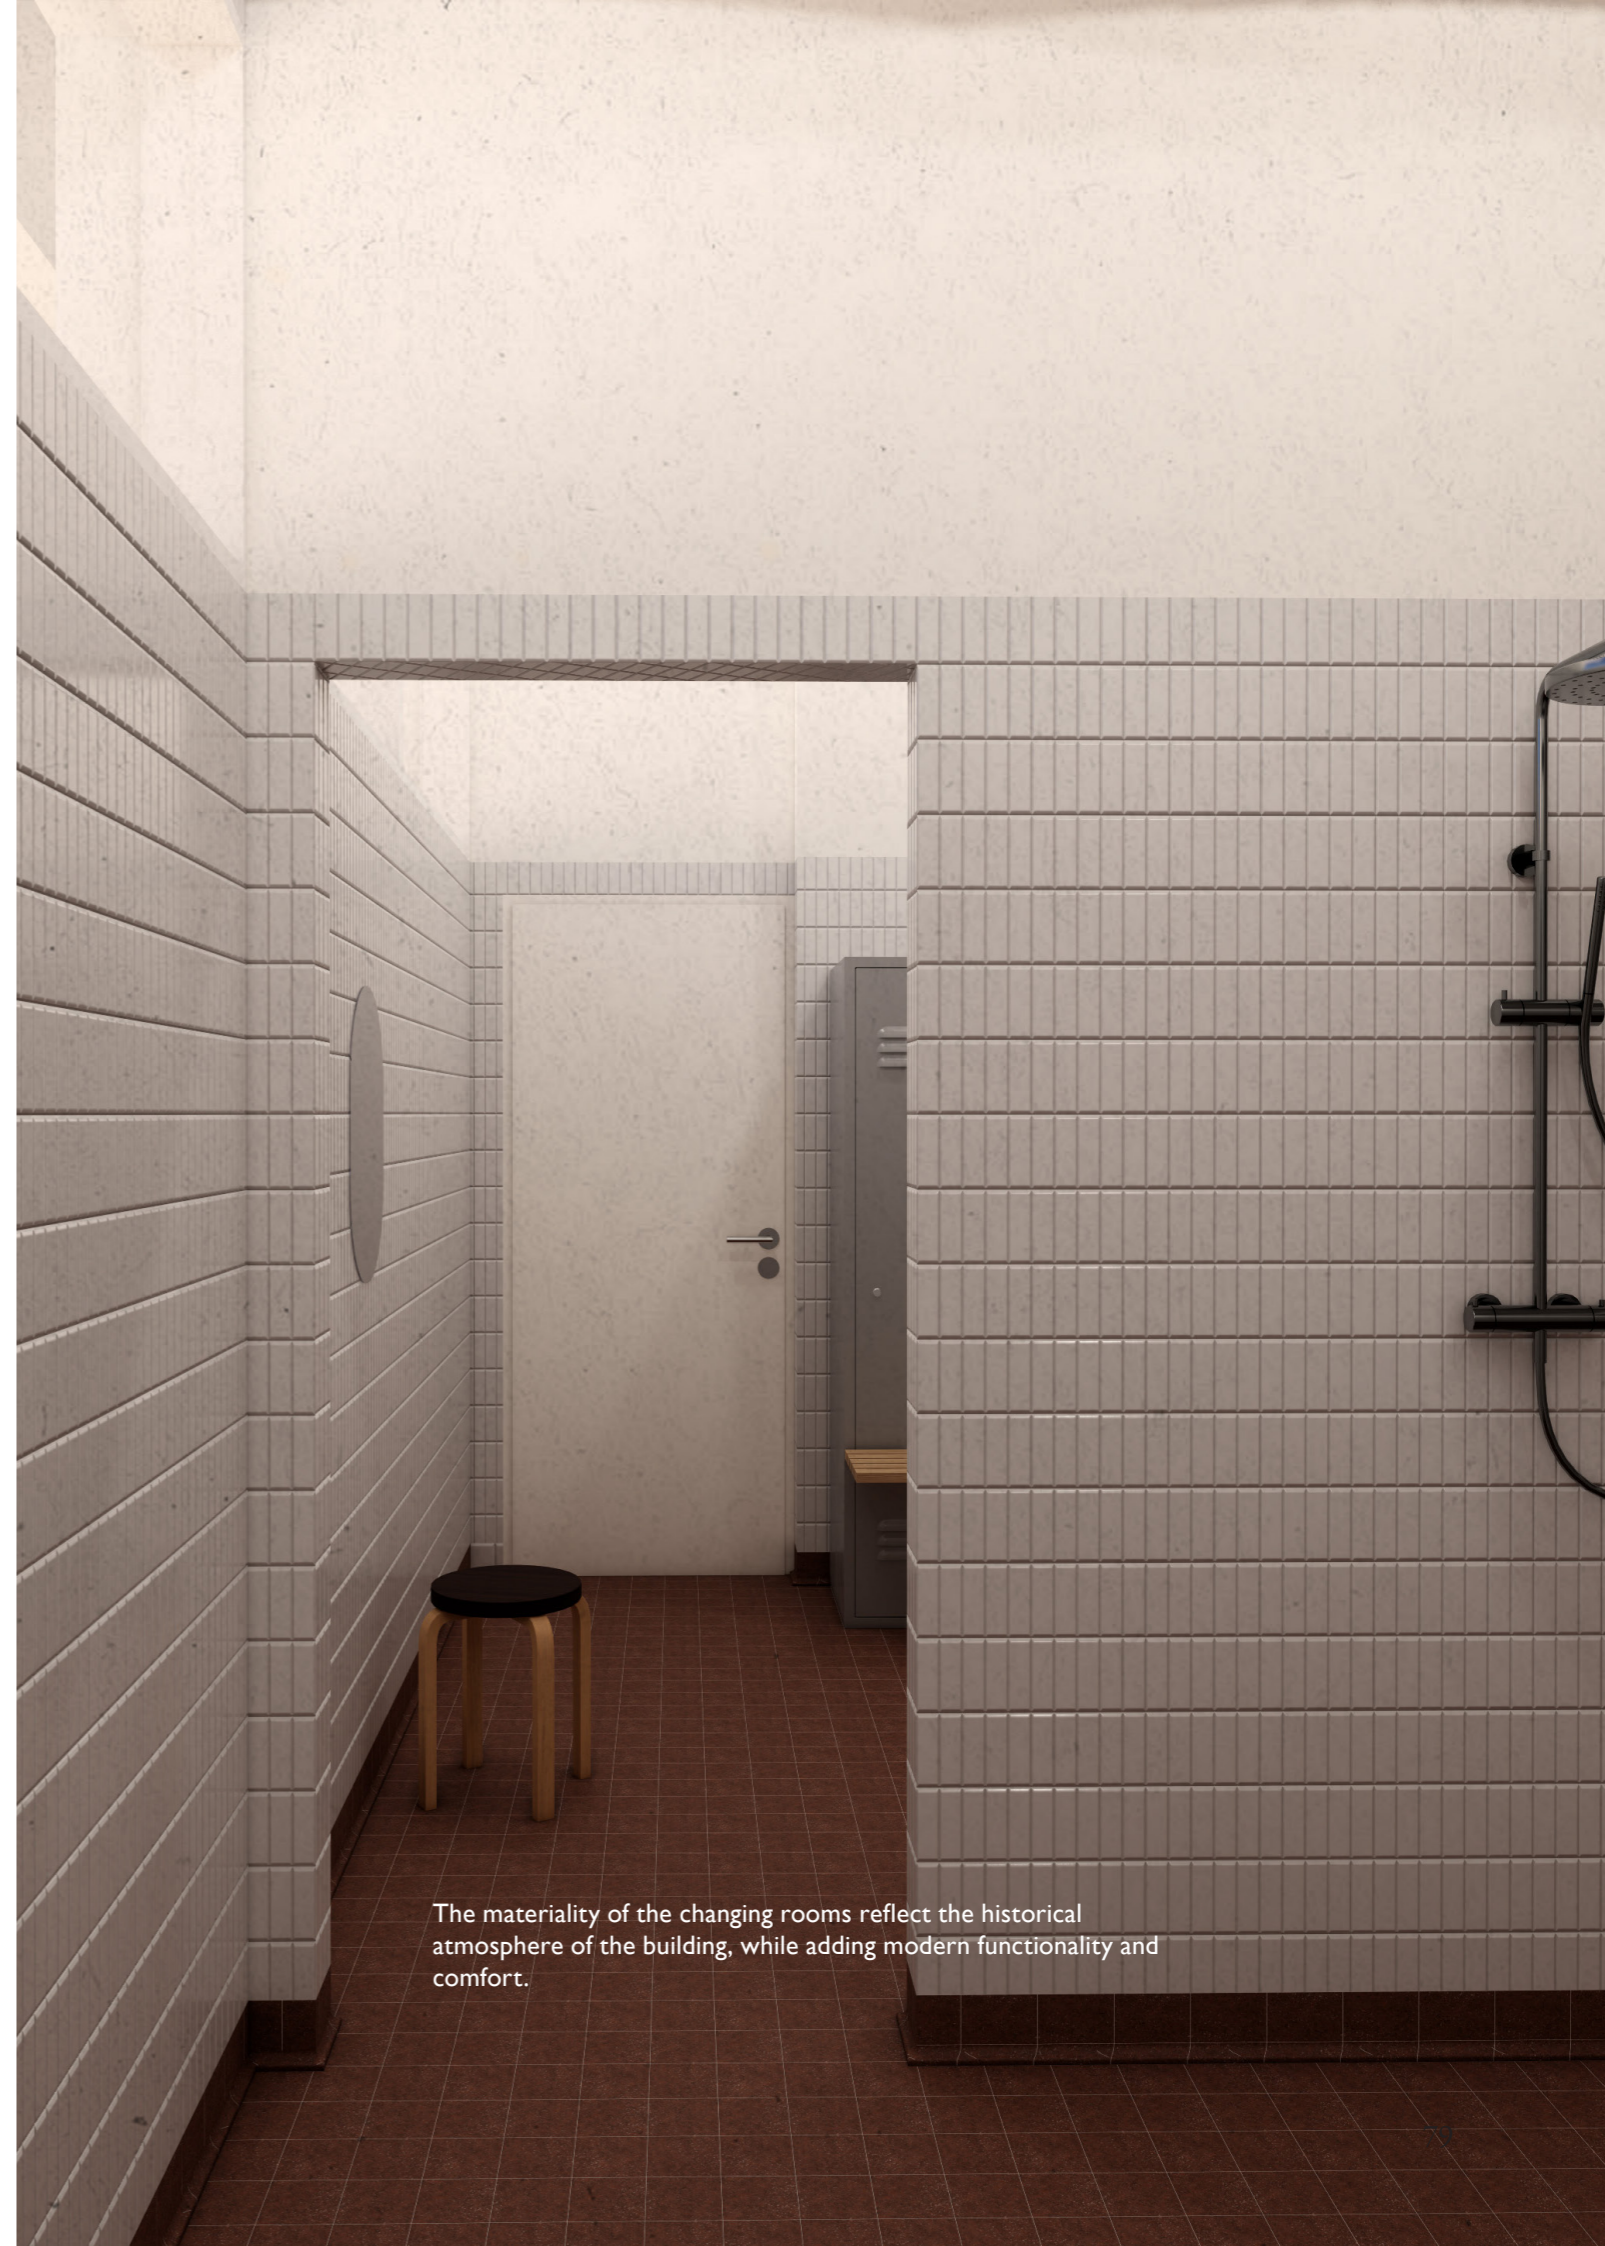
The materiality of the changing rooms reflect the historical atmosphere of the building, while adding modern functionality and comfort.

The interior spaces of the stadium consist of two sets of changing rooms. The character of these rooms relate both to the history of the building and its new function. The building is intended for sports. The walls and floors are tile for easy cleaning and maintenance. The terracotta red is a nod to modernistic architecture, while the add of color and the vertical tile adds to the contemporary identity of the adapted building.

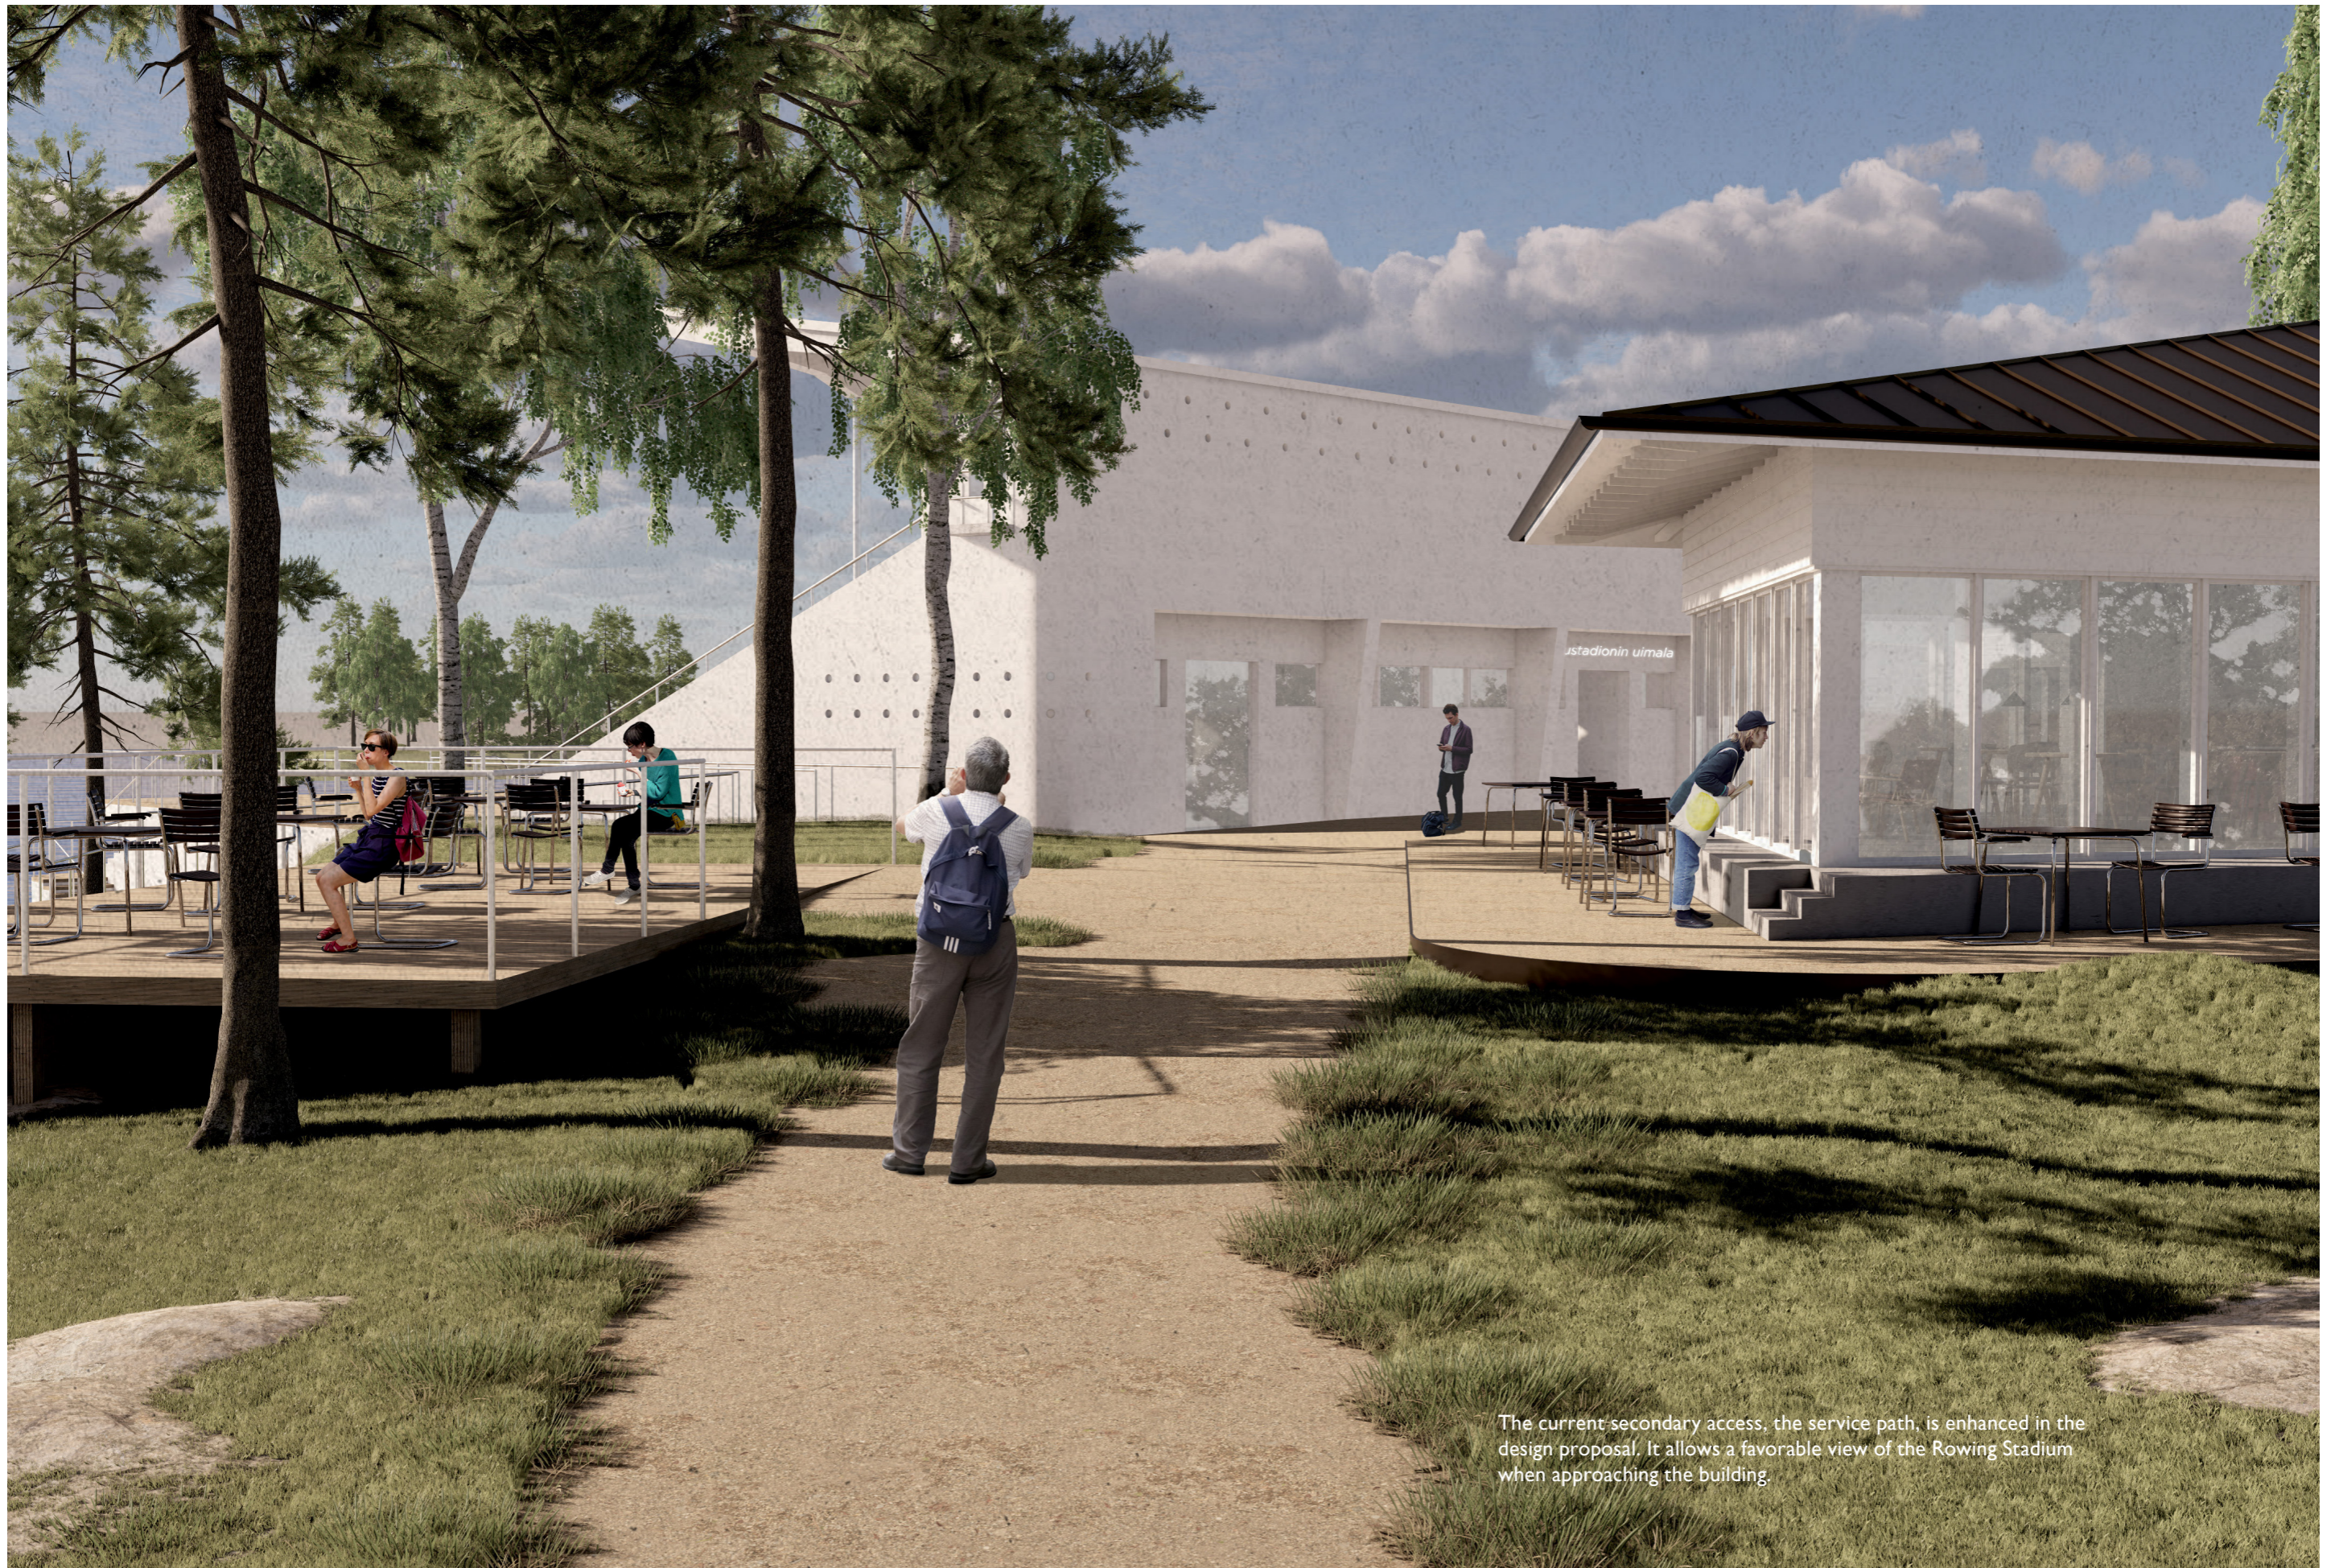
The current secondary access, the service path, is enhanced in the design proposal. It allows a favorable view of the Rowing Stadium when approaching the building.

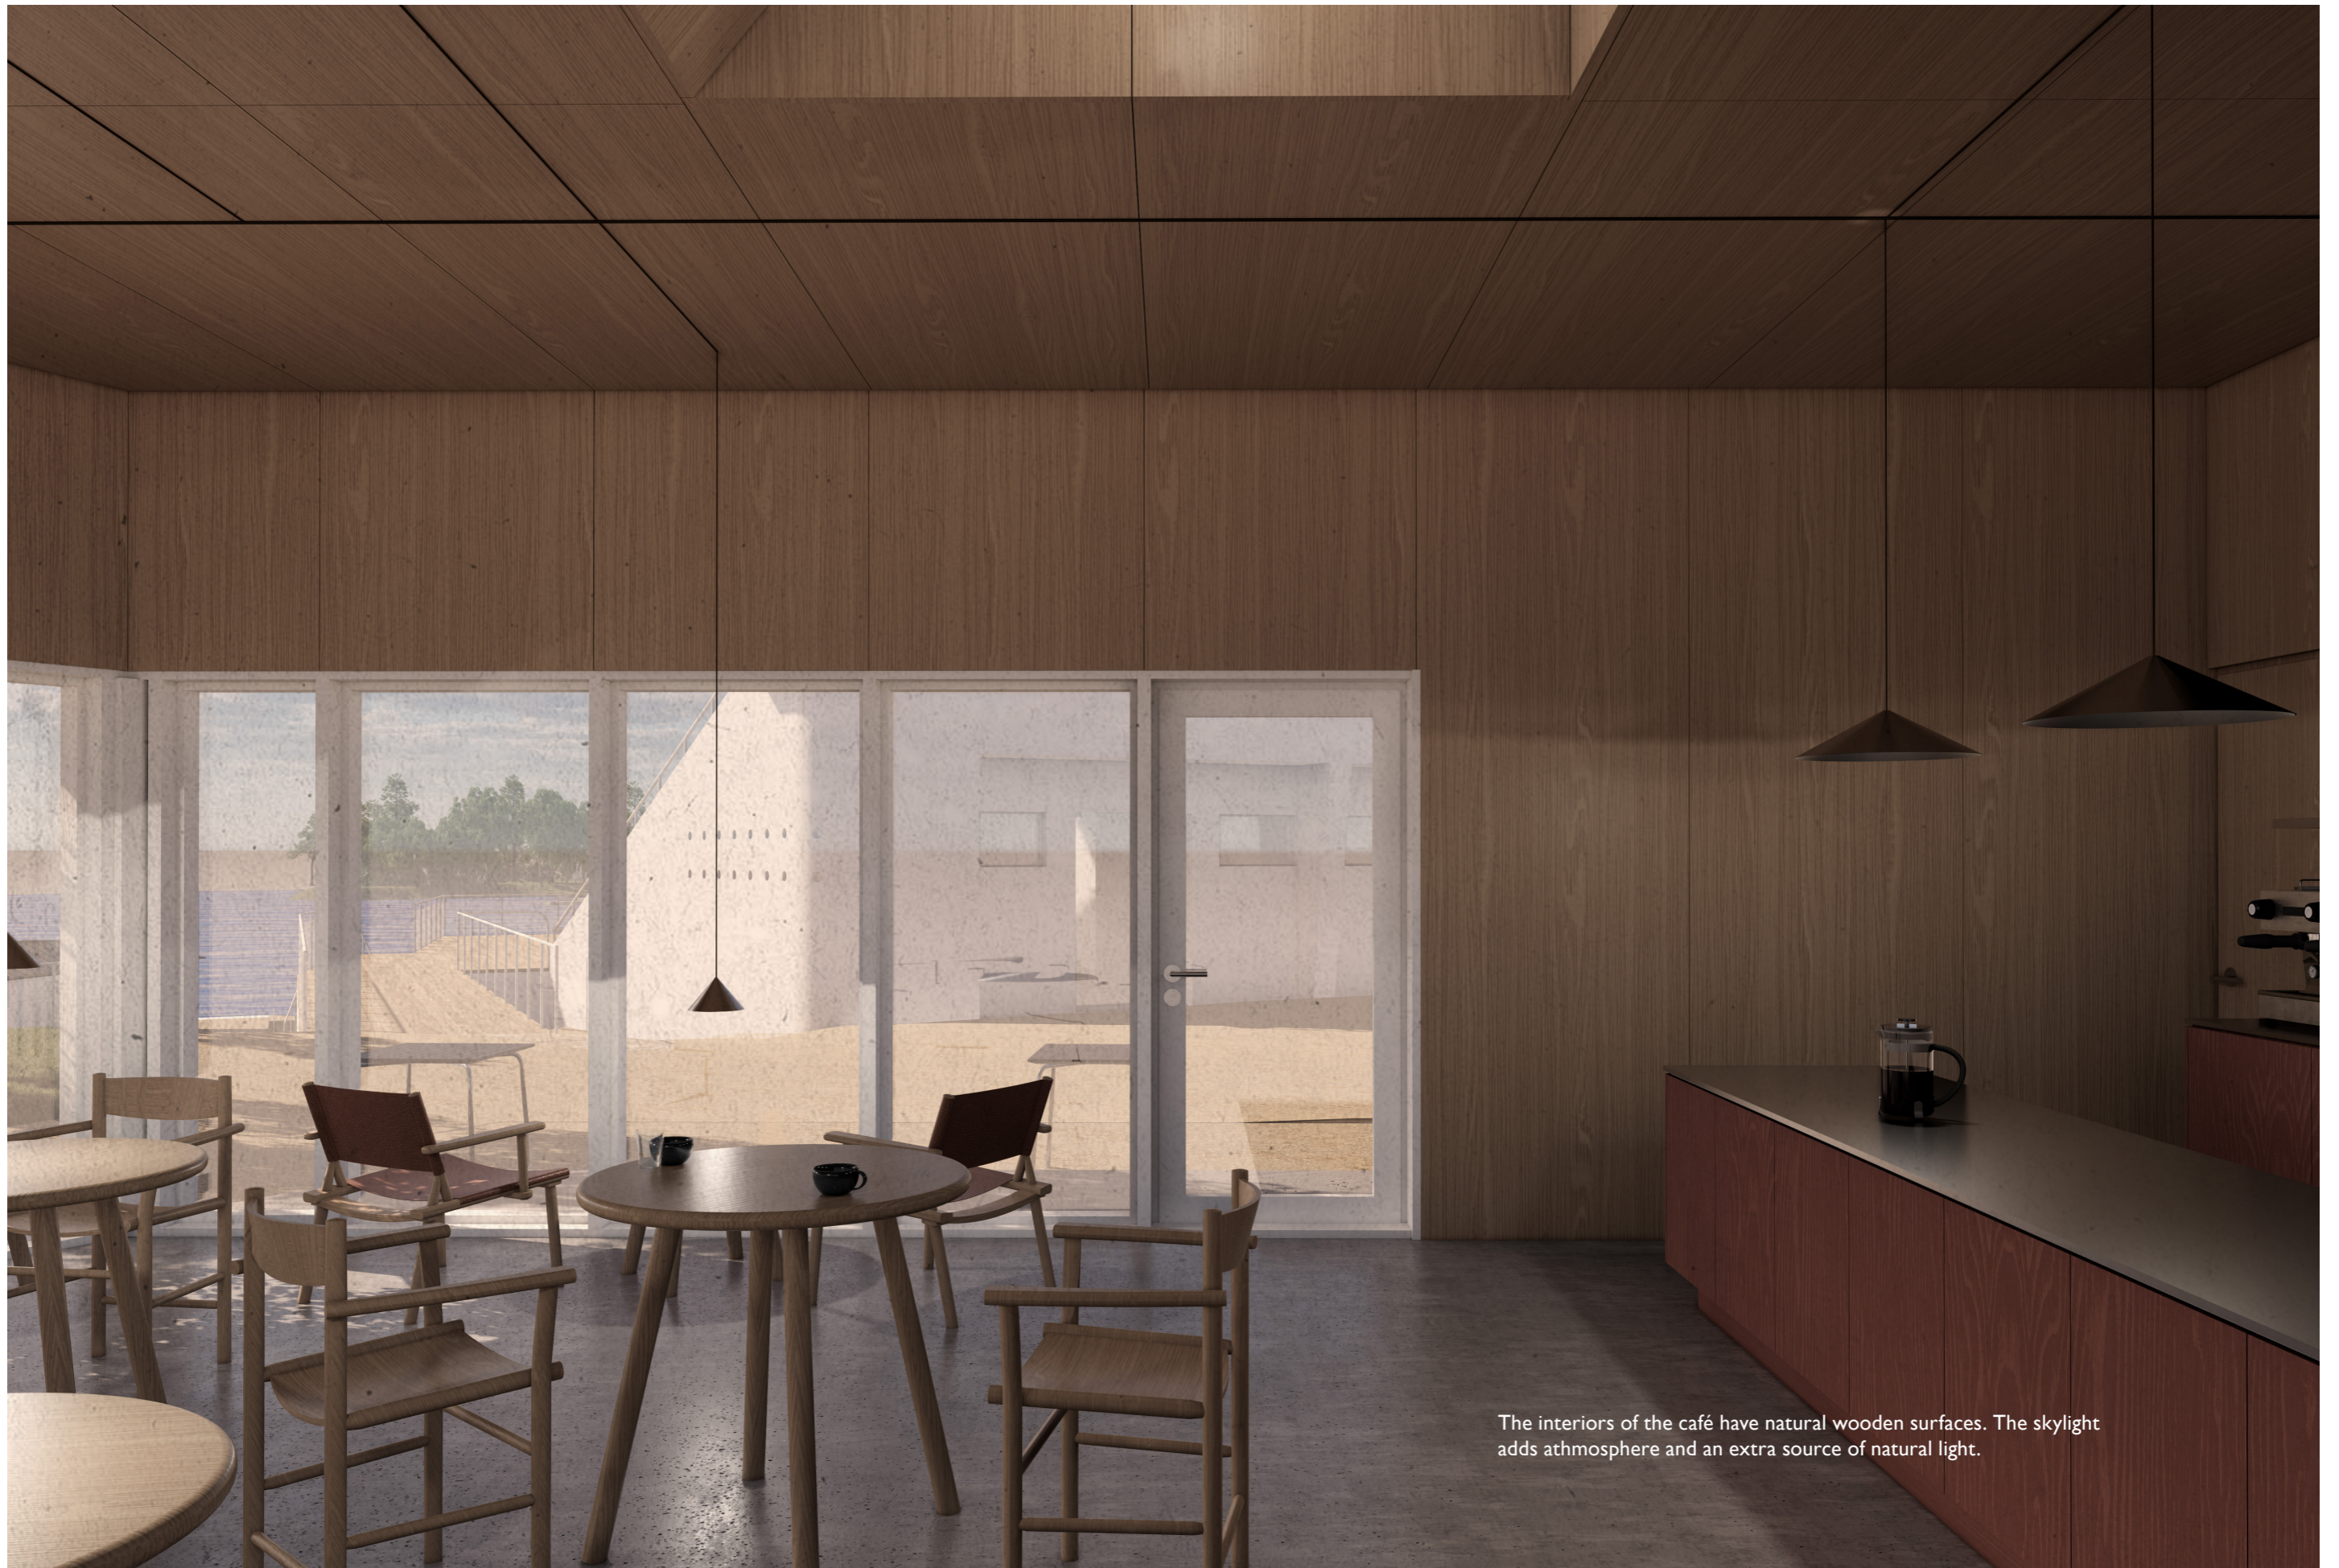
The interiors of the café have natural wooden surfaces. The skylight adds atmosphere and an extra source of natural light.

The café can be divided into three parts according to function. Firstly, the café area used by the public. Secondly, secondary spaces in the middle of the building with staff room, storage and toilets. The connection between the staff room and kiosk is a part of the surrounding terrace and is covered for comfortable access. Thirdly, the function in the north-east part of the building is a meeting space for community use. It can be accessed from the café or from a separate entrance behind the kiosk. Outside café opening hours it's accessed from the separate entrance. A sliding door isolates the café and toilets, making the toilets accessible for the meeting space outside opening hours.

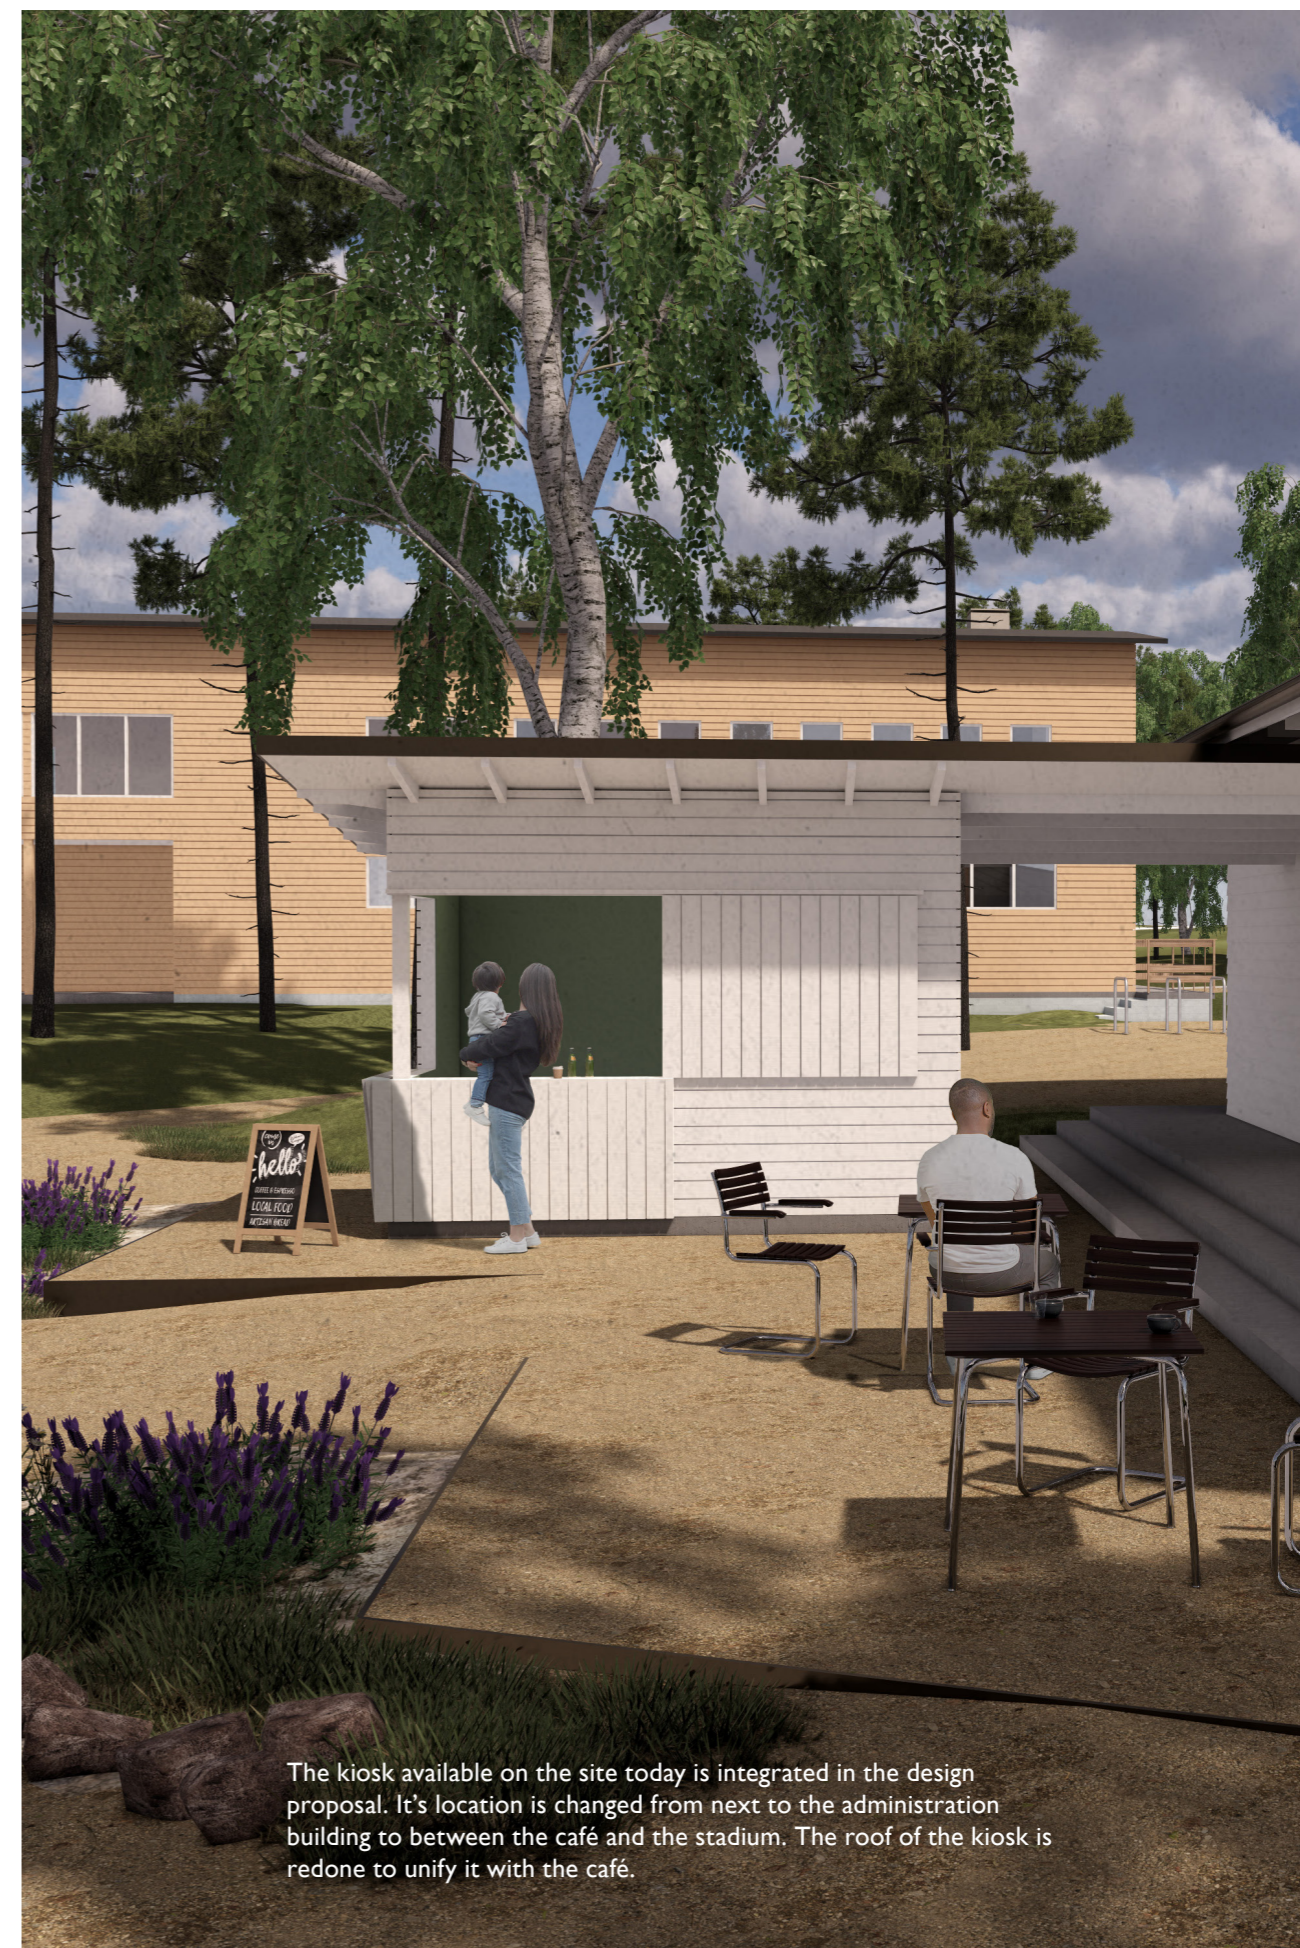
The kiosk available on the site today is integrated in the design proposal. It's location is changed from next to the administration building to between the café and the stadium. The roof of the kiosk is redone to unify it with the café.

Preserving and incorporating the kiosk ensures easy customer flow in the area for quicker purchases. It can be used for tickets to the swimming and sauna facilities or for a quick stop for ice cream on a summer boat trip.

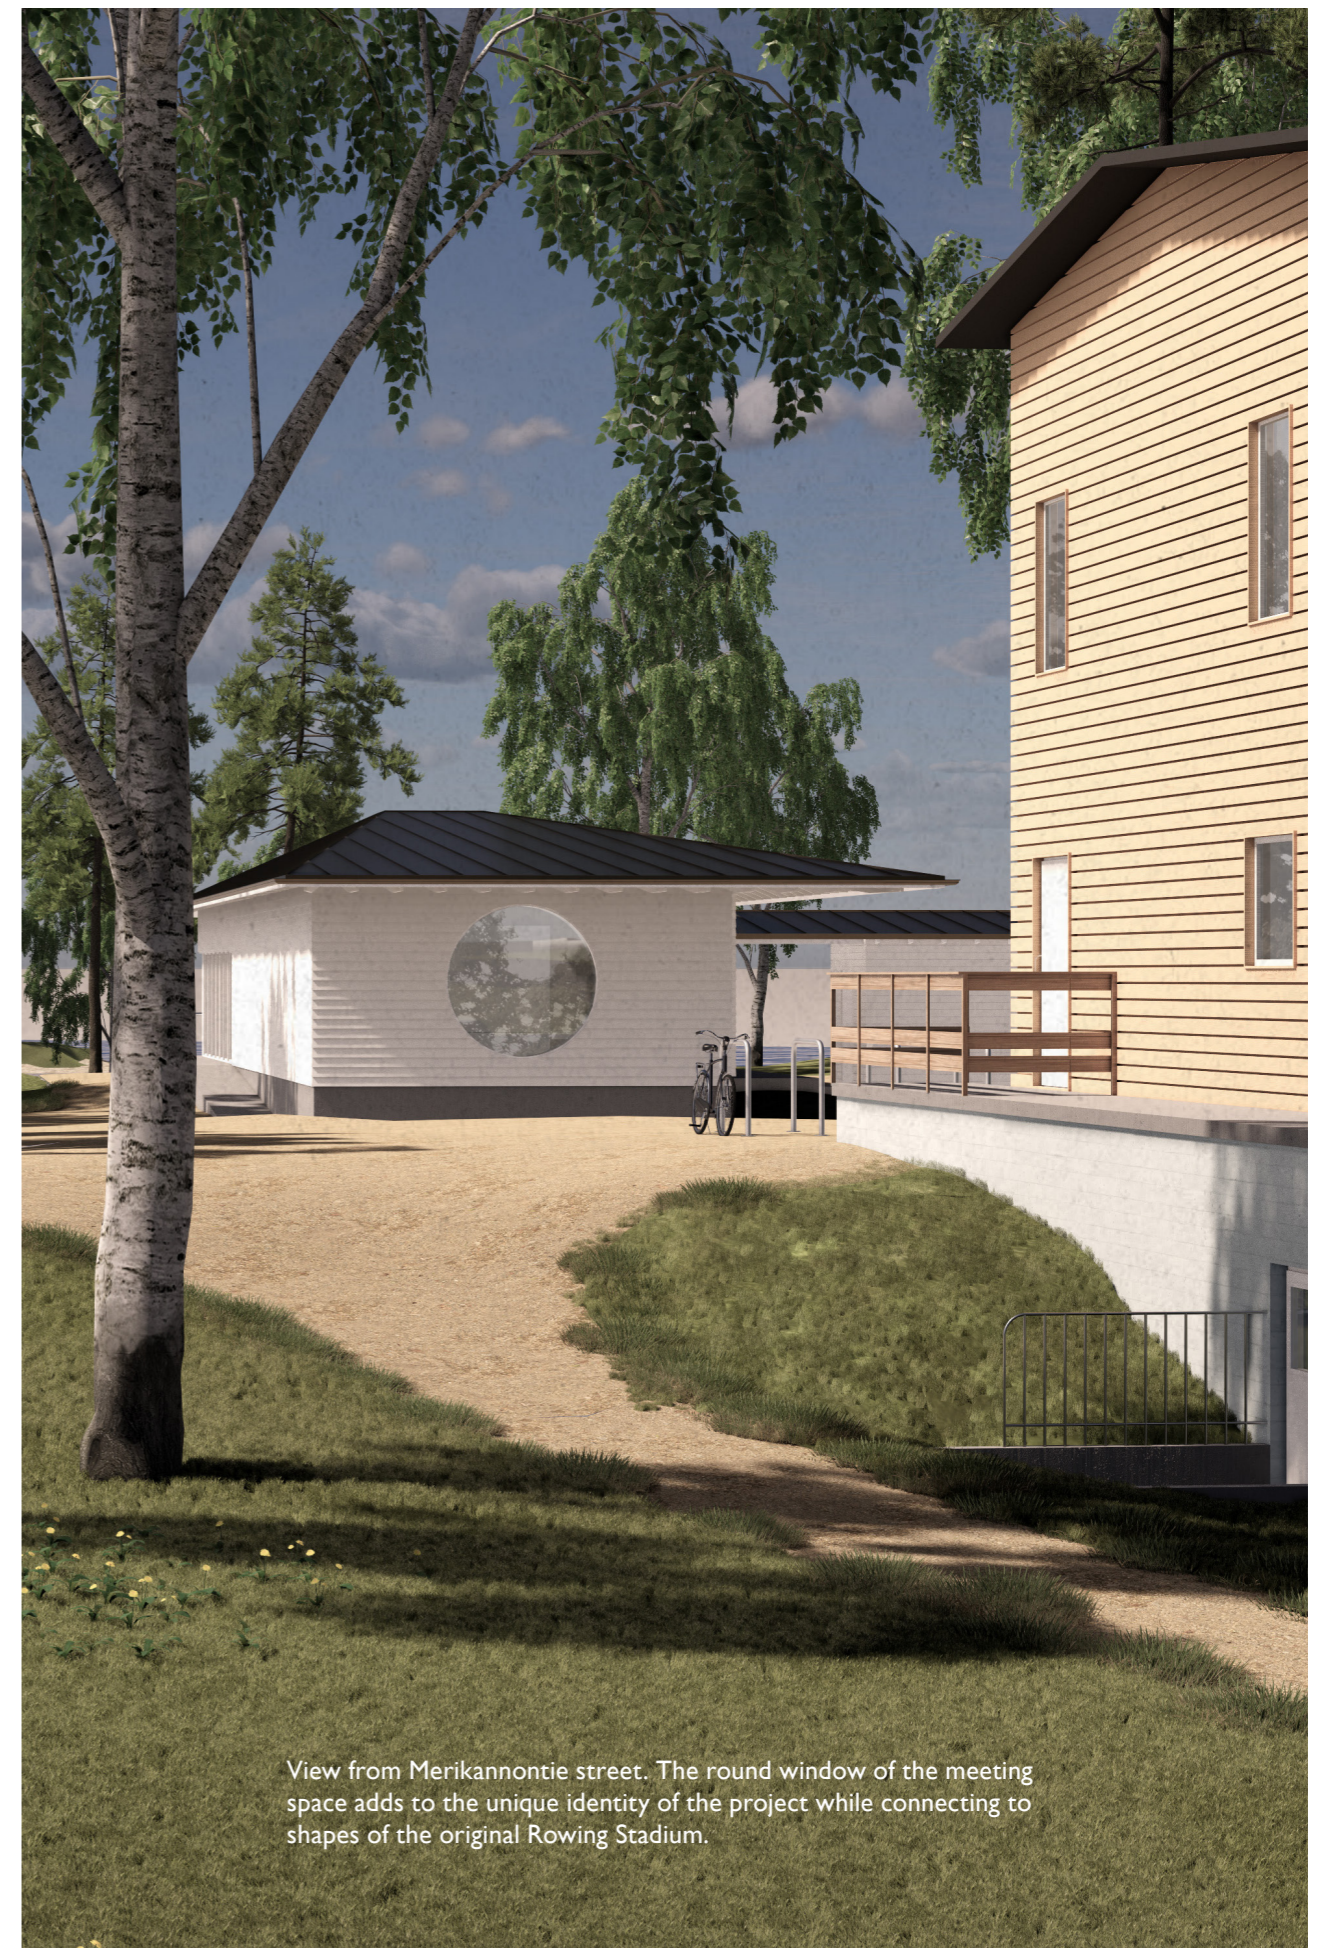
View from Merikannontie street. The round window of the meeting space adds to the unique identity of the project while connecting to shapes of the original Rowing Stadium.

A circular window on the gable of the meeting space adds to the building's own identity while reflecting the round shapes and windows of the Rowing Stadium.

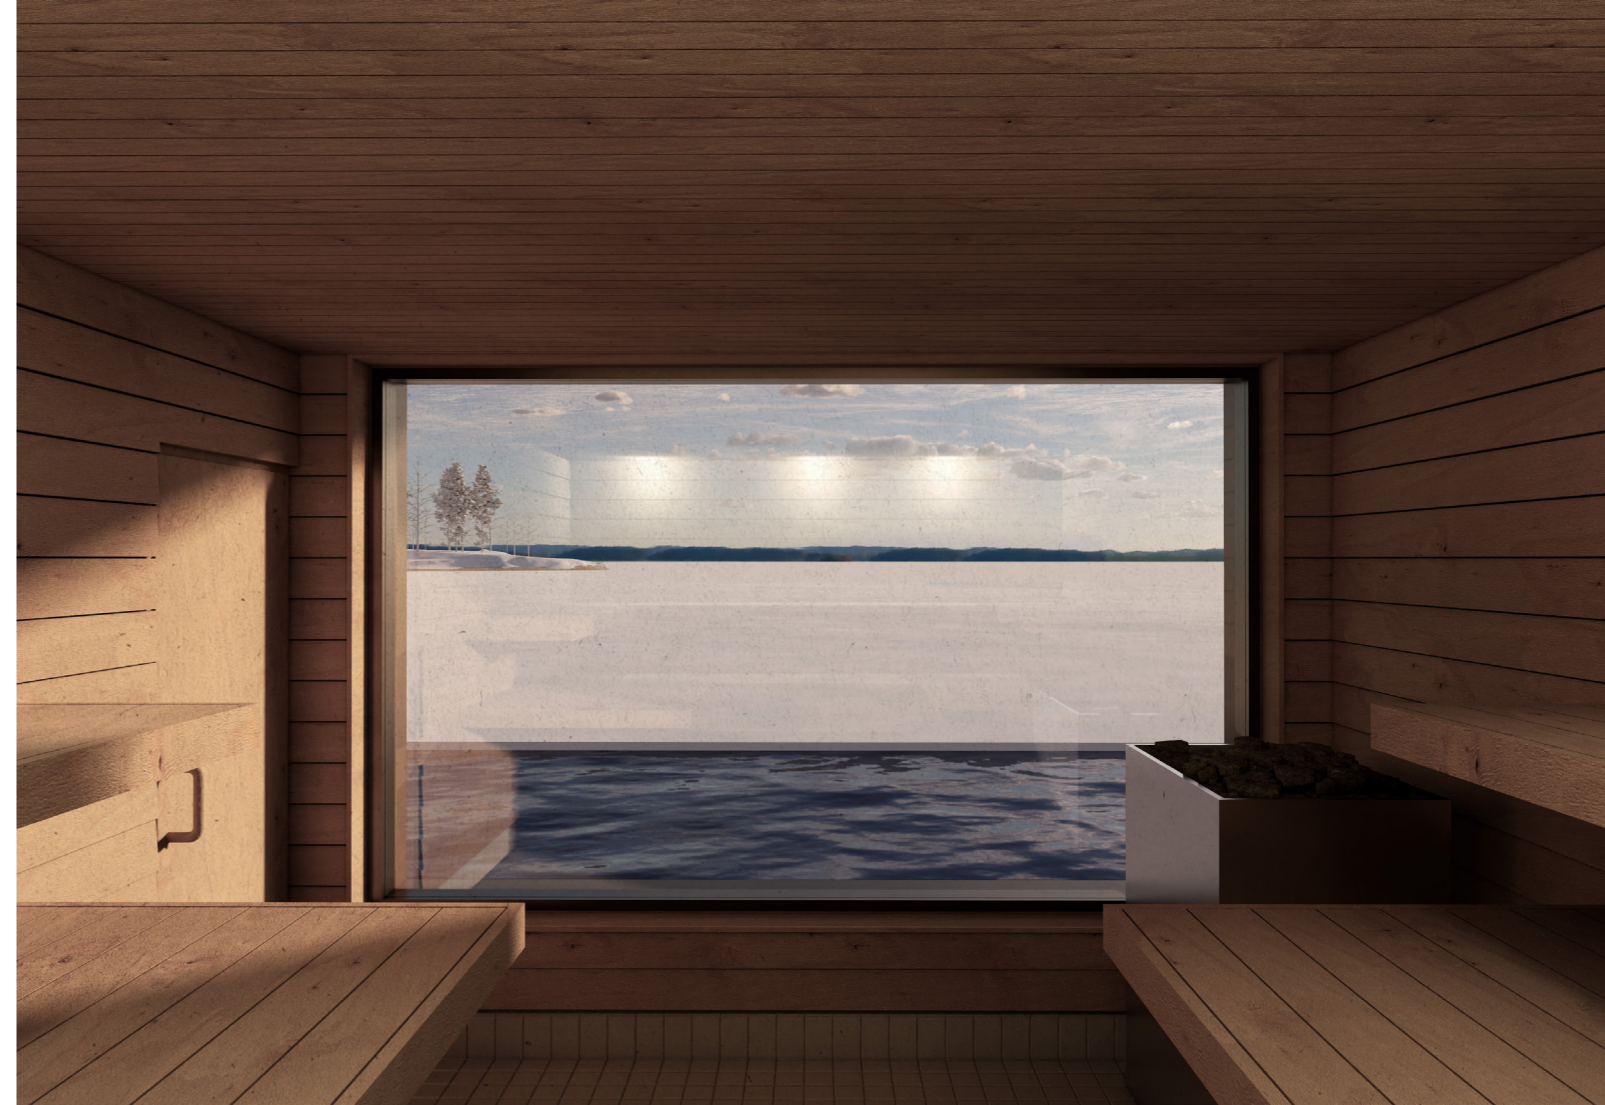
The sauna window provides a scenic view over the open water.

The Sauna is located on top of the dock, shifted in its direction in relation to the Rowing Stadium for the sauna to face the best view over the sea. The entrances have steel frames for privacy and wind shield.
