# **Repurposing cultural heritage:**

Design proposal for the Olympic  
Rowing stadium in Helsinki

Degree project in Architecture

Lund University

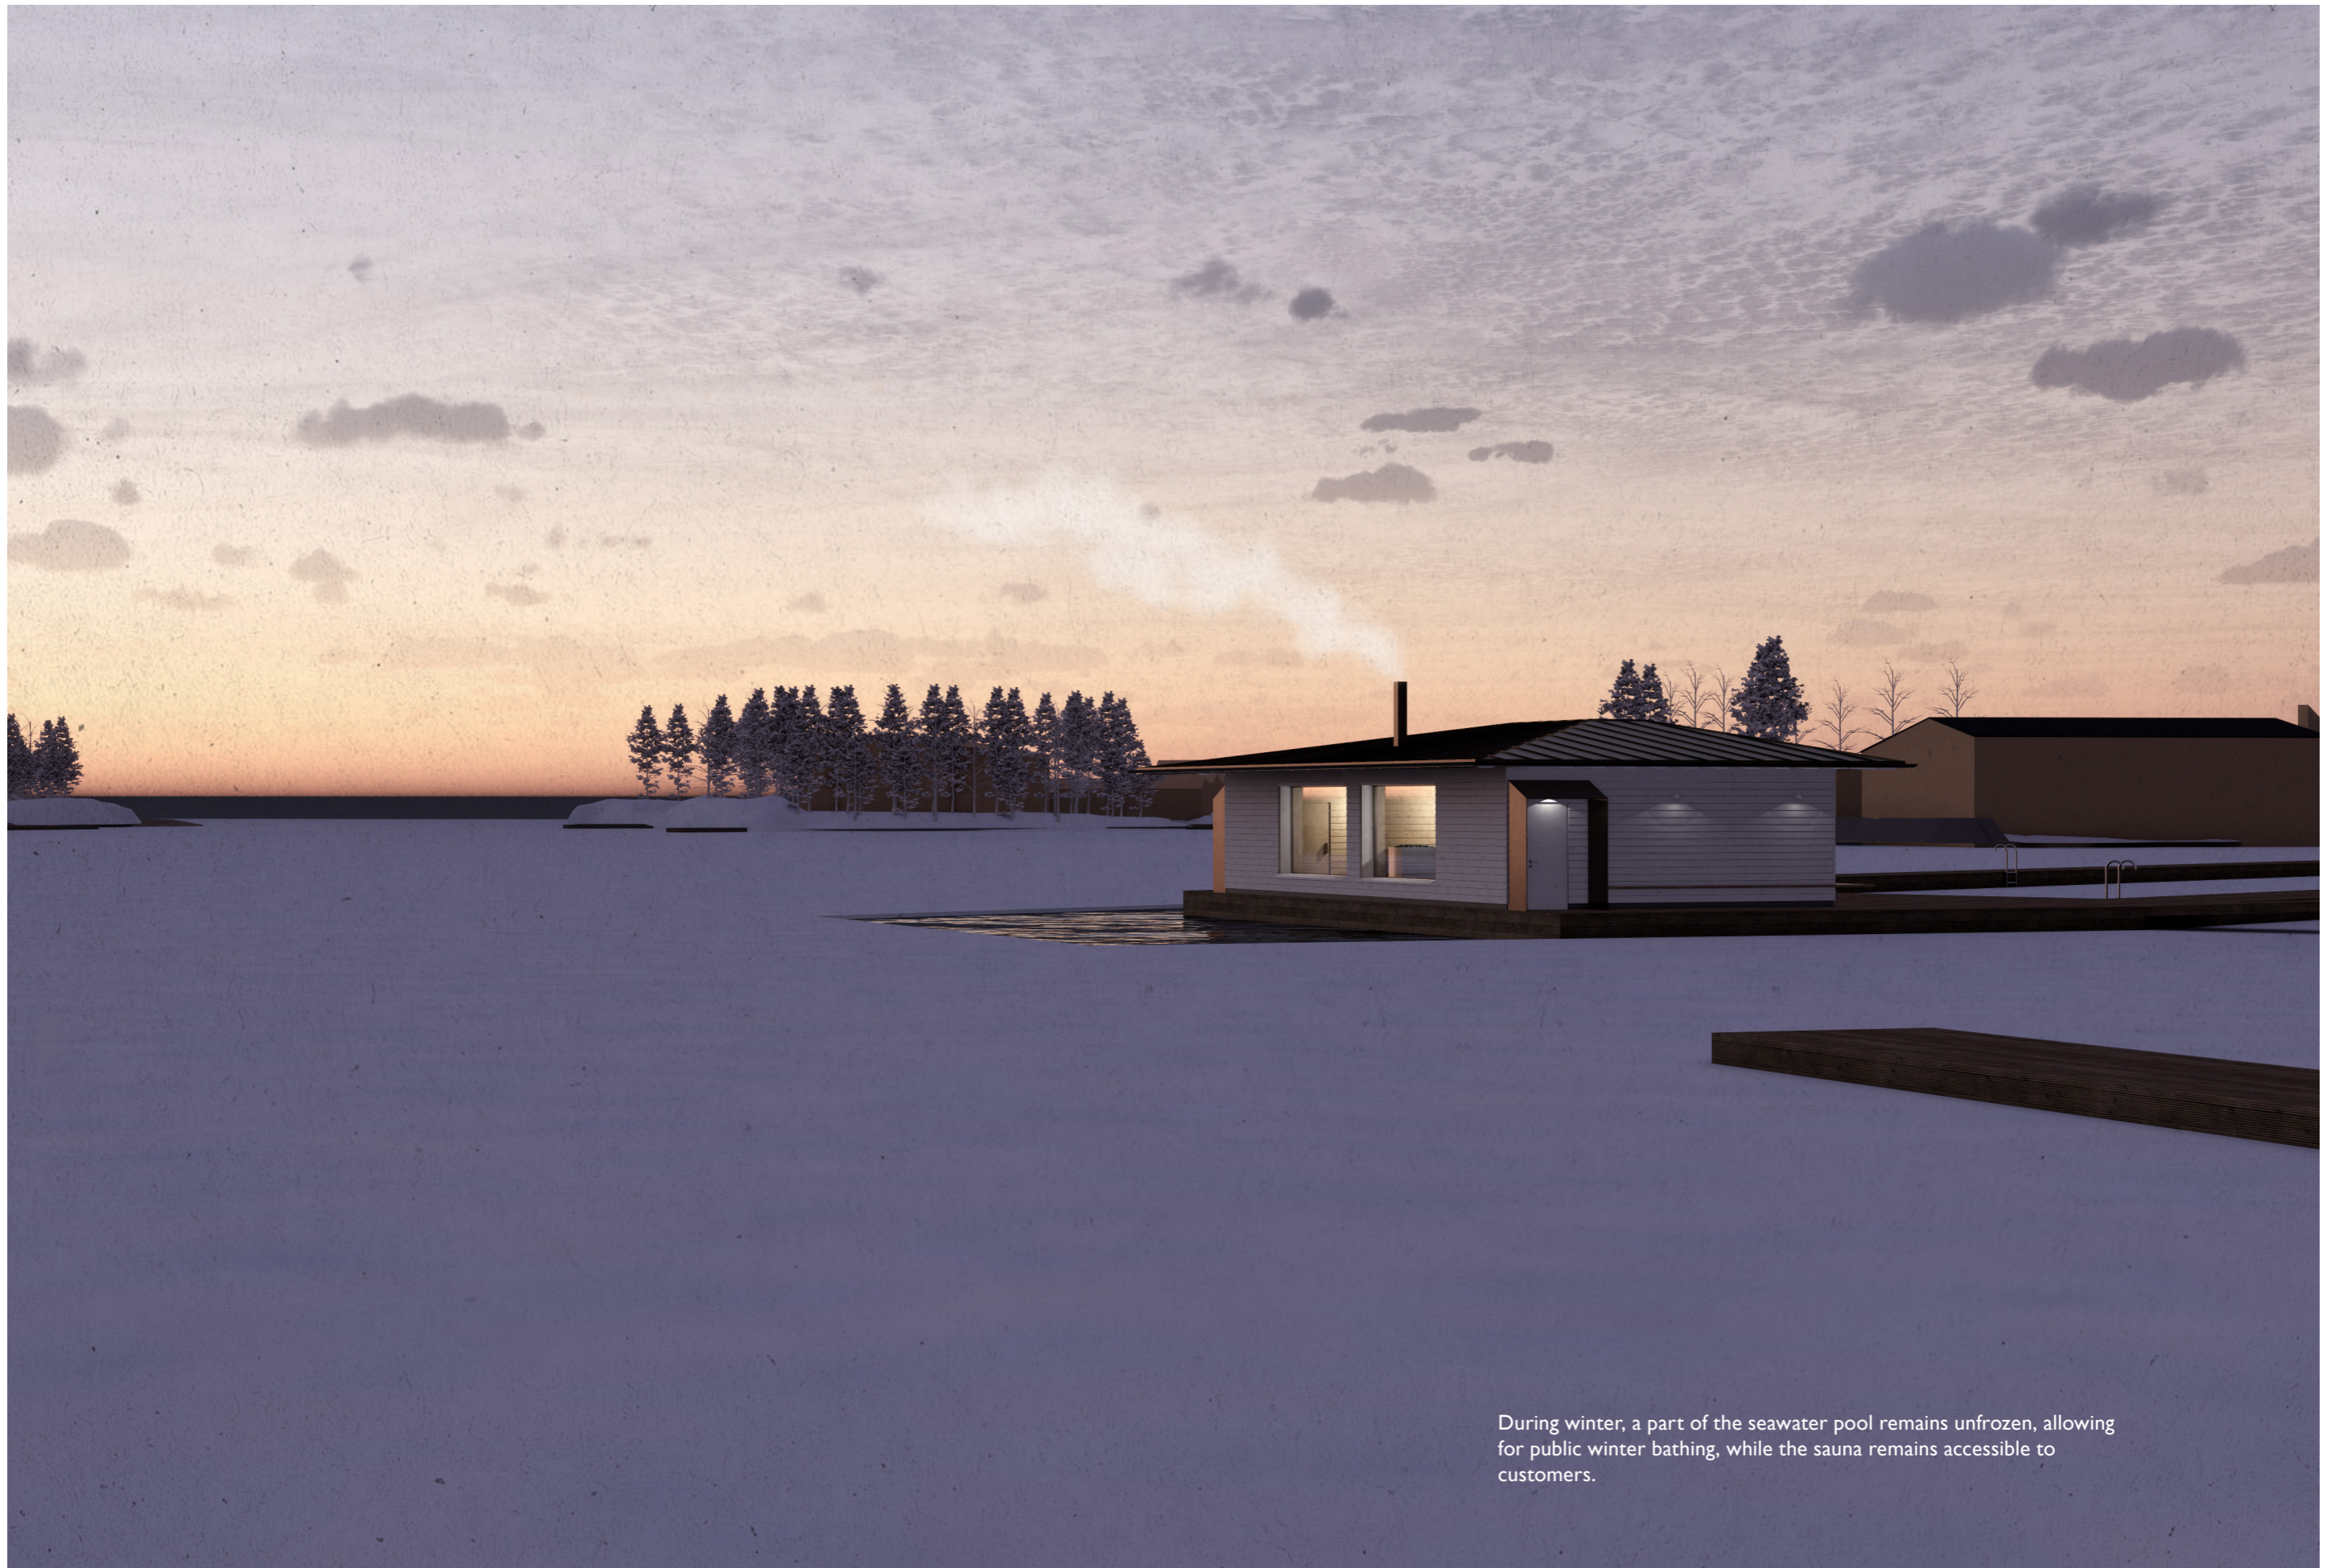
During winter, a part of the seawater pool remains unfrozen, allowing for public winter bathing, while the sauna remains accessible to customers.

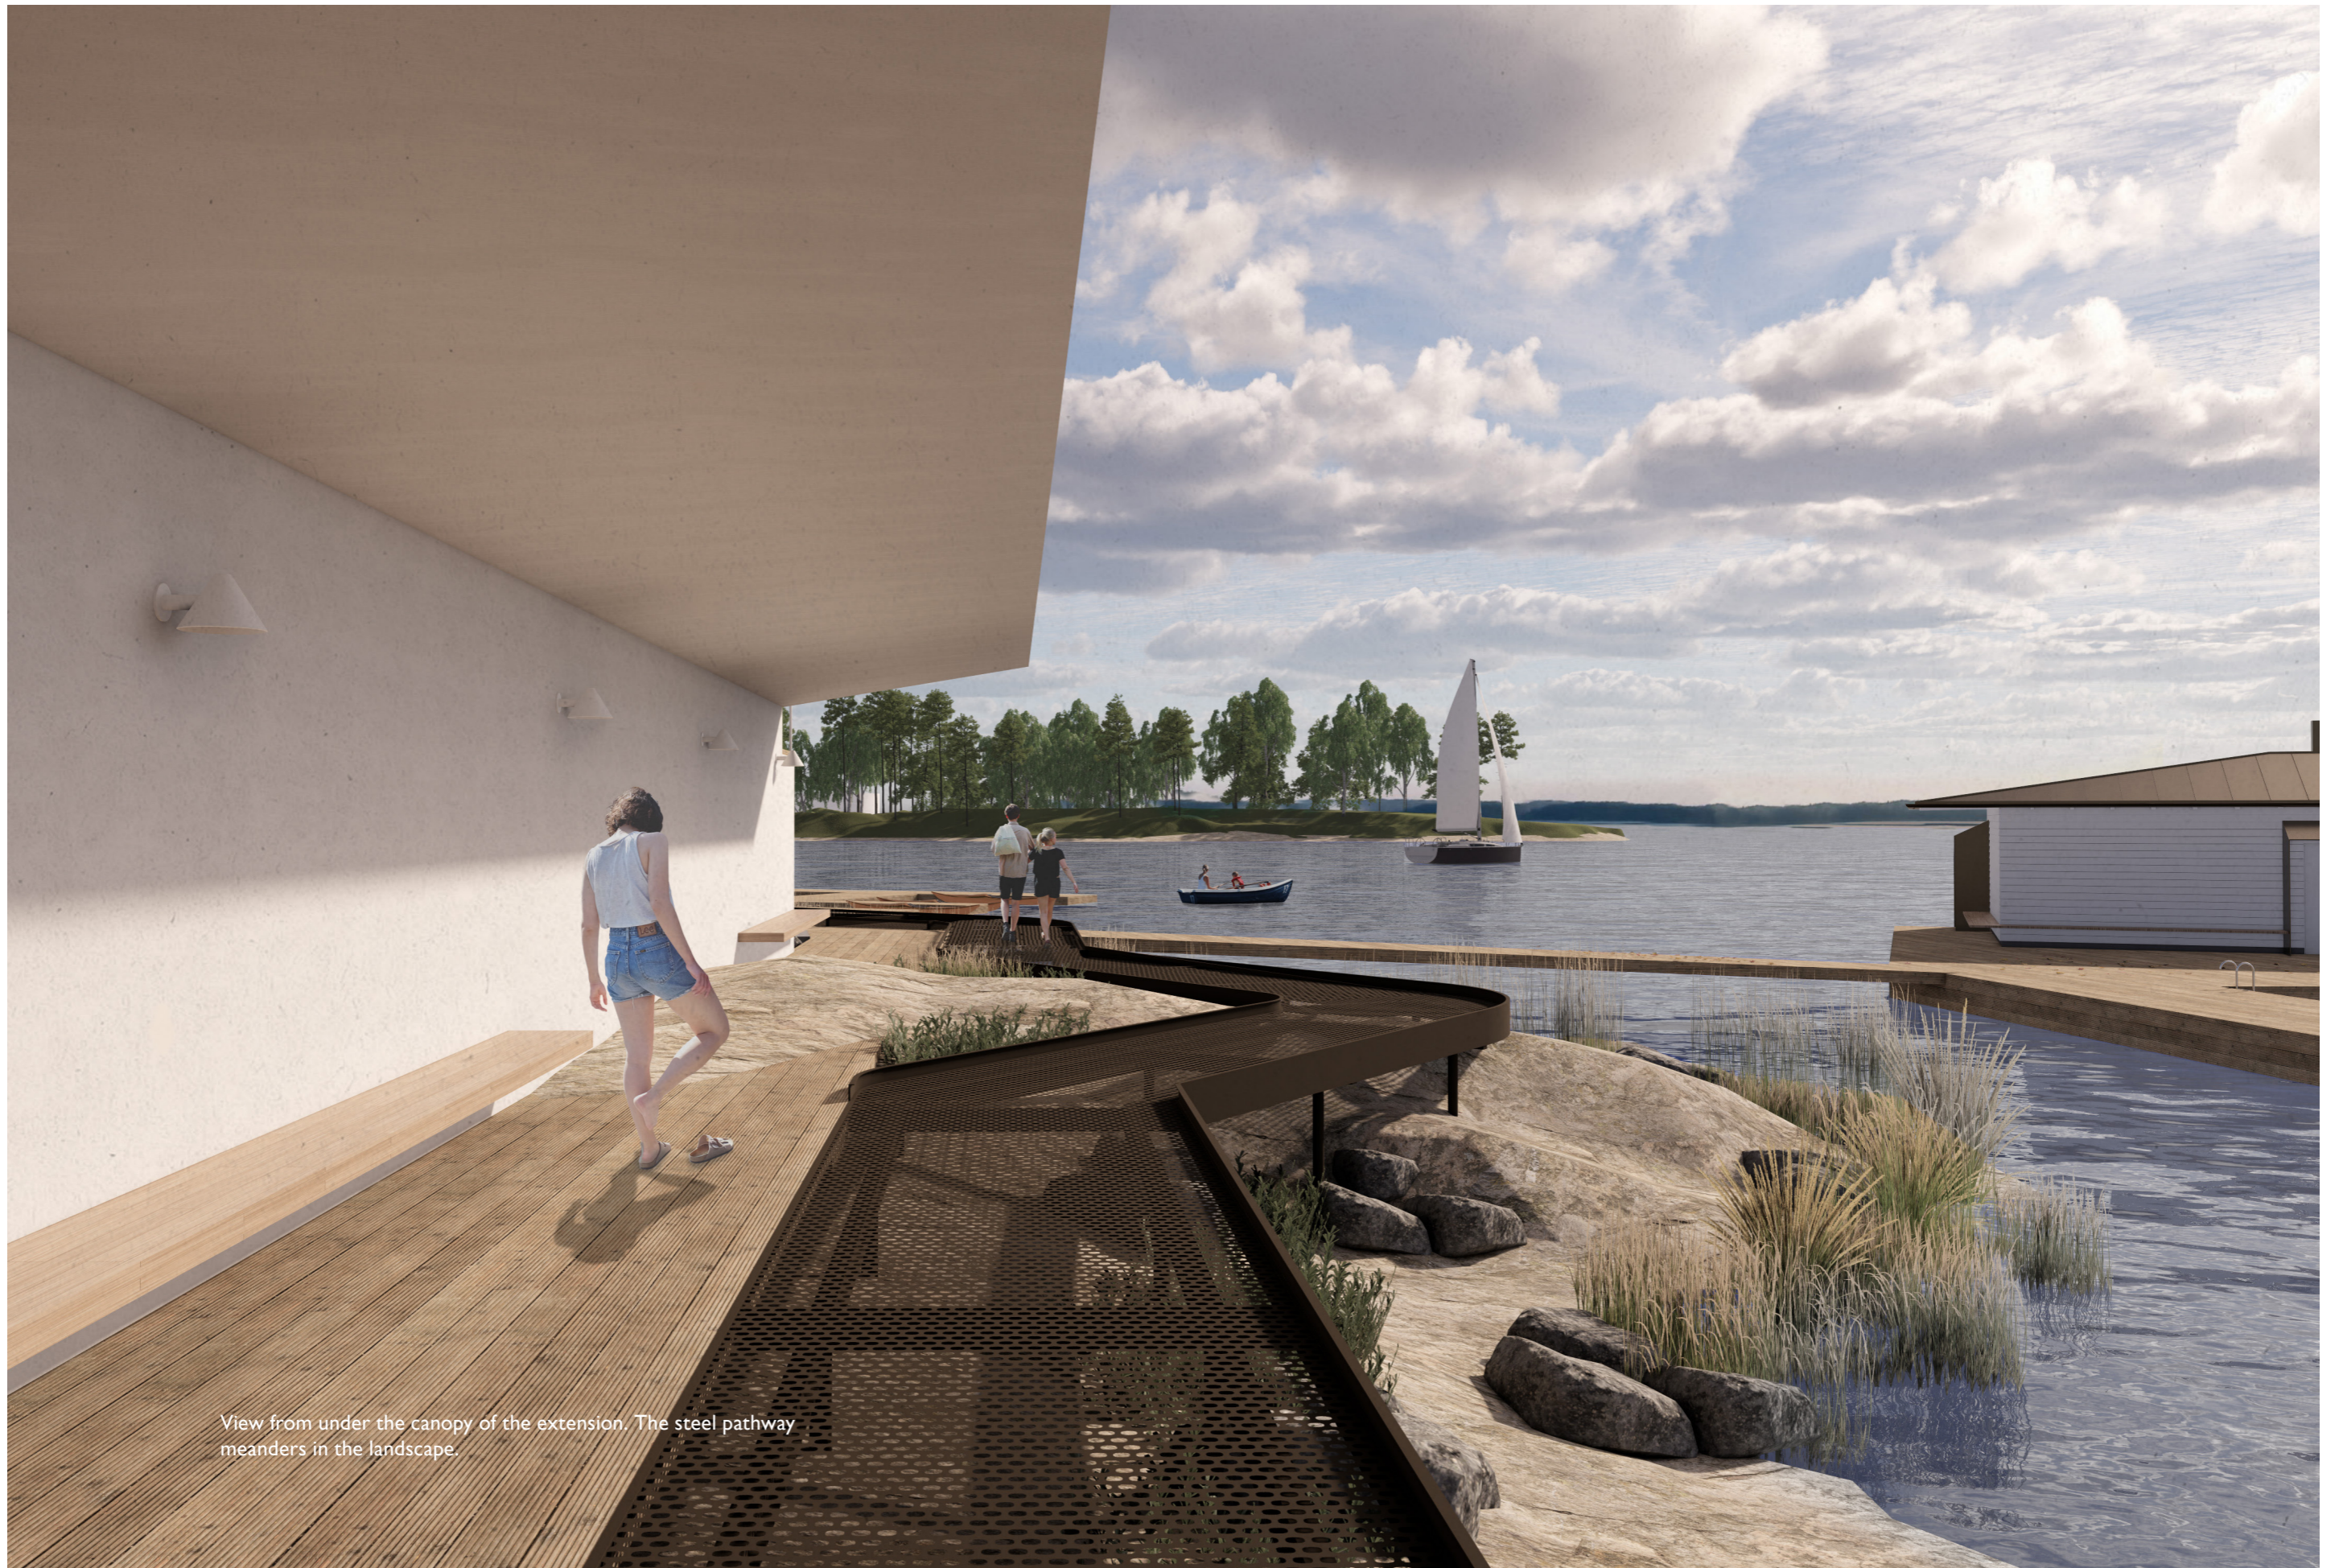
View from under the canopy of the extension. The steel pathway meanders in the landscape.

The concept for the pathway is its low impact on the landscape and respect of the surrounding nature. The steel pathway has a metal grid walking surface that allows the sea to pass through if the weather is rough. The structure is supported by helical stands due to their small surface-area against the underlying nature. The steel pathway is powder coated dark brown to blend into the landscape and be harmonious with the wooden materiality of the surrounding additions.
