Fall prevention device - Signal recordings using a mm-wave radar sensor

Selma Tomine Kjernsvik (BME-21), Ines Cela (BME-21)

Swedish title: Fallpreventionsutrustning - Signaldetektering med en millimetervågsradarsensor

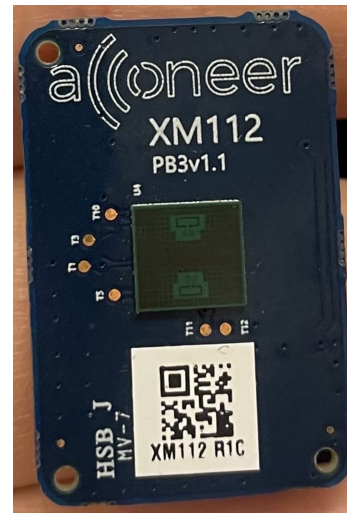
Figure 1. Acconeer 112 XM sensor

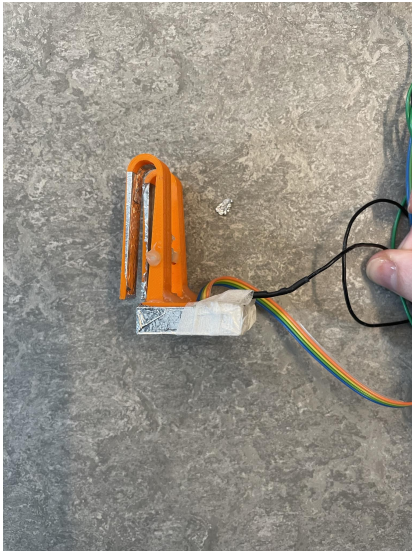
Figure 3. The sensor in its 3D printed case

The 3D printed case where the sensor sits is plastered in a self adhesive aluminium foil to minimize static electricity. Two electrodes are connected to the circuit board, one is plastered with foil and attached to the orange 3D printed case that holds the sensor, while the other is placed in contact with skin.

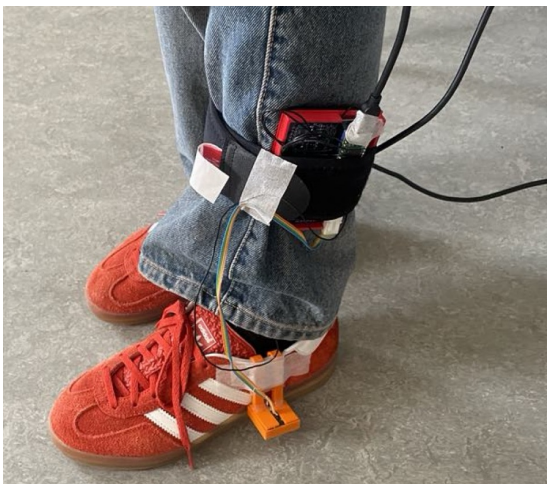
To do a signal recording, the 3D-printed part with the circuit board needed to be fastened to the ankle with the velcro band, see figure 4. One of the electrodes had to be in contact with skin and was either placed inside the sock or with a small piece of tape.

Figure 4. Sensor placed on the side of the foot

The sensors 3D-printed case was attached to the shoe using its hooks, shown in figure 4 and figure 5. The device was connected to a computer via a micro-USB cable. When ready a yellow light on the device lights up, to indicate that a stable connection is established. If the connection is unstable, a smaller red light further up lights up. To start the recording the white arrow at the top of the screen in labVIEW was clicked, and to stop the STOP button in labVIEW was clicked, see figure 6.

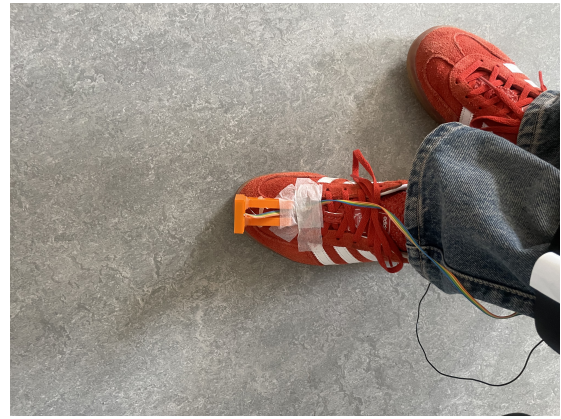
Figure 5. Sensor placed on the front of the foot

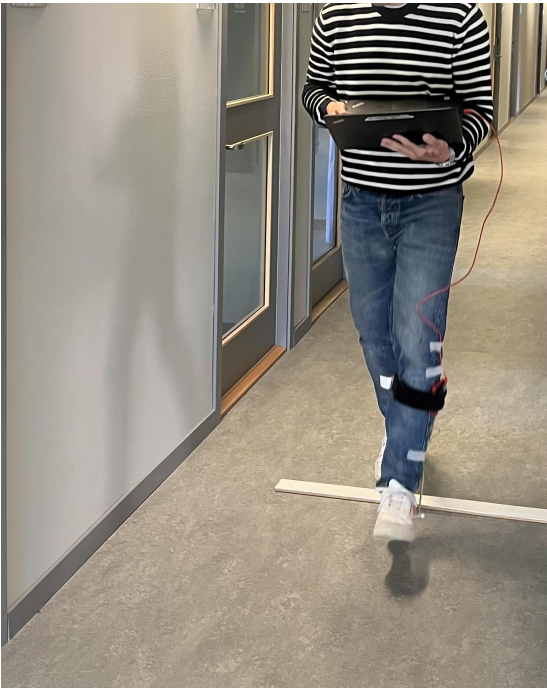
The volunteers walked with the computer in their hands and clicked the Enter button when taking a step over the object. They held down the Enter button when turning around to go back over the object, as seen in figure 7.

Figure 7. Volunteer walking over the wood threshold

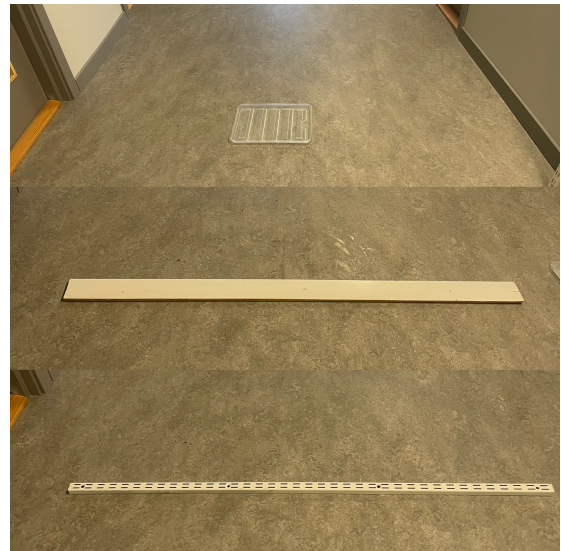
A small scale pilot study was conducted to form a protocol for the main data collection. During the protocol formation, numerous tests were done with two scenarios: the threshold and water pit. First the threshold was tested by walking in and out of rooms and around the corridor, the button was pressed when crossing the threshold. The tests were performed at varying paces, with different focuses and had different lengths. The length of the recordings ranged from 3 and 10 minutes. Ultimately it was determined that 5 minute recordings were best. For some tests the emphasis was solely to walk over thresholds with minimal movement around the corridor, in other tests the focus was to walk around in the corridor between each step over the threshold. To create an indoor water pit, first it was attempted to pour water directly onto the floor, this was not a good solution. Therefore a plastic container lid, see figure 9, was filled with water, as a more suitable solution.

Figure 9. Water pit, wood threshold, metal threshold
