Changes in the Course of the River Komadugu Yobe during the 20th Century at the Border between Niger and Nigeria

Division of Water Resources Engineering
Department of Building and
Environmental Technology

Lund University

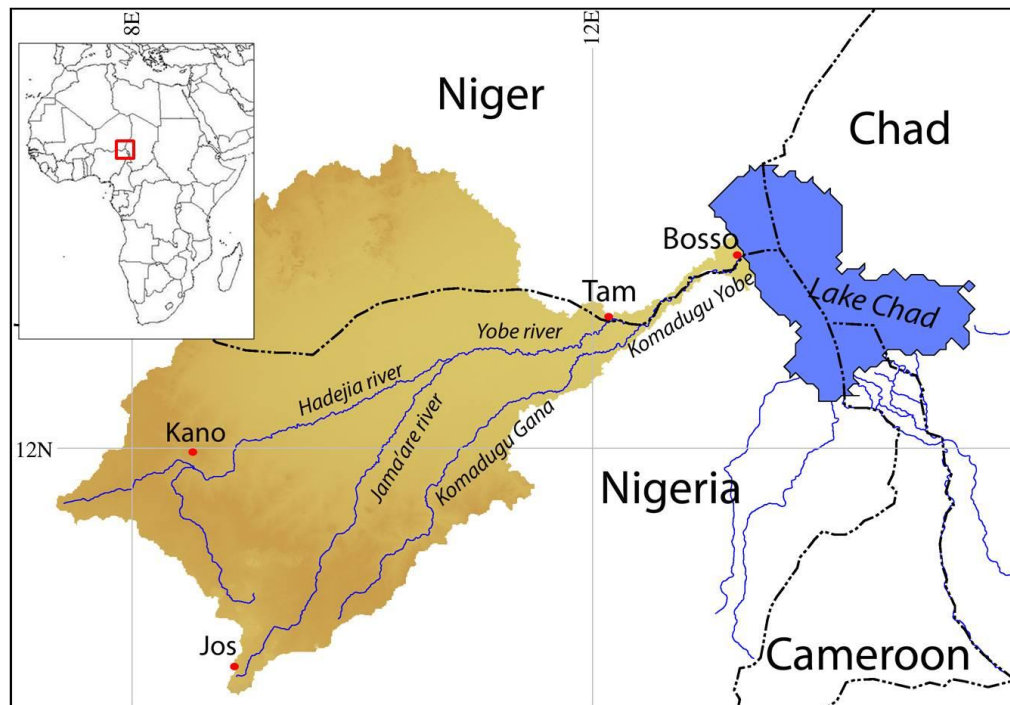
Figure 1.1. The Komadugu Yobe basin and its location in Africa (Revised from Le Coz, 2009).

The Komadugu Yobe basin is about 148,000 km² (Oyebande, 2001). It has its source in the plateaus of Kano and Jos in Nigeria (Ministère de l’Hydraulique, de l’Environnement et de la Lutte Contre la Désertification, 2002). The Hadejia river and Jama’are river in Nigeria together forms the Komadugu Yobe (Oyebande, 2001). The basin can be seen in figure 1.1.

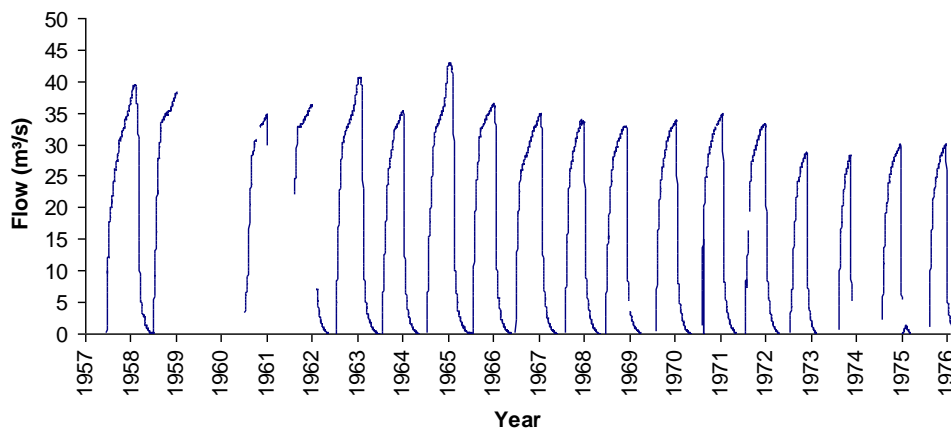
Figure 1.3. Daily flow in Gueskérou from 1957 to 1976 (Data obtained from IRD and DRH).

The daily flow in the river has been measured in Gueskérou between 1957 and 1976, with a few periods with no measurements (fig.1.3).

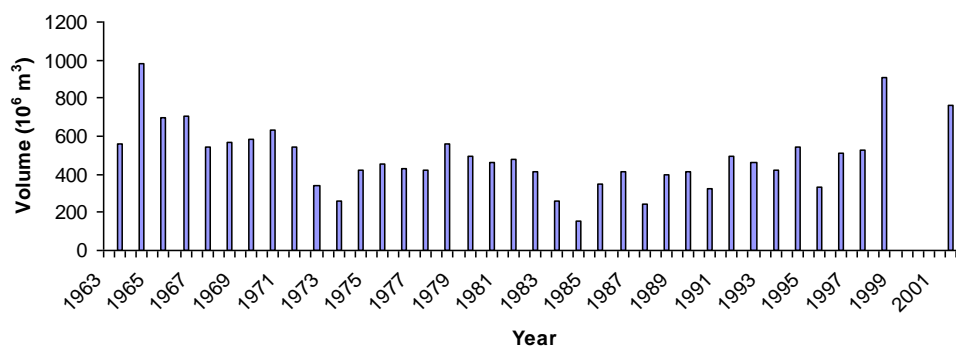
Figure 1.4. The annual runoff volume measured in Bagara from 1963 to 2002 (Data obtained from DRH).

The annual runoff volume (fig.1.4) has been measured in Bagara from 1963 to 2002. Figure 1.5 shows the runoff volume converted to millimeter for the same years. The diagram indicates that the runoff volume corresponds to a runoff of two to seven millimeters each year for the Komadugu Yobe basin (the basin for the river in Bagara is considered 140,000 km²).

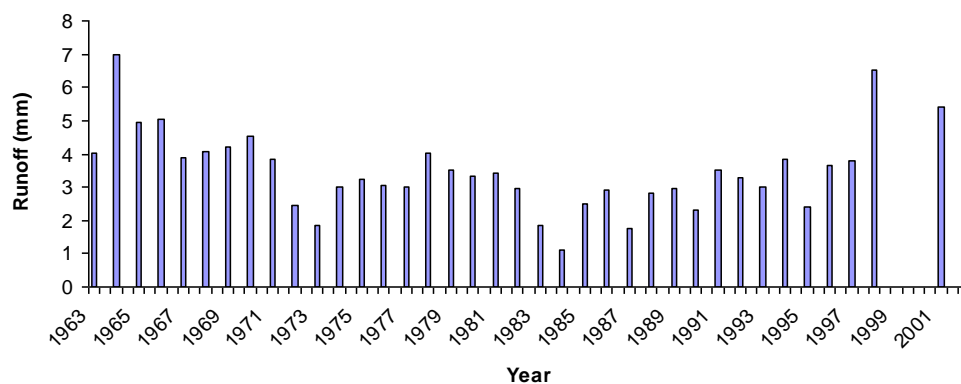
Figure 1.5. The annual runoff in millimeters for the Komadugu Yobe basin from 1963 to 2002. (Data obtained from DRH)

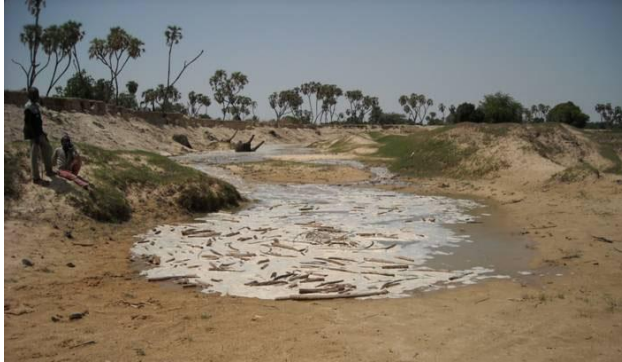
Figure 1.6. Arrival of the seasonal Komadugu Yobe in Gueskéro, 21st of July 2009 (Photo by S. Anderson, pers. comm.).

The period of which the river flows each year has been measured in Bagara from 1966 to 2002. The water in the river usually arrives in June or July (fig. 1.6). In 1970, 1973 and 1975 the water arrived in August. The water usually stops flowing in February or March (Data obtained from DRH).

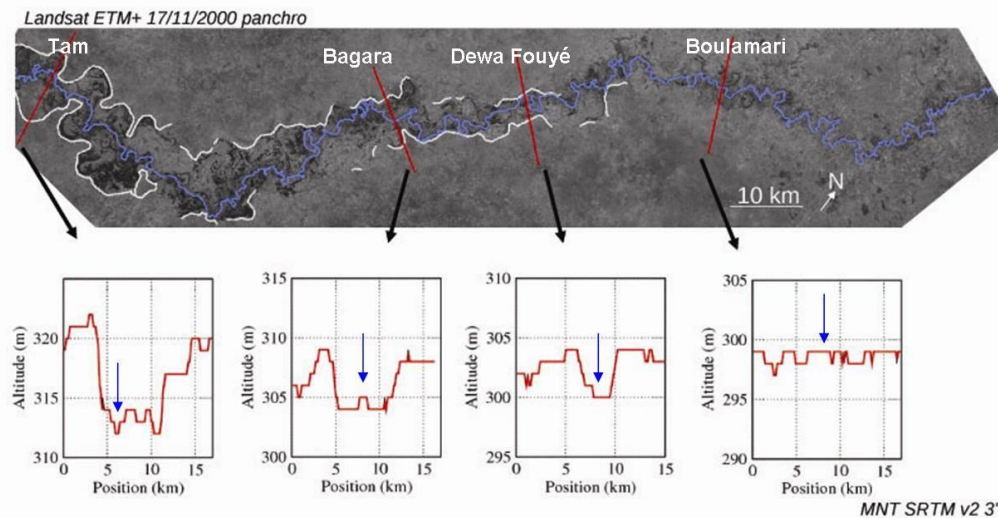
Figure 1.7. The changes in the cross-section of the Komadugu Yobe valley upstream to downstream. The blue arrows indicate the approximate position of the river's channel (revised from Le Coz, 2009).

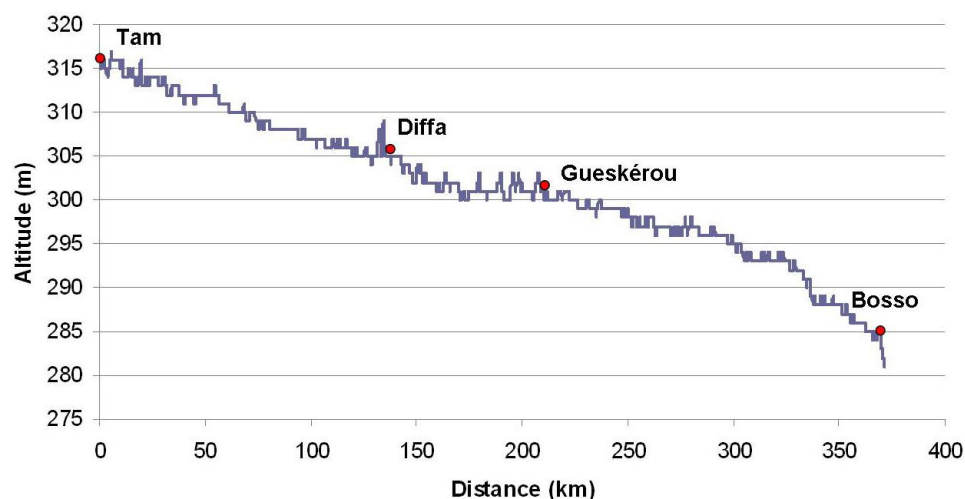
Figure 1.8. The slope of the riverbed from Tam to Bosso (Revised from Le Coz, 2009).

Figure 1.8 shows the slope of the riverbed upstream to downstream. The altitude is measured from a 3" SRTM DEM (Shuttle Radar Topography Mission, Digital Elevation Model) which has an approximate resolution of 90 meters.

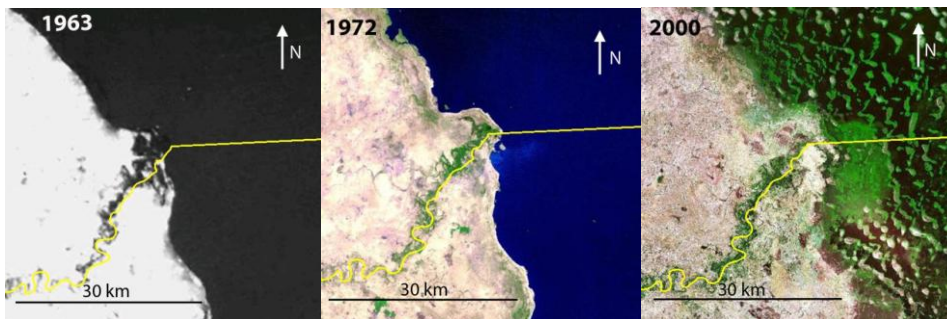
Figure 1.9. Komadugu Yobe's mouth in Lake Chad during different years (Google Earth, 2009).

The water level in the Lake Chad is fluctuating (Olivry et al., 1996). The fluctuation has an impact on the river's course at the delta. Figure 1.9 shows the part of the lake where the river has its mouth, in different years. The yellow line is constant over the years and can be used as a reference for the changes.

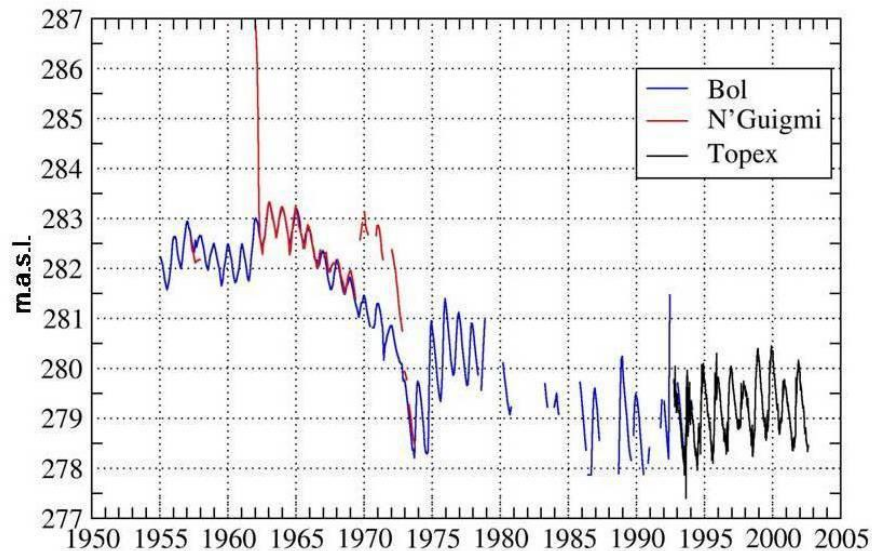
Figure 1.10. Lake Chad's altitude from 1954 to 2004 measured from three different places. (Le Coz, 2009. Data obtained from: Olivry et al (1996), ORSTOM and LEGOS).

Figure 1.10 shows the variation in the water level in Lake Chad from 1954 to 2004. The measures were extracted from three different places: water level observations in Bol and N'Guigmi, and estimated levels from the Topex/Poseidon satellite. Bol is a village situated in Chad from where the water level in the southern pool of the lake is measured. N'Guigmi is a village situated in Niger and from where the water level in the northern pool, where the Komadugu Yobe intersects, is measured. Topex/Poseidon is a satellite measuring the level in the southern pool. As seen in the figure, the water level has diminished since 1954 with a sudden drop in the 1970s.

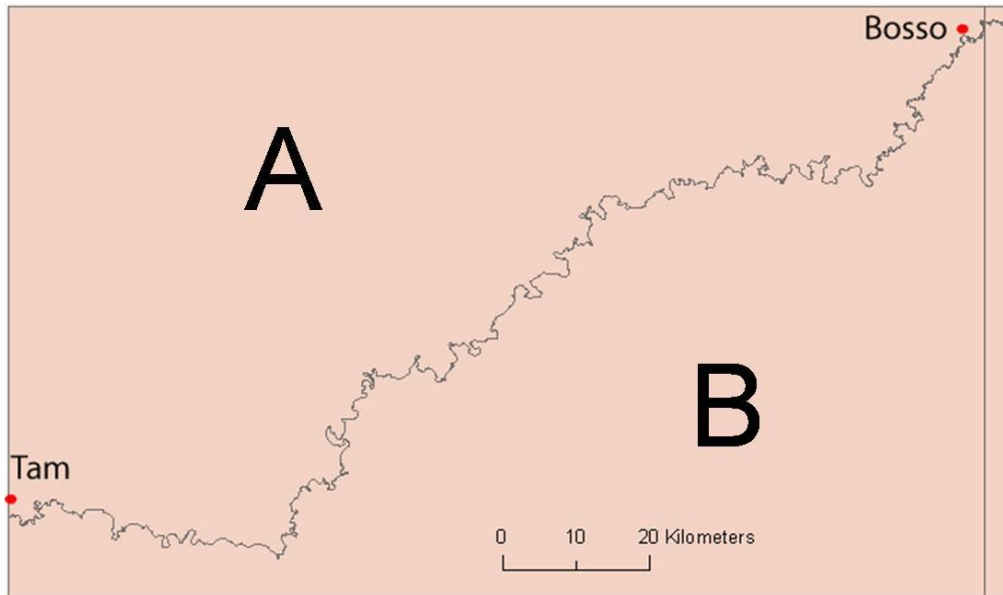
Figure 2.3. Example of a polygon squaring the polyline representing the river from the Landsat images from 1999/2000.

The surface area was calculated from the beginning of the river in Tam until downstream of Bosso, just before the river separates into two channels. The straight vertical line after Bosso in figure 2.3 shows the limit of the surface area calculation.

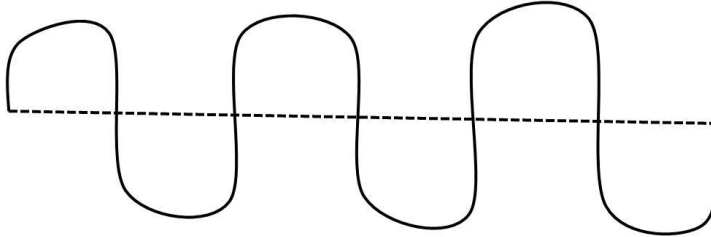
Figure 2.4. A polyline representing a meandering river and a dashed line representing the straight line from the starting point to the end point of the river.

the starting point to the end point of the river. The quotient is the sinuosity of the river.

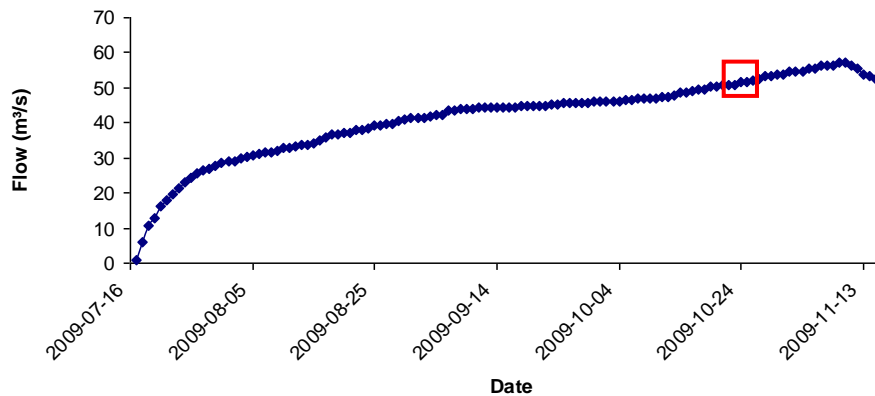
Figure 2.5. Diagram indicating that the time of the field visit (red rectangle) was made near the maximum flow at Bagara (Data obtained from DRH).

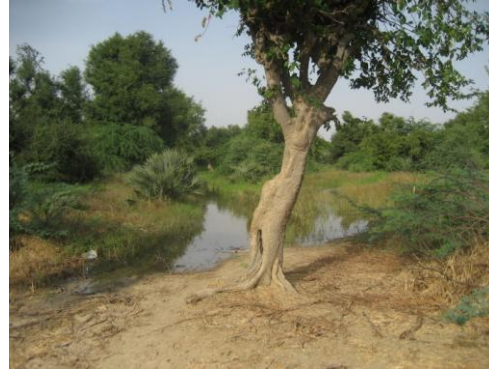
Figure 2.7. Water in front of Gaidam Tchouckou, 24th of October 2009.

The travel to the villages was sometimes difficult (fig. 2.6) and Gaidam Tchouckou was not visited as it was inaccessible due to the river flooding the surroundings of the village (fig. 2.7).

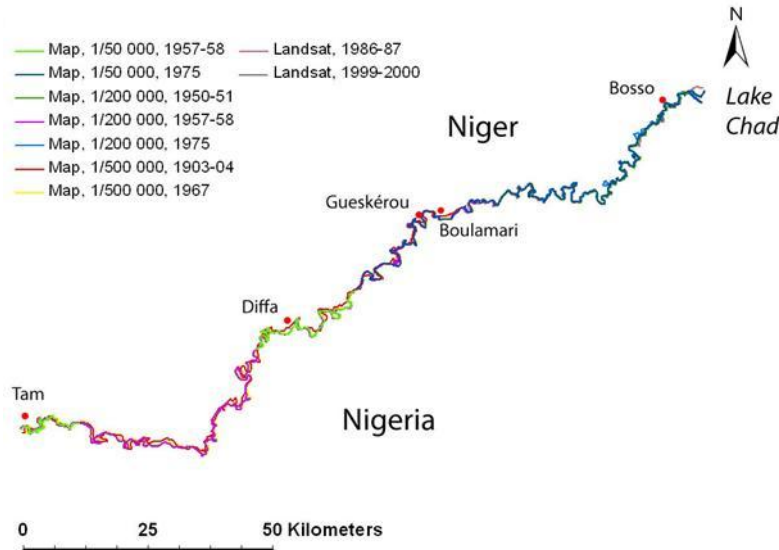
Figure 3.1. The polylines representing the different courses of the river.

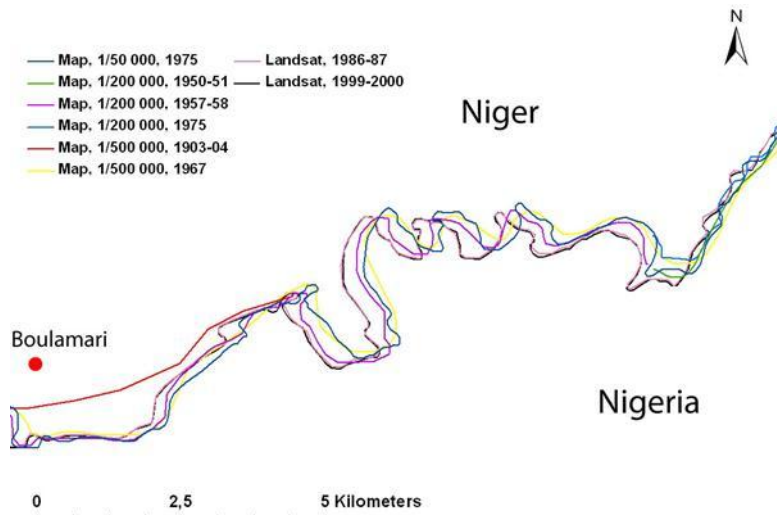
Figure 3.2. Zoom of the different polylines representing the river.

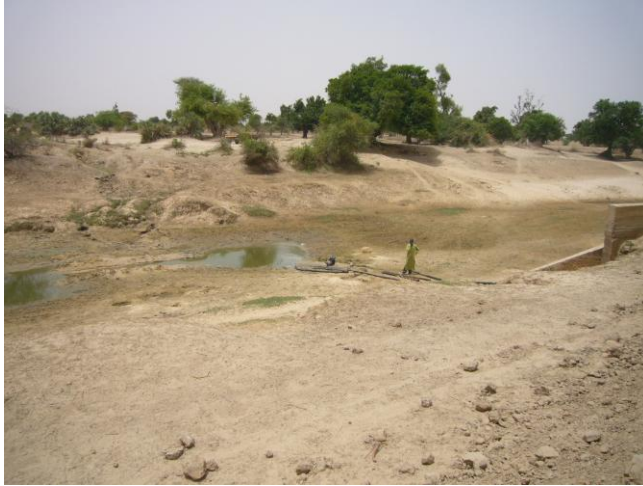
Figure 3.3. Pumping of outcropping groundwater in the riverbed during the dry season in June 2009 (Photo by G. Favreau, pers.comm.).

bored “a well” in the riverbed to be able to reach the groundwater when the river is dry as the layer of sand has become thicker (fig. 3.3).

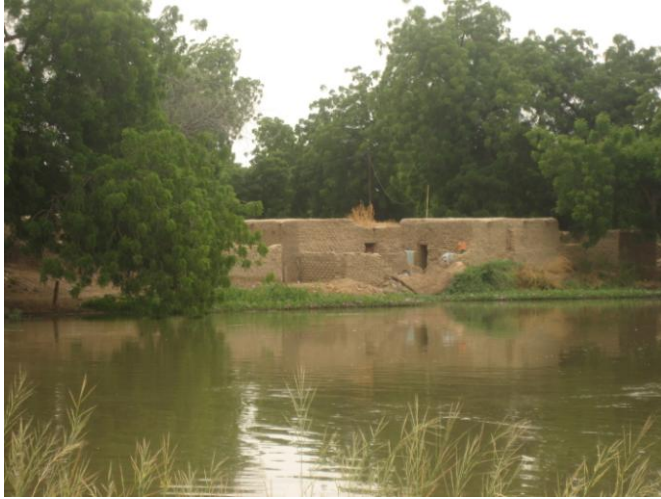
Figure 3.4. Threatened houses at the riverbank in Lada, October 2009.

All villagers living along the river are aware of that the river is the border. Some said that when the river's course changes, so does the border (Tam, Dewa Fouyé, Abadam). The change of national territory concerning their property does not seem to be a problem as the lands would still be theirs on the other side of the border (Bagara, Assaga, Boulamari). The Nigerian villagers are also cultivating on the Niger side of the border. The biggest problem that comes with the dynamic river is when it destroys fields and sometimes even houses (Lada, Bagara, Gaidam Tchouckou). In Lada three or four houses have been destroyed recently (fig. 3.4).

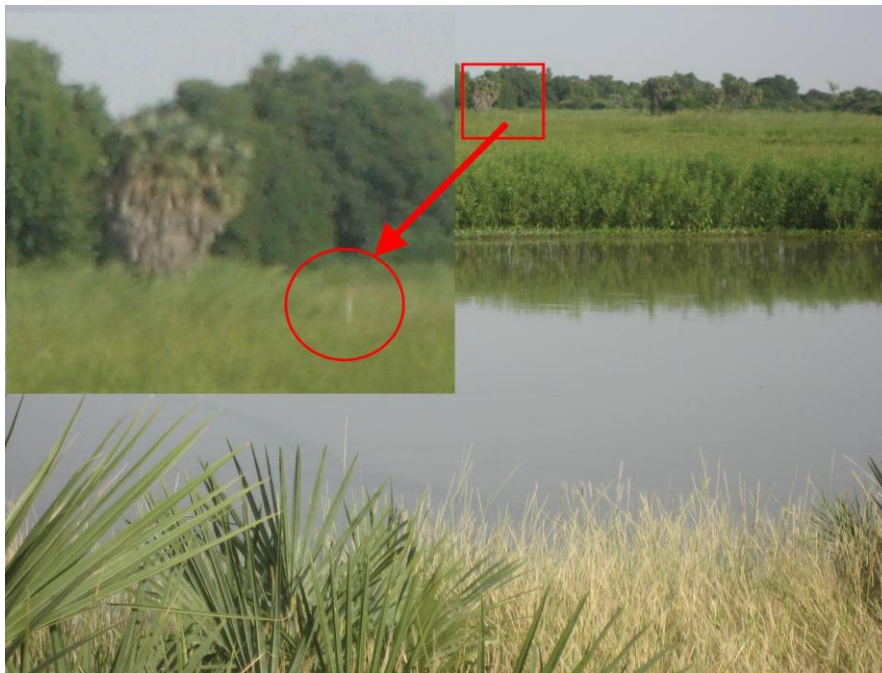
Figure 3.5. Photo of old beacon 148, October 2009.

It was sometimes difficult to interpret what the villagers meant. Concerning beacon 148 at Tam, the villagers said that the present beacon has been there for three years and that the old one was replaced by the military in 2004. It was then moved six meters to the north. They are also mentioning that the replacement of the old beacon was done by the commission of the delimitation of the border.

The two different beacons have been seen on the field and it is verified that there are two. However, it is not a distance of six meters between them. The distance is approximately 300-500 meters. The interpretation of this is that the old beacon was first replaced in 2004 and moved six meters to the north. Then, in 2006, another new beacon was put into place and it is this one which now marks border.

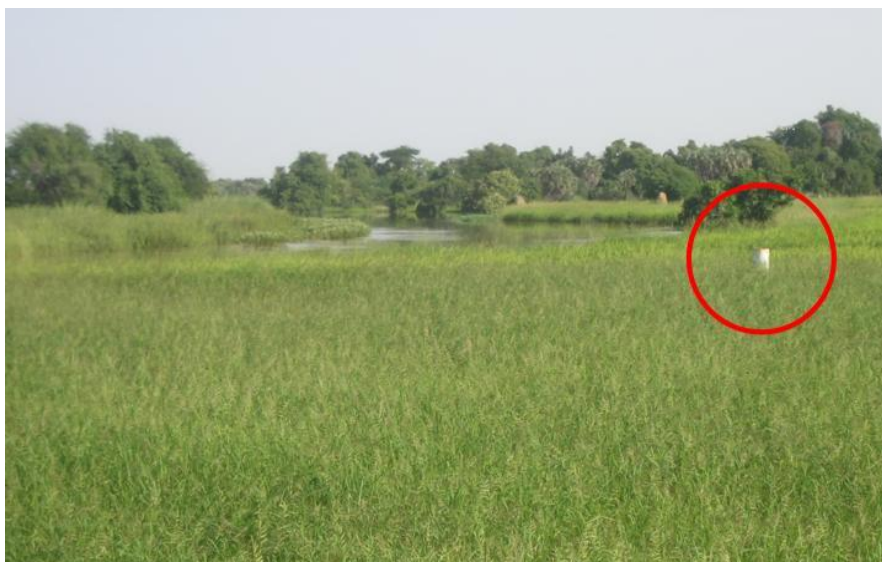
Figure 3.6. Photo of new beacon 148, October 2009.

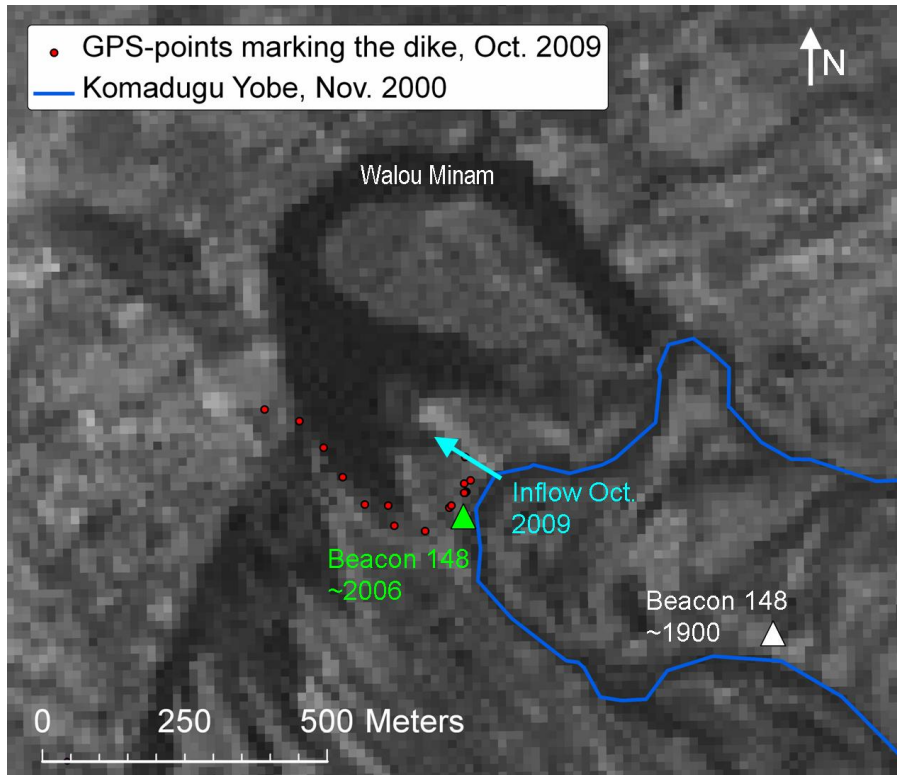
Figure 3.7. Location of beacons, dike and water flowing into the oxbow lake “Walou Minam” the 22nd of October 2009.

The river is eroding the banks surrounding the oxbow lake “Walou Minam” seen in figure 3.7. A dike has been built to protect the oxbow lake. The villagers at Tam said it would be a problem for them if the river connects to the oxbow lake. Other villagers along the river said they were not concerned about the changing border as they can continue to cultivate on their field, even if the river would move the field to the

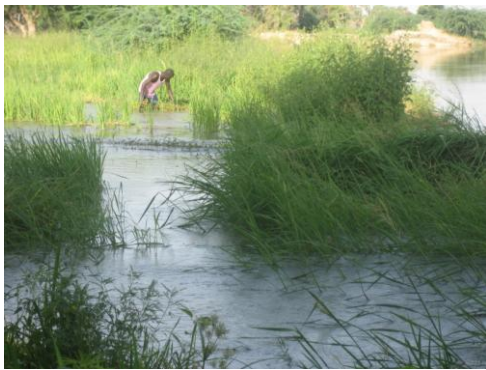
Figure 3.8. Inflow to the oxbow lake “Walou Minam”, October 2009.

opposite side of the border. The problem the villagers in Tam meant is probably connected to fishing. Today they can fish in the whole oxbow lake. If the river connects to it, they would only have the right to fish on their half. During the time of the visit, there was water flowing into the oxbow lake (fig. 3.8).

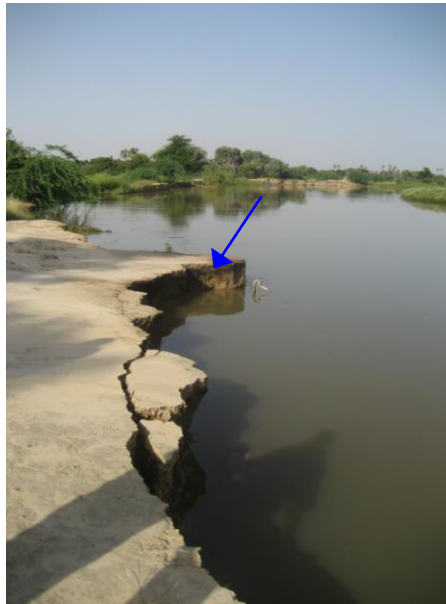
Figure 3.9. Photo showing erosion on the banks and ash traces at the tip of the arrow from the old settlement of Baradi, October 2009.

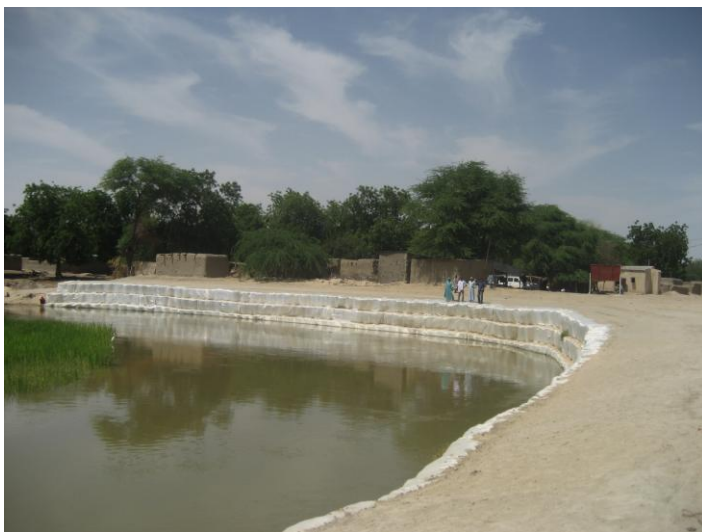
Figure 3.10. Reinforcement of the banks of the meander, by the local organization PADL, at Bosso.

The erosion is threatening numerous villages and houses along the river. In Bosso, the erosion on the meander is threatening the village and official buildings. The banks have been reinforced in 2009 by the local organization PADL (fig. 3.10).

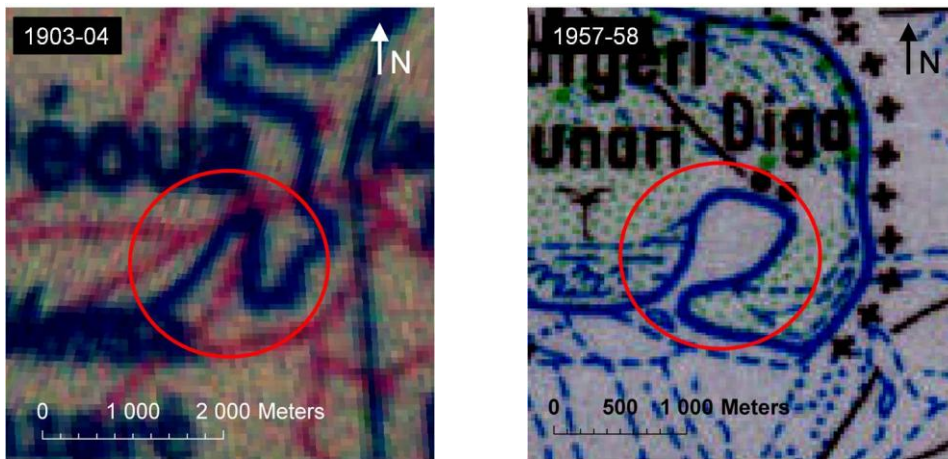
Figure 3.11. At the left, a map drawn from astronomic observations in 1903-04 and to the right, a map drawn from aerial photos in 1957-58. Both are showing a non-cut meander at Dewa Fouyé.

The meander close to the village Dewa Fouyé has been cut off. It happened after the colonisation according to the villagers. The village chief said that when he was young the meander was not cut off. It started during the highest water level the villagers have ever known and progressed during two to three years. Visually it happened when the river eroded through white sand. The maps from 1903-04 and 1957-58 show a non cut meander (fig. 3.11), while it is cut off on the aerial photo from 1975 (fig. 3.12). The flow measurements between these years (fig. 1.3) show that the biggest flow was in January 1965 (43 m³/s). This indicates when the meander might have been cut off. When this happened the land inside became a part of Niger territory.

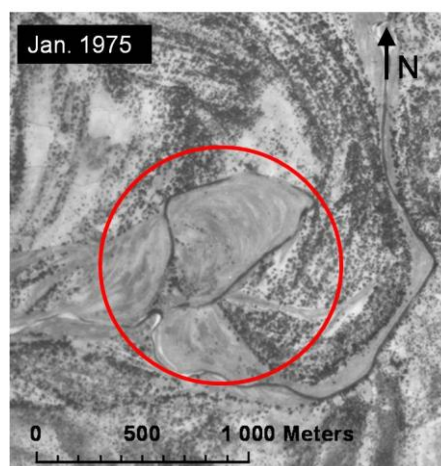
Figure 3.12. Aerial photo from January 1975 showing the meander being cut off at Dewa Fouyé.

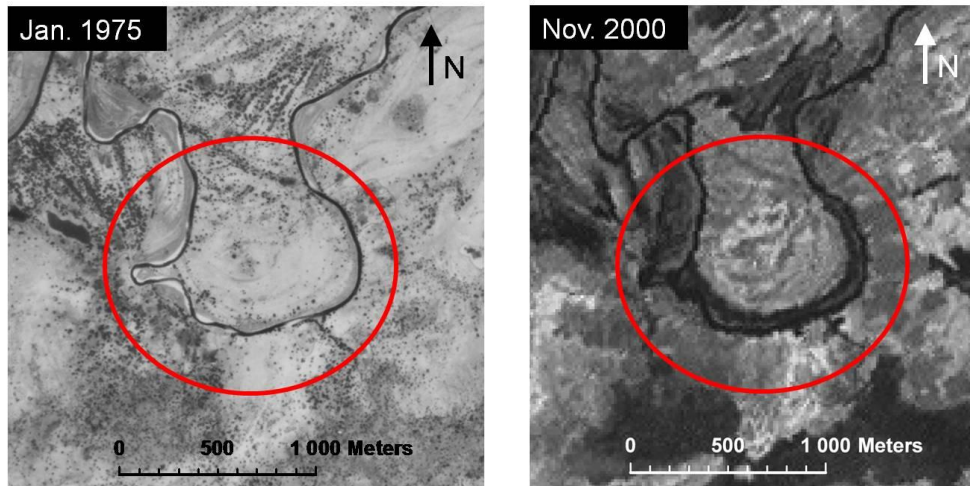
Figure 3.13. At the left, an aerial photo from January 1975 showing only one channel and to the right, a Landsat image from November 2000 showing two channels at Zarwaram.

The villagers in Zarwaram said the river flows in two channels at the tip of the meander east of the village. In the past there was only one channel. The change happened around 1999. It can be observed when comparing the aerial photo from 1975 with the Landsat image from 2000 (fig. 3.13).

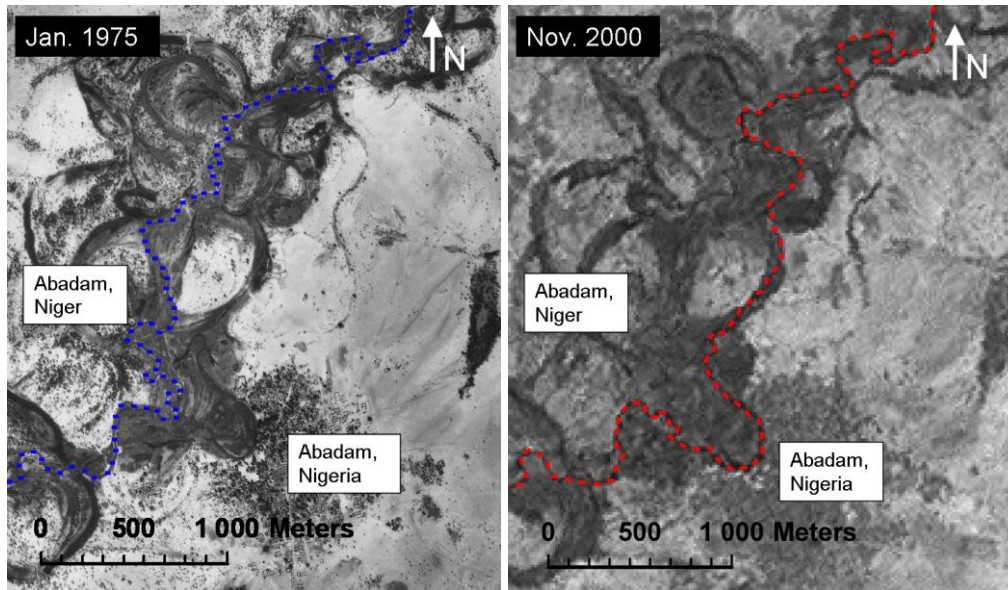
Figure 3.14. At the left, an aerial photo from January 1975 and to the right, a Landsat image from November 2000 showing the different channels between Abadam in Niger and Abadam in Nigeria.

On the map and the aerial photo from 1975, the river flows in the channel closest to Abadam in Niger. A small channel close to Abadam in Nigeria can be observed, but the dominating channel is the one closest to Abadam in Niger. Therefore, the change can not have happened around 1950. See figure 3.15 for a comparison between the two channels. The villagers showed where the diversion of the channel happened. The GPS-coordinate at this place (N 13°37,314', E 13°15,515') corresponds to the location for the diversion seen on the map and Landsat image. The territory in the middle of the river belongs to Niger.

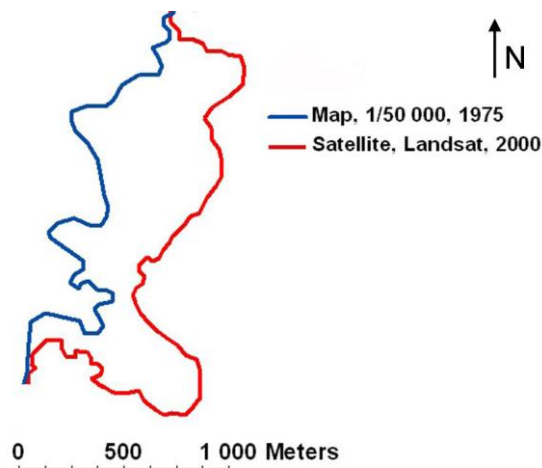
Figure 3.15. Polyines representing the two different channels at Abadam.

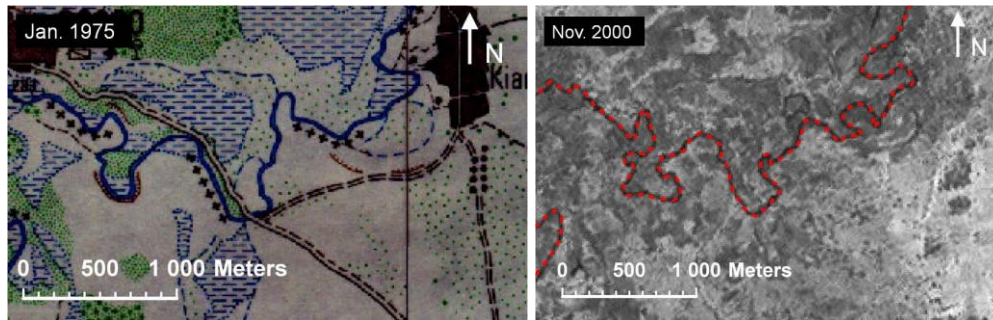
Figure 3.16. At the left, a map drawn from aerial photos in January 1975 and to the right, a Landsat image from November 2000 showing the river between Bosso in Niger and Kiari Kagari in Nigeria.

In-between Bosso in Niger and Kiari Kagari in Nigeria the river's course has changed. The change can be observed while comparing the map from 1975 and the Landsat image from 2000 (fig. 3.16 and 3.17). The Mayor of Bosso said the change is due to erosion and cultivation.

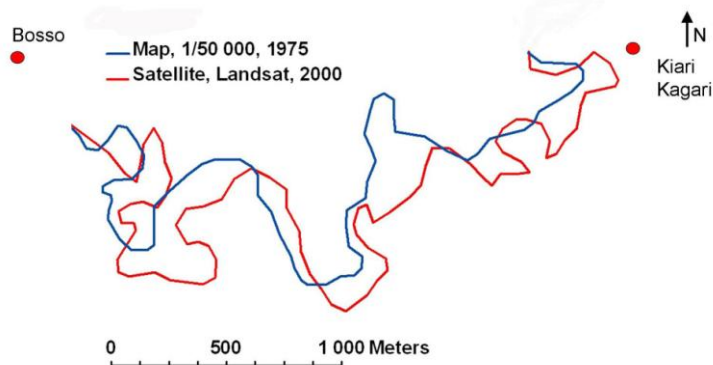
Figure 3.17. Polylines representing the two different channels between Bosso and Kiari Kagari in Nigeria.

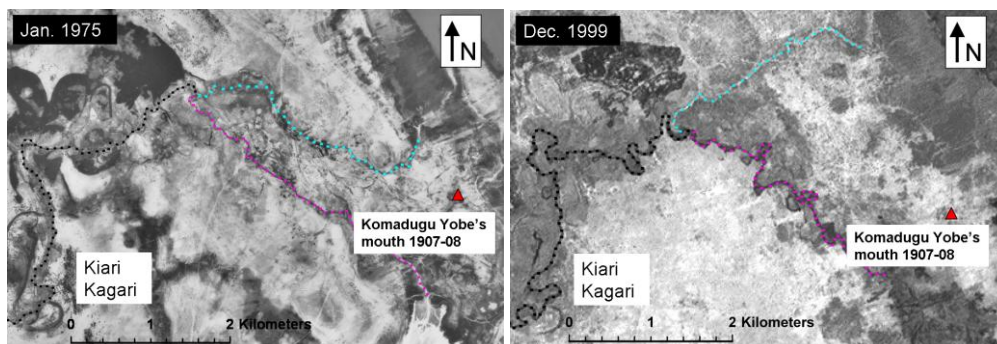
Figure 3.18. At the left, an aerial photo from January 1975 and to the right, a Landsat image from December 1999 showing the river's mouth into the lake. The turquoise dots mark the natural channel while the pink dots mark the man-made channel. The coordinates for the Komadugu Yobe's mouth in 1907-08 are written in section. 2.1.1.
