Oxidation behaviour of PVD coated tools for metal cutting applications

MASTER THESIS
DIVISION OF PRODUCTION AND MATERIALS ENGINEERING
FACULTY OF ENGINEERING, LUND UNIVERSITY

This study compares the performance of four concept coatings with two reference coatings: TiN and TiAlN. The substrate material of the tool is cemented carbide, WC-6 % Co, being coated with the PVD cathodic arc technique. The coatings are heat treated in furnace as well as tested in machining operation, turning, in two different environments: argon respectively air, applied on the tool at high pressure to ensure respectively eliminate oxygen. The workpiece material to be machined was the difficult-to-cut Alloy 718, deployed both at elevated speed to stress the coating thermally for five seconds, and performance tested for a couple of minutes.

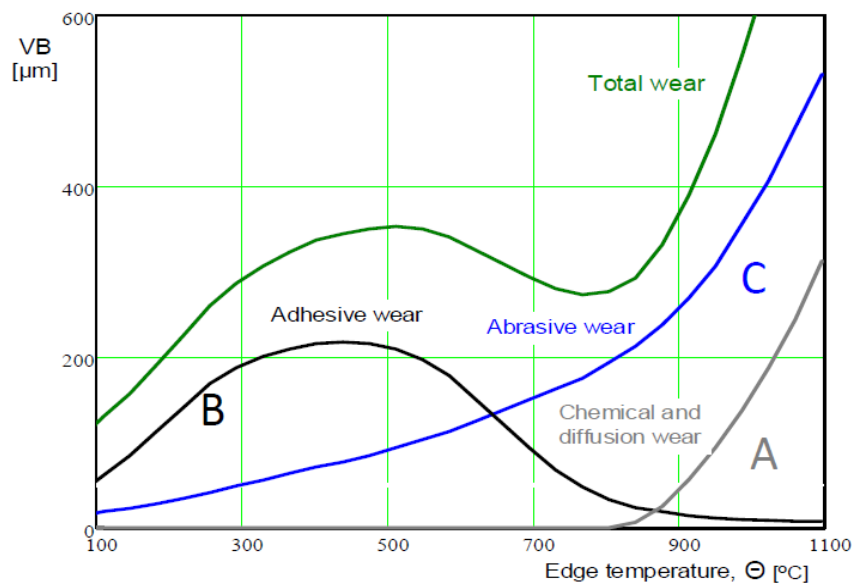
Figure 2-6 Schematic diagram of wear mechanisms on a cemented carbide cutting tool at different temperatures. [1]

Different applications and cutting tools can have different dominant mechanism affecting the tool wear, or by a combination of mechanisms. The effect of the different tool wear mechanisms depends on the process temperature, shown in Figure 2-6, with adhesive wear having big impact on the wear at lower temperatures and diffusion- and chemical wear being dominant at higher temperatures. [1]

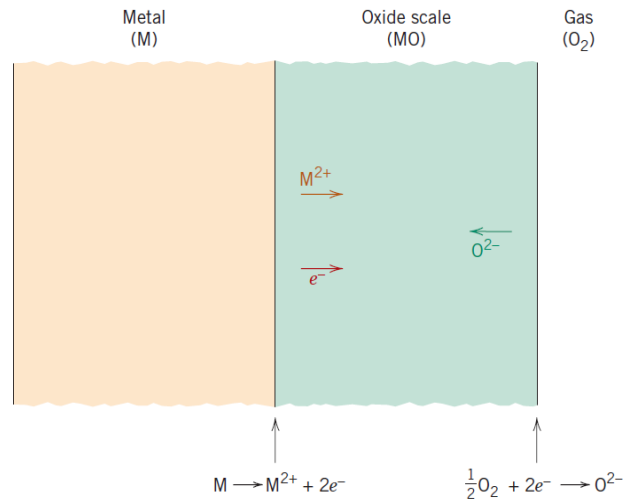
Figure 2-8 Schematic representation of the oxidation process. [4]

Regarding oxidation of metals, or electrochemical reactions, that normally takes place in gaseous atmospheres, unlike corrosion of metallic materials that takes place in aqueous solutions. This is when an oxide layer or scale forms on the surface of a metal, which is sometimes termed *scaling*, *tarnishing* or *dry corrosion*. This formation is an electrochemical reaction, where metal ions are formed on the metal-scale interface when the metal atoms react with the oxygen in the atmosphere, shown with generalized reactions in Figure 2-8. The scale thickness can grow if the electrons can be conducted to the scale-gas interface, and if the metal ions can diffuse from the metal-scale interface and/or the oxygen ions can travel to the same

interface. This scale might act as a barrier with most metal oxides being highly electrically insulated, which can protect the metal from rapid oxidation. [4]

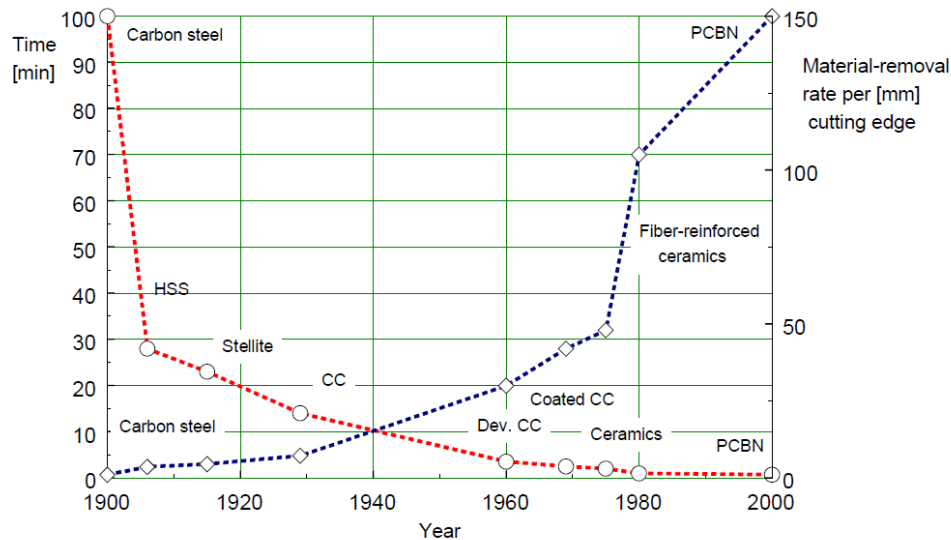
Figure 2-11 Historical development of different materials that cutting tools can be composed of, with the red line showing the relative time required for a particular processing step and the blue line showing the relative processing capacity of the tool in terms of cm^3 chips per minute for each mm of the cutting edge. The carbon steel provides reference values for comparison. [2]

In the beginning of the last century, many discoveries and innovations were made in the development of tool materials, which can be seen in Figure 2-11 above, that played a big role in industrial development. A major advance was when high speed steel (HSS) replaced carbon steel as cutting tool material, which, for example, played a central role for the mass production of vehicles. HSS is still an important tool material today. Cemented carbides (CC) were originally commercialized in 1929 by the German industrial concern Krupp. In Sweden, commercial production was introduced by Fagersta Bruk (Seco Tools AB today) in 1932 and by Sandvikens Jernverk (Sandvik Coromant today) in 1942. Another big innovation step was done by Sandvik Coromant in 1969 when they coated cemented carbides with, initially, titanium carbide. Later, other substances of coating materials were used, which have played a major role in modern cutting tool development. [1]

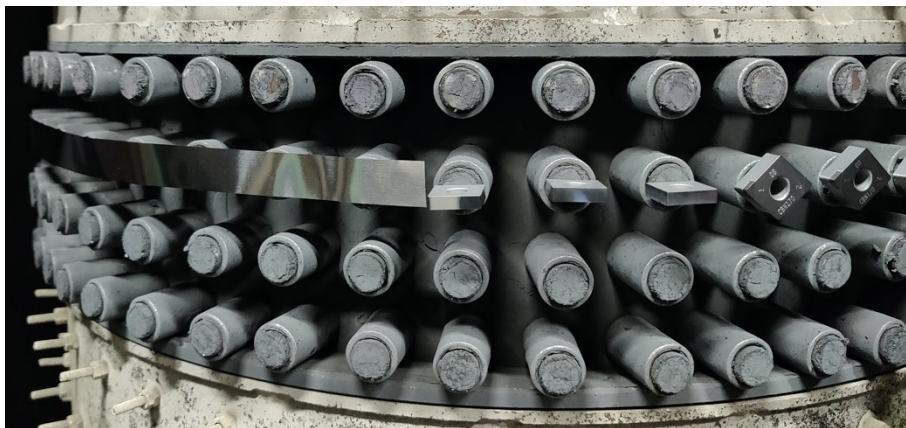
Figure 3-1 Foil and tools mounted at a specific level in the PVD furnace.

Figure 3-1 shows the setup of foil and tools mounted in the PVD furnace used to deposit the coating. Three reference tools, to the right of the foil, were used to verify that desired quality of the coating is reached.

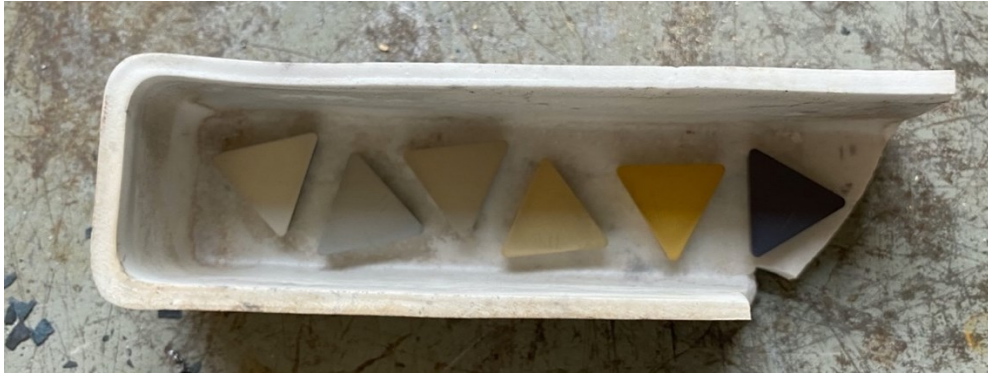
Figure 3-2 Coating C1, C2, C3, C4, TiN, and TiAlN before being exposed to 800 °C for 1 hour.

Each tool was marked with a number (1 – 6) on the top surface, to make sure they would be recognizable in case of an accident or a major change of the tool. The crucible was placed in room temperature to cool down. All six tools were cut and prepared, with the tool preparation steps described below, before bringing them to the SEM.

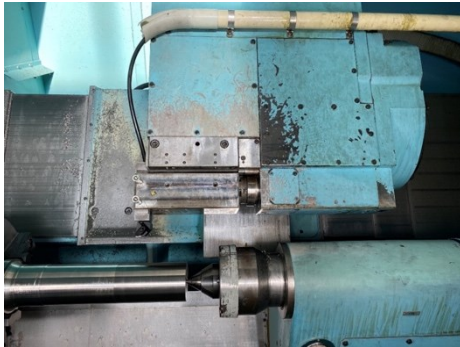
Figure 3-3 Machining setup, elevated speed.

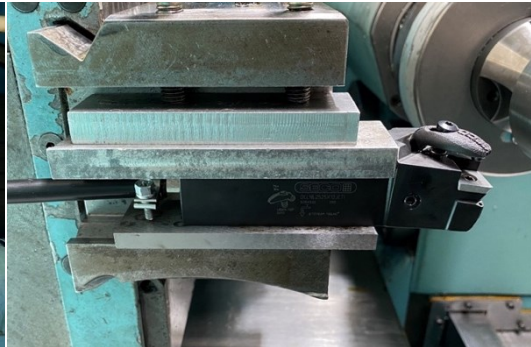
Figure 3-4 Tool holder setup, elevated speed.

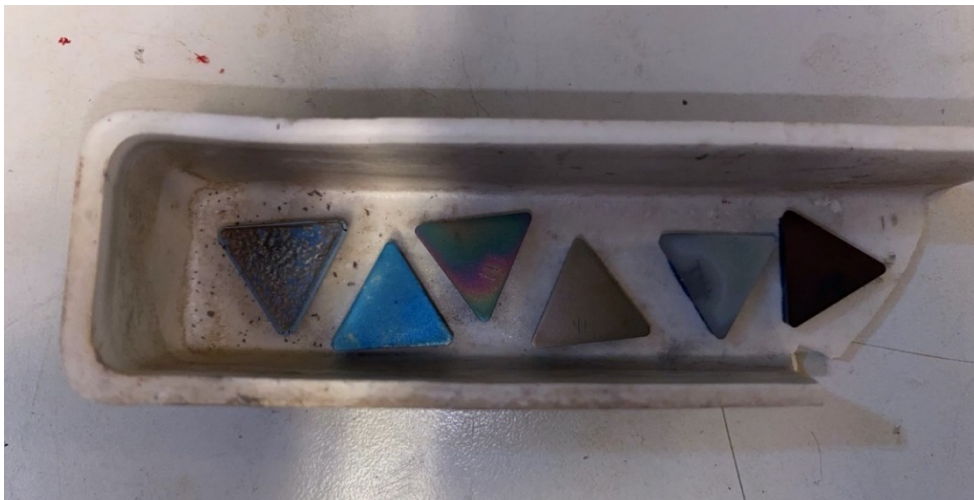
Figure 4-3 Furnace samples placed from the left: C1, C2, C3, C4, TiN and TiAlN, after 1 hour in 800 °C.

C1 coating probably oxidized all the way to the substrate, which resulted in the coating to create a crack all around the edge line. When preparing the tools, the oxidized coating loosens from the tool and could not be fully prepared for SEM microscopy. With machining experiments performed in parallel with this, C1 and C2 performed significantly worse compared to the other coatings, and were not tested further after this stage.

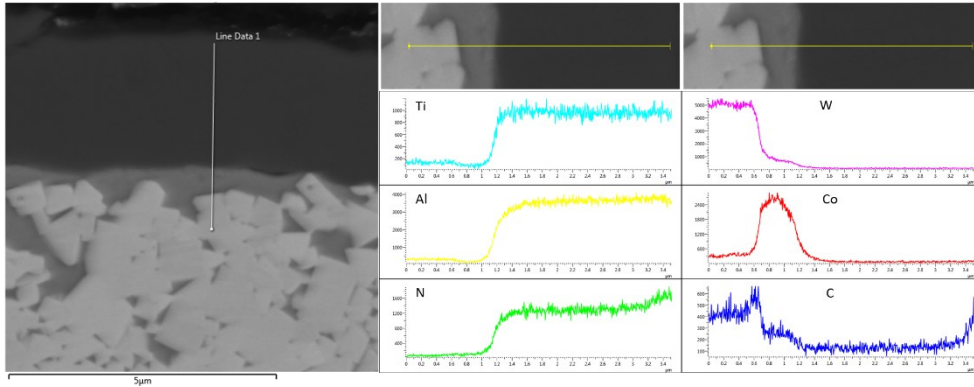
Figure 4-8 EDX of TiAlN, cross section, after 1 hour in furnace at 800 °C.

SEM and EDX results, Figure 4-7 and Figure 4-8, shows that there is barely any oxidation found in the TiAlN coating. The oxygen signal was weak and considered as insufficient. The thickness of the coating is not affected with this test.

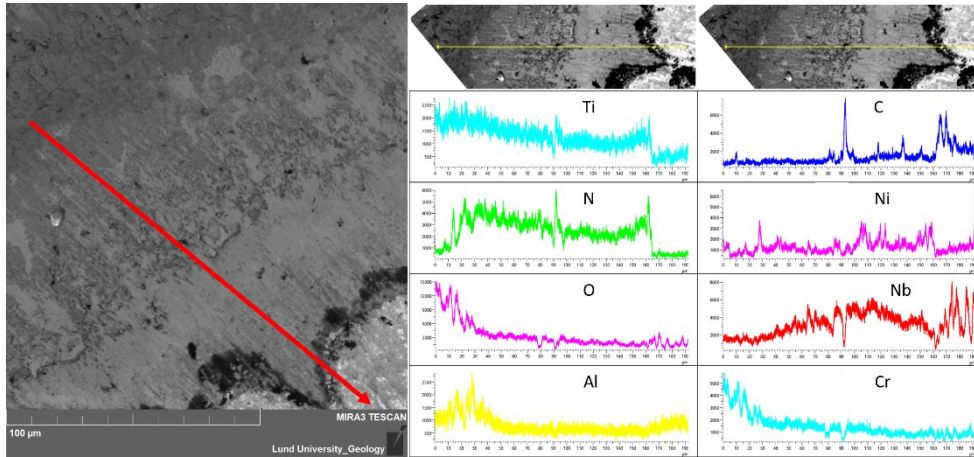
Figure 4-15 Surface EDX of TiN, machined 5 seconds in HP air at $v_c = 200$ m/min.

Cr and O have EDX peaks close to each other and might interfere each other, especially when there is a low amount of the substance, as in this case.

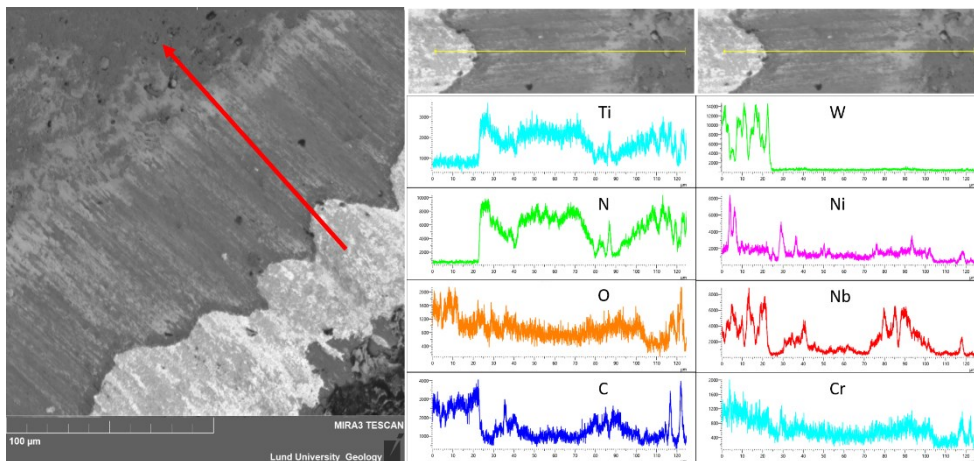
Figure 4-16 Surface EDX of TiN, machined 5 seconds in argon at $v_c = 200$ m/min.

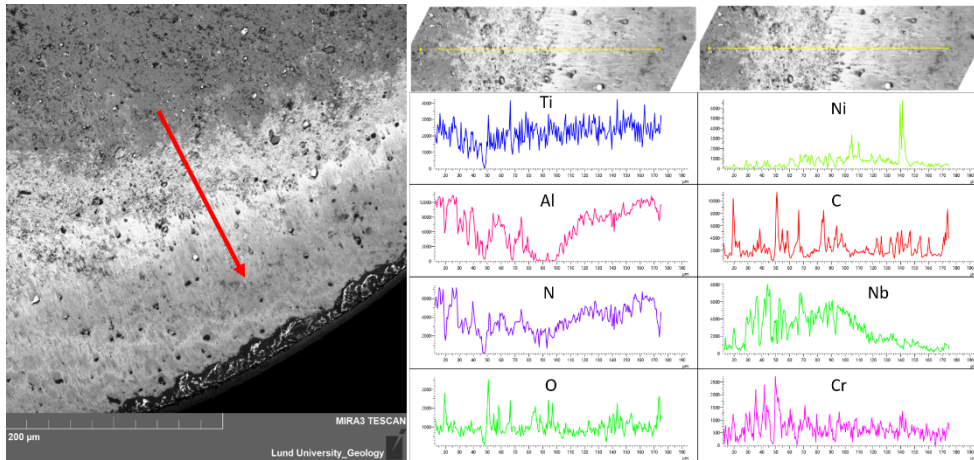
Figure 4-23 Surface EDX of TiAlN, machined 5 seconds in HP air at $v_c = 200$ m/min.

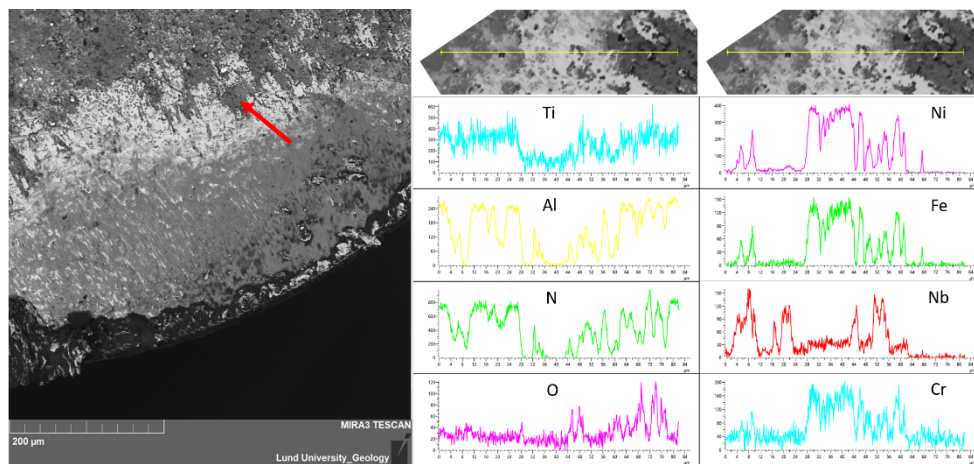
Figure 4-24 Surface EDX of TiAlN, machined 5 seconds in argon at $v_c = 200$ m/min.

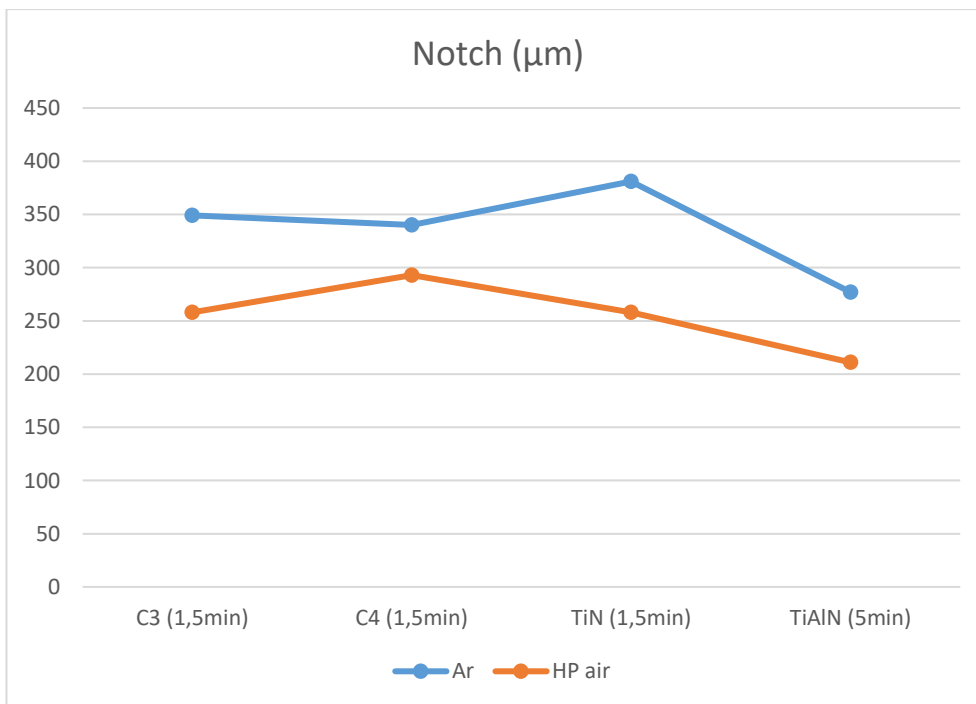
Figure 4-46 Notch measured from performance test of C3, C4, TiN and TiAlN coatings, in argon- respectively high pressure air environment.
