# IMPACT OF EXTREME FLOWS ON BRIDGES. A CASE STUDY FROM LAGAN RIVER, LJUNGBY

*Assad Tahir<sup>1</sup>, Fainaz Inamdeen<sup>1</sup>, and Magnus Larson<sup>1</sup>*

*<sup>1</sup> Lund University, Water Resources Engineering,  
Box 118, 221 00 Lund, Sweden*

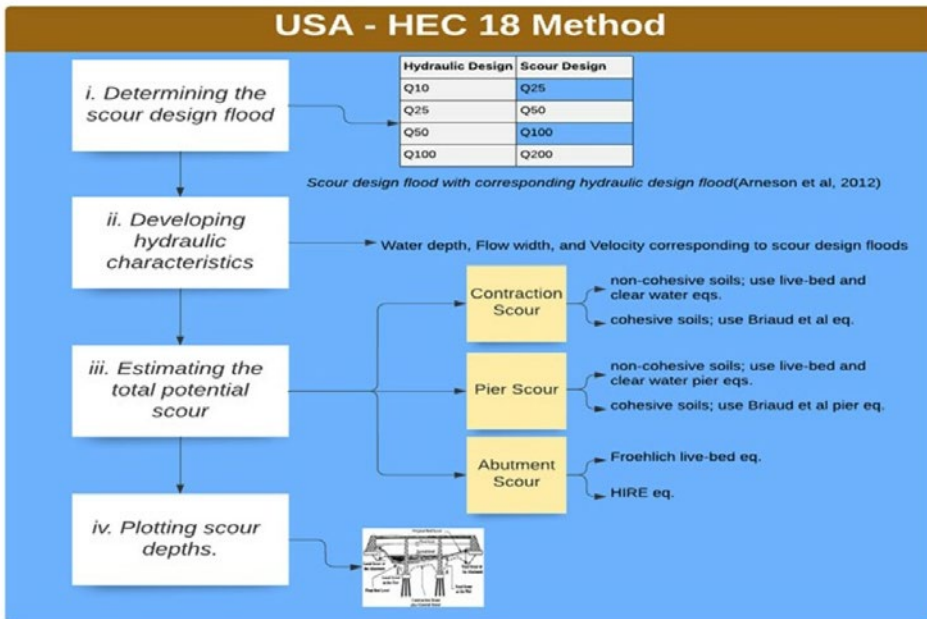
**Figure 2.** Schematic diagram illustrating how to estimate the total potential scour based on the HEC 18 method.

In the United States (USA), HEC 18 provides proper guidance for comprehensive bridge scour evaluations issued by the Federal Highway Administration (FHWA). To produce a better hydraulic design, HEC 18 has the ability to estimate the total potential scour and evaluate the bridge foundation for scour risk. The general procedures of the HEC 18 method is shown in Figure 2.

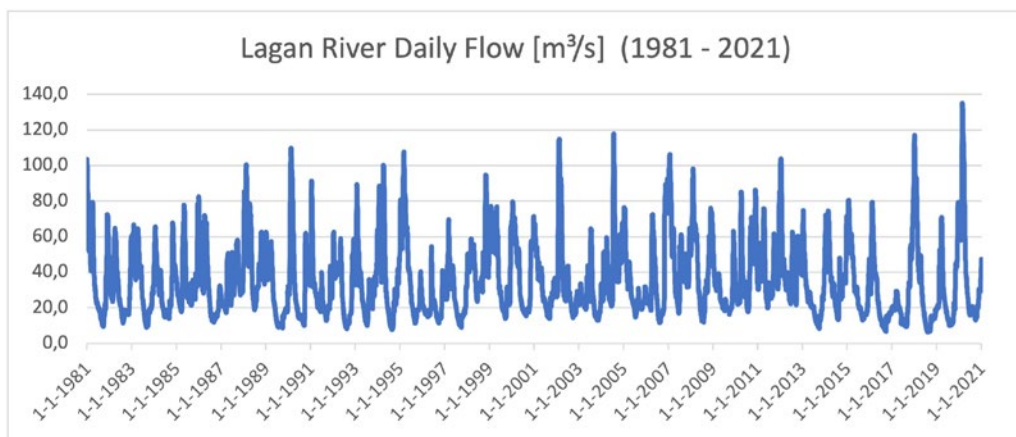
**Figure 4.** Simulated daily river flow (1981–2021).

According to the Swedish Meteorological and Hydrological Institute (SMHI), the downstream part of Lagan River receives an average flow of 35.2 m<sup>3</sup>/s based on simulations with the S-Hype hydrological model (time series from 1981–2021, daily values, see Figure 4), whereas the yearly mean for the minimum and maximum flows are 6.4 m<sup>3</sup>/s and 134.9 m<sup>3</sup>/s, respectively. SMHI developed the Hydrological Predictions for the Environment (HYPE) model to simulate the flow of water and the flux of substances from precipitation to sea through different storage compartments (Lindström et al., 2010), HYPE is a semi-distributed catchment model that uses a daily time step (SMHI, 2013).

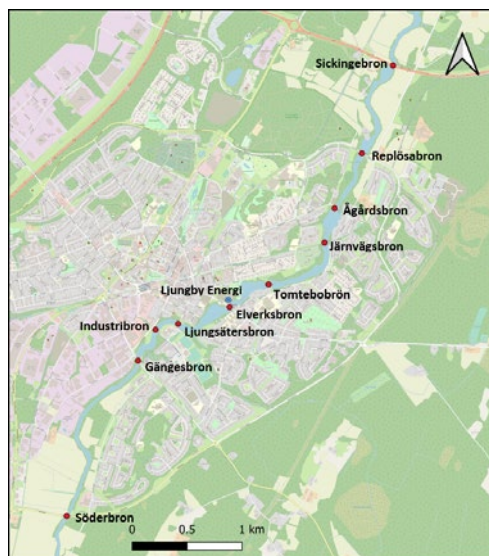
**Figure 5.** River bridges at Ljungby Municipality.

There are ten river bridges located in the study area at Ljungby, see Figure 5. In addition, a hydro-power dam owned by Ljungby Energi is located upstream to Elverksbron, controlling the river flow towards downstream.

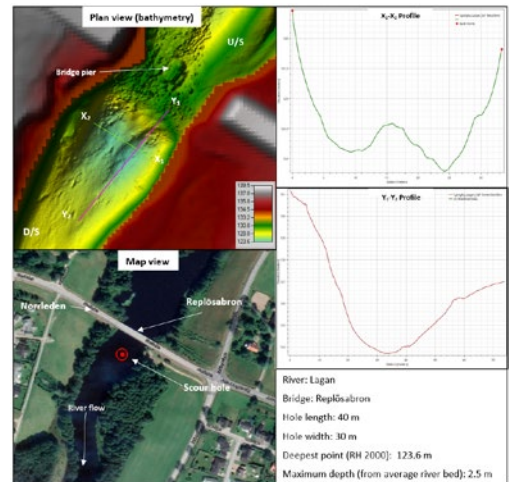
**Figure 7.** A bathymetric map showing scour hole downstream Replösabron (Das et al., 2021).

through the bridge, resulting in an asymmetrical scour hole (see Figure 6). The scour hole downstream of Replösabron measures 2.5 m in depth, 30 m in width and 40 m in length (see Figure 7).

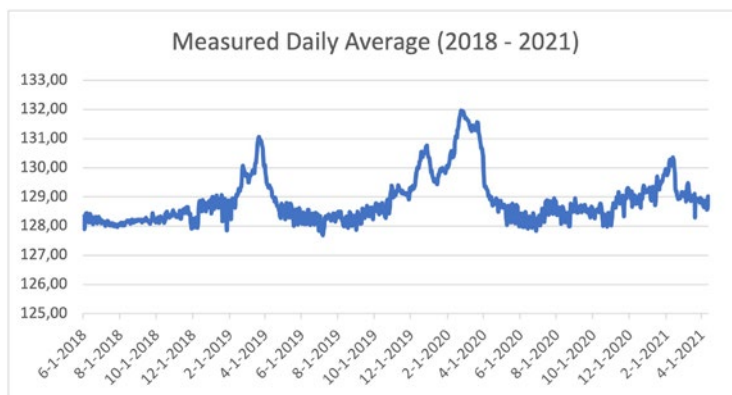
**Figure 8.** Measured daily river water level (2018–2021).

The water level measurements from 01/06/2018 to 12/04/2021 were obtained from Ljungby Municipality; hourly measurements were taken at a point located below the Gängesbron. However, water levels oscillate significantly in a single day due to control of the hydropower dam. For this study, the hourly values were averaged daily and used in the calibration and validation process, see Figure 8. A portion

of the water level measurements were used for model calibration, whereas the remaining portion was used for validation. Good agreement between model results and measurements was obtained; details on the procedure and results are given in Tahir (2022).

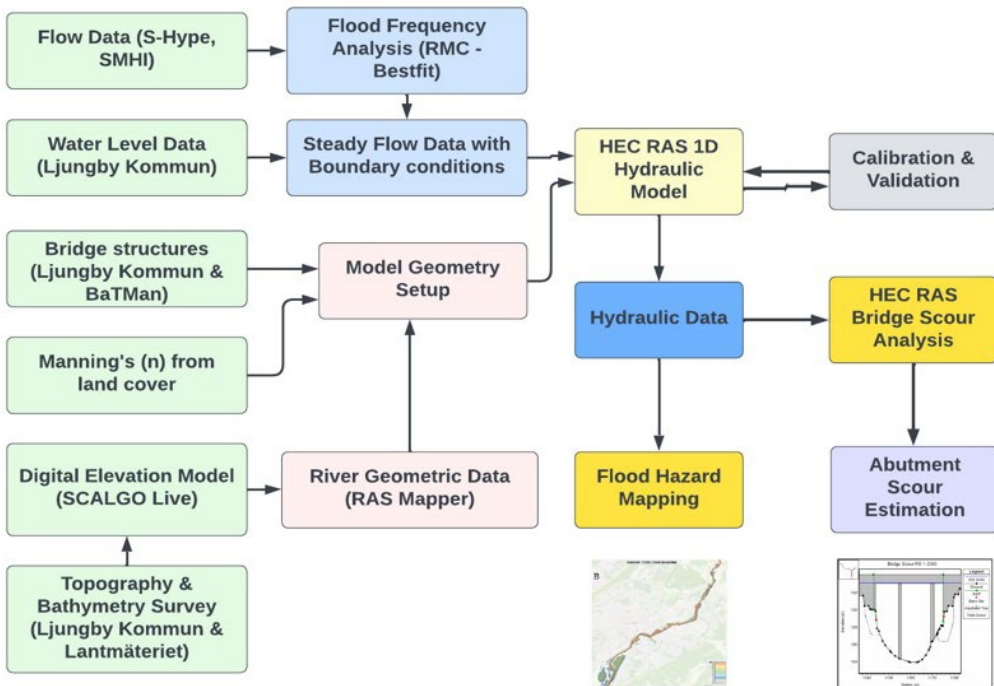
**Figure 9.** Flow chart illustrating the process of flood hazard mapping and scour analysis by HEC RAS, including the data employed.

The numerical analysis for the study was performed using the HEC RAS hydrodynamic model (Brunner, 2021). A one-dimensional hydrodynamic model was set up for Lagan study reach to determine water surface profiles assuming steady flow at each flow time step (one day). Steady flow is defined as a flow in which various parameters such as velocity, pressure, and flow density do not change over time at any given place. The surface profile is computed by solving the energy equation from one cross section to the next with standard step method. The entire modeling approach for this study was developed by Tahir (2022). The model outputs were used for flooding hazard and bridge scour analysis. Figure 9 illustrates a system-

atic approach adopted for mapping flood hazard and simulating bridge scour using HEC RAS, along with the relevant data.

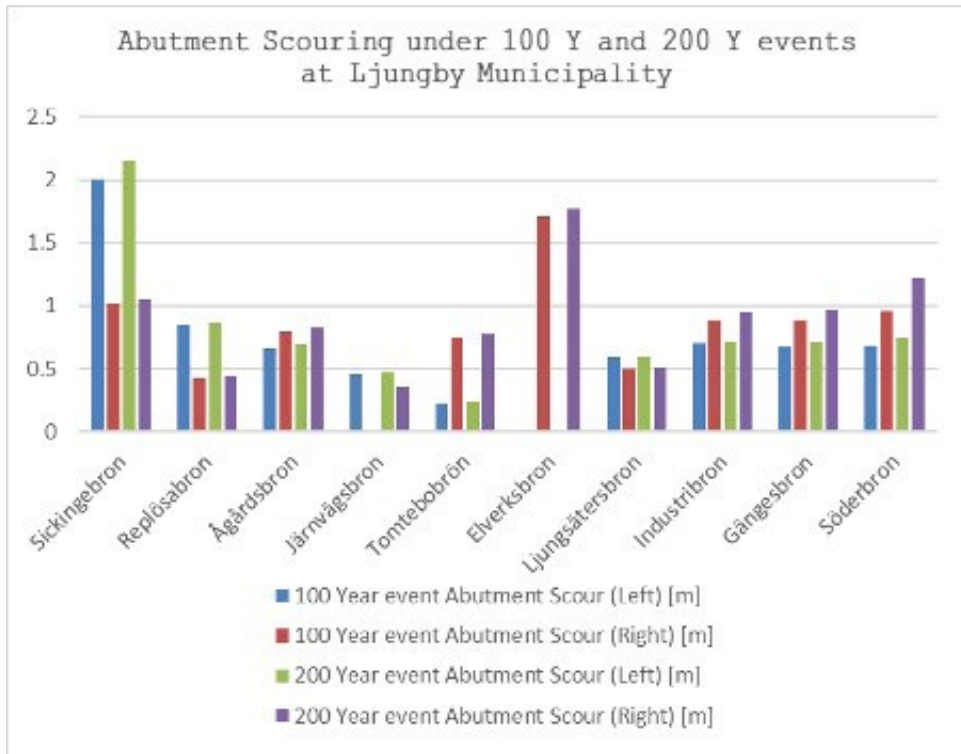
**Figure 13.** A bar graph shows scour depth at all bridges at Ljungby Municipality under Q100 and Q200 events.

The abutment scour depths (equilibrium conditions) were estimated for Q100 and Q200, as can be seen in Figure 13 below. It is important to note that the depth of abutment scour varies from bridge to bridge as a result of variations in bridge dimensions, as well as due to bathymetric and hydraulic characteristics.
