Observed beach nourishment development in a semi-enclosed coastal embayment

Anna Adell^{a,b,*}, Aart Kroon^b, Björn Almström^a, Magnus Larson^a, Caroline Hallin^a

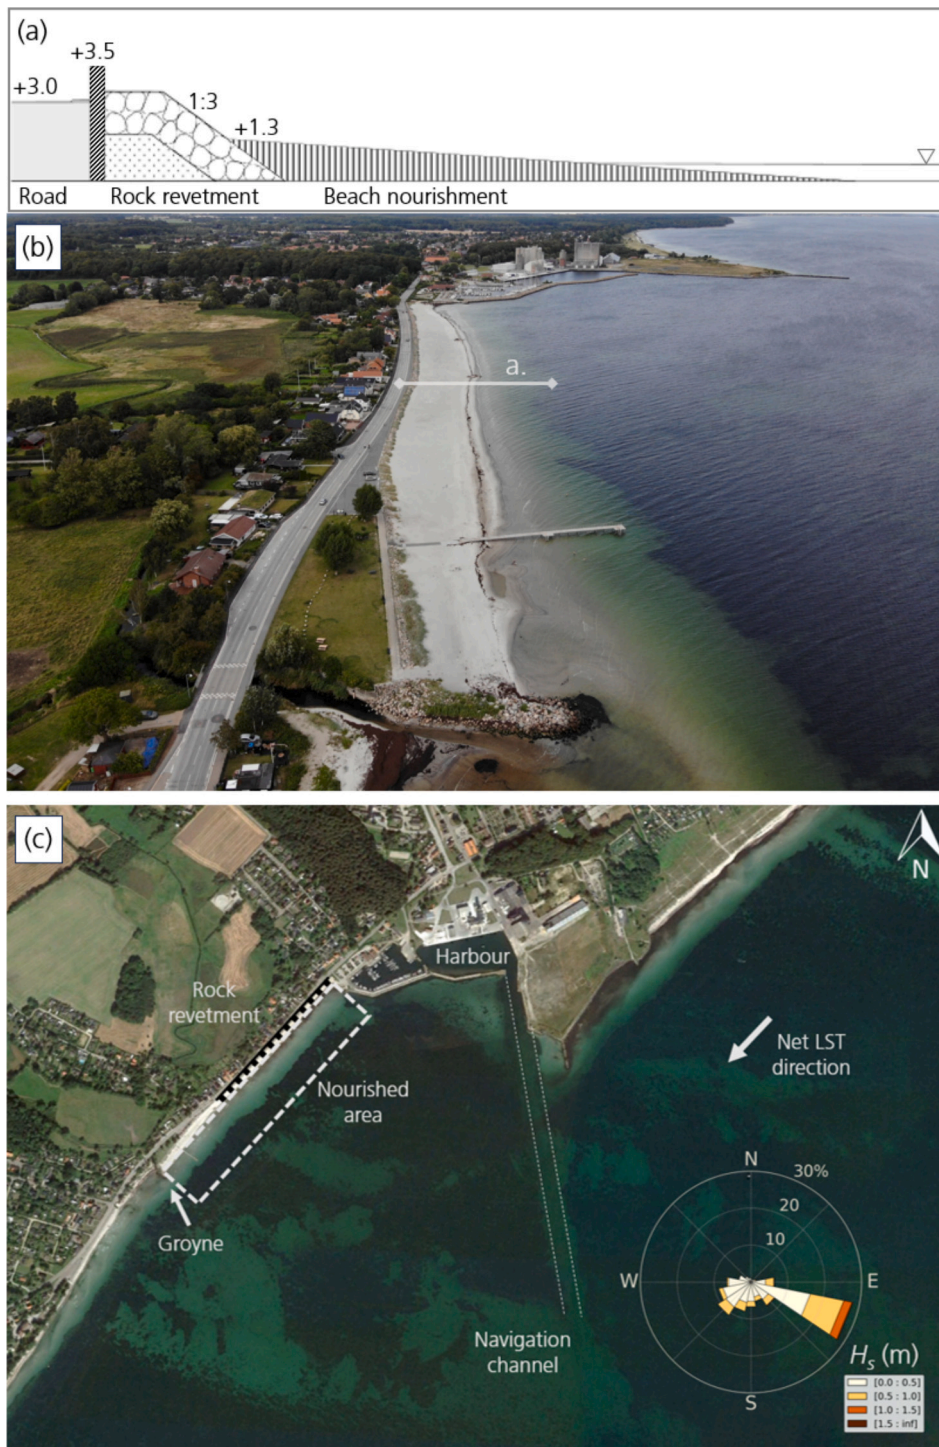
Fig. 2. Overview of the managed coastal stretch. (a) Schematic cross-section of the protection; heights are indicated in m DVR90. (b) Drone image from July 2021, just after completing the nourishment, Photo: Danish Coastal Authority. (c) Satellite image (Google Earth Pro version 7.3.6, image date: 2019/08/25) with important attributes indicated.

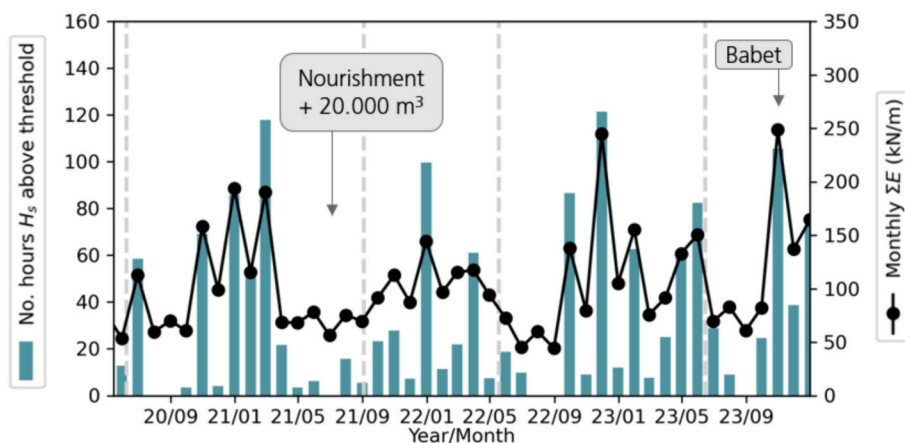
Fig. 4. The sum of monthly wave energy (black line) and the number of hours each month that H_s is above the threshold 95th percentile $H_s = 0.9$ m (bars). The dashed grey lines indicate the time for annual profile surveys.

Fig. 4 summarizes the wave conditions in the area from June 2020 to December 2023. The sum of the monthly wave energy density is presented along with the number of hours that the wave height is above the threshold (95th percentile H_s) each month. Babet contributed to making October 2023 the month with the highest wave energy, followed by December 2022. The first year after the nourishment was introduced, July 2021–June 2022, was a relatively calm year regarding wave action. Only December 2021 and March 2022 indicate the occurrence of some higher duration where H_s exceeded the 95th percentile. The next period, July 2022–June 2023, had more high energy events with notably varying distribution over the seasons. This means that the recovery times between events were shorter.

The 2021/2022 winter had low exceedance of the storm wave height threshold defined as the 95th percentile H_s (Fig. 4). The yellow line in Fig. 6a represents the observation from 2021/12/10, just after a high-energy wave event. Compared to the previous observation, the beach has eroded. The panel showing the elevation change indicates a reduction of beach elevation of >0.5 m, and erosion occurs over almost the entire extent of the cross-shore profile, from 8 to 42 m cross-shore distance (Fig. 6a). The shoreline position, defined at 0 m DVR90, retreated by 5 m, and the subaerial volume in the transect decreased by 11.8 m³/m between 2021/10/04 and 2021/12/10 (Fig. 7). The scatter plot in Fig. 6c (right panel) also shows that this period was the only period since introducing the nourishment that experienced both high waves and high water levels simultaneously for an extended duration. This explains why the erosion was observed across the whole cross-shore profile. The maximum H_s was 1.53 m from the southeast and coincided with water levels of 80 cm DVR90 during the event.

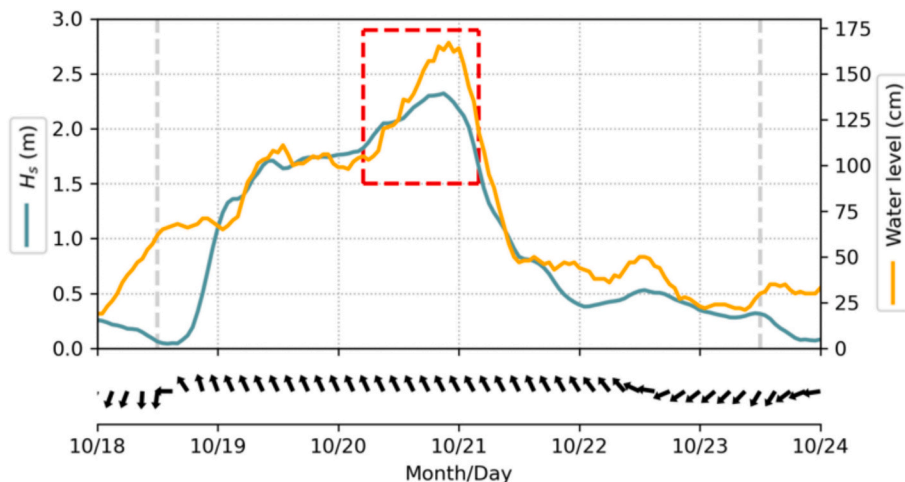
Fig. 5. Timeseries of waves and water level during storm Babet. The arrows below indicate the wave direction, and the red box corresponds to the levels under the storm peak that are indicated with red dots in the scatter plot in Fig. 3. Dashed grey lines mark the time for pre- and post-storm of profile observations.

from west to east and increased in intensity. The storm peak was reached the night between October 20th and 21st. The strong easterly winds (25 m/s mean wind speed and 30 m/s gust wind speed, according to Swedish Meteorological and Hydrological Institute, 2023) drove substantial wind setup at the southwestern part of the Baltic Sea and simultaneously generated large waves. At the peak of the storm, water levels reached 169 cm DVR90 and waves were approaching from the southeast with a maximum simulated significant wave heights of 2.3 m at the study site (Fig. 5).

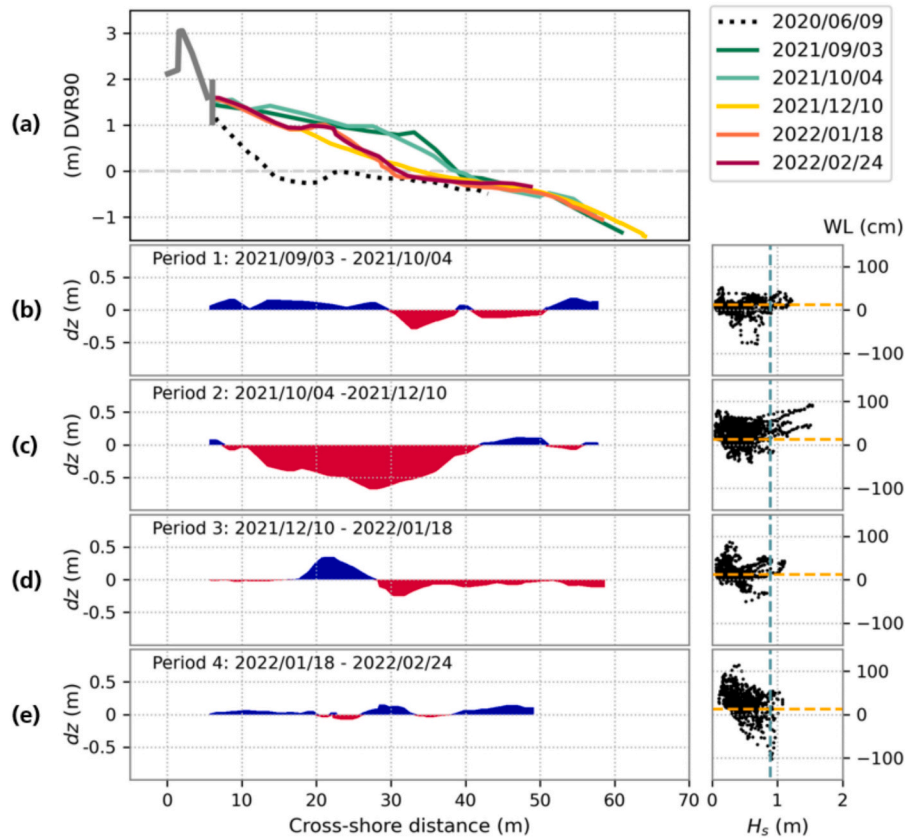
Fig. 6. Initial profile adjustment (5 months) for transect P9 located in the center section of the nourished stretch. Panel (a) shows the profile configuration over time, and panels (b-e) show the elevation difference between two consecutive surveys, where red indicates erosion and blue indicates deposition. Scatter plots to the right show the hydrodynamic conditions between two consecutive survey dates.

The initial profile adjustment after the nourishment is illustrated by transect P9 (Fig. 6) since this profile is placed in the most dynamic and central part of the nourished area. In Fig. 6a, the black dotted line represents the pre-nourishment conditions from the 2020/06/09 survey; then the subaerial part of the beach is narrow, 7.7 m, and the beach face slope is steep, 0.18. The aqua green line represents the conditions on 2021/09/03, shortly after the completion of the nourishment. Then, the subaerial part of the beach has extended to a width of 32.8 m, giving a wide upper beach with a mild slope of 0.022 and a beach face slope of 0.15.

The development in the following six months is illustrated as bed level difference between consecutive observations together with the

The third period, 2021/12/10 to 2022/01/18, (Fig. 6d) was dominated by relatively mild conditions with only a small increase in incoming wave energy on December 27–28, corresponding to a

maximum H_s of 1.10 m and water level of only +40 cm DVR90. The cross-shore profile change indicates the formation of a beach berm and a steepening of the beach face slope from 0.06 to 0.11. The following

fourth period, 2022/01/18 to 2022/02/24 (Fig. 6e), was also characterized by mild conditions, which induced minimal changes observed in the profile; the berm and beach face slope are stable in this period.

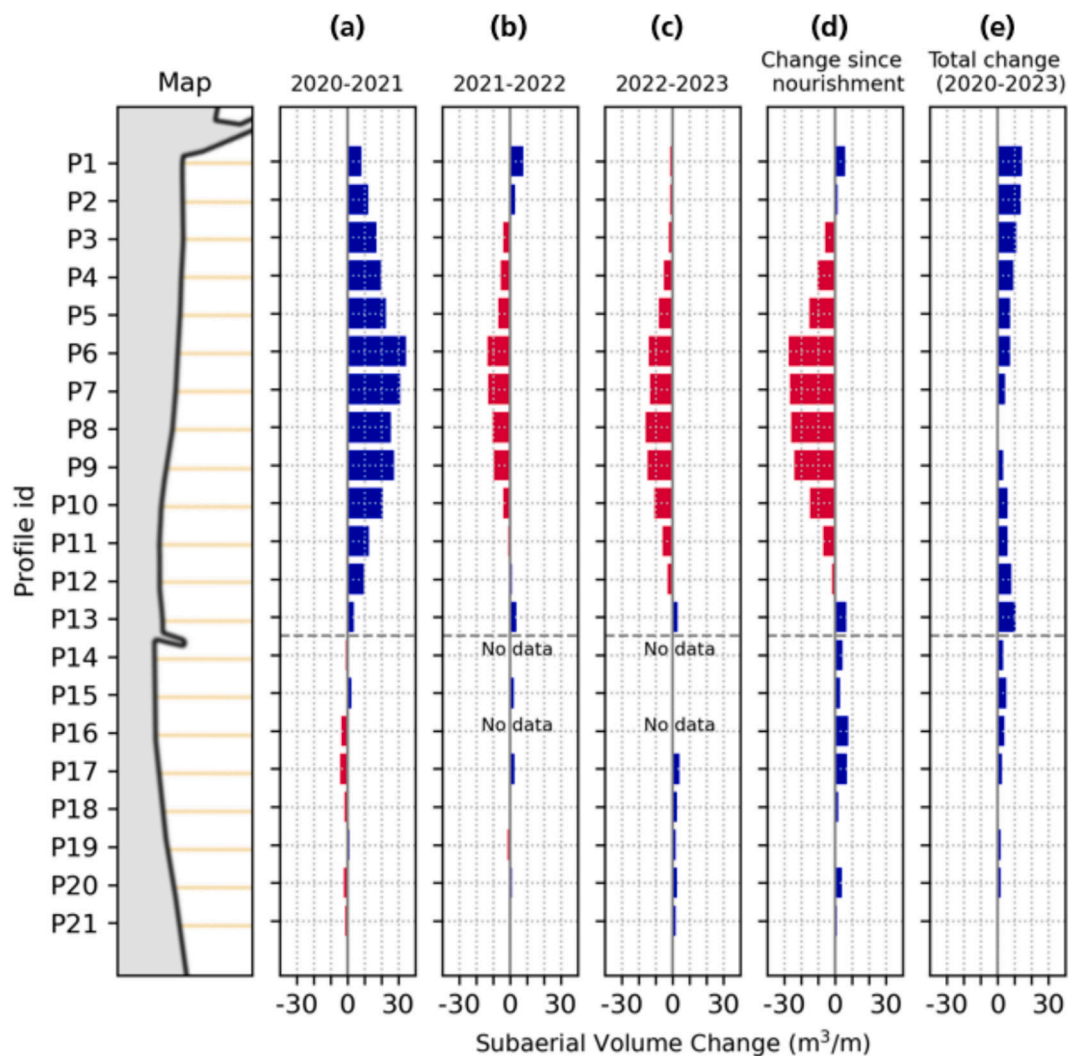
Fig. 8. Subaerial volume changes presented for each survey transect and analyzed for a period of three years. The bars align with the location of the survey transects (see the map in the left panel), red indicates erosion and blue indicates deposition.

The intra-annual volume change of the subaerial part of the profiles is presented in Fig. 8. Volume changes between surveys and for the entire extent of the investigated coastline cover three years of morphological change in the study area. Surveys from the same season are used for the comparison, i.e., 2020/06/09, 2021/09/03, 2022/05/18, and 2023/06/15.

structures. Before the nourishment, there was no material in the subaerial part of the profiles for transects P7–10, and the rock revetment was exposed. Fig. 8a shows the observed volume change between 2020 and 2021. There is an increase in subaerial beach volume after the nourishment and larger sediment volumes were added to the mid-section of the beach to create a longshore uniform beach width.

In the following two years, sediment from the subaerial beach is eroded in transect P2-P12 (Fig. 8b and c). The total volume eroded from the subaerial beach corresponds to 2620 m³ for September 2021 – May 2022 and 4629 m³ for June 2022 – June 2023. The increase in volume change documented for the second period can be explained by the relatively calm wave conditions July 2021 – June 2022 (Fig. 4). Furthermore, the May 2022 survey followed a month with very mild conditions, while the June 2023 survey followed a relatively stormy period where H_s over 0.9 m for 60 h in May 2023 and 80 h in June 2023, respectively. A positive volume change in the subaerial beach was primarily observed in transects P1 and P13, i.e., near the harbor mole and groin, respectively.

The total change since the nourishment until June 2023 (Fig. 8d) shows that the added volume has eroded from the subaerial beach in the central part and that the cross-shore transect P8 is back to a state corresponding to the initial condition before the nourishment. All panels in Fig. 8 shows a distinct spatial variability in the volume change, indicating that the presences of hard structures influence the morphological

transects are both located at the lee side of shore perpendicular hard structures. The minimum volume in the nourished area before the storm was found in P8 with $5.08 \text{ m}^3/\text{m}$ and the minimum volume downdrift in P18 with $7.26 \text{ m}^3/\text{m}$. During the storm, a part of the concrete wall behind the rock revetment failed. The impacted distance was approximately 110 m and located landwards from transects P7–9, which had the least subaerial volume before the storm (Fig. 8e).

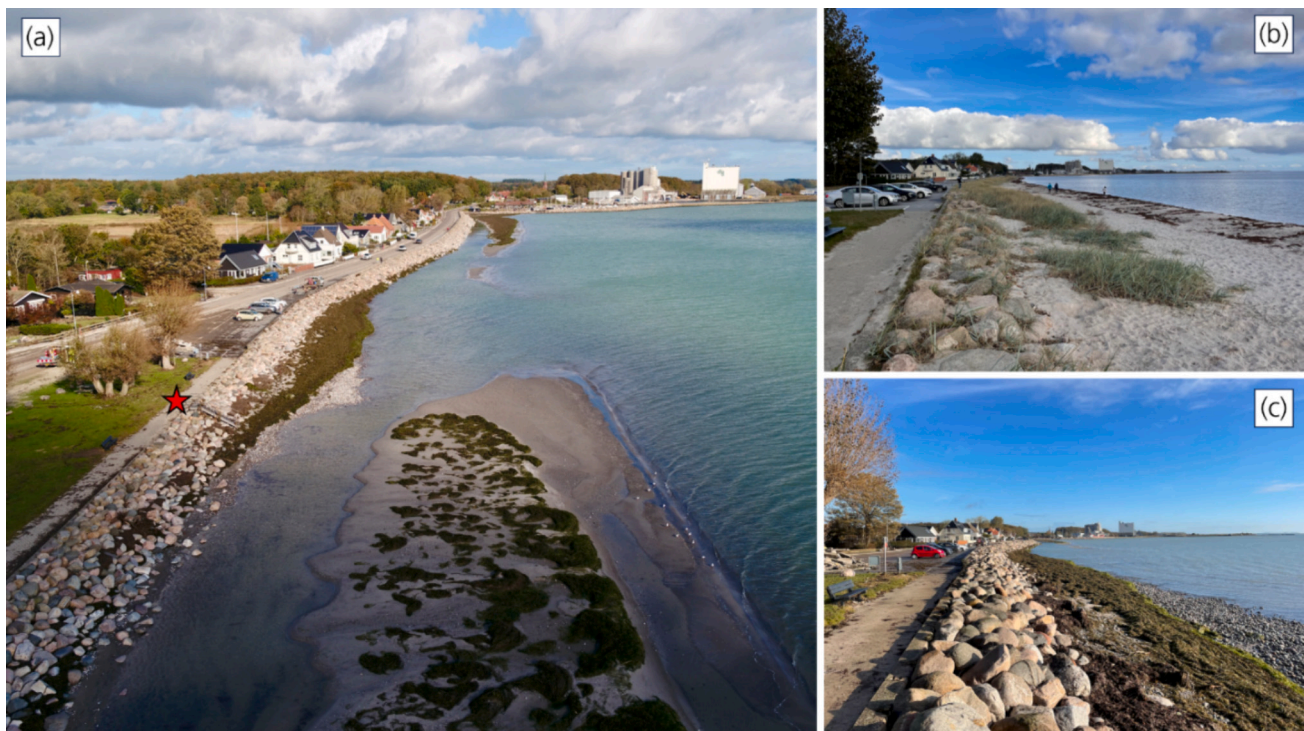
Fig. 10. Images showing the post-storm view of the nourished coastal stretch; (a) drone image from 2023/10/23, Photo: Gregor Luetzenburg (b) before the storm on 2023/10/18, water level is +60 cm, and (c) after the storm on 2023/10/23, water level is +30 cm. The star in (a) indicates the location where pictures (b) and (c) are taken Photo: Anna Adell.

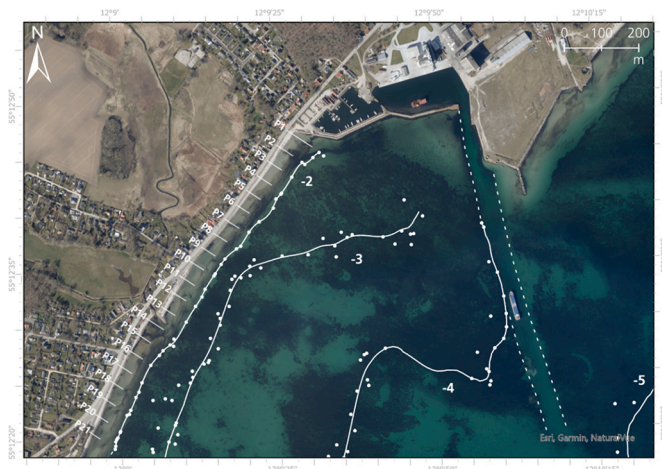
Fig. 11. Map showing the location of 2-, 3-, and 4-m depth contour lines. White points are bathymetry observations from filtered single-beam data, and the lines correspond to the depth contours obtained by fitting a spline function through the points. Background map: Contains data from the Danish Agency for Data Supply and Infrastructure, Ortophoto 2021 geodanmark_2021_12_5cm, WMS.
