The Poorhouse as materialized poverty in eighteenth- and nineteenth-century Sweden

THE POORHOUSE AS MATERIALIZED POVERTY IN EIGHTEENTH- AND NINETEENTH-CENTURY SWEDEN

Martin Hansson

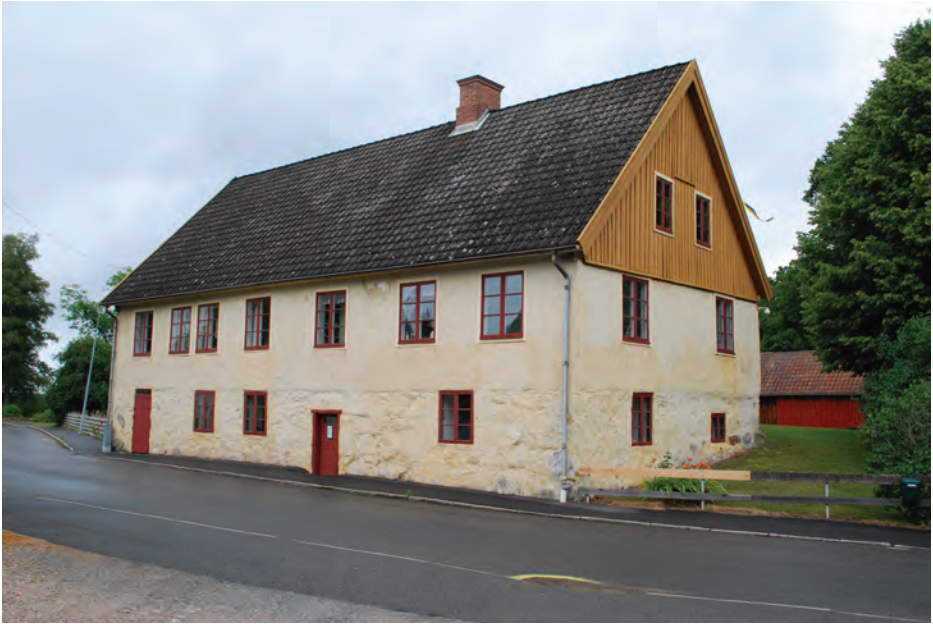
Figure 8.1 The combined poorhouse/schoolhouse in Norra Mellby built 1816. In 1849 the second floor was added. Photo: Martin Hansson, 2024.

In 1842, schooling for younger children became compulsory in Sweden and the responsibility was given to the parishes. Norra Mellby already had a school, but now the number of children attending the school increased dramatically. In 1849 a second floor was added to the building, this time made of timber. The upper floor had a separate entrance at the back of the building and was used for teaching up to ninety children. The teacher was also given new and better accommodation on this floor. The ground floor was left entirely to the poor. At that time there were still six poor people living here: two men and four women. The poorhouse was never staffed (Hammarlund 1994).

Unlike the first poorhouse, the one built in 1816 had a central location in the village, next to the church along the main road. It was built in a slope, which means that its eastern long side was dug into the slope. When the upper floor was added, the building took on its present appearance and, together with the church, formed the public centre of the parish. While the vicarage and the church represented the religious well-being of the parishioners, the combined school and poorhouse represented a social consideration for both young and old. The large, partly stone-built poorhouse also materialized and symbolized the parish's collective efforts to care for the needy. While the well-built poorhouse tells one story, the lack of staff to care for the poor and the reluctance of the parish to fund staff tells another story about the parishioners' interest in caring for the poor (cf. Baugher 2009: 7–9).

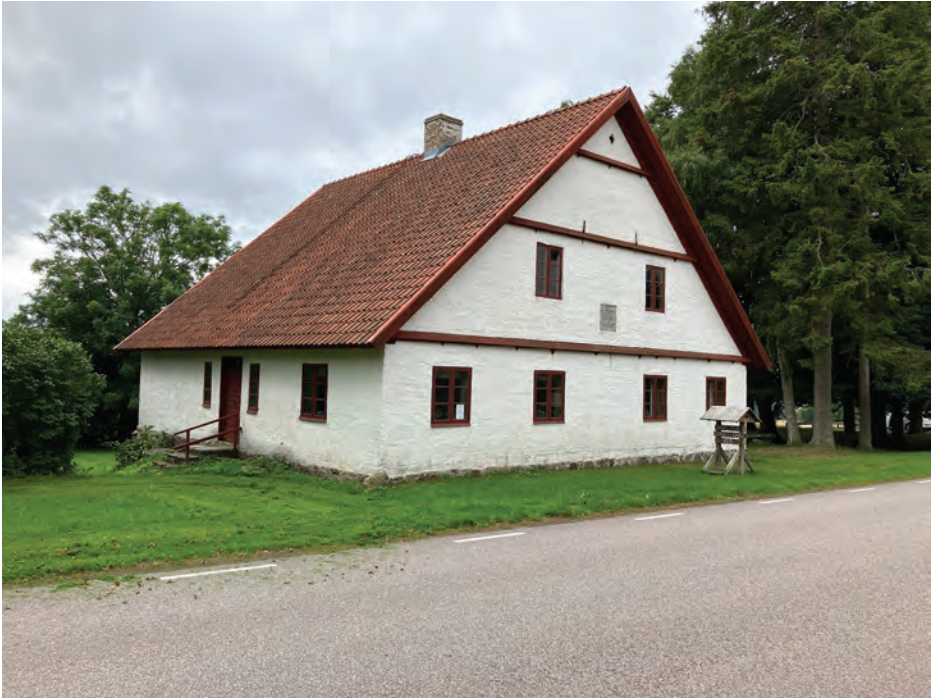
Figure 8.2 Harlösa donationshus built 1823–4. Photo: Martin Hansson 2023.

The building was erected next to the parish church and vicarage in Harlösa, in the centre of the village, in a position where it definitely would be noticed. It was a rather unusual quadrangular single-storey brick building, thirteen by thirteen metres in size, with four apartments centred around a central fireplace (Figure 8.2). The ground plan of the building was approximately 169 square metres, giving each of the eight intended inmates a living space of approximately 21 square metres, which was spacious compared to most other poorhouses. Each flat originally had a separate entrance and consisted of an entrance room, a living room and a smaller chamber. Each flat was designed for two people. There was a small fireplace for cooking, which was connected to the central fireplace, which contained a communal oven. From the beginning, the poorhouse had a small kitchen garden where the inmates could grow vegetables. The poorhouse had no staff (Westerlund 1987).

The square ground plan gave the building an unusually steep and large roof, which distinguished it from other buildings in the area. The building's function is also revealed by a stone plaque on the north side of the building (facing the church), which states that it was built as a poorhouse by the lord of the manor in 1823 and 1824. As such, it not only served the poor of the estate but was also a material reminder of the local lordship.

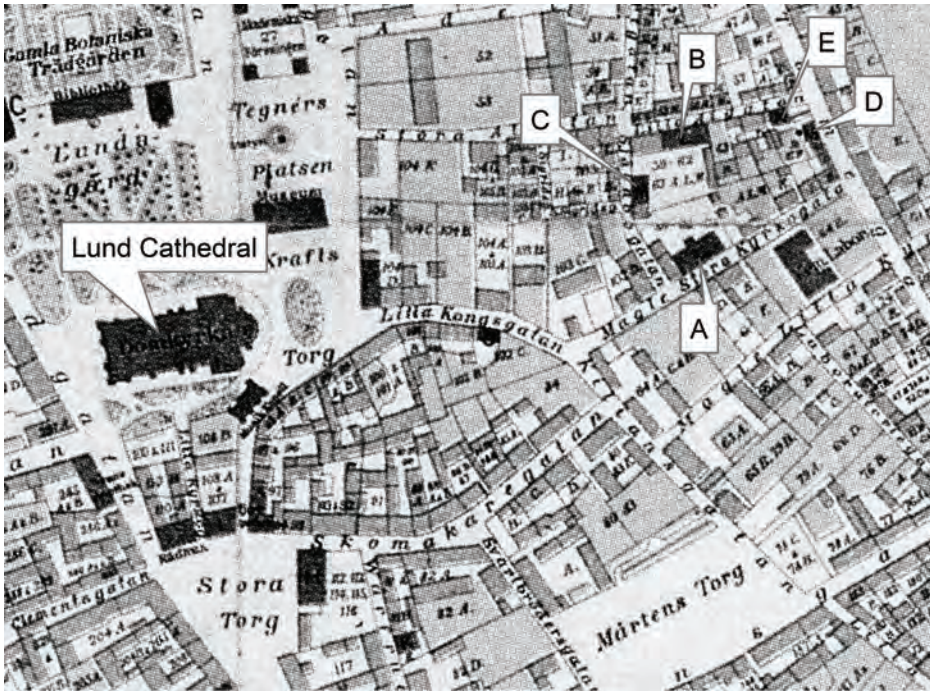
Figure 8.3 In nineteenth-century Lund, poorhouses and other social institutions were grouped together in one block in the eastern part of the town. A. Combined work/poorhouse/school/bath. B. Work/poorhouse. C. City council poorhouse. D. University poorhouse. E. Torslow Foundation poorhouse. Extract from F. V. E. Palmcrantz' map of Lund printed 1878, adapted by Martin Hansson.

In Lund in the nineteenth century, several public social institutions were thus concentrated in the same city block. The number of buildings with social functions

gradually increased as existing buildings along the streets were given new functions or new buildings were erected. The concentration of social institutions also led to the recruitment of staff to work in the new poorhouse in 1860. The school, workhouse and poorhouse, built in 1835 and 1860 respectively, were large two-storey brick buildings that differed from ordinary townhouses in size, with a long façade along the street. Although not in the central part of the city, they were located within the medieval city limits (Persson 1967; Lund Stads Bevarandeprogram, Kv Sjölabodar, Krafts Rote).
